## RESIDENTIAL REPORT

1234 Main St.  
Star ID 83669

04/21/2019 9:00AM

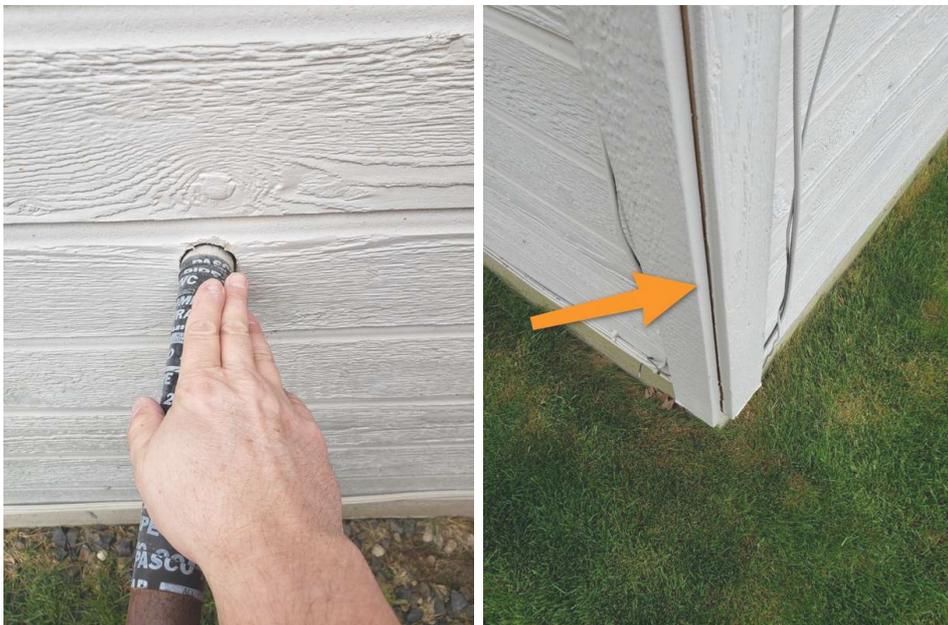
Recommend applying silicone, or properly patching all exterior gaps noted; around pipe entrances into the interior of the home, etc.. Perform work to prevent against possible water intrusion into/onto the interior walls of the home.

Contact a handyman or DIY project

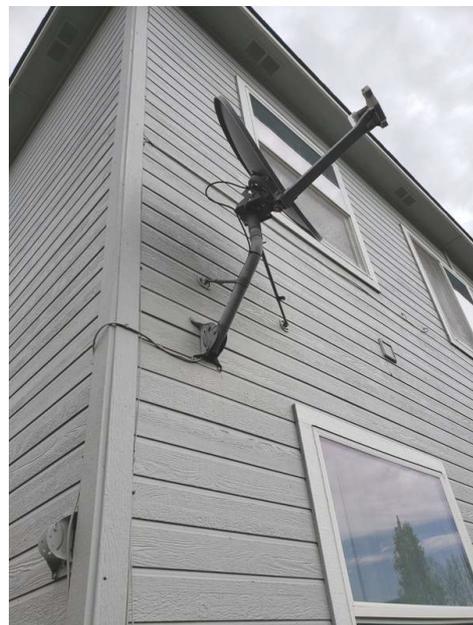
3.1.2 Siding, Flashing & Trim

**SATELLITE DISH INSTALLATION TO EXTERIOR WALL**

A satellite dish appears to be mounted directly to the exterior wall the noted location. Ensure all fasteners are properly sealed to prevent against any potential water intrusion due to the condition.

Recommend relocation.

Contact a handyman or DIY project

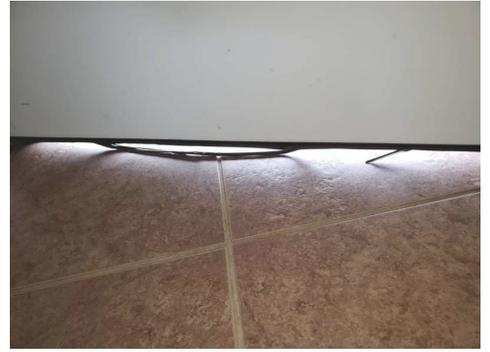
3.2.1 Exterior Doors

**WEATHERSTRIPPING - UPGRADEABLE**

The weather stripping present to the noted exterior doors appear upgradeable/serviceable. Correct as needed to ensure against increased heating and cooling costs to the home.

Replace door sweep.

Contact a handyman or DIY project

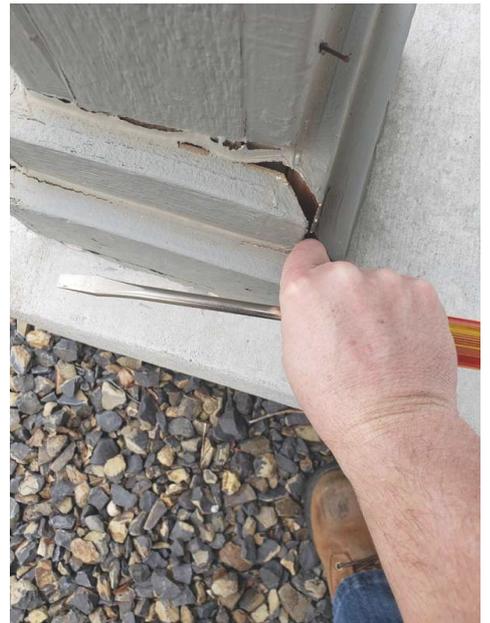
#### **COLUMN - DAMAGE**

Some damage appears present to the noted column. Repair as needed to correct.

some of the base trim appears to have come loose. Potentially from moisture swelling of the materials. Evaluate and correct as needed.

Contact a handyman or DIY project

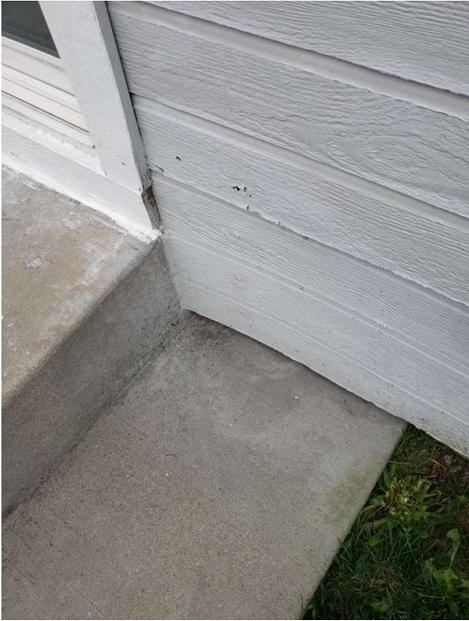
### 3.7.1 Wood Composition

#### **DAMAGE**

Some damage/rot appears present to the noted cladding at the noted location of the home. Recommend further evaluations and proper repairs be performed as needed to correct.

Contact a qualified siding specialist.

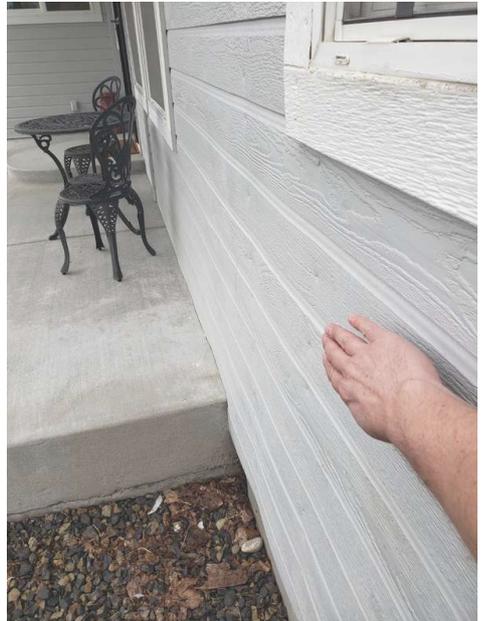
3.7.2 Wood Composition

Wood composition siding was warping or buckling in areas. This is often as a result of nailing siding boards too tight to the home, preventing expansion/contraction. Recommend a qualified siding contractor evaluate and repair.

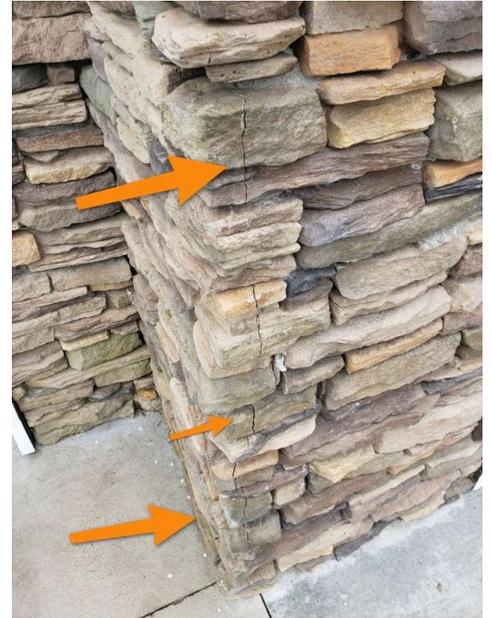
3.8.1 Brick Veneer

**DAMAGE**

Some damage appears present to the brick veneer at the noted location of the home. Recommend further evaluations and proper repairs be performed as needed to correct.

Cracking believed to be due to settlement. Correct to protect against moisture intrusion.

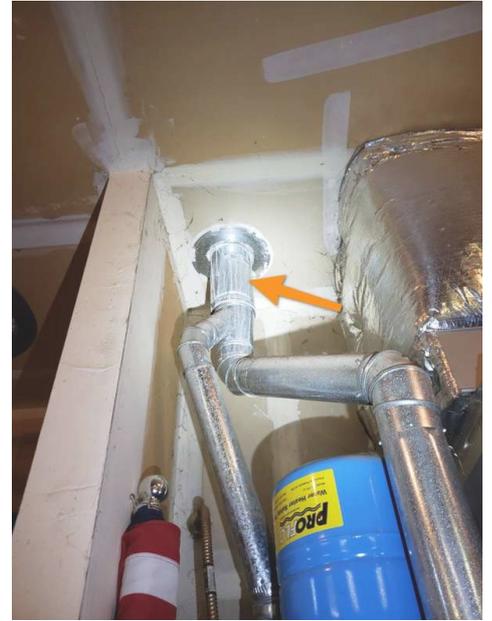
Streaking is noted to the chimney flue at the noted location of the home. This may be indicating water intrusion from the metal cap/chimney flue cap from the exterior of the home, or condensation build up over time. Recommend monitoring the condition during rain for any presence of water intrusion. If present, recommend further evaluations and proper repairs be performed by a qualified licensed contractor to correct and protect, as needed.

Recommend monitoring.

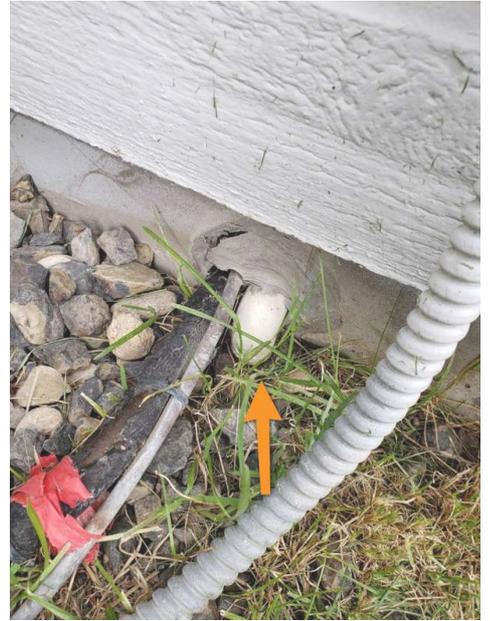
The condensation line set up for cooling, and/or high efficiency heating appears to be unnecessary as set-up, or in need of repairs. Recommend further evaluations and proper repairs be performed as needed to correct.

Its appear too close to the ground. This may result in clogging. It is believed that the secondary condensation line has been active due to stains present to the garage slab near the evaporator coil. Evaluate and correct as needed/possible.

Contact a qualified HVAC professional.

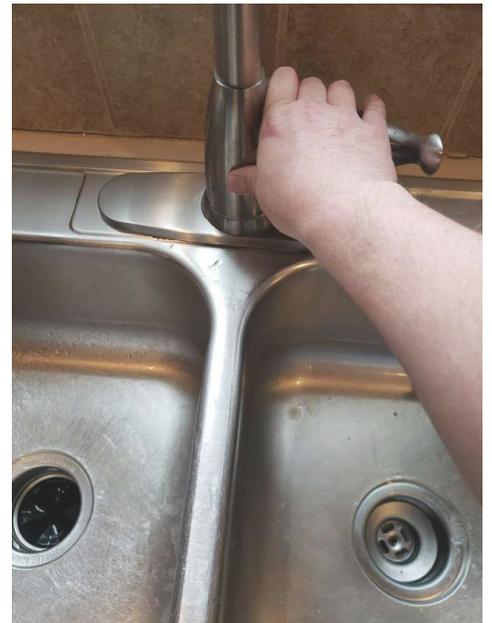
#### FAUCET - LOOSE

The faucet(s) handles at the noted location(s) appears to be loose. Recommend further evaluations and proper repairs be performed by a licensed qualified contractor, handyman, or DIY to correct as needed. Serviceable - loose.

Contact a handyman or DIY project

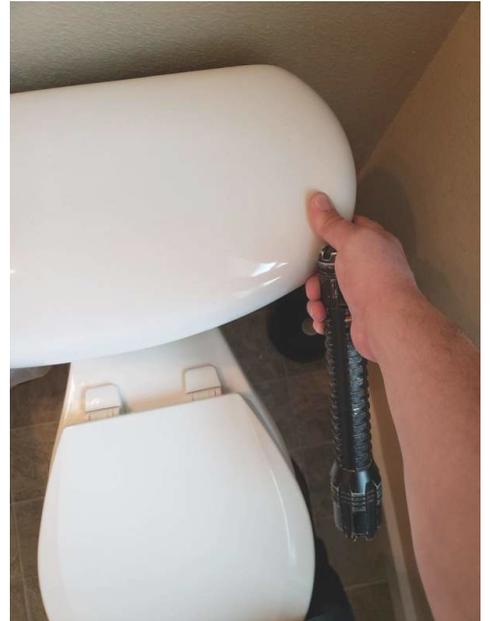
**TOILET - TANK LOOSE**

The toilet tank(s) at the noted location(s) of the home is loose to its base. Recommend properly re-tightening the tank(s) to its base to protect against excessive movement to the connective seal which can lead to its failure. Recommend work to be performed DIY, or by a qualified plumbing contractor to correct to prevent against the listed implications.

Contact a handyman or DIY project

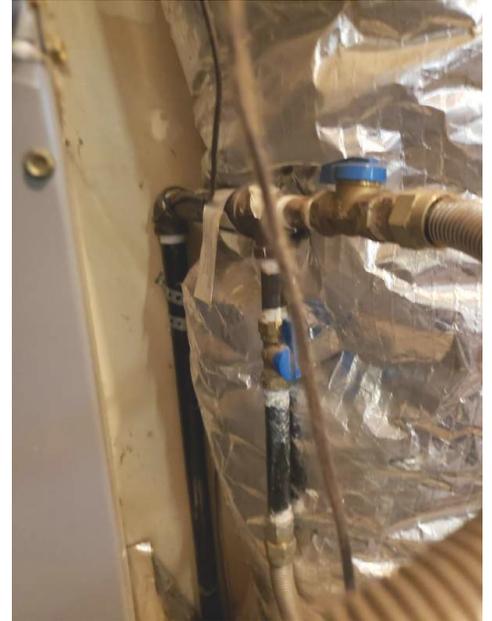
### DRIP LEG - MISSING

No dirt dump appears present to the gas supply piping (hot water heater, furnace, or both) at the noted locations of the home. Recommend the installation/upgrade of a dirt dump to prevent against the listed implications. Recommend work to be performed by a qualified licensed plumbing contractor ONLY for safety.

Contact a qualified HVAC professional.

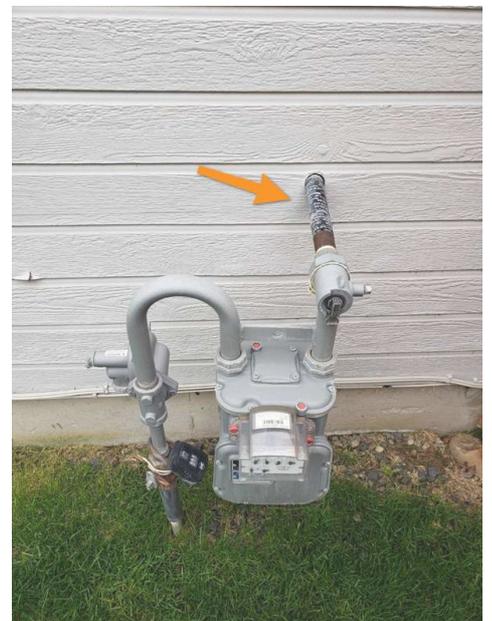
#### 7.5.2 Fuel Storage & Distribution Systems

The gas lines present to the home did not appear to be properly bonded to the electrical system (GEC) of the home. Recommend further evaluations and proper upgrades be performed as needed.

No visible bonding to the gas lines was noted to the home. This was not a requirement when the home was initial built. Any upgrades are to be performed at the buyers discretion.

Contact a qualified electrical contractor.

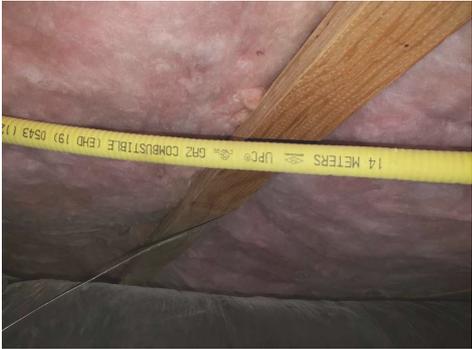
7.5.3 Fuel Storage & Distribution Systems

TracPipe, Gastite, or Wardflex branded CSST gas distribution product is present within the home. A class action lawsuit (issued only in Maryland, and claims have since past their deadline) has been issued over the products inability to properly test its resistance to lightning strikes. The thin wall design of these can be susceptible to perforation by an electrical arc generated by a lightning strike. This is for the buyers information only, and its being provided to the client as a notification of class action lawsuit only. As a pre-cautionary, the buyer may wish to advise with a qualified licensed plumbing contractor on the presence of this gas distribution material. If so, it is recommended to be performed before the end of the contingency period.

The gas lines present to the home could not be verified to be bonded at the meter.

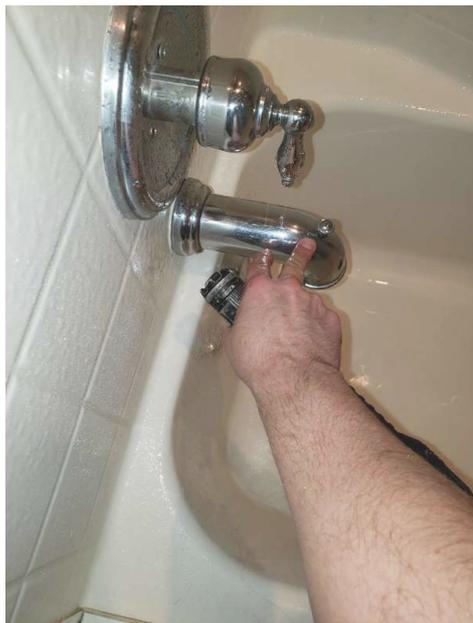
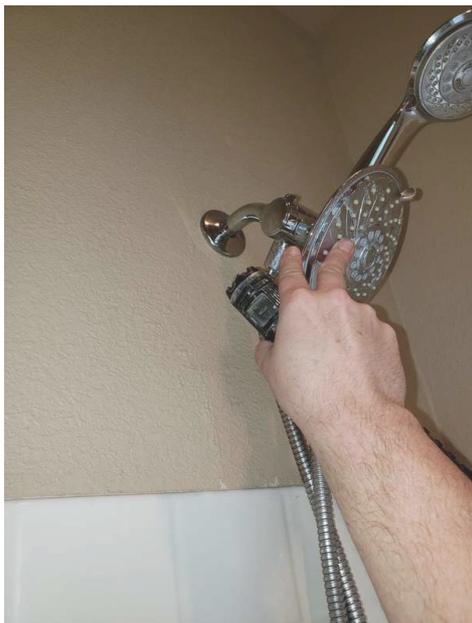
**SHOWER RISER - LOOSE**

The supply piping for the shower shower riser appears to be noticeably loose. Recommend further evaluations and proper repairs be performed by a qualified plumbing contractor, handyman or DIY to correct as needed. Movement in the riser could eventually arise stress leaks at fittings.

Contact a qualified handyman.

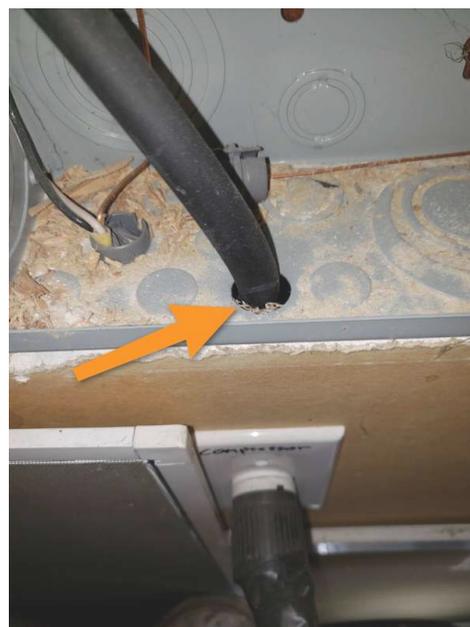
**MISSING BUSHINGS, CLAMPS, GROMMETS - CONCENTRIC KNOCKOUT**

Conductors passed through knock-outs in the noted panel that had no protective device installed. Connectors designed to protect conductors where they pass through sheet metal include bushings, cable clamps, grommet, or other connectors. Without some protective device, the sharp edges of sheet metal may damage the conductors. This condition is a potential a shock/electrocution or fire hazard. The Inspector recommends that protective devices approved for this purpose be installed by a qualified electrical contractor.

Contact a qualified electrical contractor.

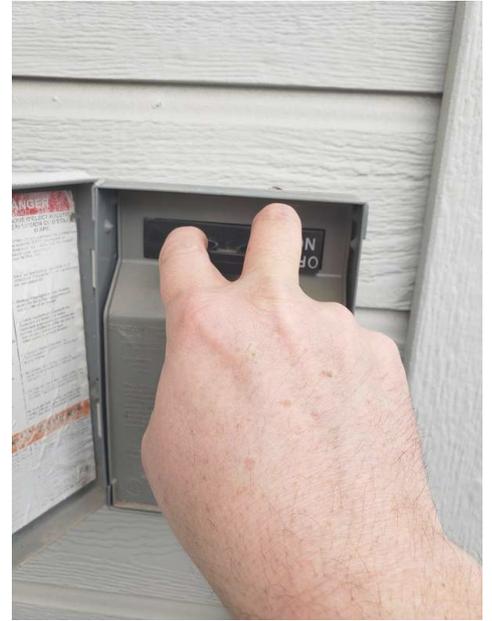
8.2.2 Main & Subpanels, Service & Grounding, Main Overcurrent Device

The disconnect box, at the noted location of the home, possessed a disconnect that could not be easily removed. It was not removed or inspected at the initial time of the inspection as to ensure against damage to the disconnect. Further evaluate and correct the condition to ensure proper functionality.

Contact a handyman or DIY project

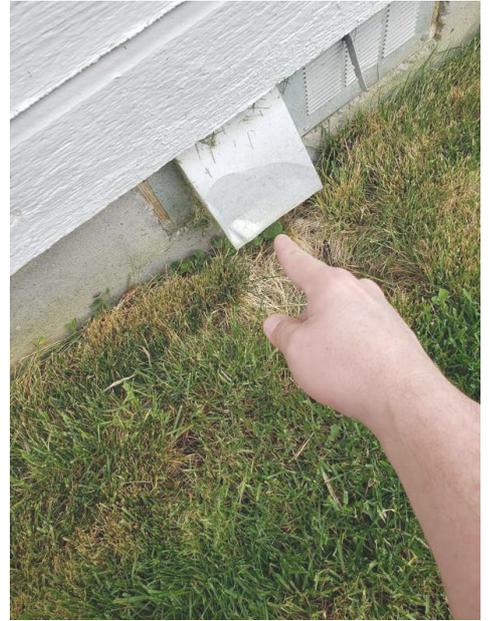
9.4.1 Exhaust Systems

### DRYER VENT - NO FLAP

Contact a qualified professional.

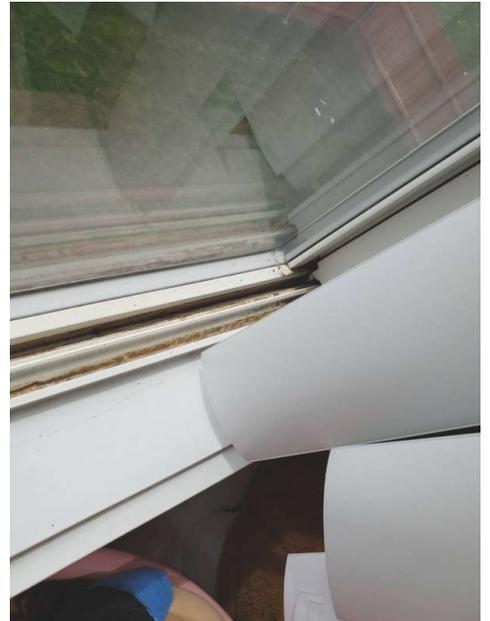
Track appear stained. monitor for moisture during rain. Weep holes may need to be cleaned to prevent against water build-up in the track.

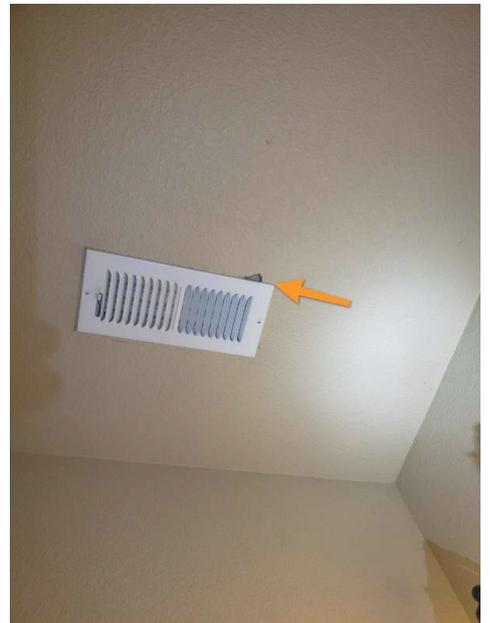
Seal gaps to prevent against unwanted air entrance from the interior into the attic.
