## HOME INSPECTION REPORT

1234 Main St.  
Bastrop TX 78602

# PROPERTY INSPECTION REPORT

**Concerning:** 1234 Main St. Bastrop TX 78602  
(Address or Other Identification of Inspected Property)

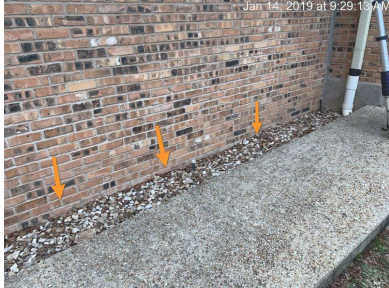
**Deficient:** Soil elevations are too high on right side of garage . Industry standards call for a minimum of 4-6' inches of the foundation be visible on all elevations.

Should be 4-6' inches of foundation visible.

Recommendation: Contact a qualified landscaping contractor

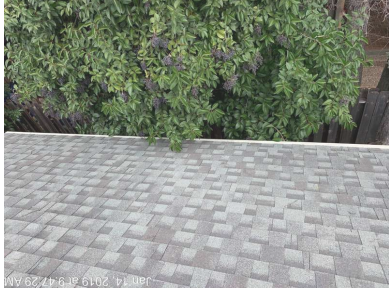
**Deficient:** All tree limbs should be cut back away from roof covering a minimum of three feet to prevent damage from occurring during storm events.

Cut tree limbs back a minimum of three feet from roof covering.

Recommendation: Contact a qualified tree service company.

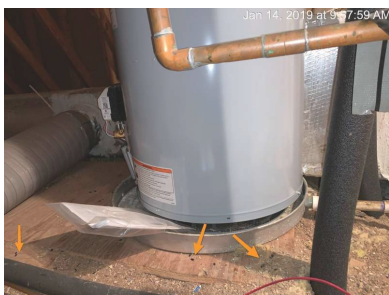
**Observation:** Possible rodent activity was observed in attic space. have a pest professional further evaluate and provide recommendations.

Evidence of rodent activity.

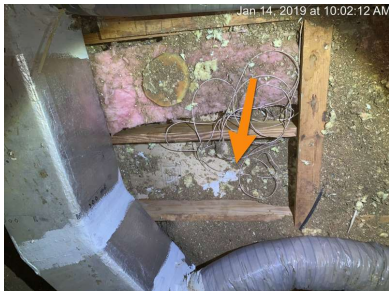
**Deficient:** Attic insulation is missing in several locations. Have a insulation specialist provide needed repairs.

Missing attic insulation.

Recommendation: Contact a qualified insulation contractor.

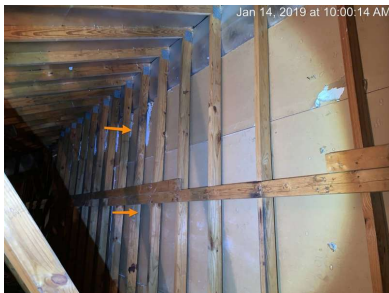
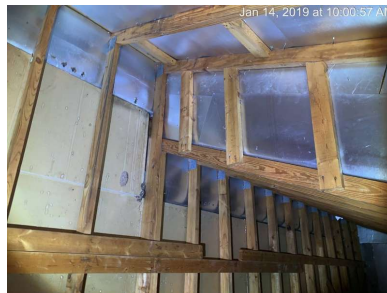
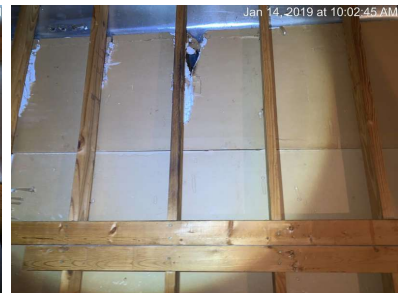
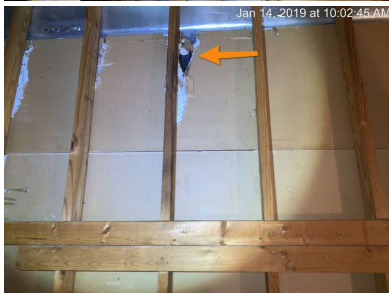
**Deficient:** Party wall in between units in attic space is required to be sealed to prevent fire from easily moving from one unit to the next. Pipe penetrations and incomplete sheet-rock was observed. Have a drywall specialist perform needed repairs.

Opening in draft stop

Recommendation: Contact a qualified drywall contractor.

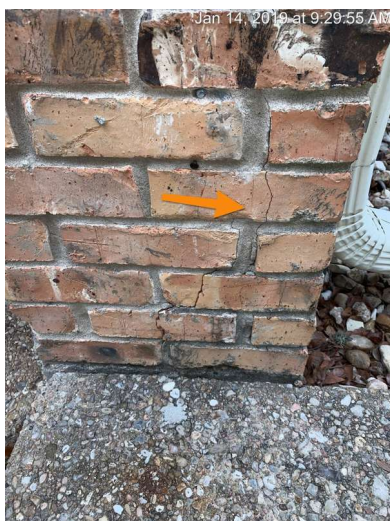
**Minor cracking was observed in wall structure.** This is common in homes this age. Recommend monitoring.

Minor cracking in brick veneer. Recommend monitoring to determine if any additional movement is occurring.

Recommendation: Recommended DIY Project

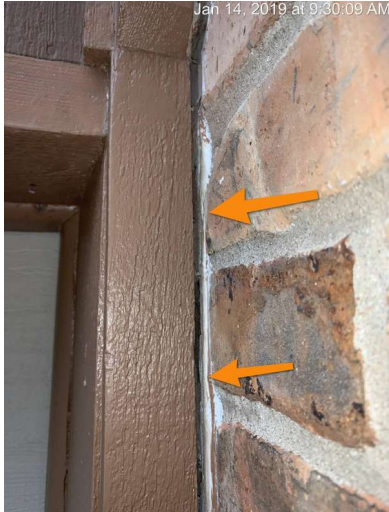
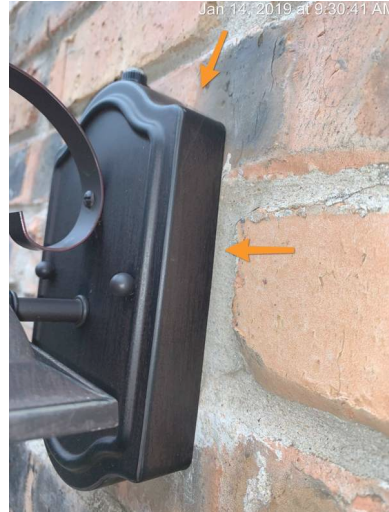
**Deficient: Seal all dissimilar materials such as wood to brick** and light fixtures to brick to prevent water penetration.

Seal to prevent water intrusion.

Recommend using urethane based sealant such as NP-1. here is a link:

Recommendation: Contact a qualified painter.

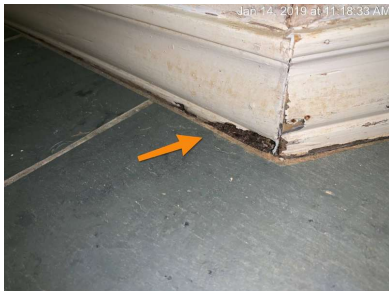
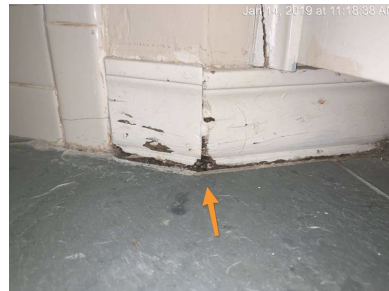
**Deficient:** Rotted wood was observed at the base board in the hallway bathroom. Have a carpentry specialist perform needed repairs.

Rotted wood.

Recommendation: Contact a qualified carpenter.

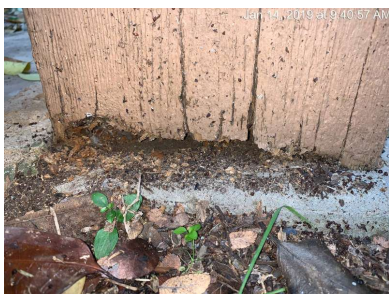
**Deficient:** First support beam for patio is showing evidence of rot and deterioration. Recommend installing post base to prevent additional damage. Have a carpentry specialist inspect all support beams and perform needed repairs.

Recommendation: Contact a qualified carpenter.

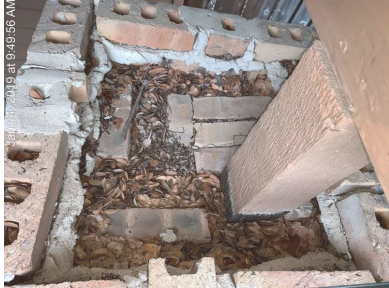
**Deficient:** Brick column at front entry does not have a cap on the top to prevent moisture entry. Have a carpentry provide needed repairs.

No cap for brick column.

Recommendation: Contact a qualified carpenter.

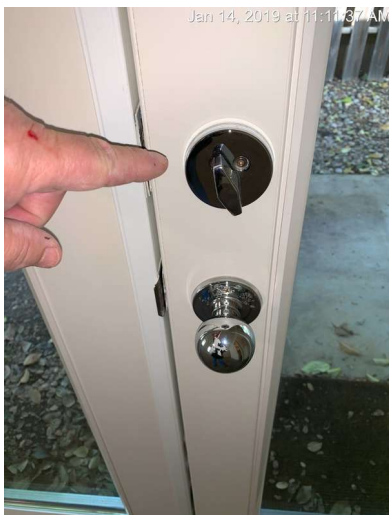
**Deficient:** Deadbolt on exterior double door is not performing and will need to be replaced. have a handyman perform needed repairs.

Recommendation: Contact a qualified handyman.

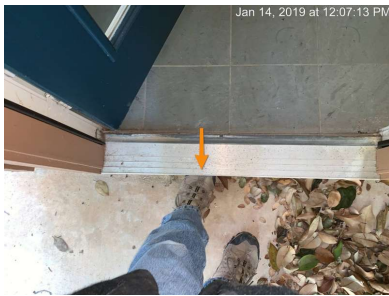
**Deficient:** **Overhang on back entry door is a trip hazard .** Have builder provide needed repairs.

Threshold overhang is a trip hazard.

Recommendation: Contact your builder.

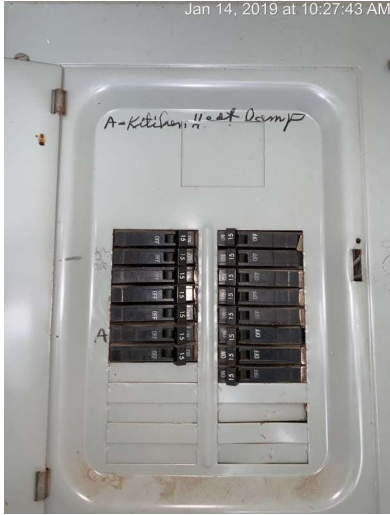
**Deficient:** Sub-panel circuits are not labeled as required. All circuits are required to be properly labeled indicating what area the circuit is servicing. Recommend having a licensed electrician perform needed repairs.

Recommendation: Contact a qualified electrical contractor.

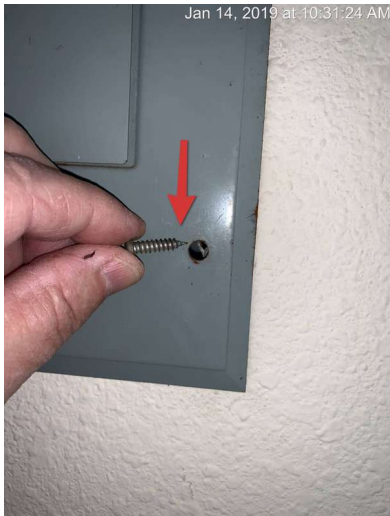
**Deficient:** Sub-panel front has been installed with sharp pointed screws. This is prohibited, sharp screws could pierce a wire and cause a shock and possible fire. Have an electrical specialist perform needed repairs.

Sharp screws used to install panel cover.

Recommendation: Contact a qualified electrical contractor.

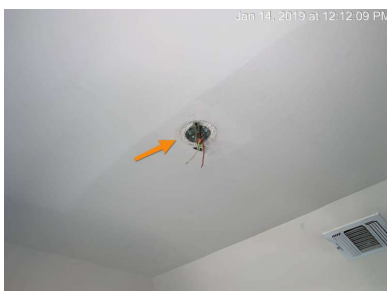
Fixture missing leaving exposed wiring.

Recommendation: Contact a qualified electrical contractor.

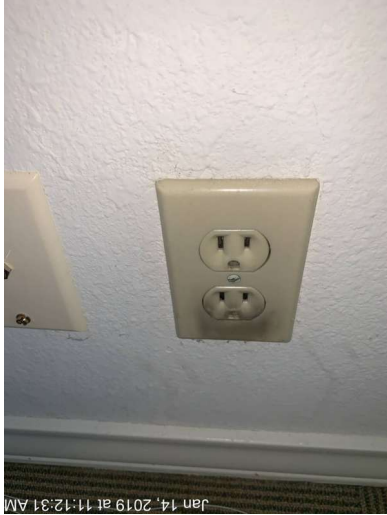
Overheated Receptacle.

Recommendation: Contact a qualified electrical contractor.

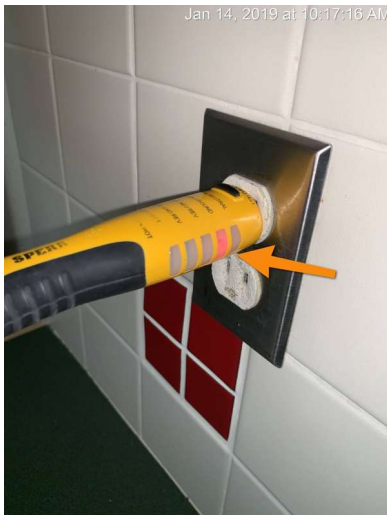
Receptacle showing "open ground"

Recommendation: Contact a qualified electrical contractor.

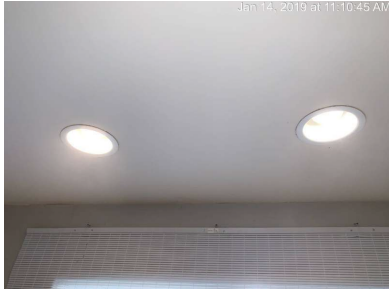
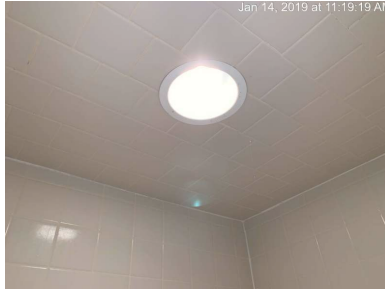
Recess lighting not rated for use in a wet location.

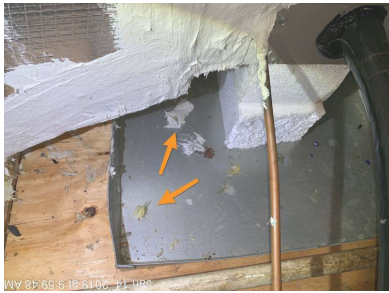
Debris in condensate pan should be cleaned.

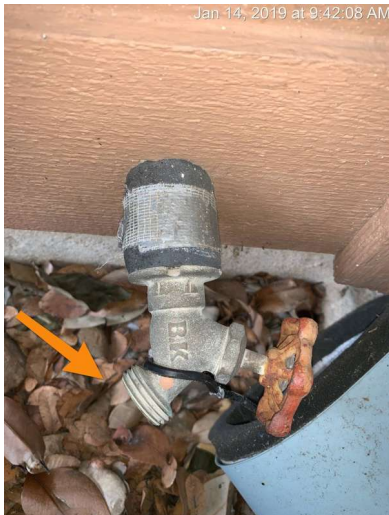
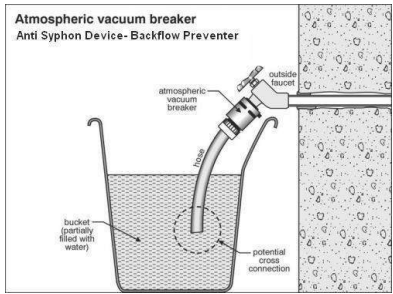
No anti-siphon device in place as required.

Recommendation: Contact a qualified handyman.

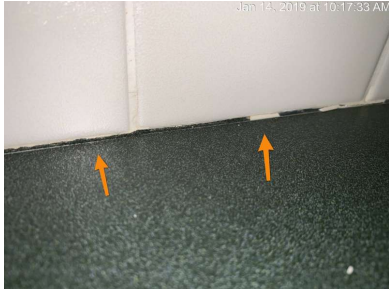
Seal kitchen back splash to prevent moisture intrusion.

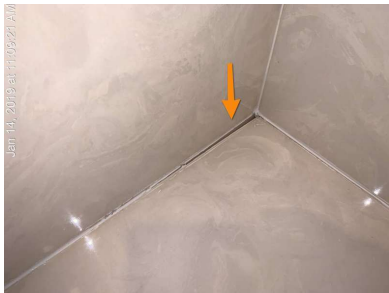
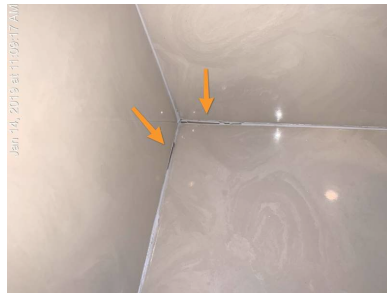
Seal master bathroom bench.

Recommendation: Contact a qualified handyman.

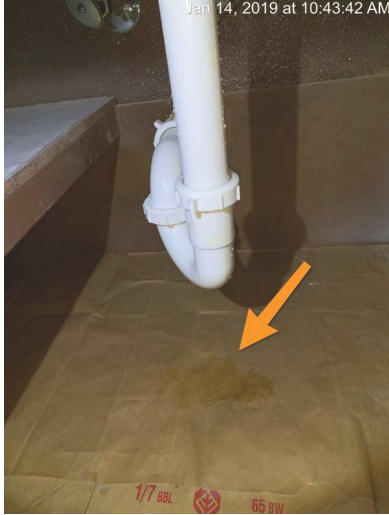
Bar sink leaking.

Recommendation: Contact a qualified plumbing contractor.

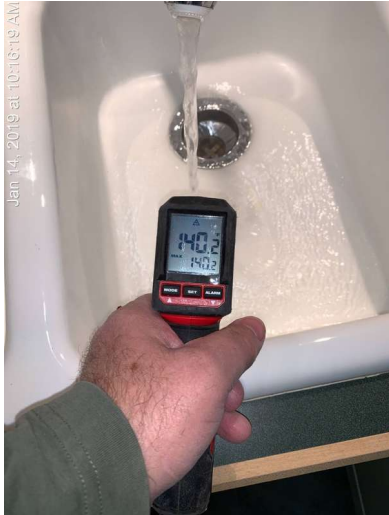
**Note:** Water temperature at kitchen sink was 140 degrees, recommend setting water temp to no more than 125 degrees.

Water temp 140 at kitchen sink.

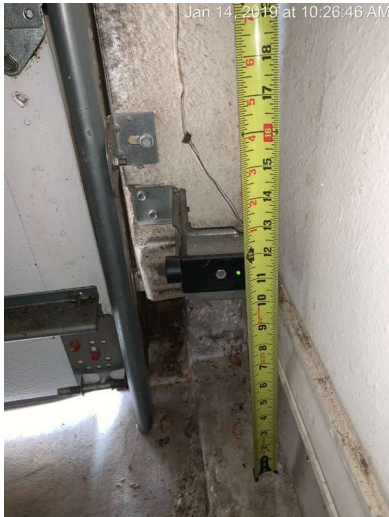
Garage door sensors are installed higher than six inches.

Recommendation: Contact a qualified garage door contractor.

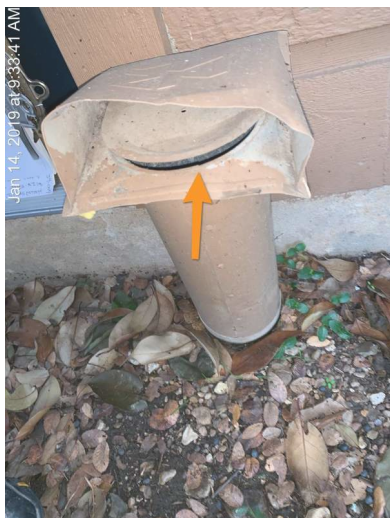
Flapper on dryer vent not closing.  
Recommend replacement.

Recommendation: Contact a qualified handyman.
