PGR HOME INSPECTIONS

RESIDENTIAL HOME INSPECTION REPORT

1234 Main St.
Charleston SC 29414

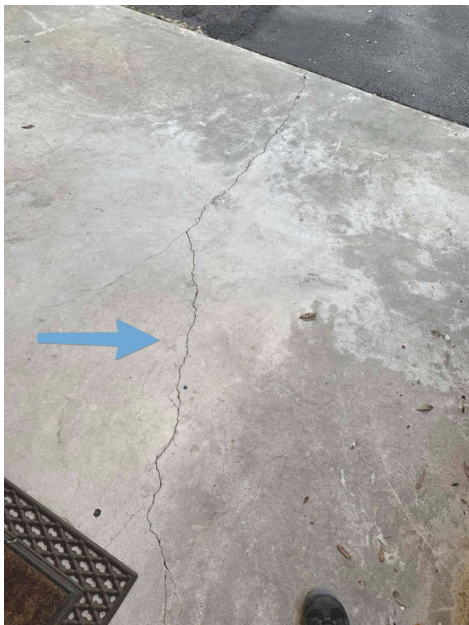
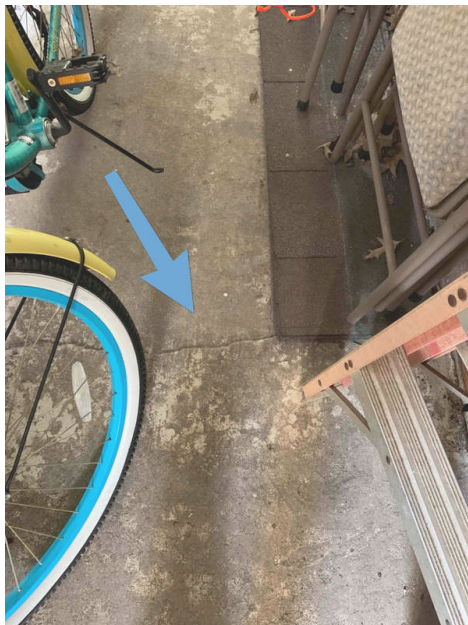
DRIVEWAY, SIDEWALK, PATIO CRACKING

One or more cracks observed, which may indicate movement in the soil (settlement) or expansion/ contraction of the material. Recommend monitoring and/or have concrete contractor patch and seal.

Contact a qualified concrete contractor.

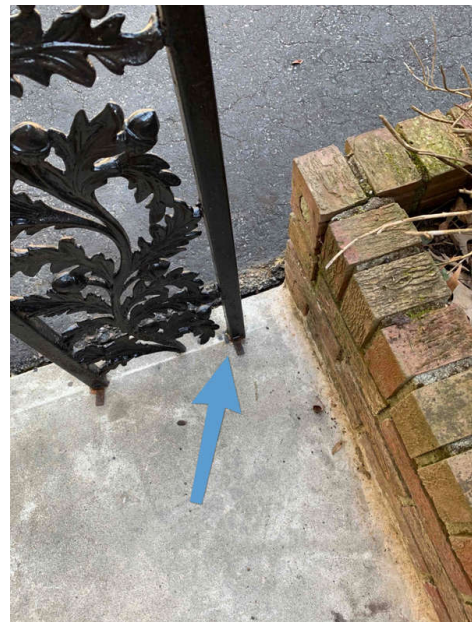
2.1.2 Driveway, Sidewalk, Patio

SUPPORT LOOSE AT BOTTOM

Front porch decorative support post is loose at the bottom and unattached from its bracket. Recommend a qualified professional reattached properly.

Contact a qualified professional.

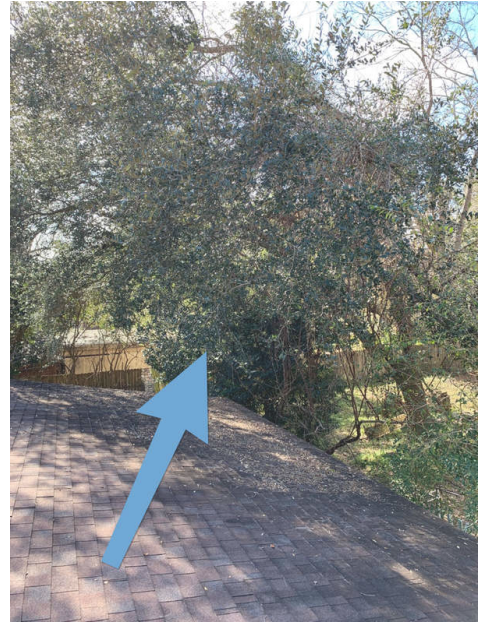
Trees observed overhanging the roof. This can cause damage to the roof and prevent proper drainage. Recommend a qualified tree service trim to allow for proper drainage.

Contact a qualified tree service company.

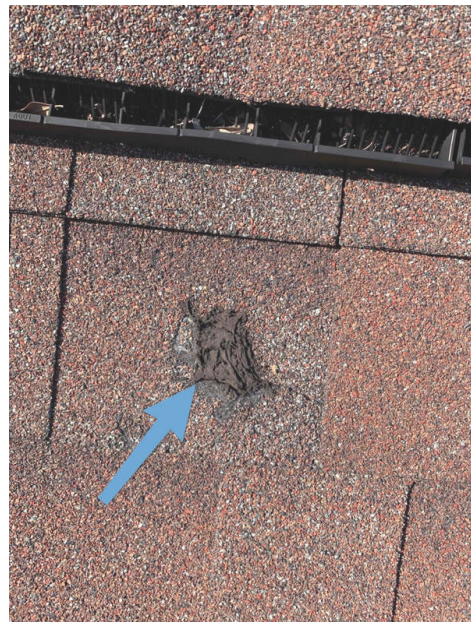
Back side of roof

Damaged shingle was previous repaired with sealant. Recommend monitoring for potential future issues as the sealant deteriorated from UV exposure.

Recommendation
Recommend monitoring.

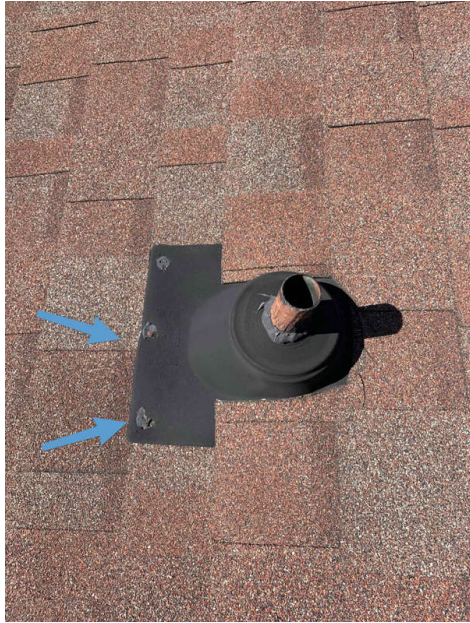
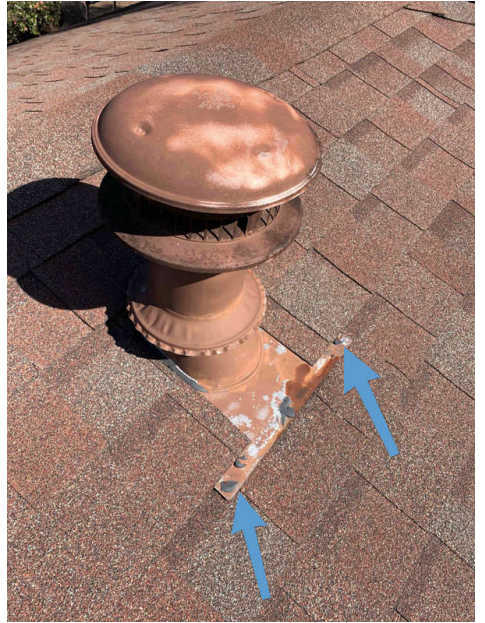
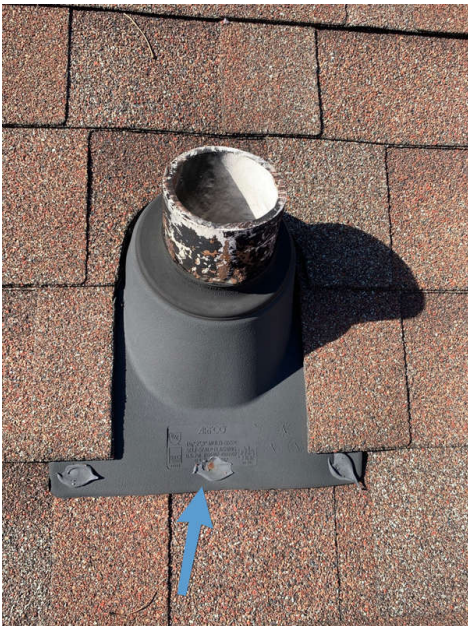
Possible water intrusion point where nail heads are exposed. Recommend sealing properly to prevent possible water intrusion and evaluate the other visible sealant and repair as needed.

Recommendation
Contact a qualified professional.

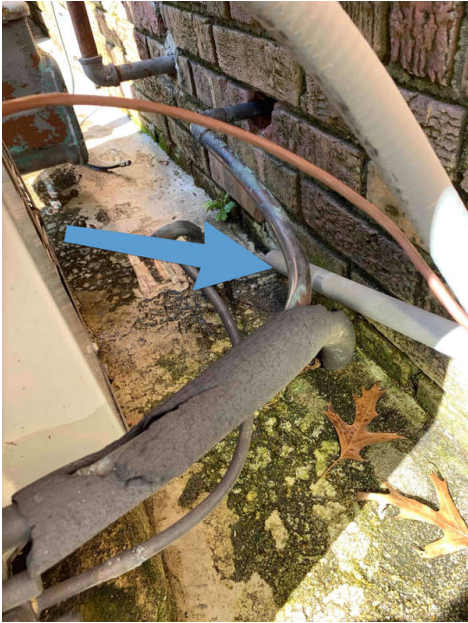
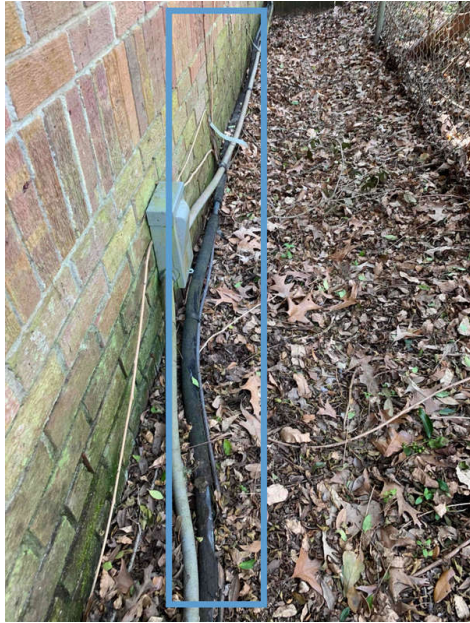
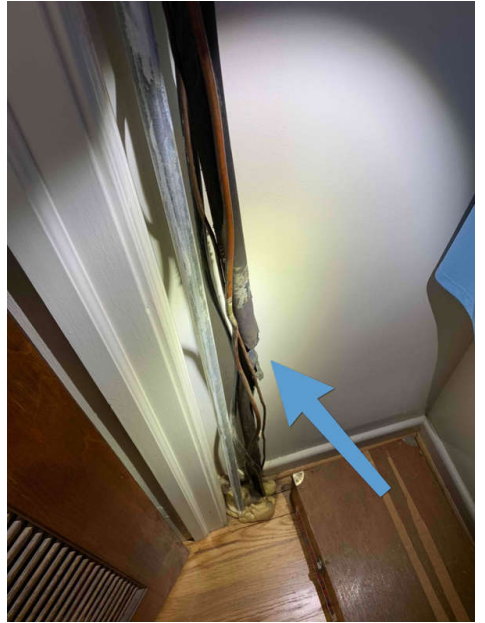
9.2.3 Cooling Equipment

INSULATION DETERIORATING/ MISSING

Contact a qualified HVAC professional.

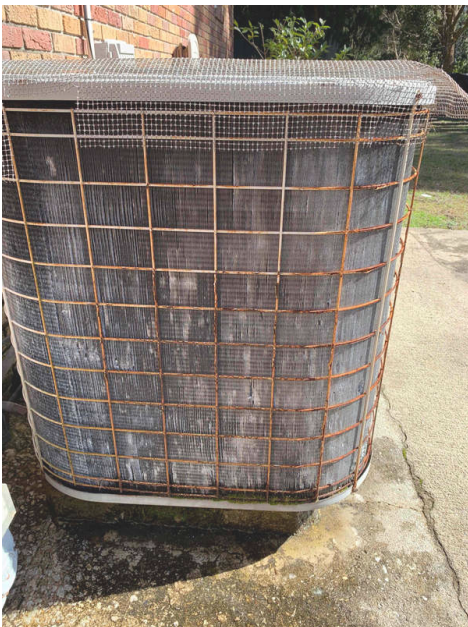
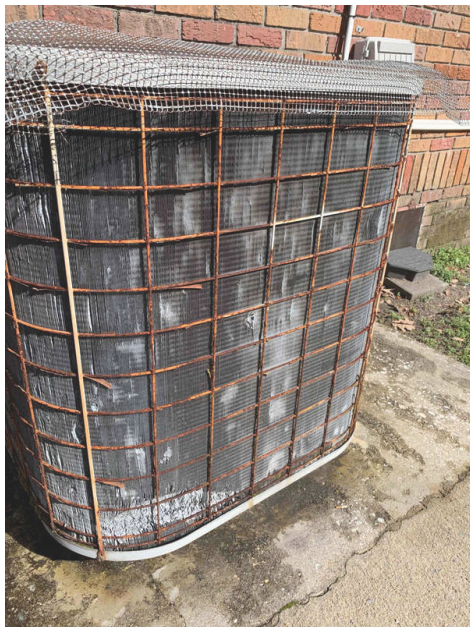
9.2.4 Cooling Equipment

FINS DAMAGED

Contact a qualified HVAC professional.

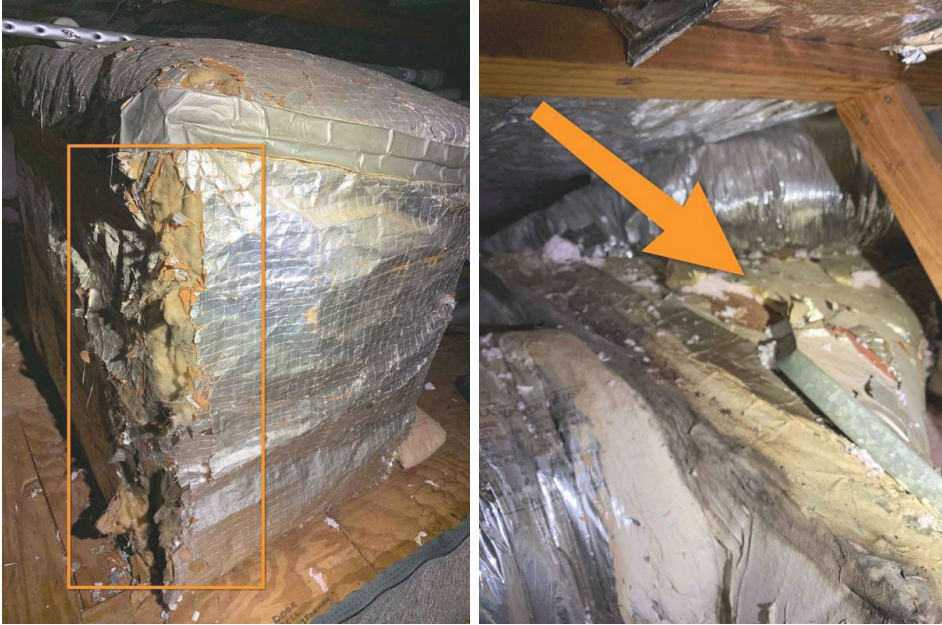
9.2.5 Cooling Equipment

LOW TEMPERATURE DIFFERENTIAL

Contact a qualified HVAC professional.

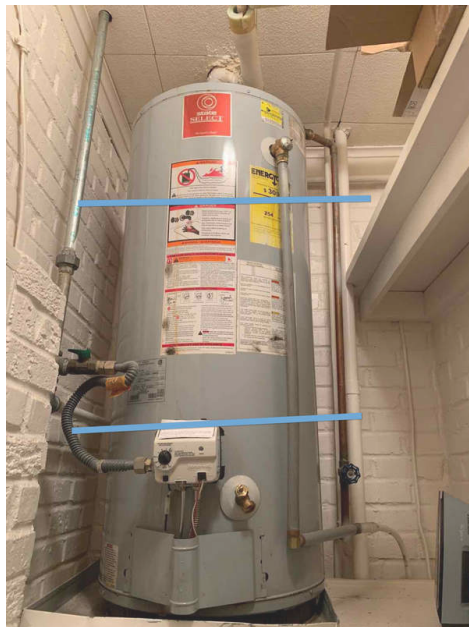
10.3.3 Water Heater

SEISMIC STRAPS MISSING

Contact a qualified professional.

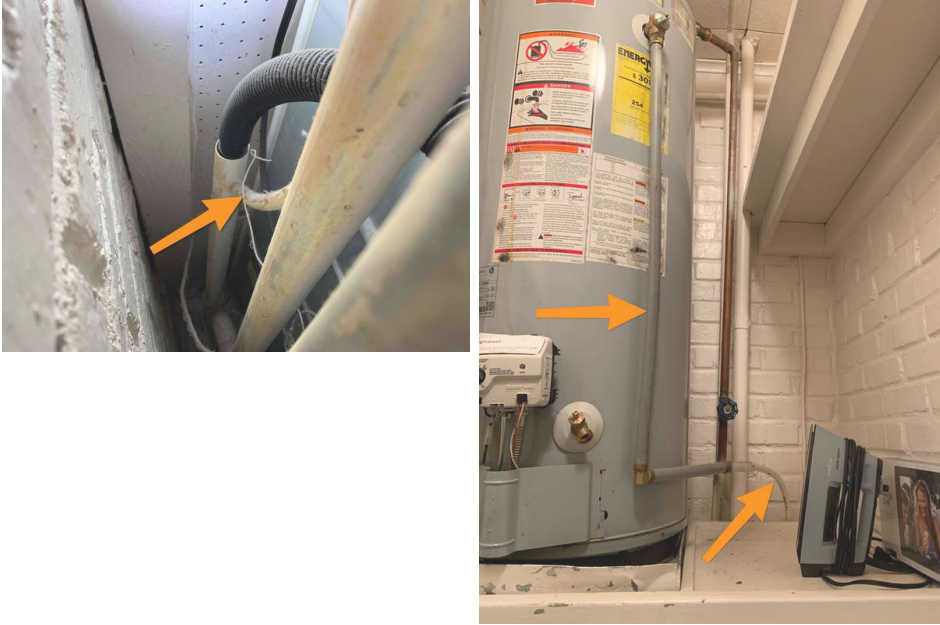
10.3.4 Water Heater

IMPROPER TPRV DISCHARGE PIPE SETUP

Contact a qualified plumbing contractor.

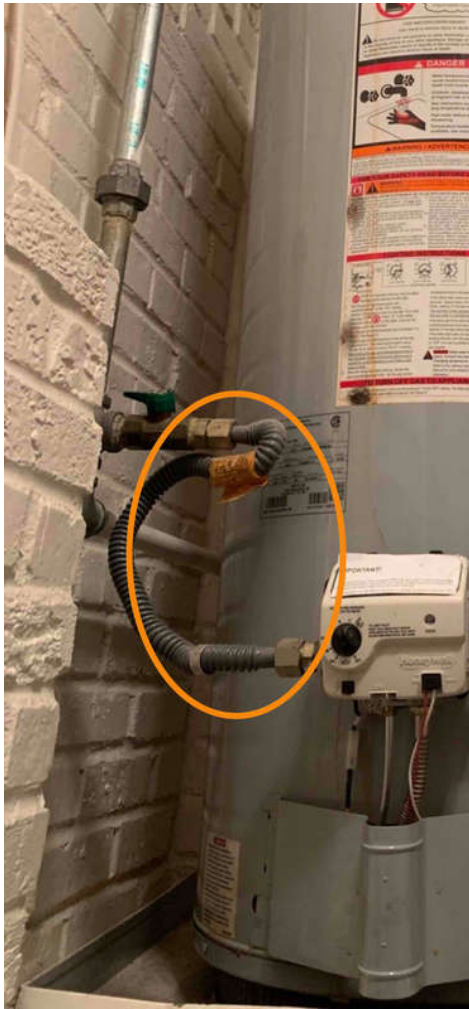
10.4.1 Fuel Shut Off

NO SEDIMENT TRAP

Contact a qualified plumbing contractor.

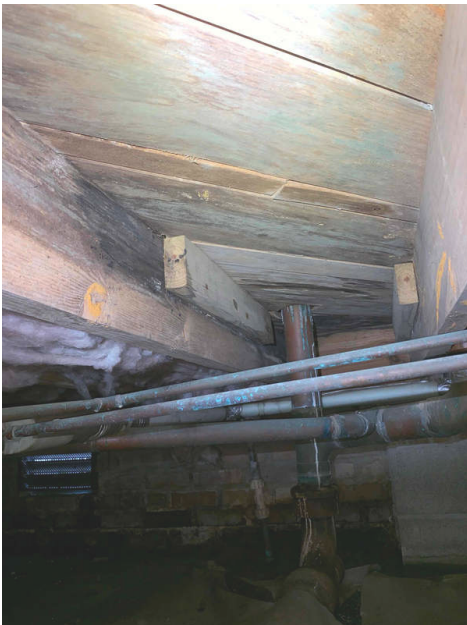
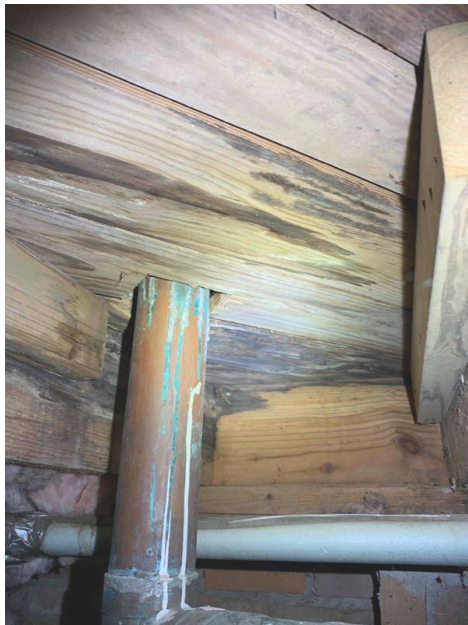
12.3.1 Floor Structure

MOISTURE INTRUSION/ WOOD ROT

Contact a qualified general contractor.
