RESIDENTIAL INSPECTION

1234 Main St. Virginia Beach VIRGINIA 23453

Buyer Name 01/07/2019 9:00AM

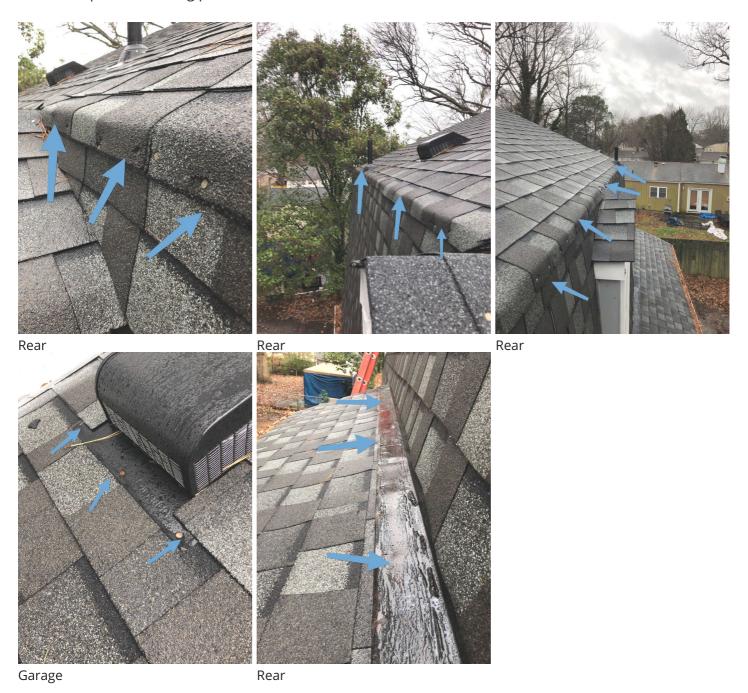
2.1.1 General

DETERIORATED ROOFING CEMENT

One or more area of the roof has roofing cement that is beginning to deteriorate. The roofing cement should be properly repaired to help prevent future leaks due to deterioration.

Contact a qualified roofing professional.

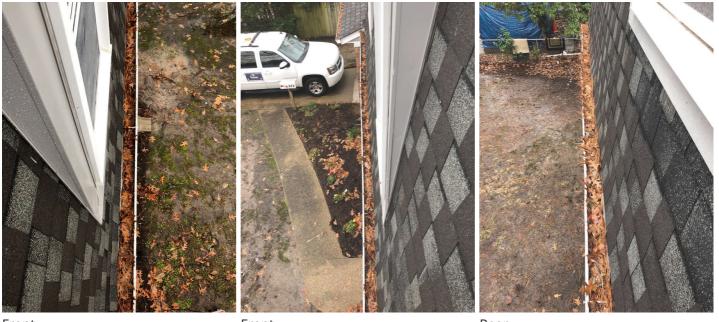
Front Front Rear

CLOGGED GUTTERS/DOWNSPOUTS

and downspouts now and as necessary in the future.

Significant amounts of debris have accumulated in one or more gutters or downspouts. Gutters can overflow and cause water to come in contact with the building exterior, or water can accumulate around the foundation. This is a conducive condition for wood-destroying organisms. Recommend cleaning gutters

Recommended DIY Project

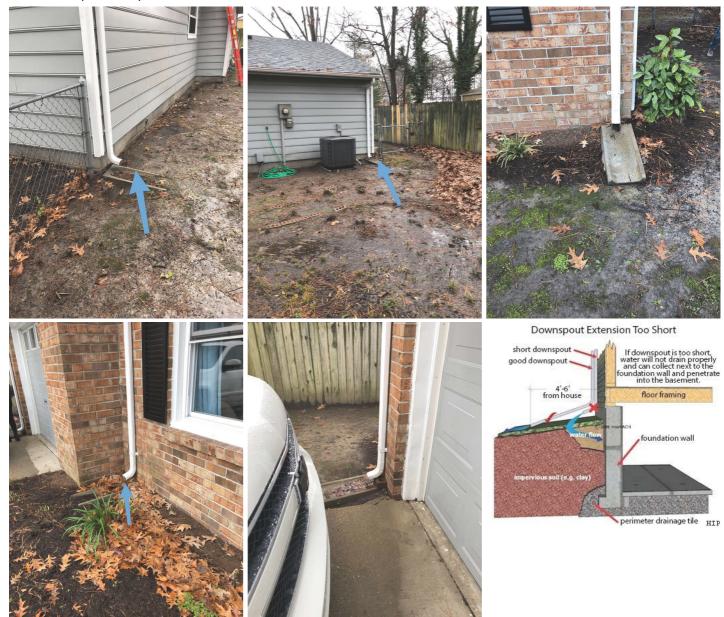
3.7.1 Gutters and Flashing

DOWNSPOUT EXTENSIONS

Extensions such as splash blocks or drain pipes for one or more downspouts were *missing / poorly sloped / misaligned / clogged / substandard / damaged*. Water can accumulate around the building foundation or inside crawl spaces or basements as a result. Recommend that a qualified person install, replace or repair extensions as necessary so rainwater drains away from the structure.

Contact a qualified professional.

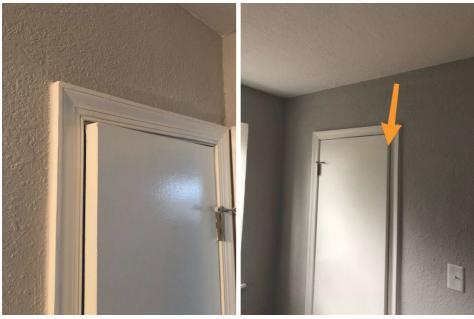
2nd floor Hall

DOOR-BINDS IN JAMB

One or more doors bind in their jamb and cannot be closed and latched, or are difficult to open and close. A qualified contractor should evaluate and repair as necessary. For example, adjusting jambs or trimming doors

Contact a qualified door repair/installation contractor.

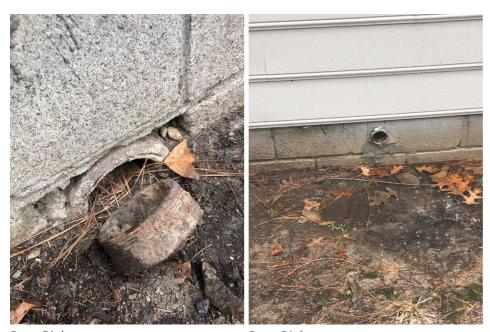
Rear Right Rear Right

WASTE CAP MISSING

One or more waste pipe cleanouts have no cap installed. This is a safety hazard because sewer gases may vent into the structure. A qualified plumber should install a caps where missing.

Contact a qualified plumbing contractor.
