RESIDENTIAL REPORT

1234 Main St.
Edmonton AB T5T3E9

02/12/2018 9:00AM

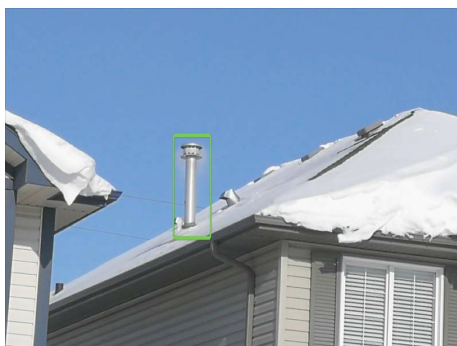
Skylights, Chimneys & Other Roof Penetrations: For Your Information

West
Appears serviceable

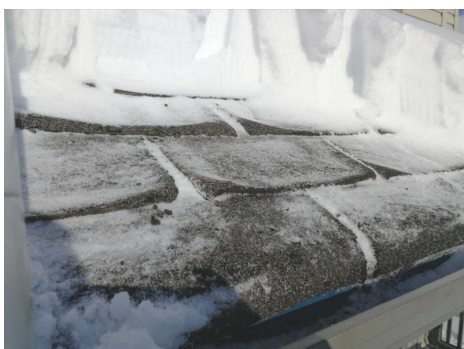
Coverings: Roof shingles lifespan

Observed functional at the time of inspection although according to manufacturer recommendation roof shingles remaining life is about 10 years. Recommending evaluation when weather permits by professional roofer.

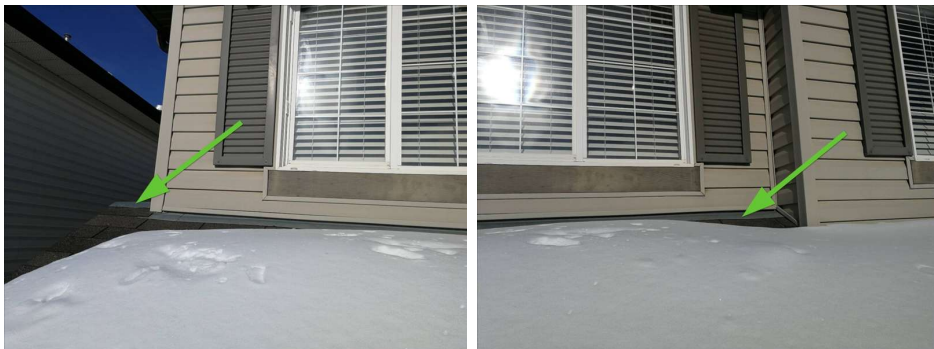
Flashings: Material

Functional at the time of inspection.

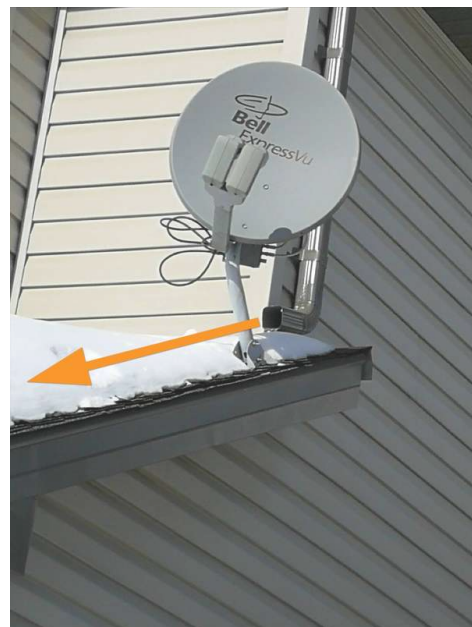
2.1.1 Coverings

SIGNS OF POPPING

Observed signs of popping shingles where water discharge on lower roof, recommend downspouts extension to void further damage, also recommend professional roofer for evaluation, when weather per

Contact a qualified roofing professional.

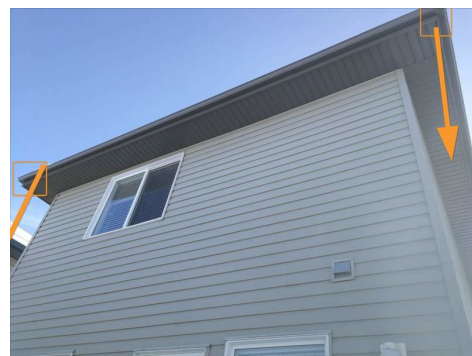
2.2.1 Roof Drainage Systems

DOWNSPOUTS MISSING

The home was missing downspouts in one or more areas. This can result in excessive moisture around the exterior, which can lead to significant damage. Recommend a qualified contractor install two downspout extensions that drain at least 6 feet from the foundation.

Contact a qualified roofing professional.

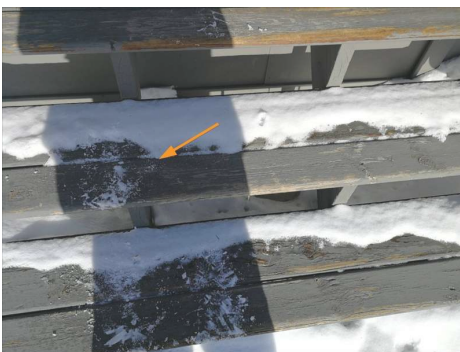
Walkways, Patios & Driveways: Patio South

One or more steps of the exterior stairs are deteriorated. Recommend qualified concrete contractor evaluate & repair.

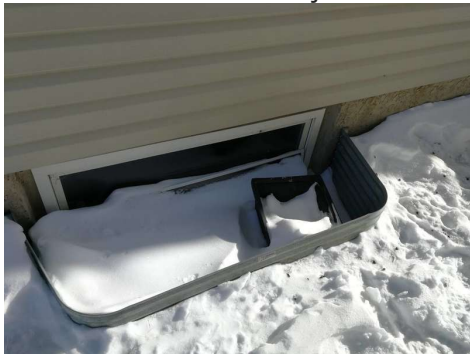
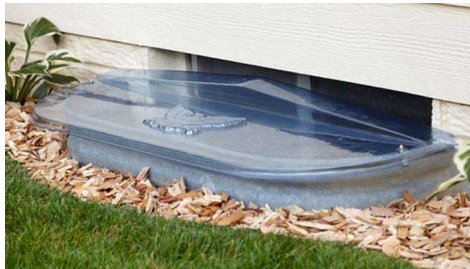
3.2.1 Exterior Doors

EGRESS WINDOW

Recommend window well covering to avoid excessive moisture accumulating near the foundation.

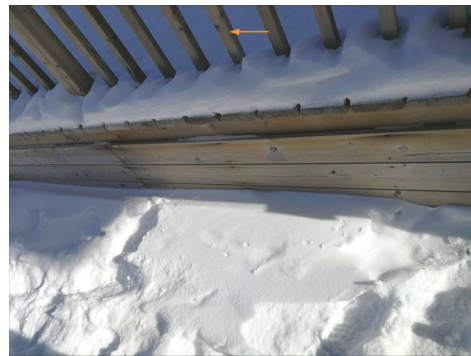
3.4.1 Decks, Balconies, Porches & Steps

RAILING UNSAFE

There is an unsafe opening in the railing. The spacing on the rail should not exceed 4". An opening greater than 4" is a serious safety hazard especially for children as their head or other body part can become trapped.

Observed 4.5" and 5"

Contact a qualified deck contractor.

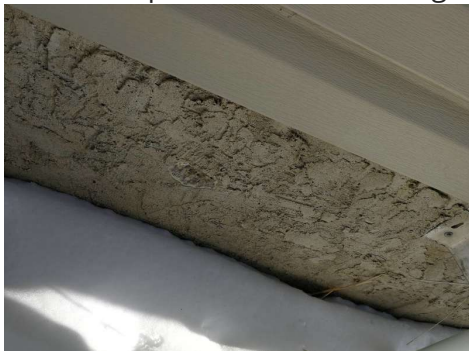
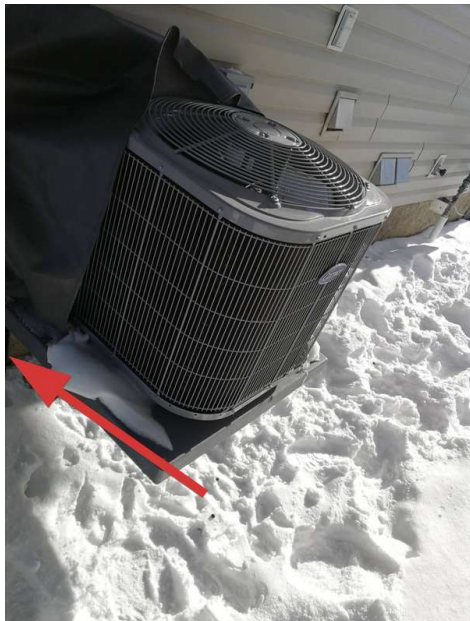
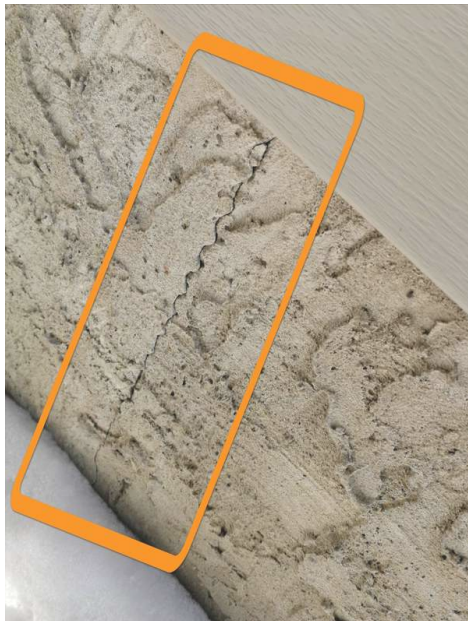
4.1.1 Foundation

FOUNDATION CRACKS - MINOR

Minor cracking was noted at the foundation. This is common as concrete ages and shrinkage surface cracks are normal. Recommend installing AC unit on the ground to avoid movement into the foundation monitoring for more serious shifting/displacement.

Ac unit attached to the foundation.

Contact a qualified structural engineer.

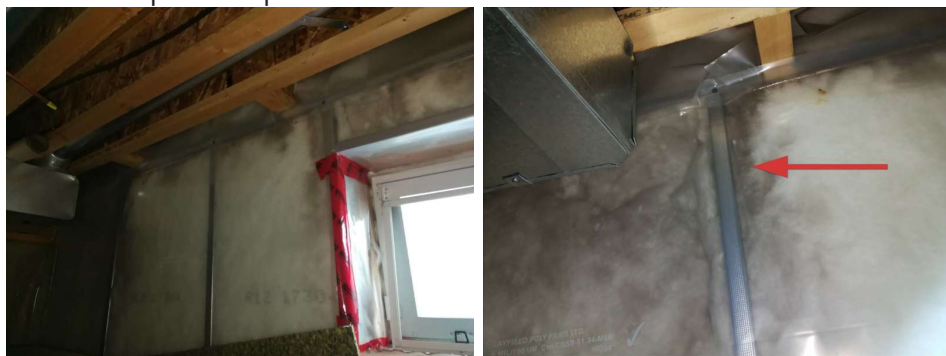
4.2.1 Basements

**IMMEDIATE/SAFETY ITEM****MOISTURE INTRUSION**

Observed Moisture trap in insulation on a large area in the basement. The insulation discoloured, recommend for mould testing, the sample has been sent out to the lab. Mould sampling report will be updated once received.

Contact a qualified professional.

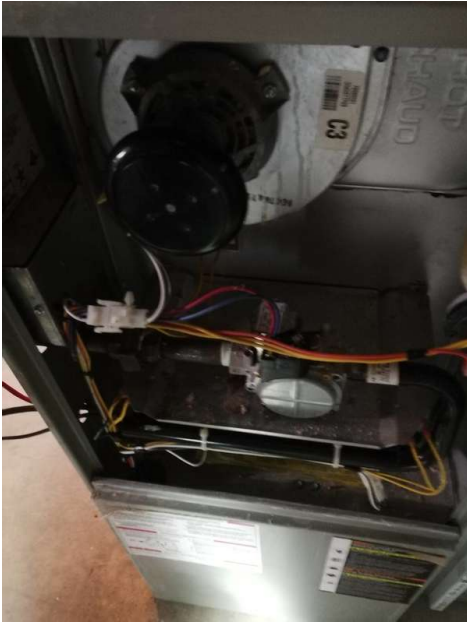
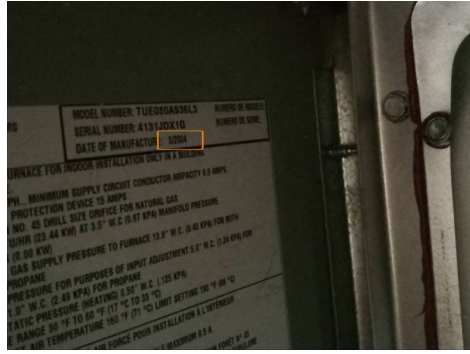
5.1.2 Equipment

NEEDS SERVICING/CLEANING

Furnace should be cleaned and serviced annually. Recommend a qualified HVAC contractor clean, service and certify furnace.

Contact a qualified HVAC professional.

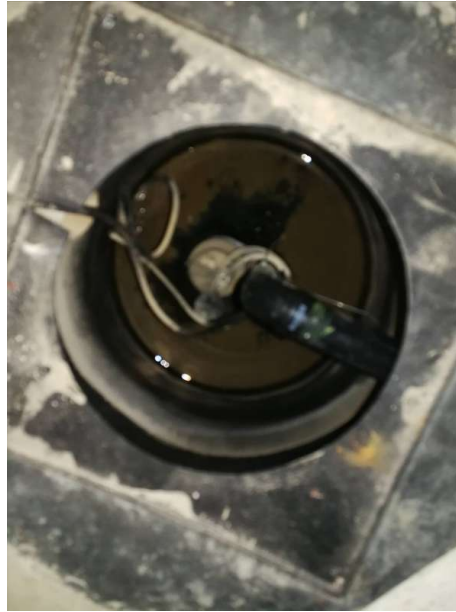
Sump Pump: Location

Functional at the time of inspection.

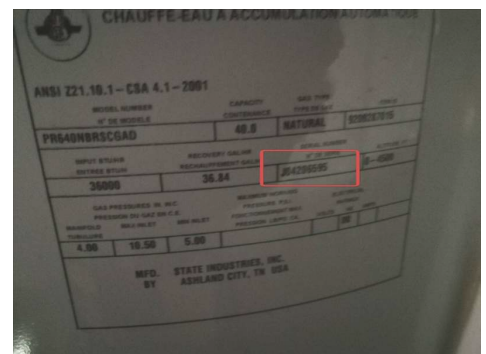
7.4.1 Hot Water Systems, Controls, Flues & Vents

NEAR END OF LIFE

Water heater showed normal signs of wear and tear. Recommend monitoring it's effectiveness and replacing in the near future.

2004 Build

Contact a qualified plumbing contractor.

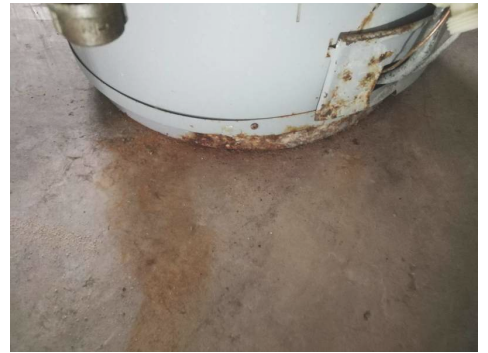
7.4.2 Hot Water Systems, Controls, Flues & Vents

WATER STAINS - LEAKAGE

Water stains were observed beneath water heater, indicating a past or present leak. Recommend further evaluation and repair by a qualified plumber.

Contact a qualified plumbing contractor.

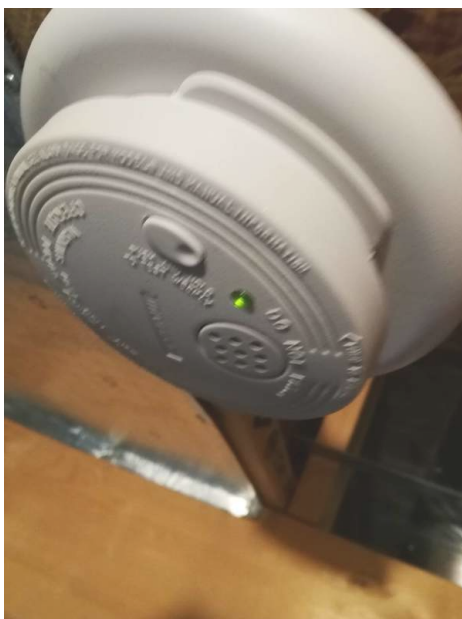
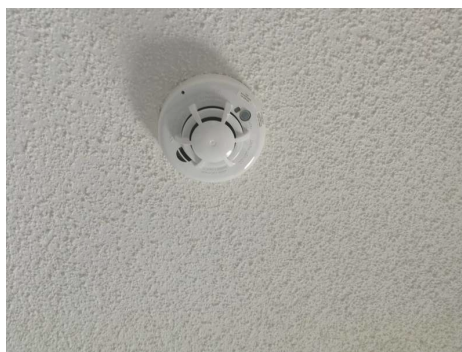
Smoke Detectors: Tested

Functional at the time of inspection.

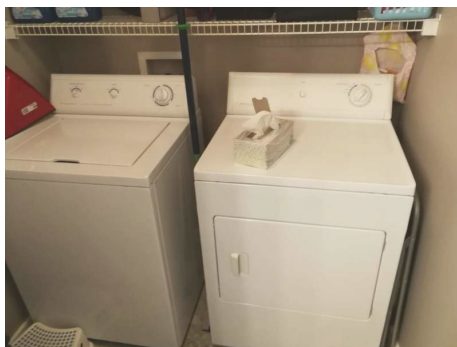
Dryer Metal flex Vent is deteriorate, Recommed replacing

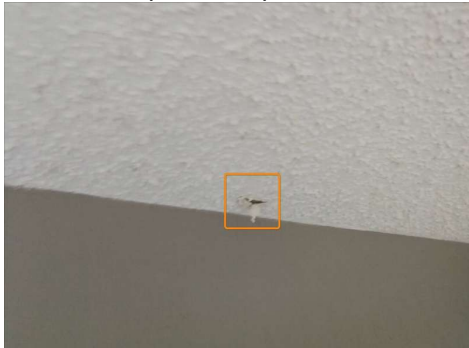
2nd Floor Full Bathroom

MINOR DAMAGE

Minor damage or deterioration to the ceiling was visible at the time of the inspection.

Contact a qualified professional.

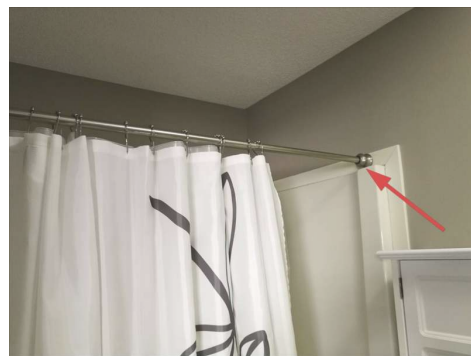
10.5.2 Ceilings

LOOSE BATHROOM'S CURTAINS HANGER

Observed loose/not secure , Reommed

Contact a qualified handyman.

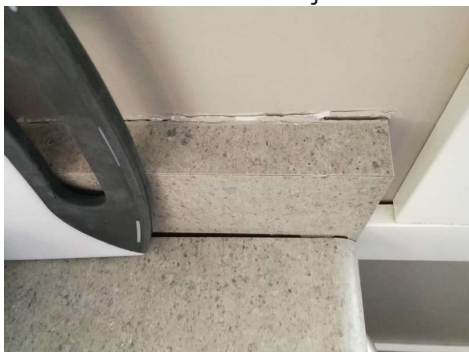
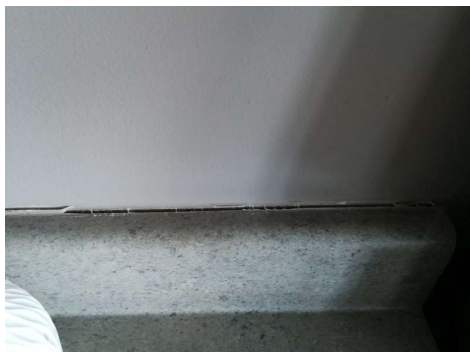
10.7.1 Countertops & Cabinets

POOR/MISSING CAULK

Bathroom countertop was missing sufficient caulk/sealant at the wall. This can lead to water damage. Recommend adding sealant at sides and corners where counters touch walls.

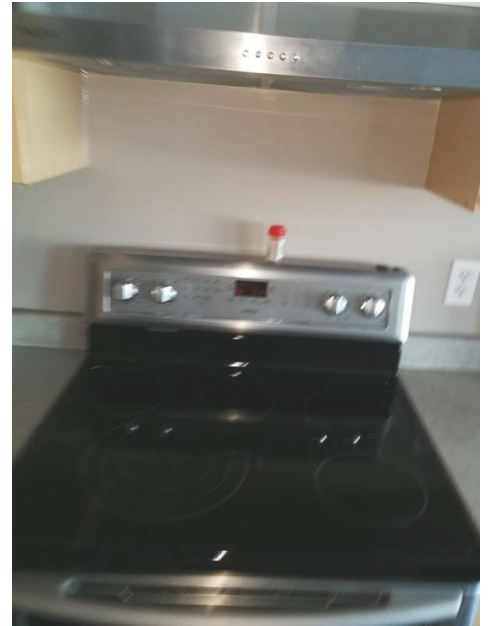
10.7.2 Countertops & Cabinets

**BACK SPLASH**

Observed fire hazard. Recommend 12" Backsplash in the kitchen and 18" behind Stove

Contact a qualified professional.
