## YOUR HOME INSPECTION

1234 Main St.  
Garland Texas 75043

# PROPERTY INSPECTION REPORT

**Concerning:** 1234 Main St. Garland Texas 75043  
(Address or Other Identification of Inspected Property)

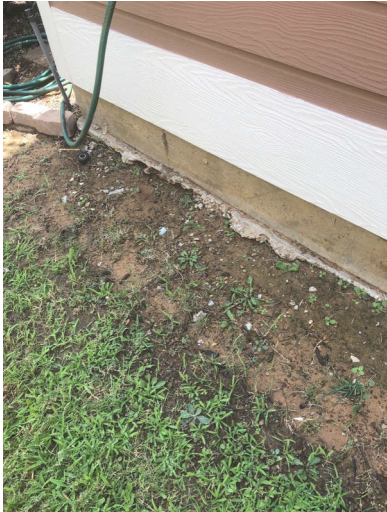
Ground erosion was observed. Fill dirt is needed against the foundation perimeter wall where the soil line is to low to help support the foundation footer properly.

Recommendation: Contact a qualified landscaping contractor

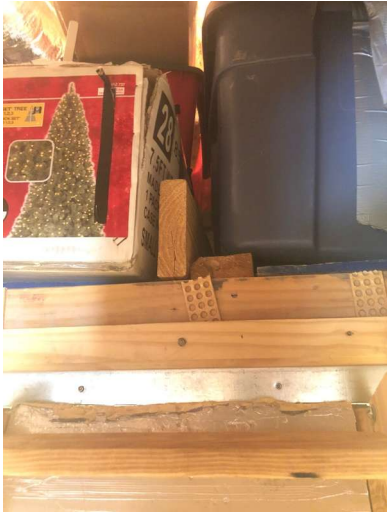
The roof structure attic space does not appear to be adequately ventilated. It is recommended to increase the amount of lower and upper ventilation to help prevent heat buildup in the attic space area. This condition should be further evaluated and corrected as necessary.

Recommendation: Contact a qualified roofing professional.

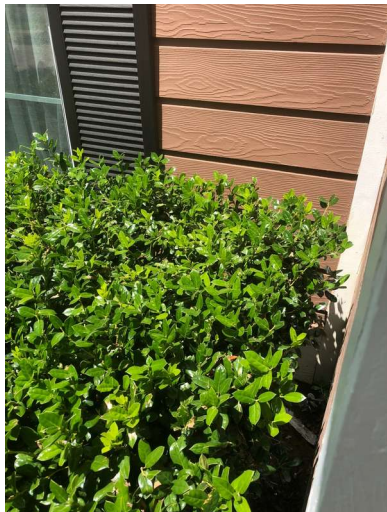
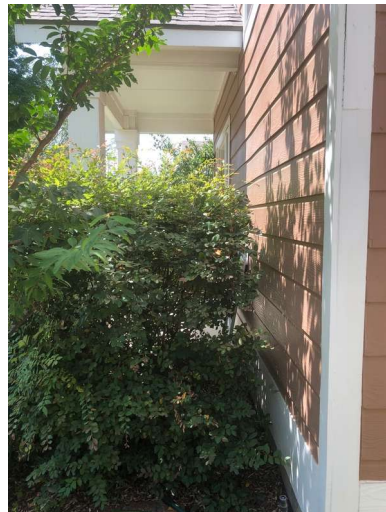
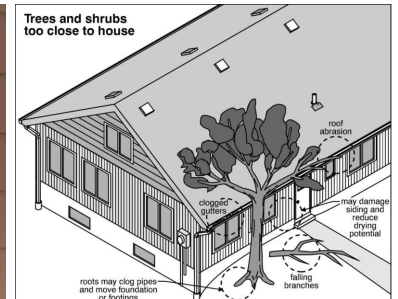
*Heavy Foliage :*

The heavy foliage growing on, over or around the exterior walls of the structure should be trimmed back at least 18-inches. The heavy foliage will limit the Inspectors visual observation of the exterior surfaces. It is advised that any foliage over three feet tall be at least three feet from the foundation.

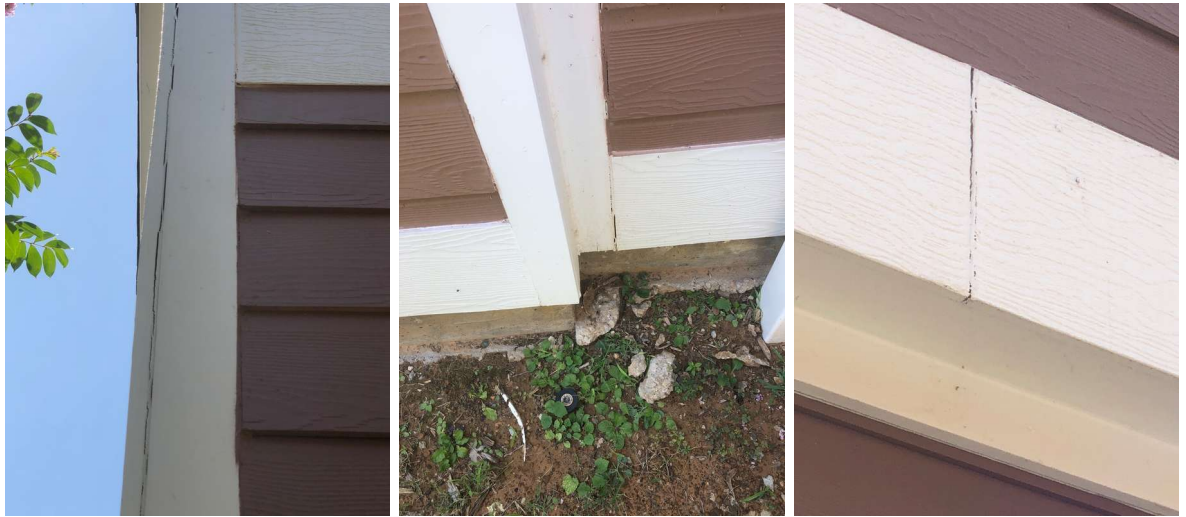
**1: Seal Trim/ Penetrations**

It is recommended to use elastomeric caulking.

Recommendation: Contact a handyman or DIY project

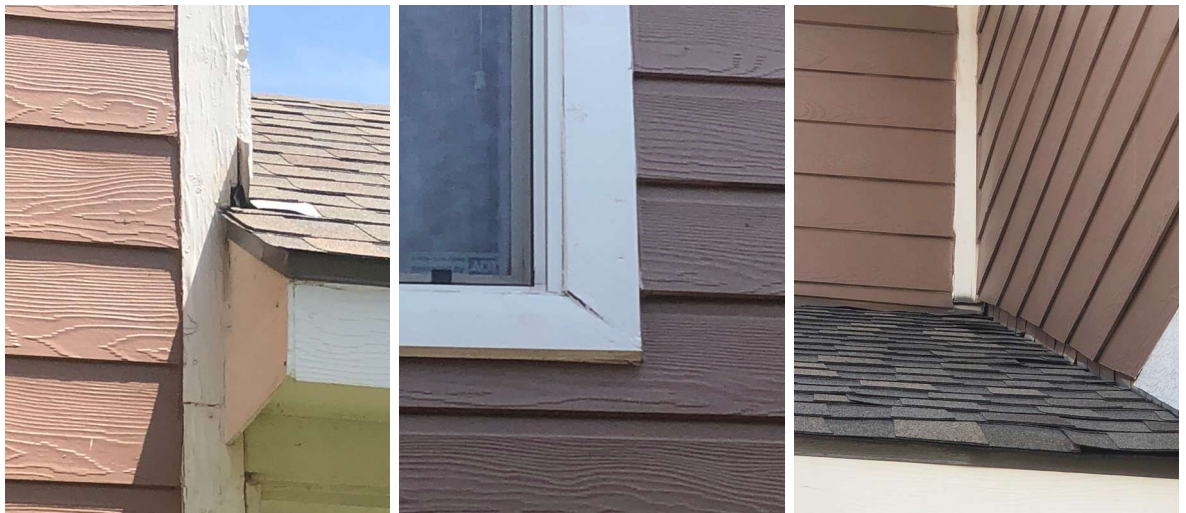
**2: Trim Damaged**

The wood veneer trim has some deterioration or damage.

Recommendation: Contact a handyman or DIY project

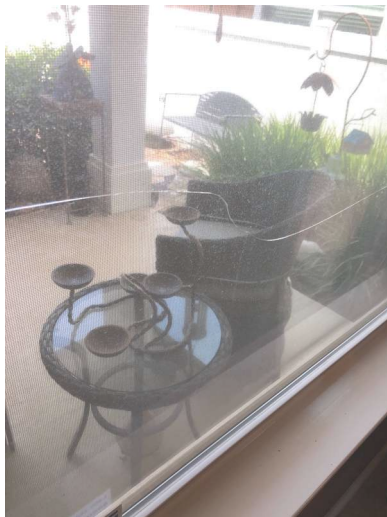
**1: Window Glass Broken**

Cracked and/or broken window glass was observed.

Recommendation: Contact a qualified window repair/installation contractor.

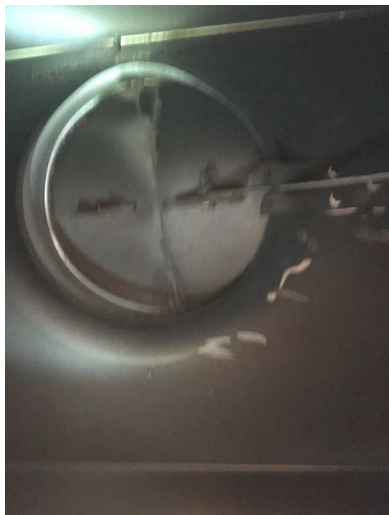
When artificial gas logs are installed in a firebox with a damper; the damper should be permanently blocked open with a damper clamp to prevent accidental spillage of carbon monoxide into the living space.

Recommendation: Contact a qualified chimney contractor.

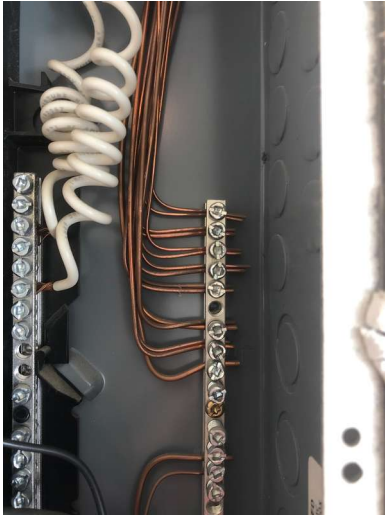
There are double tapped neutral and or ground wires on the bus bar. This may be an as-built condition but Per TREC standards of practice we are required to report this condition as a deficiency.

Recommendation: Contact a qualified electrical contractor.

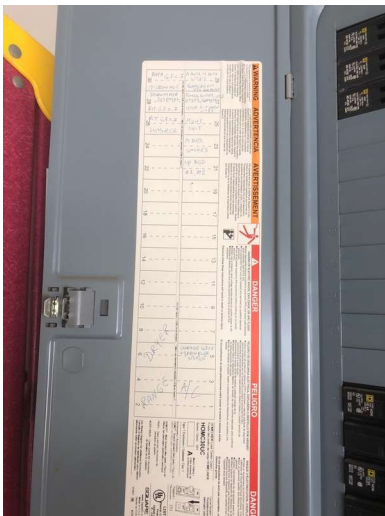
**2: Not Labeled Properly**

The breakers (overcurrent devices) in the electrical panel are not properly labeled.

Recommendation: Contact a qualified electrical contractor.

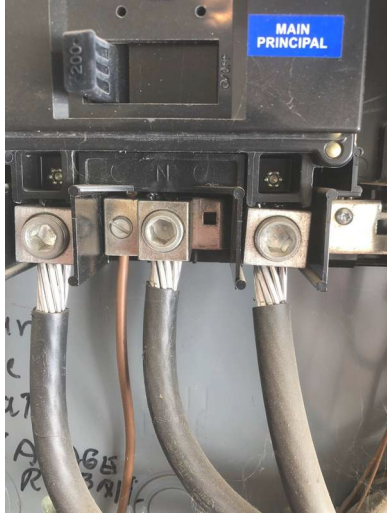
**3: No Anti-Oxidant Aluminum**

There was no anti-oxidant gel observed on the exposed aluminum conductor terminations.

Recommendation: Contact a qualified electrical contractor.

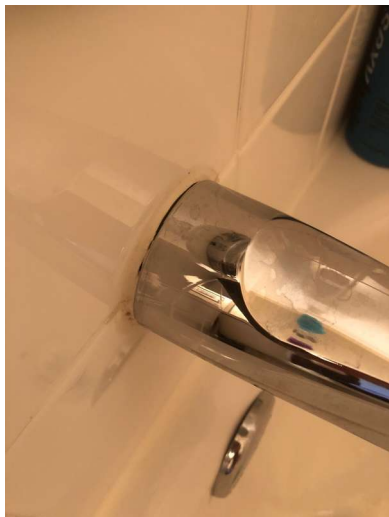
Tub spout should be sealed to avoid water intrusion in the wall.

Recommendation: Contact a handyman or DIY project

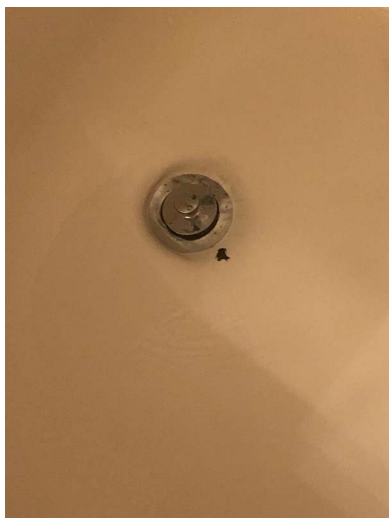
**2: Surface damage**

The bathtub surface has some damage.

Recommendation: Recommend monitoring.

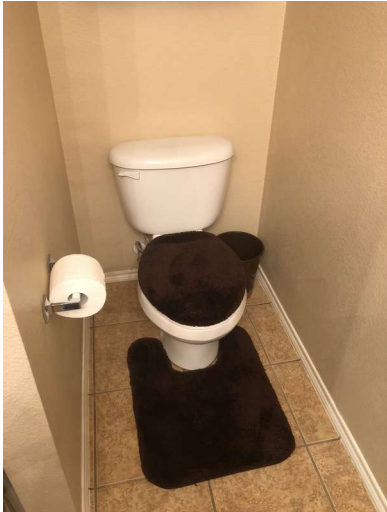
**3: Commode loose**

The commode is loose at the floor mount.

Recommendation: Contact a qualified plumbing contractor.

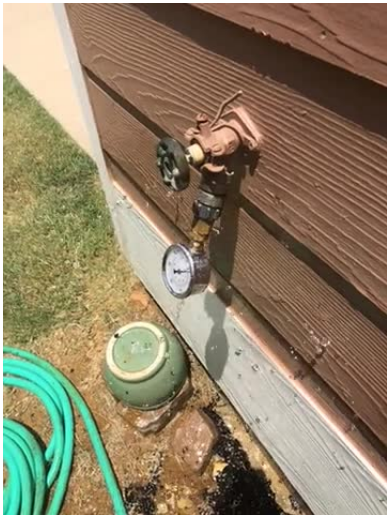
**4: Vacuum breaker damaged**

The hose bibb vacuum breaker was observed to be damaged

Recommendation: Contact a qualified plumbing contractor.

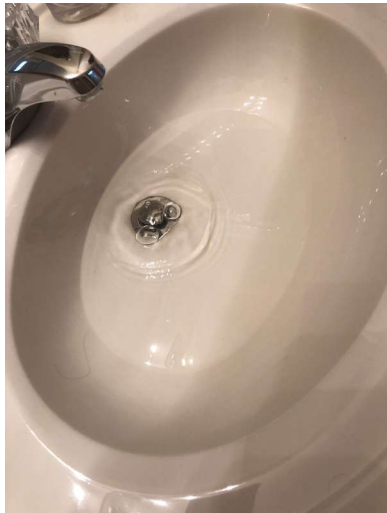
The sink was observed to drain slowly, suggesting that an obstruction may exist.

Recommendation: Contact a qualified plumbing contractor.

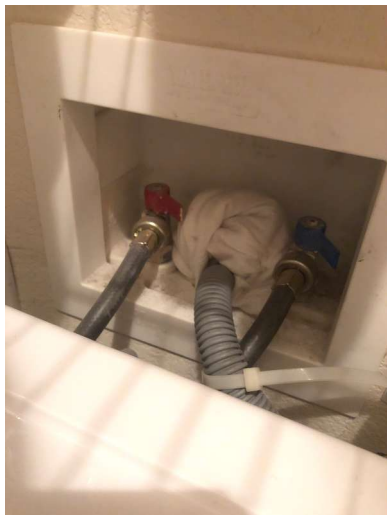
**2: Laundry drain**

Laundry drain is wrapped. This indicates previous issues. Recommend that you request disclosure.

Recommendation: Contact a qualified professional.

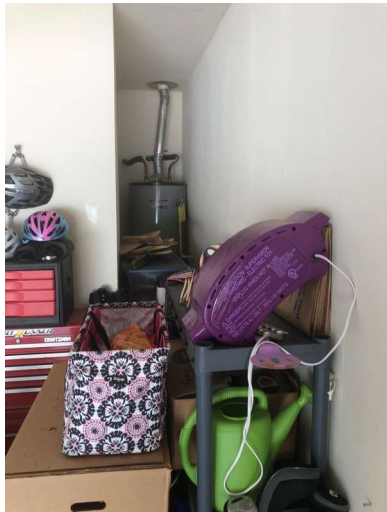
*Not accessible:*

What are heater was an accessible due to heavy storage.

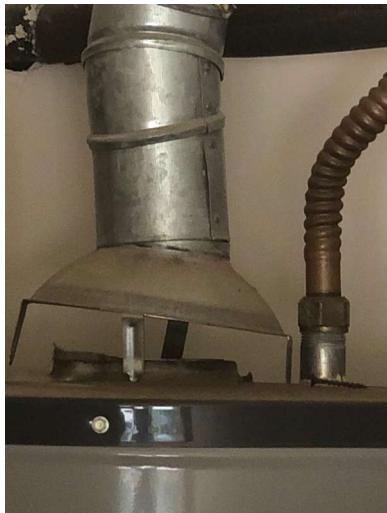
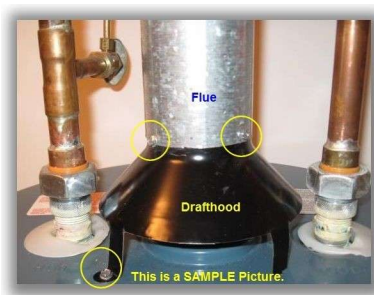
The draft hood is not properly mounted on the water heater. This configuration will emit Carbon Monoxide into the heater compartment, which is a known safety hazard

Recommendation: Contact a qualified plumbing contractor.

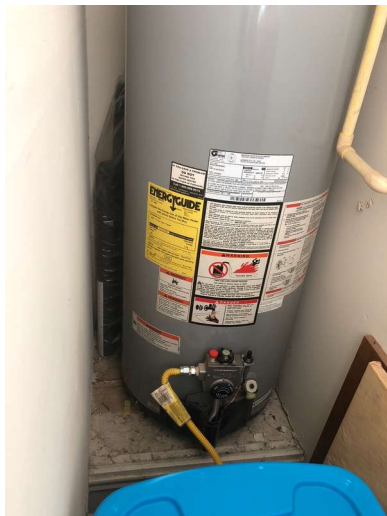
**4: No pan**

There is no pan installed under the water heater. This may be an as-built condition but Per TREC standards of practice we are required to report this condition as a deficiency.

Recommendation: Contact a qualified plumbing contractor.

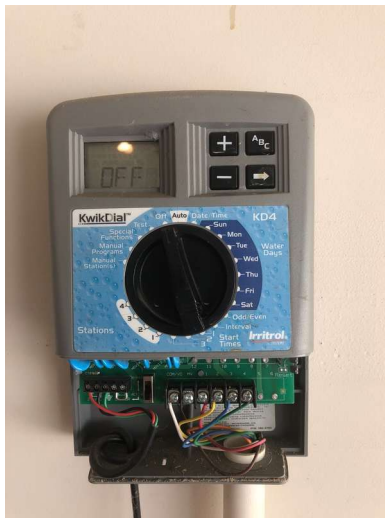
*Needs Tune Up:*

The sprinkler system should be "tuned up". Currently several of the heads are spraying the house, windows, and concrete flatwork.
