YOUR HOME INSPECTION COMPANY

ERIC JONES HOME INSPECTION

1234 Main St.
Upper Darby PA 19082

Buyer Name
10/16/2018 9:00AM

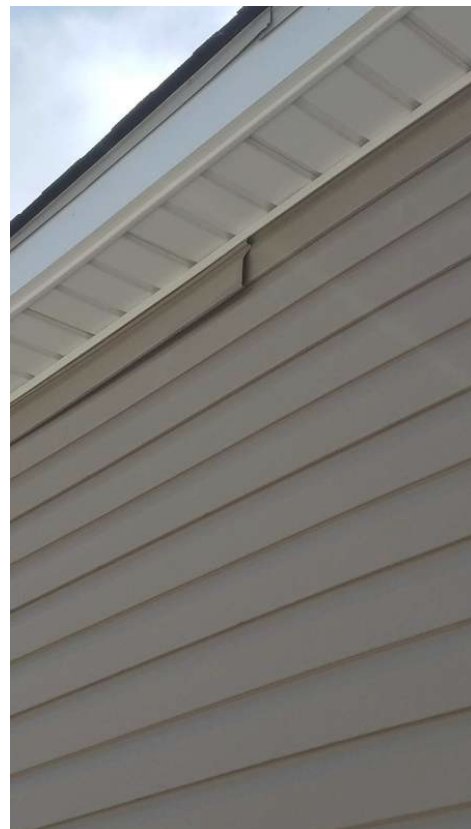
2.1.1 Base Information

LOOSE SIDING

WEST ELEVATION - UNIT A

Secure loose siding.

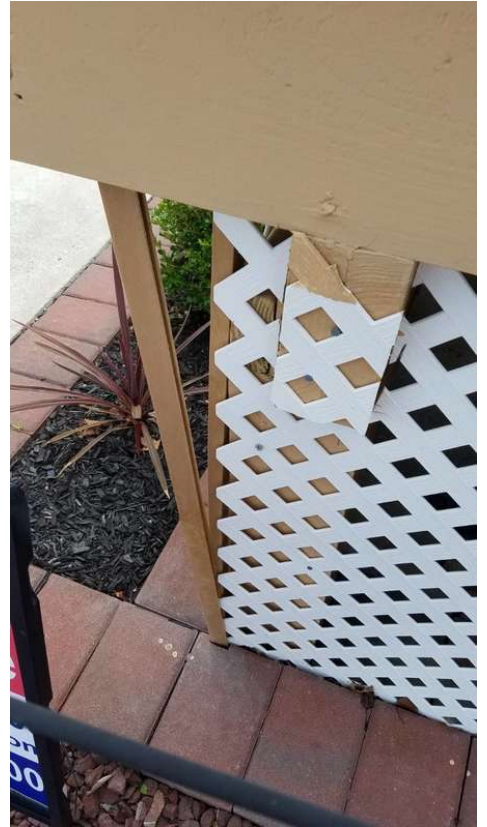
2.1.2 Base Information

LOOSE LATTICE SUPPORT

UNIT A - UNDER PORCH

Resecure channel at corner of front porch

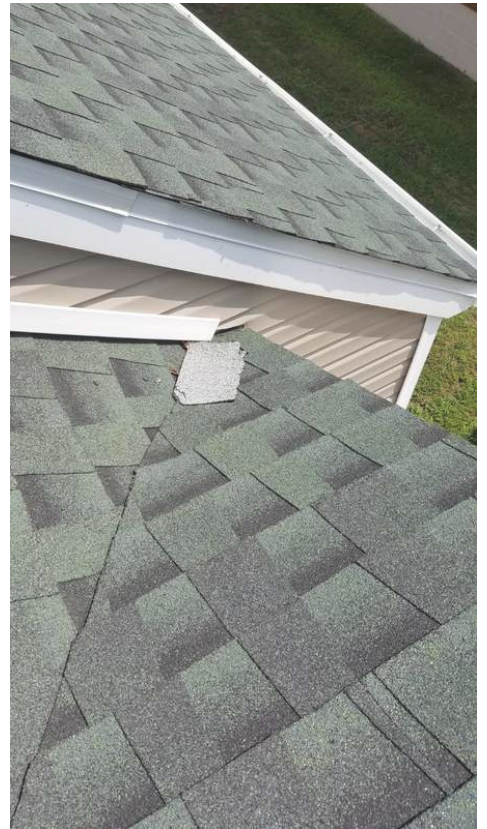
2.2.1 Wall Covering, Flashing & Trim

KICKOUT FLASHING

UNIT B - REAR VALLEY

Kickout flashing was missing at one or more locations. Kickout flashing directs water away from the dwelling as it exits the roof to prevent moisture intrusion inside. Recommend roofer install kickout flashing. Please note any areas concealed behind walls are not able to be evaluated for damage inside.

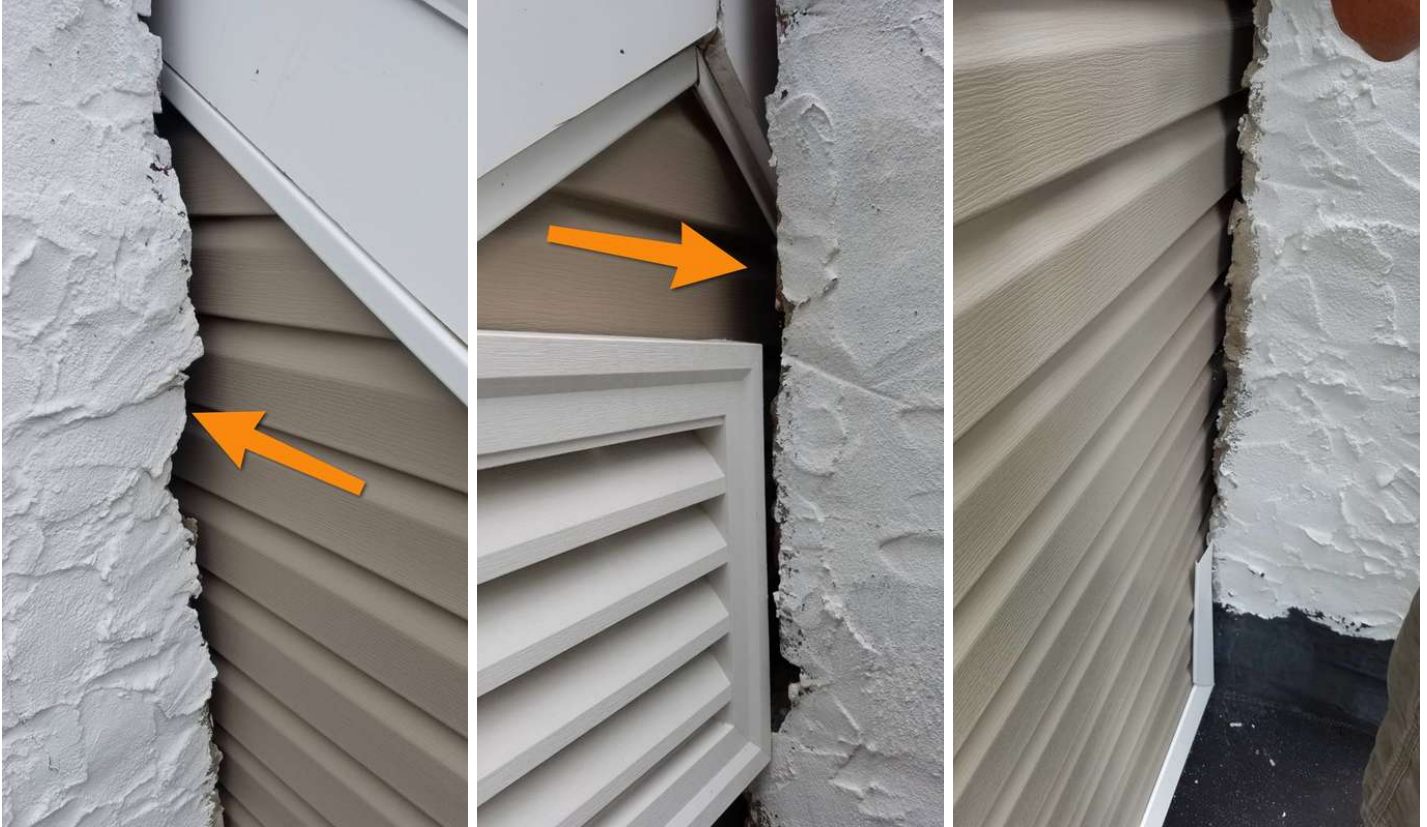
2.2.2 Wall Covering, Flashing & Trim

SIDING AT CHIMNEY - UNIT A

There is a gap between the siding and chimney over the flat roof - see additional comments for repair in Roof section.

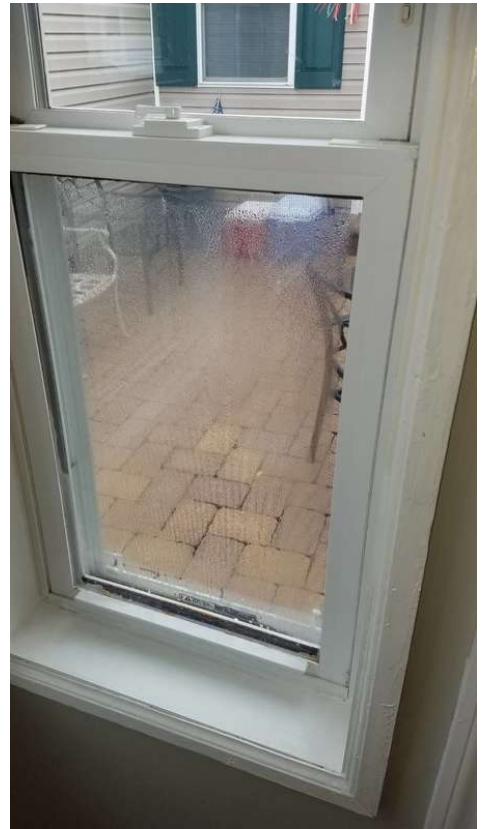
2.5.1 Windows - Exterior

UNIT A WINDOW SEALS BROKEN

@ of the smaller windows in the rear Mud room of Unit A were fogging - seals have been broken. Recommend replacement of window sash if possible to find replacement.

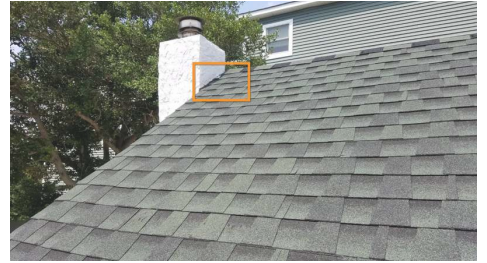
3.1.1 Base Information

INSTALL STEP FLASHING

UNIT A ROOF AT CHIMNEY

Water intrusion at connection of main roof to Chimney - Step flashing should be installed where roof meets chimney. Also, a counter flashing shall be installed over the step flashing and secured to chimney. Additional comments on Siding section.

Install step flashing with counter flashing

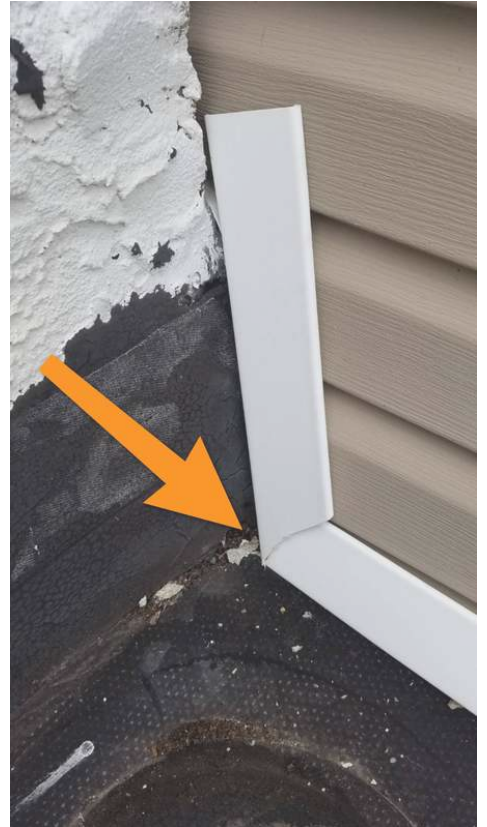
3.4.1 Flat Roof

PATCHED/SEALED

UNIT A - LOWER FLAT ROOF - CHIMNEY

One or more areas were patched or sealed where the flat roof meets the Chimney. These areas may have been leaking previously - signs of moisture were detected in the closet below this connection. Recommend consulting with seller or property disclosures. These areas should be repaired. If leaks are observed, a licensed roofing contractor may need to evaluate and repair.

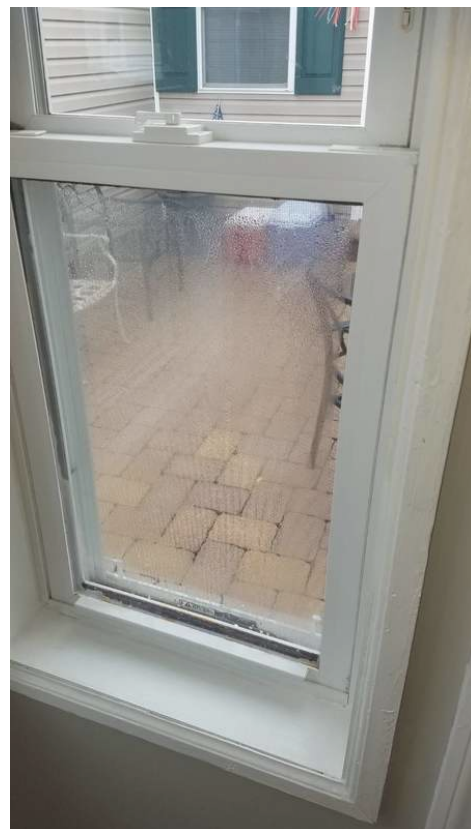
5.1.1 Base Information

WINDOW SEAL BROKEN

UNIT A - REAR MUD ROOM

2 Windows in Unit A rear mud room had seals broken and the window was fogging.

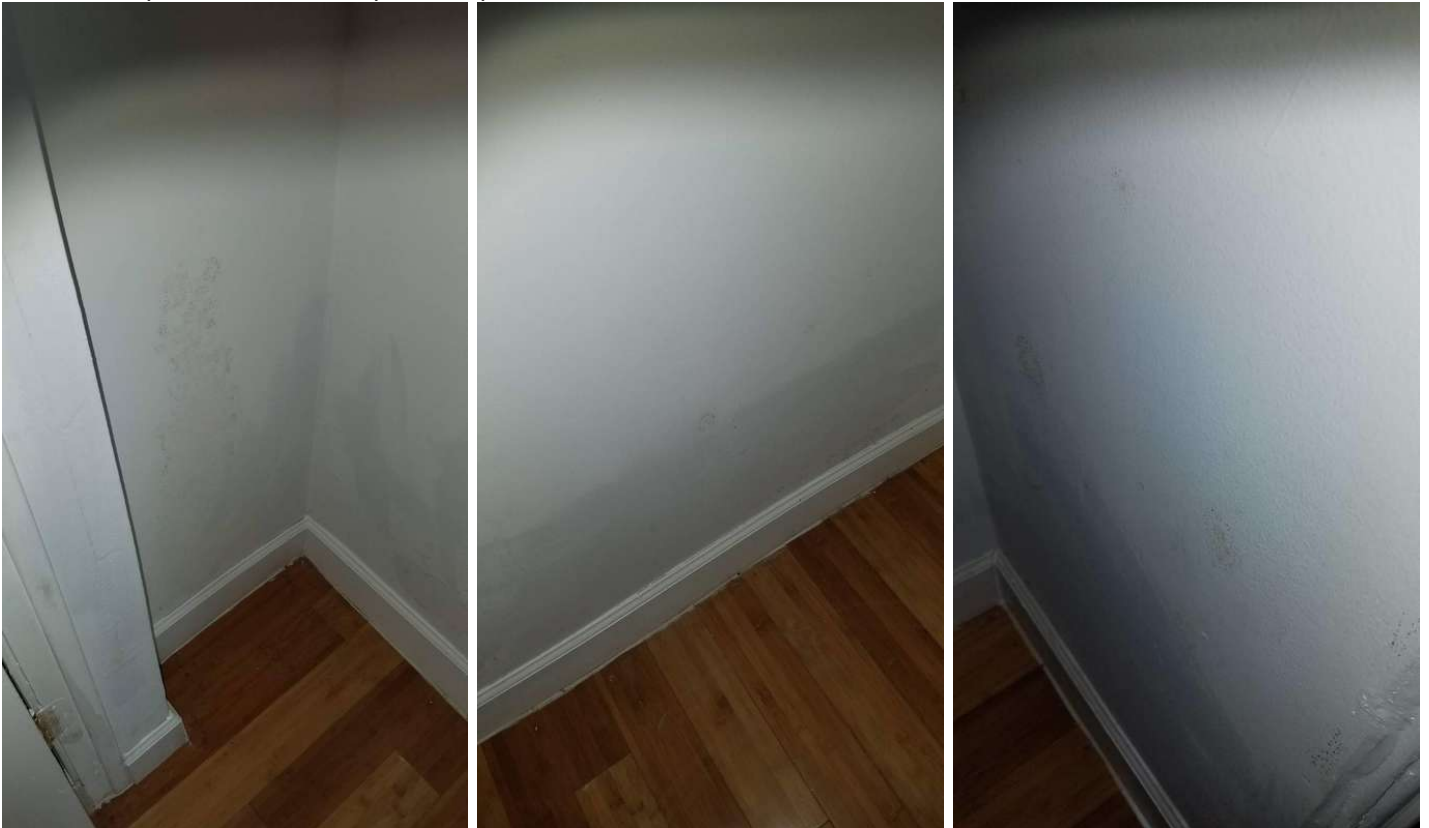
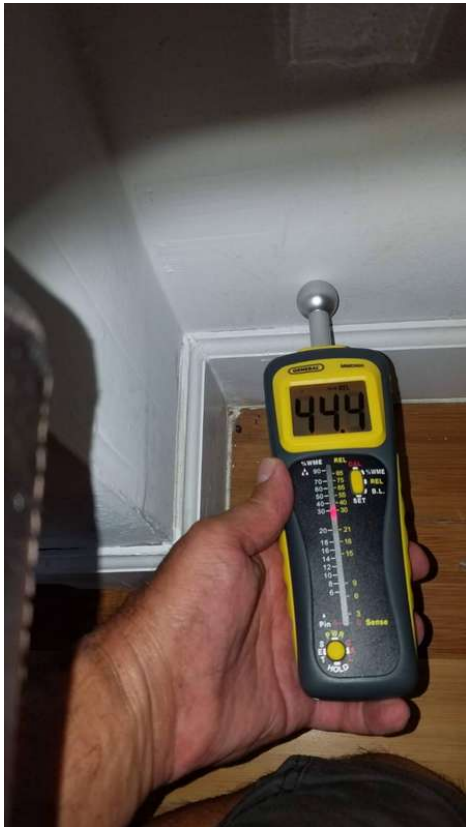
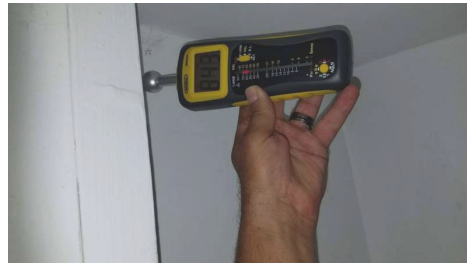
5.3.1 Walls

Observed signs of mold in one or more areas in the wall structure. Recommend identifying source or moisture intrusion and sending samples to a lab for testing. Expected caused is the connection of the Chimney at the flat roof. Siding does not go behind the chimney allowing water intrusion at base of chimney.

POSSIBLE MICROBIAL GROWTH

UNIT A REAR BEDROOM CLOSET

There was evidence of possible microbial growth on the wall(s). Recommend sample collection and further testing by a qualified lab. Wall covering should be removed in order to determine any possible mold growth inside the wall cavity. Clearance from a Certified Mold inspector should be given before closing any work.

High moisture level at top of closet

Moisture reading of 44% - should be below 10%.

Siding should have a backer rod and Joint sealer installed between the Chimney and siding. Closet drywall should be replaced and tested while open by a Mold inspector.

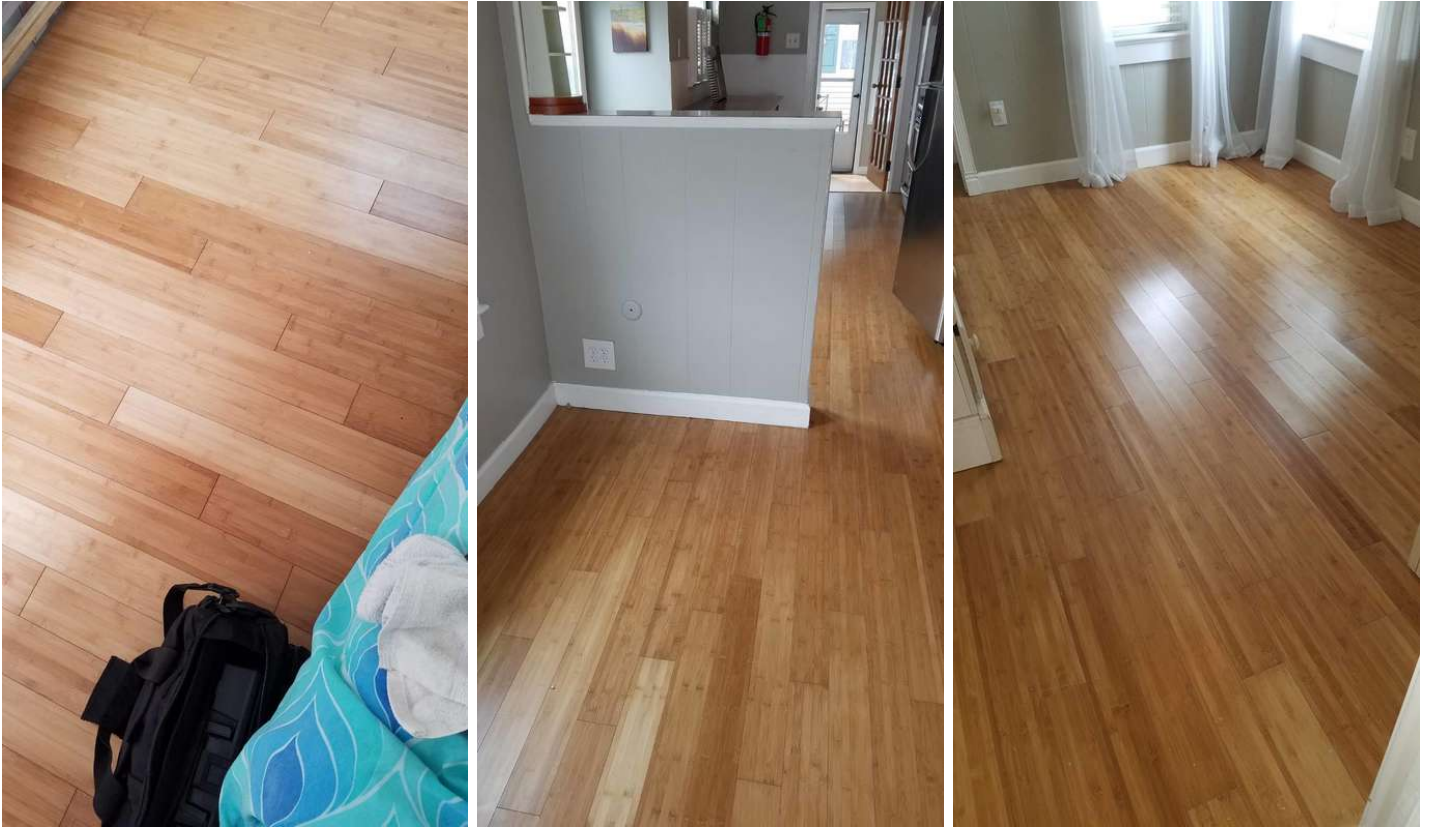
5.4.1 Floors

MODERATE WEAR

THROUGHOUT

Floors had moderate surface wear along major paths of travel.

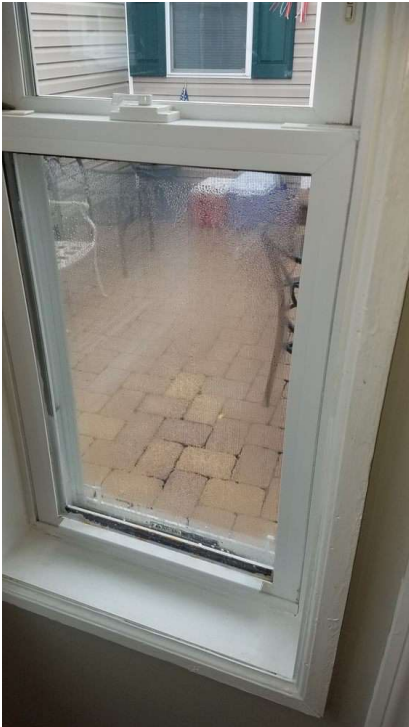
5.7.1 Windows

FAILED SEAL

UNIT A - REAR MUDROOM

Observed condensation between the window panes, which indicates a failed seal. Recommend qualified window contractor evaluate and repair or replace.

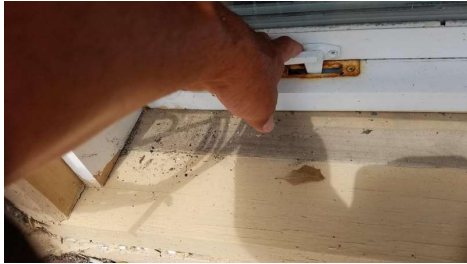
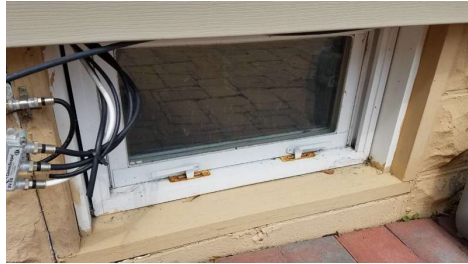
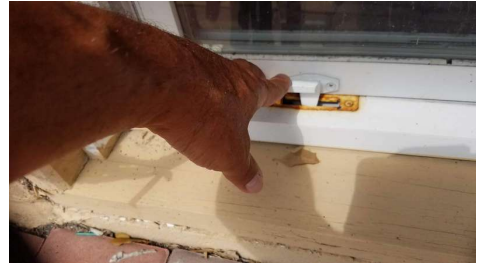
5.7.2 Windows

**LOOSE WINDOW FRAME**

Unit A - East elevation - casement window to Crawl space was not secure. Window pulled away from frame when attempting to open window.

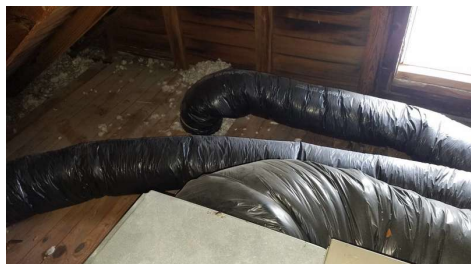
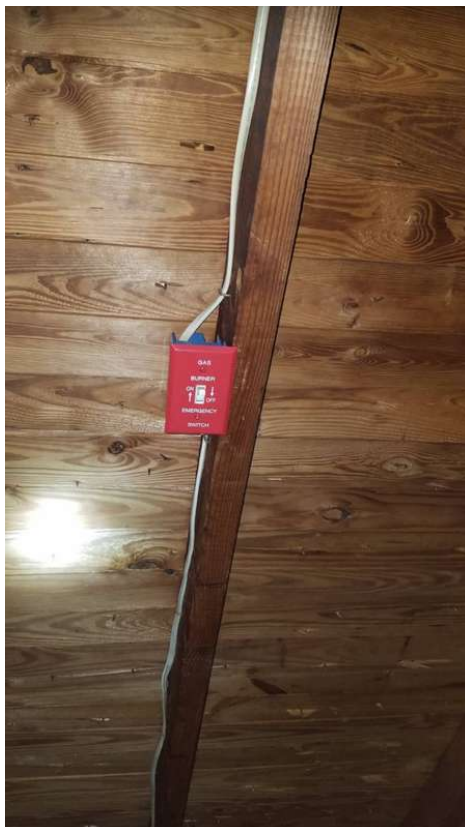
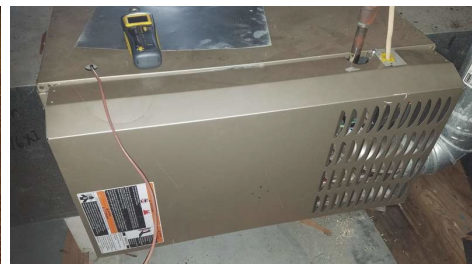
NO GAS SERVICE

UNIT A

Unit in attic of Unit A could not be operated because the Gas service was not on in Unit. Installation of flexible insulated duct-work made access to the unit difficult. Also note location of Emergency shut off of unit is located on rafters for future use.

Emergency Shut Off of attic Furnace.

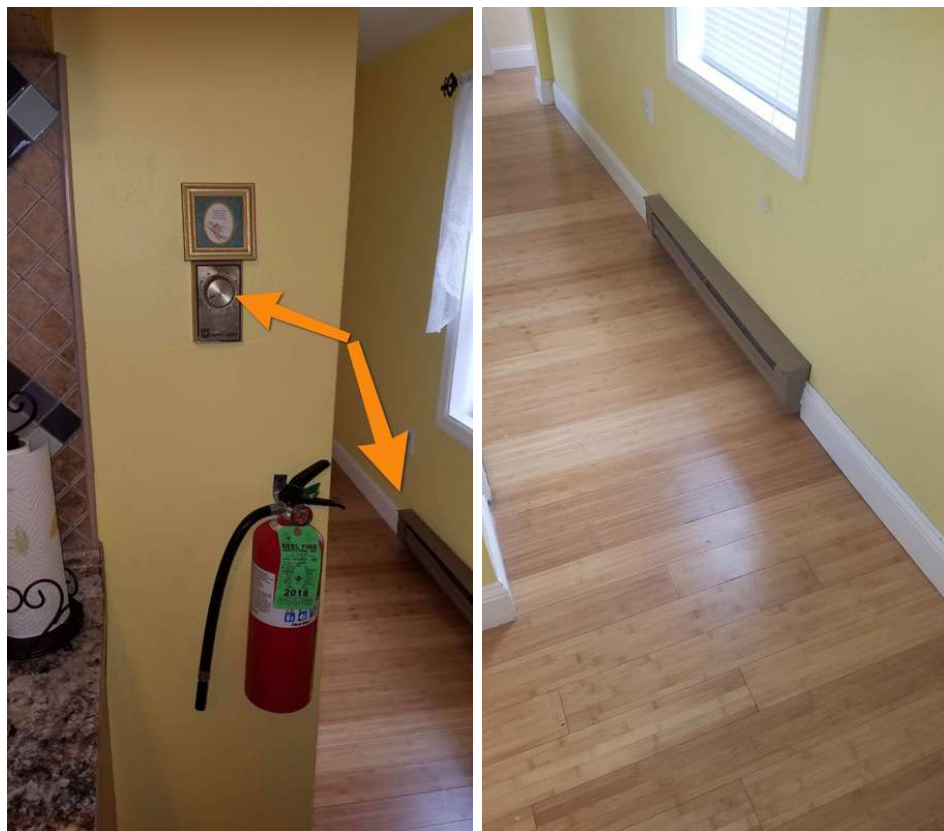
6.1.1 Base Information

UNIT B - BASEBOARD HEAT

Unit B had baseboard electric heat as heat source. Unit were tested by turning on Thermostat (wall mounted at each location) and activated. Living room had couch pushed up against the baseboard heat which should be relocated away from Heat source.

Typical - wall thermostats that operate base heating system.

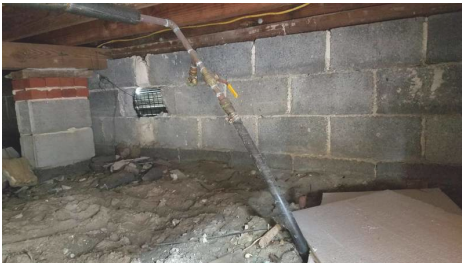
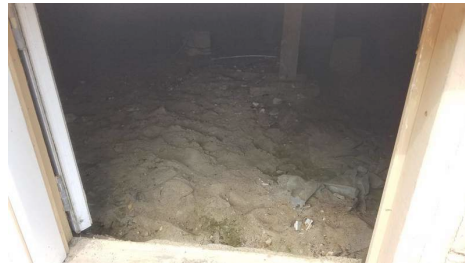
Service: Photos
Crawl Space

Enter crawl space from Driveway - open lattice cover and window and turn to your right. Install balance of Insulation over piping to entry point on floor before winter.

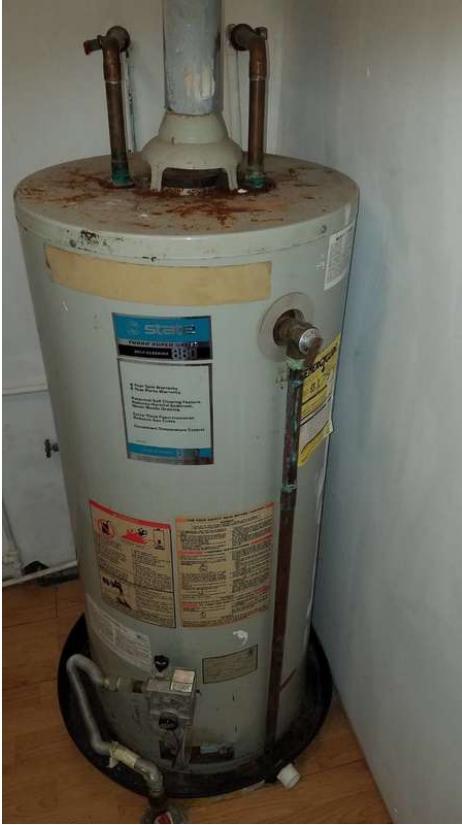
Hot Water Heater: Older Water Heater

Unit A - laundry room

The water heater was 8+ years old. The average estimated life expectancy of a water heater is 8 to 12 years. Due to the age of the water heater, it could be more prone to breakdown and should be budgeted for replacement in the future. At the time of the inspection the water heater was performing satisfactorily.

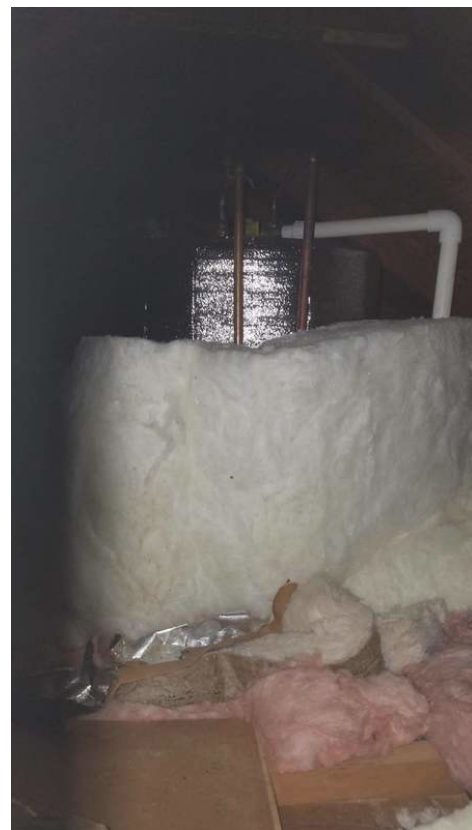
THERMAL BLANKET

UNIT B - ATTIC

Thermal Blanket installed on water heater prevented inspection.

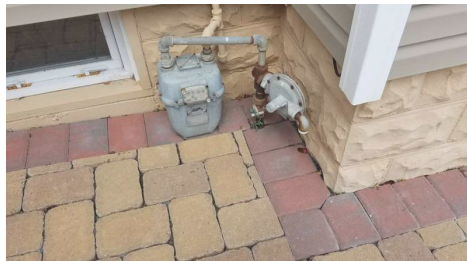
UNIT A

HWH could not be operated due to no gas service. Service should be turned on and Unit reinspected. Due to the age of the HWH recommendation is for replacement.

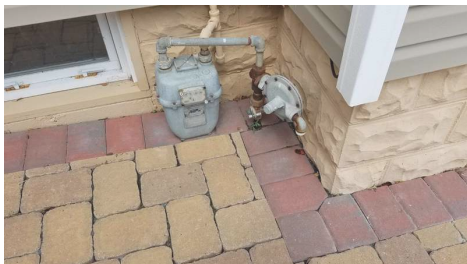
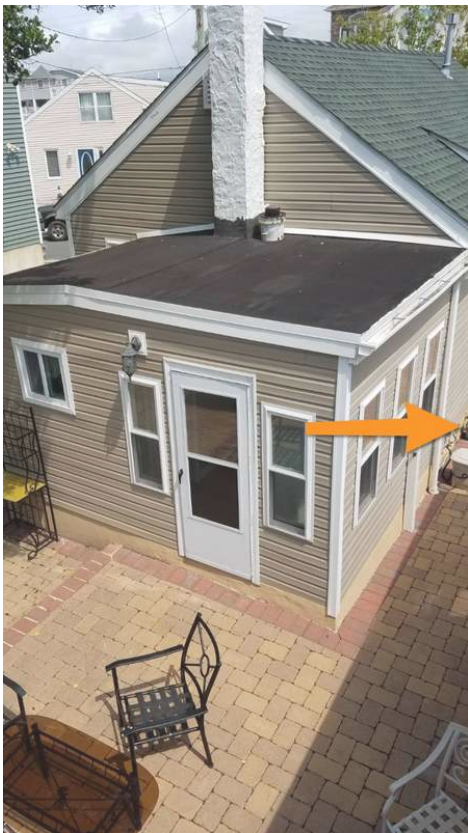
GAS SHUT OFF

EXTERIOR DRIVEWAY

Gas was off at the main. Recommend local utility company turn on and check all gas appliances prior to deadlines.

Gas meter location in driveway.

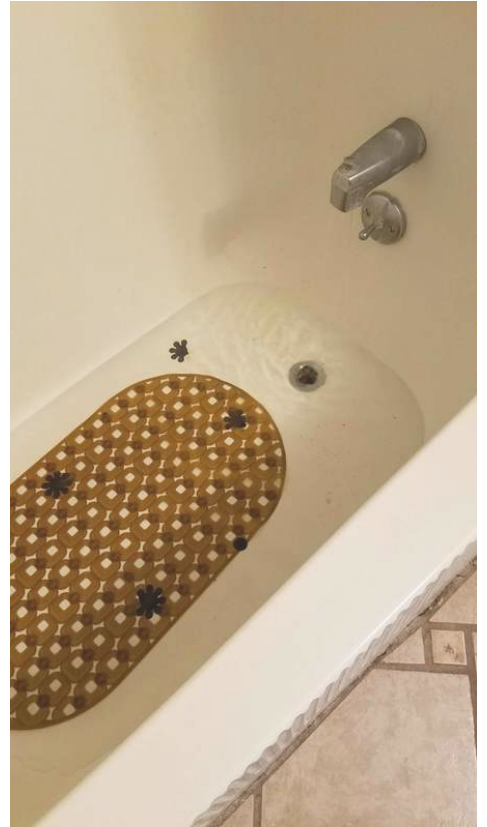
The bathtub or shower drained slowly. Recommend clearing drain and/or that a qualified plumber repair if necessary.

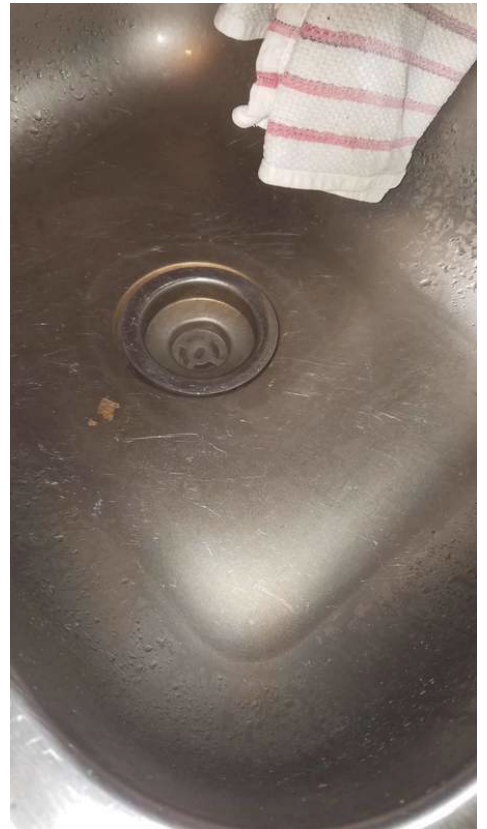
9.5.1 Drain, Waste and Vent

UNIT B SLOW DRAINS

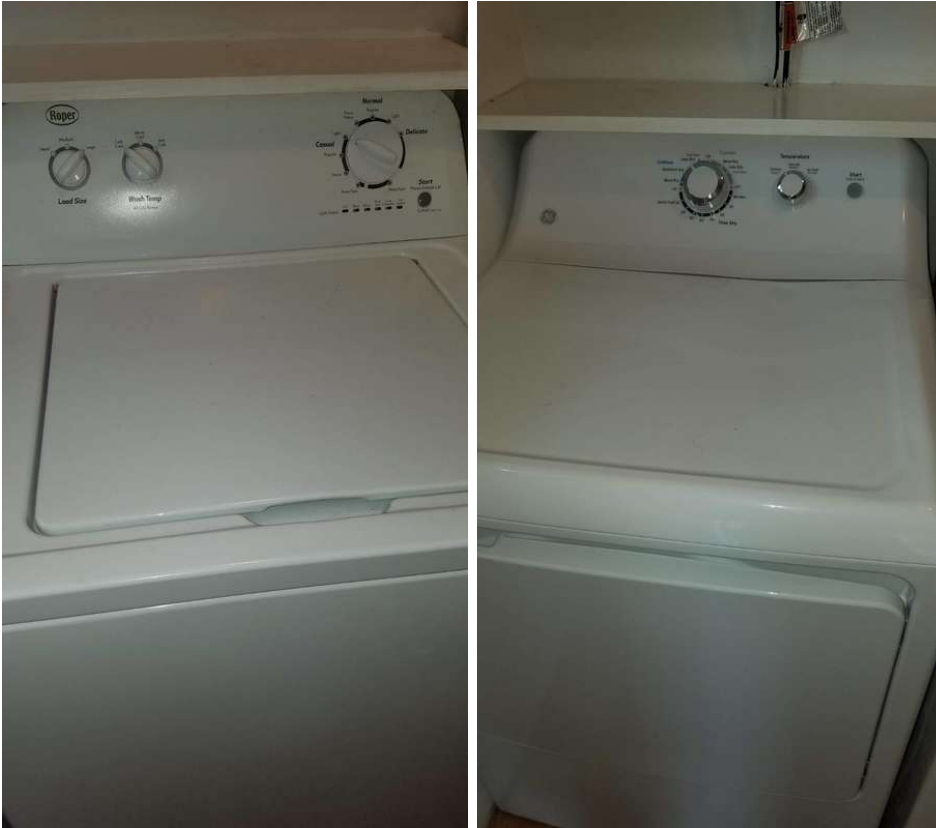
9.6.1 Laundry

UNIT A

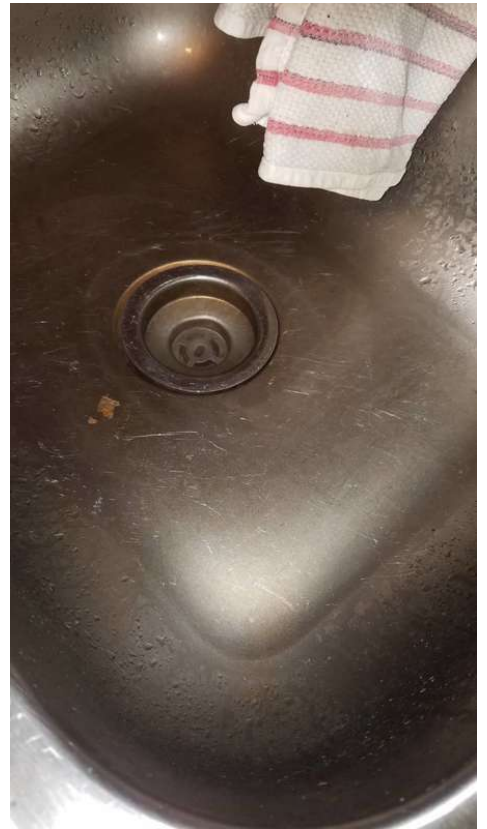
One or more sinks drained slowly. Recommend clearing drain and/or having a qualified plumber repair if necessary.

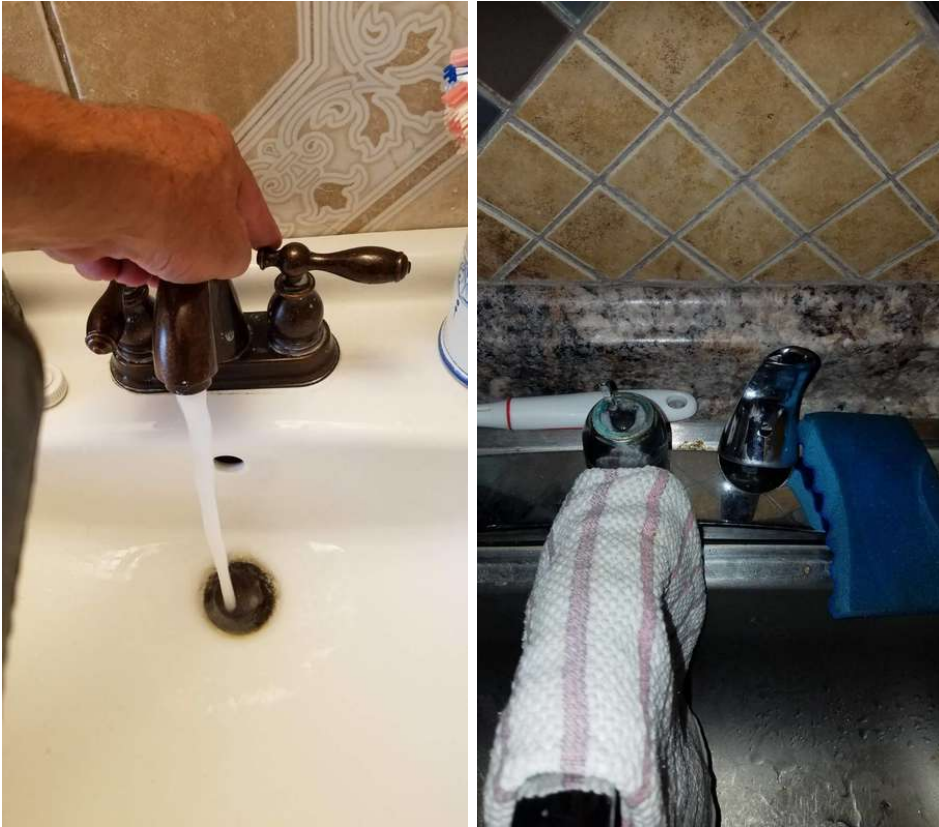
9.8.2 Water Supply Fixtures

FAUCET DAMAGED

One or more faucets were loose and/or damaged. Recommend repair or replacement.

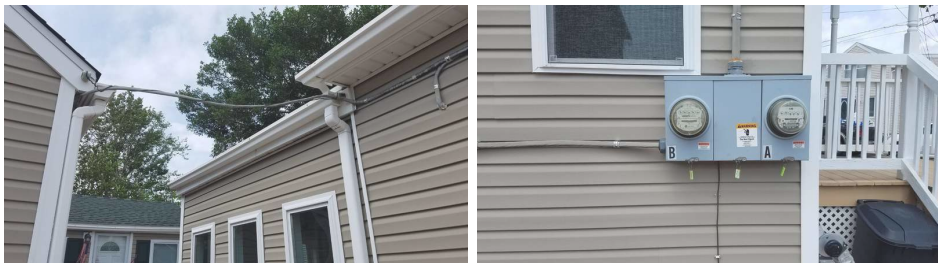
Meter location for Units A & B. Service cable is run from the meter location to each panel location inside of the Unit. The service cable for Unit B is too low and needs to have a Professional Electrician determine the best repair to safely have the cable relocated.

The electric service cable for Unit B was installed across the pathway to the back unit and does not meet the minimal height clearance requirements. This could be a serious safety concern if sheathing becomes deteriorated and exposes electrical conductors. Recommend an evaluation from a certified electrician for proper fix of this issue.

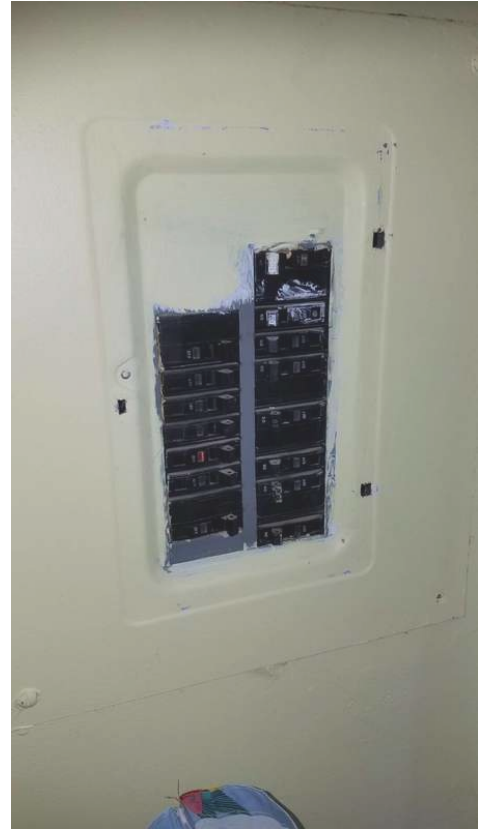
**PANEL/COVER DAMAGED**

Panel Cover missing or damaged at one or more locations.
Recommend repair

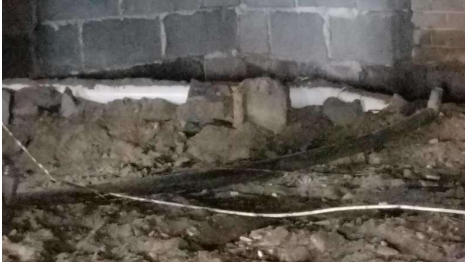
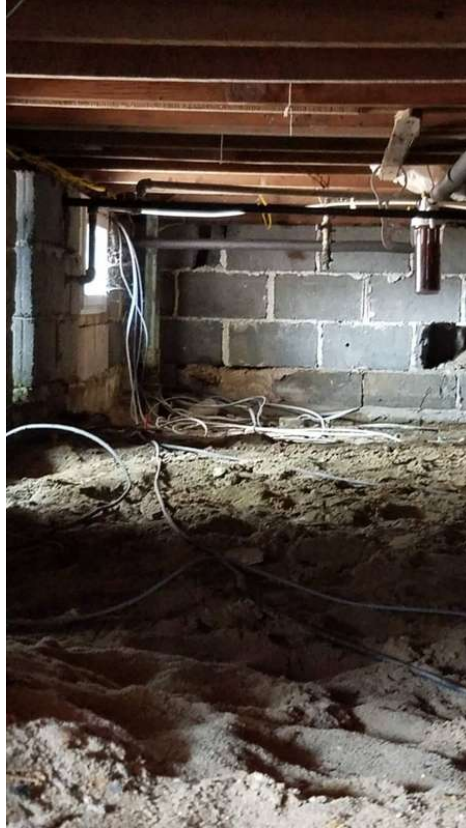
Crawlspace wiring was not secured to joists and was laying on the ground. This is a safety hazard. Recommend a qualified electrician properly secure all loose wiring to floor joists per standard building practices.

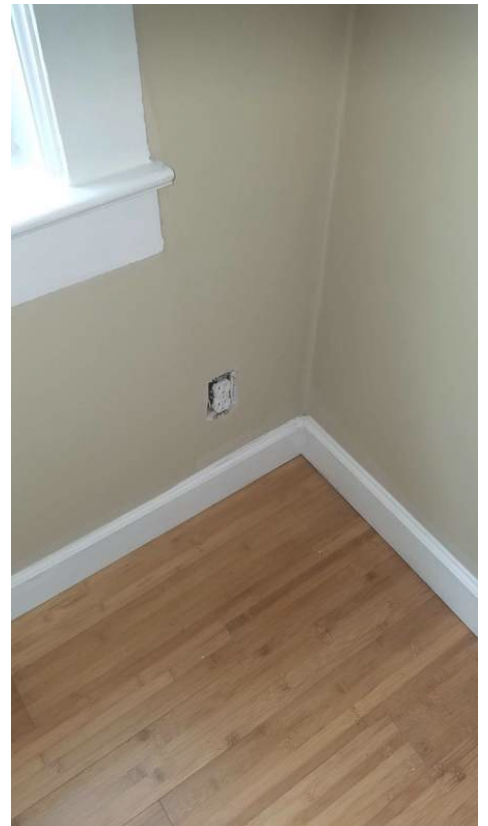
10.6.1 Receptacles

One or more cover plates for switches, receptacles (outlets) or junction boxes were missing or broken. These plates are intended to contain fire and prevent electric shock from occurring due to exposed wires. Recommend that a qualified person install cover plates where necessary.

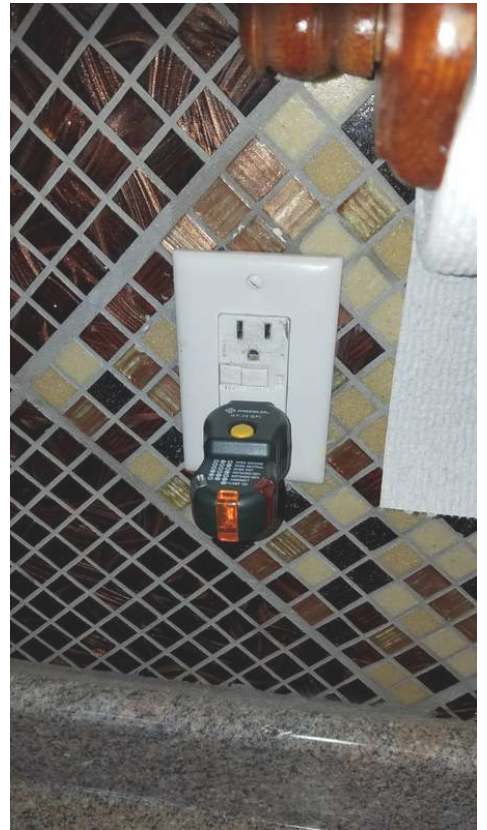
10.6.2 Receptacles

Recommendation**GFCI ISSUES**

One or more ground fault circuit interrupter (GFCI) receptacles (outlets) were not functioning properly (would not trip/would not reset). Recommend replacing with new gfc outlet.

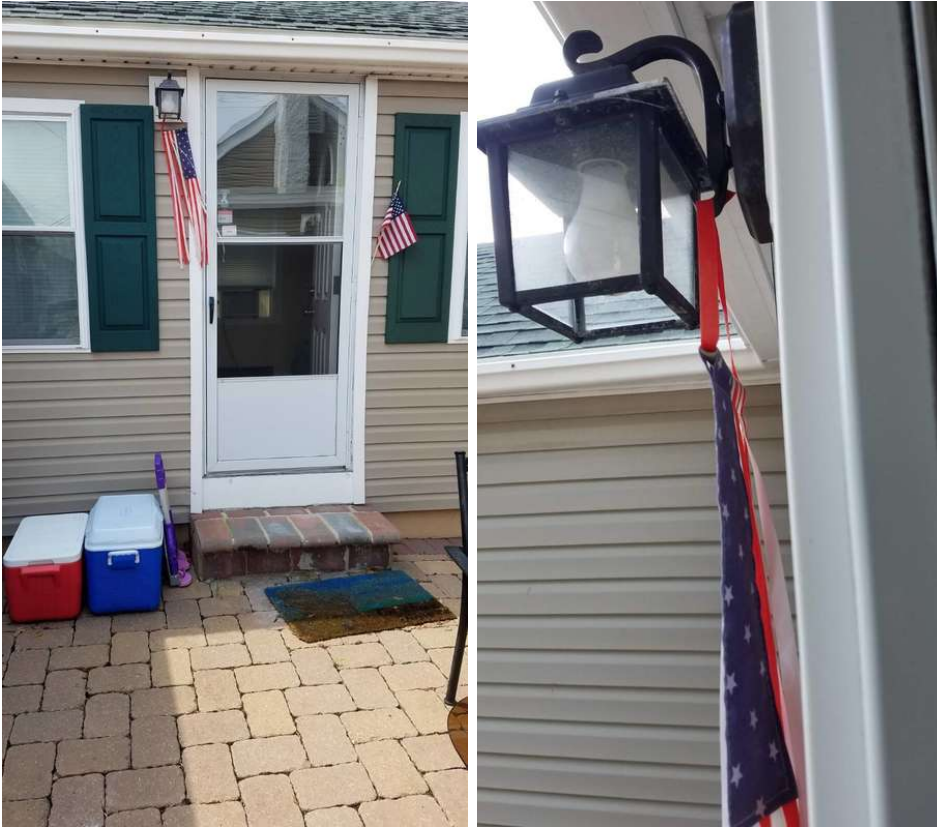
Recommendation**BULBS MISSING/BROKEN**

Bulbs in one or more light fixtures were missing or not functioning. These light fixtures couldn't be fully evaluated. If replacement bulbs are inoperable, then recommend that a qualified electrician evaluate and repair or replace light fixtures as necessary.

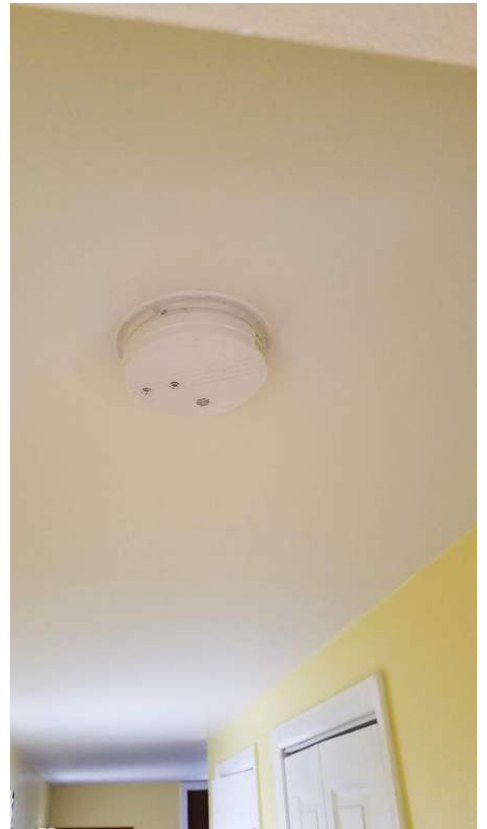
Smoke detector failed to respond when tested. Recommend battery be replaced or units to be relaced. Since this was installed prior to current codes smoke detectors were not interconnected or hard wired. Only battery operated units were installed.

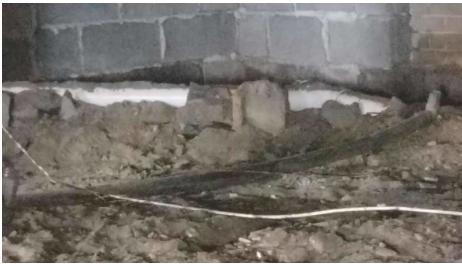
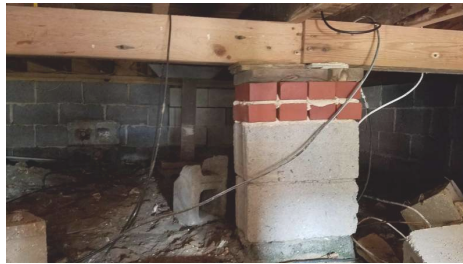
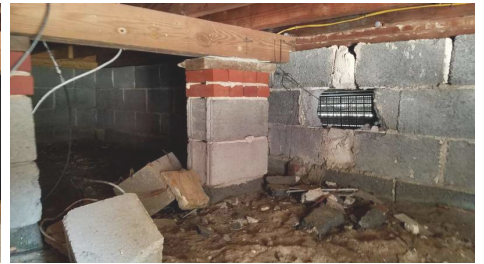
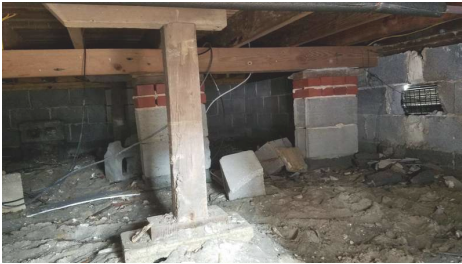
Crawlspace: Unit A Crawl space

No insulation was installed under the floor above the crawl space. Recommend that a qualified person install insulation for better energy efficiency and per standard building practices. Typically this is R-19 rated fiberglass batt with the attached facing installed against the warm (floor) side.
