## RESIDENTIAL HOME INSPECTION

1234 Main St.  
Wellington 6022

Buyer Name  
10/27/2018 9:00AM

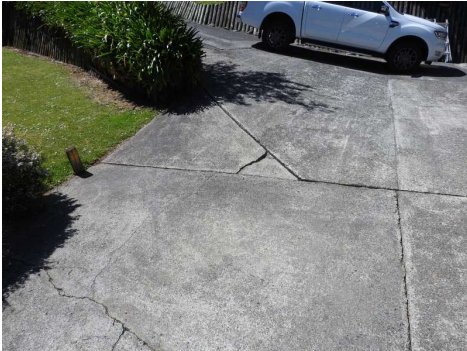
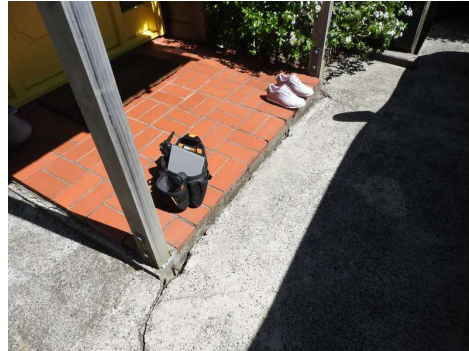
**DRIVEWAY CRACKING - MINOR**

Minor cosmetic cracks observed which may indicate movement in the soil. Recommend monitor and/or have concrete contractor patch/seal.

Contact a qualified concrete contractor.

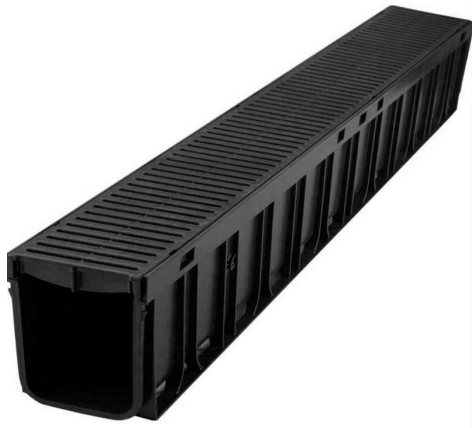
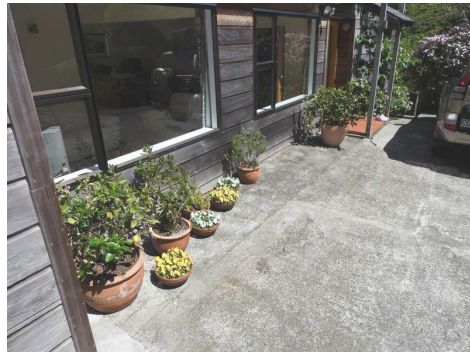
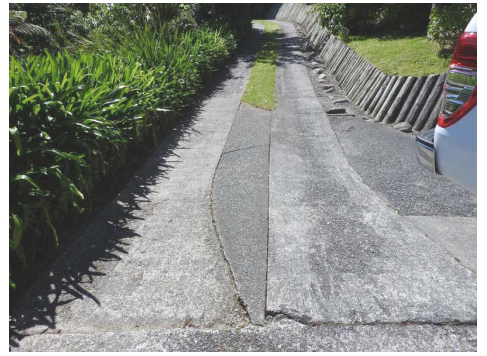
## 5.3.2 Driveway

**DRIVEWAY DRAINING TOWARDS HOME**

The driveway has a negative slope and drains towards the structure. Recommend a driveway contractor to install a threshold drain.

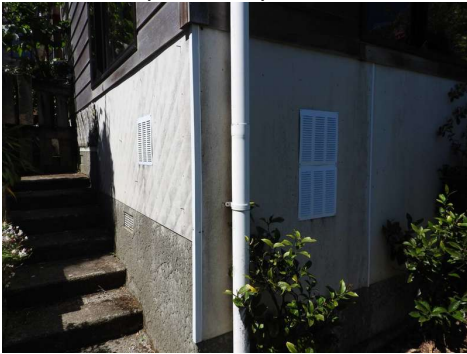
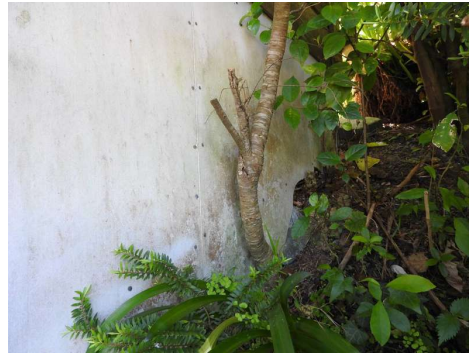
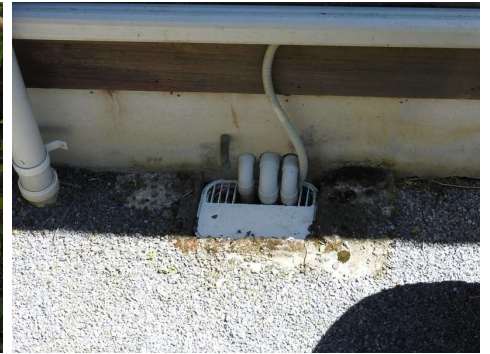
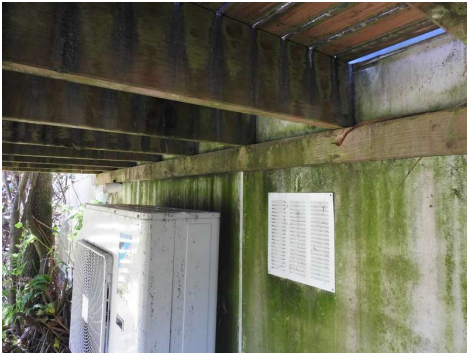
6.2.1 Fibre cement sheet product

ASBESTOS PRODUCT SUSPECTED. (ACM) These fibre cement sheet products are quite likely to be ACM. There is some damage and cracking in isolated areas, not considered to be living areas, however, wind can carry these fibres. We recommend encapsulate/sealing these products with flexible paint on a product.

Contact a qualified professional.

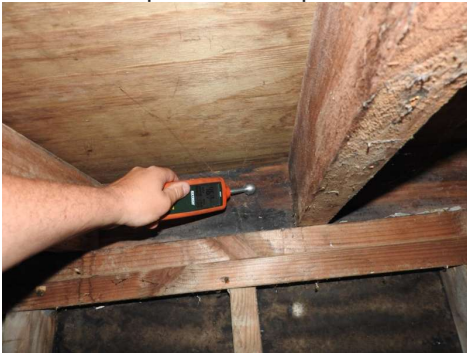
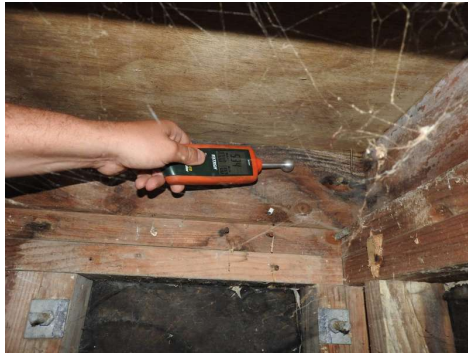
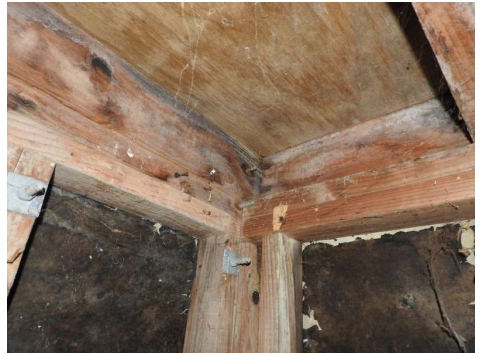
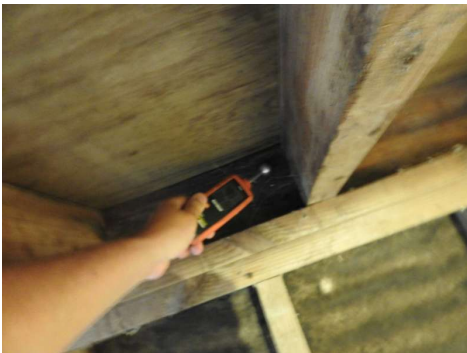
8.3.1 Jack frame

There are some elevated moisture readings in the area under the waterproofed deck substrate, located at the back door. This is a fairly well-protected area and may cause future problems if left unchecked - check under here during the next storm for a good indication on whether or not the waterproofing membrane is performing as it should. The owner mentioned that this has been installed fairly recently, recommend checking if there is a still warranty from the builder.

Rot is conditional to the environment surrounding the timber, there are many types of rot with many different causes. Change the environment and you will fix the issue, replace the timber like for like but use H4 treated timber this time.

Contact a qualified carpenter.

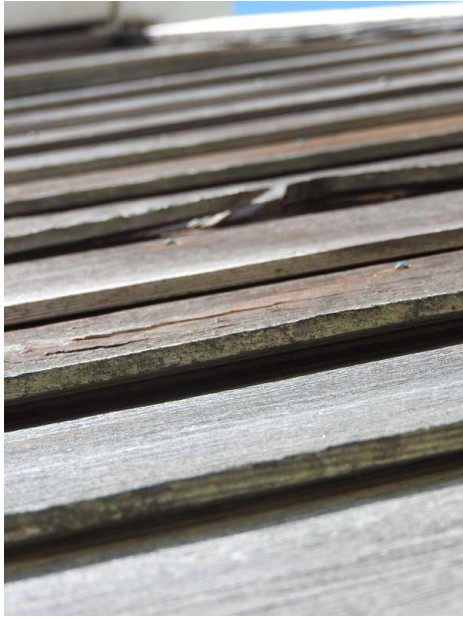
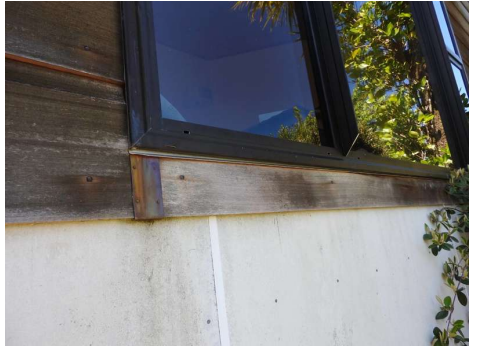
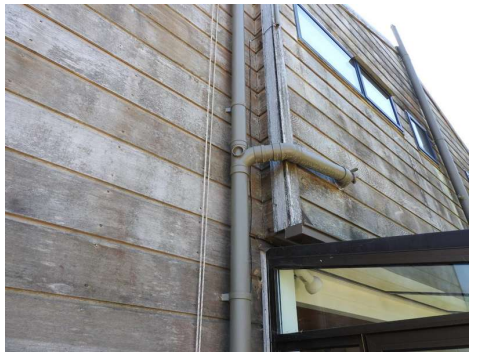
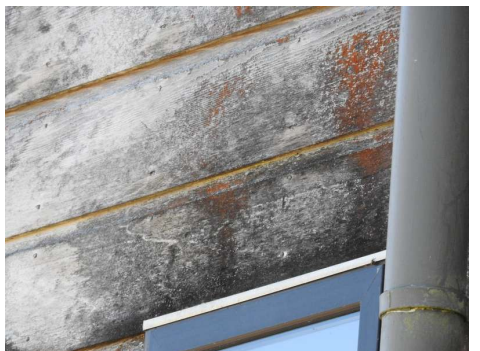
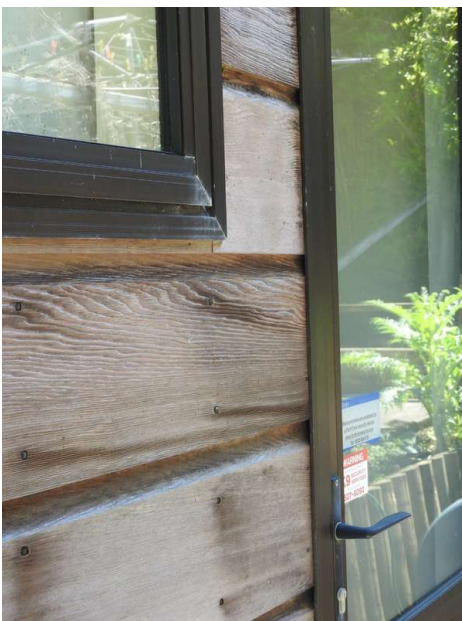
There are some cupping and splitting of boards found in isolated areas, some scribes are missing and there is some evidence of intermittent rainwater ingress in some of the upper floor bedrooms around the window wall penetrations. Would recommend these are fixed up swiftly to prolong the life of the cladding system.

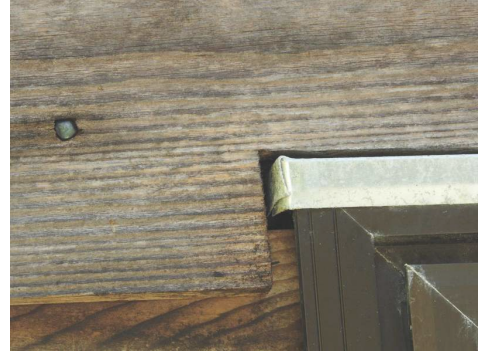
Some of the cutouts around the window head flashings have not been done properly and may be leaking during times of stormy weather.

The raking windows should have kick out flashings, this in a modern building requirement because these have been known to leak.

Contact a qualified carpenter.

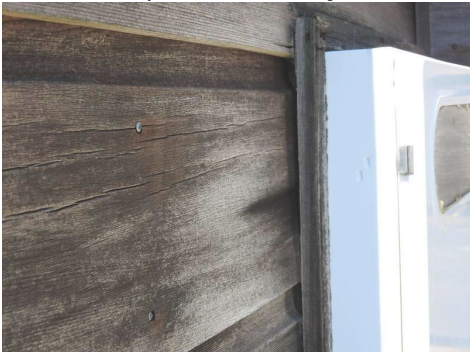
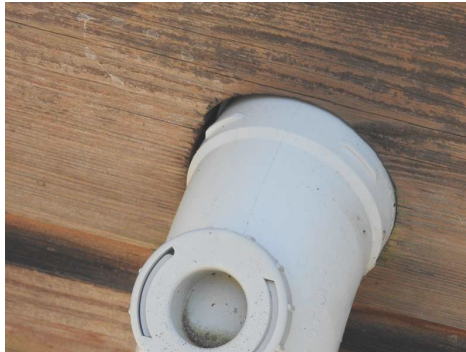
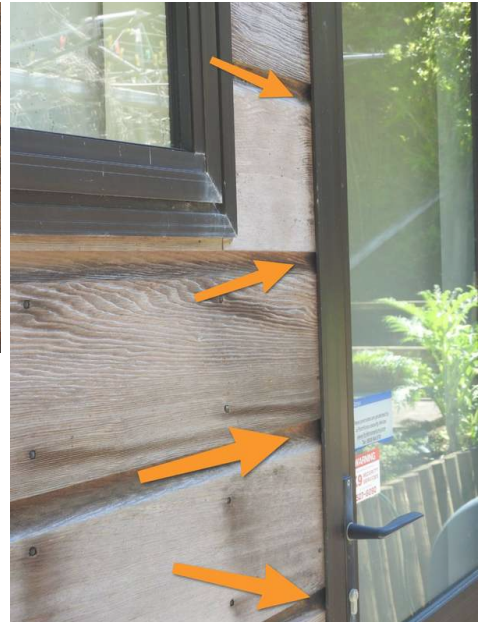
### 10.1.2 Weatherboard - Timber

The windows on the back wall (master bedroom an ensuite) have no scribe plugs, this is poor workmanship and may be leaking during times of stormy weather

Contact a qualified handyman.

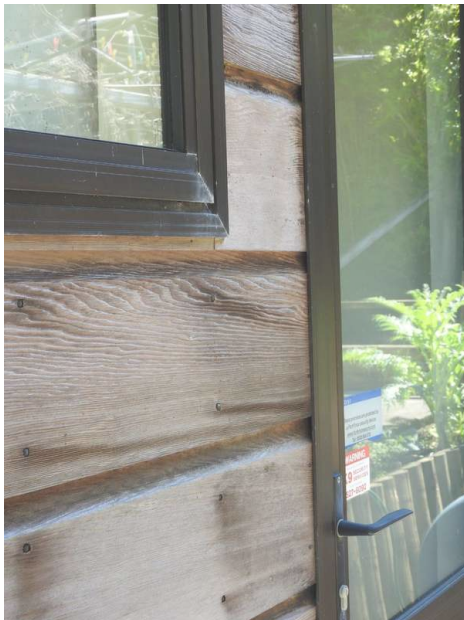
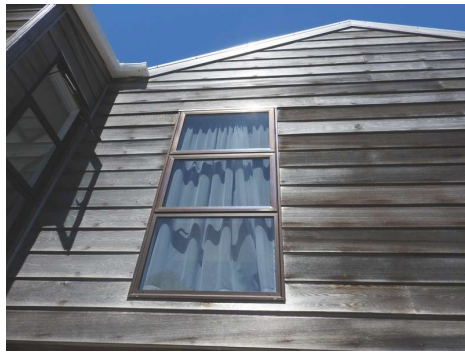
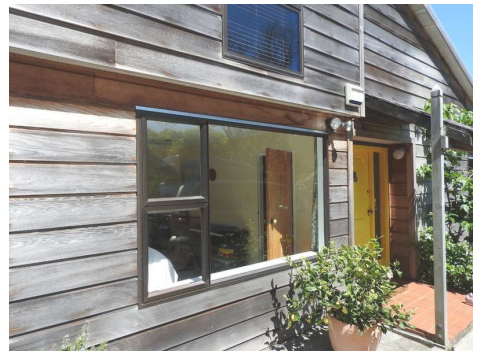
The retrofitted double glazed windows - with the added weight of the double glazing this may cause the window joinery to sag where these are installed as new. modern windows would have WANZ bars installed into the framework to account for the extra weight. This is showing on the bay window in the kitchen, you can see the weight of the roof and the window has dropped and it's putting stress on the joins.

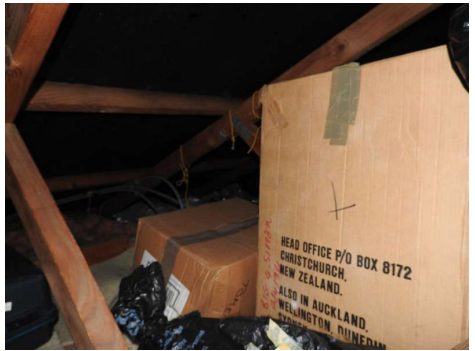
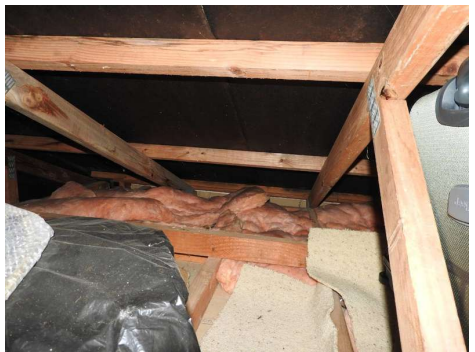
This area looks to be in great condition, there is a tear in the roofing underlay, it doesn't appear to be leaking there.

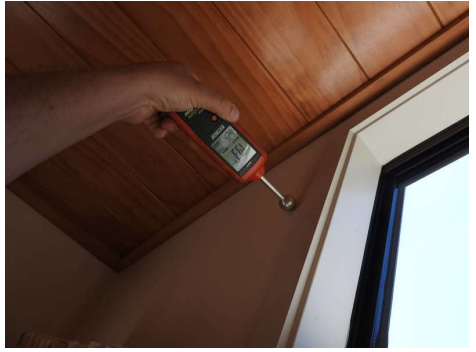
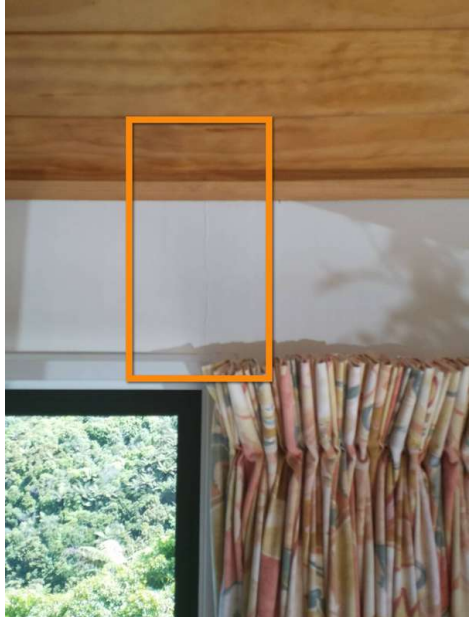
this plasterboard is cracked due to poor placement of sheet joins.

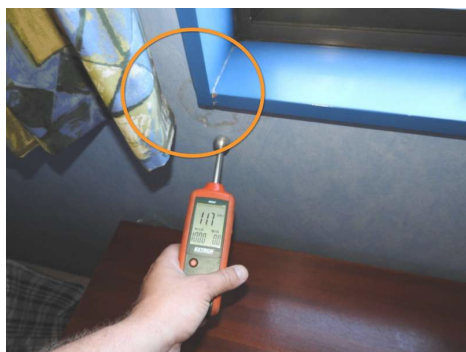
this is reading dry however there is a water stain on the wall here indicating evidence of a leak or condensation issues.

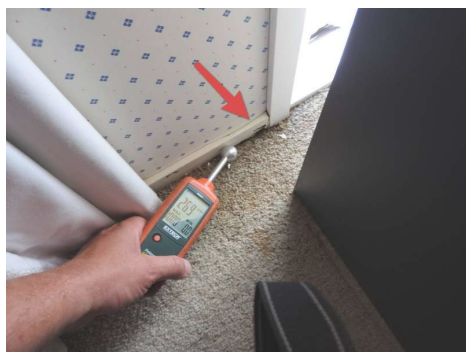
this area is currently reading dry however there is evidence of a leak here.

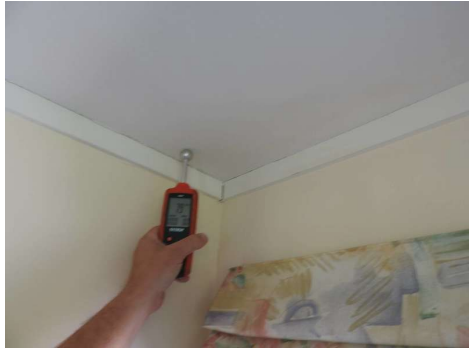
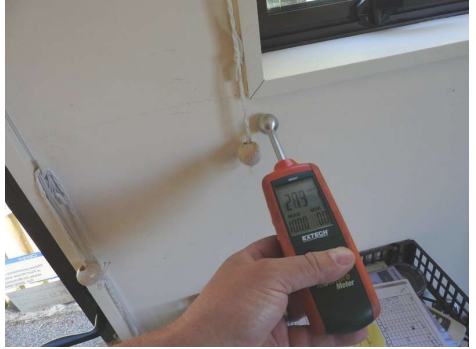
there is evidence of a leak by this door it is reading dry.
