WING BROTHERS HOME INSPECTIONS

RESIDENTIAL INSPECTION

1234 Main St. Lawton Ok 73505

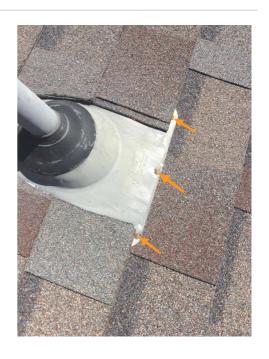
2.2.1 Flashings

EXPOSED NAILS

Exposed nails were observed in one or more roof flashings. This can lead to moisture intrusion. Recommend Repair: Seal with an approved sealant.

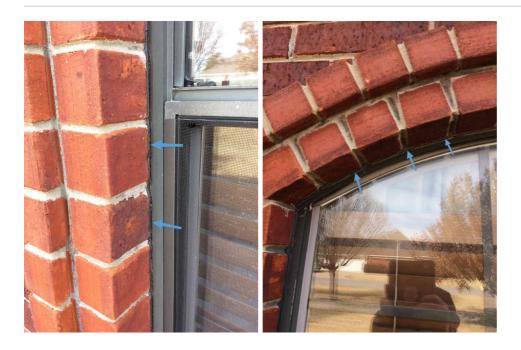
3.7.1 Windows

DETERIORATED/MISSING SEALANT

One or more windows have deteriorated/missing sealant. This can effect the energy efficiency of the property. Recommend Repair: Seal with an approved sealant.

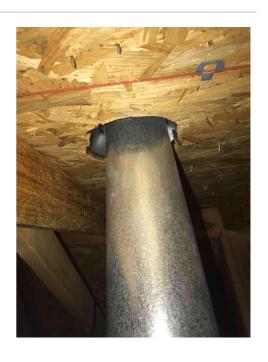
4.1.1 Roof Structure & Attic

INSUFFIENCT FLUE AND COMBUSTABLE CLEARANCE

The type B gas vent serving the water heater has improper clearance. Type B gas vent requires one inch clearance to combustibles. Recommend Repair.

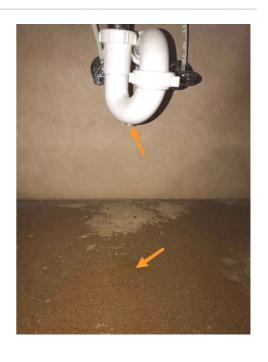
8.6.1 Drain, Waste, & Vent Systems

LEAKING

GUEST BATHROOM

Plumbing leaks were observed in one or more areas of the property. This can cause damage to interior components and furnishings. Recommend Repair/Replace.

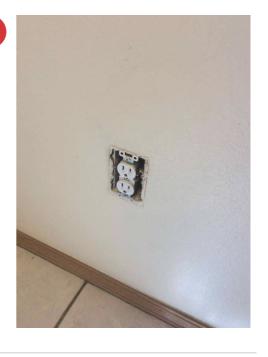
9.5.1 Connected Devices and Fixtures

COVER PLATES MISSING

KITCHEN

One or more receptacles are missing a cover plate. This causes short and shock risk. Recommend Repair: Install cover plates.

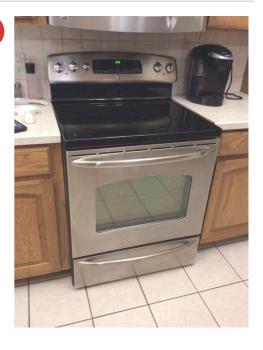
11.3.1 Range/Oven/Cooktop

Range was not fastened to the floor. This poses a safety hazard to children. Recommend Repair: Secure range according to manufacturers specifications.
