HOMEFIRST INSPECTIONS

RESIDENTIAL INSPECTION

1234 Main St. Newnan Georgia 30263

Buyer Name 05/17/2019 9:00AM

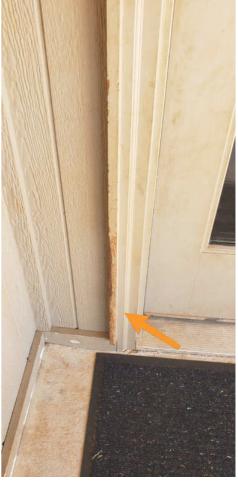
EXTERIOR DOOR(S) DAMAGED

Exterior door(s) have damage in one or more areas. Please see individual picture comments for more specific information.

Rear Entry. Apparant dog scratches

Contact a qualified professional.

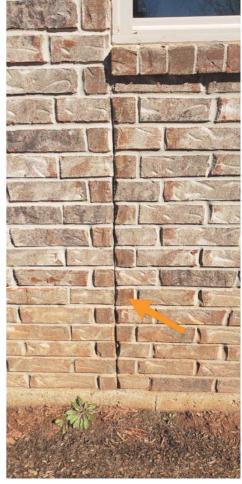
Multiple Locations

EXPANSION JOINT SEALANT MISSING

Expansion joint sealant is missing.

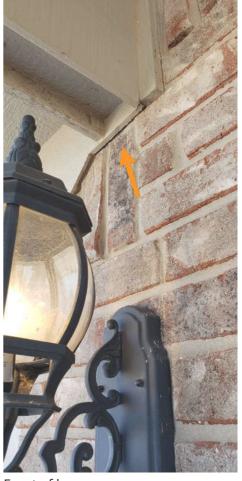
Front of home

CAULKING NEEDED

Recommend caulking to prevent moisture intrusion and wood rot.

Contact a qualified professional.

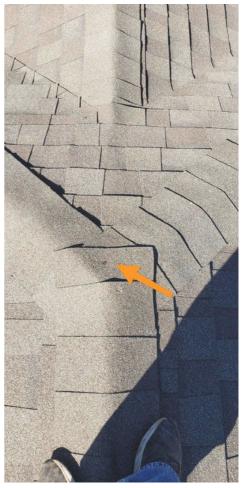
Multiple Locations

EXPOSED FASTENERS

Seal exposed fasteners to prevent moisture intrusion.

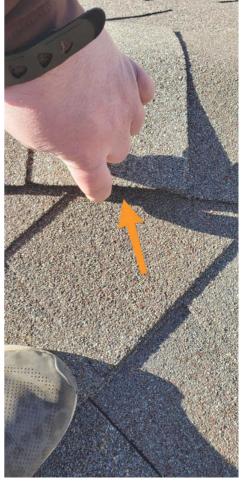
Entire ridgeline

VALLEY(S) NOT SEALED

One or more roof valleys and/or ridges were not properly sealed at time of inspection. It is recommended to properly seal the valley and/or ridge to avoid water intrusion.

Contact a qualified roofing professional.

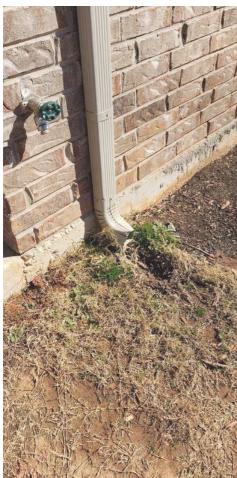
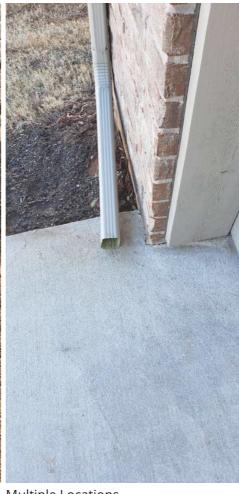
DOWNSPOUTS DRAIN NEAR HOUSE

One or more downspouts drain too close to the home's foundation. Adjust downspout extensions to drain at least 4-6 feet from the foundation.

Contact a qualified gutter contractor

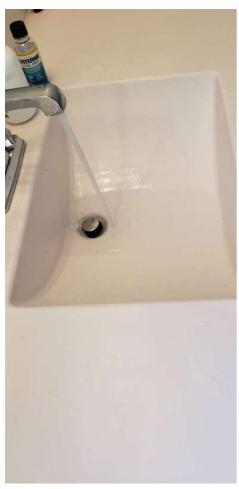
All Bathrooms

Fixtures, Water Supply, & Distribution Systems: No over-flow drains

There are no over-flow drains at the bathroom sink or sinks. Never walk away from sink while filling with water.

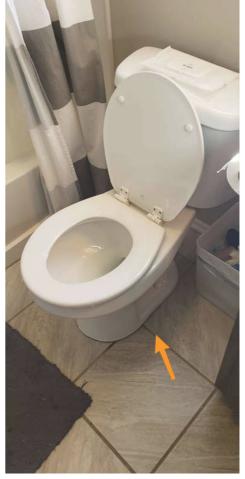
Guest Bath

TOILET(S) LOOSE

One or more toilets was noted as being loose where it attached to the floor. Leaks can occur if not repaired.

Contact a qualified plumbing contractor.

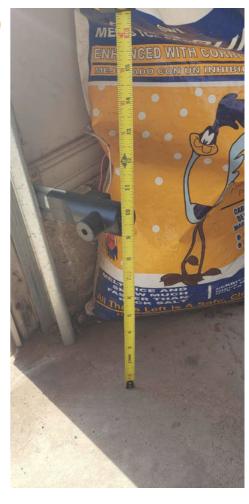
FLOOR SENSORS TOO HIGH

Floor sensors are recommended to be placed 4-6 inches above the floor.
