ALTO HOME INSPECTION, LLC

1234 Main St.
colden NY 14033

Buyer Name
03/05/2019 9:00AM

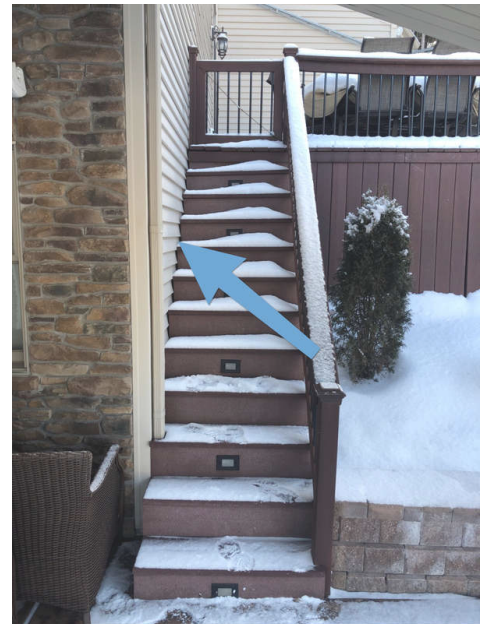
2.6.1 Stairs

HANDRAIL MISSING

For safety purposes, it is recommended to have stairway handrails on both the left and right sides. To improve safety, add a handrail to the left side.

Contact a qualified deck contractor.

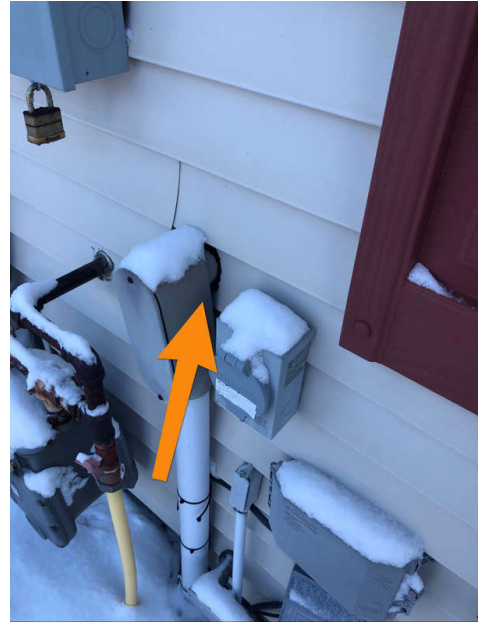
Gaps in the siding were observed which were not properly sealed. It is recommended that these gaps are properly sealed in order to prevent moisture intrusion and damage to underlying building materials.

Contact a qualified siding specialist.

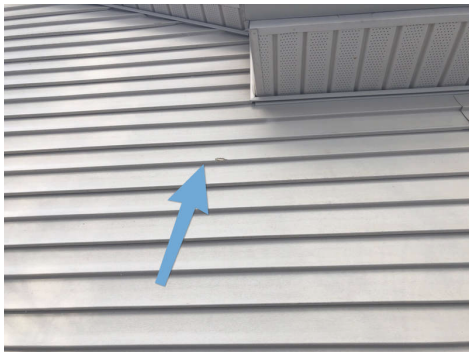
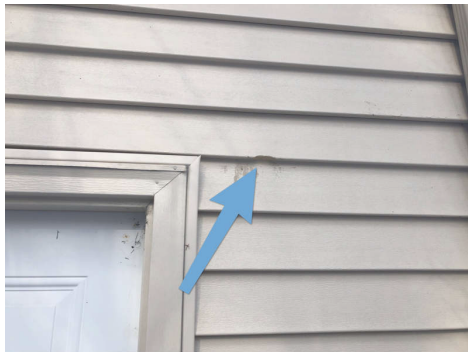
3.1.2 Siding, Flashing & Trim

DAMAGED SIDING

Contact a qualified professional.

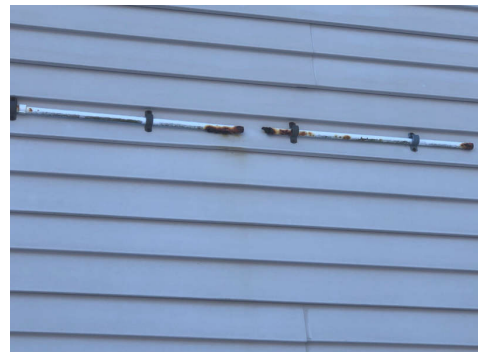
3.1.3 Siding, Flashing & Trim

NON-FUNCTIONAL ITEM

Contact a qualified professional.

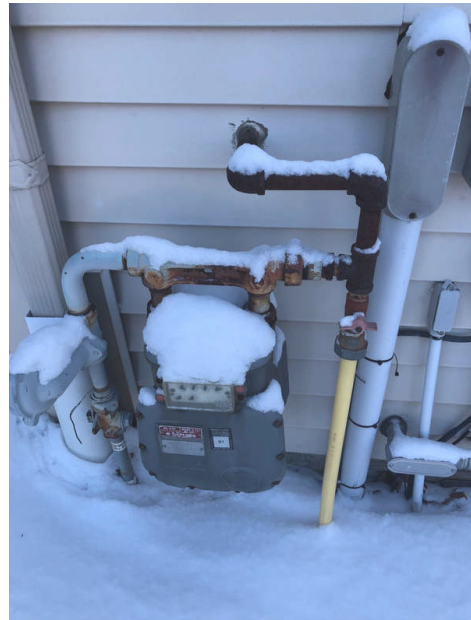
3.7.1 Gas service entrance

RUSTED GAS PIPING

Rust was present on the exterior gas piping that services the home. Have a plumber replace this piping, it is recommended that paint is touched up annually to help prevent future rust on new piping.

Contact a qualified plumbing contractor.

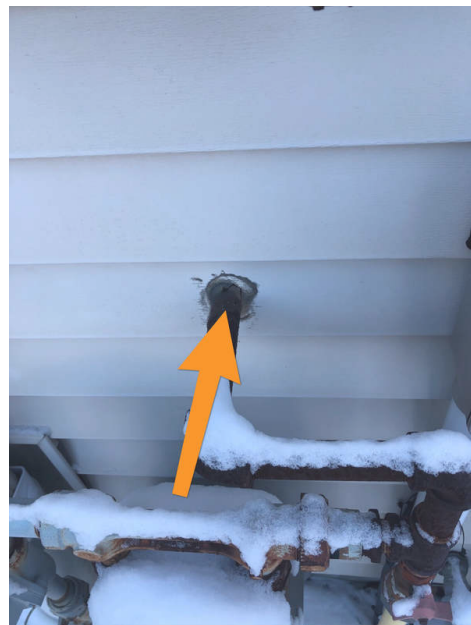
3.7.2 Gas service entrance

CRACKED SEALANT

Cracked sealant was present at the exterior wall penetration where the gas line piping enters the home. This sealant will further disintegrate and may provide an access path for insects and rodents.

This sealant should be removed and replaced with an appropriate product.

Contact a handyman or DIY project

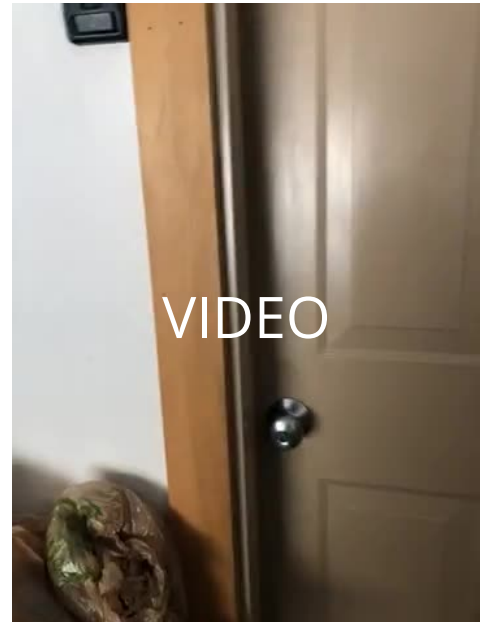
NOT SELF-CLOSING

Door from garage to home should have self-closing hinges to help prevent spread of a fire to living space. Recommend a qualified contractor install self-closing hinges.

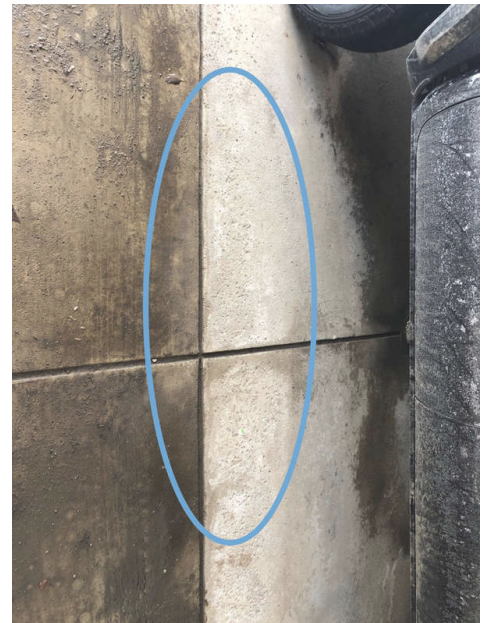
5.6.1 Garage Floor

SPALLING

The garage floor concrete showed signs of spalling, which commonly occurs in older concrete when exposed to frequent moisture and road salt. If desired, this section of concrete can be removed and replaced.

Contact a qualified concrete contractor.

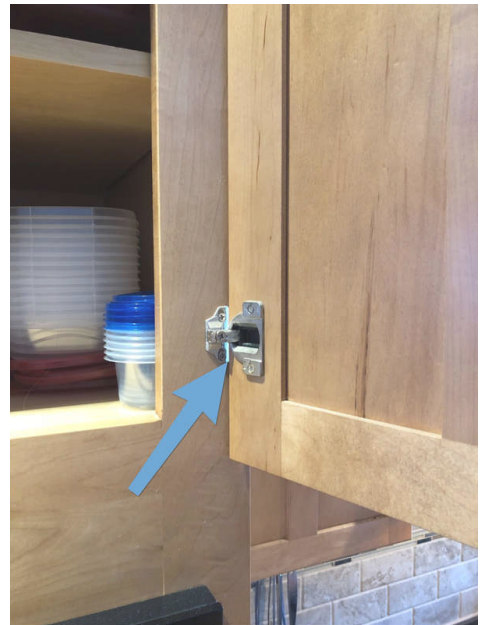
6.5.1 Cabinets & Countertops

HINGES NOT OPERATING PROPERLY

The hinges on at least one kitchen cabinet door are not operating properly. Most likely, they have suffered an internal break and need to be replaced.

Contact a handyman or DIY project

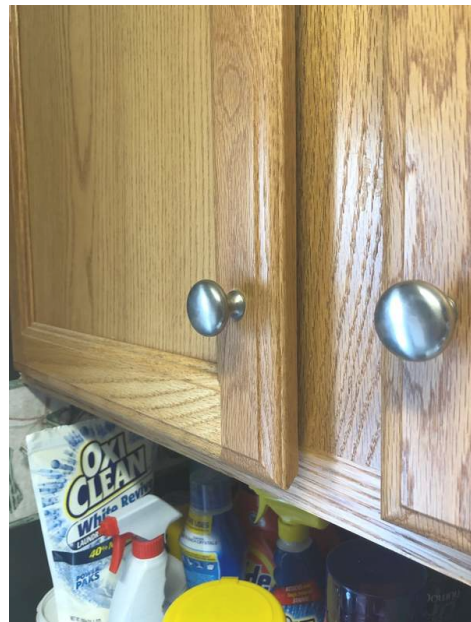
DAMAGED HINGE

Contact a handyman or DIY project

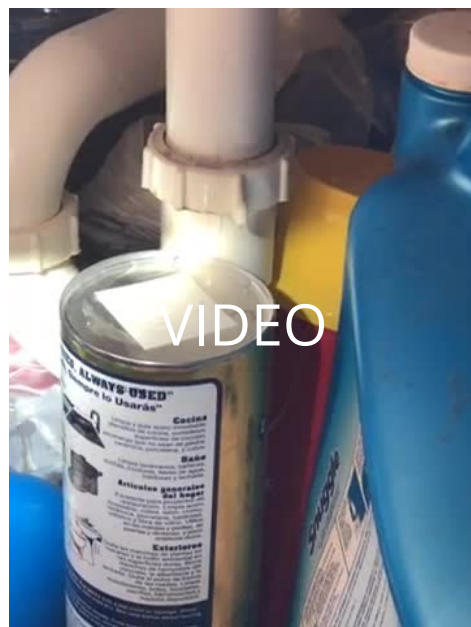
7.4.1 Visible Plumbing

ACTIVE LEAK

An active leak in the exposed plumbing under the laundry sink was observed.

Contact a qualified plumbing contractor.

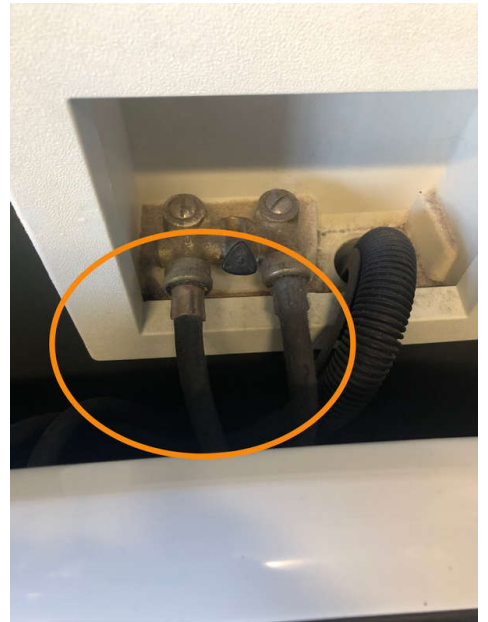
7.4.2 Visible Plumbing

REPLACE FLEXIBLE SUPPLY LINE

Contact a qualified plumbing contractor.

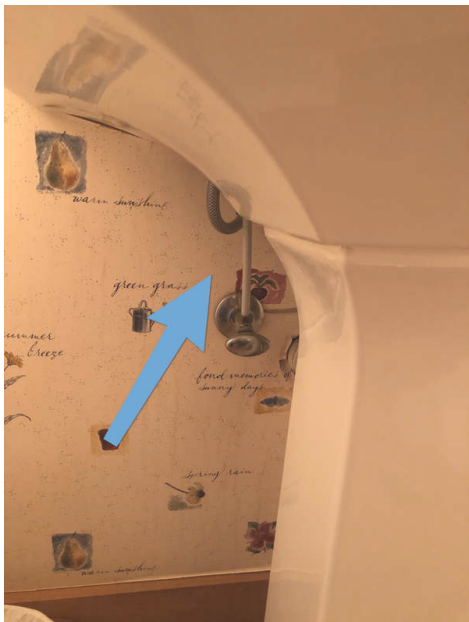
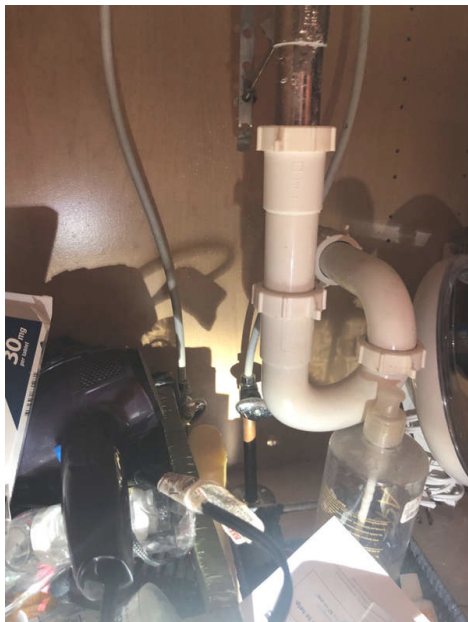
8.3.1 Visible Bathroom Plumbing

REPLACE FLEXIBLE SUPPLY HOSES

Contact a qualified plumbing contractor.

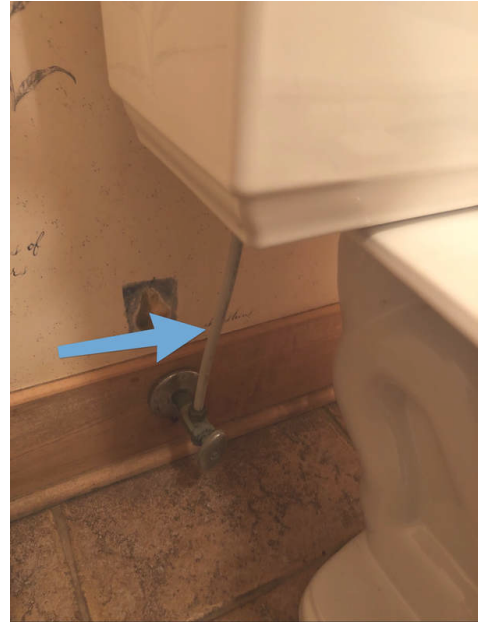
8.6.1 Toilet(s)

REPLACE FLEXIBLE SUPPLY LINE

Contact a qualified plumbing contractor.

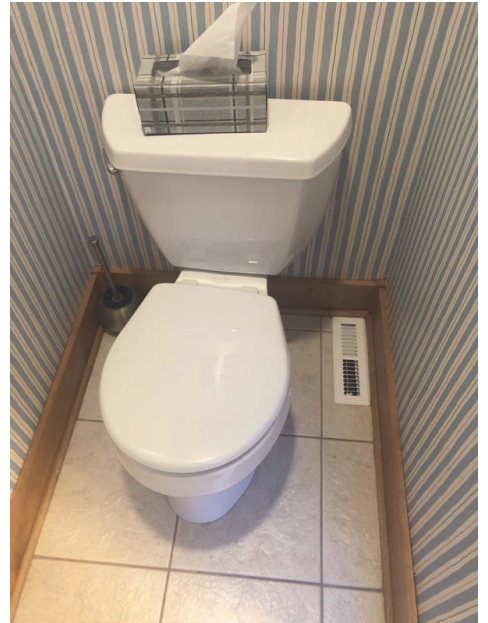
8.6.2 Toilet(s)

TOILET LOOSE

Contact a handyman or DIY project

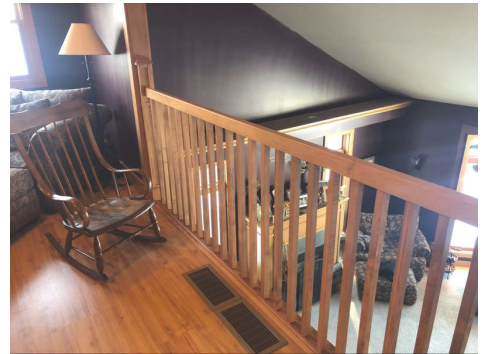
LOOSE HANDRAIL

The railing at the loft area moved more than expected when shaken. It is recommended to bolster the strength of the handrail in order to better protect small children from potentially breaking the railing.

Recommendation
Contact a qualified carpenter.

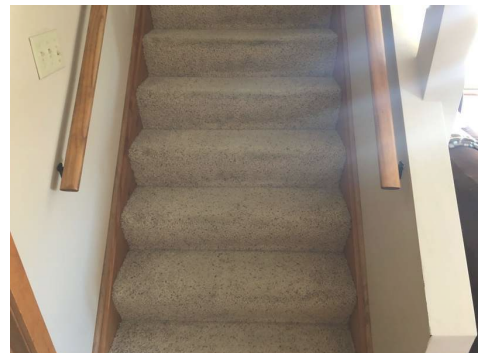
9.4.2 Steps, Stairways & Railings

HANDRAIL RETURNS MISSING

For safety purposes, it is recommended that stair handrails end at the wall instead of in free air. Engage a carpenter to discuss options for making this safety improvement.

Recommendation
Contact a qualified carpenter.

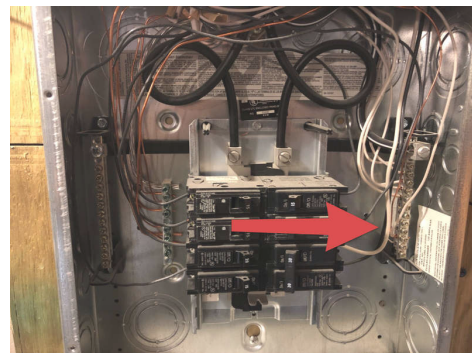
14.3.1 Distribution Panel/Sub-Panel

GROUND WIRE INSTALLED ON NEUTRAL BUS IN SUBPANEL

Significant Defect

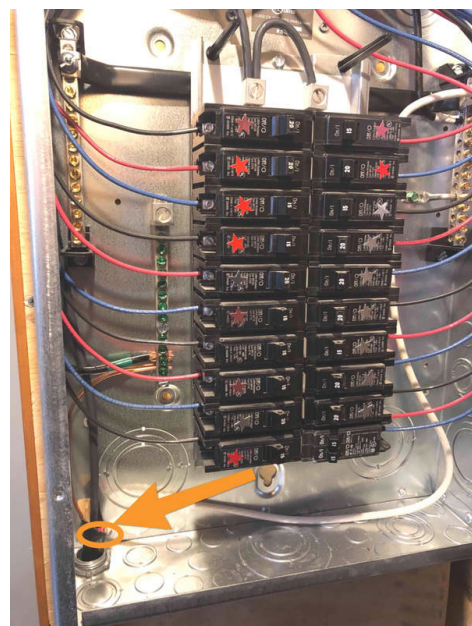
14.3.2 Distribution Panel/Sub-Panel

UNCAPPED AND EXPOSED WIRING

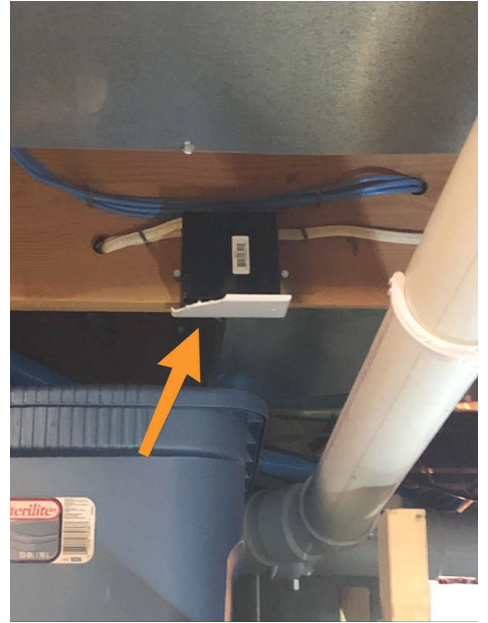
14.6.1 Branch Wiring

BROKEN COVER

Contact a qualified professional.
