## HOME INSPECTION

1234 Main St.  
Liberty TX 77575

# PROPERTY INSPECTION REPORT

**Concerning:** 1234 Main St. Liberty TX 77575  
(Address or Other Identification of Inspected Property)

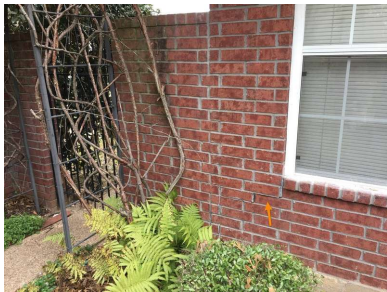
The foundation shows signs of settling around the home, evident mainly by cracks in the slab or brick walls, cracks above doors and windows, gaps around exterior trim or lowered areas of the floor. Further evaluation by a structural engineer is recommended to help determine if corrective action is necessary.

Left rear of house. There appears to be rotation of the brick face just below the corner of the window.

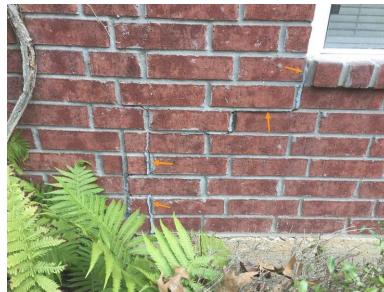
There appears to be rotation of the brick face just below the corner of the window.

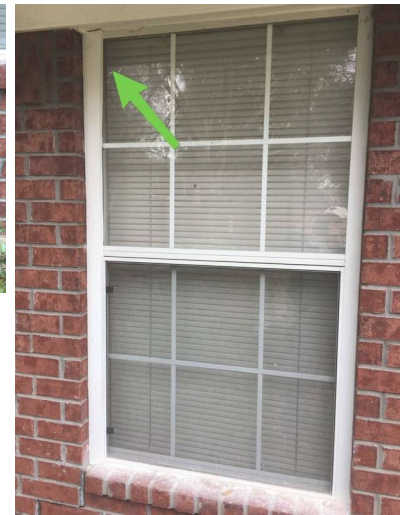
A trim piece has been added, presumably to cover a gap between the window and the brick.

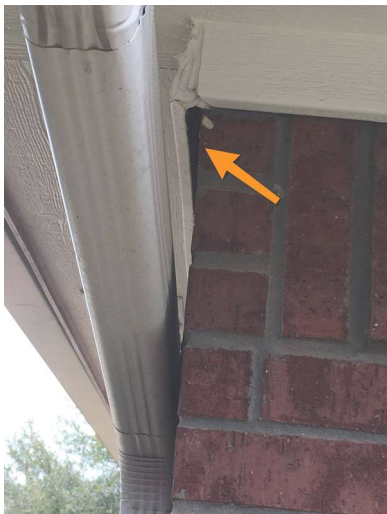
Separation of the brick mold from the wall.

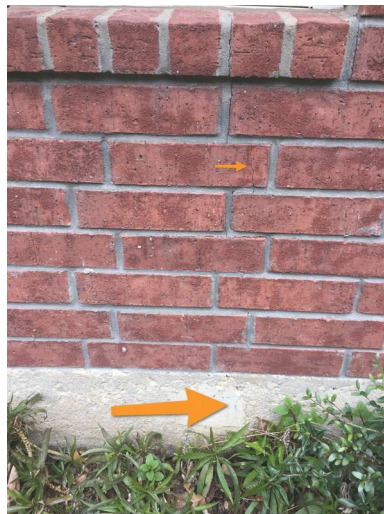
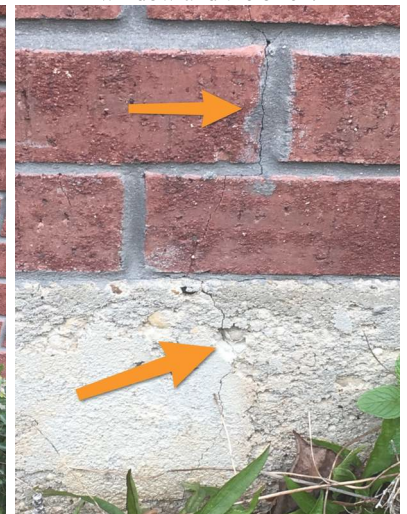
Cracks at the foundation wall and brick wall.

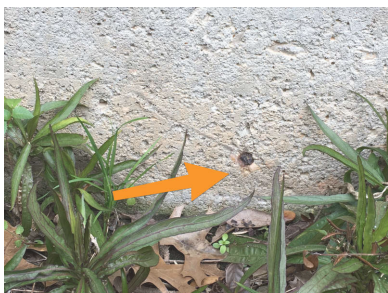
Post tension cable ends, rebar or nails were found to be exposed at the time of inspection and showing signs of rust. It is recommended to clean the exposed metal of rust and apply a non-shrink grout to help prevent rust which may lead to cracks in the slab.

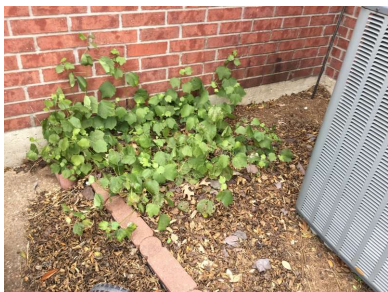
Planting beds have been constructed near the exterior walls. Water for plants will eventually soak into soil and may reach soil supporting the foundation. Excessively high moisture levels in soil supporting the foundation can effect its ability to support the weight of the structure above.

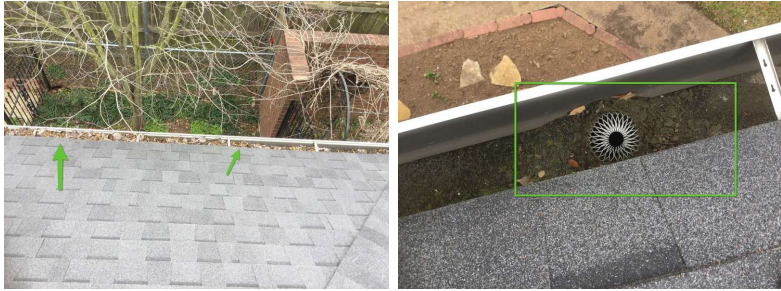
Debris visible in the gutters at the time of the inspection should be removed to help encourage proper drainage. This is a maintenance item.

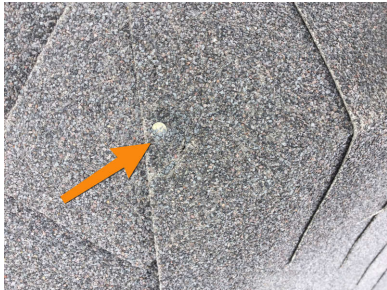
Some areas of the roof had fasteners visible. Fasteners have been installed to secure shingles or flashings from being blown loose by wind. Exposed fasteners should be sealed periodically to prevent moisture intrusion into the roof structure.

Recommendation: Contact a qualified roofing professional.

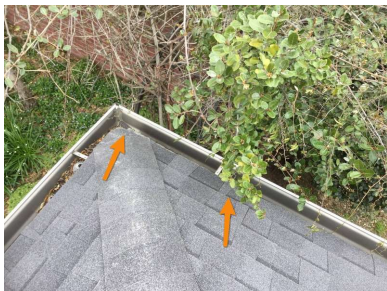
The tree limbs that are in contact with the roof or hanging near roof can cause abnormal wear and moisture penetration at the roof. Recommend trimming all tree limbs at least 18" away from the edge of the roof.

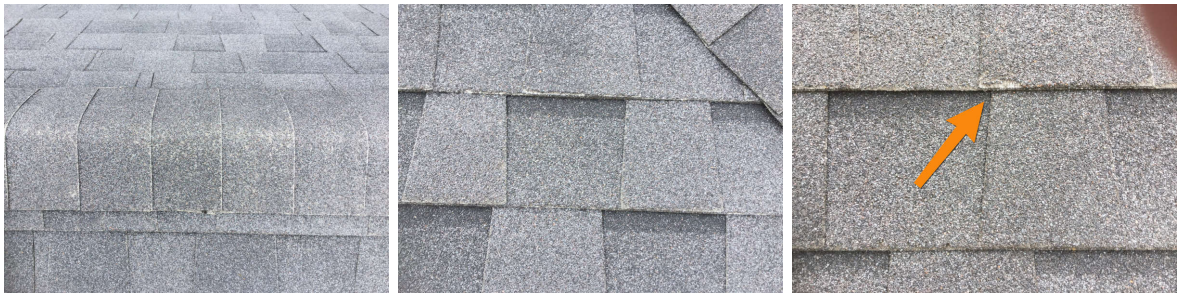
Shingles exhibited signs of minor deterioration commensurate with the age of the roof at the time of inspection. Given the age of the roof (approximately 15 years old), we recommend budgeting to replace the roof within the next few years.

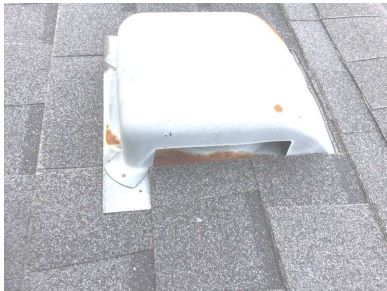
At the time of the inspection, flashing, turtle vents, and lead boots were showing signs of rust or corrosion. These may need to be replaced before it begins to leak to help prevent damage from moisture intrusion to the home materials, the roof structure and to help prevent development of microbial growth.

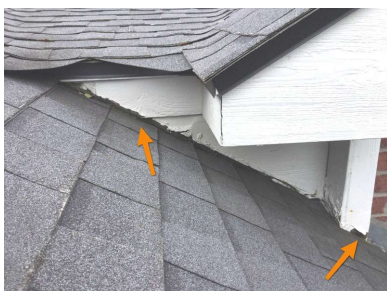
Above and to the left of front door

Flashing appeared to be missing or improperly installed and may allow moisture intrusion resulting in damage to home contents or materials. It is recommended to have this corrected to help prevent moisture intrusion into the roof structure.

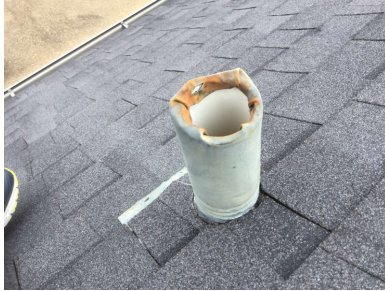
The lead "boots" on a number of vent pipes are beginning to rust. This leads to pitting, and then leaking, which allows moisture penetration down the outside surface of the vent pipe, into the attic, and possibly the ceiling.

Recommendation: Contact a qualified professional.

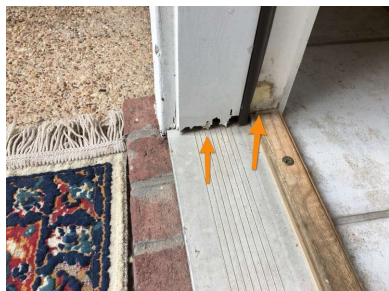
Front door

Exterior trim had decay visible in areas. This condition should ideally be corrected to help prevent water penetration into the wall structure and to help prevent further deterioration.

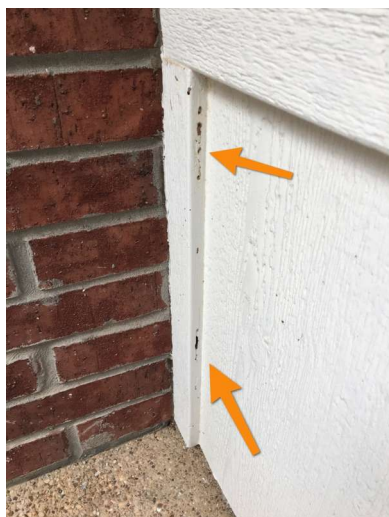
There is evidence of activity by possible wood-boring insects. Recommend an inspection by a licensed pest inspector.

Recommendation: Contact a qualified professional.

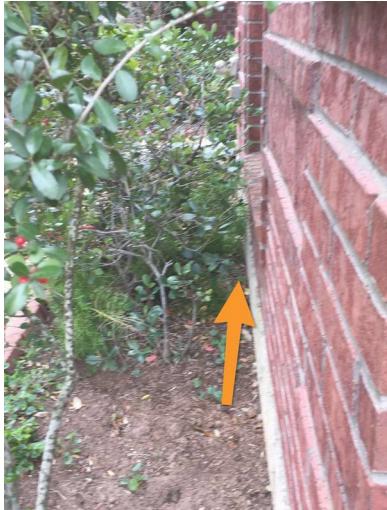
Vegetation was observed growing against the house at various locations. This contributes to wear and provides a pathway for insect access, including wood-boring insects. Recommend cutting vegetation away from the house at least 18 inches.

Recommendation: Contact a qualified professional.

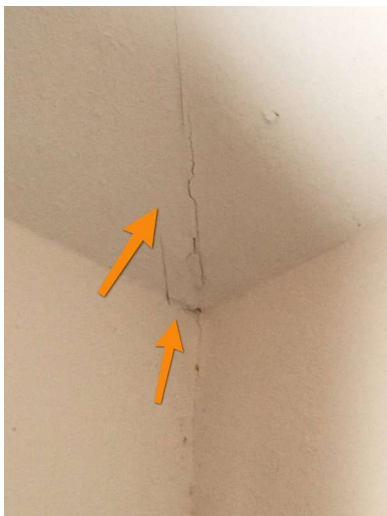
The ceiling has cracks, which may be an indication of settlement.

Master bedroom, at the outside corner.  
There is a similar crack on the same outside wall in the opposite corner.

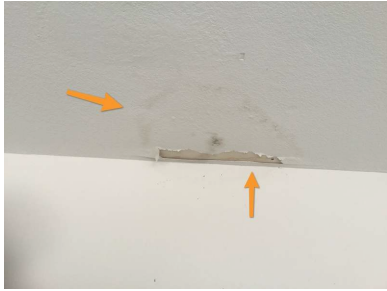
A moisture meter indicated the possibility of moisture in the garage ceiling materials. This may be an indication of roof leakage, leaking pipes or condensation in the attic and should ideally be corrected by a qualified professional to help prevent further deterioration.

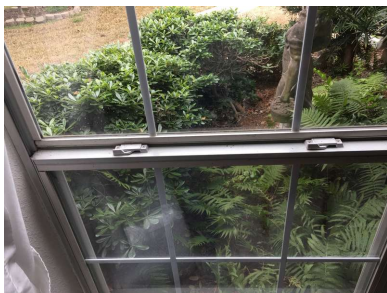
Condensation or signs of moisture between panes of double pane windows typically indicates failure of the seals and may not be visible at all times, depending on weather conditions and other factors. The inspector reports the condition of the property at the time of inspection and makes every effort to find and report all defects, but signs of failed seals may be detected after the inspection as conditions change. [Click here for more information](#)

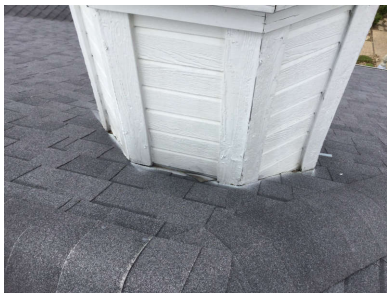
The chimney had no cricket. A cricket is a small roof built on the uphill side of the chimney to prevent roof drainage from pooling and causing damage from roof leakage. Crickets are recommended for chimneys measuring 30 inches or more in width (measured parallel to the eaves). This chimney appeared to measure more than 30 inches in width. Further evaluation by a qualified professional is recommended.

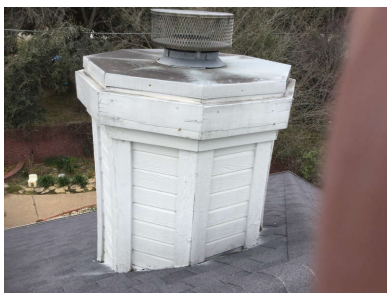
The chimney is showing signs of weather deterioration and should be repaired by a qualified professional.

Recommendation: Contact a qualified professional.

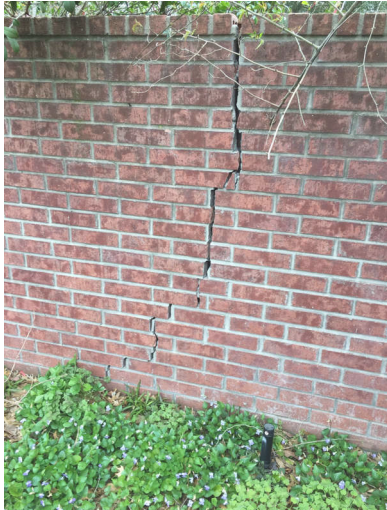
Significant settling cracks exist in the brick fence. Recommend a structural engineer evaluate.

Recommendation: Contact a qualified professional.

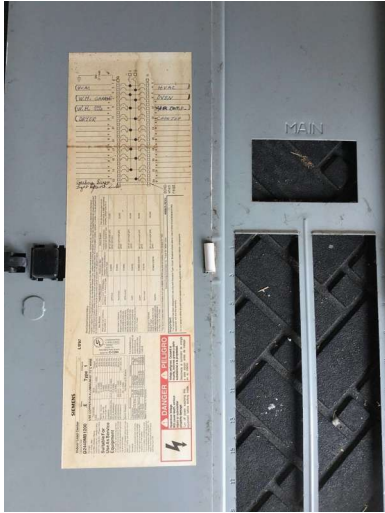
A Circuit Directory identifying individual electrical circuits was missing, illegible or inaccurate at this panel. The panel should contain a clearly-marked label identifying individual circuits so that in an emergency, individual circuits can be quickly shut off.

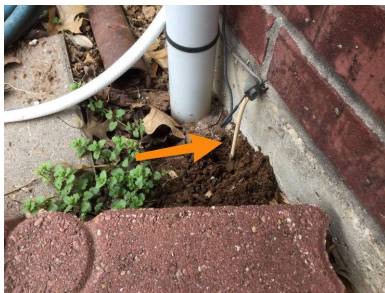
While there was a grounding cable connected to the panel, the inspector was unable to verify the presence of a grounding rod. Recommend a licensed electrician evaluate and repair if necessary.

Recommendation: Contact a qualified professional.

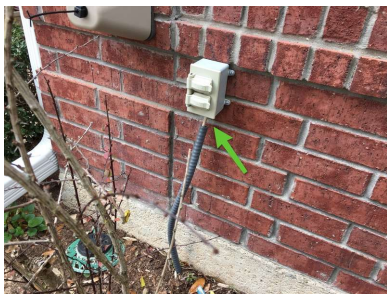
Front flower bed, right of front door

No ground fault circuit interrupter (GFCI) protection of some of the home electrical receptacles was provided in areas at the time of inspection. Also, wiring was exposed at this location and at the base of the mailbox. These issues should be repaired by a licensed electrician.

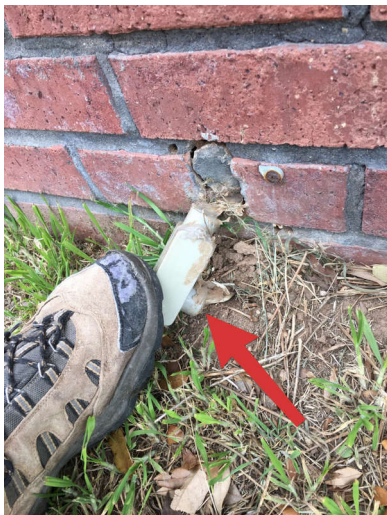
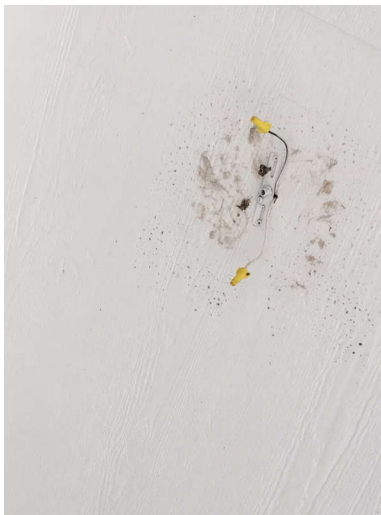
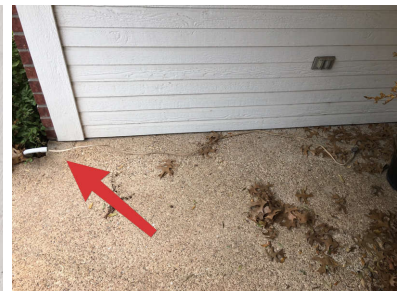
Base of mailbox, Back porch ceiling, back patio

Exposed wiring was visible and should be protected from physical damage as a safety precaution. This should ideally be performed by a qualified professional.

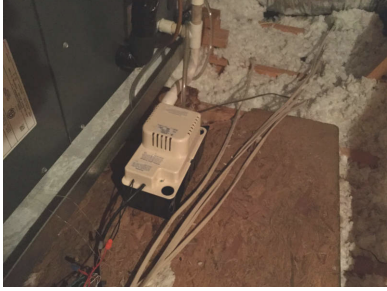
The attic unit uses a condensate pump to remove condensation from the a/c unit. The inspector was unable to test or activate this pump manually. This does not imply that the unit is defective, only that the inspector was not able to observe its function at the time of the inspection.

Recommendation: Contact a qualified professional.

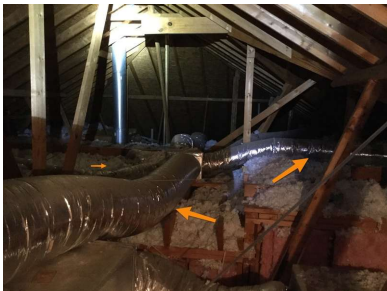
Air conditioning duct work should be suspended by proper strapping material. Allowing ductwork to lay directly on ceiling joists compacts insulation and increases the possibility of condensate buildup.

Recommendation: Contact a qualified professional.

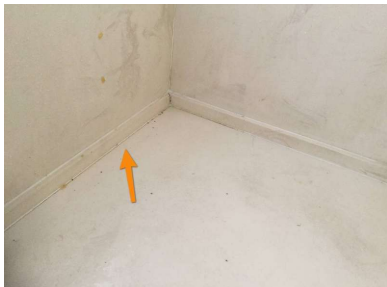
Master bath shower

The sealant where the shower floor meets the wall was old and had sections of sealant missing, which may allow damage from moisture intrusion of the wall assembly.

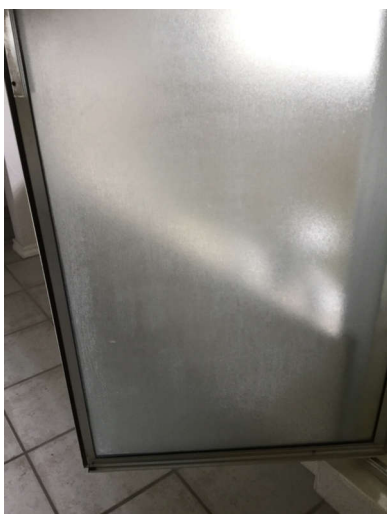
The glass shower enclosure may not have been made from tempered glass or the label was not visible at the time of inspection. Tempered glass is typically required in this area. Further evaluation by a qualified contractor is recommended if this is an area of concern to you.

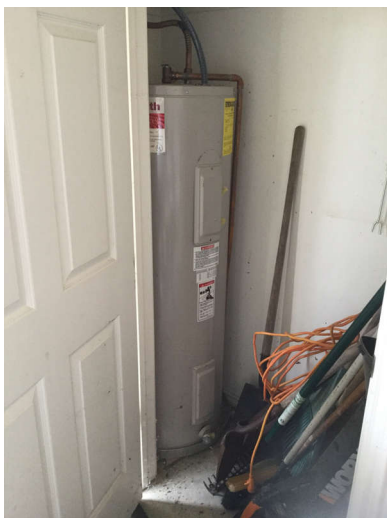
Although this gas water heater was installed in the garage, it was not installed on a raised platform a minimum of 18 inches in height as is required by generally-accepted modern safety standards for water heaters that are not a Flammable Vapor Ignition Resistant (FVIR) type. This water heater did not appear to be a FVIR Type. The Inspector recommends correction by a qualified plumbing contractor.

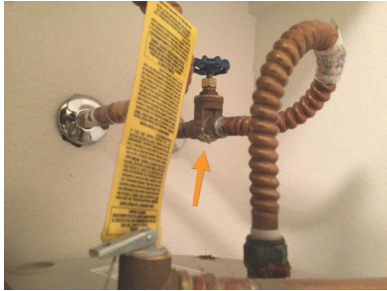
The cold water supply shutoff to this water showed visible evidence of long term leaking. This valve appeared to have failed, cutting off the water supply to the water heater, which allowed no hot water function at the attached hot water faucets. Recommend a qualified plumber evaluate and repair as needed.

Recommendation: Contact a qualified professional.
