PINPOINT HOME INSPECTIONS

RESIDENTIAL INSPECTION REPORT

1234 Main St.
Knoxville TN 37918

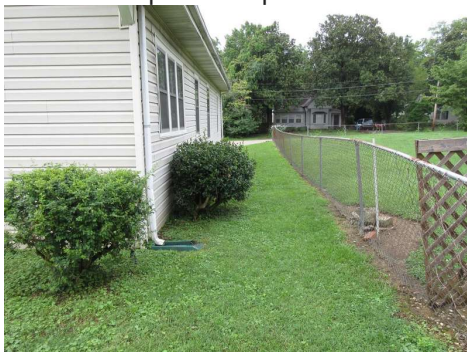
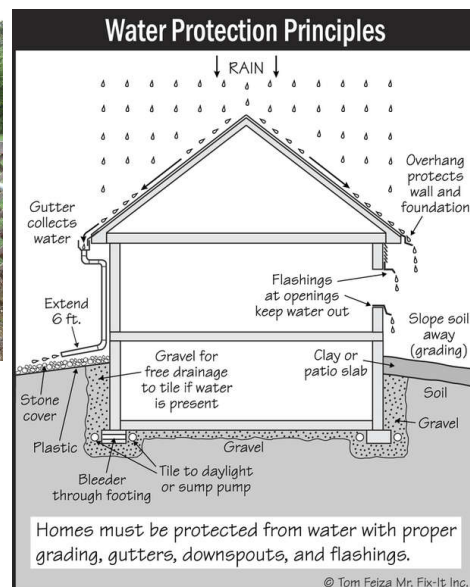
2.1.1 Grading, Vegetation, & Retaining Walls

The soil or grading sloped down towards building perimeters in one or more areas. This can result in water accumulating around building foundations or underneath buildings. It can be a conducive condition for wood-destroying organisms. Recommend grading soil so it slopes down and away from buildings with a slope of at least 1 inch per horizontal foot for at least 6 feet out from buildings.

Contact a qualified professional.

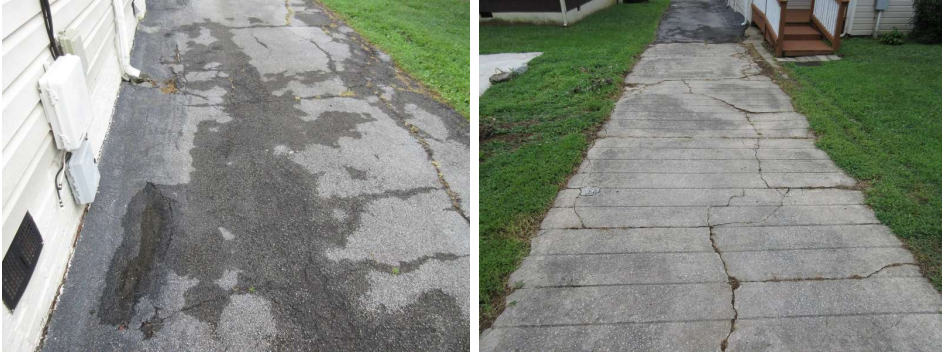
Deficiencies**DRIVEWAYS - NEED REPAIR**

Cracks, holes, settlement, heaving and/or deterioration were found in the driveway. Recommend that qualified contractor repair as necessary. Trip hazards were present.

Contact a qualified professional.

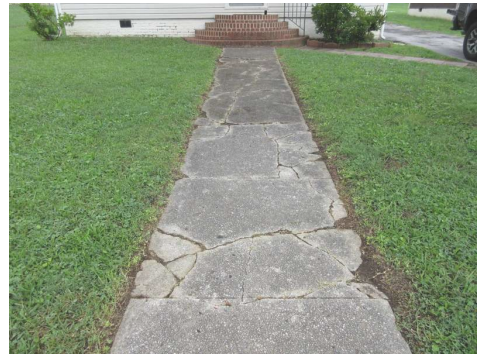
Deficiencies**SIDEWALK; NEEDS REPAIR**

Cracks, holes, settlement, heaving and/or deterioration were found in sidewalks. Recommend that qualified contractor repair as necessary.

Contact a qualified professional.

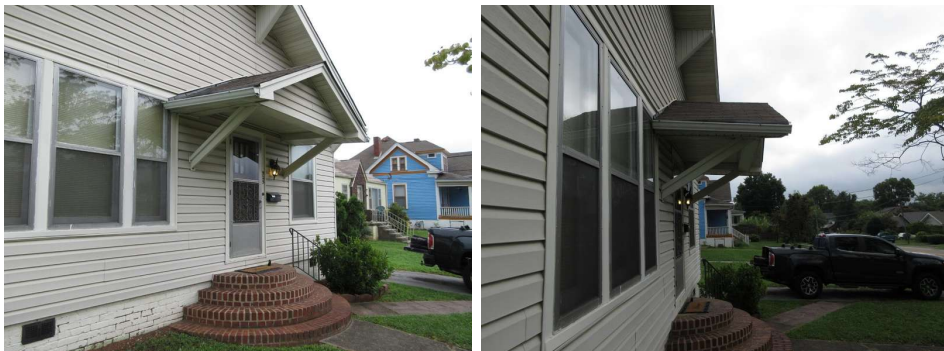
Significant Deficiencies**UNSTABLE OR SAGGING; EVALUATE OR REPAIR**

The porch roof appeared unstable due to substandard bracing, lack of diagonal bracing, or lack of attachment to the main building. This is a safety hazard since severe movement may cause the cover to collapse. A qualified contractor should repair as necessary.

Contact a qualified professional.

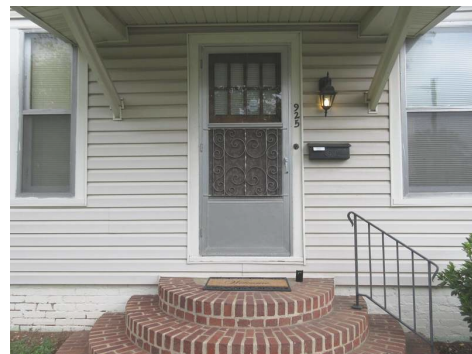
2.6.1 Stairs

A door swung outward over one or more sets of stairs, and either no landing was installed, or the landing didn't extend at least 20 inches beyond the outermost swing area of the door. This a safety hazard since someone standing on the stairs can fall or be pushed backwards if the door is opened. Recommend that a qualified contractor repair per standard building practices.

Contact a qualified professional.

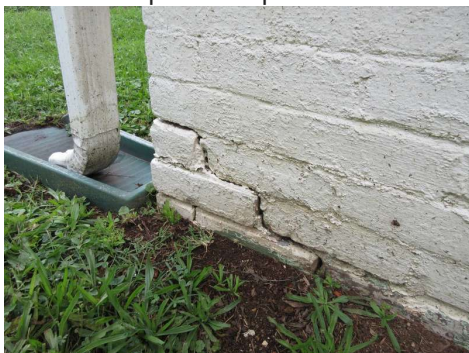
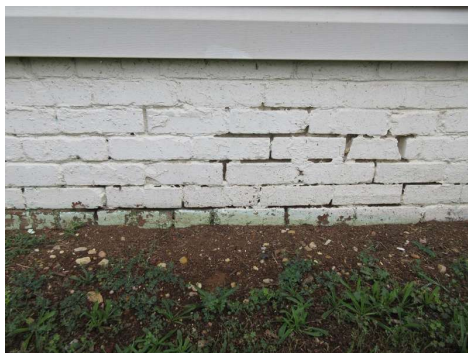
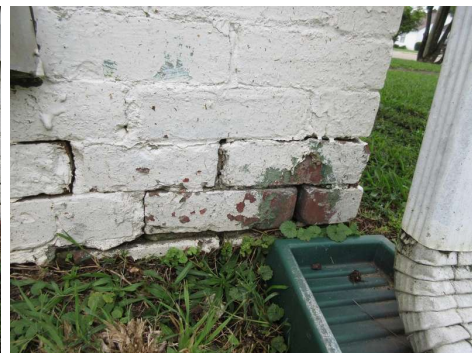
BRICK, STONE VENEER - CRACKS, DETERIORATION

The masonry (brick) veneer was deteriorated or damaged in some areas. Where cracks or openings are exposed, water can enter the wall structure causing mold, fungal growth and structural damage. This is a conducive condition for wood-destroying organisms. Recommend that a qualified contractor repair as necessary. For example, by repointing mortar or replacing broken or missing masonry.

Contact a qualified professional.

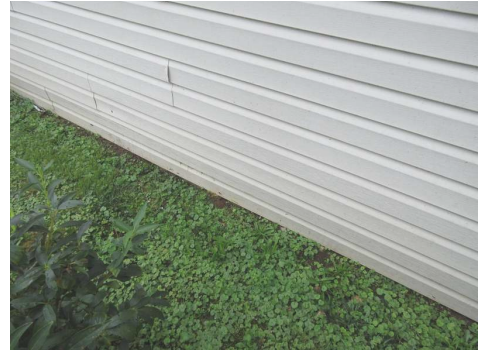
2.8.2 Exterior Walls & Trim

Soil was in contact with or less than 6 inches from siding or trim. Regardless of what material is used for siding, it should not be in contact with the soil. If made of wood, siding or trim will eventually rot. For other materials, ground or surface water can infiltrate siding or trim and cause damage to the wall structure. Wood-destroying insects are likely to infest and damage the wall structure. This is a conducive condition for wood-destroying organisms. Recommend grading or removing soil as necessary to maintain a 6-inch clearance. Note that damage from fungal rot and/or insects may be found when soil is removed, and repairs may be necessary.

Contact a qualified professional.

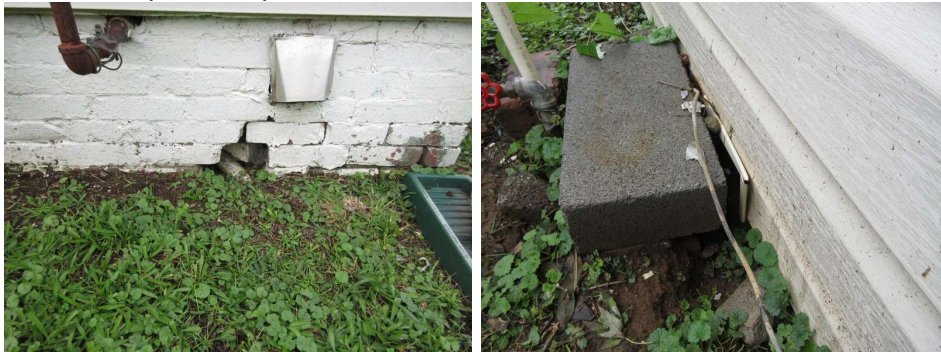
HOLES, GAPS

One or more holes or gaps were found in siding or foundation walls. Vermin, insects or water may enter the structure. Recommend that a qualified person repair as necessary.

Contact a qualified professional.

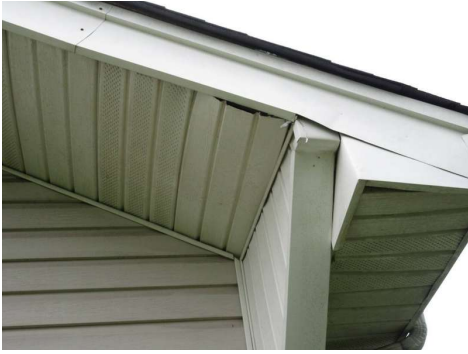
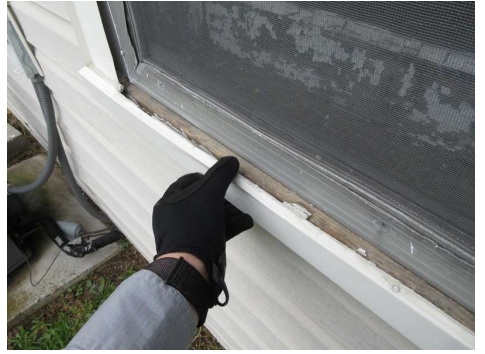
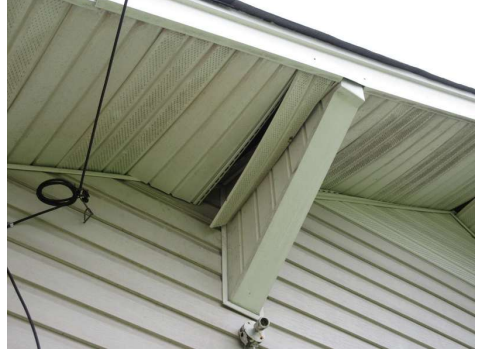
VINYL SIDING, TRIM; DAMAGE OR DEFICIENCIES

Vinyl siding, trim, soffits and fascias covering exterior walls contained several deficiencies. Multiple sections of soffit were loose or damaged. Aluminum fascia trim was loose and damaged in several areas. Vinyl siding covering exterior walls was loose, bulged, and contained damage which may allow moisture intrusion. Recommend a qualified contractor evaluate the home's wall cladding and trim and provide options and costs for repair.

Contact a qualified professional.

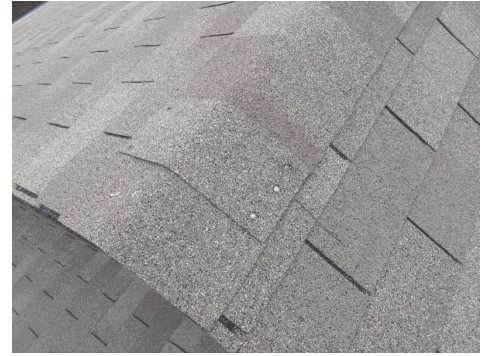
Nail heads were exposed at one or more shingles. More than just a few exposed nail heads may indicate a substandard roof installation. Recommend applying an approved sealant over exposed nail heads now and as necessary in the future to prevent leaks.

Contact a qualified professional.

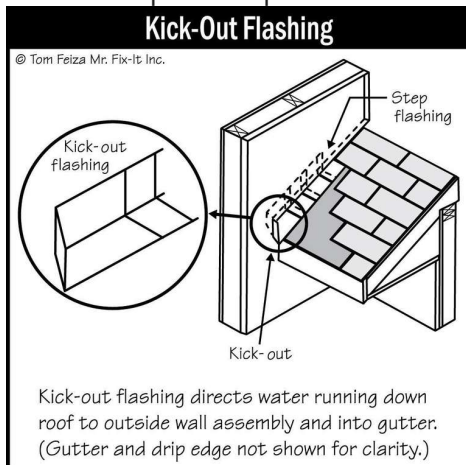
3.2.1 Flashings

Kick-out flashing was missing where walls extended past the roof edge. Leaks can occur as a result. This is a conducive condition for wood-destroying organisms. Recommend that a qualified person repair as necessary.

Contact a qualified professional.

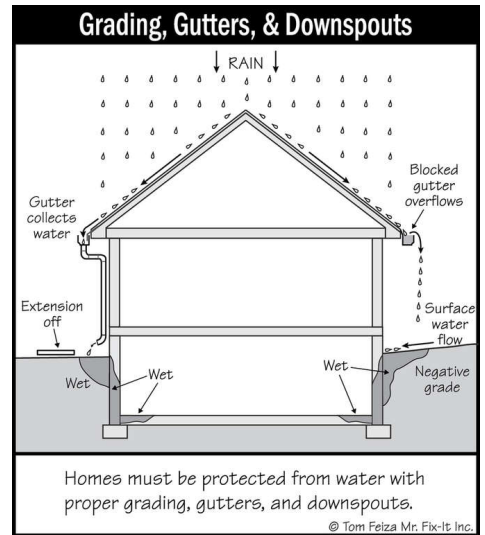
Downspouts discharged roof runoff too close to the home's foundation. Water can accumulate around the building foundation or inside crawl spaces or basements as a result. Recommend that a qualified person install, replace or repair extensions as necessary so rainwater drains away from the structure a minimum of 6 feet.

Contact a qualified professional.

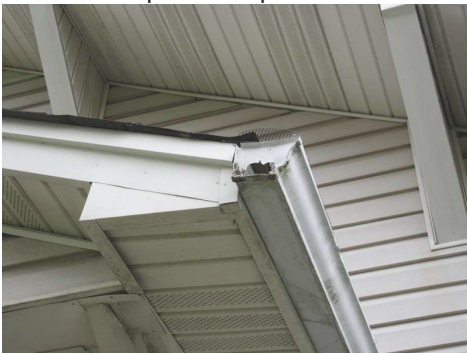
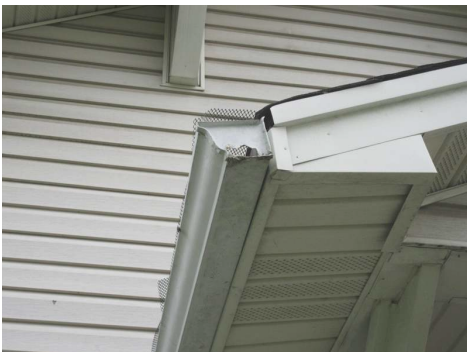
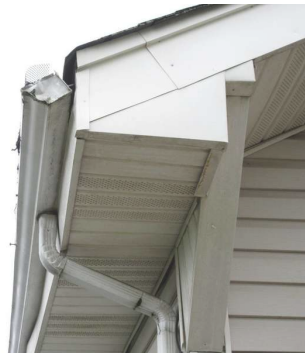
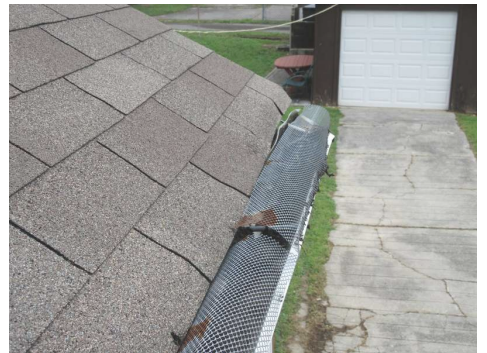
3.3.2 Gutters, Downspouts, & Extensions

Gutters and downspouts were loose and damaged. Rainwater can come in contact with the building exterior or accumulate around the building foundation as a result. This is a conducive condition for wood-destroying organisms. Recommend that a qualified person repair as necessary.

Contact a qualified professional.

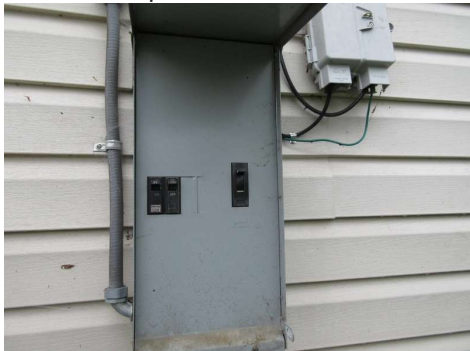
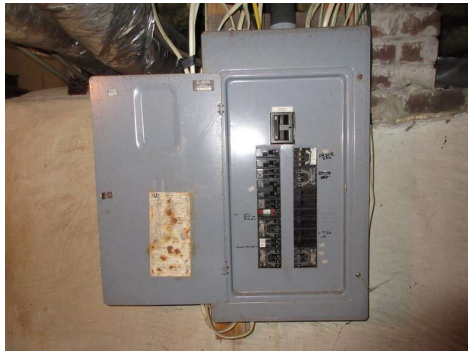
LEGEND MISSING, SUBSTANDARD

The legend/directory for circuit breakers was incomplete. This is a potential shock or fire hazard in the event of an emergency when power needs to be turned off. Recommend correcting the legend so it's accurate, complete and legible. Evaluation by a qualified electrician may be necessary.

Contact a qualified electrical contractor.

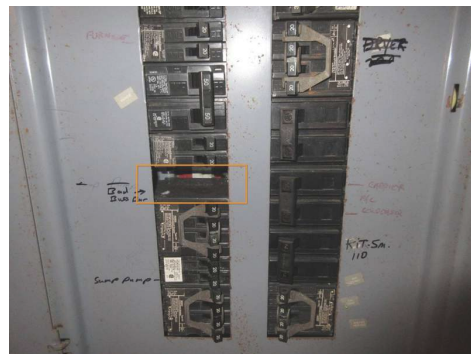
MISSING KNOCKOUT

One or more knockouts were missing from the sub-panel. Holes in panels are a potential fire hazard if a malfunction ever occurs inside the panel. Rodents can also enter panels through holes. Recommend that a qualified person install knockout covers where missing and per standard building practices.

Contact a qualified electrical contractor.

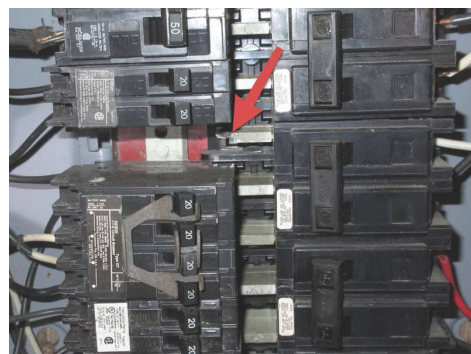
PANEL; DAMAGE

The sub-panel contained damage to the bus bar and minor surface rust was present. Recommend consultation with a qualified electrical contractor to determine if repair or replacement is necessary.

Contact a qualified electrical contractor.

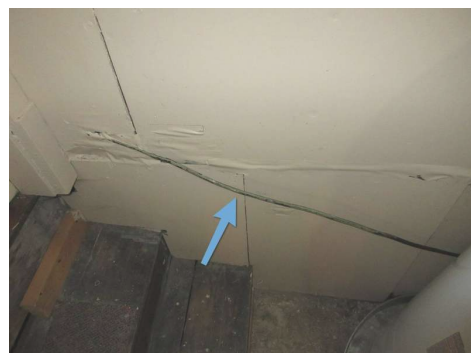
BASEMENT STAIRWAY

Non-metallic sheathed wiring was installed at one or more locations, and was subject to damage such as on easily accessible wall or ceiling surfaces. The insulation can be damaged by objects coming in contact with it, resulting in exposed, energized wires. Also, copper conductors can break after being repeatedly moved or bent. This is a potential shock or fire hazard. Recommend that a qualified electrician repair per standard building practices. For example, by installing protective conduit or re-routing wires through walls or ceilings.

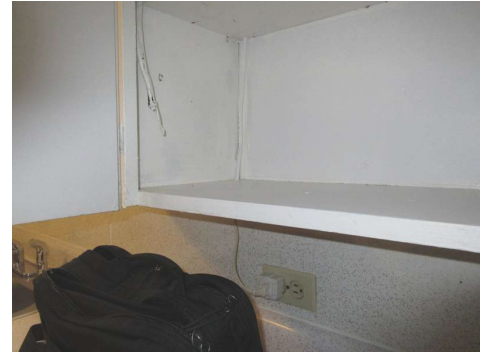
Extension cords were being used as permanent wiring at one or more locations. They should only be used for portable equipment on a temporary basis. Using extension cords as permanent wiring is a potential fire and shock hazard, and indicates that wiring is inadequate and needs updating. Extension cords may be undersized. Connections may not be secure resulting in power fluctuations, damage to equipment, overheating and sparks that could start a fire. Recommend that a qualified electrician repair per standard building practices and eliminate extension cords for permanently installed equipment.

Contact a qualified electrical contractor.

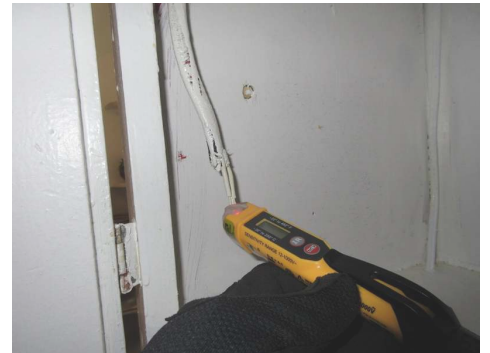
EXPOSED SPLICES OR ENERGIZED WIRING

Energized wiring was exposed to touch. This is a potential shock or fire hazard. Recommend that a qualified electrician repair per standard building practices. For example, by removal or proper termination of wiring.

Contact a qualified electrical contractor.

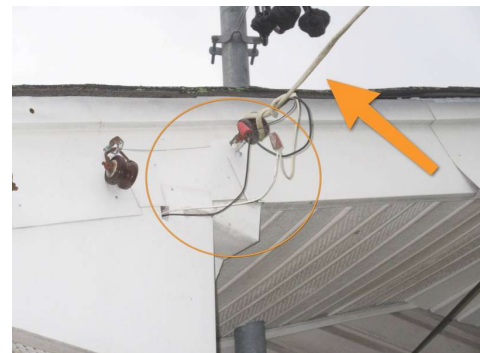
WIRING

Substandard wiring was found at the building exterior. For example, exposed wiring and wiring not suitable for its use. This is a safety hazard. Recommend that a qualified electrician evaluate and repair as necessary and per standard building practices.

Contact a qualified electrical contractor.

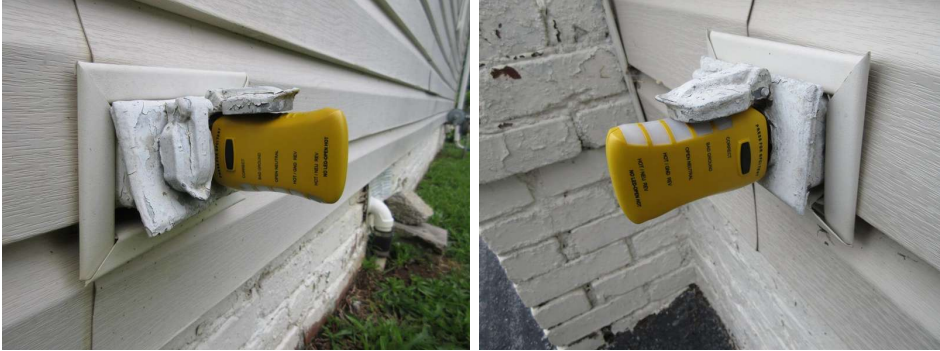
Deficiencies**EXTERIOR; COVERS BROKEN**

One or more exterior receptacle covers were broken, worn, or damaged. This condition may allow moisture intrusion. Recommend that a qualified person replace covers where necessary.

Contact a qualified electrical contractor.

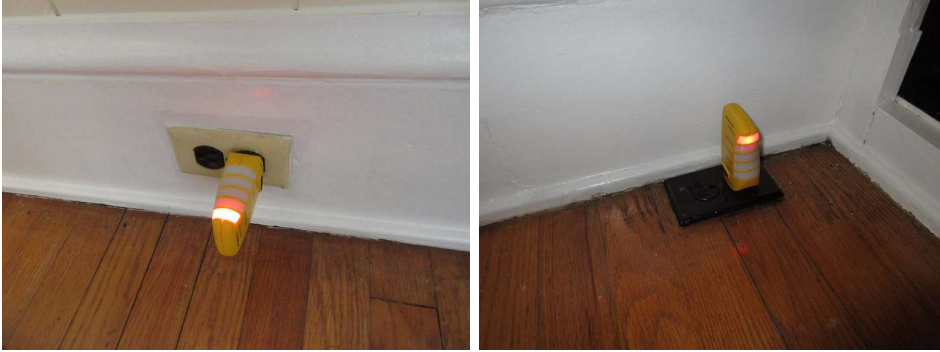
Deficiencies**HOT-NEUTRAL REVERSE**

One or more electric receptacles had reverse-polarity wiring, where the hot and neutral wires were reversed. This is a shock hazard. Recommend that a qualified electrician repair as necessary. For more information, visit:

Contact a qualified electrical contractor.

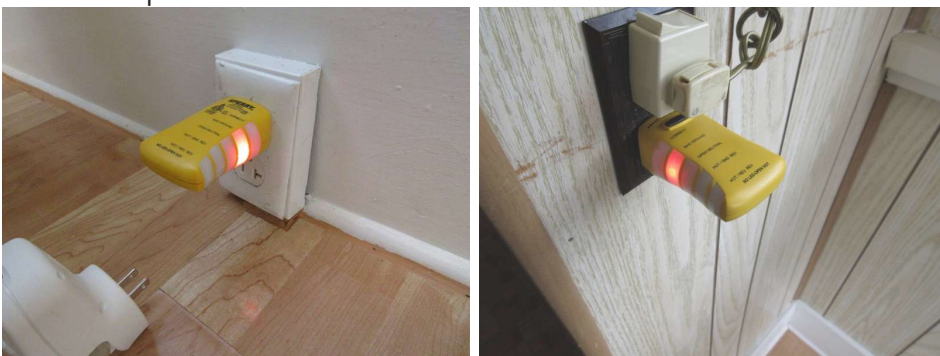
OPEN GROUND - REWIRE OR REPLACE WITH 2-SLOT

One or more modern, 3-slot electric receptacles were found with an open ground. Three-slot receptacles should have a hot, a neutral and a ground wire connected. Homeowners often install new 3-slot receptacles on older, 2-wire circuits that only have hot and neutral wires. This is a shock hazard when appliances that require a ground are used with these receptacles. Examples of such appliances include computers and related hardware, refrigerators, freezers, portable air conditioners, clothes washers, aquarium pumps, and electrically operated gardening tools. Where the electric system was installed prior to when grounded circuits were required (1960s), it is permissible to replace 3-slot receptacles with 2-slot receptacles to prevent appliances that require a ground from being plugged in to an ungrounded circuit. However, the client should be aware of this limitation when planning use for various rooms, such as an office. For newer electric systems, circuits should be repaired so grounded, 3-wire cables provide power to 3-slot receptacles. Recommend that a qualified electrician repair per standard building practices.

Contact a qualified electrical contractor.

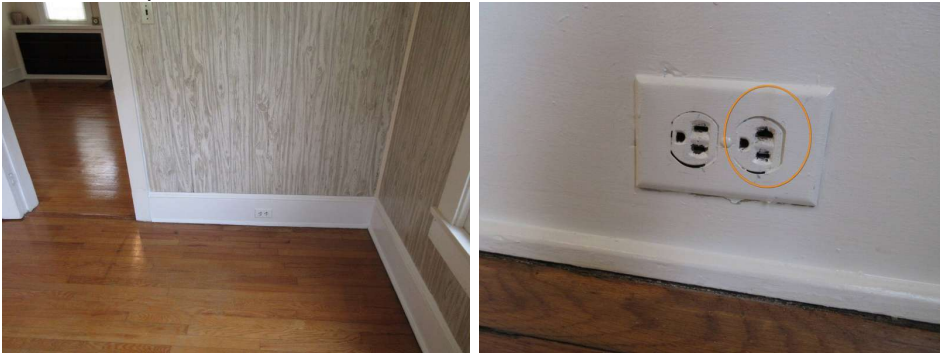
Deficiencies**SCORCHED**

One or more receptacles were scorched. The wiring for these receptacles may be damaged due to overheating. Recommend that a qualified electrician replace such receptacles, evaluate related wiring and repair if necessary.

Contact a qualified electrical contractor.

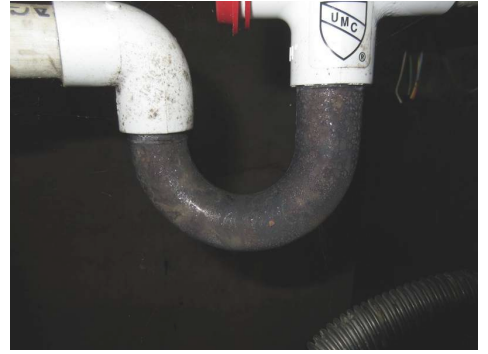
BASEMENT

The condensation tube or trap designed to safely dispose of condensate produced by the operation of the air-conditioning evaporator coils was blocked or partially blocked and may not properly dispose of condensate. Recommend servicing and repair by a qualified professional.

Contact a qualified professional.

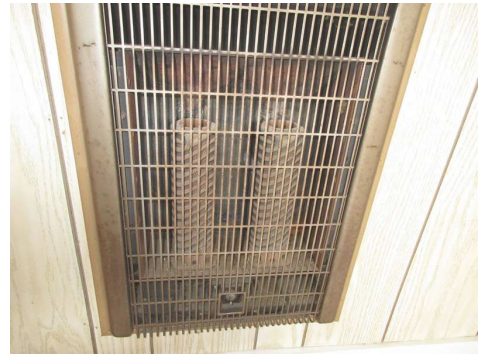
KITCHEN

The wall heater was abandoned or inoperable at the time of the inspection. Recommend repair or replacement as desired.

Contact a qualified professional.

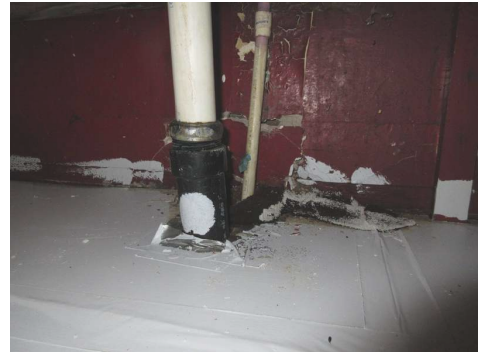
STAINS

Stains and/or damage were found in the shelving or cabinets below the sink. Plumbing leaks may have occurred in the past. The moisture meter showed not signs of current leakage at the time of the inspection. Recommend repair as desired.

Contact a qualified professional.

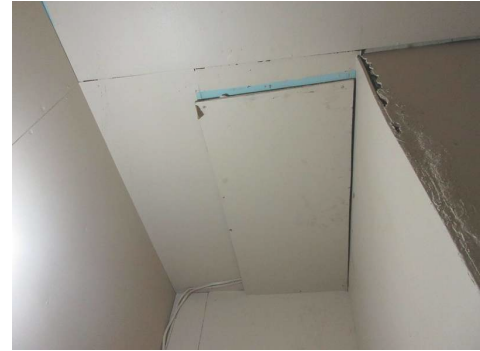
BASEMENT STAIRWAY

The attic access was not readily accessible or its inspection posed an unnecessary risk to the inspector (located over stairway). We could not inspect the interior side of roof structure, insulation, electrical, or other components therein.
