# INSPECTOR CLUSEAU'S HOME INSPECTION SERVICE

## INSPECTION REPORT

1234 Main St.  
Loudon TN 37774

08/28/2018 9:00AM

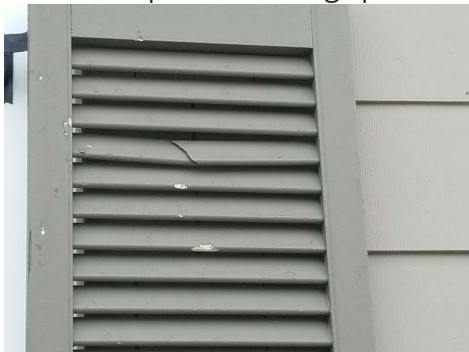
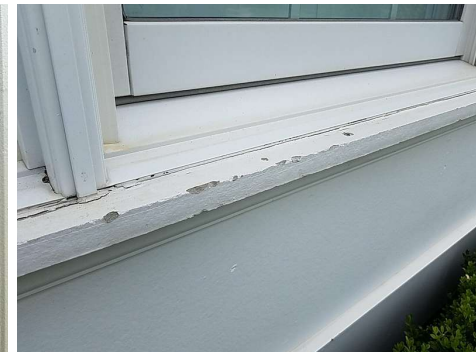
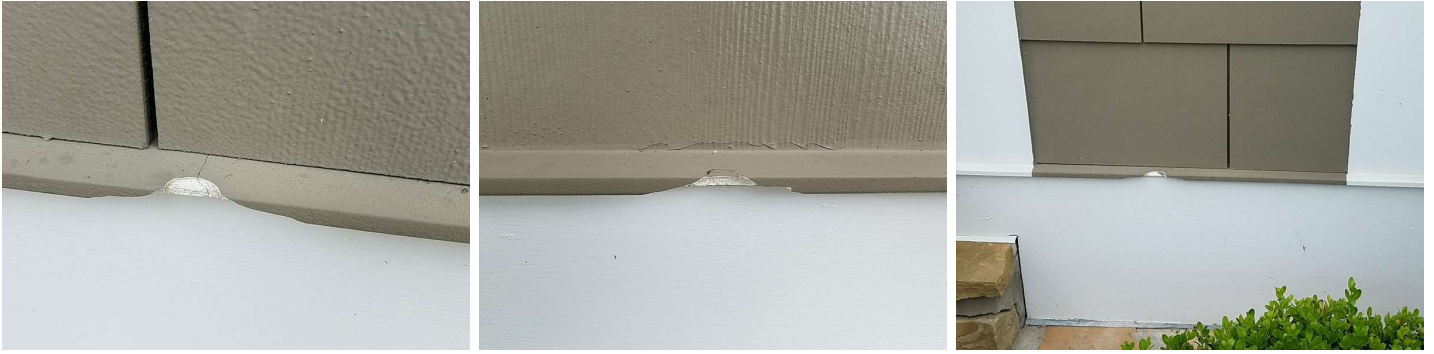
There are blemishes in the surface at several areas around the home (primarily on the front wall - west side facing directional weather). The blemishes are in the surface of the shutters and trim pieces. Wood surfaces should be repaired and painted to discourage deterioration. The blemishes on the trim pieces are mainly aesthetic and can be replaced as desired.

Contact a qualified siding specialist.

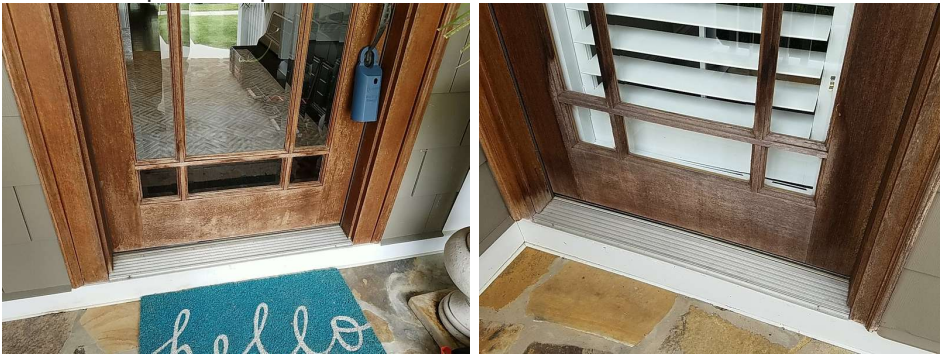
### 2.4.1 Exterior Doors

## WEAK STAIN ON DOORS

The stain is weak on the front exterior doors. This is normal to occur, especially for doors facing west and exposed to sunlight. The doors can be re-stained as desired.

Contact a qualified painter.

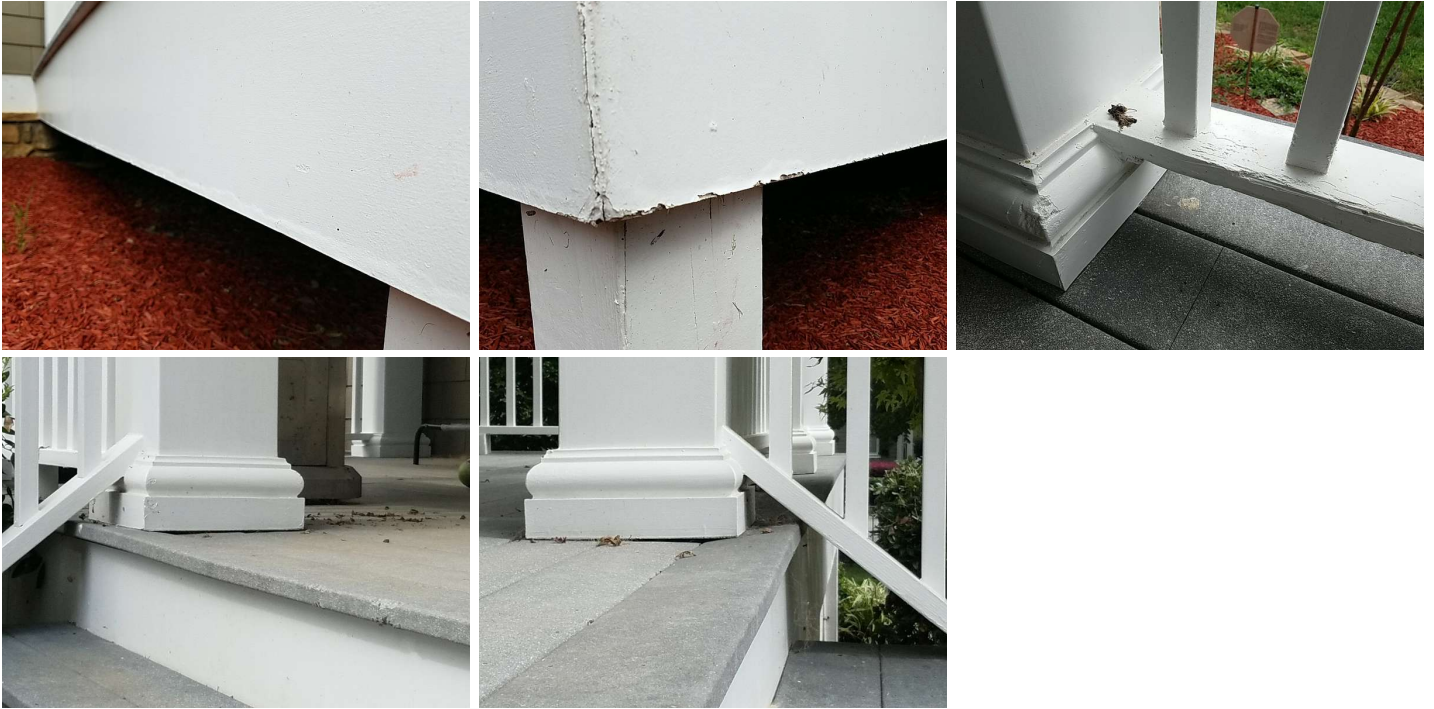
### 2.5.1 Deck

## MISCELLANEOUS DECK CONCERNS

- The trim board along the outer perimeter of the deck is weathered. Re-painting the board can help to discourage deterioration.
- Some of the rails are scuffed (caused by pet/s).
- The surface is not level along the outer edge. There were visible issues with the framing below the outer end.

These items do not affect functionality or integrity and can be repaired or addressed as desired.

Contact a qualified deck contractor.

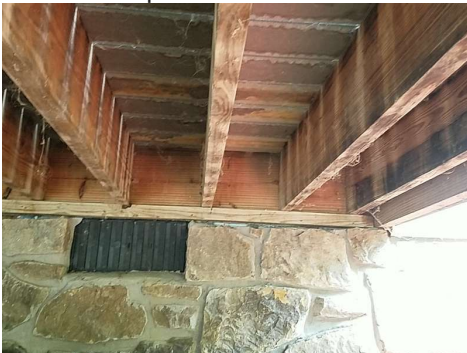
2.5.2 Deck

**LEDGER NOT BOLTED**

Contact a qualified deck contractor.

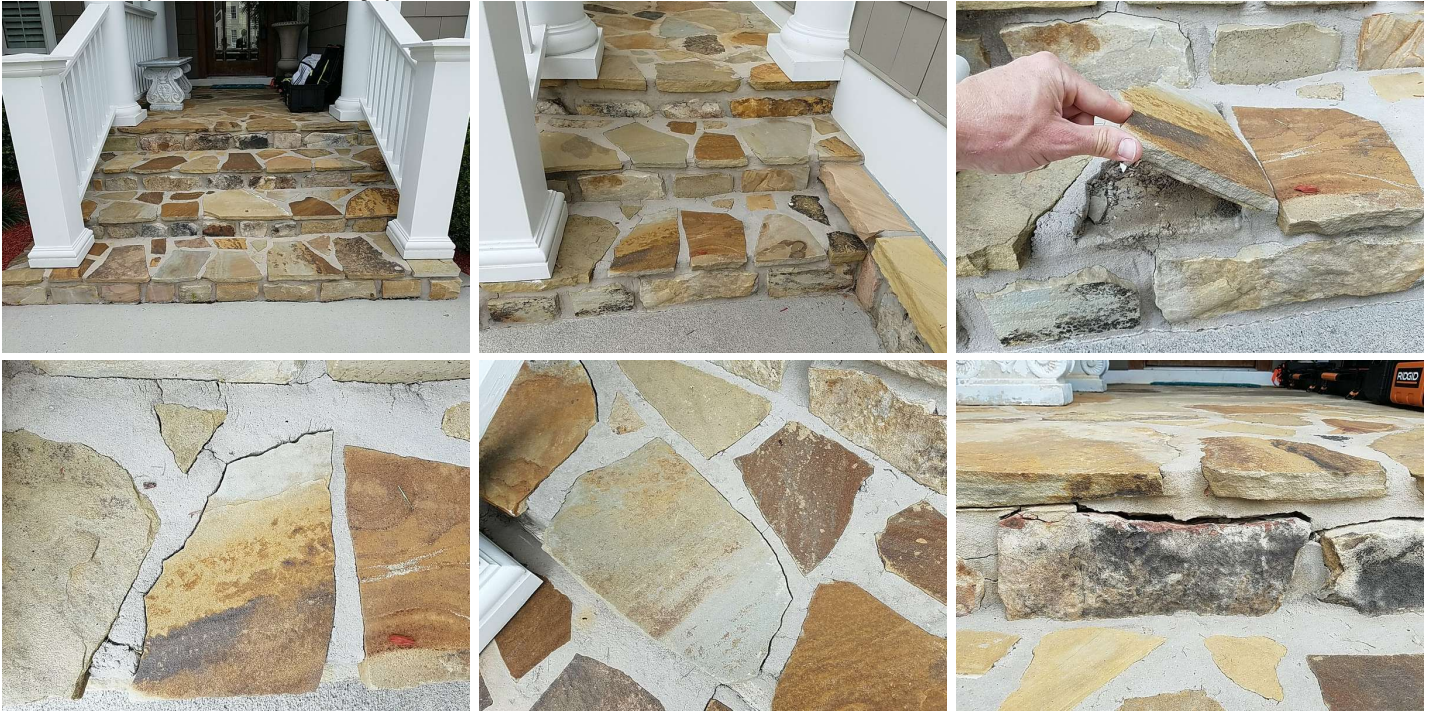
Some of the stones are loose at the porches on the front of the home. In addition, there are cracks in the mortar between the stones at various locations. All loose stones should be properly secured and any open joints in the mortar should be sealed to discourage further deterioration.

Contact a qualified masonry professional.

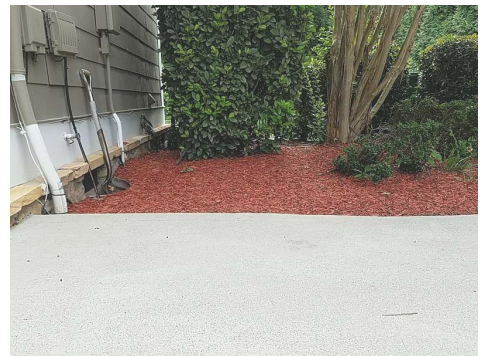
## 4.4.1 Grading and Drainage

**NEGATIVE GRADING**

Areas of the soil do not maintain proper slope away from the foundation. This could allow surface water to flow towards the foundation. All areas of the soil around the home should slope away from the foundation to encourage proper drainage away from the structure. If proper grading cannot be achieved, alternative means of drainage may be necessary (surface drain, french drain, etc.).

Contact a qualified grading contractor.

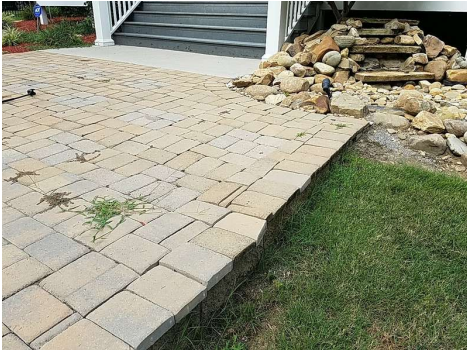
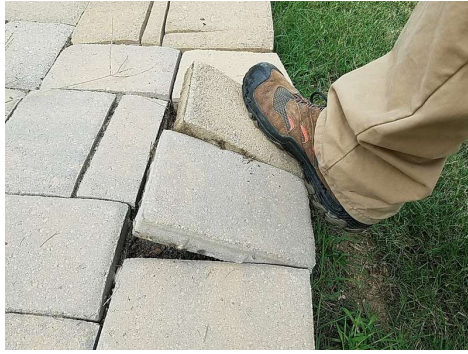
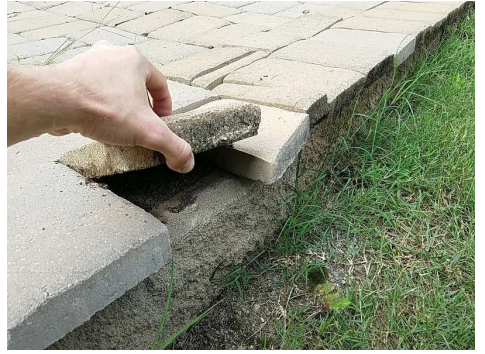
## 4.5.1 Patio

**LOOSE PAVERS**

Some of the pavers are loose along the edge of the patio. This is a potential trip hazard. I recommend all pavers be properly secured.

Contact a qualified general contractor.

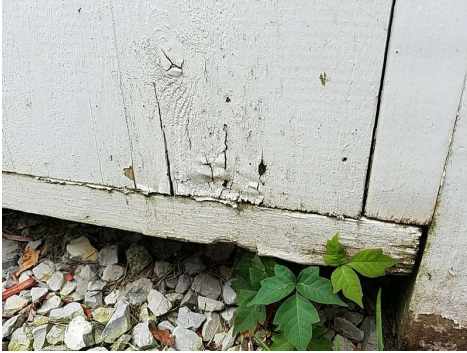
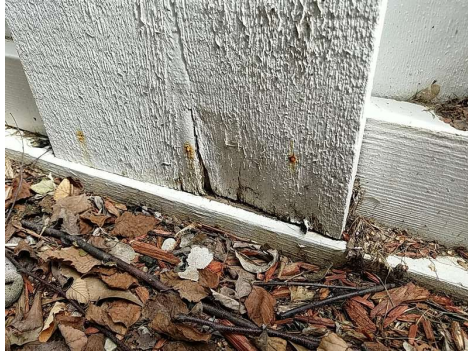
4.7.1 Fence

**DAMAGE TO FENCE BOARDS**

Some of the boards are beginning to rot on the privacy fence around the HVAC equipment. The boards can be repaired or replaced as necessary.

Contact a qualified handyman.

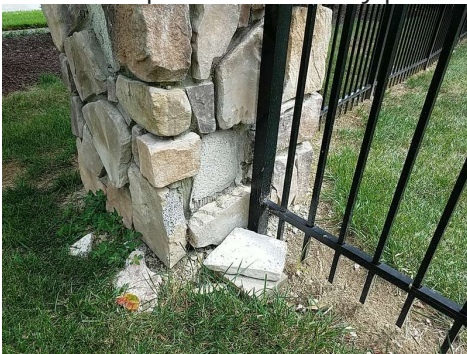
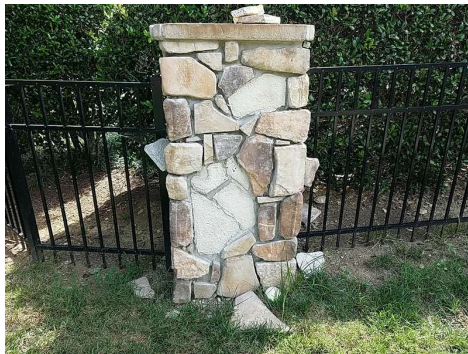
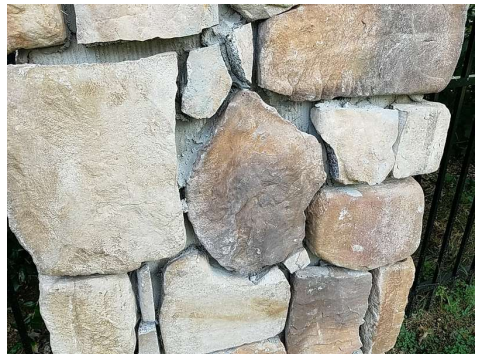
4.7.2 Fence

**LOOSE STONES ON COLUMNS**

The stonework is incomplete on the columns for the fence. Some of the stones have come loose and there is no mortar between the stones.

Contact a qualified masonry professional.

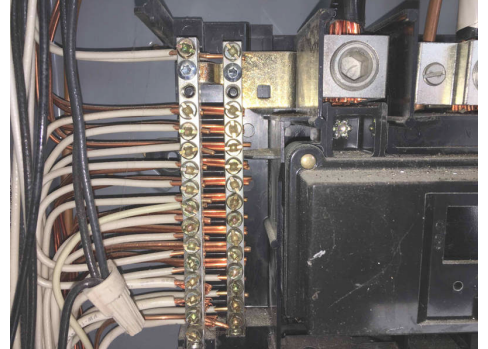
This item does not affect functionality of the system and can be repaired as necessary (in context with other electrical repairs that may be performed).

Contact a qualified electrical contractor.

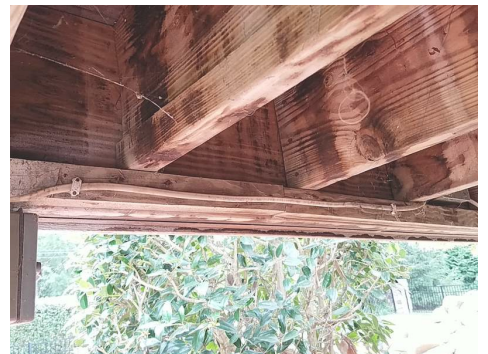
## 5.4.1 Branch Wiring

**EXTERIOR WIRE NOT IN CONDUIT**

The wire at the listed location is not contained in conduit. This may result in damage to the wire and is a potential shock hazard if the wire is damaged. I recommend all exterior wires be contained in protective conduit.

Contact a qualified electrical contractor.

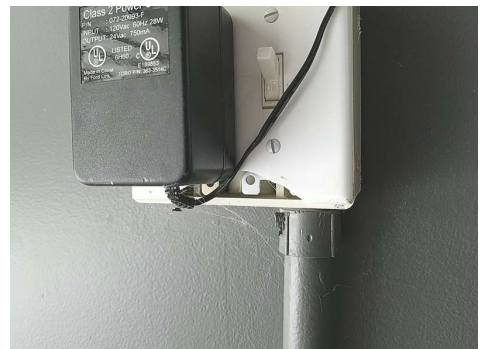
## 5.5.1 Fixtures

**COVER PLATES DAMAGED**

Cracked / broken cover plates were observed on the electrical fixtures. NOTE: I recommend replacing damaged covers.

Contact a qualified handyman.

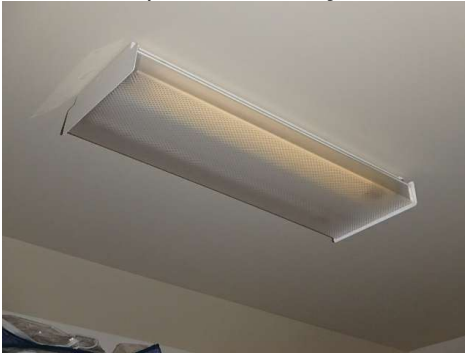
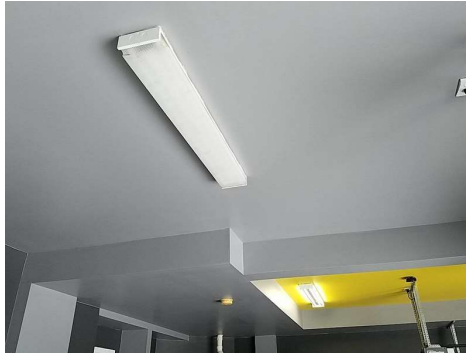
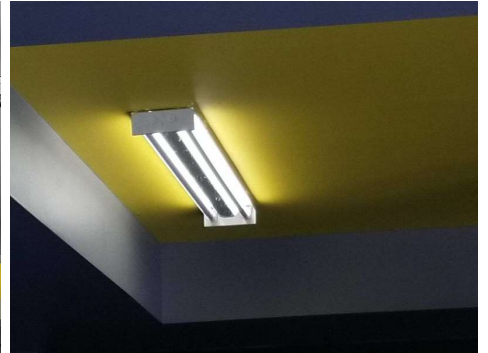
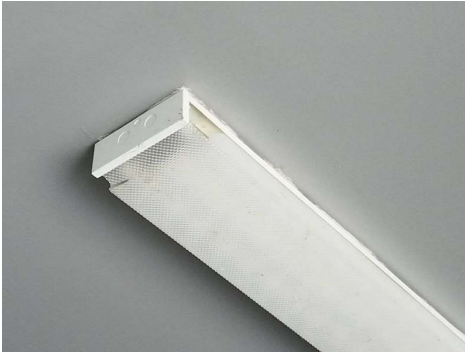
The fluorescent lights in the guest bedroom closet and garage are not working. I suspect the bulb or the ballast is bad and should be replaced.

In addition, the cover has been removed from one of the lights in the garage and the cover is broken on the other light in the garage. The covers can be replaced.

Contact a qualified handyman.

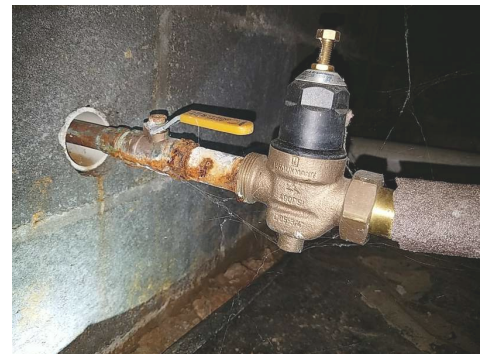
#### CORROSION ON PIPING

There is corrosion on the water piping at the listed location. The affected pipe should be replaced to ensure prevent undetected leaks.

Contact a qualified plumbing contractor.

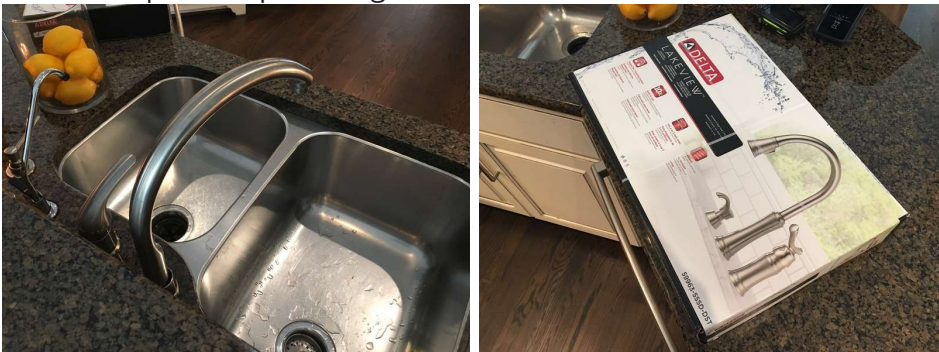
### 7.5.1 Kitchen Sink

#### FAUCET TO BE REPLACED

The kitchen sink faucet is broken. A new faucet is intended to be installed prior to closing.

Contact a qualified plumbing contractor.

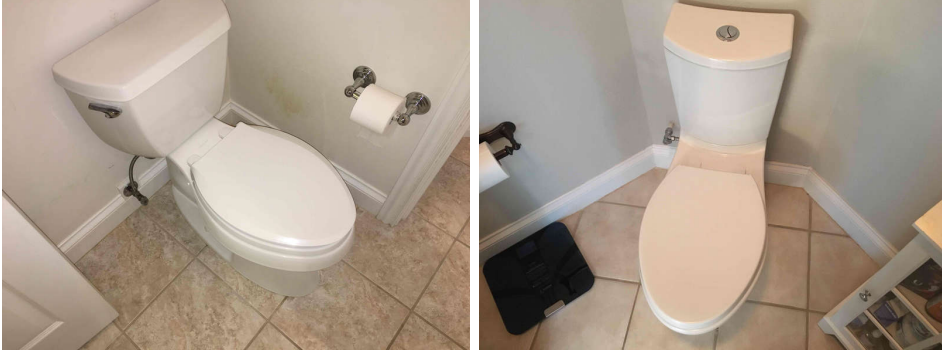
## 7.6.1 Bathrooms

**TOILET LOOSE / NOT SECURED**

The toilet is not secured tightly to the floor at the listed location. This raises potential for leaks at the seal. Necessary repairs should be made to secure the toilet and ensure there are no leaks or underlying concerns.

Contact a qualified plumbing contractor.

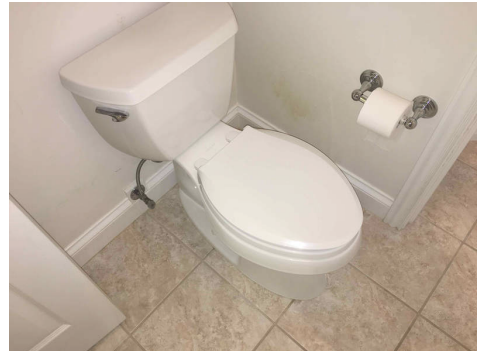
## 7.6.2 Bathrooms

The water continuously runs at the toilet at the listed location. The internal components will need to be repaired / replaced.

Contact a qualified plumbing contractor.

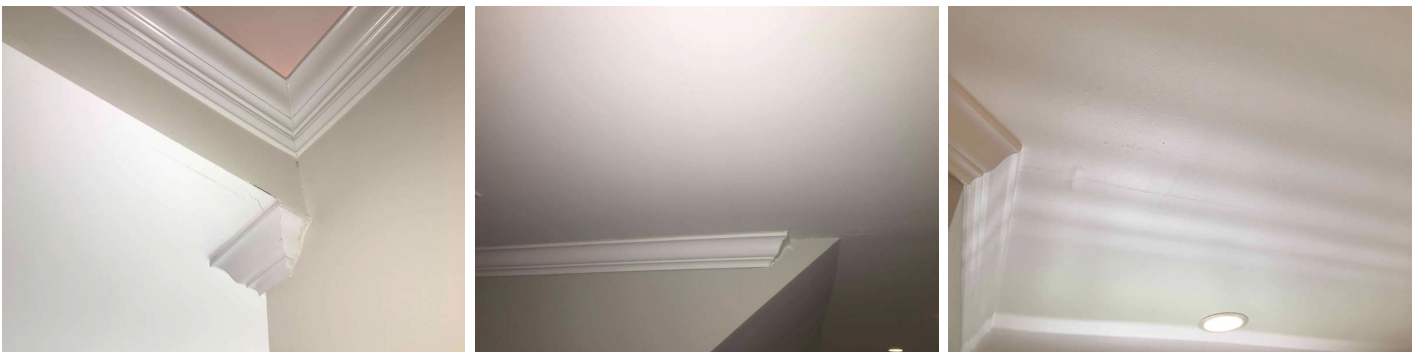
#### Walls and Ceilings: Settlement Cracks, Nail Pops, and/or Loose Tape Joints

There were settlement cracks, nail pops, and loose tape joints in the drywall at various walls and ceilings. The cracks, loose tape joints, and nail pops, are common to occur due to normal settling and/or to the expansion and contraction that occurs when heating and cooling the home.

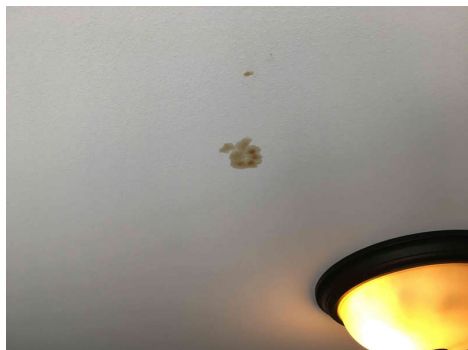
Upper Level Bedroom

There is a stain on the ceiling in the rear guest bedroom. This appears to be a surface stain and is not an indication of any previous leak or concern. The stain can be cleaned / removed and the ceiling re-painted as necessary.

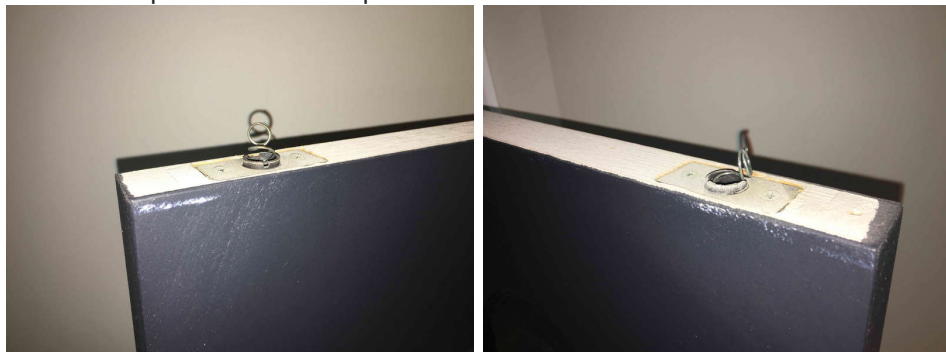
**BALL CATCH BROKEN**

The ball hinge is broken on the door in the master bathroom. The hinge will need to be repaired / replaced.

Contact a qualified door repair/installation contractor.

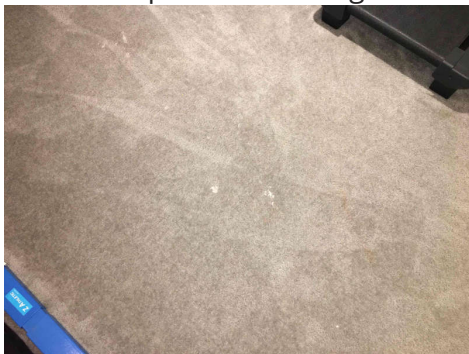
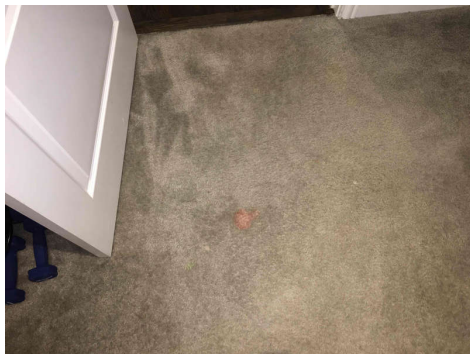
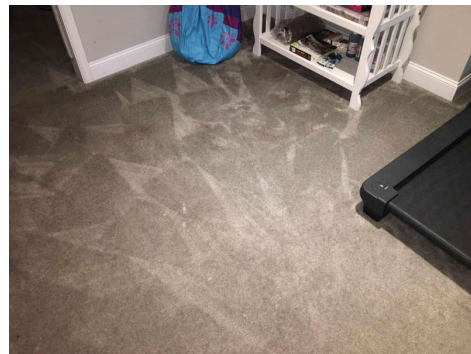
8.5.1 Floors

**CARPET STAINS**

The carpet is stained at various locations. The carpet can be cleaned or replaced as desired. NOTE: Some stains may not be able to be removed.

Contact a qualified flooring contractor

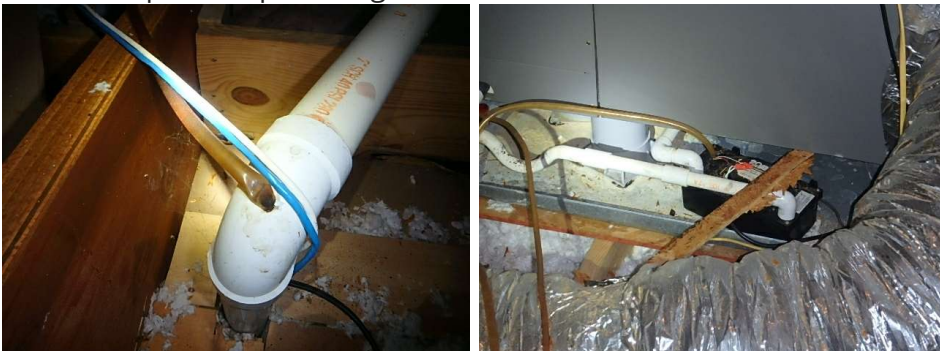
The condensate drain tube is connected to the plumbing vent pipe in the attic. The tube is kinked where connected into the vent pipe, which raises concern for the line to clog and crack. In addition, the drain tube does not have a proper fitting where attached to the vent pipe.

Contact a reputable plumbing company to make necessary repairs to the piping for best functionality and to prevent future concern.

Contact a qualified plumbing contractor.

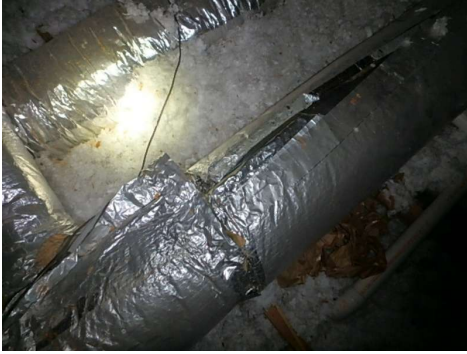
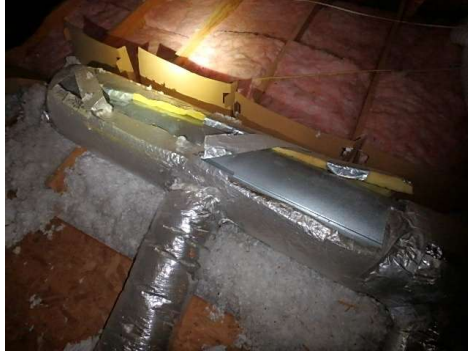
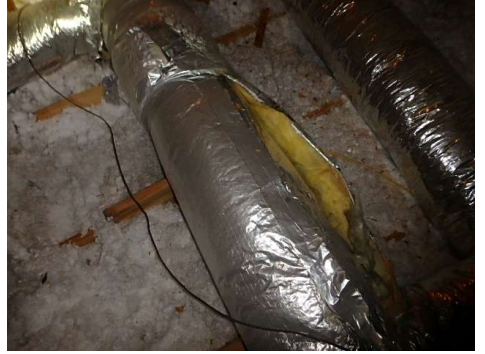
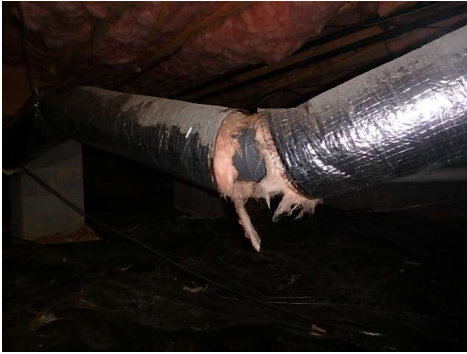
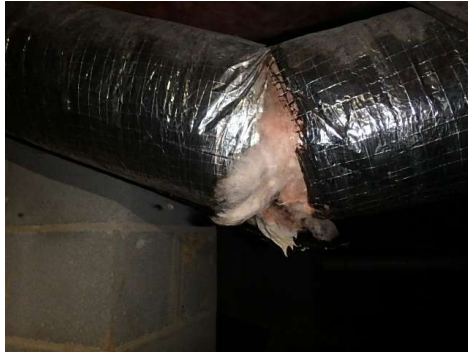
9.3.1 Ducts

### DUCT INSULATION IS LOOSE / TORN

The insulation is loose / torn on sections of the air ducts at the listed locations. The insulation on the ducts should be repaired.

Contact a qualified HVAC professional.

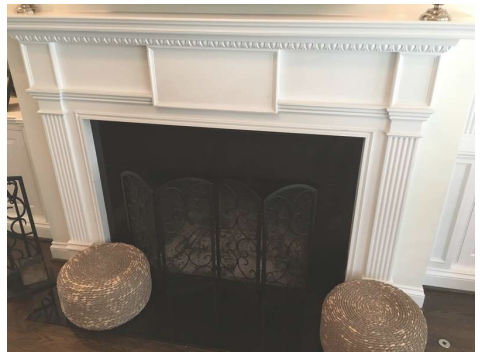
#### 9.4.1 Fireplace

### RECOMMEND CLEANING

I recommend having the fireplace flue professionally cleaned / swept.

Contact a qualified fireplace contractor.

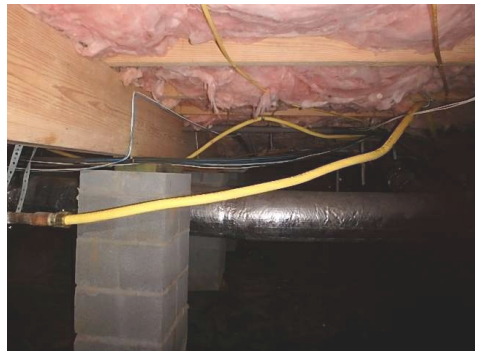
#### 9.5.1 Gas Service and Piping

### CSST PIPE BONDING

Contact a qualified electrical contractor.

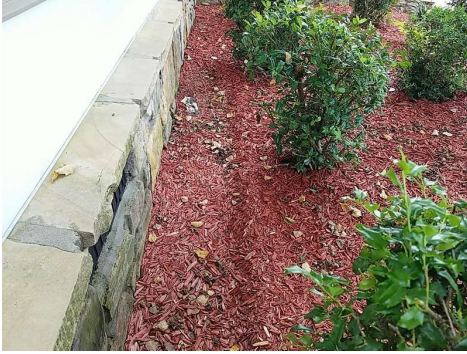
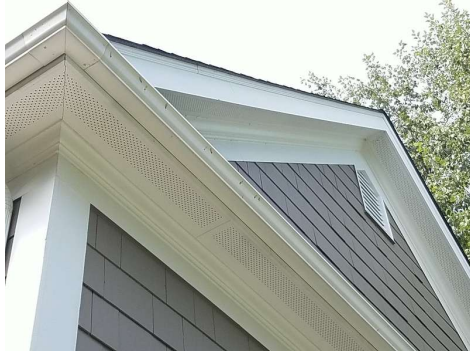
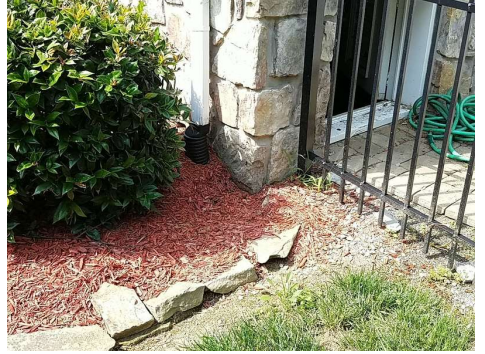
10.5.1 Roof Drainage Systems

### SIGNS OF OVERFLOW

Contact a qualified gutter contractor

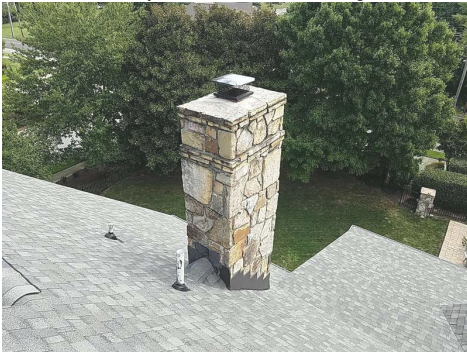
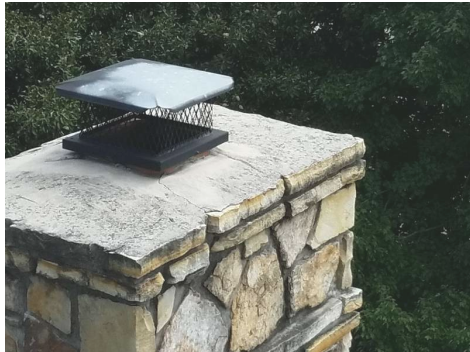
### 10.6.1 Chimney

## SEAL OPEN JOINTS

Contact a qualified chimney contractor.

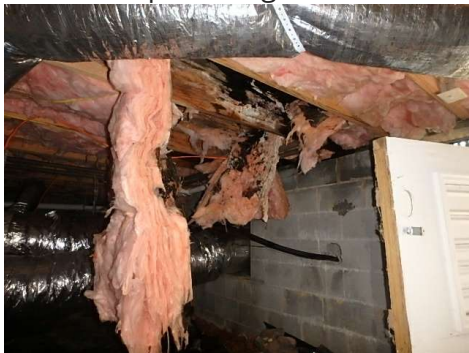
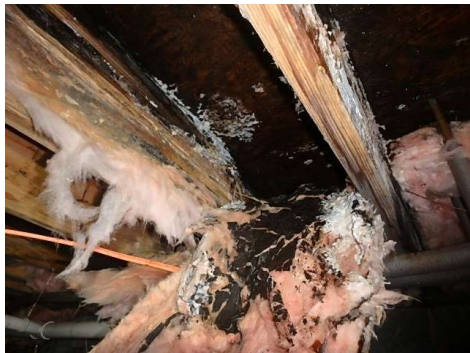
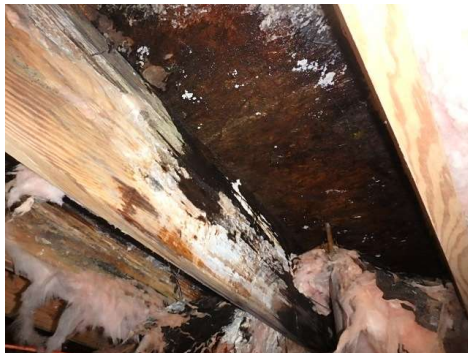
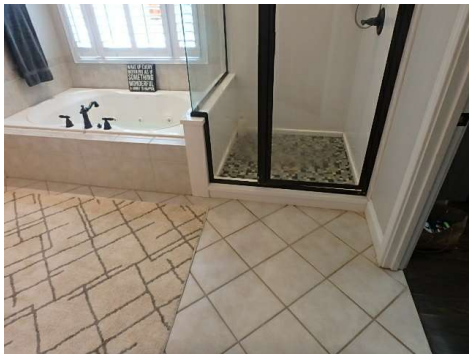
### 12.3.1 Framing

## DAMAGED FRAMING

Contact a qualified general contractor.
