HOME INSPECTION

1234 Main St.
Bastrop TX 78602

PROPERTY INSPECTION REPORT

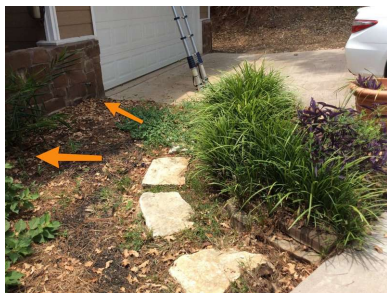
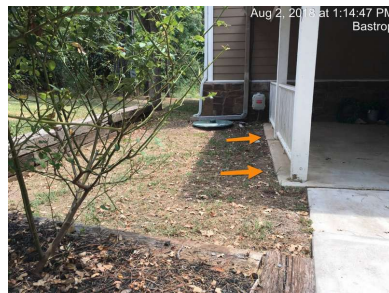
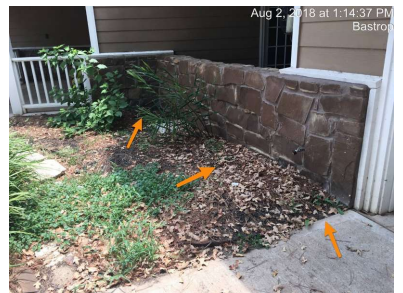
1: Negative Grade

Deficient: Front and right side of home has negative grade towards the home. Industry standards call for a minimum of 6" inch slope away from the foundation in the first 10 feet. Recommend having a landscaping specialist provide further evaluation and establish guidelines for achieving positive drainage in these areas.

Recommendation: Contact a qualified landscaping contractor

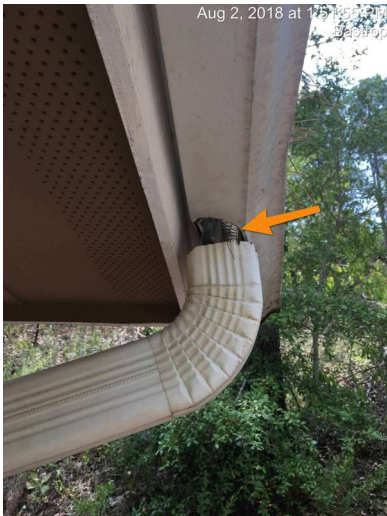
2: Gutter Downspout Disconnected

Deficient: Down spout disconnected at bottom of gutter to the right of garage. Have a gutter specialist perform needed repairs.

Recommendation: Contact a qualified gutter contractor

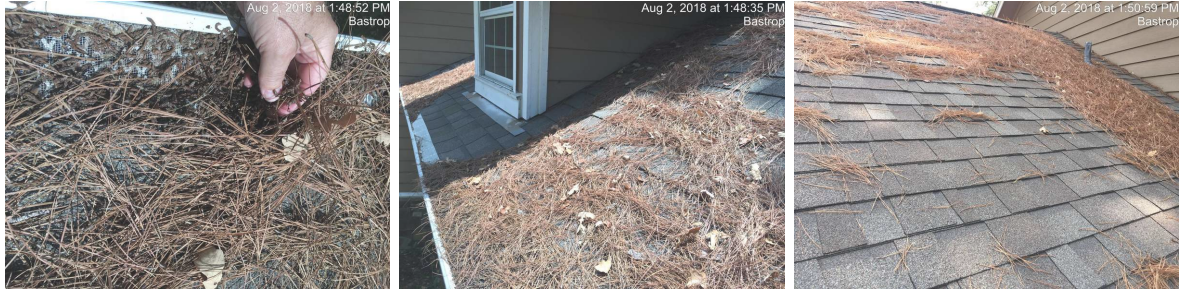
1: Excessive Debris

Deficient: Roof covering has excessive amount of debris such as pine needles collecting on the surface. Gutters are being clogged and this can cause rain water to back wash onto fascia and into soffit cavities causing rot and deterioration in these locations. Recommend regular cleaning to prevent water damage from occurring.

Recommendation: Contact a handyman or DIY project

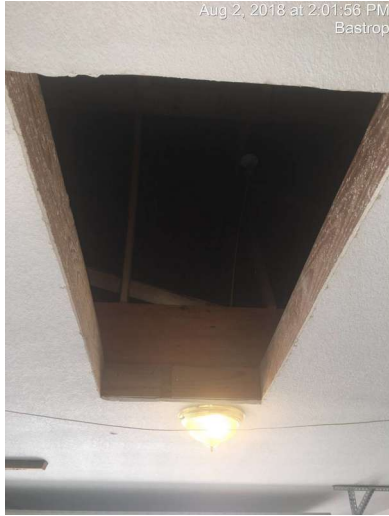
1: Un-Insulated Attic Cover

Deficient: Drywall cover for attic opening in master bedroom closet is not insulated and is allowing conditioned air to escape into attic space resulting in higher utility bills. Recommend replacing drywall cover with insulated materials available at the local building supply.

Recommendation: Contact a handyman or DIY project

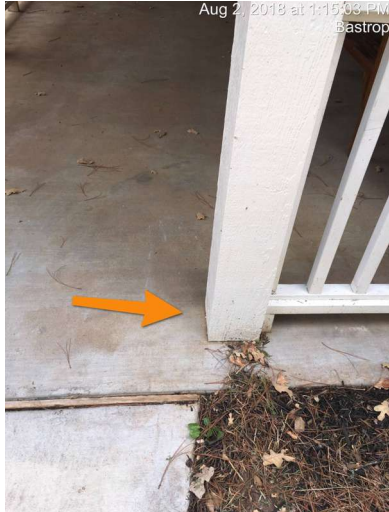
1: Support Post Bases:

Deficient: Support post on front porch should have metal post bases installed to prevent deterioration and rot from occurring from wood to concrete contact. Recommend having a carpentry specialist perform needed repairs.

Recommendation: Contact a qualified carpenter.

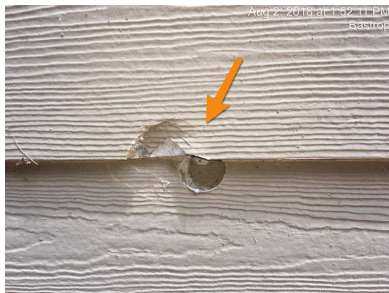
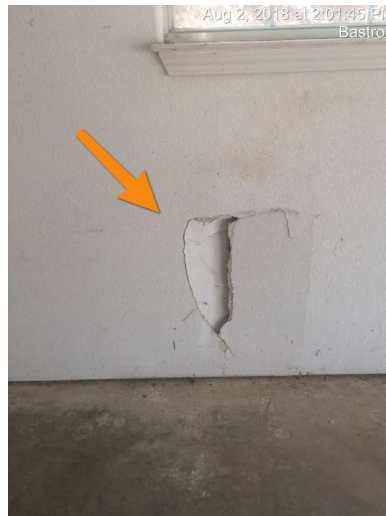
2: Wall Damages

Deficient: Exterior siding has one minor area with damage on the right side of the garage, and the interior wall of the garage has some sheet rock damage. Have a handyman provide needed repairs.

Recommendation: Contact a qualified handyman.

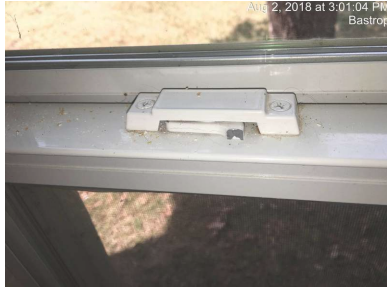
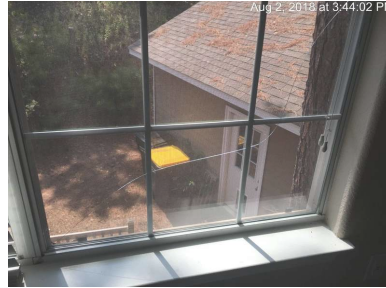
Deficient: The following issues were discovered with windows:

Latches are broken on downstairs front bedroom window.

Upstairs master bedroom window has a broken glass.

Have a window & glass specialist perform needed repairs.

Recommendation: Contact a qualified window repair/installation contractor.

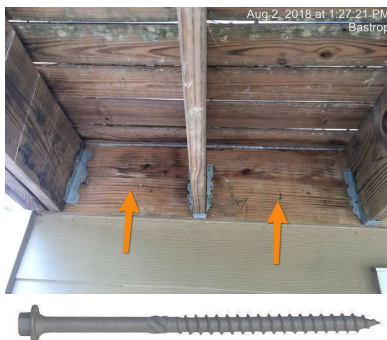
Deficient: Ledger board supporting back balcony deck is required to have specific fasteners installed in a specific pattern. (see attached diagram) Recommend adding wood supports under the outside band joist to add additional stability.

Recommendation: Contact a qualified carpenter.

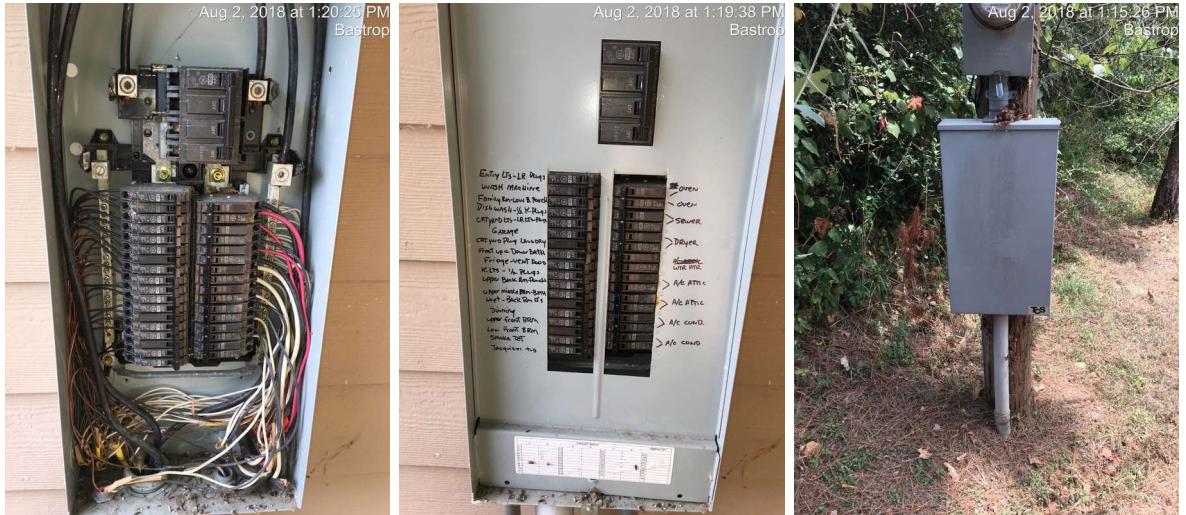
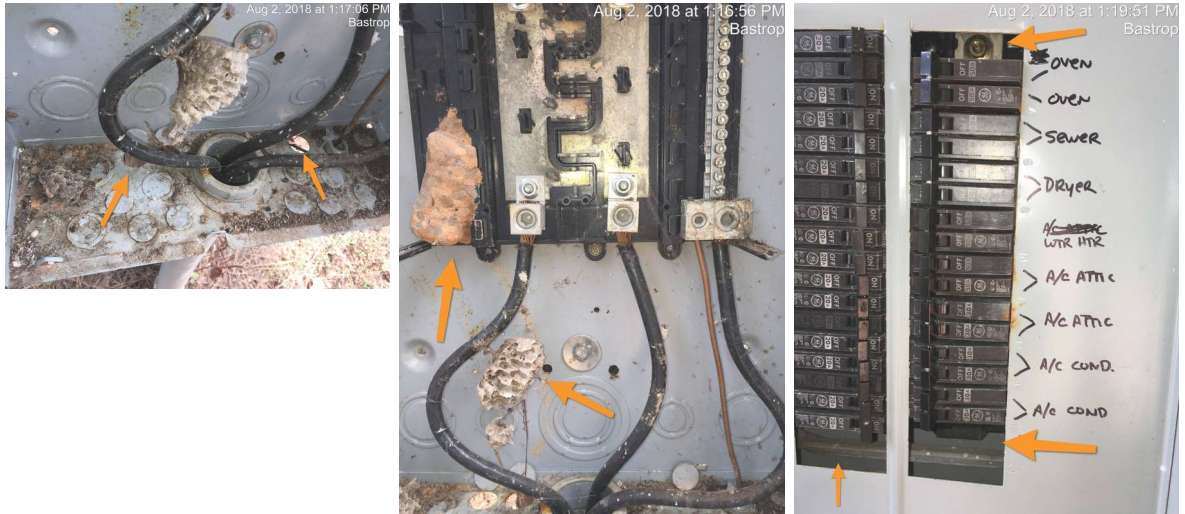
1: Service Panel Issues:

Deficient: The following deficiencies were discovered with the service panels:

Panel located right below meter with the main disconnect is not sealed. There are openings in the bottom of the panel allowing insects such as wasp to build nest inside the panel. This can very easily cause a short and can be very dangerous. Recommend having an electrical specialist perform needed repairs.

Sub-panel located on exterior of wall does not have the required space in front of the panel to allow for a safe environment when working on the panel. Industry standards call for a minimum of 36" inches in front of the panel with 30" inches free space on either side of the panel. Recommend cutting tree that is obstructing this space back to allow for proper access.

Sub-panel has knock-out covers missing on panel cover to protect live wiring on the inside of the panel. Have an electrical specialist perform needed repairs.

Recommendation: Contact a qualified electrical contractor.

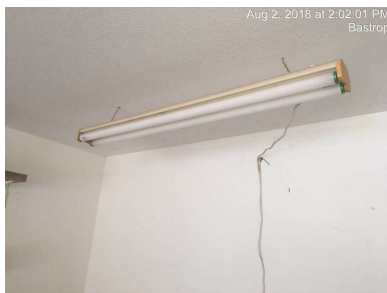
Deficient: All exposed light bulbs are required to have a shatterproof globe as protection. Have a handyman provide needed repairs.

Recommendation: Contact a qualified handyman.

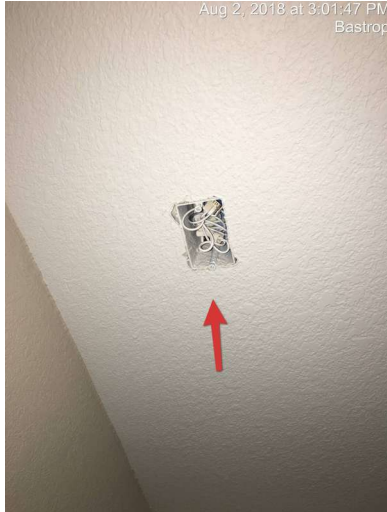
2: Missing Smoke Detectors

Deficient: Two bedrooms have missing smoke detectors, hallway outside of bedrooms does not have a smoke detector as required. Have an electrician install all new combination smoke /carbon monoxide detectors as now required.

Recommendation: Contact a qualified electrical contractor.

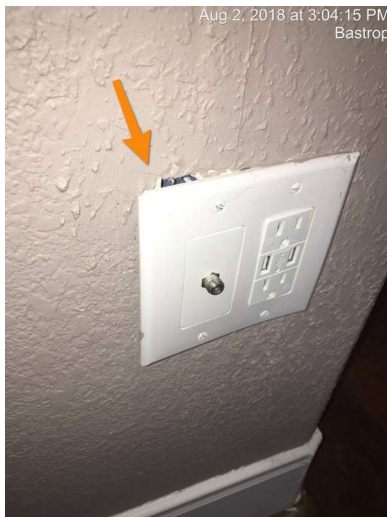
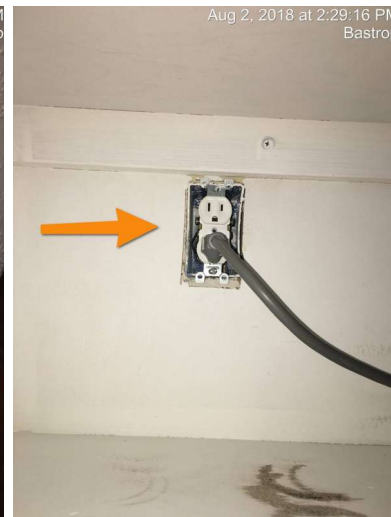
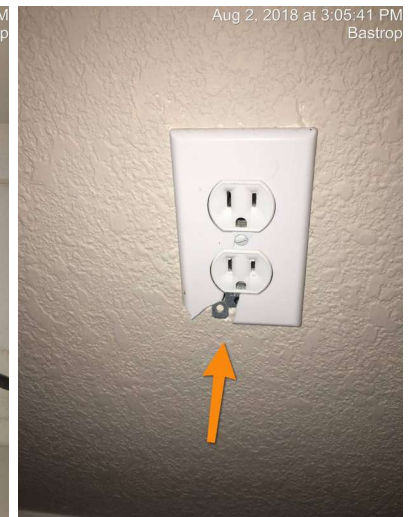
3: Receptacle Issues:

Deficient: The following receptacle issues were discovered:

Receptacle cover damaged in upstairs bedroom.

Receptacle cover missing in cabinet above microwave.

Recommendation: Contact a qualified electrical contractor.

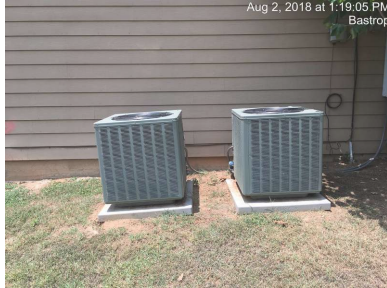
1: Unit Not Level

Deficient: Concrete pad supporting one of the outdoor condensing units is not level . This can cause accelerated deterioration of components. Recommend licensed HVAC contractor level the unit.

Recommendation: Contact a qualified HVAC professional.

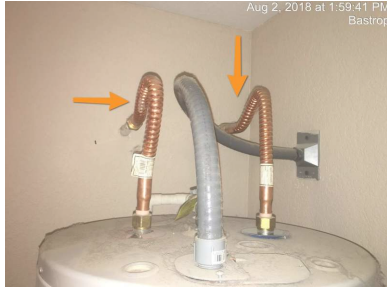
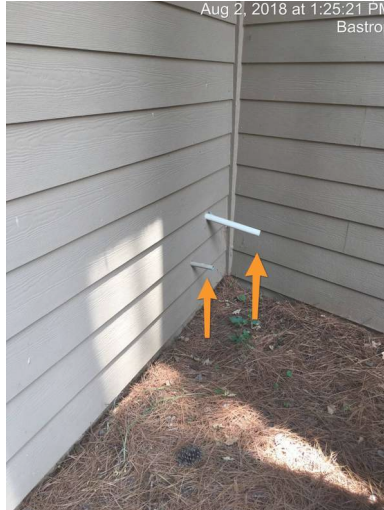
Deficient: Cold water supply line for the water heater does not have a cut-off valve at the entrance to the tank as required. Cold water line into water heater should have a cut-off valve to allow water supply to be turned off for service or in an emergency event.

Deficient: Drain line terminations should have a 90 degree turn-down installed that terminated approx. six inches above grade.

Note: It is also recommended that hot water line be insulated.

Have a plumbing specialist perform needed repairs.

Recommendation: Contact a qualified plumbing contractor.

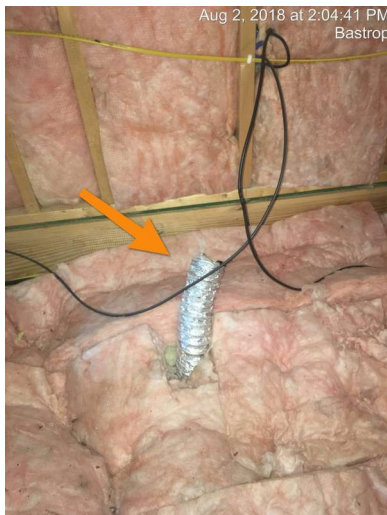
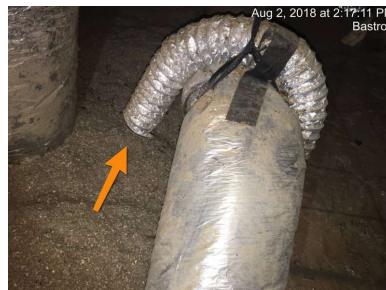
1: Improper Venting

Deficient: **Improper venting practices were noted. All bathroom exhaust fans are terminated into attic space and are required to vented to the exterior of the home.** Have a plumbing specialist provide needed repairs.

Recommendation: Contact a qualified plumbing contractor.

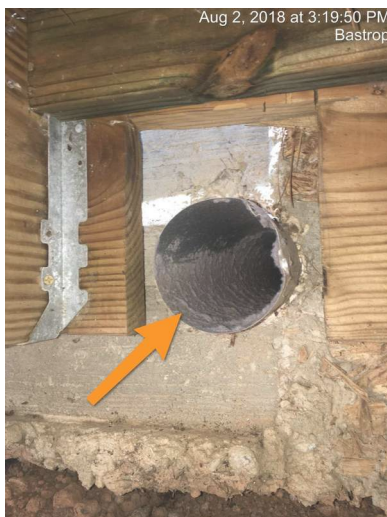
Deficient: Dryer vent exhaust pipe is clogged with lint and will need to be cleaned by a professional. Annual cleaning is recommended to prevent build-up of lint.

Recommendation: Contact a qualified professional.
