HOME INSPECTION REPORT

1234 Main St.
Roanoke VA 24018

Buyer Name
02/13/2019 9:00AM

Inspector
Brian Cullop
VA LIC#3380001082
540.293.6622
brian@theacecrew.com

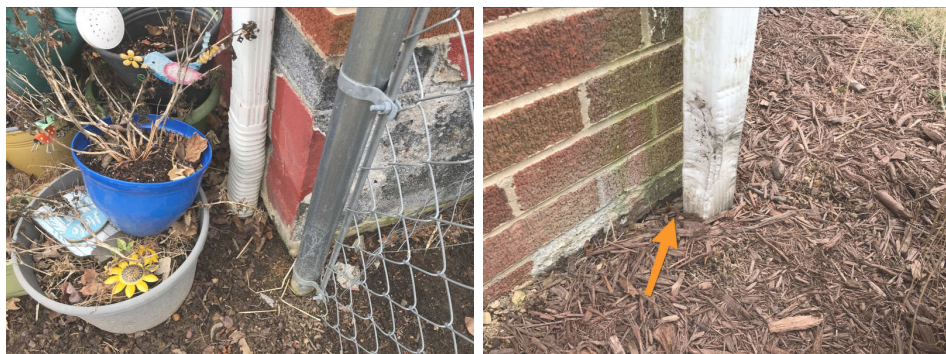
2.4.1 Roof Drainage System

BLOCKAGE- QC

WEST AND EAST DINING ROOM

Some downspouts designed to discharge roof drainage appeared to be clogged with debris. This condition can cause excessively high moisture levels in soil next to the foundation that can effect the ability of the soil to support the weight of the structure above and/or can cause damage related to soil/foundation movement. The Inspector recommends repair or replacement of the downspout by a qualified contractor.

Contact a qualified professional.

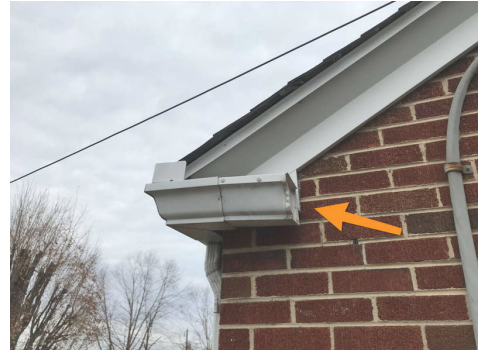
2.4.2 Roof Drainage System

IMPROPER SLOPE- QC

NORTHEAST

Gutters in certain areas sloped incorrectly. This will result in spillage and runoff draining to the foundation. This condition can result in excessively high moisture levels in soil at the foundation. Excessive moisture levels in soil near the foundation can effect the ability of the soil to support the weight of the structure above. The Inspector recommends correction to help protect the home structure and occupants. All work should be performed by a qualified contractor.

Contact a qualified professional.

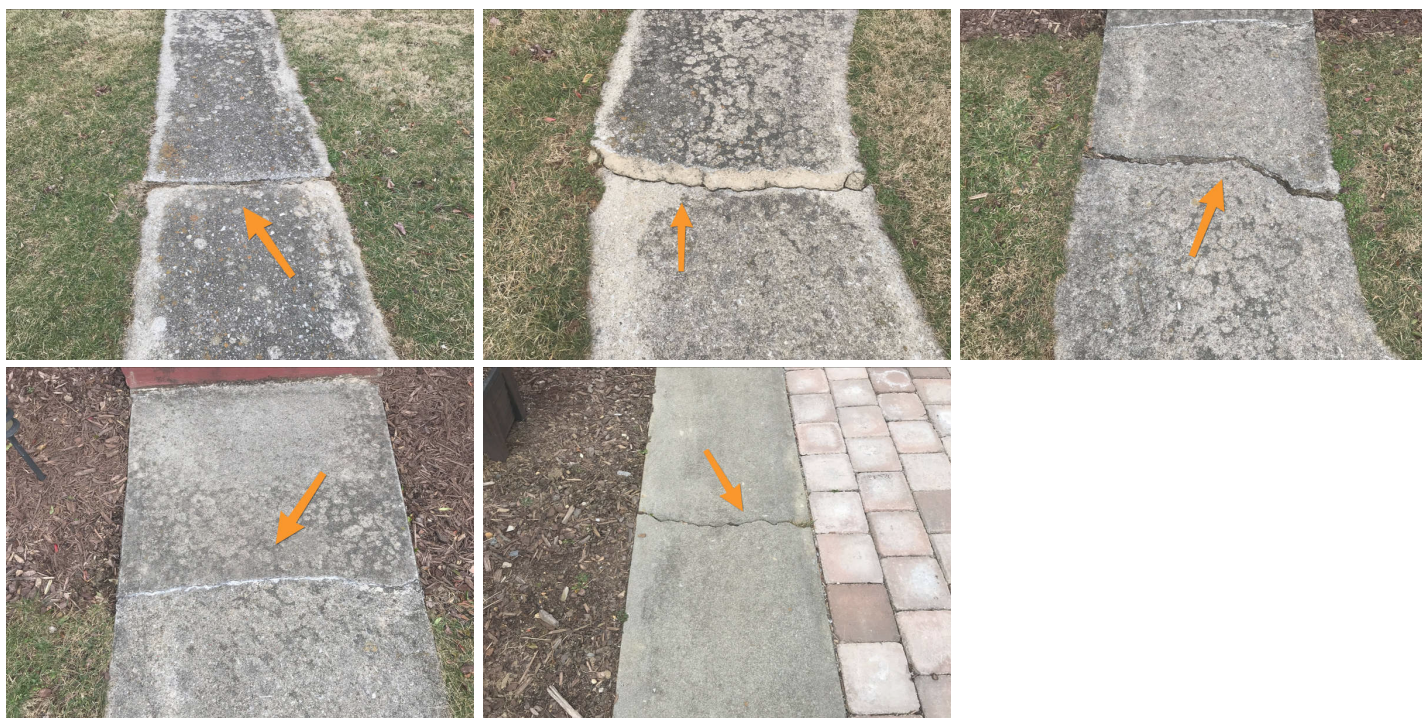
4.2.1 Walkways

COMMON CRACKS

Common cracks (1/4 inch or less) were visible in the sidewalk at the time of the inspection. Cracks exceeding inch should be patched with an appropriate sealant to avoid continued damage to the walkway surface from freezing moisture.

West

Contact a qualified professional.

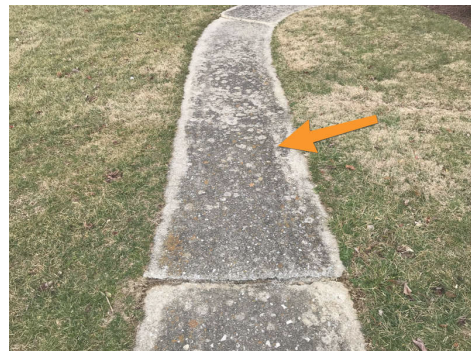
4.2.2 Walkways

EXPOSED AGGREGATE

Some walkways exhibited concrete pitting with aggregate (concrete-embedded stones) visible in the bottoms of pits. This condition is typical of the use of types of aggregate that absorb water and expand during freezing weather, causing the immediately-overlying concrete to fracture.

Contact a qualified professional.

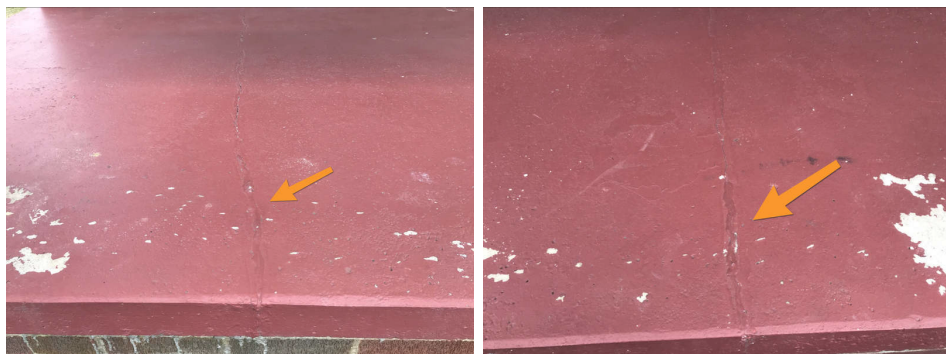
4.5.1 Porch

MODERATE CRACKING- SE/QC

EAST

Moderate porch foundation cracking was visible at the time of the inspection This condition appeared to be consistent with cracking caused by soil movement. If this condition was caused by inadequate compaction at the time of original construction, soil will have stabilized by now. If it was caused by expansive soil, or excessive amounts of moisture in the soil supporting the foundation, movement and cracking may continue. Determining the soil condition would require the services of a soils (geotechnical) engineer. The Inspector recommends crack repair by a qualified masonry contractor to help prevent future damage from freezing moisture.

Contact a qualified professional.

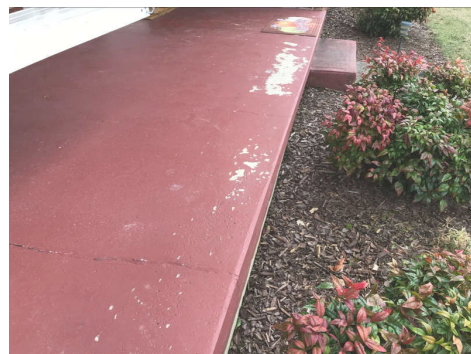
4.5.2 Porch

AGE- WEATHERING

The porch exhibited weathering commensurate with its age.

Contact a qualified professional.

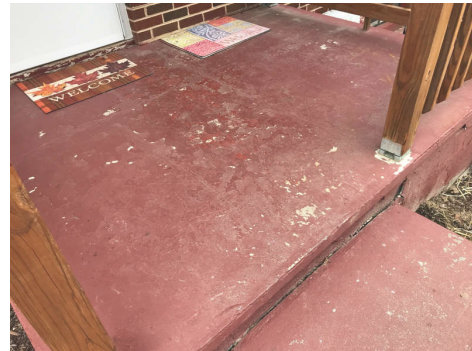
4.6.1 Deck, Balcony, Bridge and Porch,

PEELING PAINT

WEST

The back porch had peeling paint that needed maintenance. Failure to maintain the finish coating will allow Ultra Violet (UV) radiation from sunlight, heat, moisture and freezing moisture to reduce the lifespan of concrete exposed to weather. The Inspector recommends repainting the porch to protect it from further damage.

Contact a handyman or DIY project

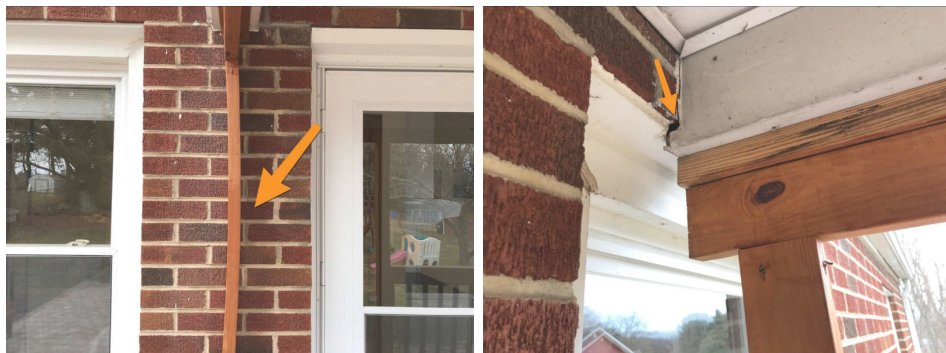
4.6.2 Deck, Balcony, Bridge and Porch,

POOR CONNECTIONS

WEST PORCH

Framing members at this porch cover were poorly connected. This condition could result in structural failure, expensive damage, or injury. The Inspector recommends that you consult with a qualified contractor to gain an idea of options and costs for correction.

Contact a qualified professional.

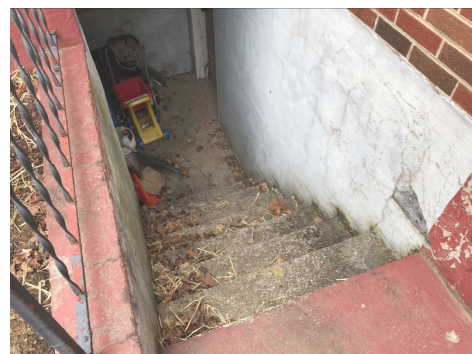
4.7.1 Exterior Stairs

NO HANDRAIL- QC

This exterior staircase had no handrail. Generally-accepted current safety standards mandate that stairs with 4 or more risers should have a handrail.

Contact a qualified professional.

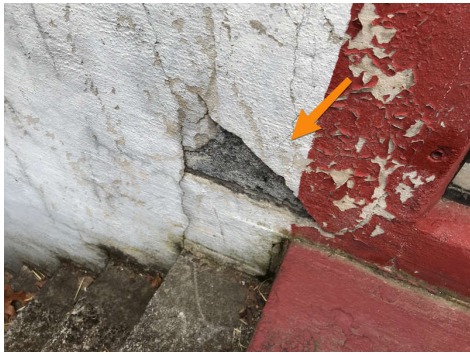
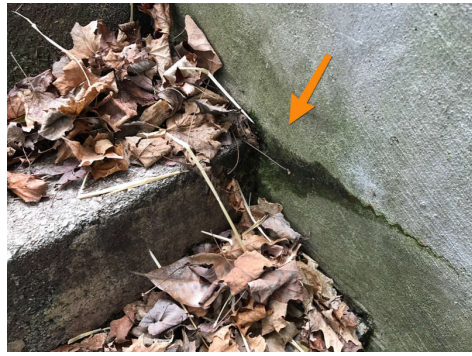
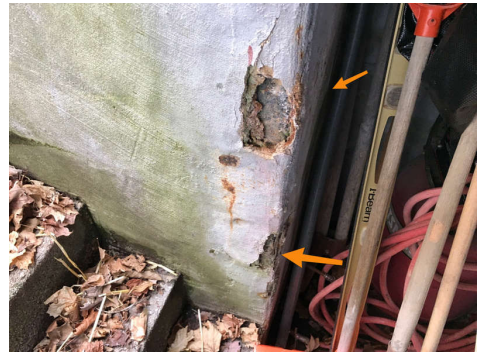
4.7.2 Exterior Stairs

CONCRETE

The treads of this staircase were made of concrete.

Contact a qualified professional.

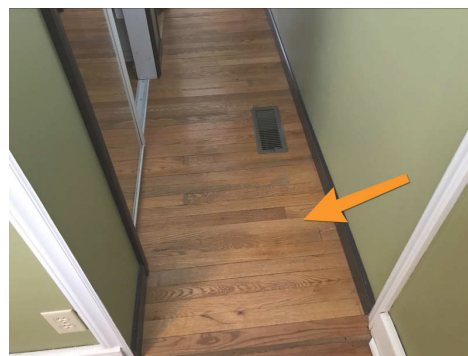
6.1.2 Floors

SEVERE SQUEAKING, SPECIFIC- QC

Wood floors in the Master bedroom exhibited severe squeaking along the major path of travel. This is usually due to fastener movement- either of the wood flooring or the subfloor beneath it. If the fault lies with the flooring fasteners it can be difficult to correct because the flooring is fastened as it is installed in such a manner that fasteners are not accessible once installation is complete. You may wish to consult with a flooring contractor to discuss options and costs for correction.

Contact a qualified professional.

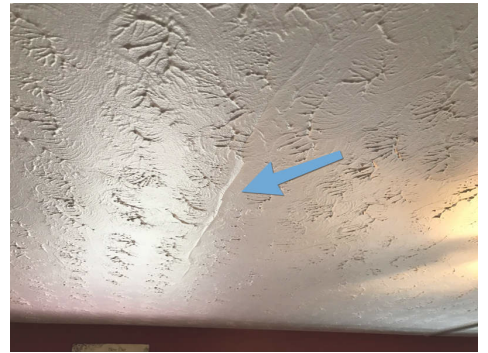
6.3.1 Ceilings

CEILING MOSTLY OK

1ST FLOOR LIVING ROOM

At the time of the inspection, the Inspector observed few deficiencies in the condition of the home ceilings. Any exceptions will be listed in this report.

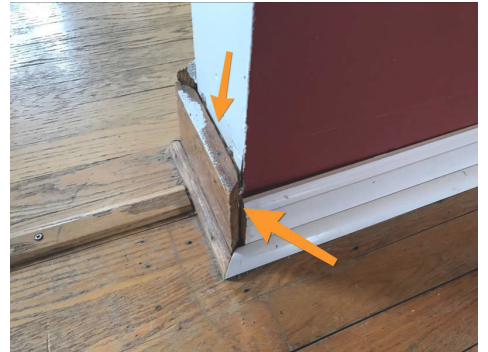
6.7.1 Interior Trim

POOR QUALITY INSTALLATION-SPECIFIC

1ST FLOOR LIVING ROOM

Interior trim in the living room is different sizes.

Contact a qualified professional.

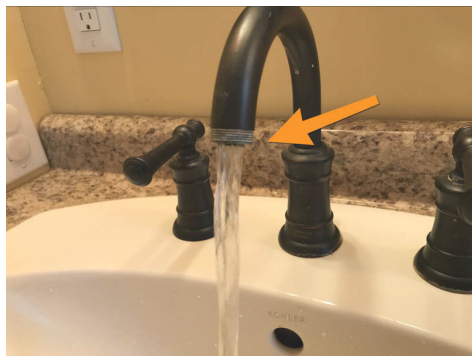
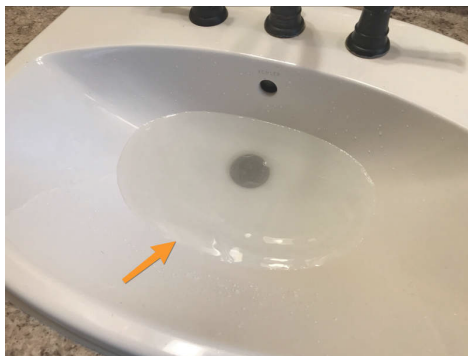
9.15.1 Bathroom Components

SINK FAUCET

Bathroom faucet at sink is missing aerator and slow drain, recommend repairing

Contact a qualified professional.

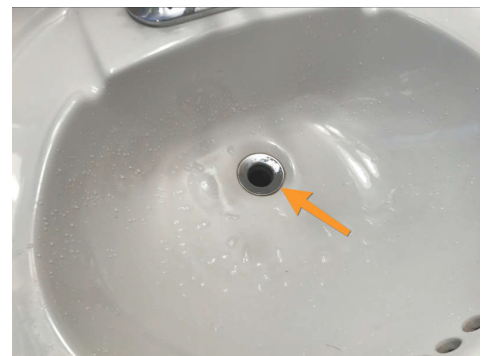
11.15.1 Bathroom Components

INOPERABLE STOPPER

In the 2nd floor bathroom the sink stopper was inoperable.

Contact a qualified professional.

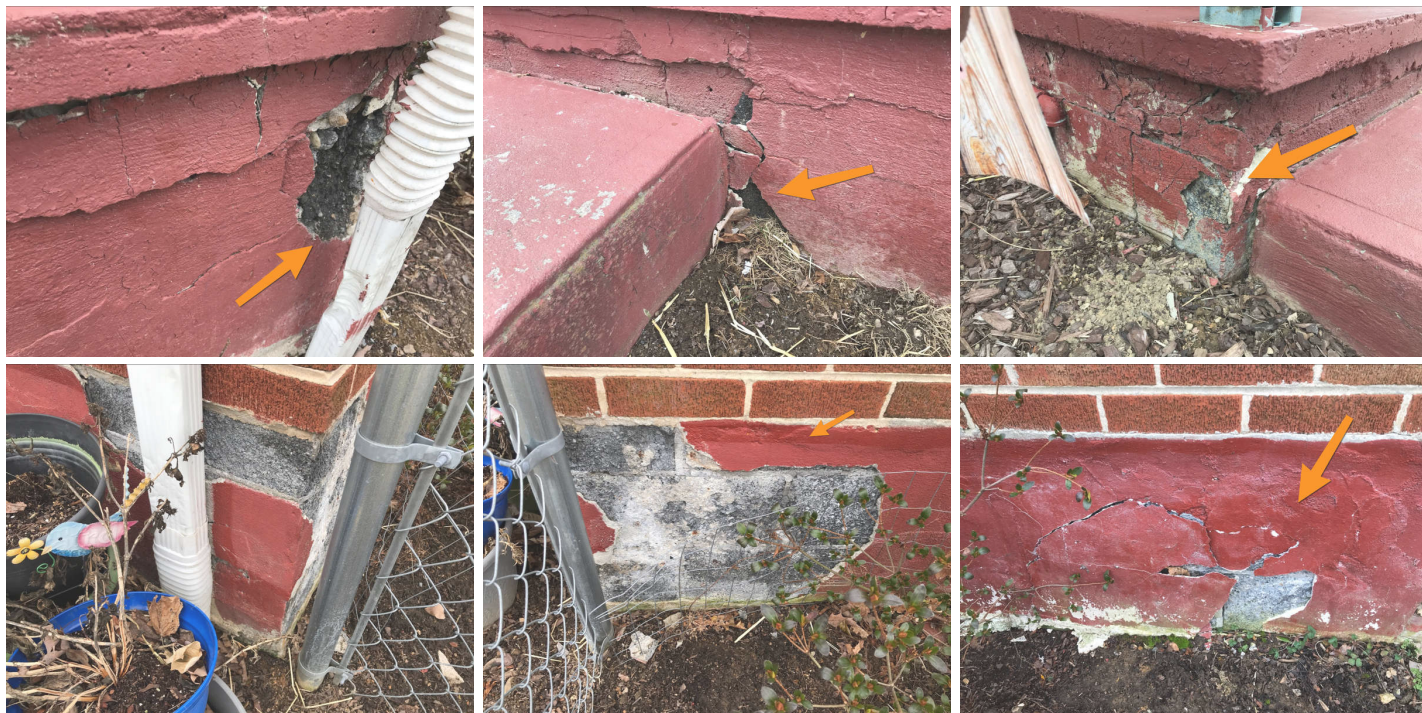
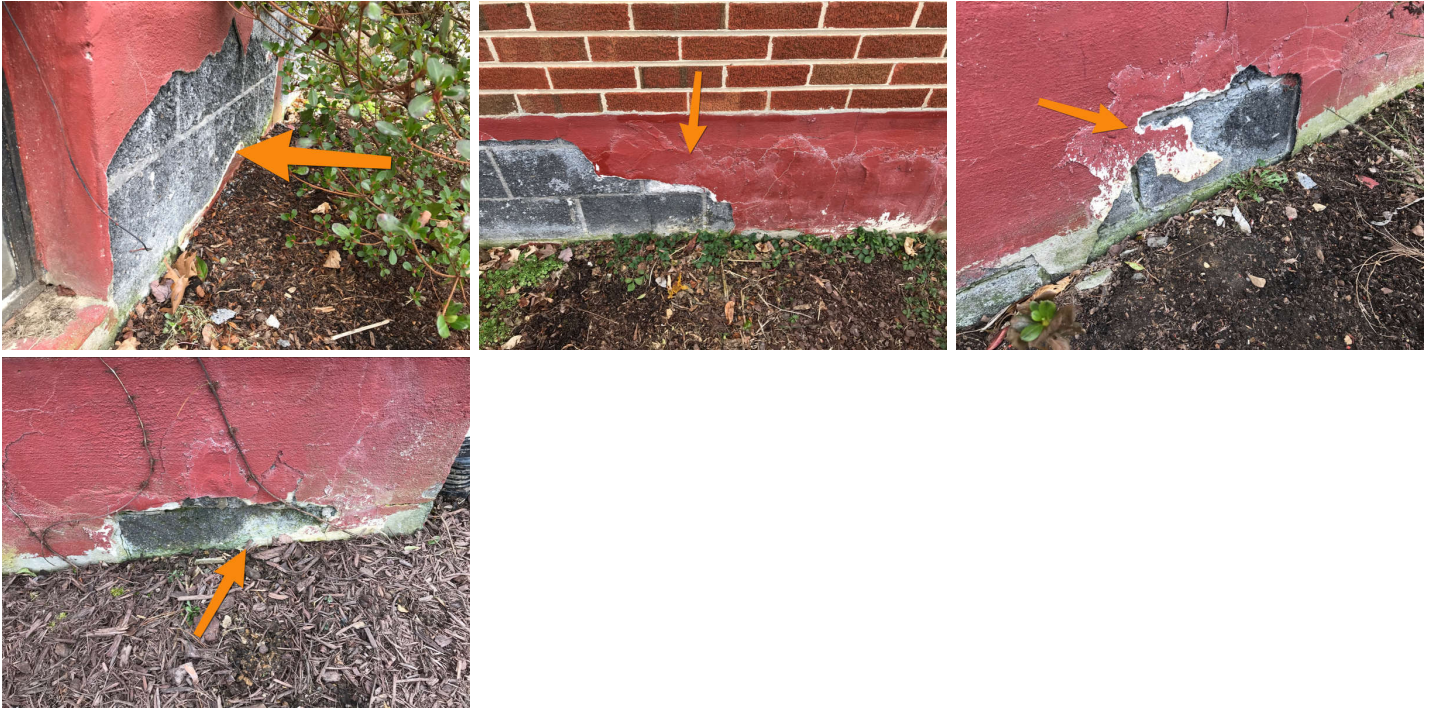
12.1.1 Exterior Wall Construction

MODERATE BLOCK CRACKING- QC

Concrete Masonry Unit (CMU) exterior walls had moderate cracking visible in CMU blocks. Cracking should be patched to avoid freeze damage and the cause of cracking should be determined and corrected. The Inspector recommends that you consult with a qualified contractor to discuss options and costs for stabilization or correction.

Contact a qualified professional.

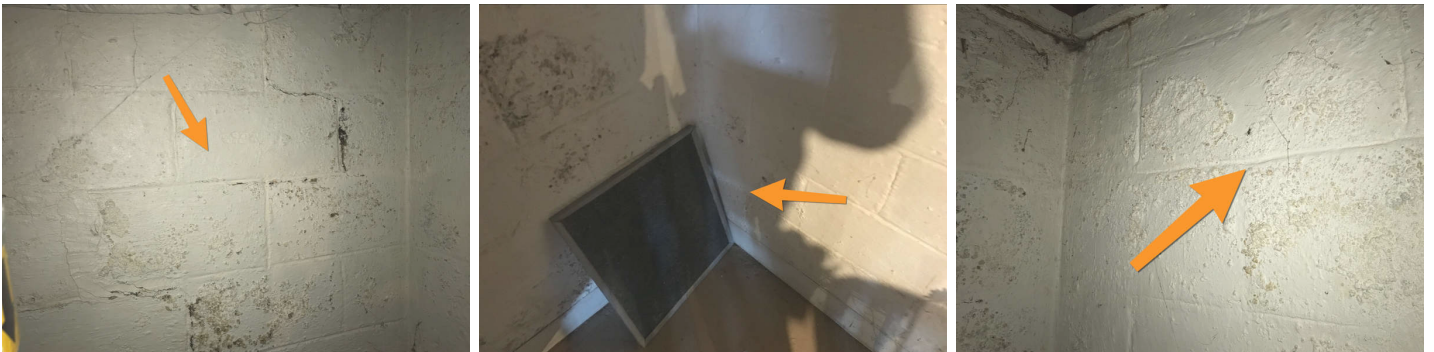
12.3.1 Foundation

EFFLORESCENCE VISIBLE

Efflorescence (white powdery deposits) visible on the surface of the concrete floor slab is an indication of moisture intrusion. Moisture intrusion can affect the ability of the soil beneath the foundation to carry the weight of the structure above and may cause structural damage from soil movement. Moisture intrusion can also damage materials and encourage the growth of microbes such as mold. Efforts should be made to identify the source of the moisture and correct this condition.

Contact a qualified professional.

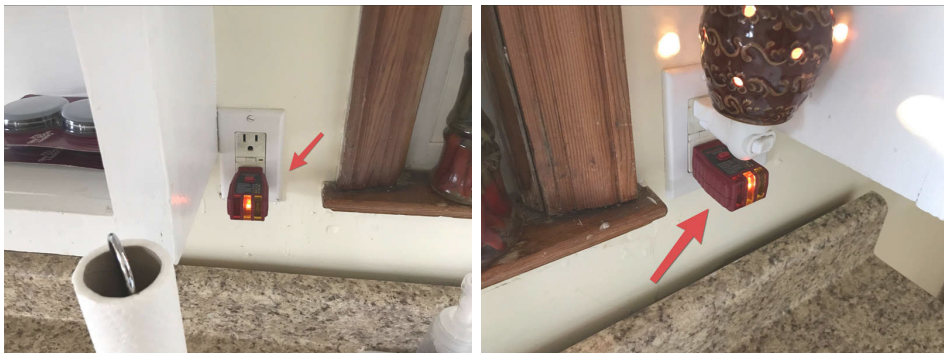
15.7.1 Receptacles and Switches

GFCI PROTECTED RECEPTACLE NON-RESPONSIVE- QC

1ST FLOOR KITCHEN

A ground fault circuit interrupter (GFCI)-protected electrical receptacle in the kitchen did not respond to testing at the time of the inspection. The Inspector recommends that this condition be corrected by a qualified electrical contractor.

Contact a qualified professional.

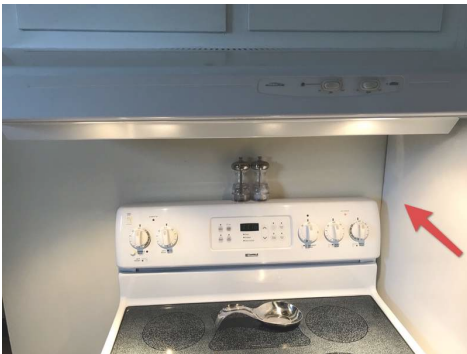
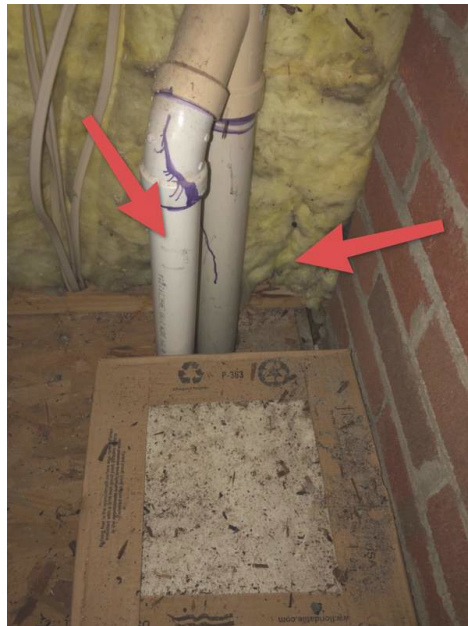
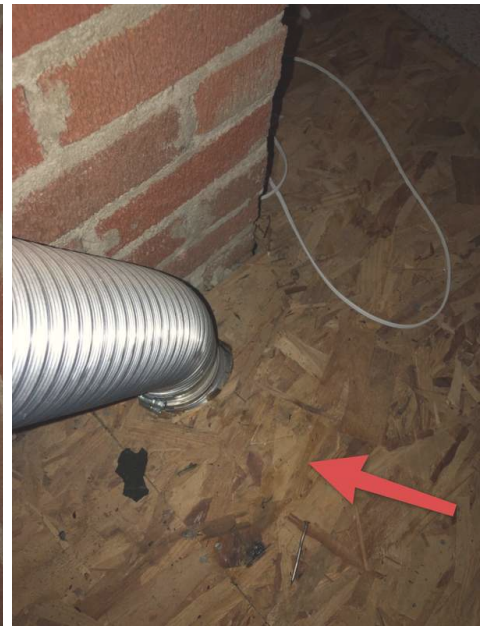
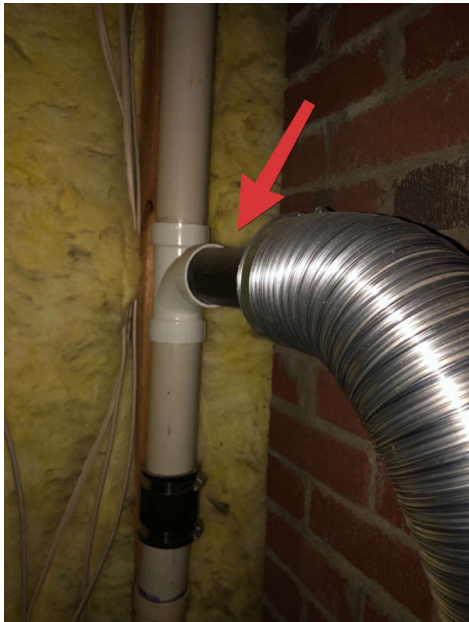
15.11.1 Range Hood

VENTS TO OUTSIDE

The exhaust vent of the range hood discharged exhaust to the home exterior. However it is connected to the plumbing vent. These are separate systems and should not be connected. Inspector recommends licensed contractor to evaluate and correct. This could be a safety issue

Plumbing stack

Hood exhaust

Joining of the two

Recommendation
Contact a qualified professional.

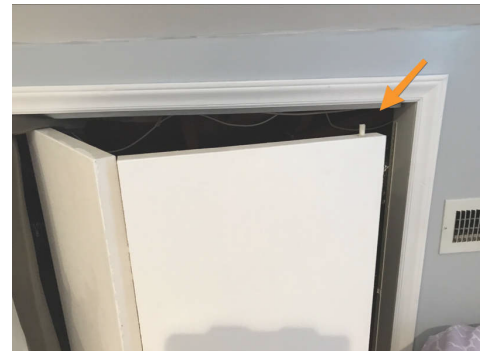
16.1.1 Attic Access

ATTIC ACCESS

Doors to attic access are broken recommend repairing

Contact a qualified professional.
