IINSPECT

RESIDENTIAL REPORT

1234 Main St.
Jefferson GA 30549

06/04/2018 9:00AM

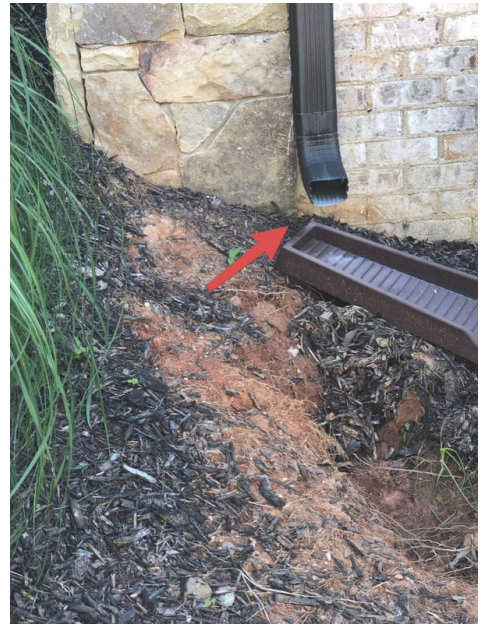
Right

3.6.1 Gutters | Downspouts | Drain Lines

RUNOFF DRAINS

RECOMMENDED UPGRADE: Adding runoff drain extensions to the gutter system is necessary so that roof run off is discharged at least six feet away from the foundation.

Recommendation
Contact a qualified professional.

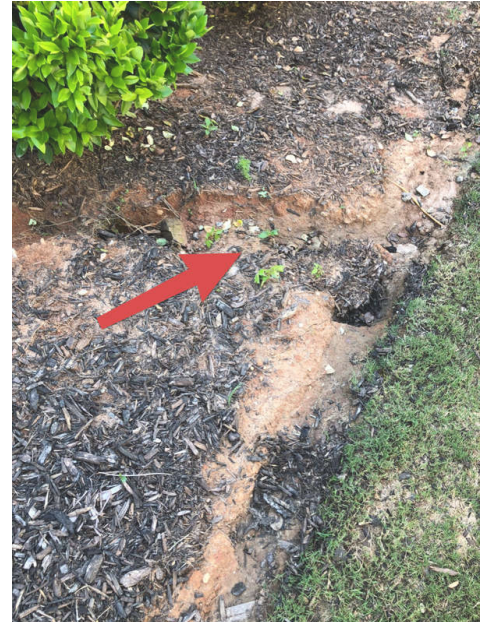
Right

4.1.1 Grading

EROSION

SERVICE / REPAIR: Erosion noted at time of inspection. Have ground area restored and make efforts to control rain water runoff to prevent reoccurrence. Some local and state municipalities can invoke fines on property owners for storm water silt runoff responsible for filling streams.

Contact a qualified professional.

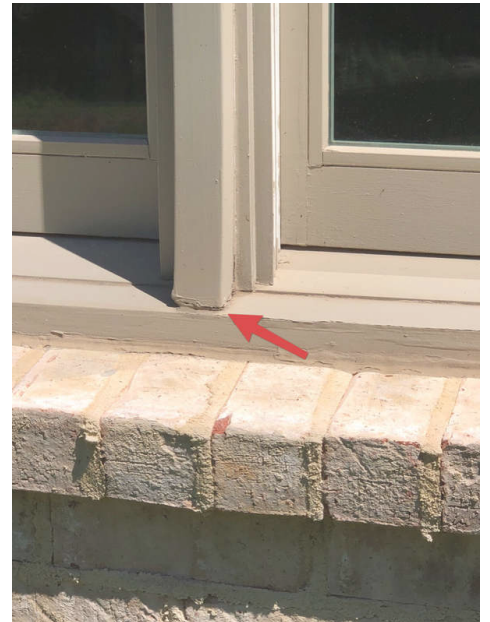
Rear

4.5.1 Windows

DAMAGED TRIM

SERVICE / REPAIR: Damaged trim found at window. Replace as needed.

Contact a qualified professional.

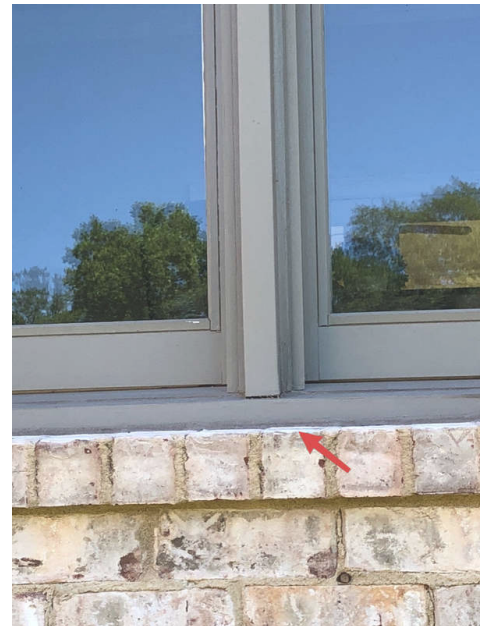
Right

4.5.2 Windows

CAULK - NEEDED

SERVICE / REPAIR: The caulk is missing and will allow moisture penetration. Have qualified contractor repair as needed.

Contact a qualified professional.

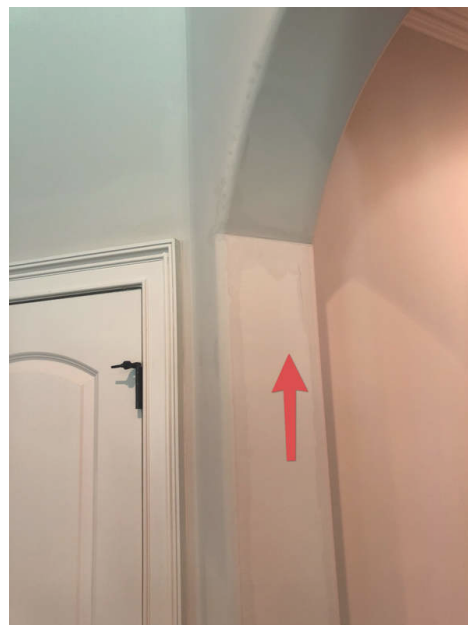
Basement

8.1.1 Walls | Ceilings

IR - DRY

GENERAL NOTE: The ceiling is water damaged. Infrared scan indicated no moisture above the ceiling and moisture meter indicates low moisture content(dry) at the time of this inspection.

Contact a qualified professional.

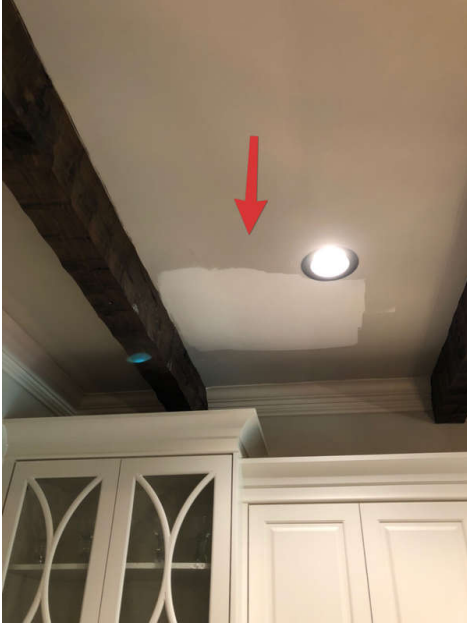
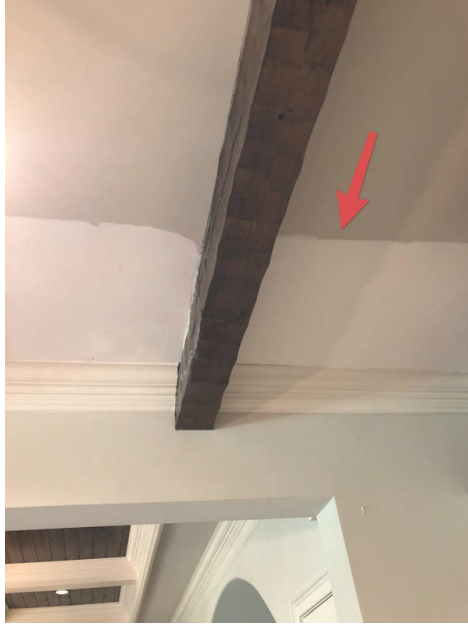
Kitchen

8.1.2 Walls | Ceilings

CEILING REPAIRS

GENERAL NOTE: Touch ups and repairs noted in ceiling(s) during inspection. Seller to disclose the source of problem, including extent of repairs made. This information may be needed for buyer's future reference. Usually requires full area painting to reduce obvious conditions.

Contact a qualified professional.

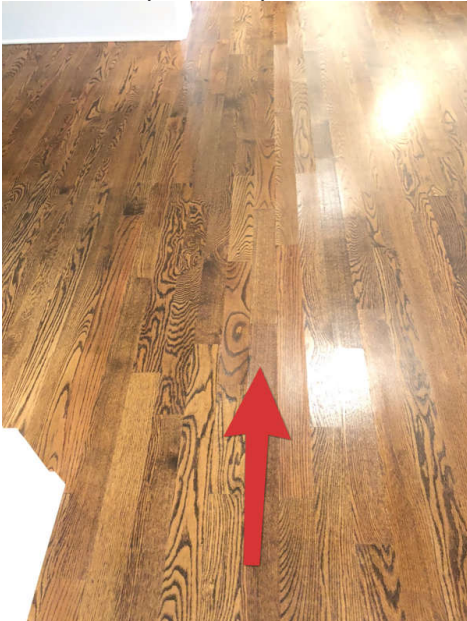
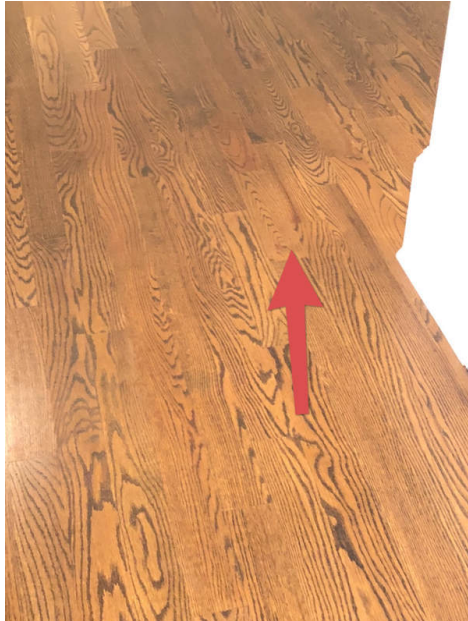
Family Room

8.2.1 Floors

DAMAGED

SERVICE / REPAIR: Damaged areas of flooring observed. Have a professional flooring contractor evaluate and repair or replace the flooring as needed.

Contact a qualified professional.

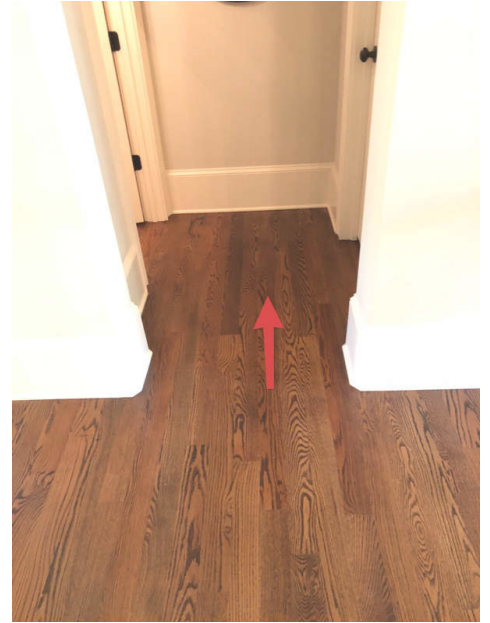
Foyer

8.2.2 Floors

WOOD - NOT LEVEL

SERVICE / REPAIR: No point on the surface of a wood floor should be more than 1/2 inch higher or lower than any other point on the surface within 20 feet, or proportional multiples. NAHB 3-8

Contact a qualified professional.

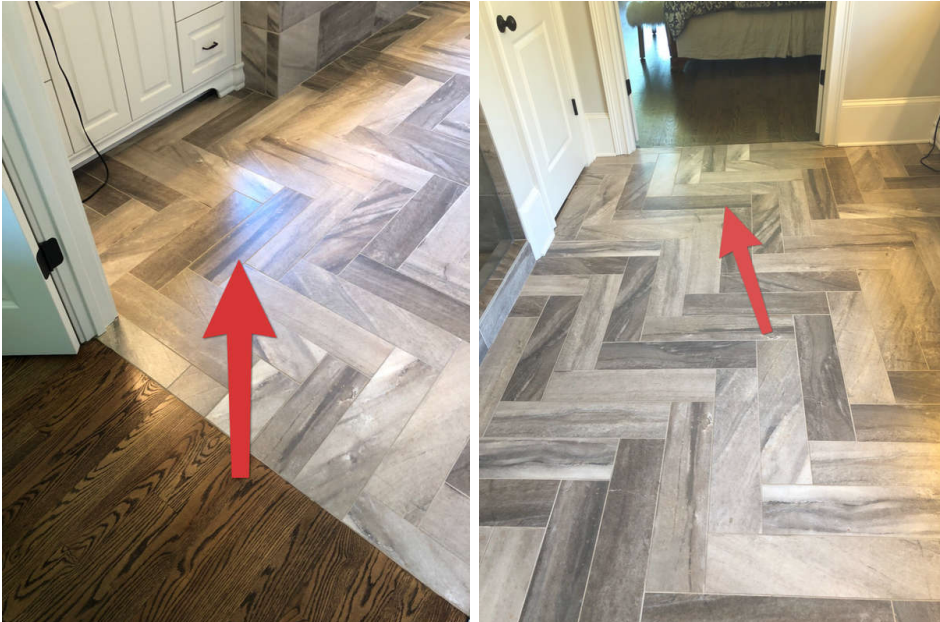
Master Bath

8.2.3 Floors

FLOOR UNEVEN

GENERAL NOTE: Observed uneven floor slope. Have qualified contractor evaluate and repair as necessary.

Contact a qualified professional.

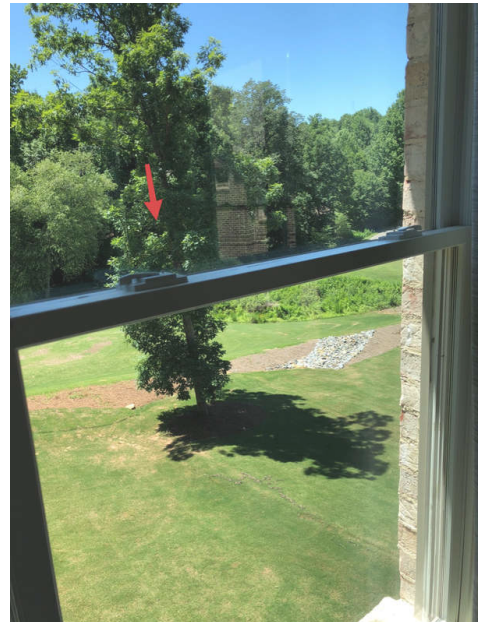
Master Bedroom

8.4.1 Windows

WINDOWS STUCK

SERVICE / REPAIR: A number of windows are painted shut. Have contractor repair as needed to ensure proper egress.

Contact a qualified professional.

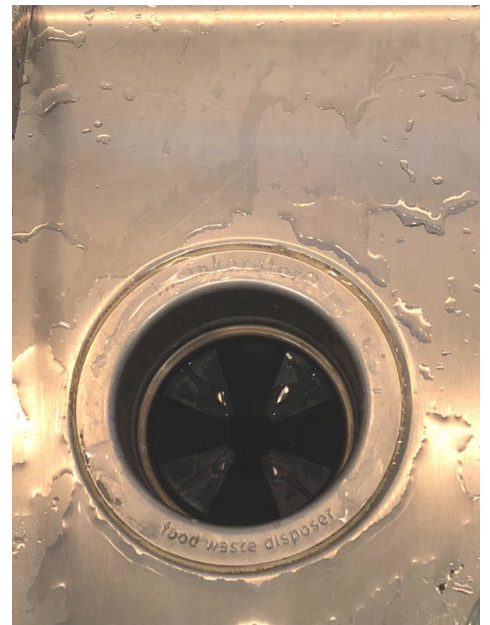
10.3.1 Food Waste Disposer

JAMMED

SERVICE / REPAIR: Disposal jammed at time of inspection with debris found inside unit. Have cleared and freed up to run correctly.

Contact a qualified professional.

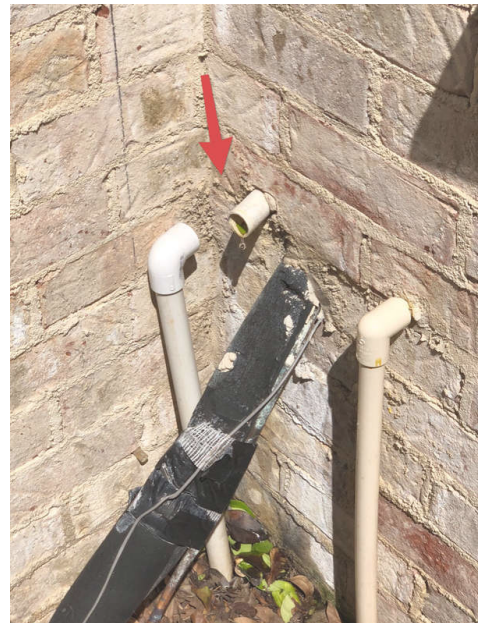
Rear

12.1.1 Air Conditioner

CONDENSATE DRAIN

SERVICE / REPAIR: The drain line is disconnected. Have a qualified contractor repair as needed.

Contact a qualified professional.

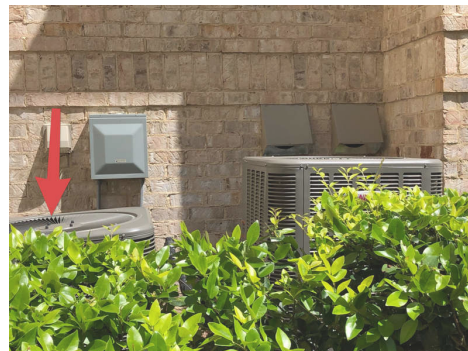
Rear

12.1.2 Air Conditioner

CONDENSER - TIPPING

SERVICE / REPAIR: Tipping the compressors more than 10 degrees can damage the unit and voids the manufacturer's warranty. Unit(s) should be leveled.

Contact a qualified professional.
