SWAN HOME INSPECTIONS PLLC

HOME INSPECTION

1234 Main St.
Porter TX 773654687

PROPERTY INSPECTION REPORT

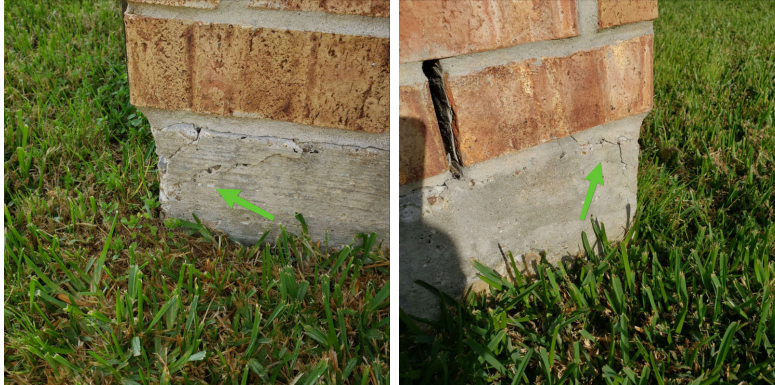
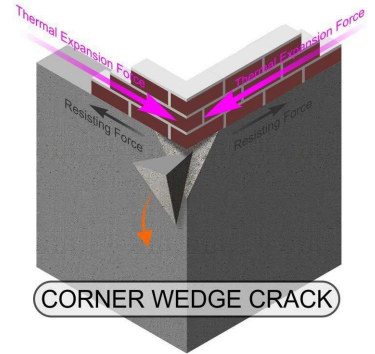
Northeast, Northwest Foundation Corners

Corner Cracks:

Foundation corners cracked and/or sheared off (corner pops); This condition does not adversely affect the performance of the foundation, however cosmetic improvements may be necessary.

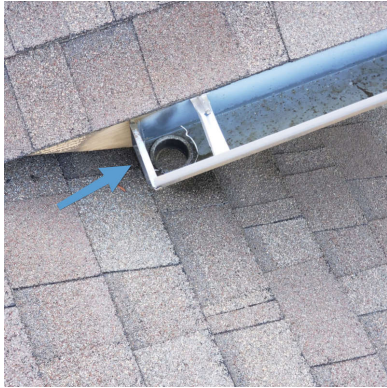
One or more gutters around the home was found to be discharging directly to the roof surface. This condition should ideally be corrected to help prevent premature deterioration of the shingles in this area due to high water volumes. This is a common issue for new homes.

Recommendation: Contact a qualified gutter contractor

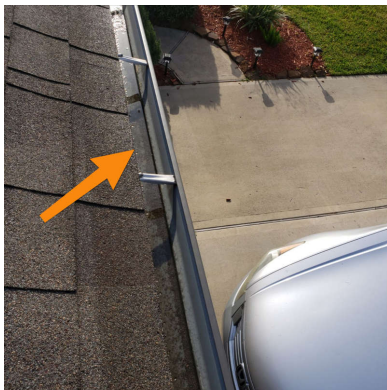
2: Gutter - Slope

Gutters around the home appeared to be sloped incorrectly. This condition can result in excessively high moisture levels and decay. The Inspector recommends correction to help promote proper drainage.

Recommendation: Contact a qualified gutter contractor

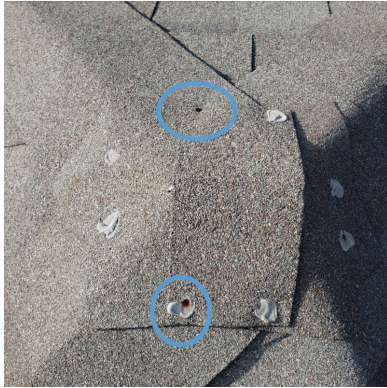
Some areas of the roof had fasteners visible. Fasteners have been installed to secure shingles or flashings from being blown loose by wind. Exposed fasteners should be sealed periodically to prevent moisture intrusion into the roof structure.

Recommendation: Contact a qualified professional.

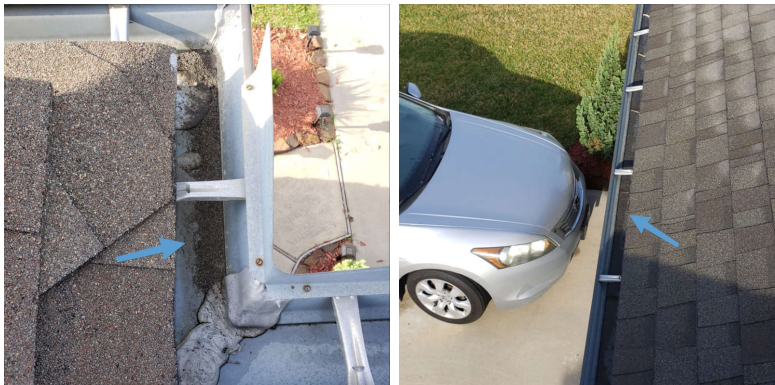
2: Granules in Gutter

Granules from the asphalt shingles were accumulated in the gutters. This is not a defective condition, but is common and expected. However, the granules trap sediment which hardens and prevents fully functional drainage of the gutters and may hasten rust or corrosion. The Inspector recommends thorough cleaning to help prevent deterioration of the gutters.

Recommendation: Contact a qualified professional.

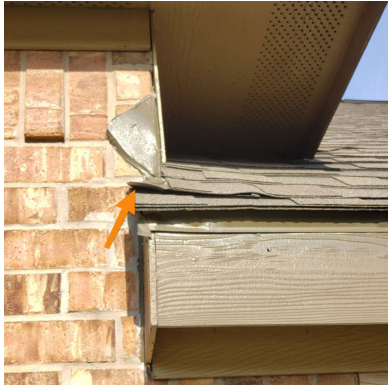
3: Raised Flashing

Raised areas of flashing was observed. Raised flashing can allow wind driven rain access to the attic. Proper repair is recommended.

Recommendation: Contact a qualified roofing professional.

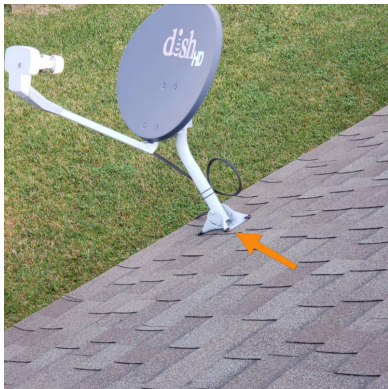
4: Satellite Bolted Through Roof

Satellite dishes bolted through the roof surfaces is not a recommended configuration. The penetrations should be properly sealed.

Recommendation: Contact a qualified professional.

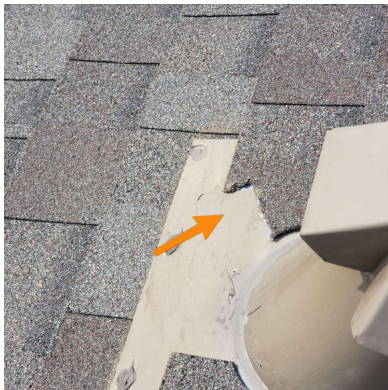
5: Damaged Shingles

Damage to areas of the shingles were observed. Damaged areas and/or shingles should be repaired or replaced.

Recommendation: Contact a qualified roofing professional.

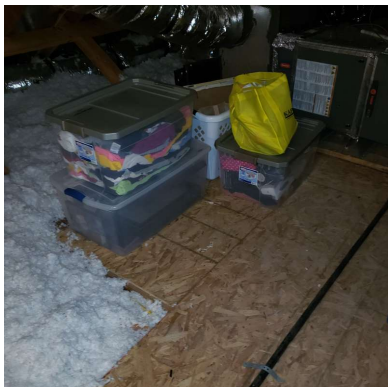
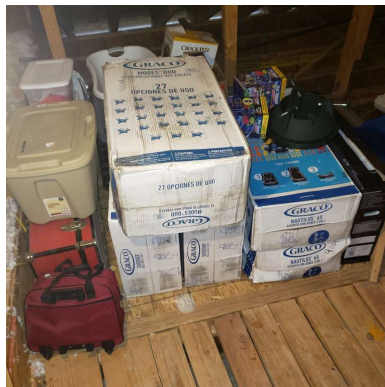
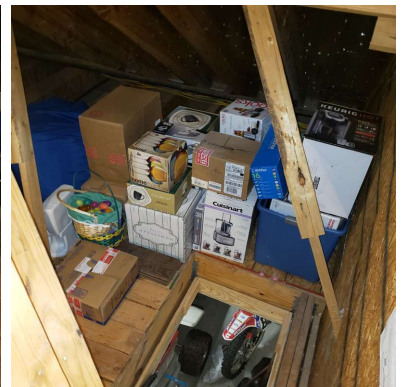
Platform Being Used As Storage :

The platform in the attic structure was being used as storage. This limits the inspection of the attic structure. If concerns exist with the attic/roof structure it is recommended a qualified professional be consulted for further evaluation.

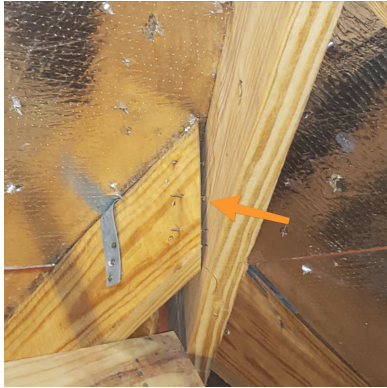
1: Rafters - Poor Top Cuts

Plumb cuts where rafters connected to the ridge were badly cut. This condition can reduce the strength of these connections. While this condition is improper, it should not warrant roof replacement at this time.

Recommendation: Contact a qualified professional.

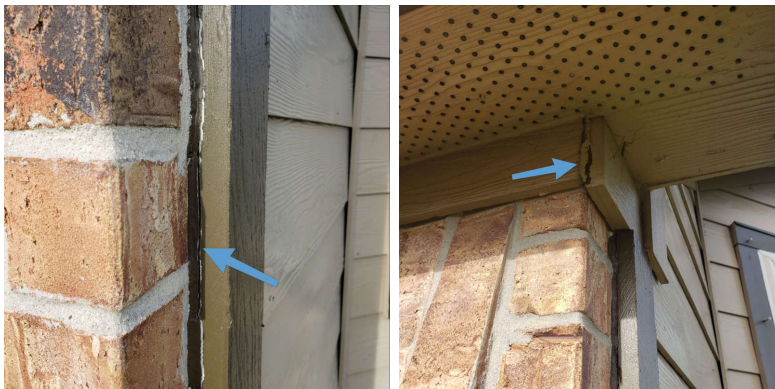
The home had visible gaps or holes in areas of the siding covering exterior walls. The Inspector recommends application of an appropriate sealant at these areas to help prevent damage from moisture intrusion to the home materials, the exterior wall structure and to prevent development of microbial growth such as mold.

Recommendation: Contact a qualified professional.

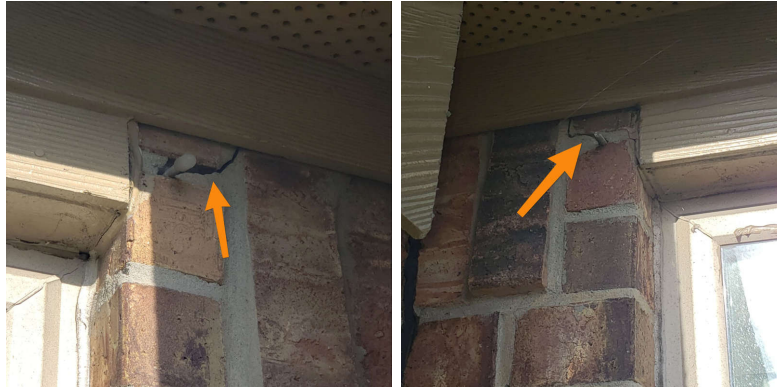
2: Mortar Deterioration

Brick exterior walls had areas of mortar joint deterioration. These areas should ideally be re-pointed to help prevent continued deterioration. You should consult with a qualified masonry contractor before the expiration of your Inspection Objection Deadline to determine options and costs.

Recommendation: Contact a qualified masonry professional.

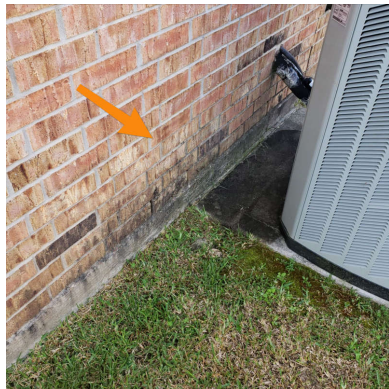
3: Roof Runoff Stains

Stains were observed on areas of the exterior walls. These stains appeared to be where moisture is discharging from the roof down the exterior walls. We recommend the areas be cleaned and that improvements be undertaken to promote moisture away from the walls/structure.

Recommendation: Contact a qualified professional.

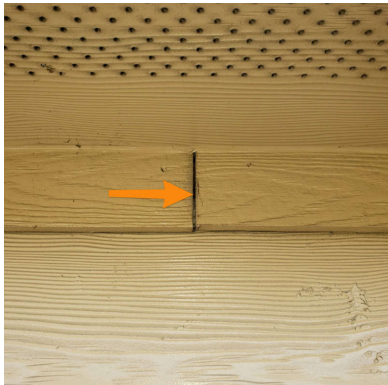
4: Siding Caulking

Cracking, deteriorated, and/or missing sealant was observed around exterior wall connection joints. It is recommended all joints be properly sealed to prevent moisture intrusion.

Recommendation: Contact a qualified professional.

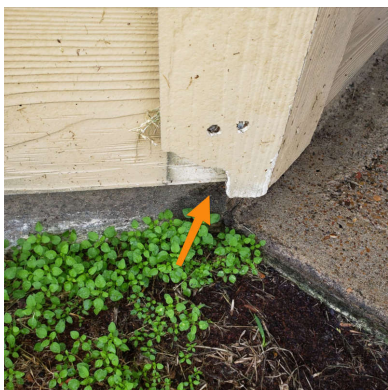
5: Siding Damaged

Areas of the exterior siding/trim were observed to be damaged. We recommend these sections of siding/trim be repaired or replaced.

Recommendation: Contact a qualified siding specialist.

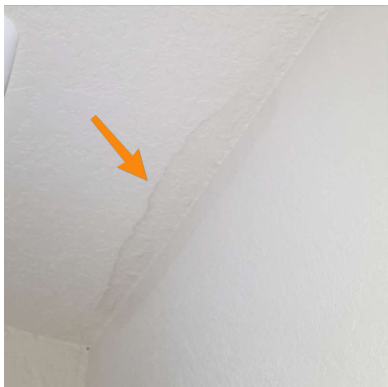
6: Moisture Stains

What appeared to be a moisture stain was observed on the interior wall in the laundry room. A thermal imaging scan and moisture meter determine that the leak was not active. Further investigation into this issue may be necessary.

Recommendation: Contact a qualified professional.

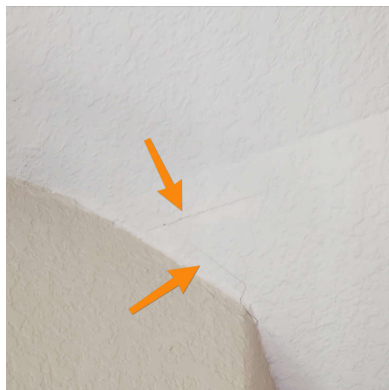
Gambrell ceilings are present within the home. It is typical that these ceiling structures will, as the home settles and "racks" or moves with high winds, develop cracks and nail pops at the corner area which intersects with the vertical wall surface below. The cause is generally accepted that the Sheetrock is attach to the rafters and as the roof flexes, the Sheetrock moves as well. This will cause the cosmetic issues mentioned earlier.

Recommendation: Contact a qualified professional.

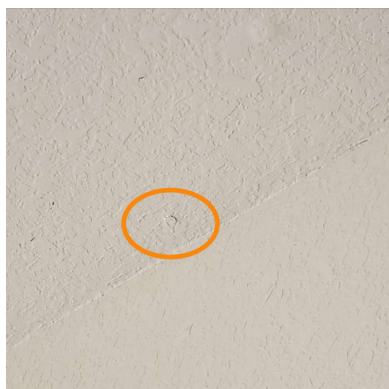
2: Nail Pop

Nail pops were observed on the interior ceilings. Cosmetic improvements are recommended.

Recommendation: Contact a qualified professional.

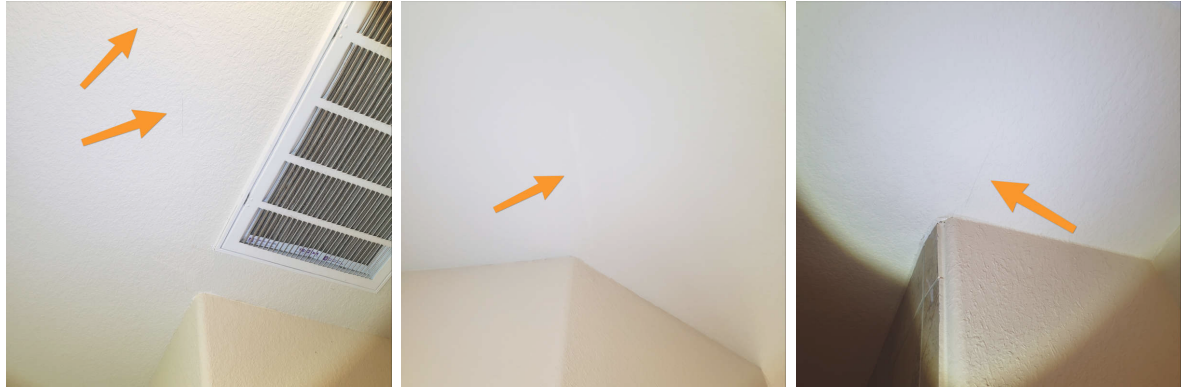
3: Typical Ceiling Cracks

Interior ceiling cracks were observed on the interior ceilings of the structure. In my opinion, the ceiling cracks appeared to be typical for a home of this age. This can imply some structural movement of the structure has occurred, as is typical of most houses. We recommend the cracks be monitored.

Recommendation: Recommend monitoring.

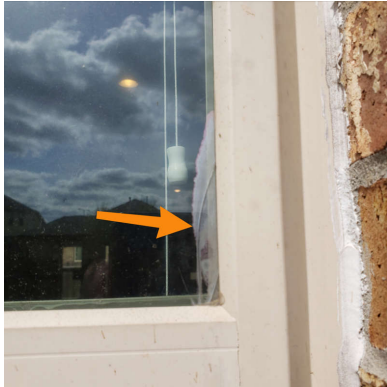
One or more windows in the home had a cracked or broken pane.

Recommendation: Contact a qualified window repair/installation contractor.
