TREC RESIDENTIAL

1234 Main St.
Melissa TX 75454

PROPERTY INSPECTION REPORT

By: Chris Scanland - Professional Inspector TREC# 23176 12/11/2018 9:00AM
(Name and License Number of Inspector) (Date)

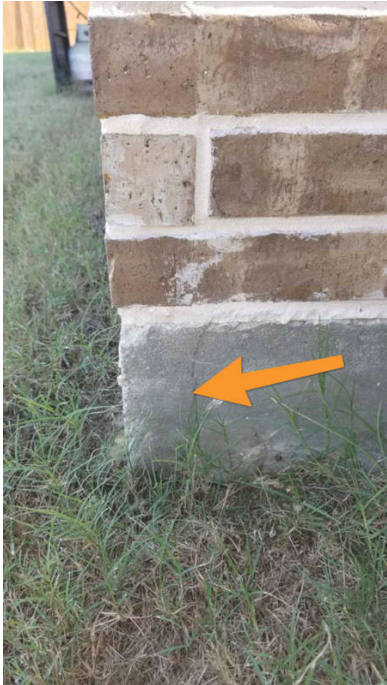
Northwest

1: Corner Pop

One or more corners of the foundation had cracking and/or damage. This is cosmetic in nature and does not effect the overall integrity of the foundation. However, the inspector recommends having corner pops repaired to prevent future damage to the brick siding.

Recommendation: Contact a qualified masonry professional.

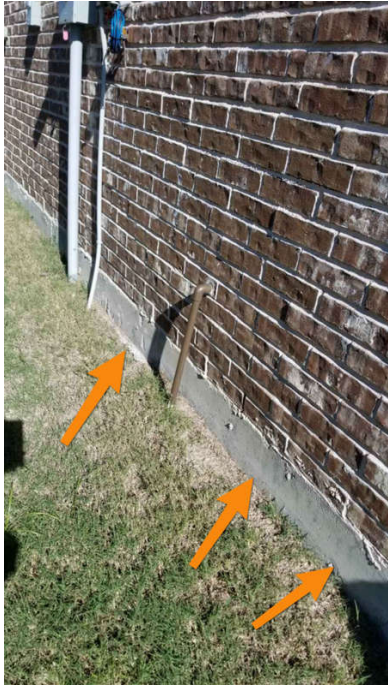
West

1: Low Soil Level

Low soil level on foundation. Recommend back-filling area to allow 4-6 inches of foundation to be visible above grading.

Recommendation: Contact a qualified professional.

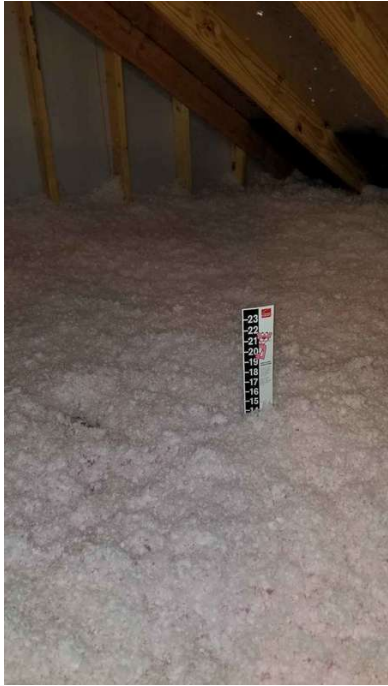
Recommended Insulation Depth

- D. Roof Structure & Attic**
Material: OSB, Wood
Type: Combination
Approximate Average Depth of Insulation: 14 Inches -
Attic appears to be adequately insulated. Fiberglass insulation is at an average of 14 inches deep.

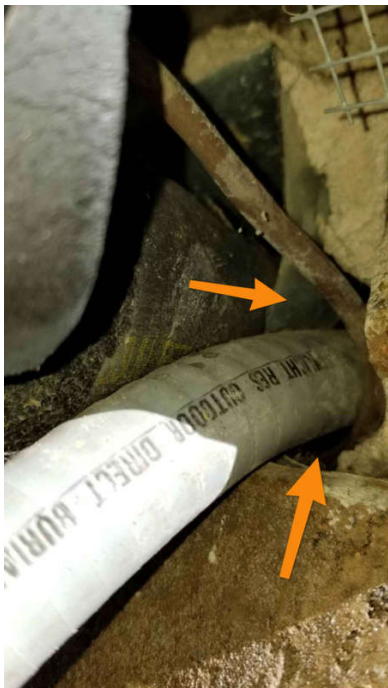
Air Conditioner Lines

1: Seal Exterior Penetrations

Exterior wall penetrations had gaps that should be sealed with an appropriate sealant to prevent moisture and insect entry.

Recommendation: Contact a qualified handyman.

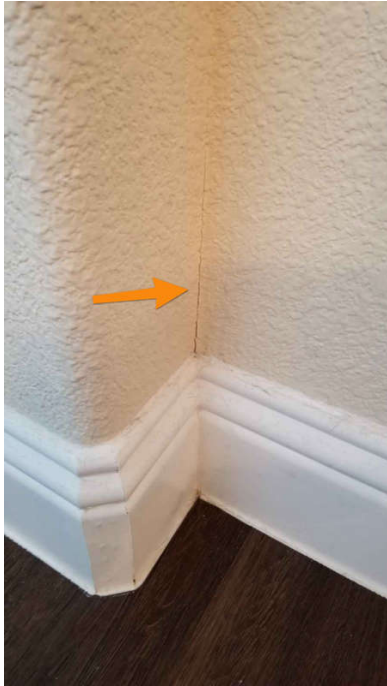
North

2: Cracks - Minor

Minor cracking was observed in drywall throughout the home. This is common and is cosmetic in nature.

Recommendation: Contact a qualified painter.

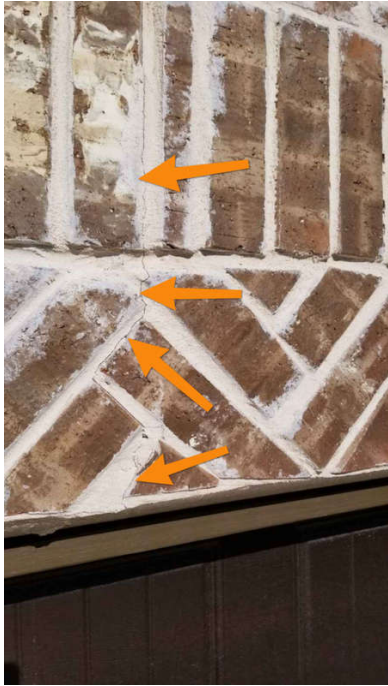
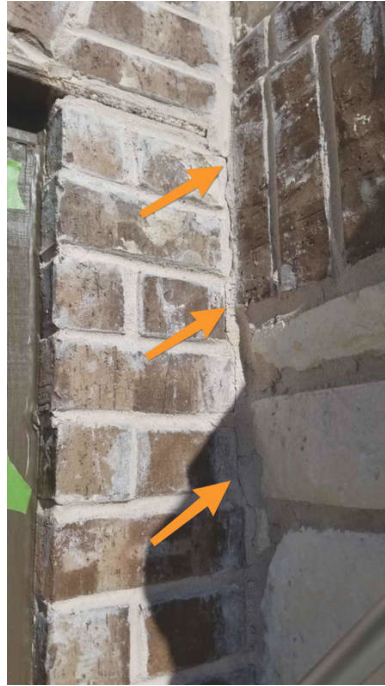
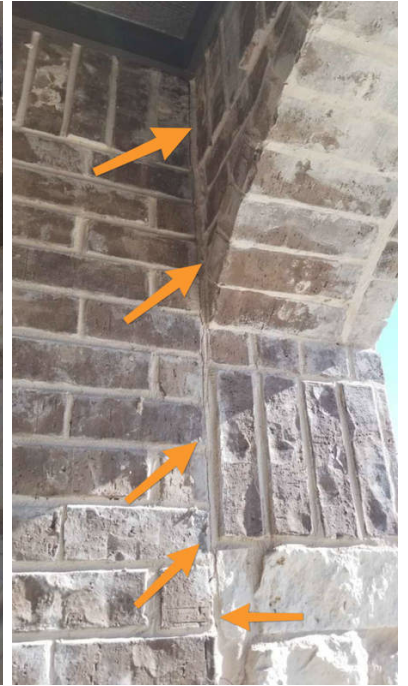
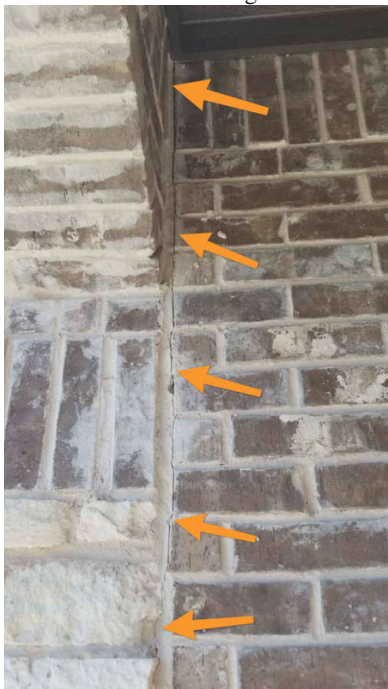
3: Cracks in Brick and Mortar

At time of inspection, there were one or more minor cracks in brick and mortar. These appear to be mostly cosmetic in nature, however, should be repaired to prevent moisture intrusion and further damage.

Recommendation: Contact a qualified masonry professional.

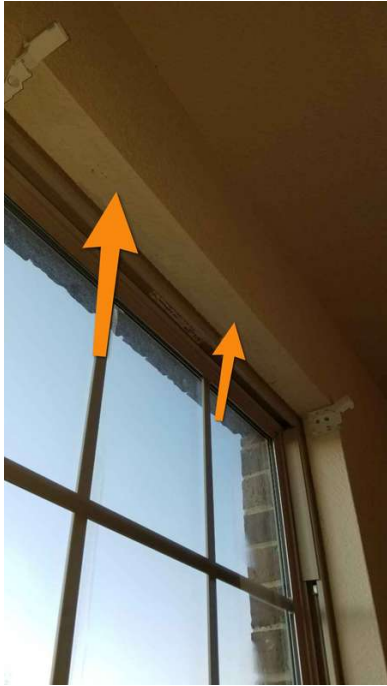
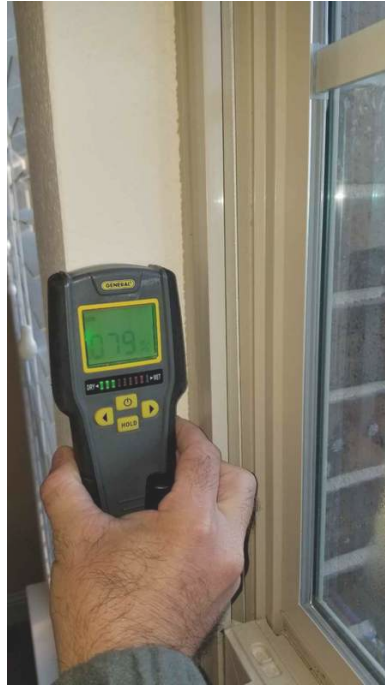
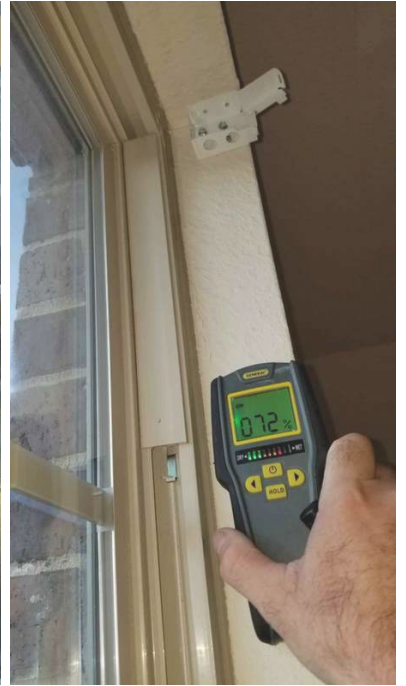
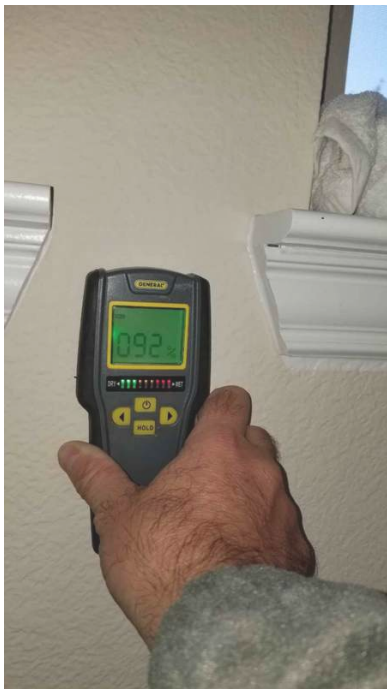
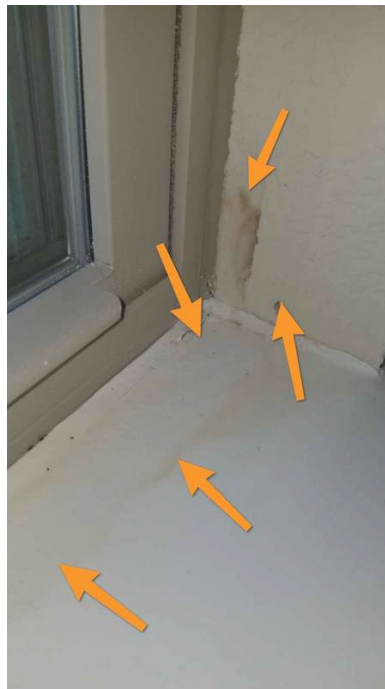
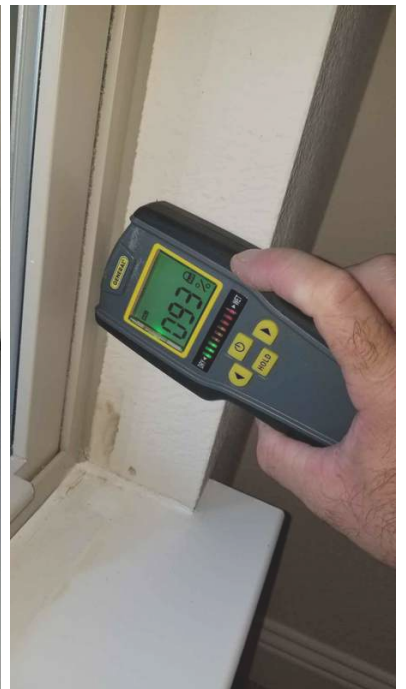
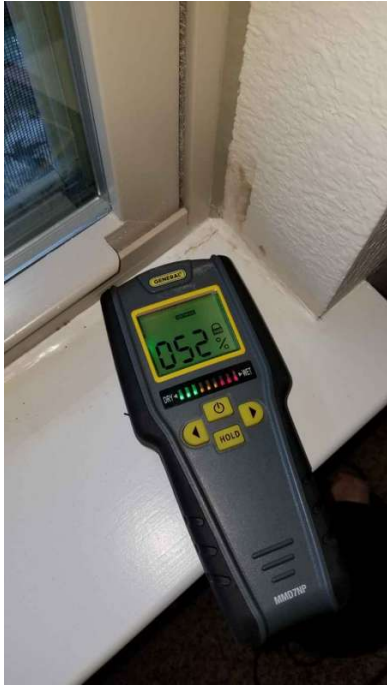
4: Moisture Damage- Active Leak

A stain on the wall was visible at the time of the inspection and appeared to be the result of moisture intrusion. The moisture meter showed elevated moisture levels in the affected areas at the time of the inspection, indicating that the leakage has been recent.

Recommendation: Contact a qualified professional.

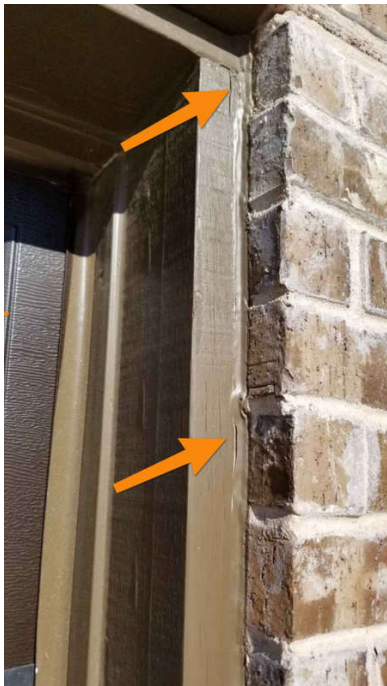
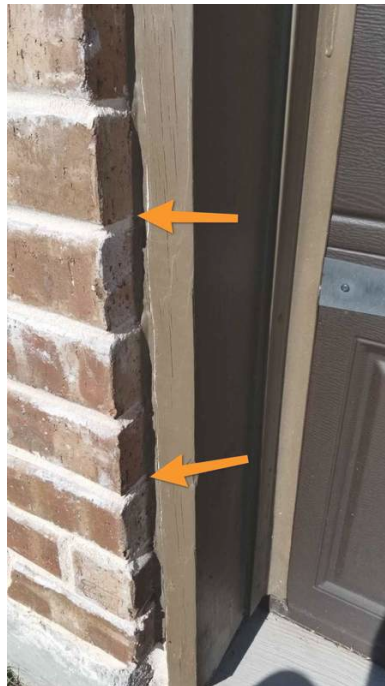
5: Trim Caulking

One or more locations need caulking replaced around trim/molding to prevent moisture and/or pest intrusion.

Recommendation: Contact a handyman or DIY project

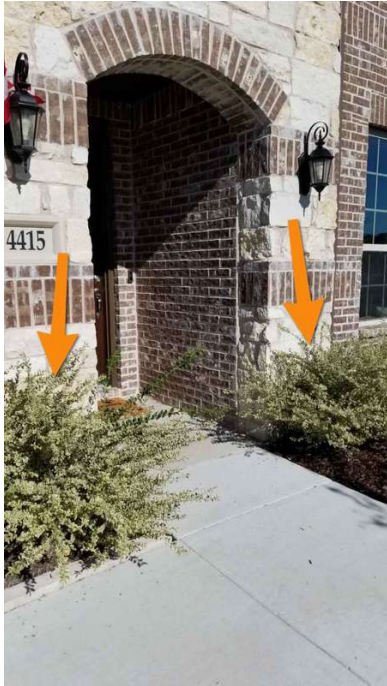
Front Porch Area

6: Vegetation/Structure Contact

Trees/shrubs in contact with exterior structure. Recommend trimming shrubs/trees away from structure to help prevent mechanical, moisture and pest damage.

Recommendation: Contact a qualified lawn care professional.

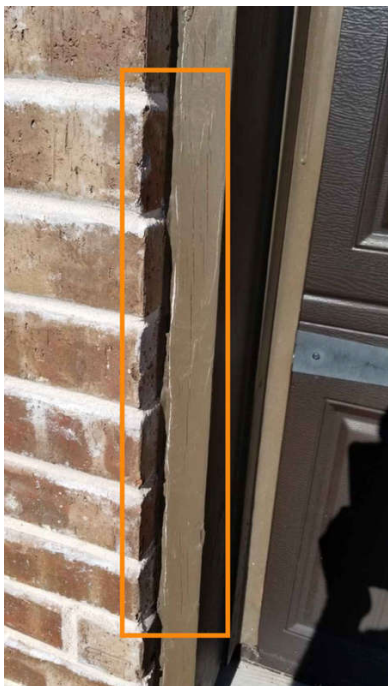
Garage Trim

8: Trim Needs Paint

Garage door trim needs touch-up paint where cracks are present. This will help prevent moisture intrusion and significantly prolong the life of the boards.

Recommendation: Contact a handyman or DIY project

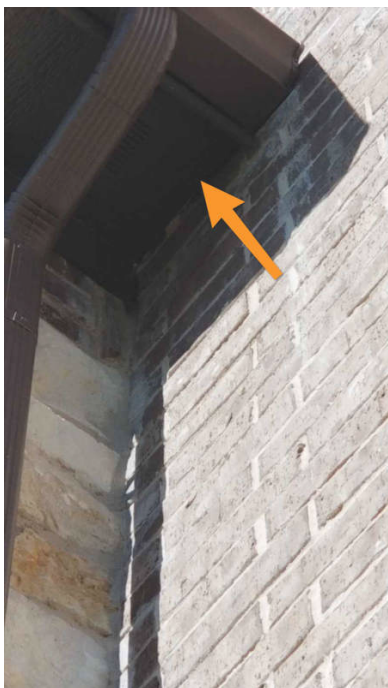
Front Roofline

9: Missing Frieze Board

Missing small frieze board on the front of the home. It appears as though one was never installed.

Recommendation: Contact a qualified professional.

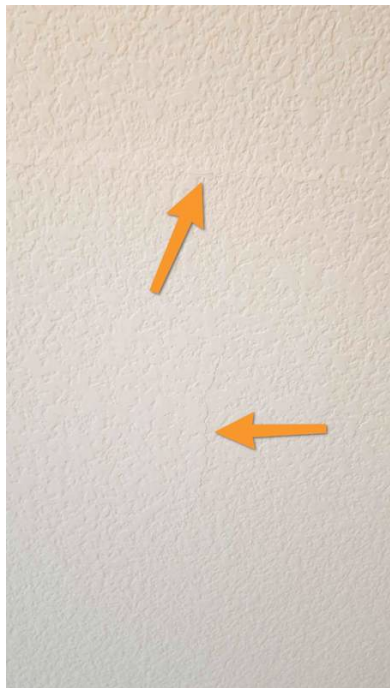
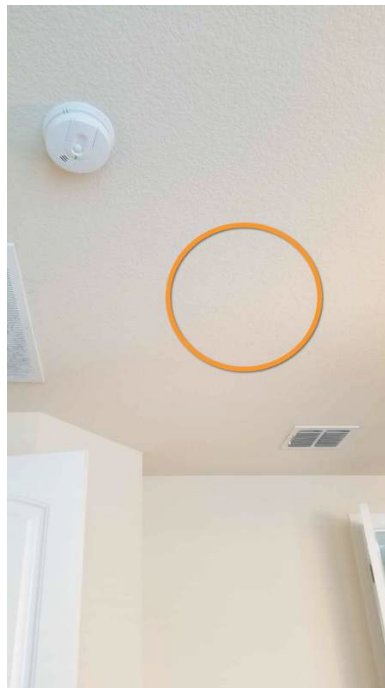
1: Ceiling - Minor Damage

Minor damage/cracking to the ceiling was visible at the time of the inspection. This is possibly from stepping on the sheet rock, or dropping something on it, while walking in the attic.

Recommendation: Contact a qualified drywall contractor.

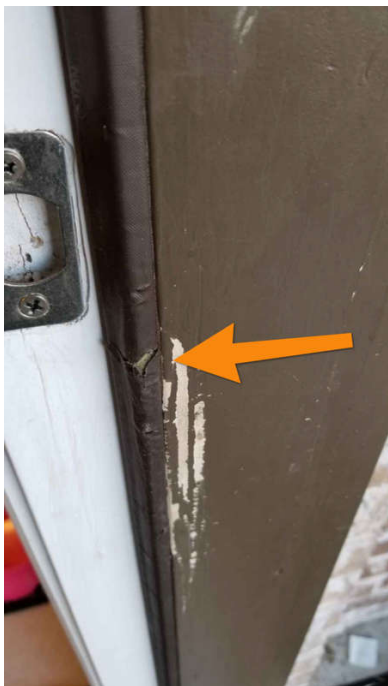
Back Door

1: Weatherstripping/Door Sweep Insufficient

One or more doors had deficient weatherstripping and/or door sweeps. This can result in significant energy loss and moisture/pest intrusion.

Recommendation: Contact a handyman or DIY project

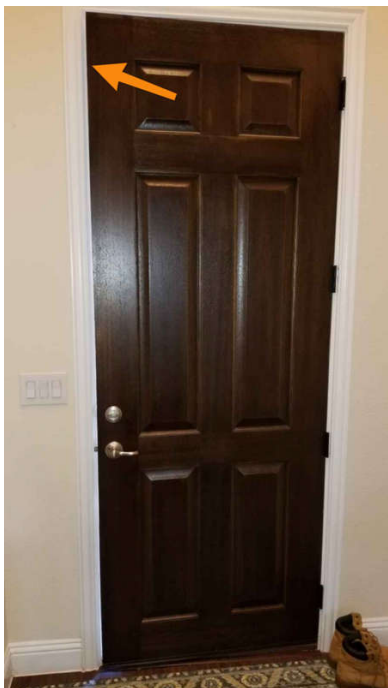
Front Door

2: Door is Binding

Door sticks and is tough to open and close.

Recommendation: Contact a handyman or DIY project

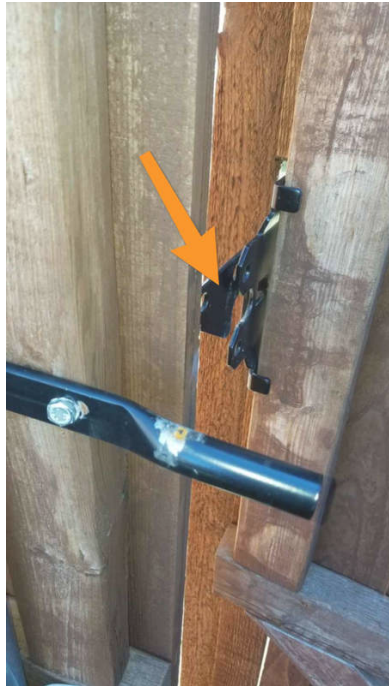
3: Gate Latch

Gate does not latch properly without manipulating it.

Recommendation: Contact a handyman or DIY project

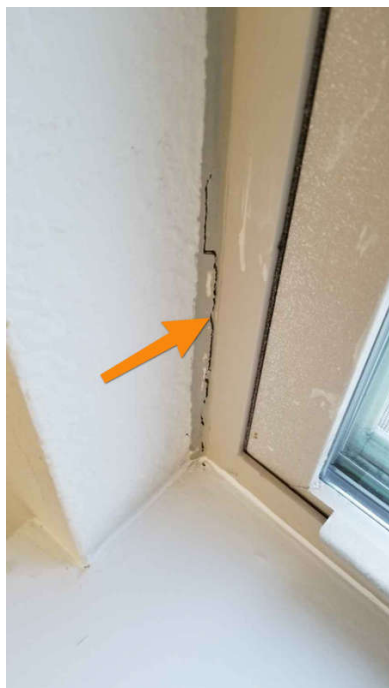
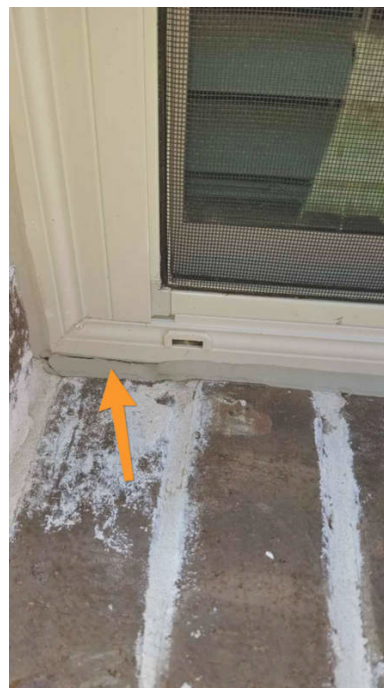
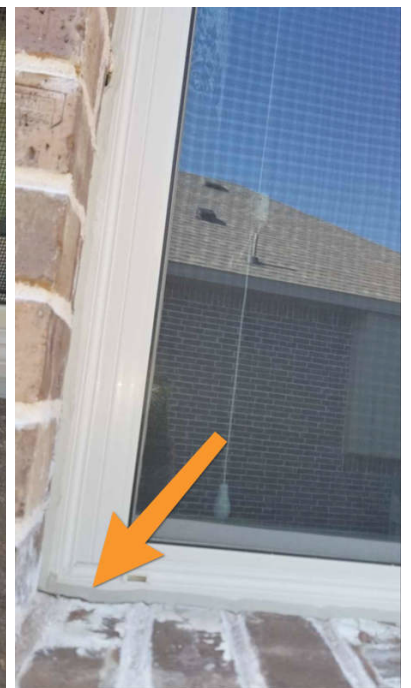
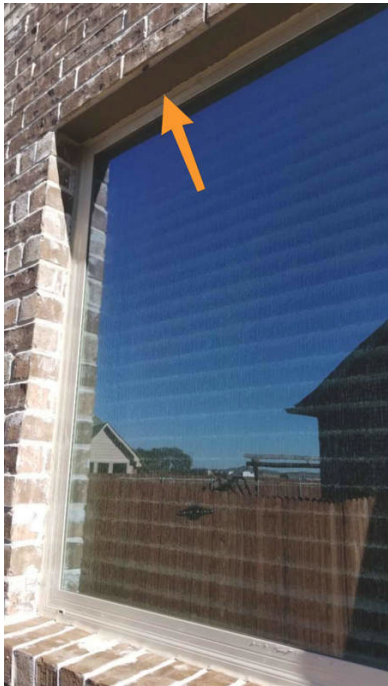
1: Caulking

One or more windows need new caulking to prevent moisture intrusion. This applies to both the inside and outside. Some examples are listed below.

Recommendation: Contact a handyman or DIY project

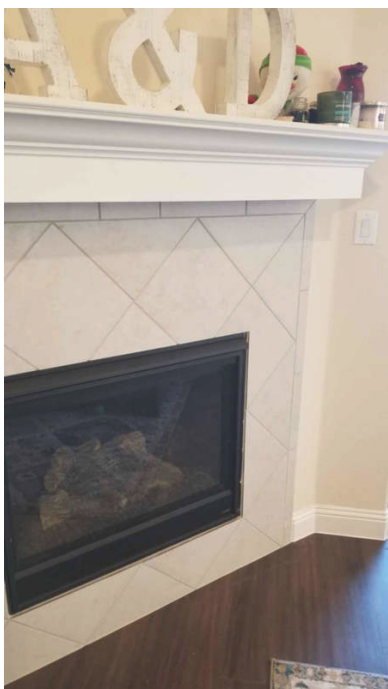
1: Would Not Light

At time of inspection, the gas fireplace would not light.

Recommendation: Contact a qualified fireplace contractor.

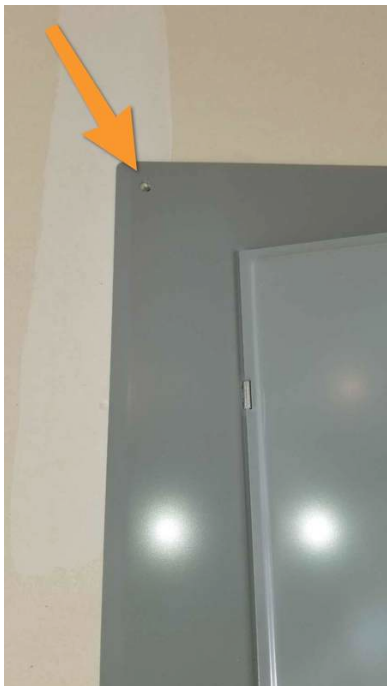
1: Panel Missing Screws

One screw is missing on panel.

Recommendation: Contact a qualified electrical contractor.

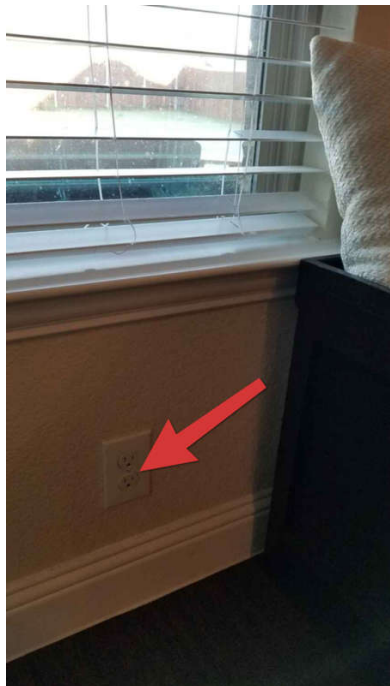
North

1: Loose Outlet

One or more electrical receptacles in the home were improperly secured and moved when plugs were inserted. Receptacles should be securely installed to prevent fire, shock and/or electrocution hazard.

Recommendation: Contact a qualified electrical contractor.

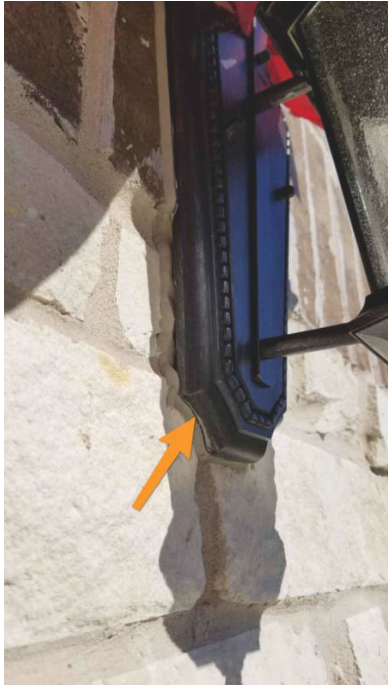
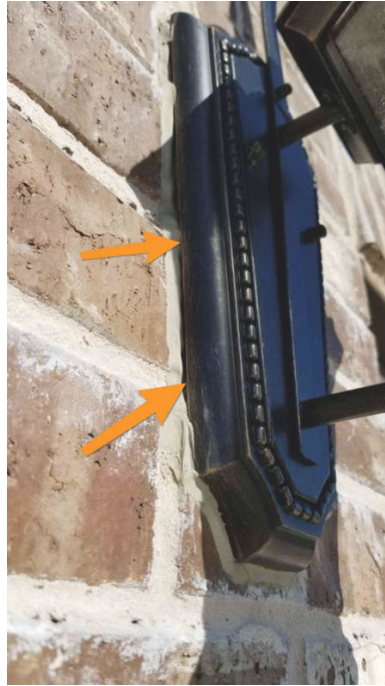
2: Exterior Light Not Sealed

One or more exterior lights need to be sealed with caulk to prevent moisture intrusion.

Recommendation: Contact a handyman or DIY project

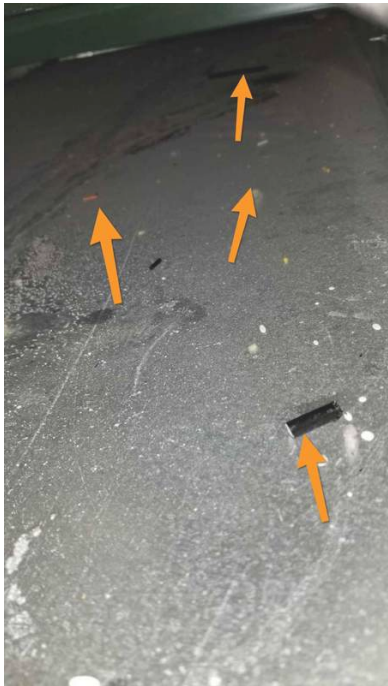
Attic

1: Drip Pan Debris

Secondary drip pan contains debris which can clog the drain line. If drain gets clogged it can result in overflowing the pan which will cause moisture damage to surrounding area. Recommend cleaning drip pan.

Recommendation: Recommended DIY Project

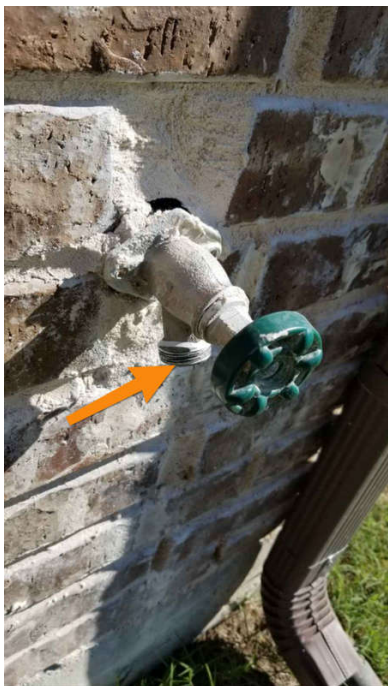
Southwest

1: Missing Backflow Device

Back-flow device not installed on exterior spigot. Recommend installing back-flow device to prevent cross contamination of the potable water supply system.

Recommendation: Contact a qualified plumbing contractor.

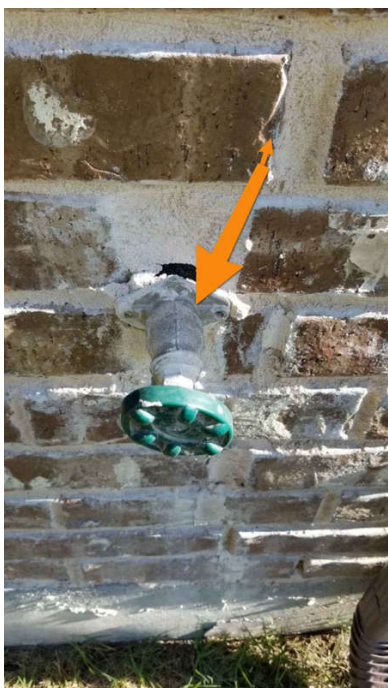
South

2: Hose Bib Not Secured

Recommend securing both hose bibs so they do not move. Any movement of these also cause the pipe in the wall to move. Over time, this can cause the pipes to leak.

Recommendation: Contact a qualified professional.

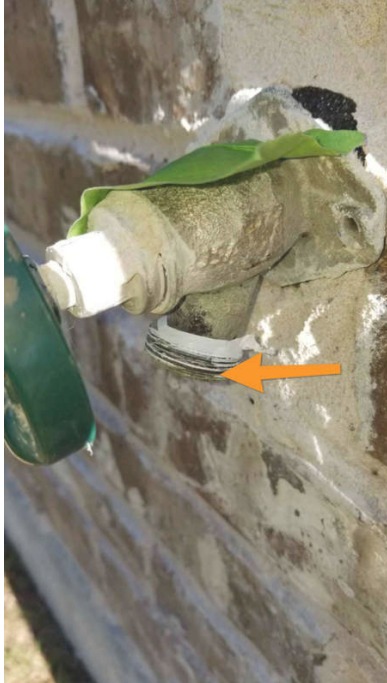
South

3: Hose Bib Threads Stripped

Stripped threads were found on hose bib.

Recommendation: Contact a qualified plumbing contractor.

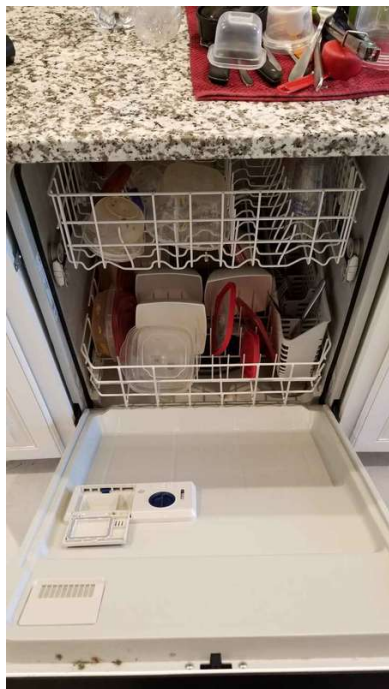
Dishwasher was full of dishes. Could not operate dishwasher to determine if it is functional.

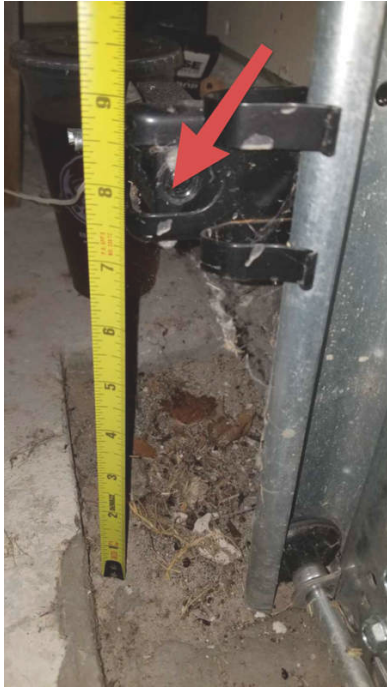
1: Sensors Too High

Garage door sensors are too high. Should be 6 inches from the deck to prevent children from being able to get under the sensors. Recommend moving sensors down to 6 inches above the deck.

Recommendation: Contact a qualified professional.
