SCOTT HOME INSPECTION, LLC

RELOCATION HOME ASSESSMENT FIELD REPORT

1234 Main St.
Arvada CO 80004

04/18/2019 9:00AM

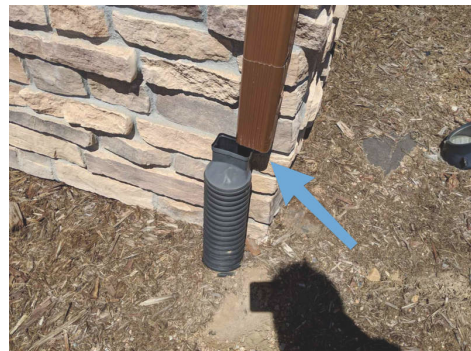
The ground drain-line has settled and pulled loose from downspout, and needs re-connecting. The drainage may not fully push away from the home in this condition. This should be evaluated and corrected by qualified contractor.

Contact a handyman or DIY project

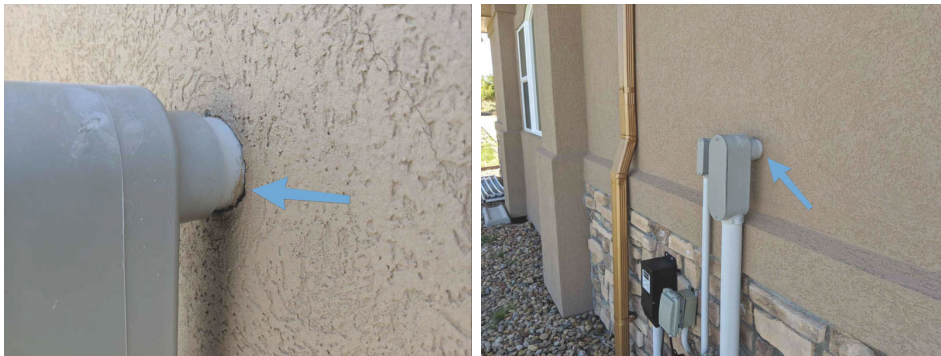
Holes in the exterior wall should be sealed to prevent pest intrusion or water damage. Work should be performed by a qualified contractor.

Contact a handyman or DIY project

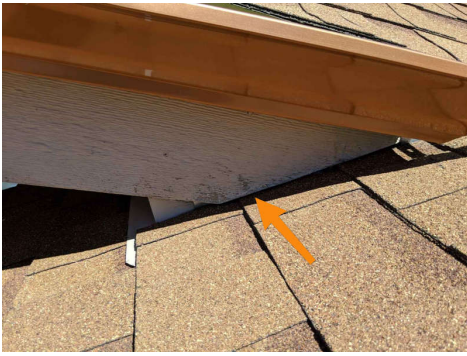
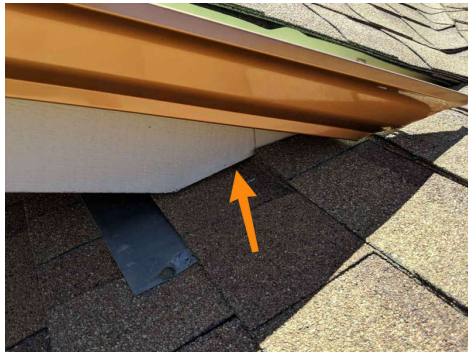
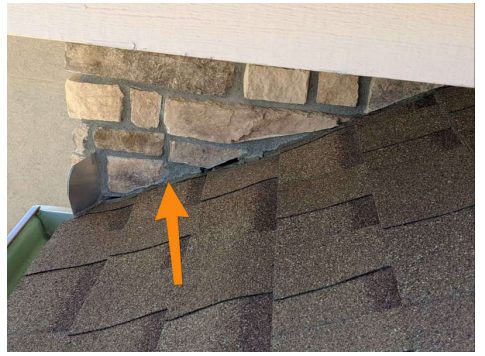
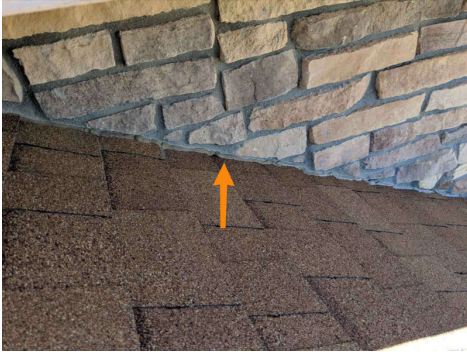
4.1.2 WALL COVERING

SIDING IN CONTACT WITH ROOF

The siding over the roof is showing deterioration to the bottom edge in areas. Normally, a 1" to 2" gap should be present between the siding and the shingles, to prevent damage to this bottom edge. It does appear that there is proper side wall flashing behind this siding. It is recommended that a siding professional repair or replace the damaged siding and ensure that a 1" gap is maintained over the roof areas, to prevent further deterioration.

Contact a qualified siding specialist.

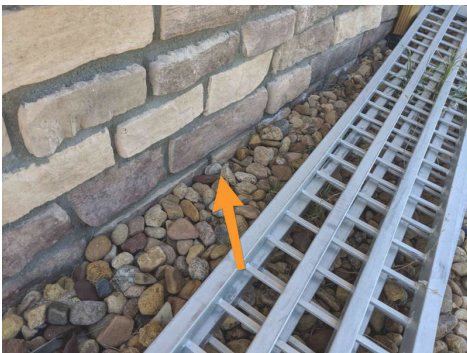
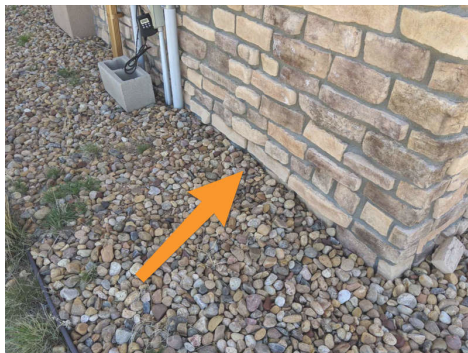
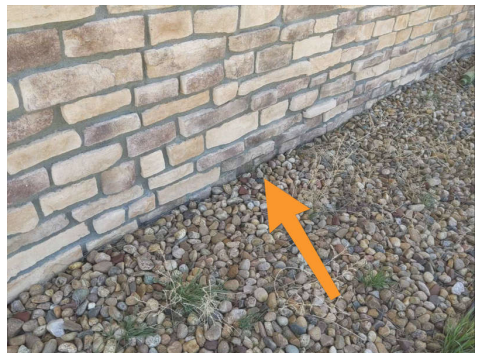
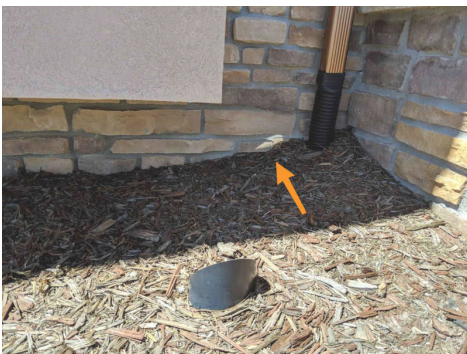
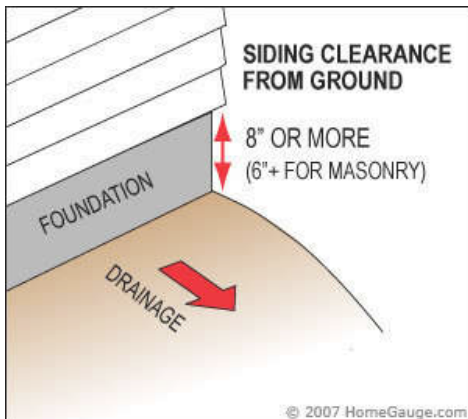
4.1.3 WALL COVERING

SIDING IN CONTACT WITH SOIL

There is inadequate soil-to-siding clearance. Direct soil contact with siding material can cause damage to the siding and be an area for water intrusion, as well as wood destroying insect intrusion into the home. I recommend the grading be reviewed and corrected in this area, to ensure there is no soil-to-siding contact, and that the drainage slopes away from the home in this area.

Contact a qualified landscaping contractor

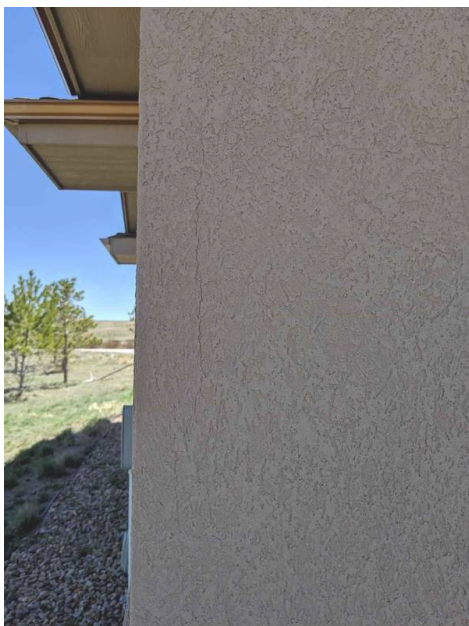
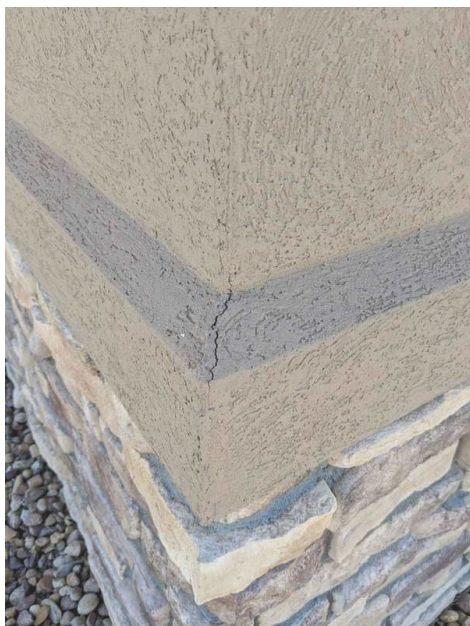
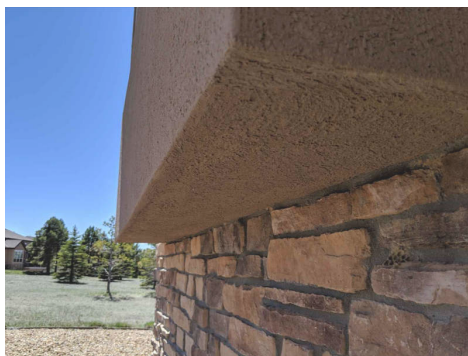
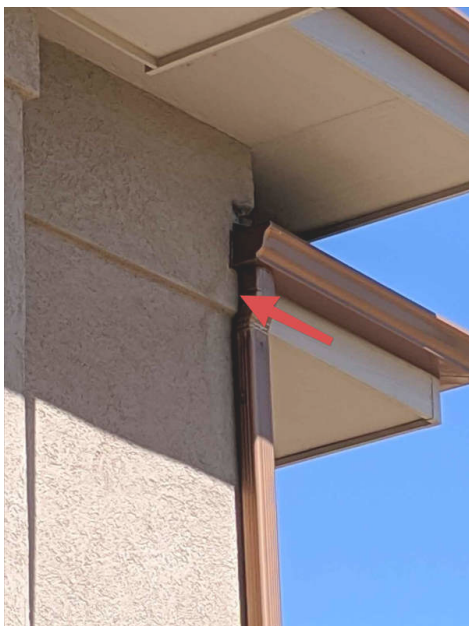
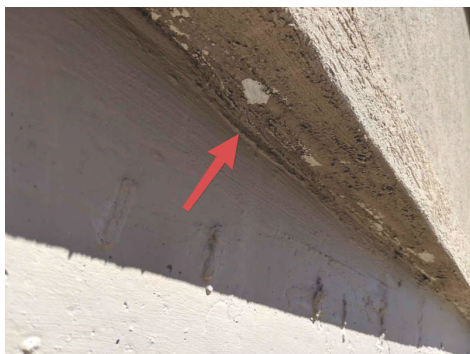
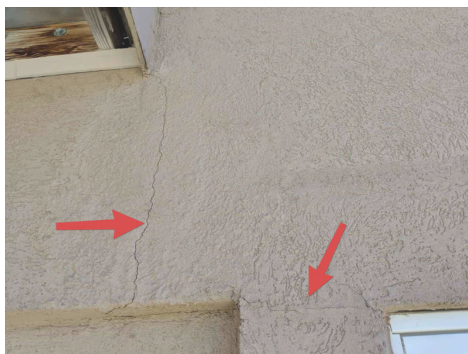
4.1.4 WALL COVERING

The house appears to be clad with a product known as Exterior Insulation Finish Systems (EIFS), also referred to as "Synthetic Stucco." Many EIFS clad houses have revealed moisture related problems such as deteriorated wood framing and mold issues. The house has some cracks present in areas around the home, representing potential moisture penetration issues. Testing of this cladding is beyond the scope of this inspection, and requires a specialist who can probe the siding and determine if moisture issues are present, and if repair is needed. I recommend a siding specialist familiar with EIFS inspect the home completely, and advise you on any repair needed.

No clear drainage plane

Contact a stucco repair contractor

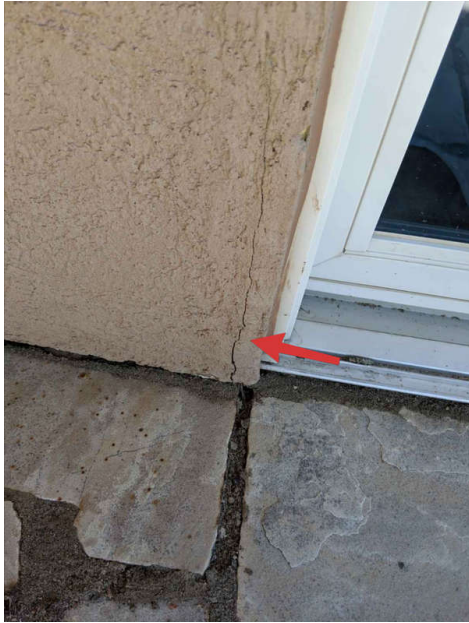
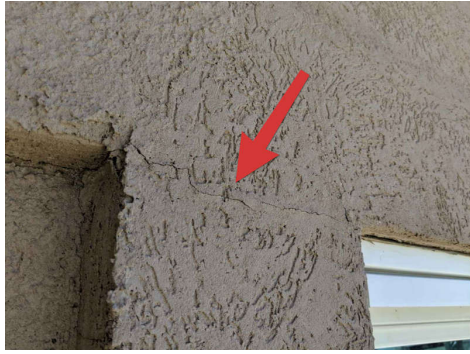
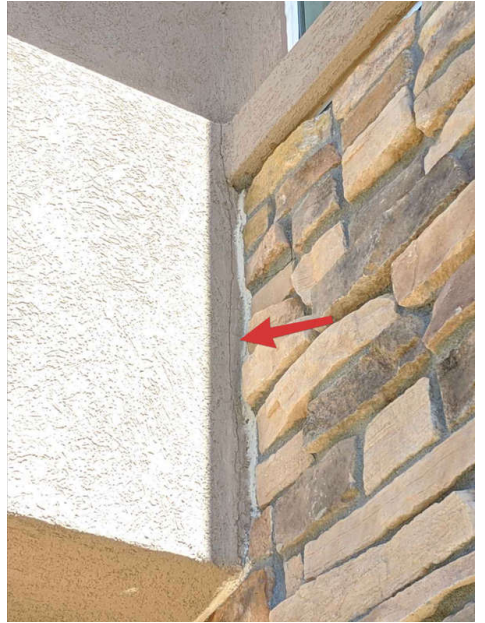
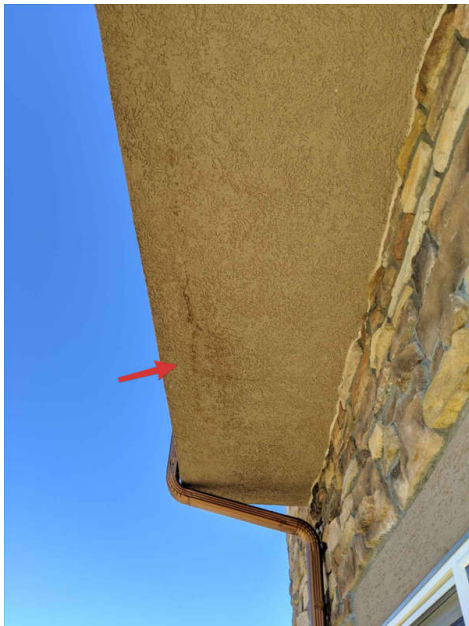
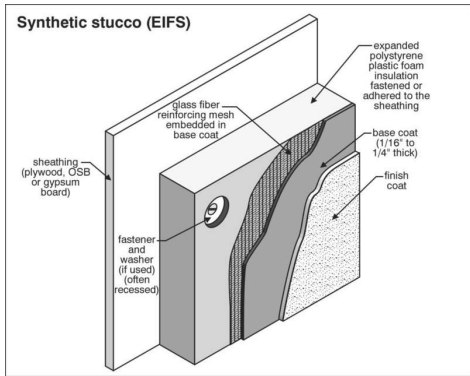
Moisture staining under west window

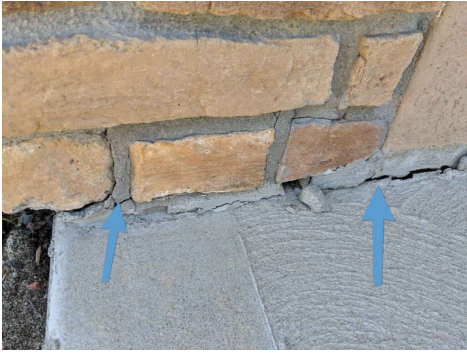
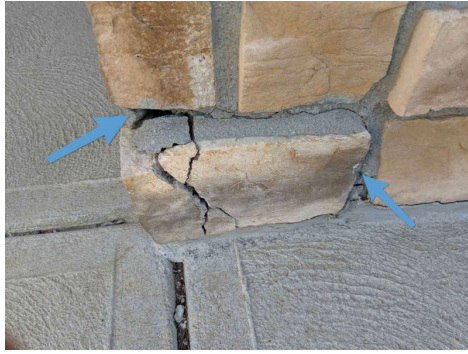
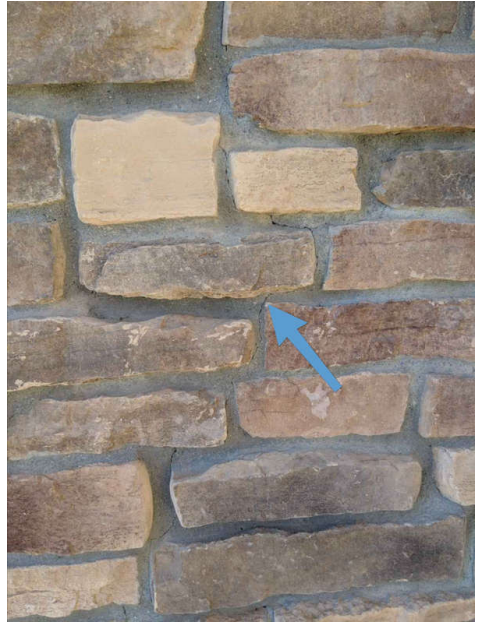
4.1.5 WALL COVERING

STONE VENEER MINOR CRACKING

The stone veneer is cracked at some locations around the home. This appears to be minor and no moisture concerns are noted. A siding contractor should repair as needed.

Contact a qualified siding specialist.

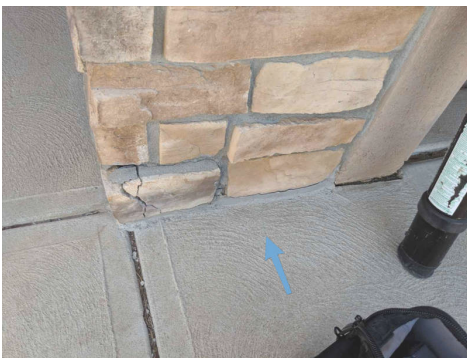
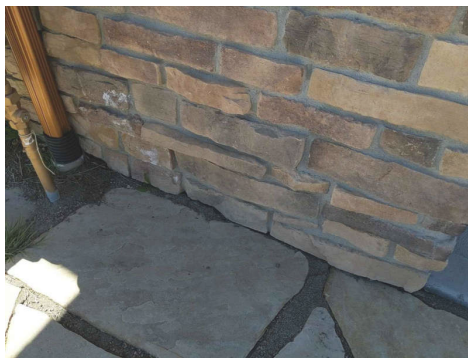
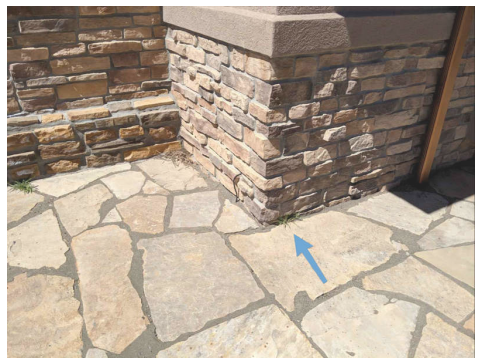
4.1.6 WALL COVERING

STONE VENEER IN CONTACT WITH HARDGRADE

The stone veneer is in contact with the concrete around the home in the above locations. No moisture concerns are noted at this time.

Contact a qualified professional.

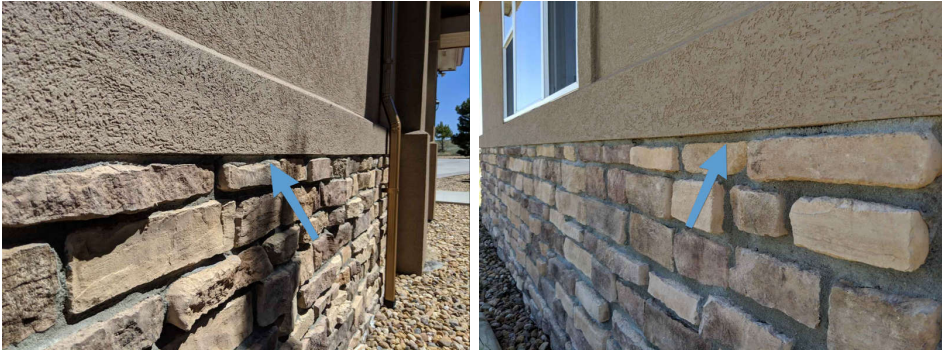
4.1.7 WALL COVERING

NO FLASHING BETWEEN MATERIALS

There's no flashing between the stucco and the stone veneer. It is unclear if this was required during the time of construction. No obvious moisture concerns present.

Contact a qualified professional.

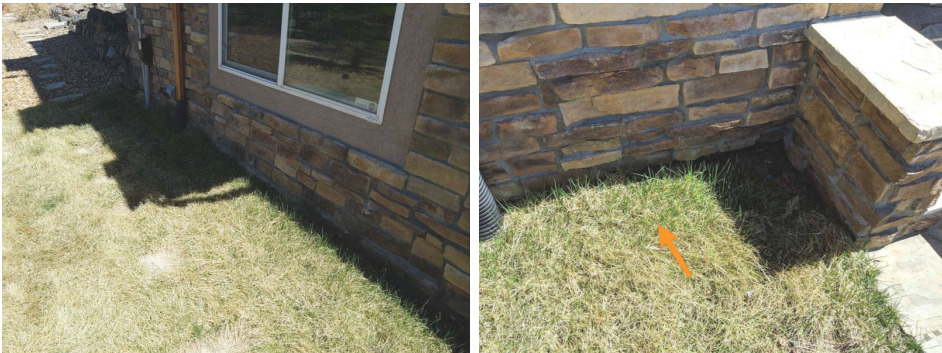
4.1.8 WALL COVERING

GRASS AGAINST FOUNDATION WALL

There is grass against the west foundation wall. If this area is watered by a sprinkler, the siding and foundation will be exposed to excessive water.

Contact a qualified professional.

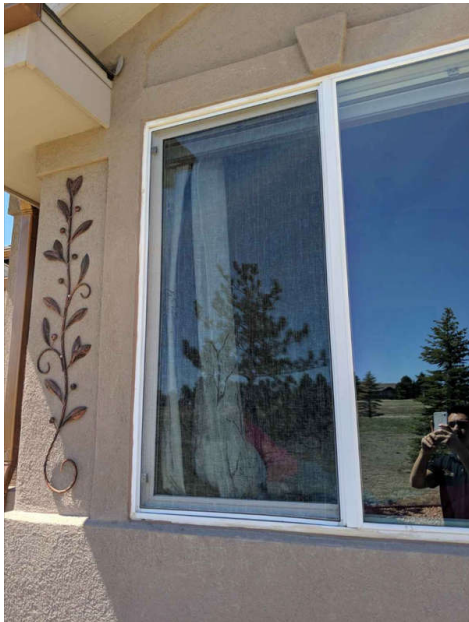
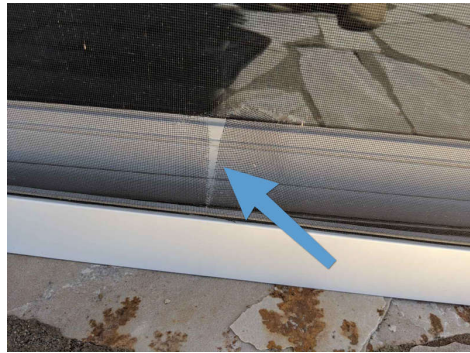
4.5.1 WINDOWS

WORN SCREENS

Contact a handyman or DIY project

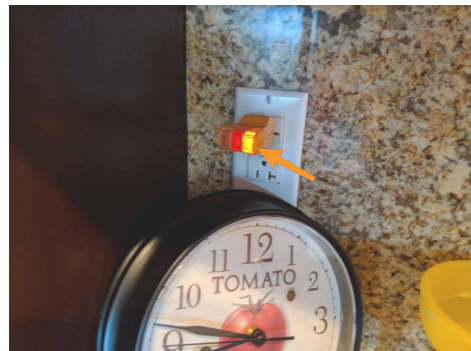
10.6.1 RECEPTACLE OPERATION
(POLARITY AND GROUNDING)

An ungrounded "three-prong" outlet(s) is present, even though 3 wire circuits with ground wires appear to be present elsewhere. This is a safety issue that needs to be corrected. An electrician should investigate and repair this item.

Contact a qualified electrical contractor.

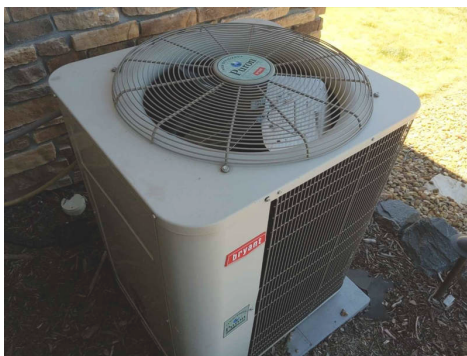
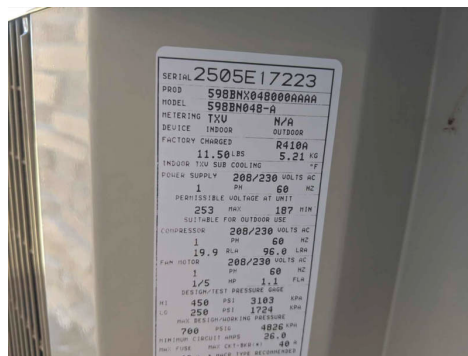
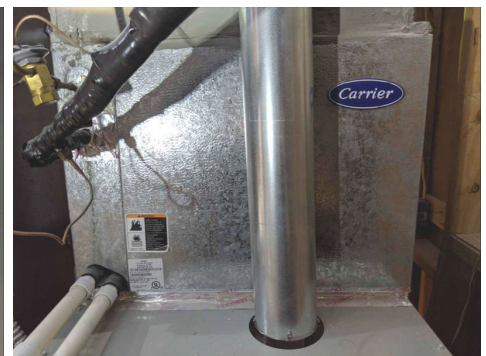
The A/C system(s) was not tested for proper operation because the outside air temperature is 65 degrees or less. Damage to the unit can occur if operated below this temperature. Liquid can be in the compressor unit, and can damage the compressor if run. A limited visual inspection of the system and electrical service was conducted with no concerns noted.

Contact a qualified professional.

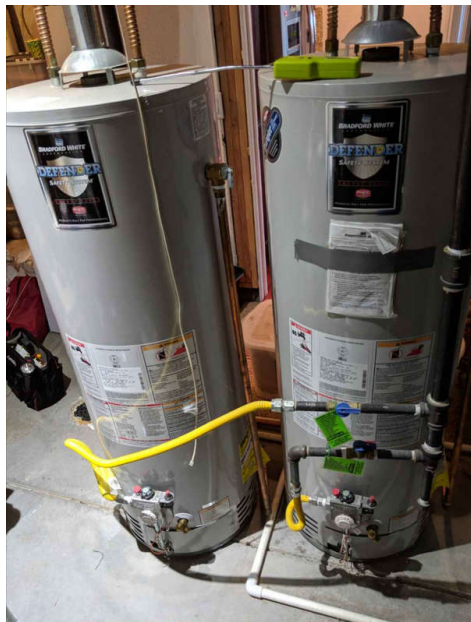
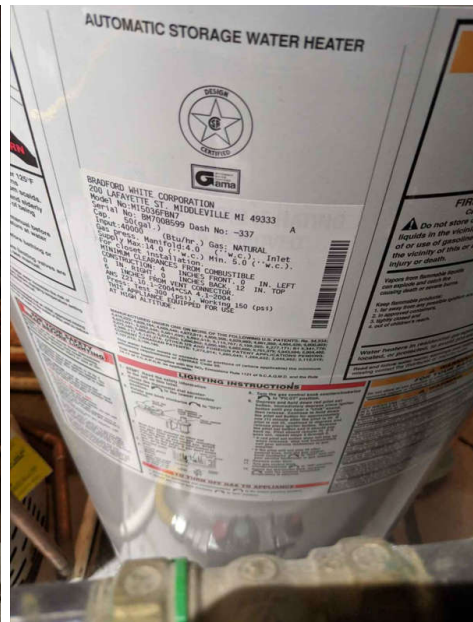
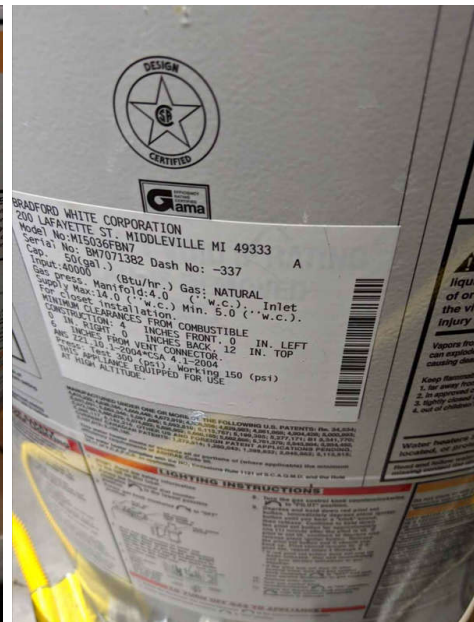
13.13.1 HOT WATER SYSTEMS, CONTROLS, CHIMNEYS, FLUES AND VENTS

The water heater is older, and is over the age of average life expectancy (10-12 years). Based upon the age and condition of the unit, leaks could develop at any time, and replacement is recommended.

Contact a qualified plumbing contractor.

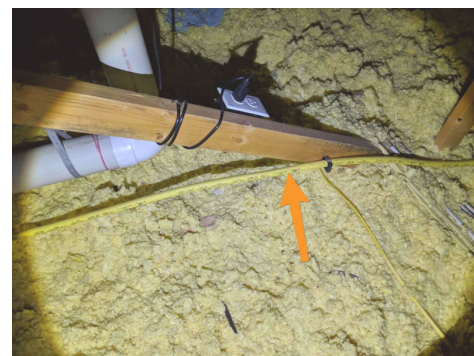
13.14.1 GAS DISTRIBUTION SYSTEMS

There is a type of flexible gas piping called CSST installed in the home. This gas piping is not properly supported & does not appear to be properly bonded. This type of piping is required by the manufacturer to be bonded to the electrical grounding system of the home for safety. This requirement reduces the likelihood of damage to the piping from an electrical surge or lightning strike, which could result in gas leaks or a fire. A professional electrical contractor should evaluate and properly bond the CSST gas piping to the electrical grounding system as required. For more information, visit <https://scotthomeinspection.com/csst-direct-bonding-tech-bulletin/>

Contact a qualified plumbing contractor.

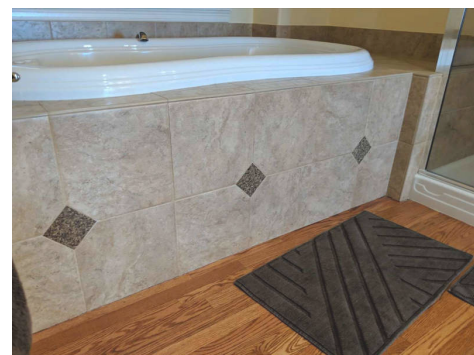
There is no access panel installed or the panel was sealed at the time of inspection for the jetted tub and I was not able to inspect the motor and connections. I recommend that a removable panel be installed to give access to the jetted motor and piping that run under and around the tub. Contact a qualified contractor for advice and necessary corrections.

Contact a qualified professional.

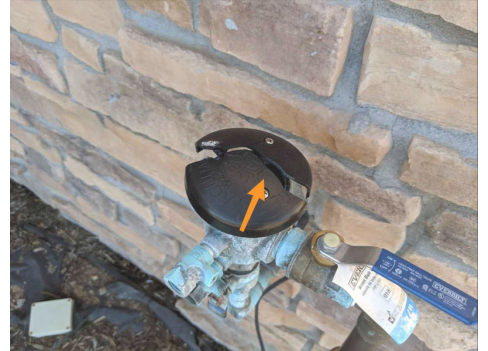
Repair Recommendation**CAP DAMAGED**

The backflow preventer cap at the lawn sprinkling supply outside is missing or damaged. This cap is needed, to protect interior components from damage and weathering. A qualified person should repair or replace as needed.

Contact a qualified landscaping contractor

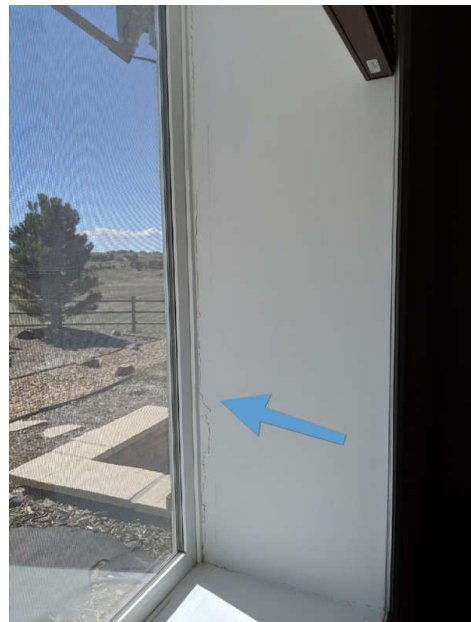
22.1.1 WALLS

MINOR CRACKING

Minor cracking was noted near the basement windows in the home. These cracks are typical of minor settling, and should be monitored for further movement, and patched and repaired as desired.

Recommend monitoring.

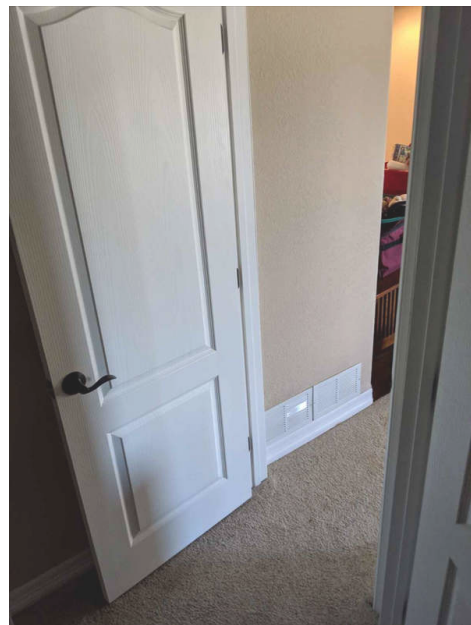
22.4.1 DOORS

The door(s) will not latch properly when closed. This door needs to be adjusted or repaired, to properly close and latch. This should be evaluated and corrected by a qualified contractor.

Contact a qualified door repair/installation contractor.

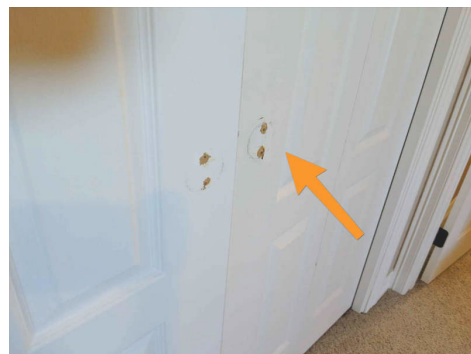
22.4.2 DOORS

DOOR MISSING HANDLE

Basement bedroom closet doors missing handles. Replacement needed.

Contact a qualified professional.
