CAP CITY PROPERTY INSPECTIONS

HOME INSPECTION REPORT COPY

1234 Main St.
Grove City OH 43123

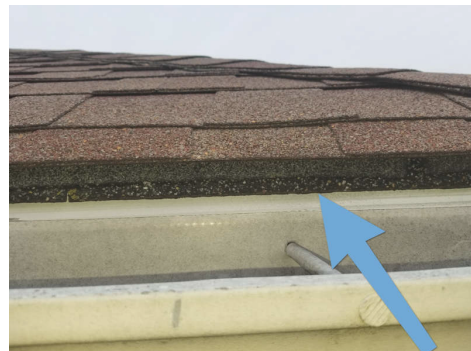
2.1.1 Roof Covering

MULTIPLE LAYERS ON ROOF

This asphalt or fiberglass composition roof surface had two or more layers of roofing materials. When this roof is replaced, recommend a complete "tear off", where all existing layers of roofing are removed before installing new roofing materials. Removing existing roofing materials will increase the cost of the next roof.

Contact a qualified roofing professional.

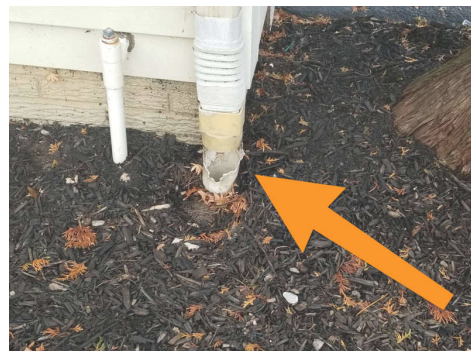
2.4.1 Gutters & Downspouts

DAMAGE/DISREPAIR OF DOWNSPOUT

One or more downspouts designed to discharge roof drainage was damaged or in disrepair to an extent that may limit its ability to function as designed.

Contact a qualified gutter contractor

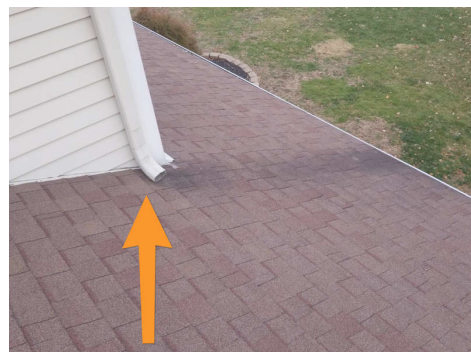
2.4.2 Gutters & Downspouts

DOWNSPOUT DISCHARGES ON THE ROOF

The downspout is improperly discharging onto the roof because of a missing transition extension.

Contact a qualified professional.

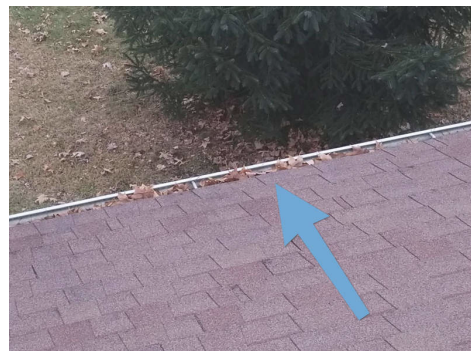
2.4.3 Gutters & Downspouts

DEBRIS IN GUTTERS.

Debris visible in the gutters at the time of the inspection should be removed to encourage proper drainage.

Contact a qualified professional.

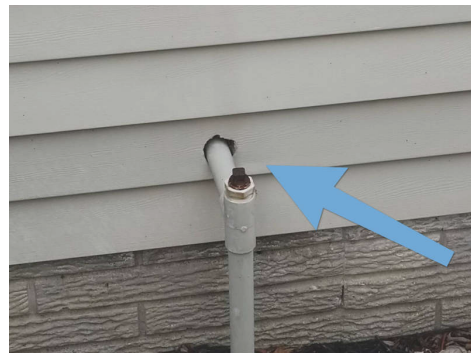
2.5.1 Walls, Trim and Foundation

HOLES IN SIDING SHOULD BE SEALED.

Exterior wall penetrations had gaps that should to be sealed with an appropriate sealant to prevent moisture and insect entry.

Contact a qualified professional.

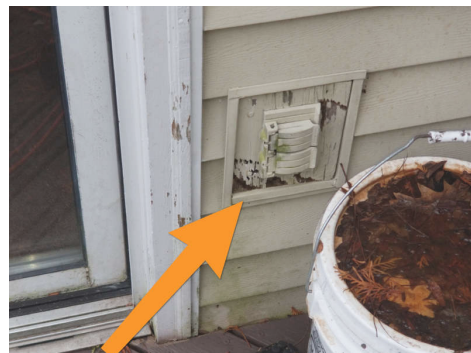
2.5.2 Walls, Trim and Foundation

DETERIORATION OF TRIM ON HOME

REAR OF THE HOME

Trim at the home exhibited weathering and deterioration. It may need to be replaced. We could not determine the condition of underlying materials.

Contact a qualified professional.

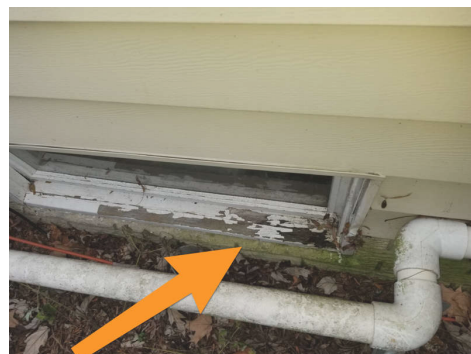
2.6.1 Doors and Windows

DETERIORATION OF WINDOW FRAME

REAR BASEMENT WINDOW

A window frame had general severe deterioration. Maintenance will be required to prevent leakage and replacement may be necessary.

Contact a qualified window repair/installation contractor.

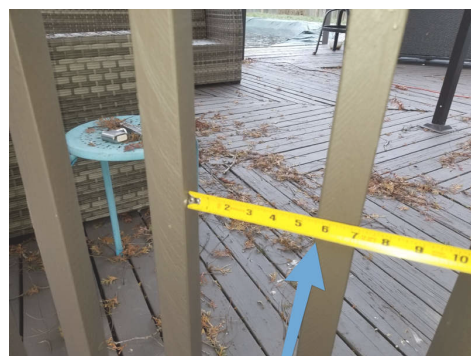
2.7.1 Deck, Porches and Patios

SPACING ON GUARDRAIL BALUSTERS OVER 4".

Spaces between guardrail balusters were too wide. Safe building practices dictate no more than a 4 inch space between balusters. This condition is hazardous to small children.

Contact a qualified deck contractor.

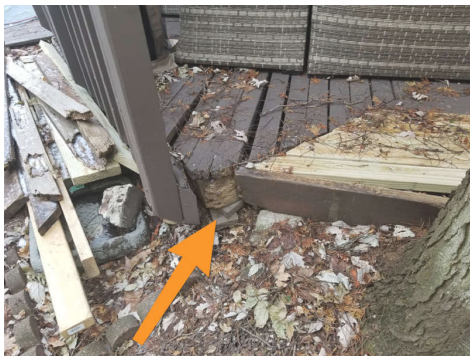
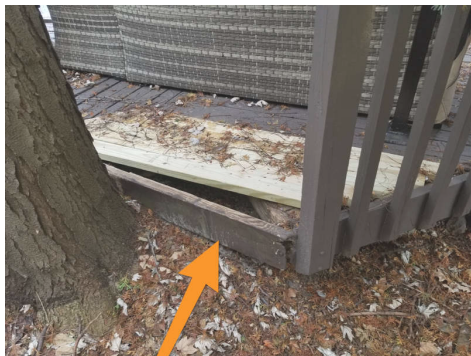
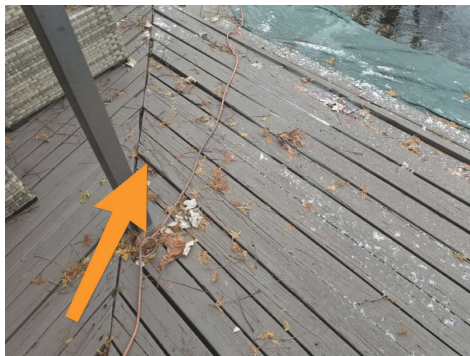
2.7.2 Deck, Porches and Patios

DECK OLD AND DETERIORATION

This deck was old and exhibited deterioration commensurate with its age. Repairs may not be sufficient and some portions may need to be replaced.

Contact a qualified deck contractor.

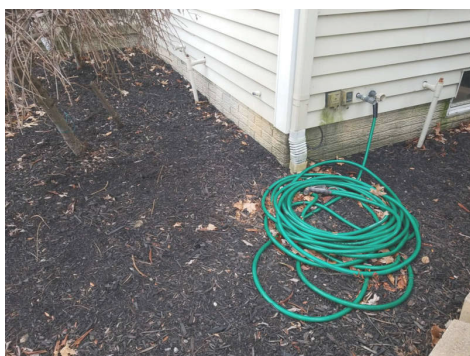
2.8.1 Walkways, Driveways and General Grounds

NEUTRAL OR NEGATIVE GRADING AROUND THE HOME.

The home had areas of neutral or negative drainage that will route runoff from precipitation toward the foundation. Excessively high moisture levels in soil supporting the foundation can effect its ability to support the weight of the structure above. The ground should slope away from the home a minimum of 1 inch per foot for a distance of at least six feet from the foundation. The Inspector recommends that these area be re-grading to improve drainage near the foundation.

Contact a qualified grading contractor.

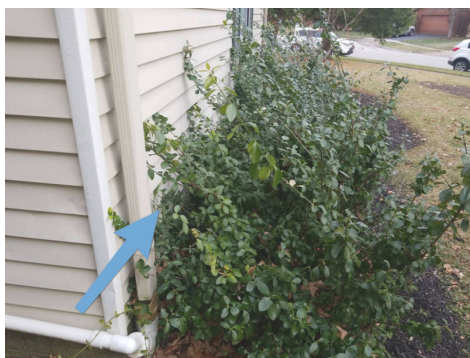
2.8.2 Walkways, Driveways and General Grounds

OVERGROWN VEGETATION

Vegetation was overgrown and needed cut back at the time of inspection.

Contact a qualified professional.

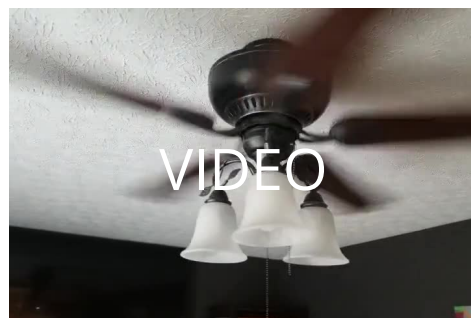
3.2.1 Ceilings, Walls & Floors

CEILING FAN WOBBLED DURING OPERATION.

FAMILY ROOM

A ceiling fan wobbled during operation and appeared to be out of balance.

Contact a qualified professional.

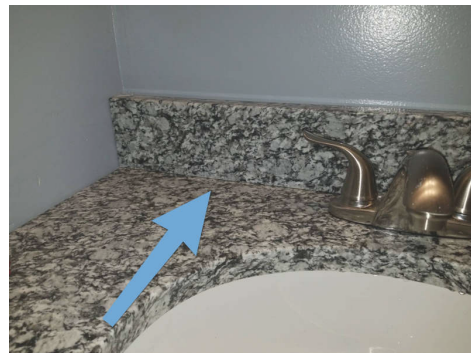
3.3.1 Cabinets & Counter-tops

COUNTERTOP SEALANT MAINTENANCE NEEDED

MASTER BATHROOM

Sealant on a counter top needed maintenance at the time of inspection.

Contact a qualified professional.

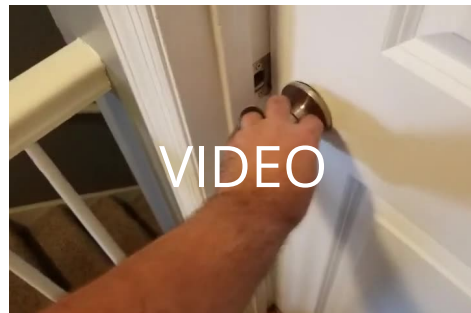
3.4.1 Doors & Windows

DIFFICULT TO CLOSE DOOR, JAMB BINDING.

MASTER BEDROOM

The door in the home was binding on the jamb and was difficult to close.

Contact a qualified professional.

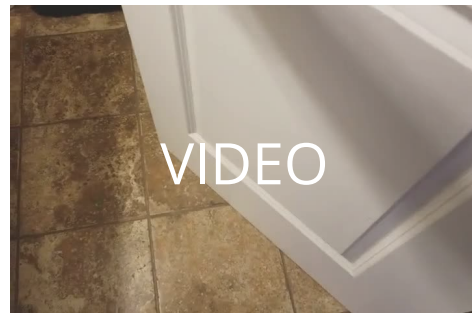
3.4.2 Doors & Windows

DOOR WOULD NOT CLOSE, RUBS FLOOR

UPSTAIRS HALLWAY BATHROOM

An interior door was rubbing on the floor and would not close.

Contact a qualified door repair/installation contractor.

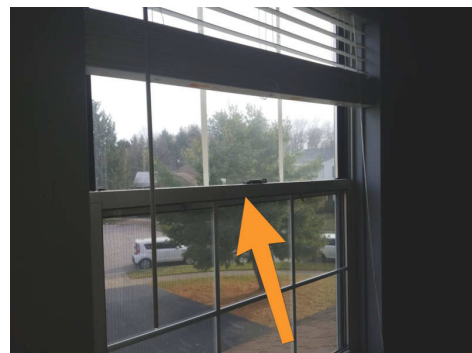
3.4.4 Doors & Windows

MULTIPLE WINDOWS HAD FAILED SEALS AND MOISTURE BETWEEN PANES

Condensation visible in the double-pane glazing of multiple windows indicated a loss of thermal integrity. Some windows may have lost their thermal integrity but may not be showing symptoms at the time of inspection. The Inspector recommends that you have each window in the home evaluated by a qualified contractor to determine the cost and exactly how many windows need to be repaired or replaced.

Contact a qualified window repair/installation contractor.

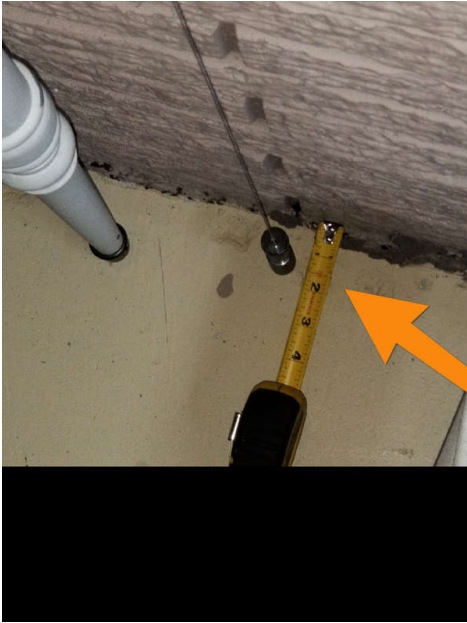
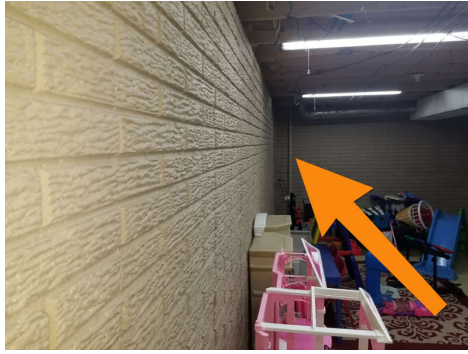
3.6.1 Foundation

FOUNDATION MOVEMENT

REAR BASEMENT WALL

Larger than typical foundation movement was observed. This is usually the result of expansive soil or frost pressure, it may have been caused by installation of the swimming pool. Lot drainage and foundation improvements should be addressed to keep water away from the building. Repairs may be necessary. The rate of movement cannot be predicted during a one-time inspection. Cracks may need sealing on the exterior to prevent moisture penetration.

Contact a foundation contractor.

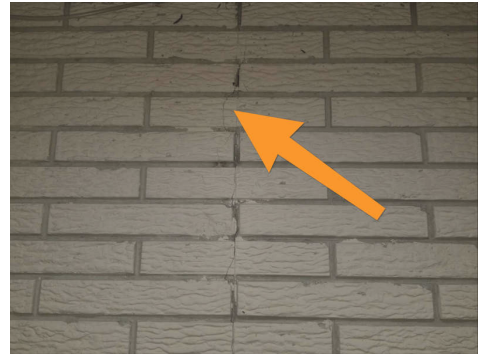
3.6.2 Foundation

SETTLEMENT CRACKS SHOULD BE SEALED.

Cracking visible at the foundation wall appeared typical of settlement cracks. They should be sealed with concrete caulk to help prevent water penetration.

Contact a qualified professional.

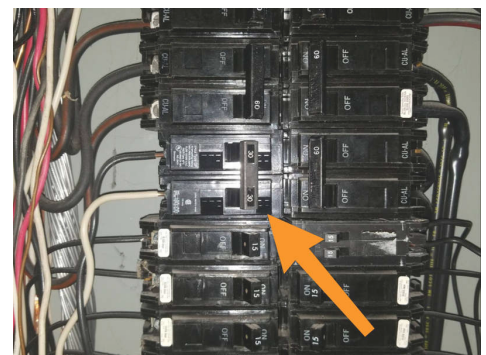
4.2.1 Service Equipment

BREAKERS DIFFERENT BRAND THAN PANEL.

Circuit breakers in the service panel were of a brand different from the main panel brand. Because circuit breakers made by different manufacturers vary in design, panel manufacturers typically require that breakers manufactured by their company be used in their panels. Breakers from one manufacturer used in the panel of another manufacturer may result in poor connections which can create a potential fire or shock/electrocution hazard.

Contact a qualified electrical contractor.

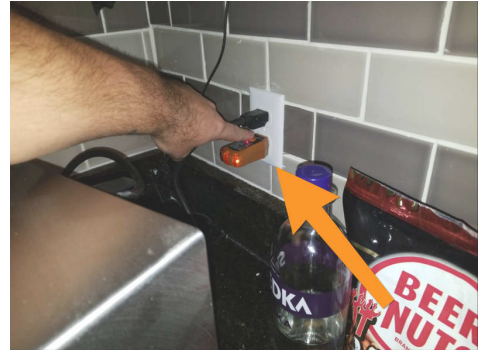
4.3.1 Outlets, Switches, Lighting

OUTLETS NOT GFCI PROTECTED

KITCHEN CORNER

No ground fault circuit interrupter (GFCI) protection of home electrical receptacles was provided at the time of inspection.

Contact a qualified electrical contractor.

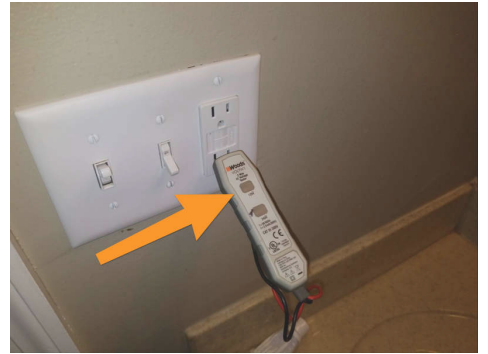
4.3.2 Outlets, Switches, Lighting

OUTLET IN HOME DID NOT OPERATE

ALL BATHROOM OUTLETS

An electrical receptacle in the home was inoperable at the time of inspection. The receptacle was tagged with a red dot marked "Non Op".

No power

Contact a qualified electrical contractor.

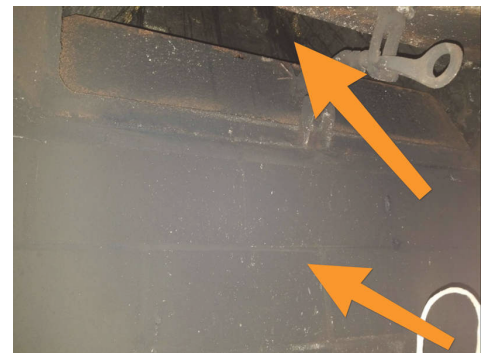
5.3.1 Fireplace

THE FIREPLACE WAS DIRTY.

FAMILY ROOM

The firebox of the wood-burning fireplace in the needed cleaning at the time of the inspection.

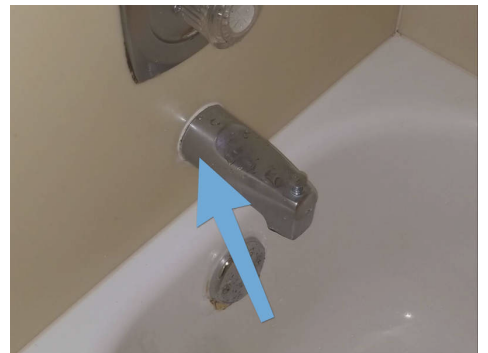
6.3.1 Fixtures

BATHTUB FAUCET NEEDS SEALANT

UPSTAIRS HALLWAY BATHROOM

The spout on the bathtub needed sealant at the time of inspection.

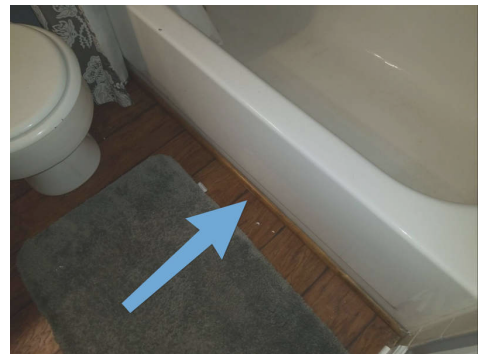
6.3.2 Fixtures

SEALANT NEEDED AROUND BATHTUB AREA

MASTER BATHROOM

The bathtub needed sealant in several areas around the bathtub. This is to help prevent moisture intrusion around the bathtub.

Contact a qualified professional.

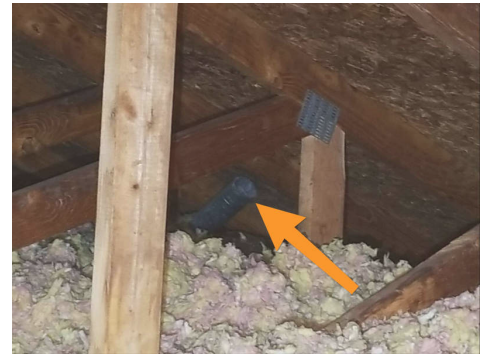
7.7.1 Bathroom Exhaust Fan

BATHROOM EXHAUST VENT DID NOT EXTEND TO THE EXTERIOR.

BOTH BATHROOMS

The exhaust vent for the bathroom terminated in the attic. To prevent excess moisture in this location, the exhaust vent should terminate at the home exterior.

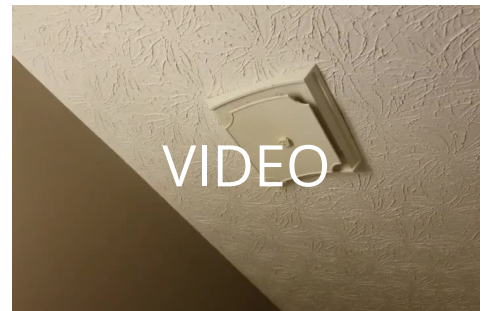
7.7.3 Bathroom Exhaust Fan

NOISY EXHAUST FAN IN BATHROOM.

UPSTAIRS HALLWAY BATHROOM

The exhaust fan was excessively noisy and may need to be replaced soon.

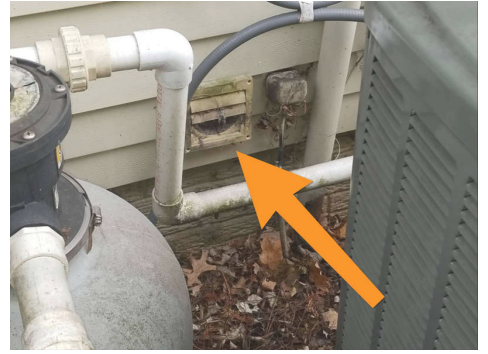
7.8.1 Dryer Venting

**DAMAGED DAMPER ON DRYER VENT.**

The dryer exhaust vent damper was damaged. This condition may allow pests to enter the vent, where they may create obstructions with nesting materials, creating a potential fire hazard. The Inspector recommends installation of a proper backdraft damper. All work should be performed by a qualified contractor.

Contact a qualified professional.

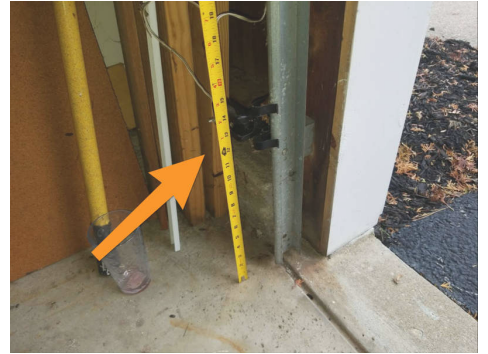
7.9.1 Garage Door Opener

**PHOTO SENSOR INSTALLED OVER 6 INCHES ABOVE FLOOR.**

An overhead garage door photo sensor was installed at a height greater than 6 inches above the floor. Photoelectric sensors are devices installed to prevent injury by raising the vehicle door if the sensor detects a person in a position in which they may be injured by the descending door. Installation of photo sensors in new homes is required by generally-accepted safety standards and limit the maximum mounting height for garage door photo sensors to 6 inches.

Contact a qualified garage door contractor.
