# PREMIER HOME INSPECTIONS OF THE CSRA

## YOUR CUSTOM HOME INSPECTION REPORT

1234 Main St.  
North Augusta SC 29841

Buyer Name  
01/23/2019 9:00AM

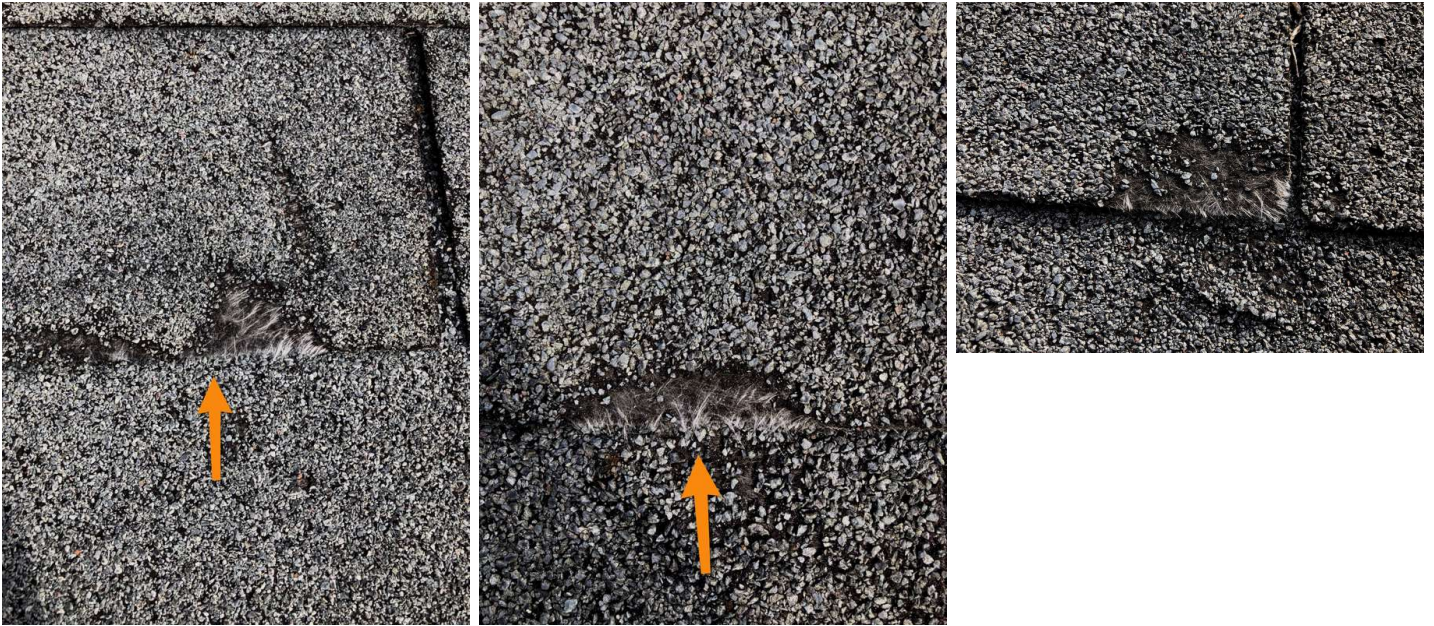
### 2.1.1 Coverings, Flashings, & Penetrations

#### SHINGLE DAMAGE (MINOR)

Minor damages to the shingles were observed in multiple locations. Given the damage was observed in various locations, this may be the result of storm damage.

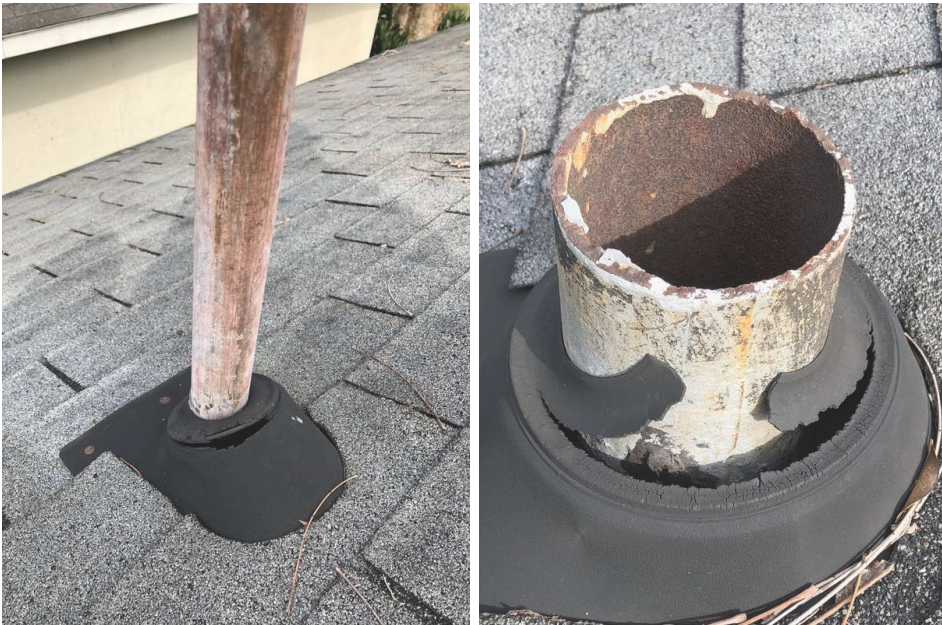
2.1.2 Coverings, Flashings, & Penetrations

**FLASHING BOOT DAMAGED**

MULTIPLE ON LEFT SIDE OF ROOF

The flashing boot was damaged at the time of the inspection. Due to the extent of damage, replacement is recommended.

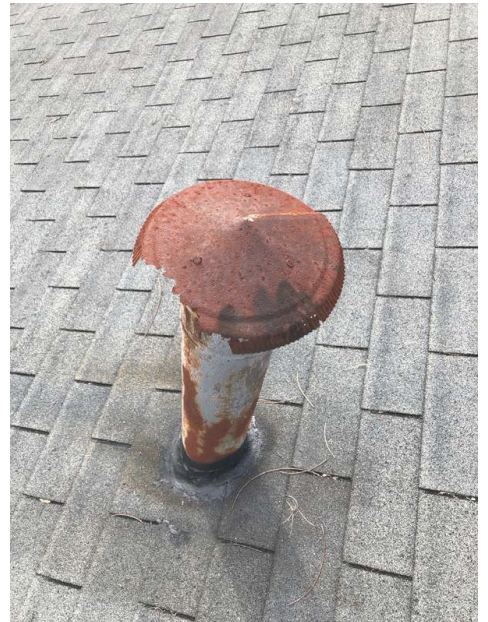
2.1.3 Coverings, Flashings, & Penetrations

**FLUE CAP DAMAGED**

The flue pipe located on the right side of the roof had a damaged flue cap. Replacement is recommended however there did not appear to be any subsequent damages as a result.

Contact a qualified professional.

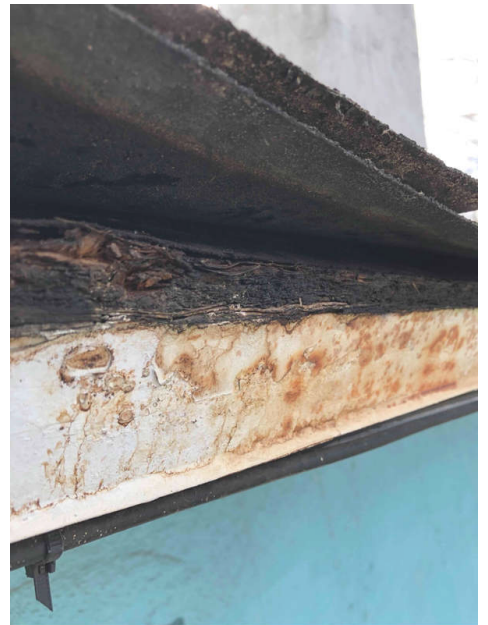
## 2.1.4 Coverings, Flashings, &amp; Penetrations

**ROOF DECKING WATER EXPOSURE**

## FRONT LEFT SIDE OF ROOF EDGE

The roof decking on the front left edge was wet. This could be the result of capillary reaction in which water running off the shingle edge wicks back up into the wood.

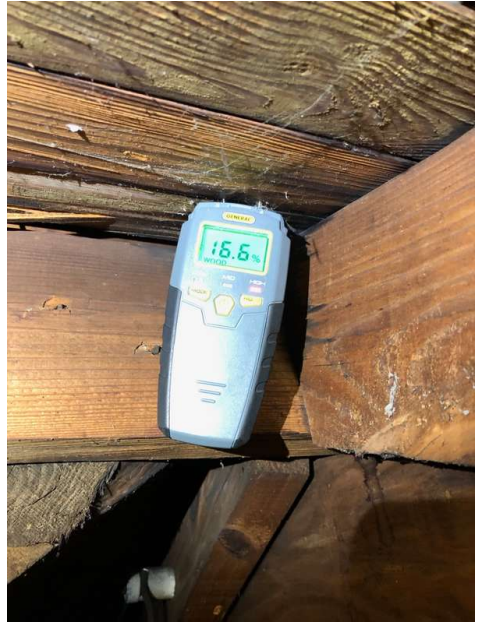
Back Left Side Vent Pipe

**ACTIVE LEAK**

There was an active leak on the roof decking. The moisture reading recorded higher than normal moisture levels. Evaluation and repairs are recommended.

\* The observed leaks were observed at the roof ridge adjacent to the front gable.

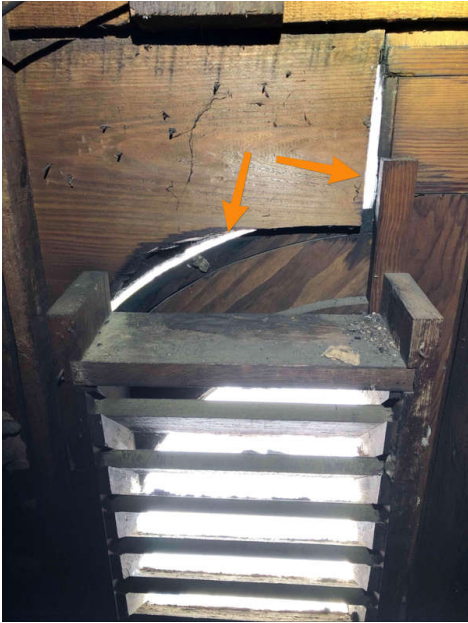
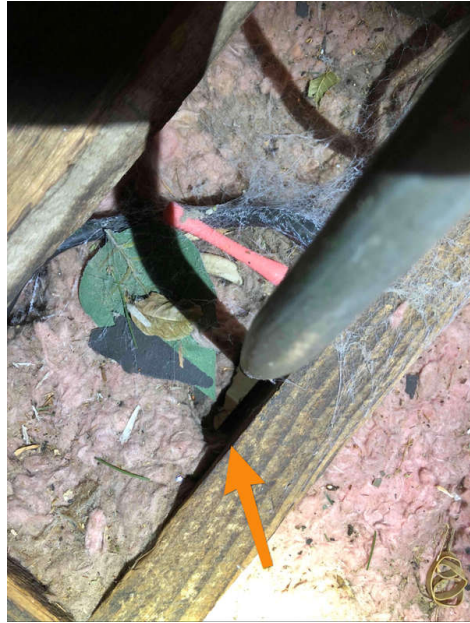
2.2.3 Roof Structure,Attic, & Ventilation

**SEAL PENETRATIONS**

FRONT GABLE VENT, REAR INTERIOR HALLWAY

Penetrations should be sealed to prevent water/moisture intrusion, potential rodent entry into attic space, and loss of conditioned air from the home.

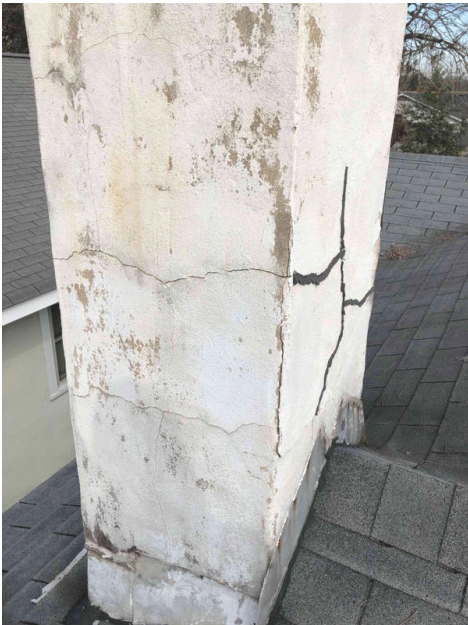
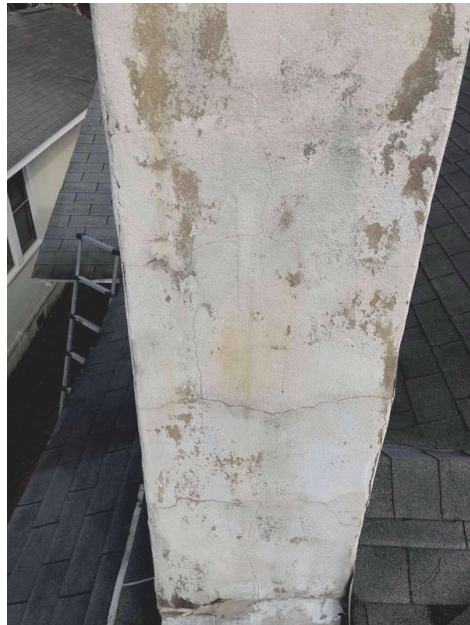
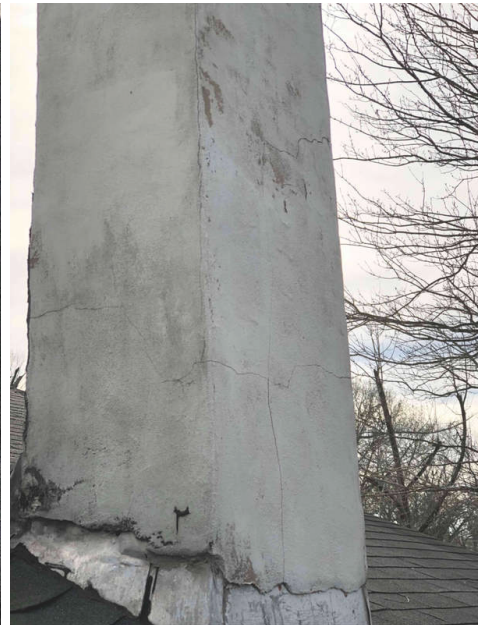
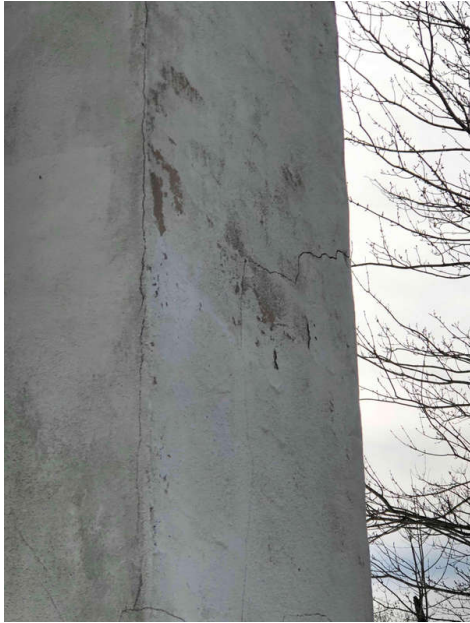
2.3.1 Skylights & Chimneys

**EXTERIOR SURFACE CRACKING**

The plaster on the exterior of the chimney was cracking in multiple locations.

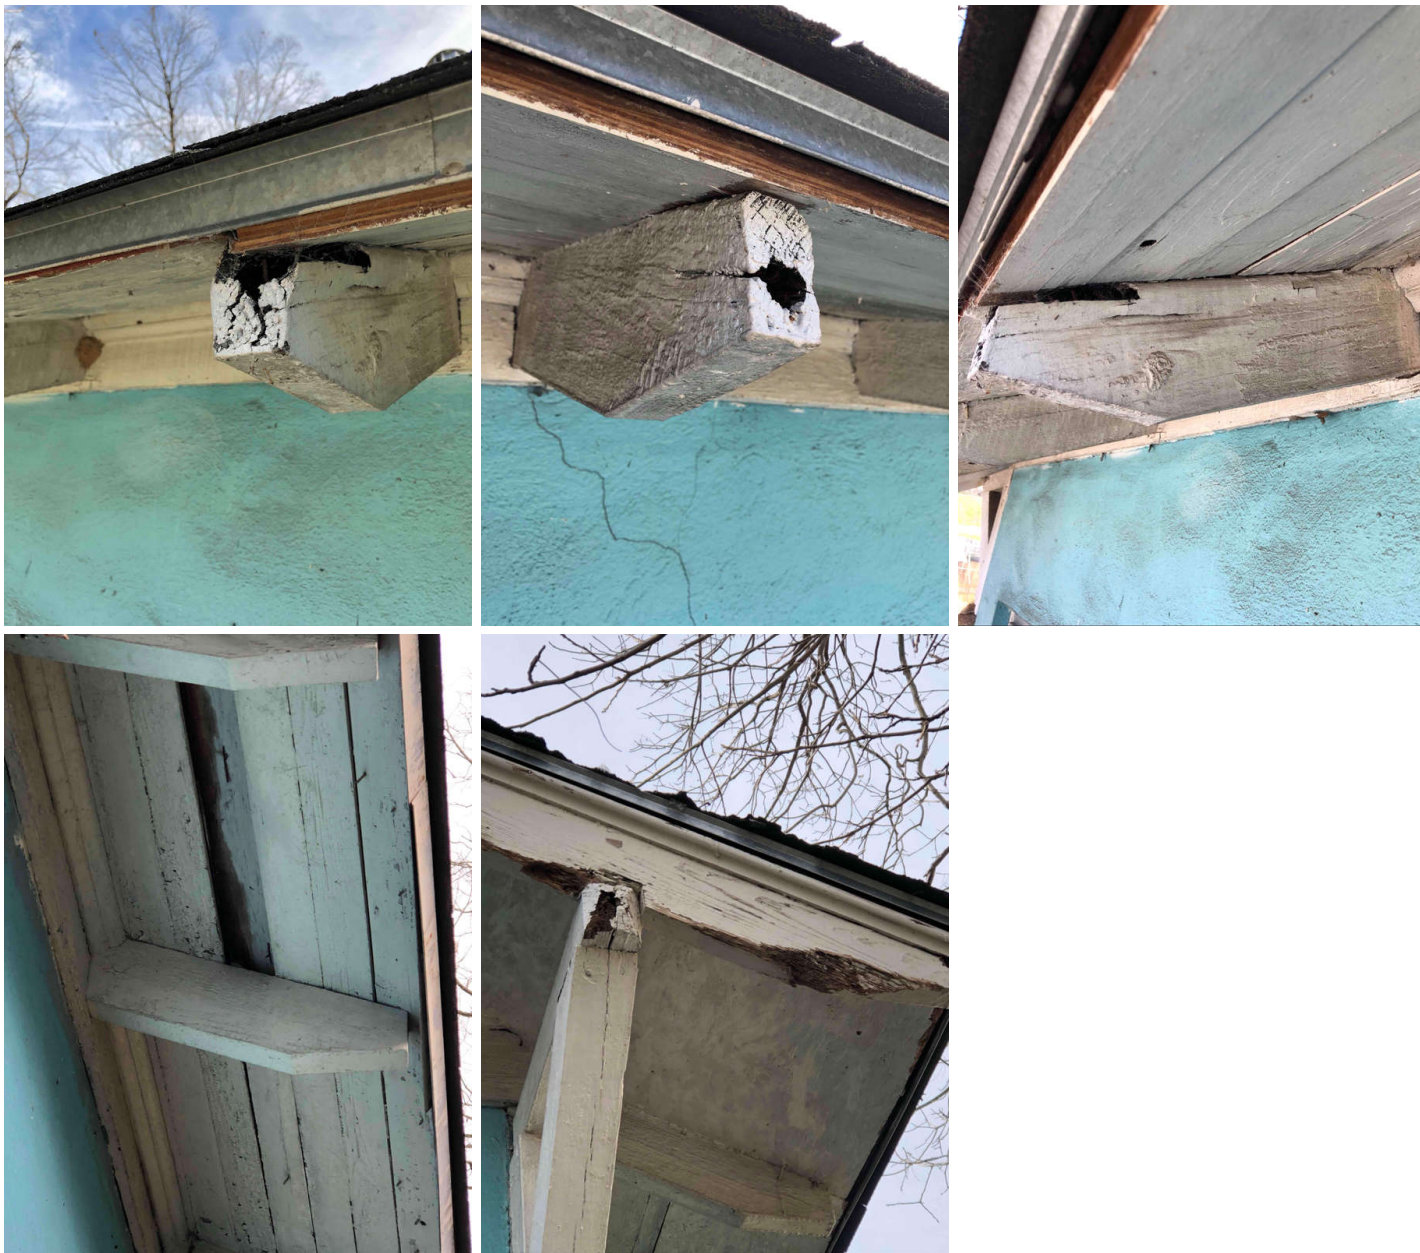
Back Left Corner

#### **DAMAGED RAFTER TAILS**

##### BACK LEFT SIDE OF ROOF EDGE

The rafter tails located on the back left side of the home were damaged.

Damaged Fascia board and Corbel were located on the back left corner.

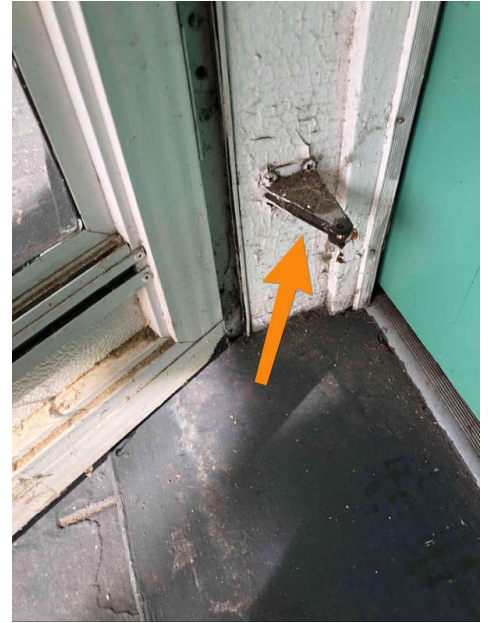
3.2.1 Exterior Doors & Windows

**HARDWARE MISSING/DAMAGED**

FRONT STORM DOOR

The front storm door hardware was missing.

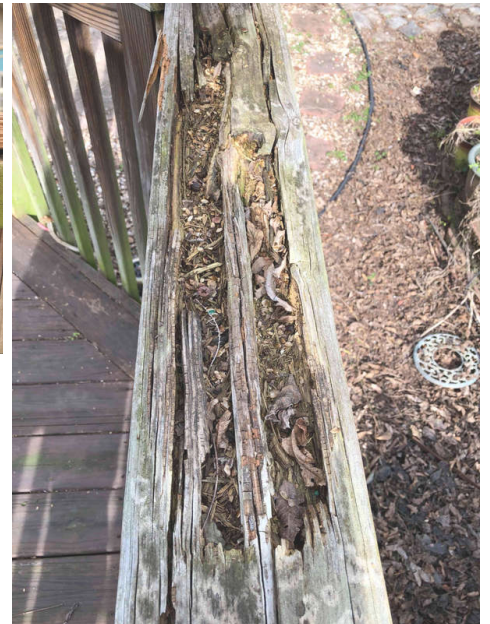
### 3.4.1 Decks, Balconies, Porches & Patios

#### **GUARD RAIL DETERIORATION**

The guard rail exhibited wood rot damages likely due to prolonged water/moisture exposure over time. The damaged areas should be replaced. As part of general maintenance, exterior decking components and the decking surface should be inspected, repainted, and sealed at least every 5 years to ensure the deck structure and all components are in good condition and to prolong the life of the deck.

\*A portion of the railing system was pulling apart. The specific location is the back left side of the railing system.

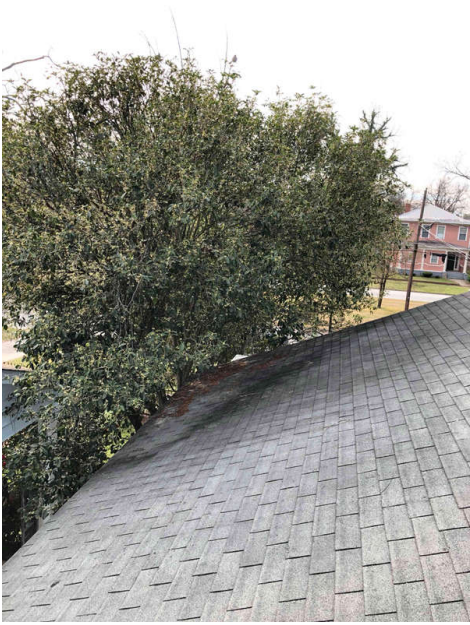
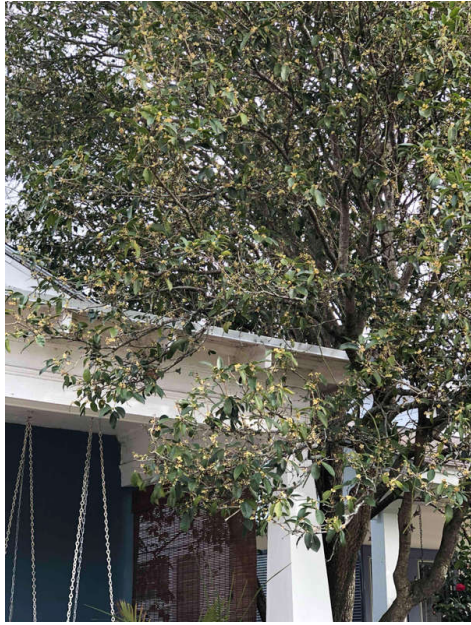
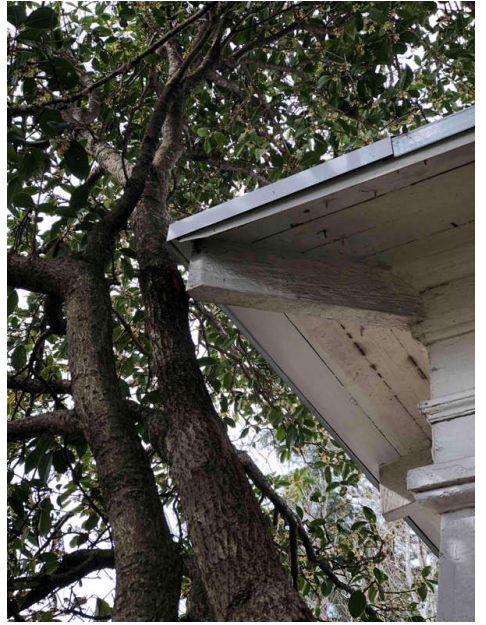
### 3.5.1 Vegetation, Grading, Drainage & Retaining Walls

#### **TREE OVERHANG**

RIGHT FRONT CORNER

Trees observed overhanging the roof. This can cause damage to the roof and prevent proper drainage.

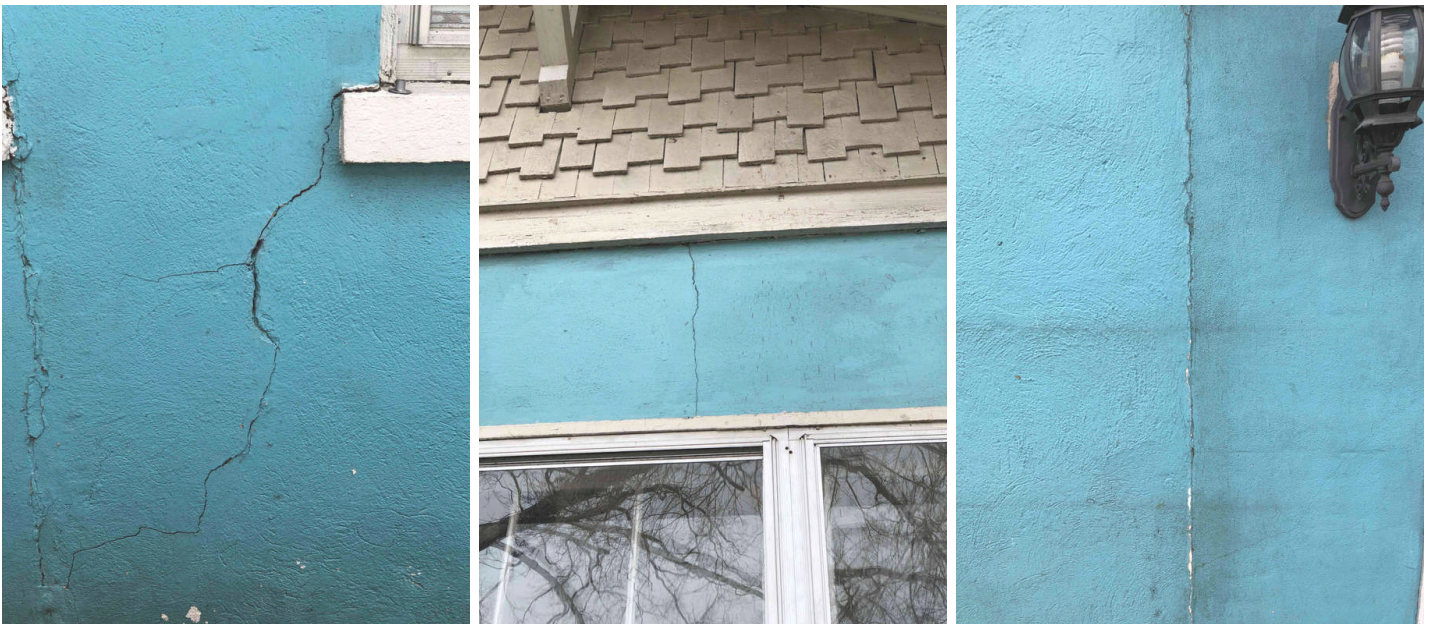
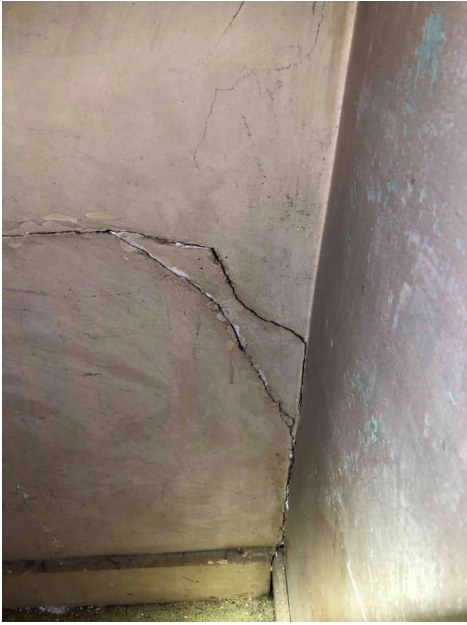
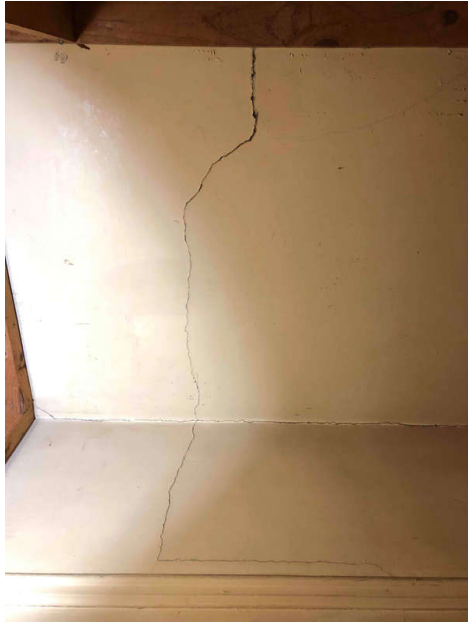
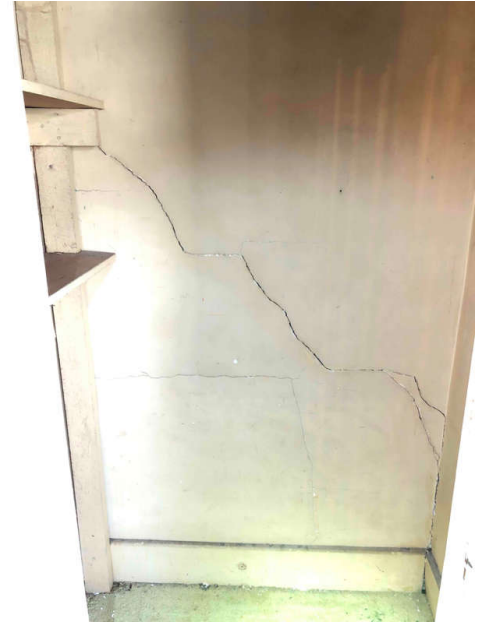
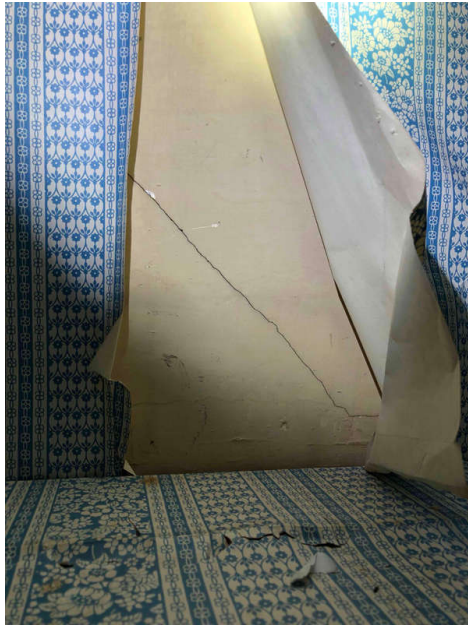
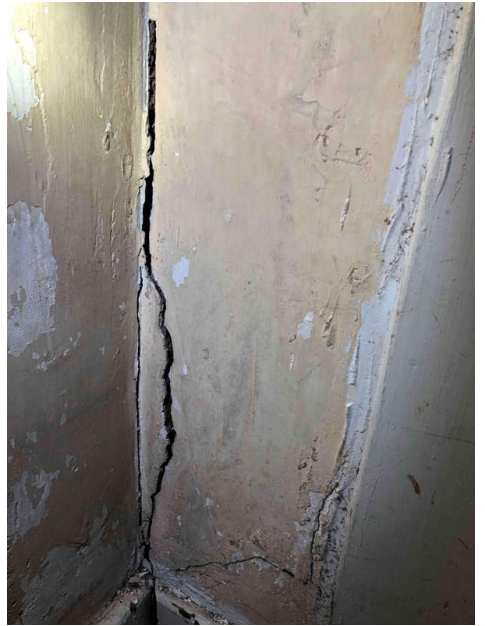
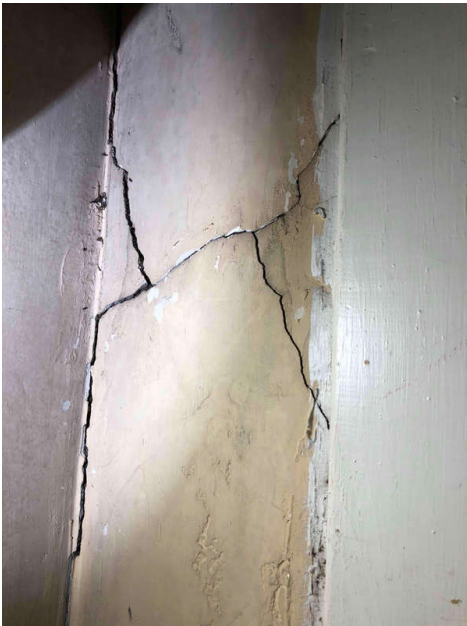
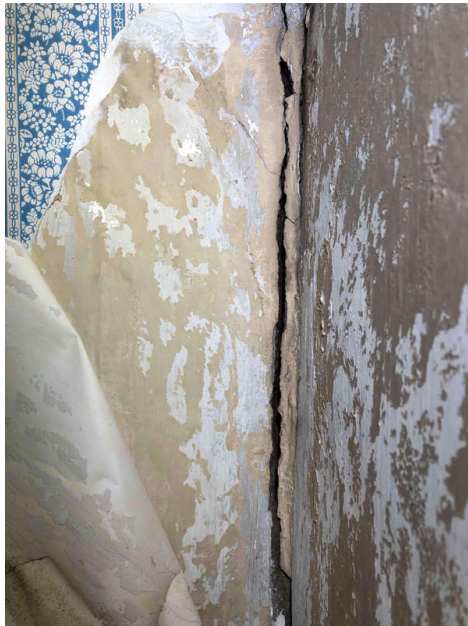
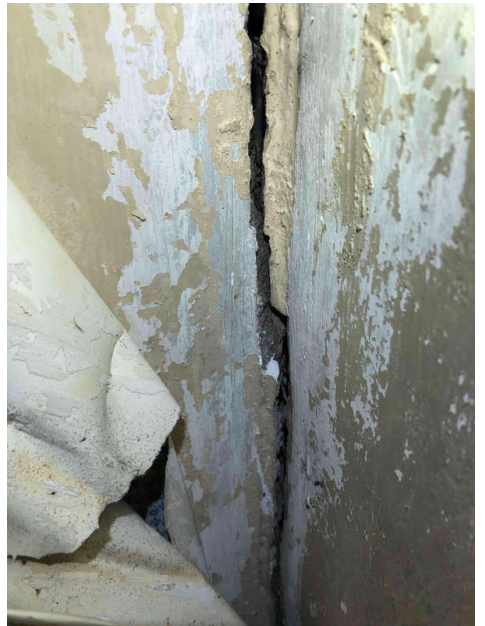
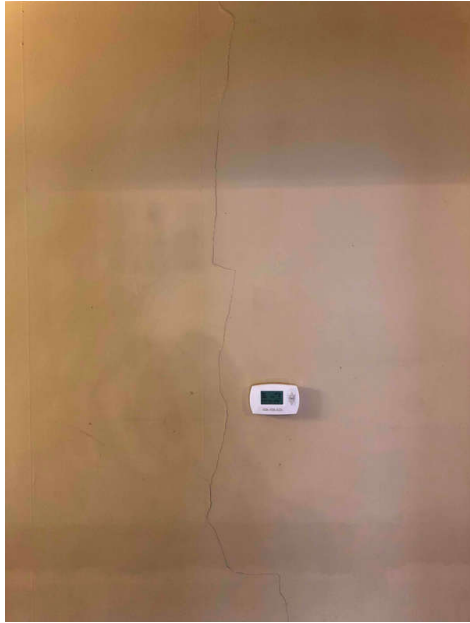
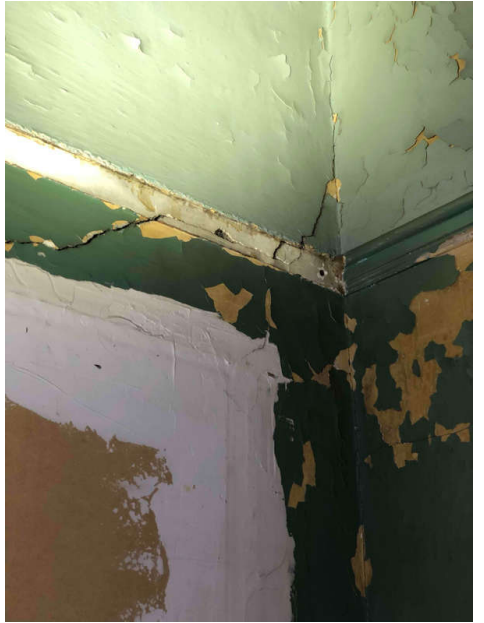
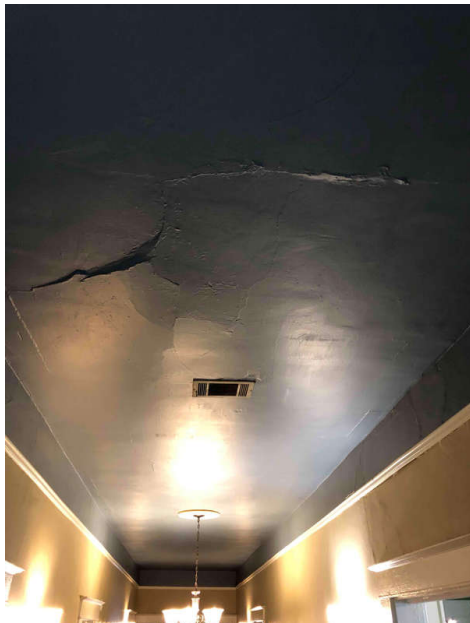
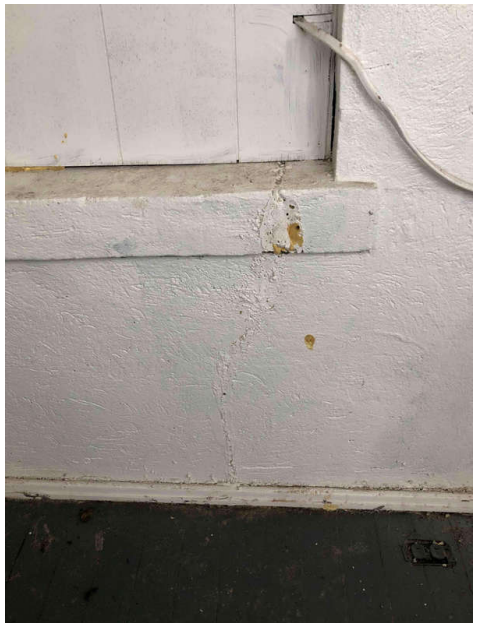
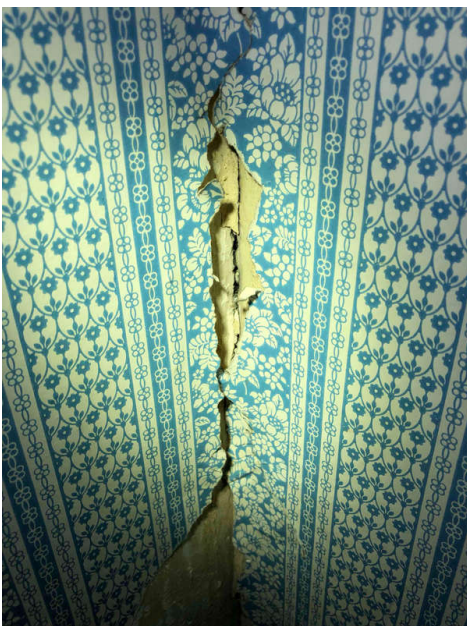
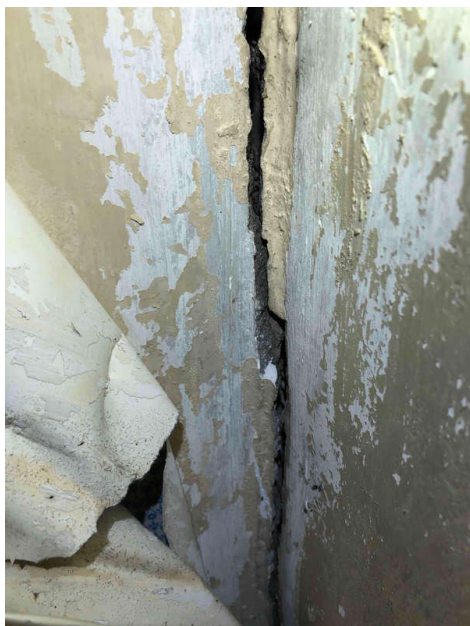
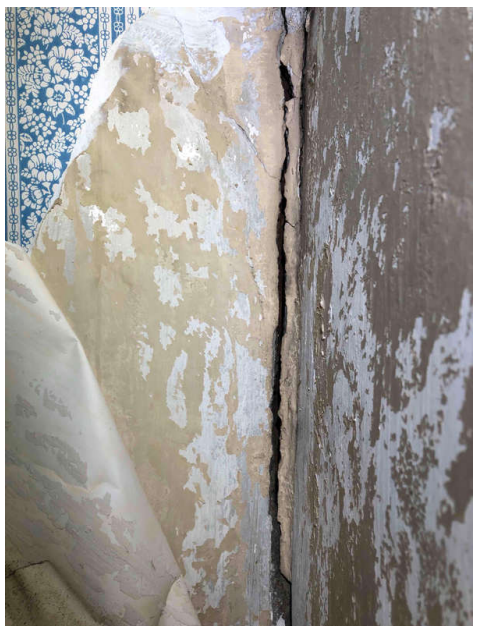
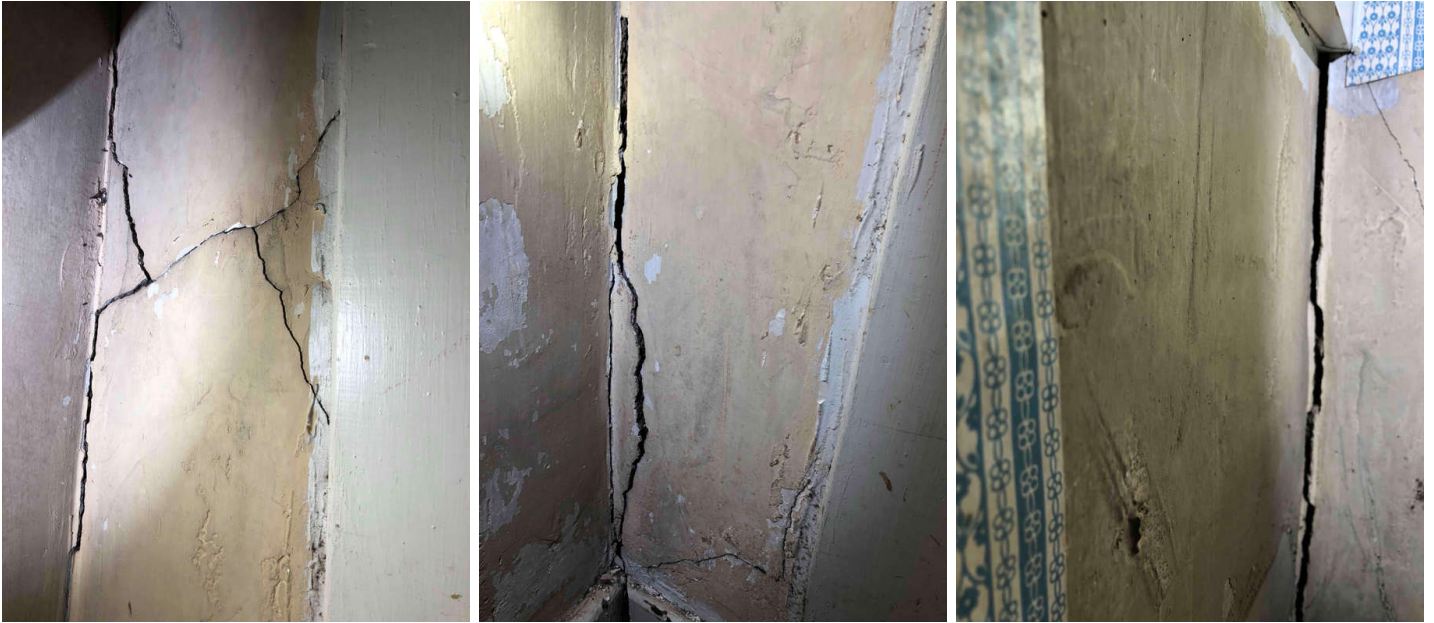
### 4.1.1 Foundation

#### DIFFERENTIAL SETTLEMENT CRACKING (SIGNIFICANT)

##### VARIOUS LOCATIONS

Settlement cracking was observed to have multiple planes of movement in multiple locations both interior and exterior. Generally speaking, the more planes of movement, the more problematic the settlement can be. Further evaluation by a licensed structural engineer is recommended.

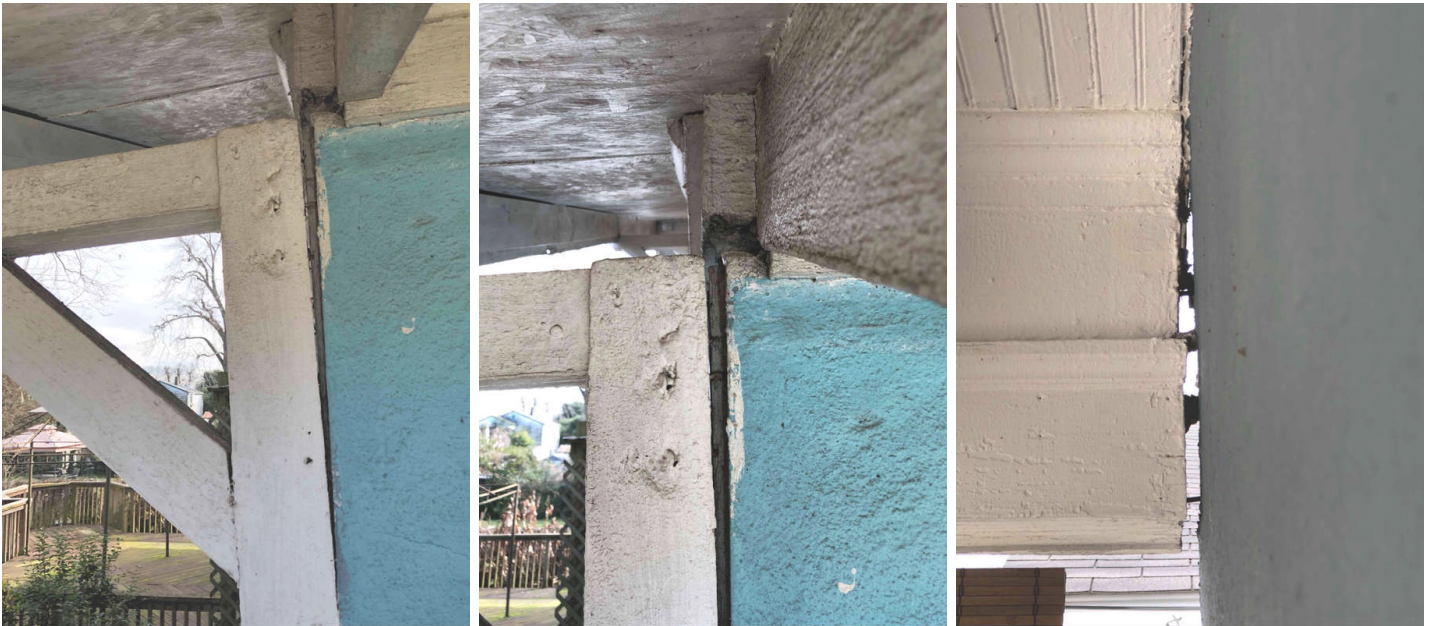
4.1.2 Foundation

**SETTLEMENT RELATED MOVEMENT**

The front porch as well as the back left Corbel exhibited signs of settlement related activity.

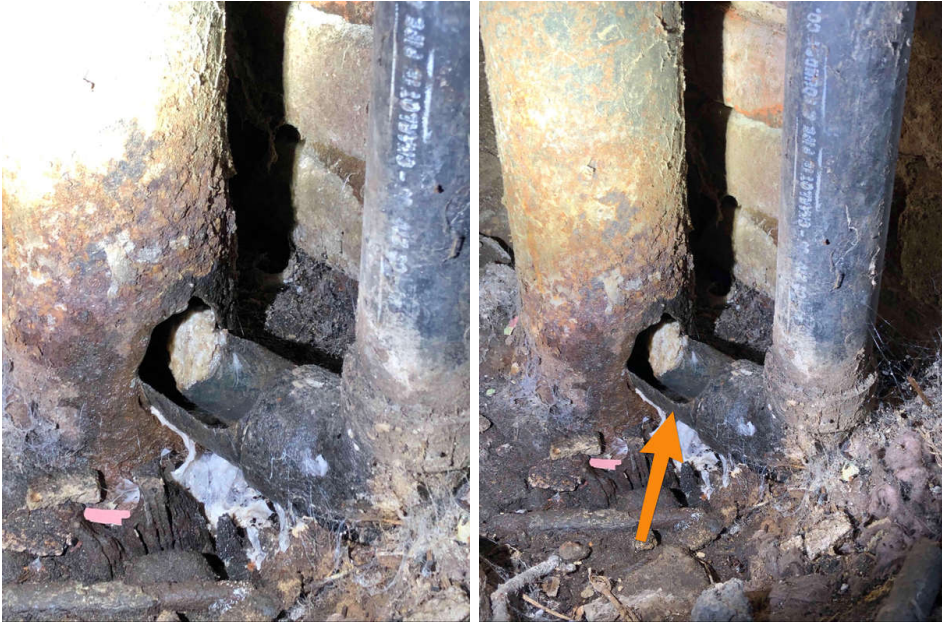
4.2.1 Crawlspace

**ACTIVE LEAK IN DRAIN LINE**

BELOW HALL BATHROOM

Active leaking was observed at the time of the inspection. The drain pipe was damaged. The damaged portion of pipe should be replaced.

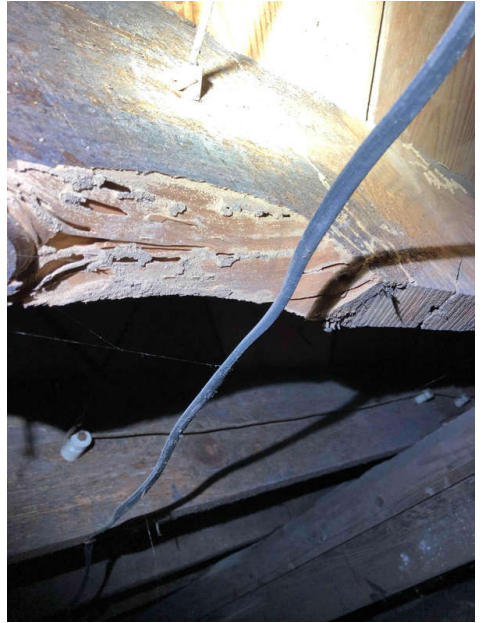
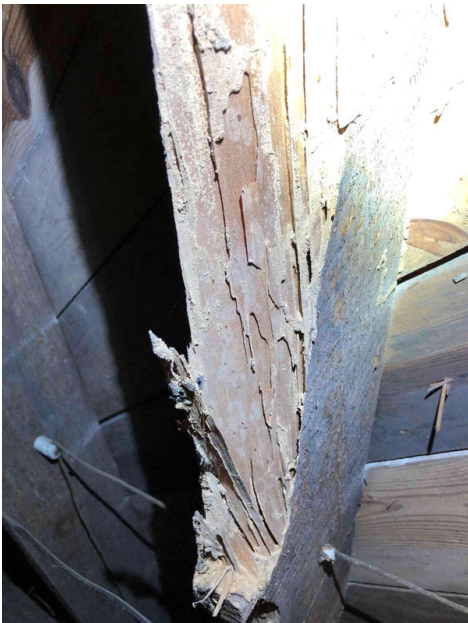
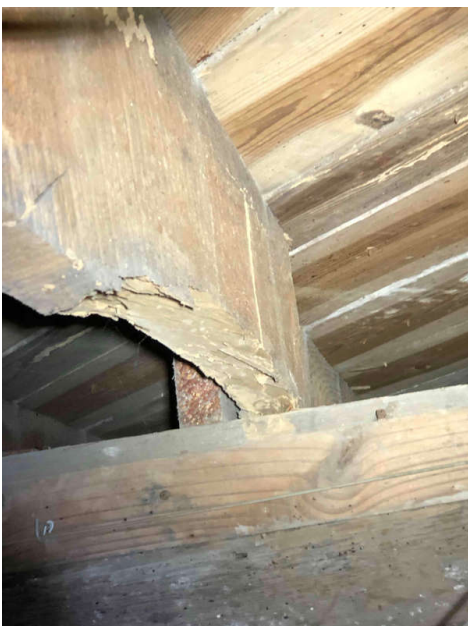
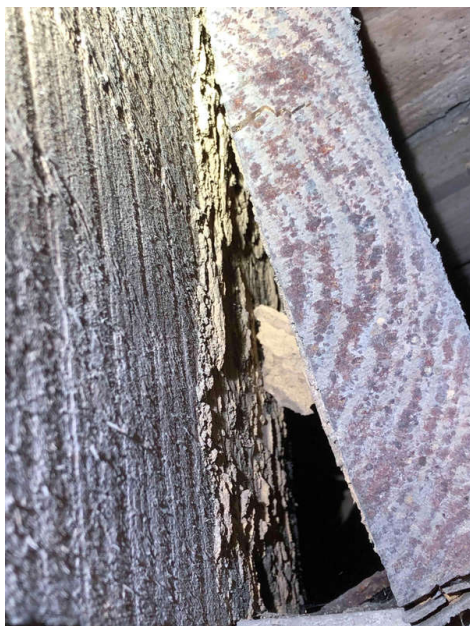
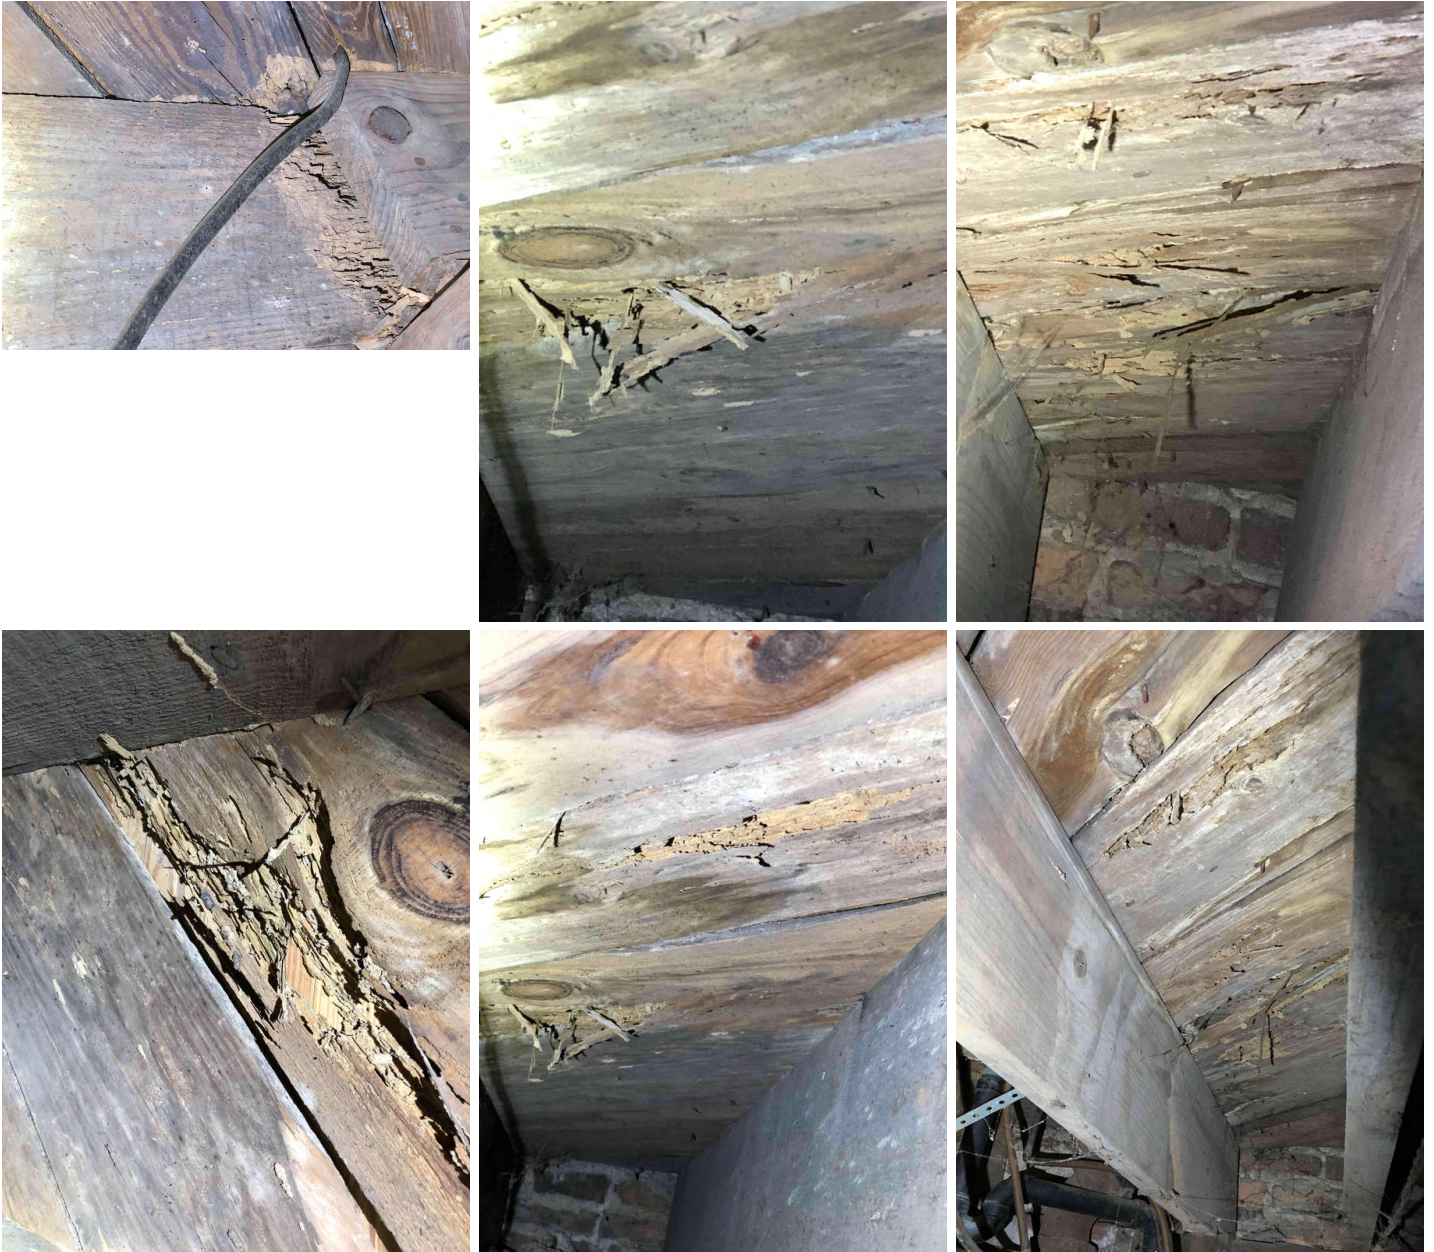
4.2.2 Crawlspace

**PAST TERMITE DAMAGE**

MULTIPLE LOCATIONS

Past termite damage observed in the crawlspace. At the time of the inspection there was no active termite activity observed. A termite letter/inspection is recommended prior to the end of your due diligence period.

\* Termite damage was observed at various locations in the crawlspace. The floor joists and subfloor exhibited damages.

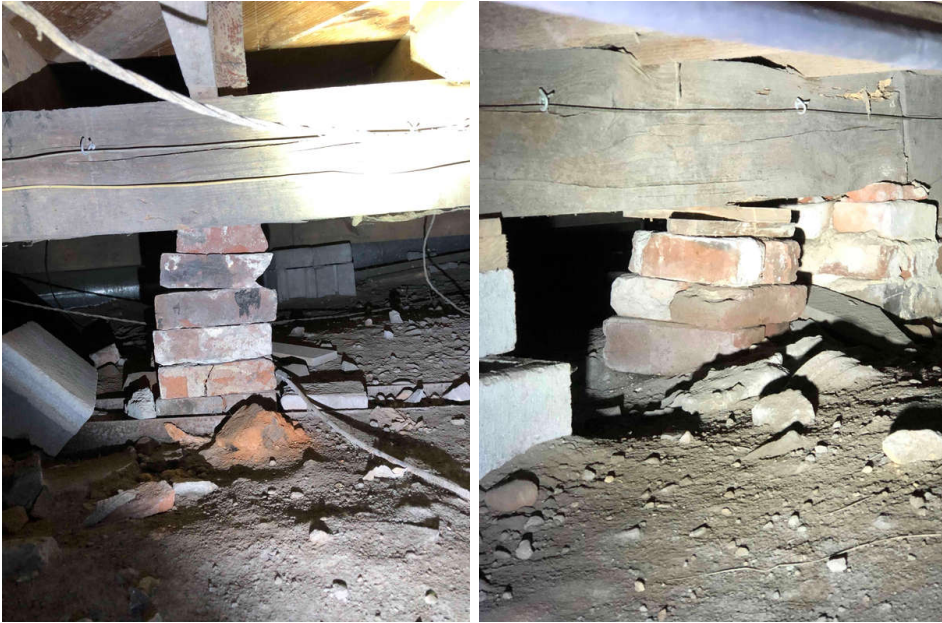
#### 4.2.3 Crawlspace

### **IMPROPER BUILDING PRACTICE**

The column was not in accordance with proper building practice. The column should be built up with the appropriate material. Consult with a General Contractor for further evaluation and repairs. No adverse damages were observed as a result of the improper practice.

\* The observed practice was used in multiple locations throughout the crawlspace.

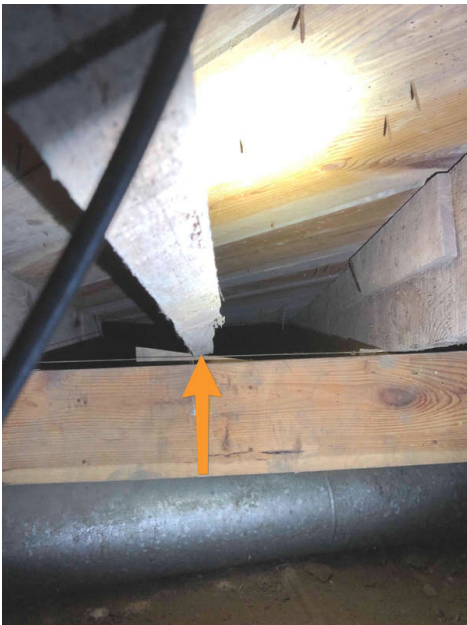
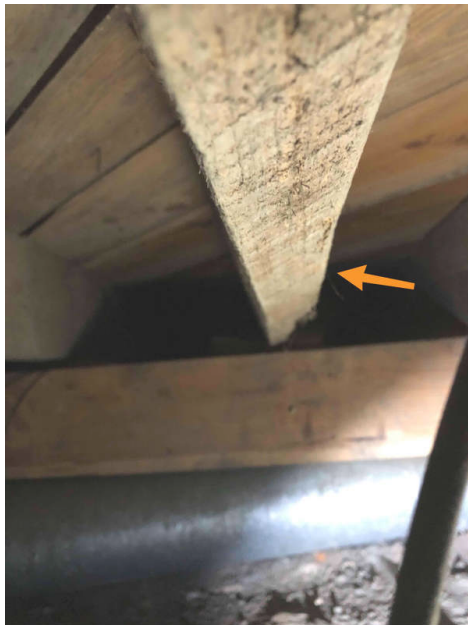
4.3.1 Floor, Wall, & Ceiling Structure

**BEAM ROTATING OR TWISTING OBSERVED**

CENTER OF CRAWLSPACE

The beam was found to be rotating or twisting. This can result in an unevenness of the floor.

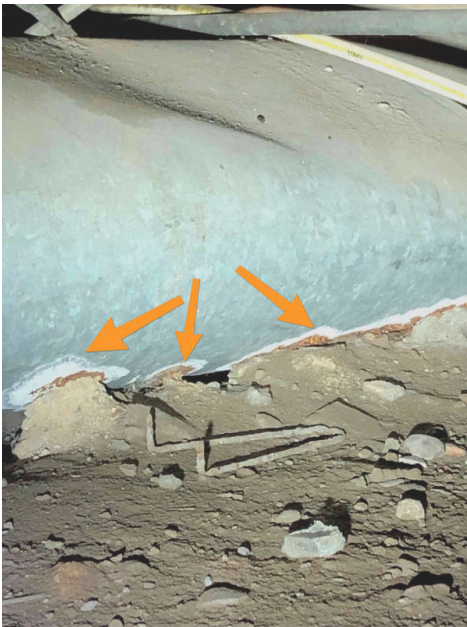
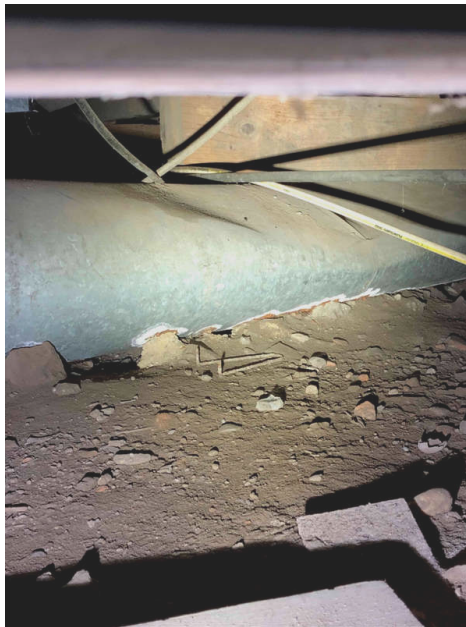
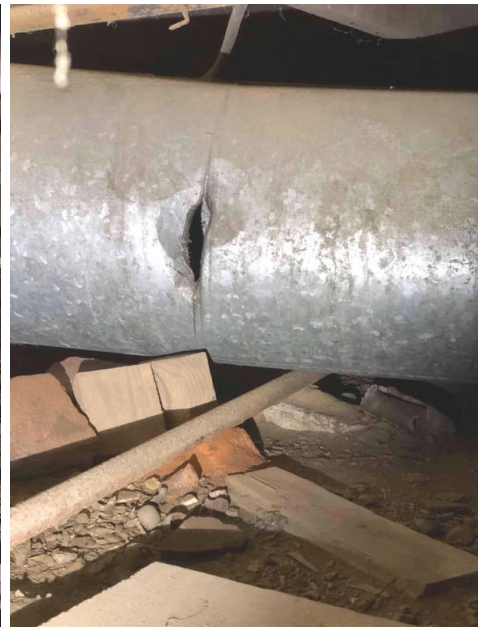
**DUCT DAMAGED**

The ductwork in one or more areas was exhibited mechanical damages.

\*The return duct showed signs of corrosion and rust in multiple areas.

\*The return duct was punctured. The puncture was observed near the rear of the crawlspace.

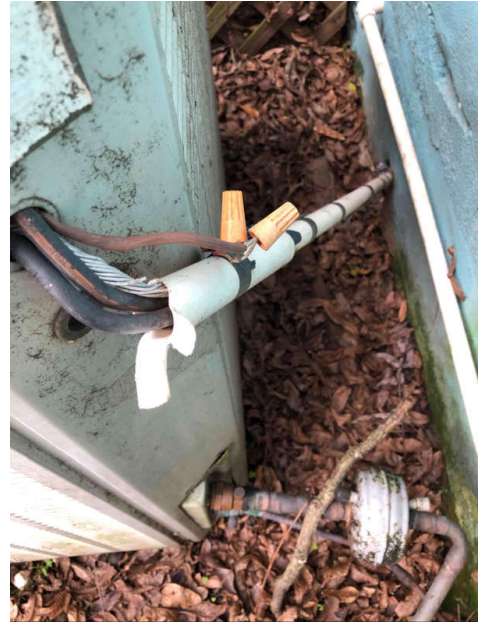
## 5.1.3 Heating &amp; Cooling Equipment

**EXPOSED ELECTRICAL WIRING**

Exposed electrical wiring on the exterior of the home may result in damages over time as a result of exposure to the weather (elements). The wiring should be concealed with conduit.

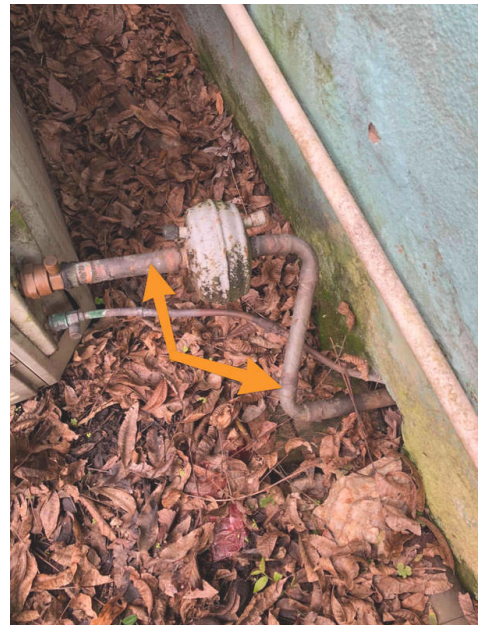
#### 5.1.4 Heating & Cooling Equipment

### PIPE INSULATION MISSING

The piping insulation on the refrigerant line was missing.

Contact a handyman or DIY project
