# PREMIER HOME INSPECTIONS OF THE CSRA

## YOUR CUSTOM HOME INSPECTION REPORT

1234 Main St.  
North Augusta SC 29841

Buyer Name  
01/23/2019 9:00AM

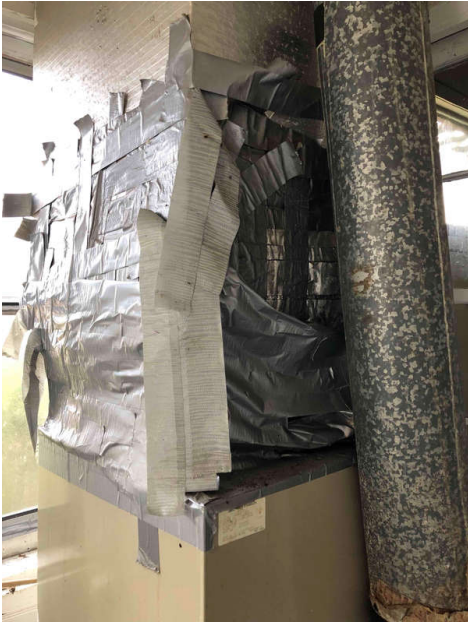
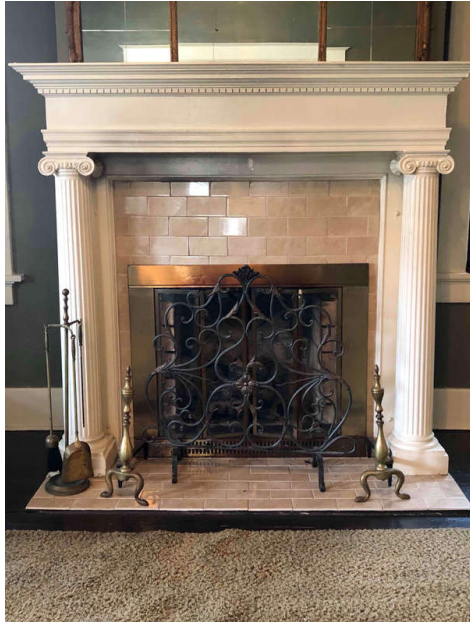
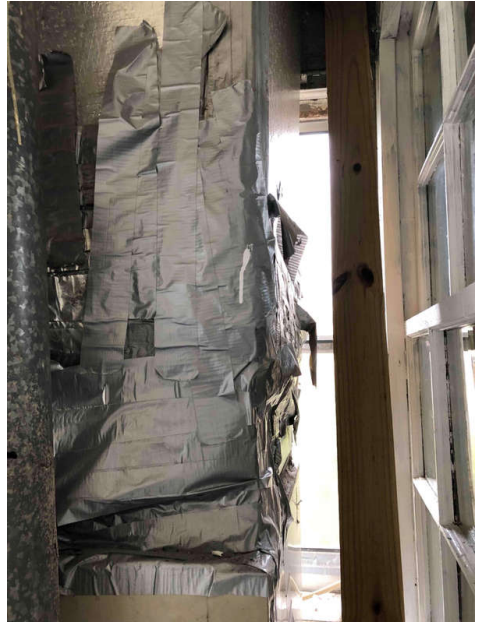
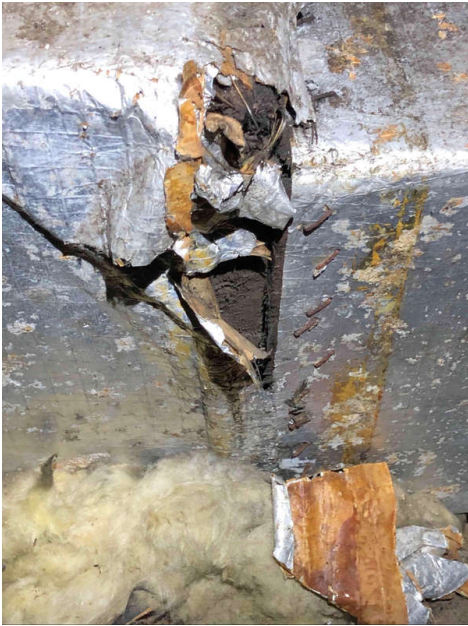
#### 5.1.5 Heating & Cooling Equipment

### DUCTWORK NOT SEALED PROPERLY

The ductwork was sealed with duck tape in multiple locations. Over time the duck tape will lose its adhesiveness and pull away resulting in ducts to become loose and potentially result in a loss of conditioned air. This was observed in some areas throughout the duct system.

Contact a qualified professional.

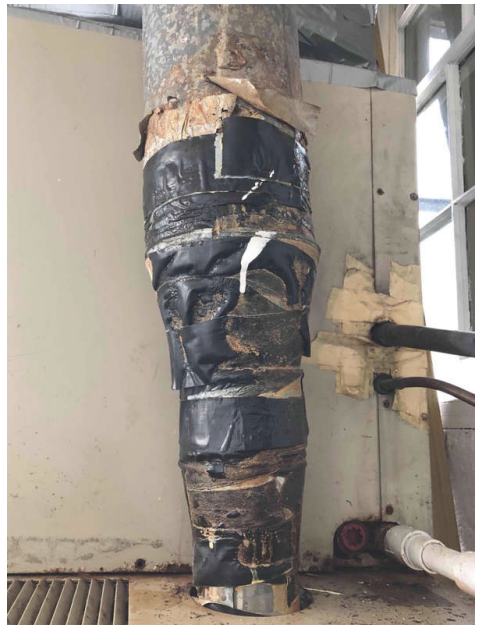
5.1.6 Heating & Cooling Equipment

**FLUE IMPROPERLY SEALED**

The flue was sealed with duck tape. Duct tape should be used. Over time the duck tape will lose its adhesiveness and fail.

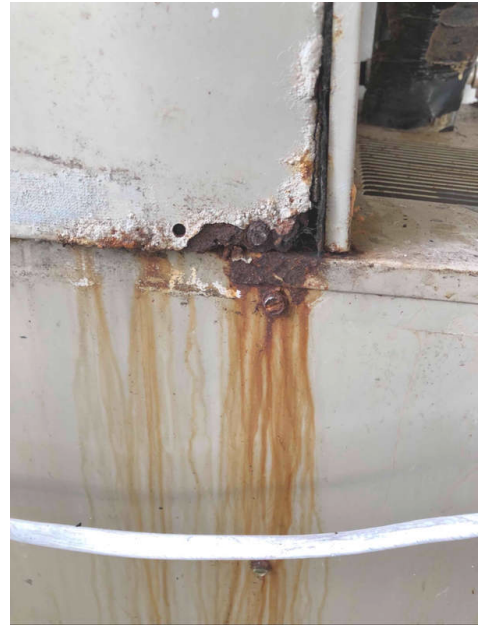
5.1.7 Heating & Cooling Equipment

**RUST OBSERVED**

Rust was observed at the base of the furnace. At the time of the inspection the furnace was functioning properly however further evaluation is recommended to determine the cause of the rust and ensure there is no on-going issue.

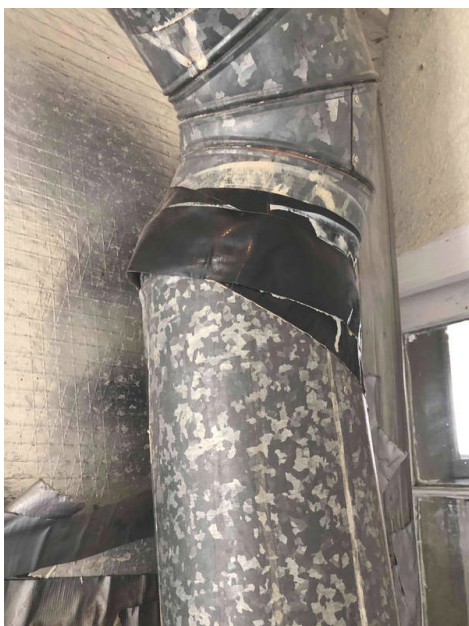
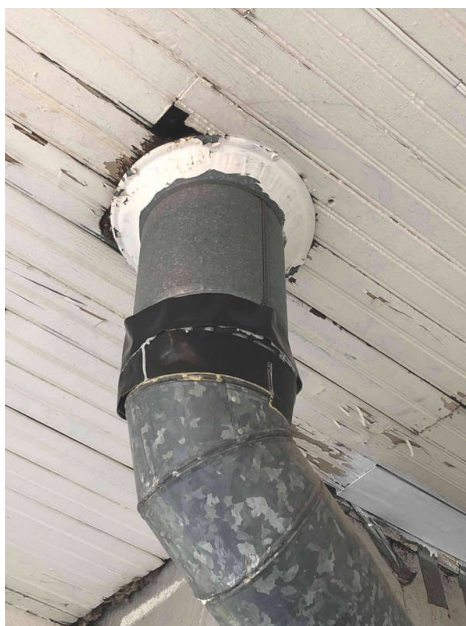
7.2.2 Hot Water Systems, Controls, Flues & Vents

**FLUE IMPROPERLY SEALED**

The flue pipe was not sealed properly.

\*See comment on furnace flue\*

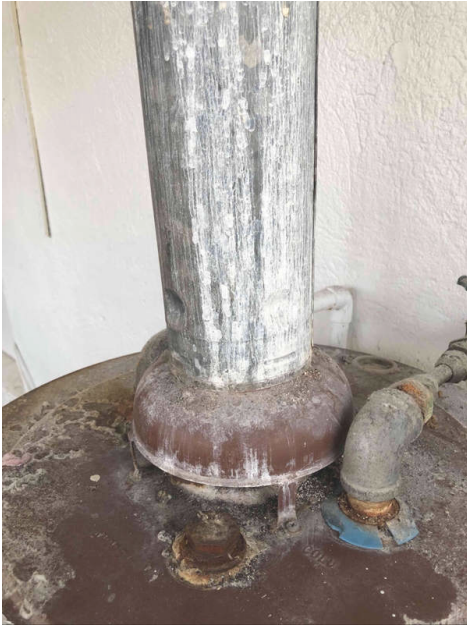
## 7.2.3 Hot Water Systems, Controls, Flues &amp; Vents

**RUST OBSERVED**

Rust was observed below the exhaust flue, at the top of the water heater. Staining on the flue suggests water leaks. There was no active leaks present. Given the age of the unit, budget for future replacement.

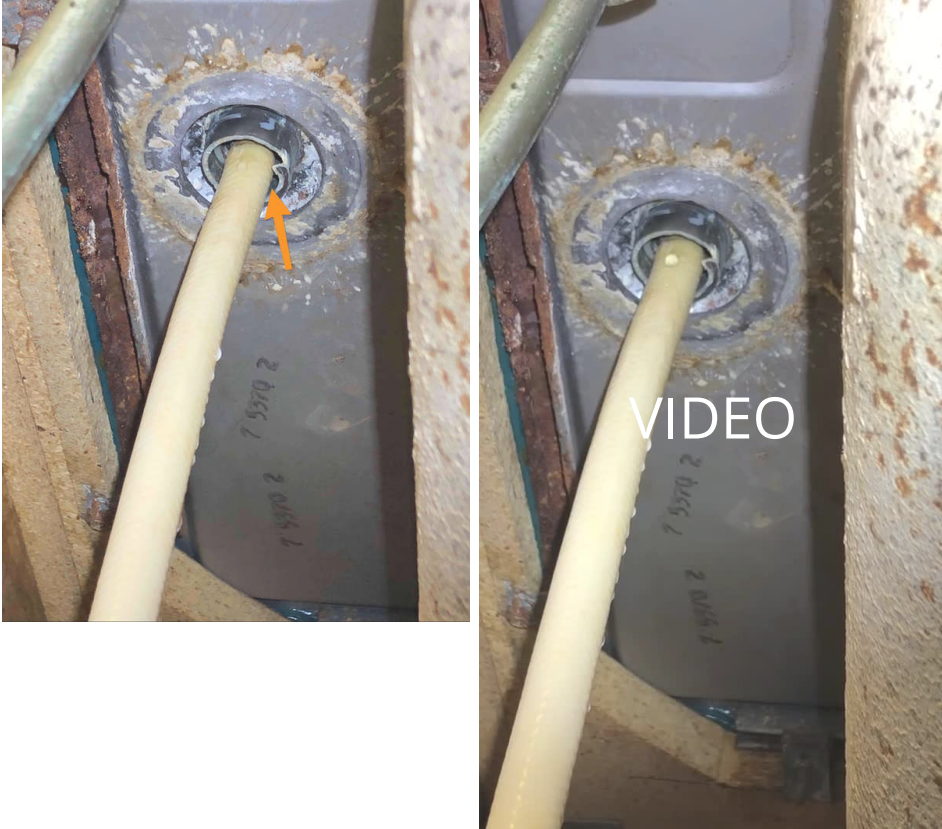
#### ACTIVE LEAK

There was an active leak below the kitchen sink. The leak was coming from the sink spray nozzle.

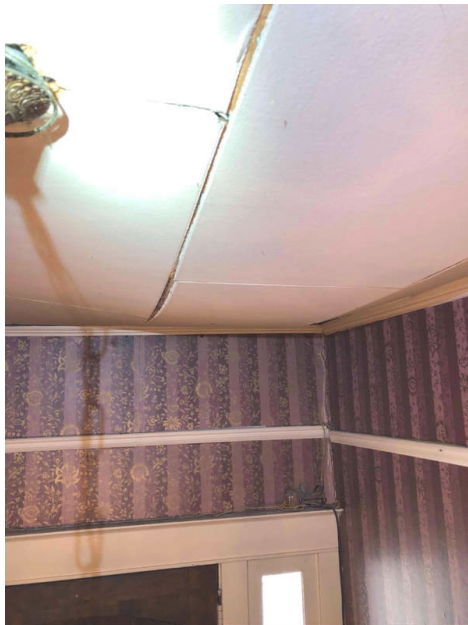
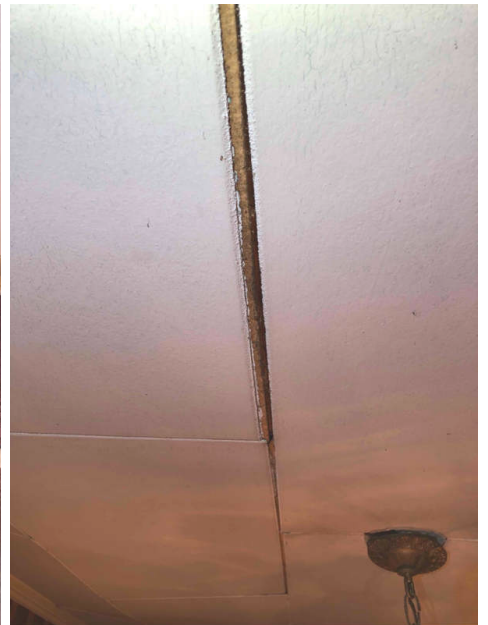
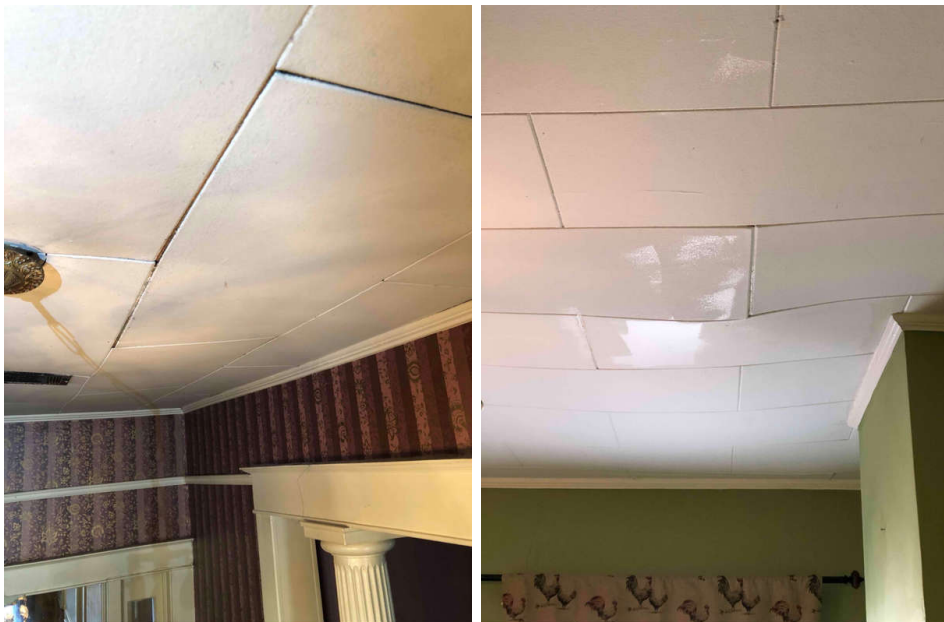
9.1.2 Living Spaces

**CEILING TILES SAGGING**

The ceiling tiles were sagging in various locations throughout the home. The most notable area of sagging was above the front door entrance.

The sagging did not appear to be the result of subsequent damage from leaks in the roof. Tiles appeared to have detached from the plaster ceiling. This may be the result of settlement, moisture, or quite possibly detachment overtime.

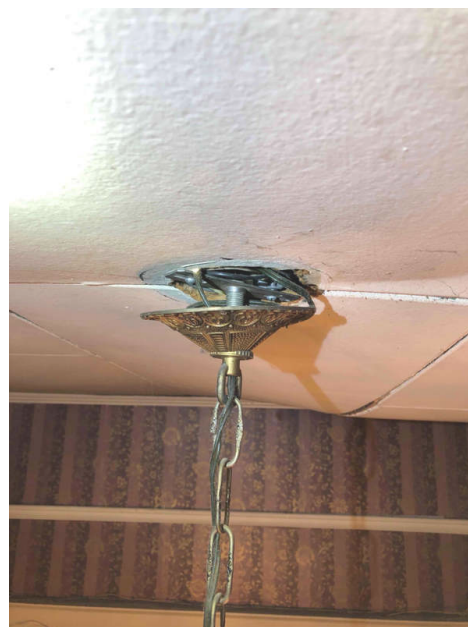
### 9.1.3 Living Spaces

#### **LIGHT FIXTURE LOOSE**

The light fixture located at the front door entrance was loose.

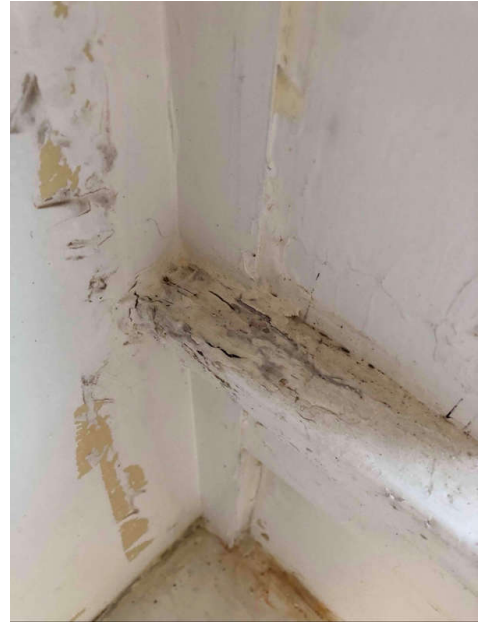
### 9.2.1 Bathrooms

#### **WATER DAMAGE**

The left side bathroom window sill exhibited water damage.

Although painted, the damaged portion was rotted as a result of excessive water exposure over time.

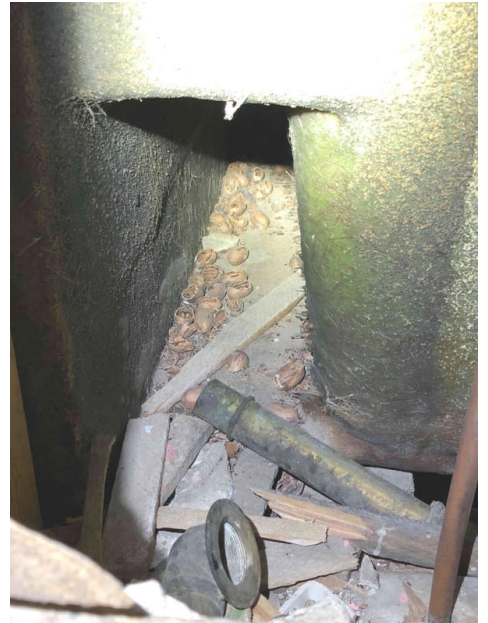
### 9.2.2 Bathrooms

#### **EVIDENCE OF RODENT ACTIVITY**

There was evidence of rodent activity below the bathtub in the right side hall bathroom. The evidence was only observed once the bathtub access panel was removed.

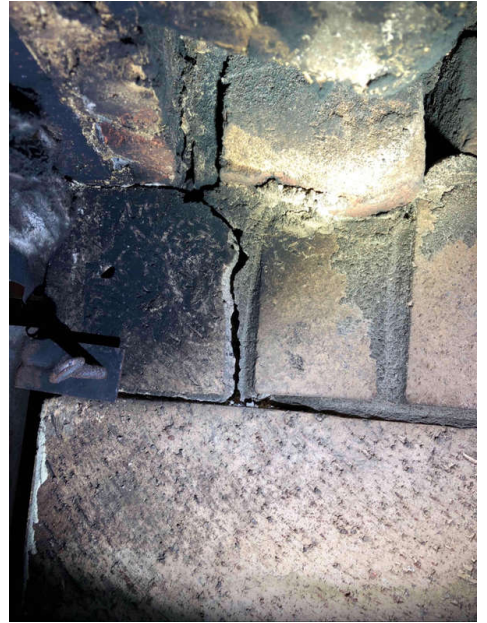
### 9.4.1 Fireplace

#### **MORTAR JOINTS NEED MAINTENANCE**

Cracking on the interior left side of the firebox needs repair. Repair the mortar with an approved fire rated compound.
