HOME INSPECTION REPORT

1234 Main St.
Port Orchard Washington 98367

01/16/2018 9:00AM

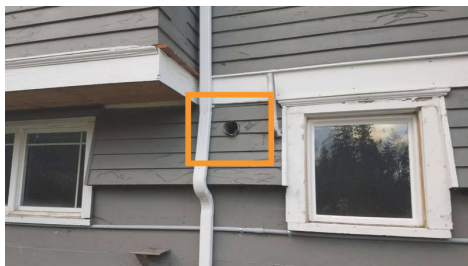
3.7.2 House Wall Finish

EXTERIOR VENTS NEED REPAIR

The vent is missing or damaged and is in need of replacement.

Contact a qualified professional.

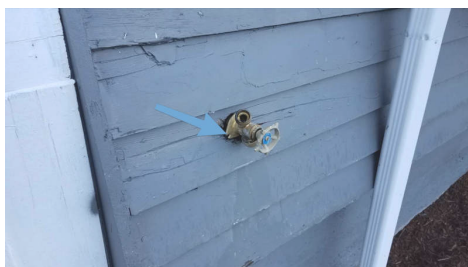
3.7.3 House Wall Finish

Gaps and/or holes were observed on one or more sides in the siding around plumbing, gas, cable, wiring and/or other penetrations. We advise that all the holes and the gaps be caulked and/or sealed to prevent moisture and/or pest intrusion.

Contact a qualified professional.

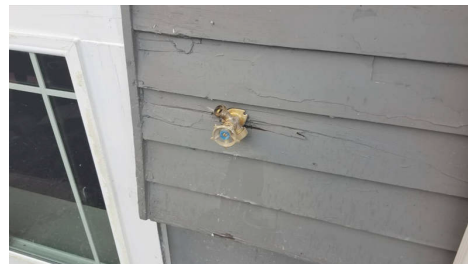
3.8.2 Exterior Plumbing

NOT SECURED TO WALL

The hose bib is not secured to the wall. This could potentially damage the Plumbing. Recommend securing.

Contact a qualified professional.

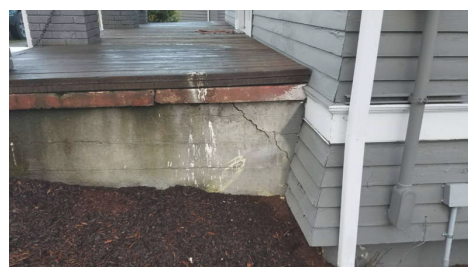
3.13.1 Patio

PATIO CRACKING

The patio has cracking. Recommended monitoring.

Contact a qualified professional.

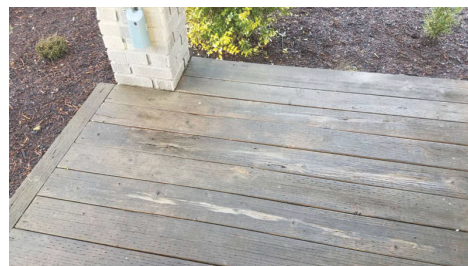
3.17.1 Deck

DRY ROT

Dry rot was observed in the structure of the deck which is usually caused by deferred maintenance and should be repaired.

Contact a qualified deck contractor.

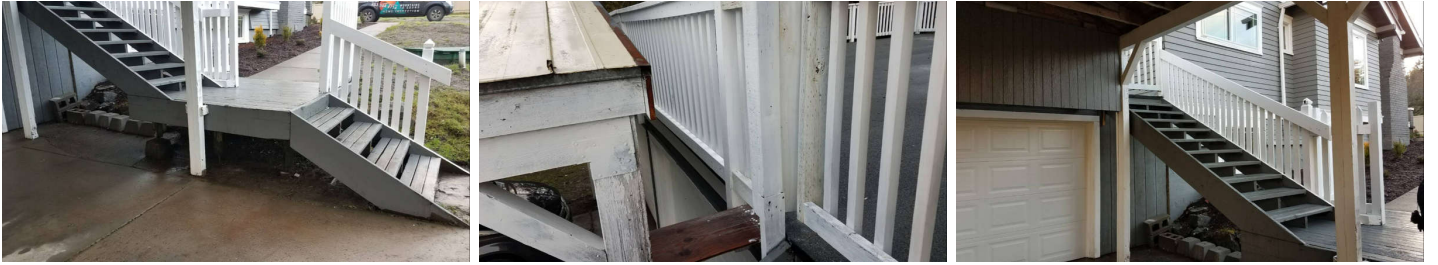
3.17.2 Deck

GUARDRAIL MISSING WHERE NEEDED

A guardrail is missing at a location where needed. We recommend installing to prevent a safety hazard.

Contact a qualified professional.

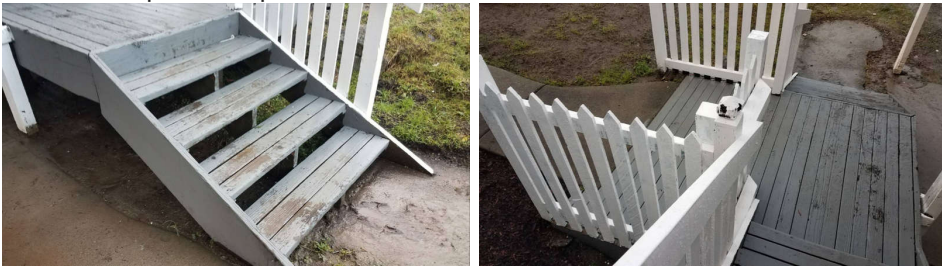
3.17.3 Deck

Portions of the deck we're weathered and in need of minor repairs and maintenance.

Contact a qualified professional.

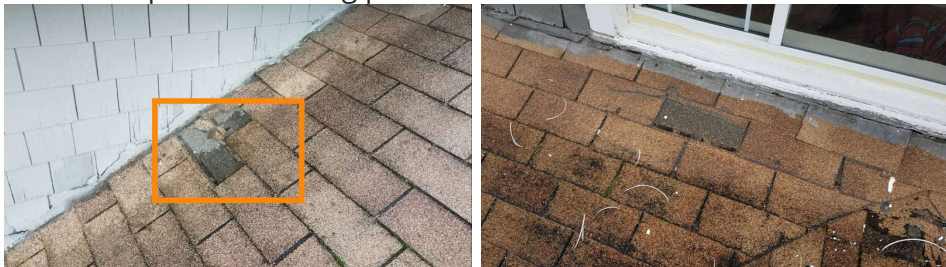
ROOF HAS A FEW MISSING SHINGLES

The roof has a few missing shingles that should be replaced by a roofing contractor, before the close of escrow and preferably within the inspection period. This will help prevent the possibility of moisture getting past the roof covering, wearing the protective barrier beneath, and into the attic or residence. We recommend having a roofer inspect the rest of the roof as well.

Contact a qualified roofing professional.

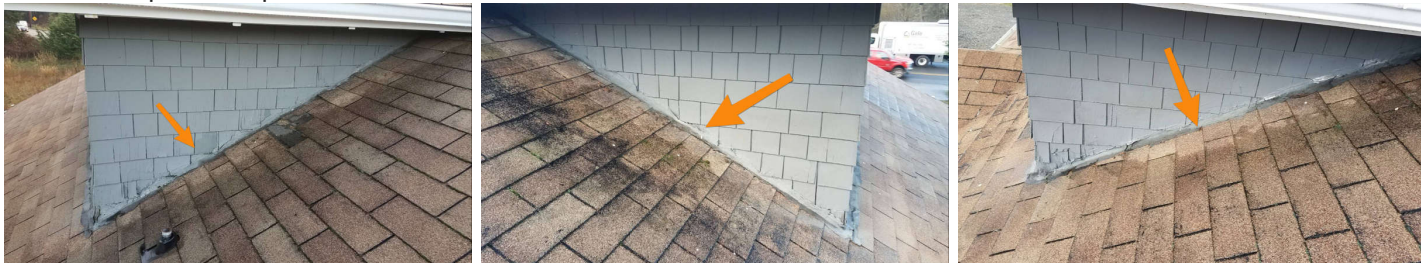
4.4.1 Vents & Flashings

SIDEWALL FLASHING MISSING

The sidewall flashing was missing. We recommend installing to prevent leaking.

Contact a qualified professional.

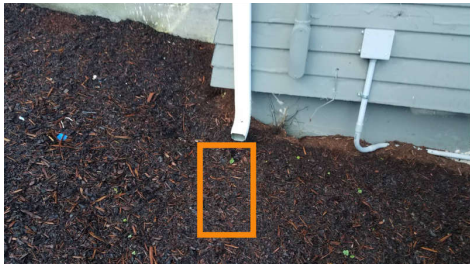
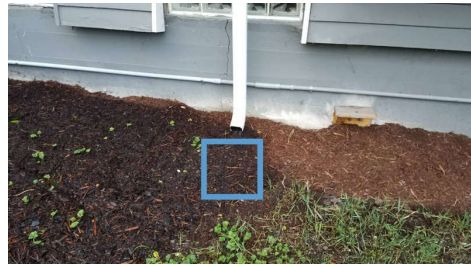
4.5.1 Gutters & Drainage

DOWNSPOUTS MISSING COMPONENTS

The downspout are missing parts. Recommend repairs to allow for proper drainage away from the structure.

Contact a qualified professional.

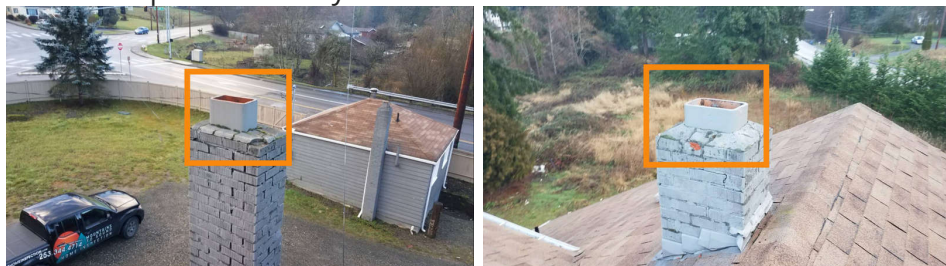
The chimney does not have a spark arrestor or weather cap which is mandated in most jurisdictions and should be installed. This will help prevent pests or debris from falling into the flue and causing an obstruction or damage.

Contact a qualified handyman.

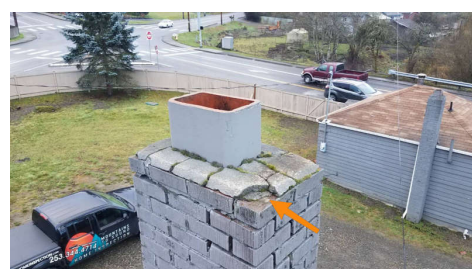
5.4.1 Crown or Termination Cap

THE IS WASHED OUT OR DETERIORATED AND SHOULD BE REPLACED

The crown, which is designed to seal the chimney wall and to shed rainwater, is washed out or deteriorated and should be repaired or replaced.

Contact a qualified masonry professional.

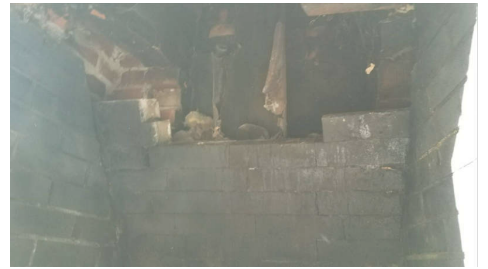
5.10.1 Common Observations

FIREPLACE NEEDS REPAIRS

The fireplace is in need or repairs prior to use.

Contact a qualified fireplace contractor.

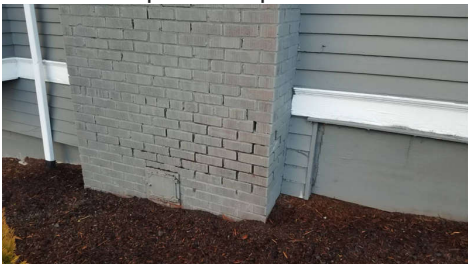
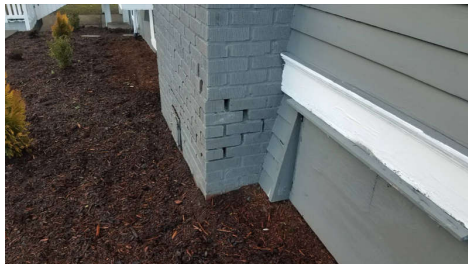
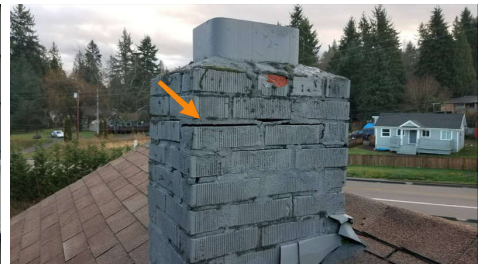
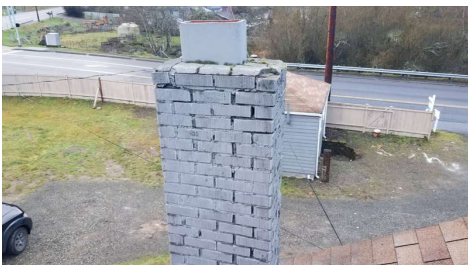
5.13.1 Chimney Condition

TUCK POINTING

The exposed sections of the exterior of the chimney needs re-pointing (tuck-pointing) due to having loose or deteriorated mortar joints. Recommend Repair of old and or eroded mortar joints.

Contact a qualified professional.

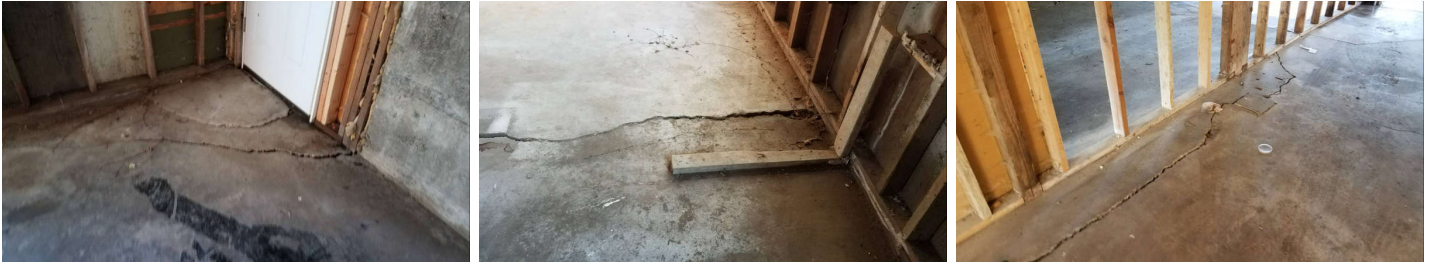
CRACKED AND SETTLED

The garage slab floor is integral, and it has cracked, settled, and slightly deformed the structure. We can elaborate on this issue, but because it has structural implications you should consult an engineer.

Contact a qualified structural engineer.

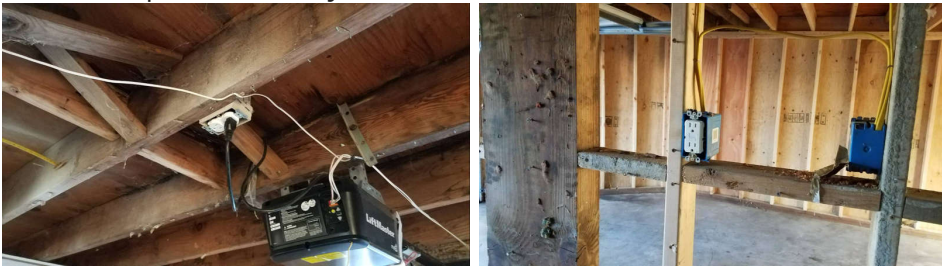
6.13.1 Outlets, Electrical

MISSING OR BROKEN COVER.

There was a missing or broken switch or outlet cover that should be replaced or installed.

Contact a qualified handyman.

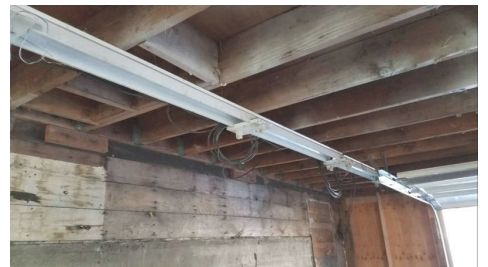
6.14.1 Lights, Wall Switches

A ceiling light does not respond, and should be serviced as necessary. Bulbs were missing. Replacement bulbs and testing is recommended.

Contact a qualified electrical contractor.

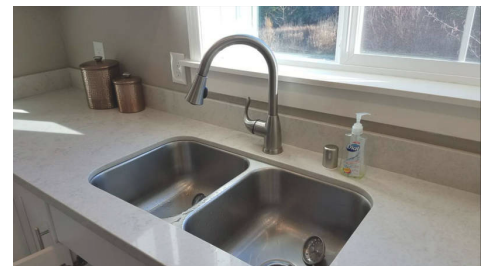
The hot and cold water lines to the kitchen faucet are reversed and should be serviced as necessary. Hot water is on the right side and cold water is on the left side; this is opposite of the usual setup. I recommend correcting this issue to help prevent the possibility of a scalding type injury.

Contact a qualified handyman.

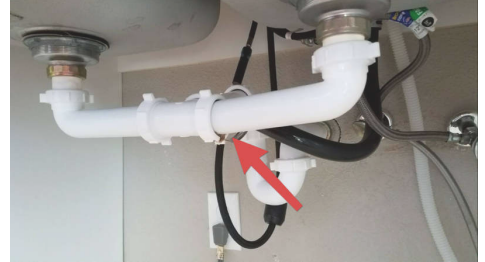
11.4.2 Trap and Drain

LEAK AT DRAIN LINE BELOW THE SINK

There is a leak at the drain line below the sink which should be repaired as necessary.

Contact a qualified professional.

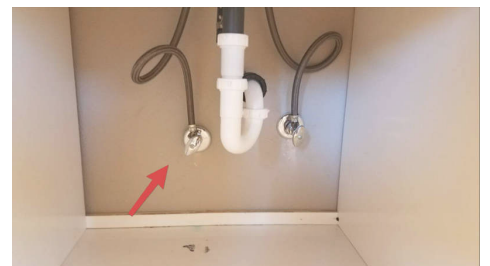
LEAK ON THE HOT WATER SHUT-OFF

There is a leak on the hot water shut-off valve below the sink, which should be evaluated and repaired as necessary by a qualified plumber.

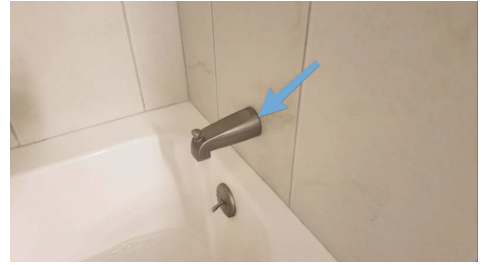
13.8.1 Tub-Shower

CAULKING OR SEALING

I recommend caulking or sealing around shower valves and faucets etc to help prevent moisture intrusion behind or into the walls.

Monitoring these areas is also recommended to help ensure an adequate seal is in place.

Contact a qualified handyman.

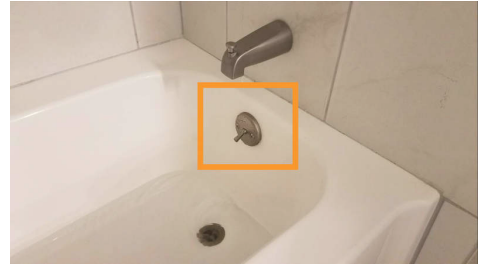
13.8.2 Tub-Shower

TUB STOPPER NEEDS WORK

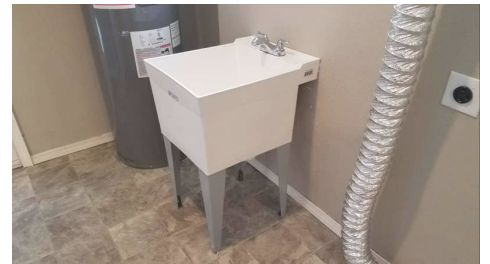
Laundry sink is not secure too. We recommend securing to prevent damage to Plumbing.

Contact a qualified professional.

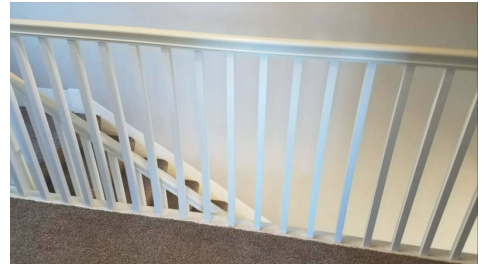
15.10.2 Handrails & Guardrails

THE BALUSTERS IN THE STAIR RAILS ARE LOOSE OR DAMAGED AND SHOULD BE SERVICED

The balusters in the stair rails are loose or damaged and should be serviced as necessary by a qualified contractor.

Contact a qualified handyman.

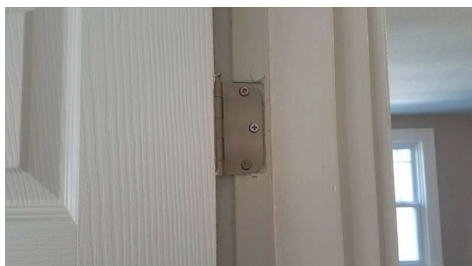
The door hardware is Missing or in need of adjustment or repair.

Contact a qualified professional.

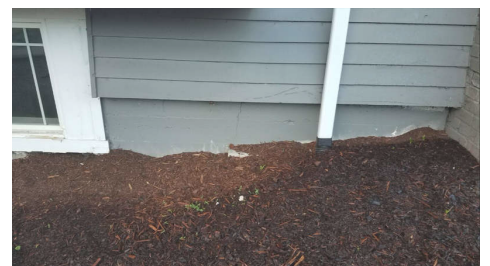
18.2.2 Foundation

SMALL CRACKS

Recommend monitoring.

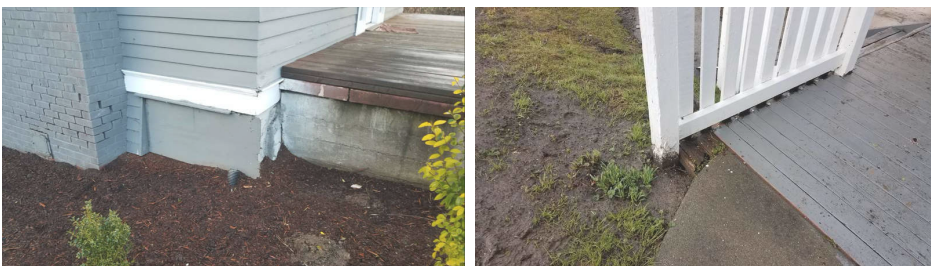
Some of the Exterior siding or other building components were embedded in the soil. Siding embedded in dirt is subject to moisture damage and creates a condition which is conducive to infestation and damage by wood destroying organisms. Generally re-grading is recommended to create and maintain a 6" clearance between any Exterior wooded elements of the structure and the soil.
