## PRE-DRYWALL INSPECTION

1234 Main St.  
Columbia MD 21044

Buyer Name  
02/16/2019 9:00AM

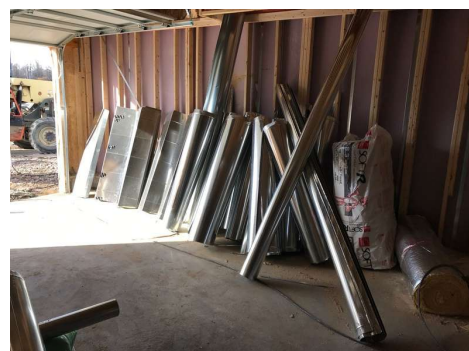
1ST FLOOR

Slab Partially Blocked By Building Materials

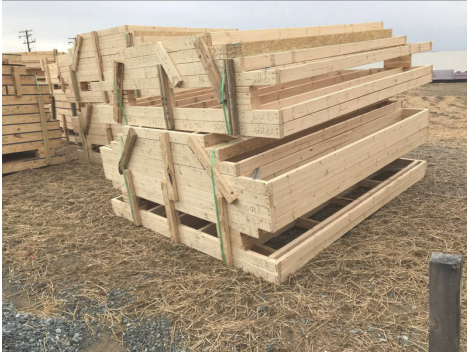
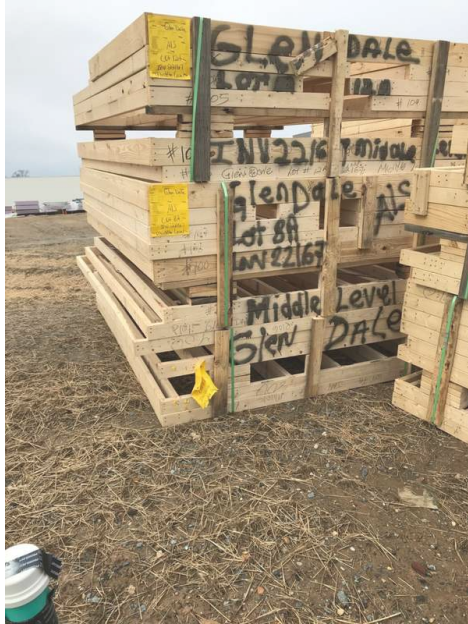
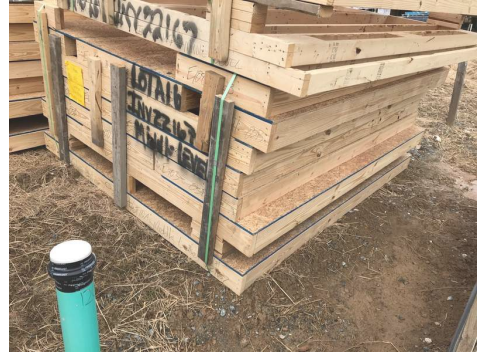
GARAGE

Some building materials were not stored properly allowing ground contact that will damage the material overtime, and may allow mold growth. We recommend to properly store these items and discard any damaged materials.

Trusses Stored With Ground Contact / Uncovered

Contact your builder.

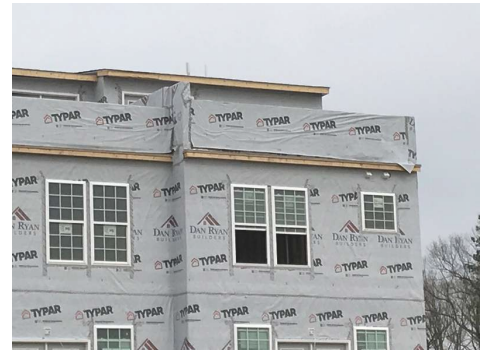
ROOF FASCIA BOARDS

The drip edge flashings and gutters were not yet installed at the time of inspection.

Gutters Not Installed

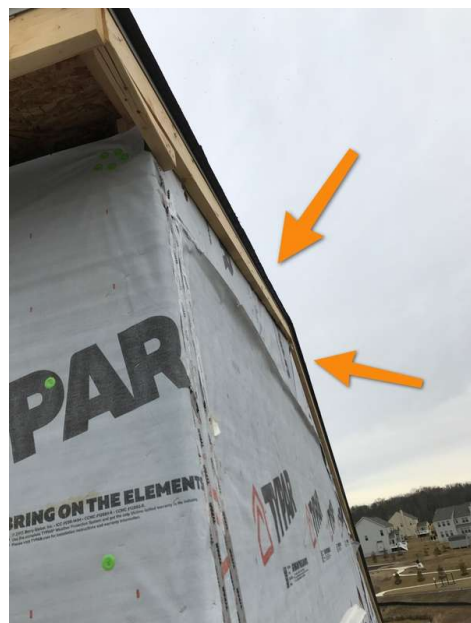
The House Wrap Tape has not been applied around the exterior wall penetrations. Tape was also missing on the upper left exterior wall. We recommend to inspect and install according to manufacturers instructions.

Missing House Wrap Tape

Contact your builder.

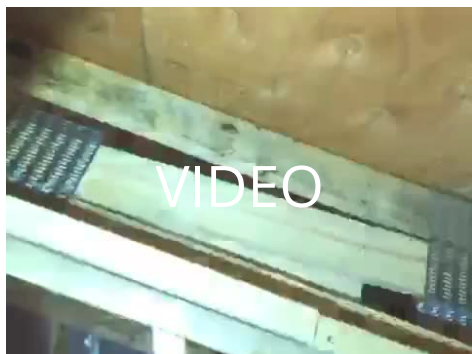
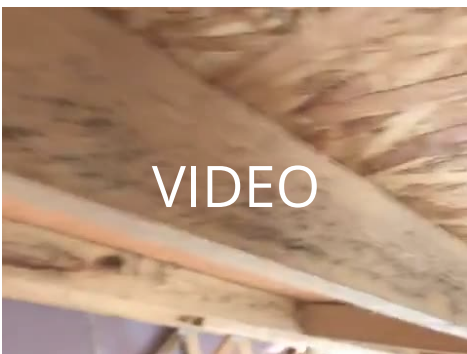
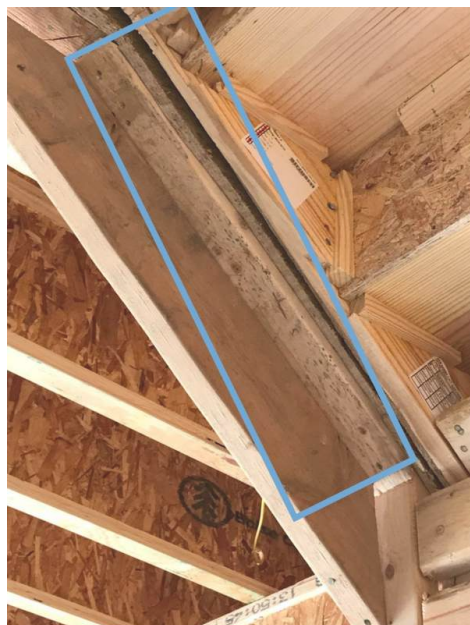
Areas of the floor and roof trusses had visible signs of microbial growth at the time of inspection. This is likely due to trusses being stored in damp areas. Affected trusses were observed on each level of the home, and in the attic space. Areas of concern on each level should be tested by a mold inspector. Fungal growth should be removed by a qualified contractor or mold remediation professional. If you have health concerns about mold you may want to consult with an environmental specialist.

Bio-Growth In Garage Adjacent To Stairs

Contact a qualified mold inspection professional.

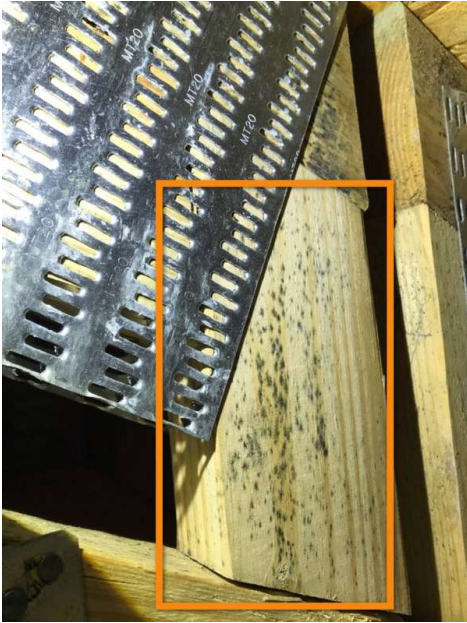
Suspected Mold On Roof Truss

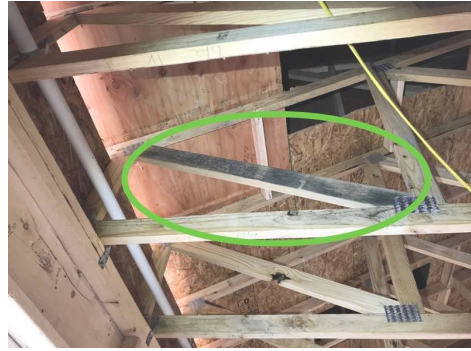
Suspected Mold Above 3rd Floor Bedroom (Front)

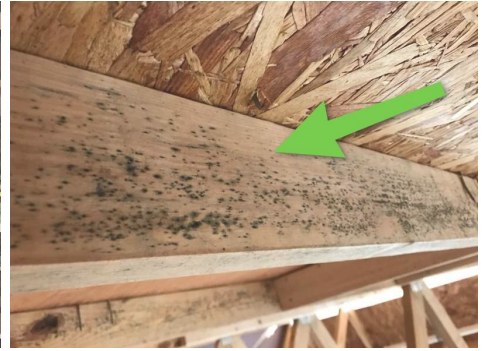
Suspected Mold On Roof Truss

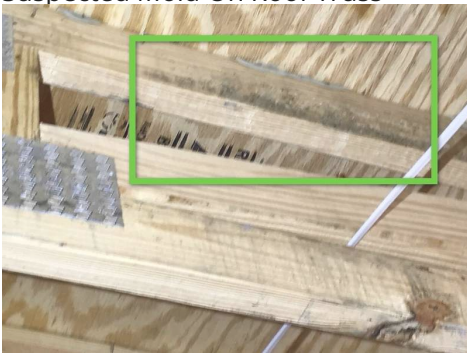
Suspected Mold On 3rd Floor Floor Truss

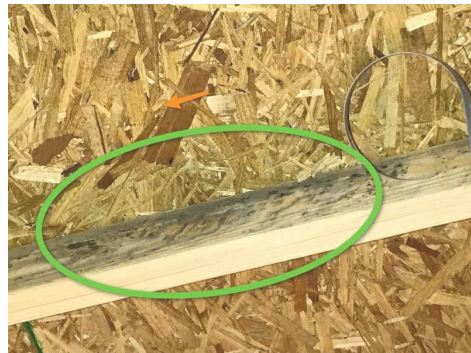
Suspected Mold On First Floor Truss

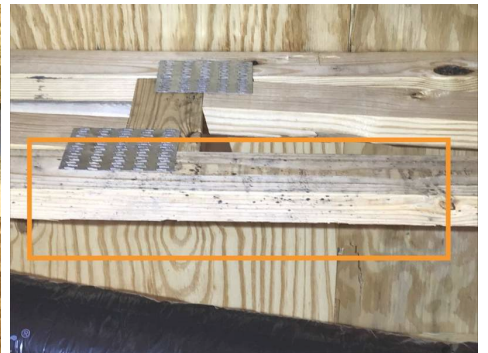
Suspected Mold Growth On Truss Above Master Bathroom

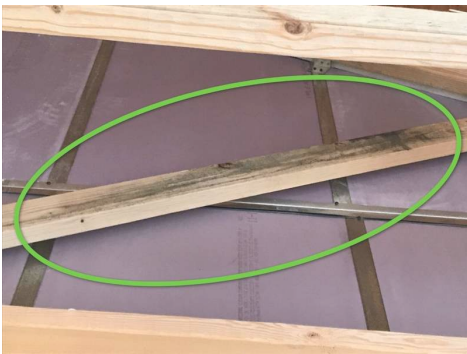
Suspected Mold Above 3rd Floor Bedroom (Front)

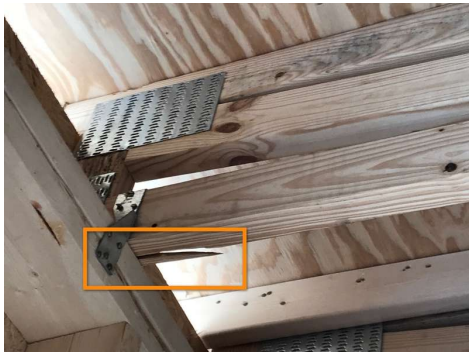
The Truss Chord was damaged/cut at the time of inspection. We recommend to have a Qualified Contractor to inspect and repair.

Damaged Chord Truss

Contact a qualified professional.

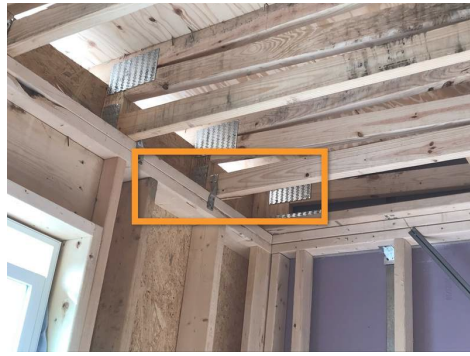
Damaged Chord Truss In Master Bedroom

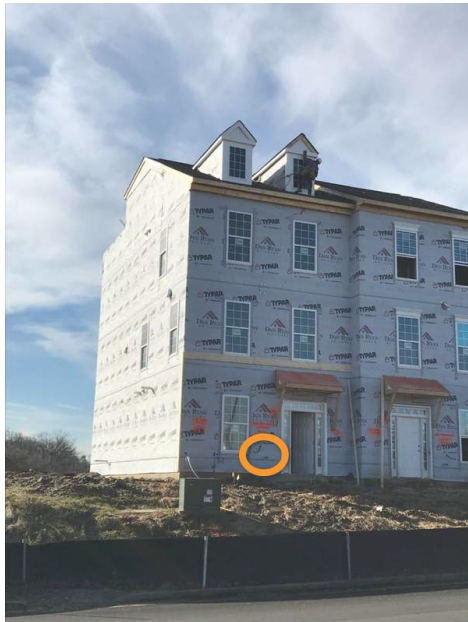
The front hose bib was loose at the time of the inspection. Recommend securing the front exterior hose bib.

Front Hose Bib Loose

Contact a qualified professional.

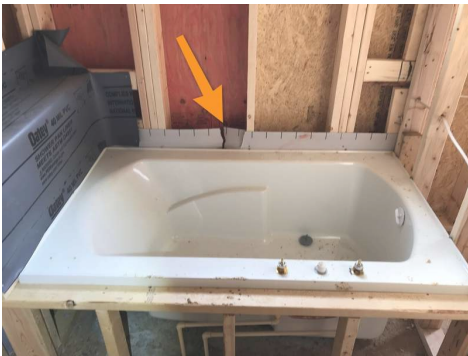
The draft Stop board behind the master bathroom tub was damaged at the time of inspection. Recommend repair or replacement by a qualified professional.

Damaged "Draft-Stop" Rigid Board

Contact a qualified professional.

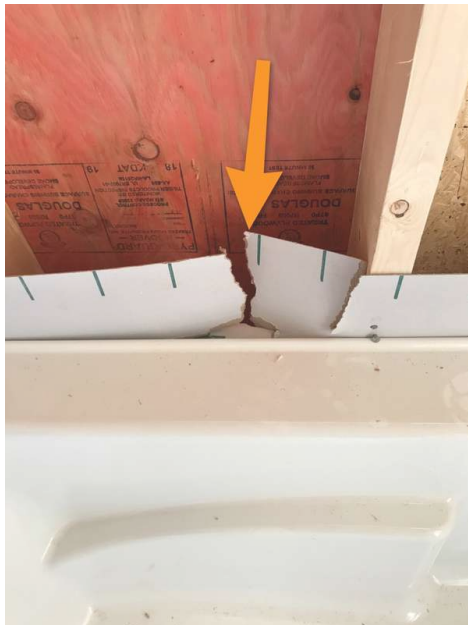
Damaged Draft Stop Board

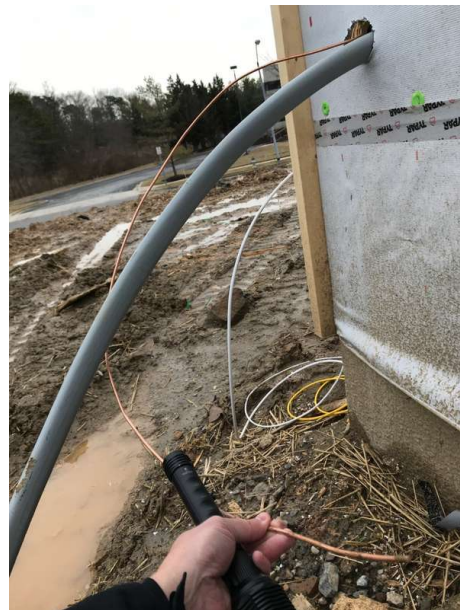
Copper Ground Wire Present, Not Yet Connected To Grounding Rod

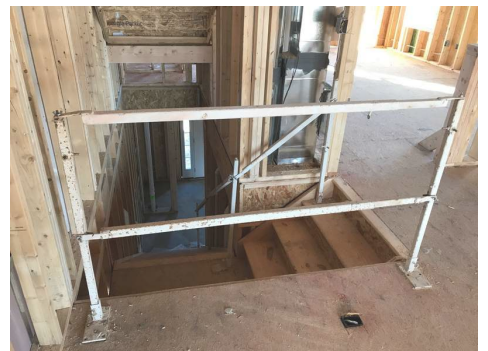
Temporary railings were in place at the time of inspection.

Temporary Railings In Place

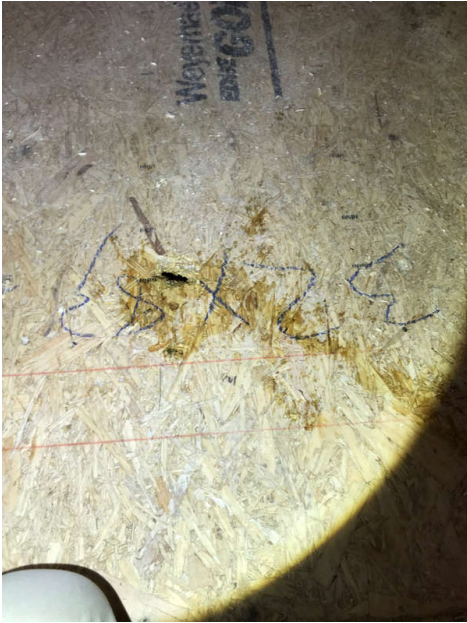
Fourth Floor

Two holes were observed in the OSB subflooring on the fourth floor. Recommend repair by a qualified professional.

Contact a qualified professional.
