RESIDENTIAL HOME INSPECTION

1234 Main St.
Wellington 6022

Inspector
Adam Collins
NZQA carpentry level 4, LBP-132631
+64 210372132
inquest.kiwi@gmail.com

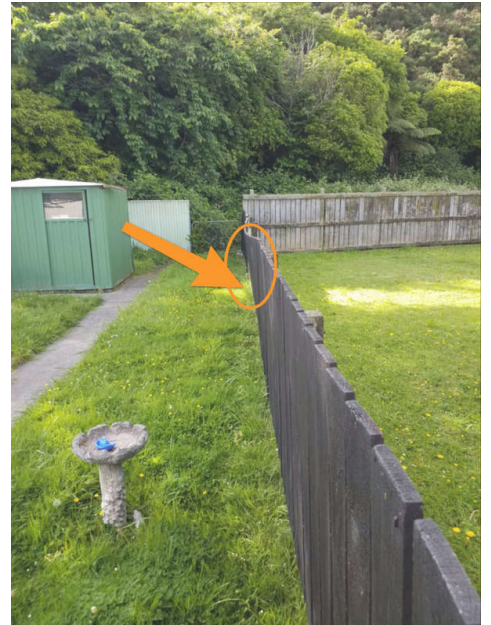
2.1.1 Fencing

FENCING - BROKEN POST

Recommendation

Contact a qualified handyman.

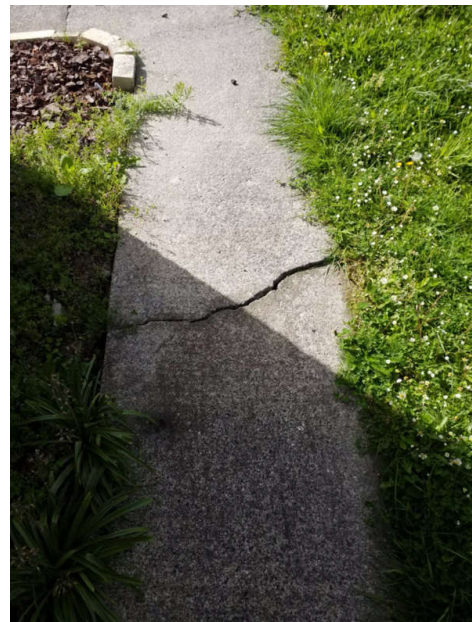
2.2.1 Paths

PATH CRACKING - MINOR

Normal settling & cracking observed. Recommend monitor and/or patch/seal.

Recommended DIY Project

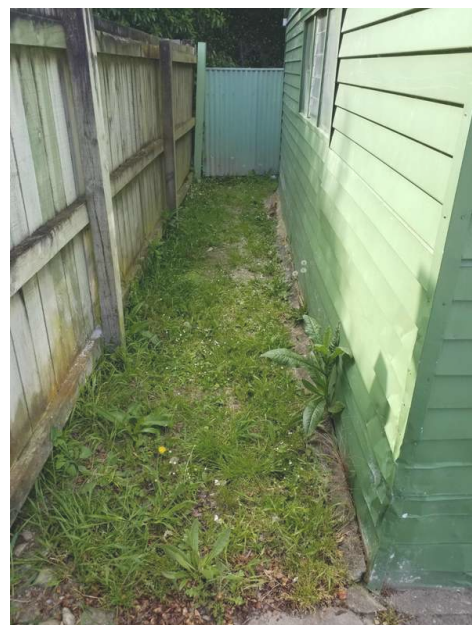
2.3.1 Contour grading

PONDING WATER

Standing water observed, which could indicate poor drainage and/or grading. Recommend monitor and/or have landscaper correct.

Contact a qualified landscaper or gardener.

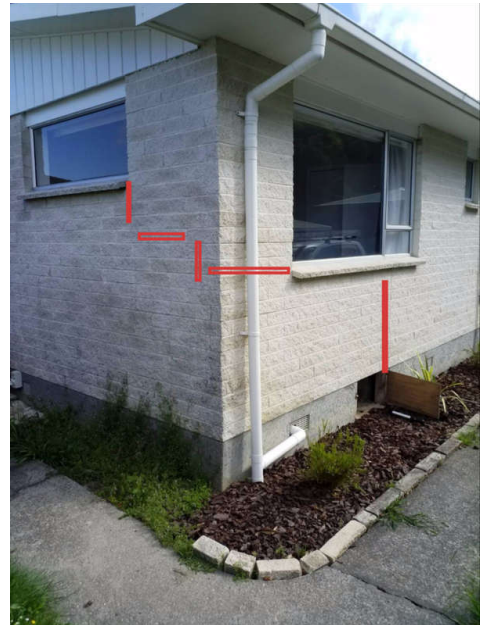
3.2.1 Structural Masonry

STRUCTURAL MASONRY - MAJOR DEFECT

Our inspector has found what we would consider major Issues, we recommend you seek advice from a professional specific to this type of construction or obtain a structural engineers report

Contact a qualified structural engineer.

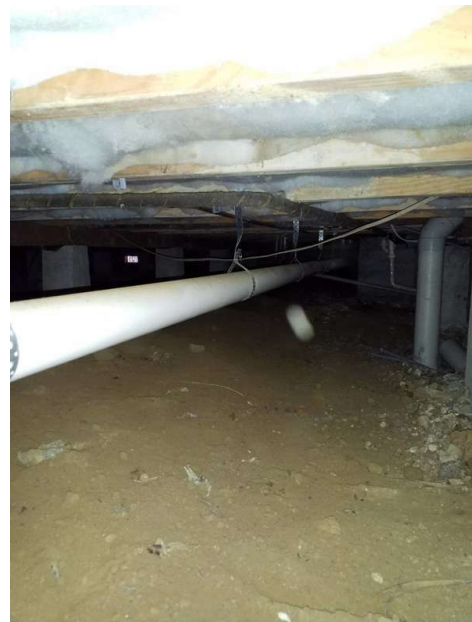
5.1.2 Subfloor Space

ELECTRICAL - SUPPORT

Loose or hanging cables can be a safety hazard especially if they come into contact with the ground.

We recommend these cables be properly secured and checked for fault or redundancy by a registered electrician.

Contact a qualified electrical contractor.

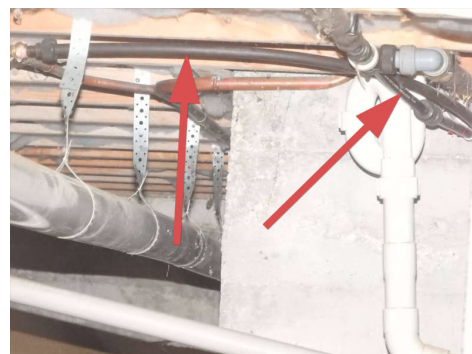
5.1.3 Subfloor Space

PLUMBING - DUX QUEST

Often insurance companies won't cover damage done by Dux Quest piping, especially if it has leaked before.

Contact a qualified plumbing contractor.

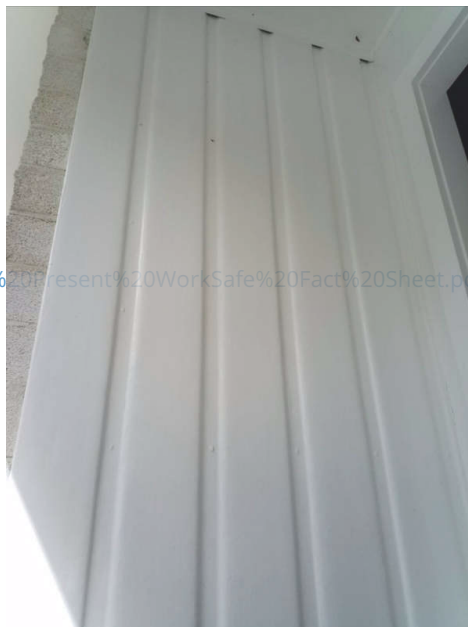
7.2.1 Fibre cement sheet product

Please note that should you want this altered or replaced, there would be an increased cost for removal and disposal of any product containing asbestos.

Contact a qualified professional.

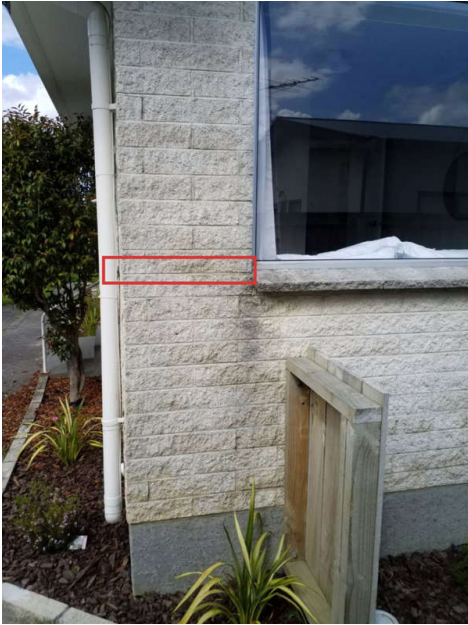
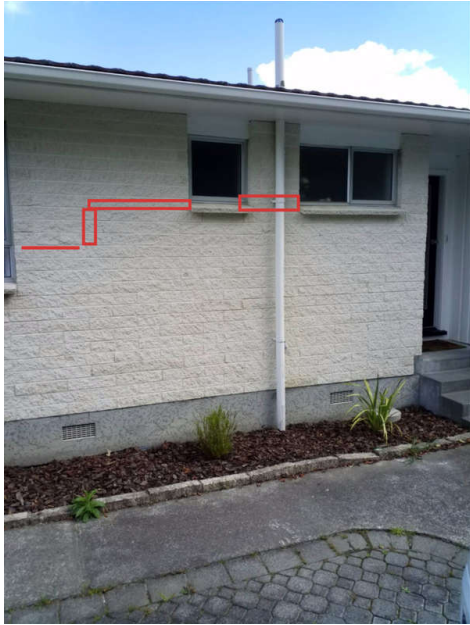
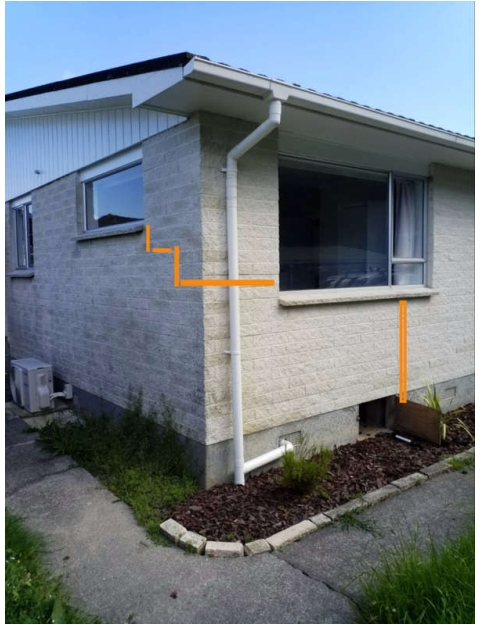
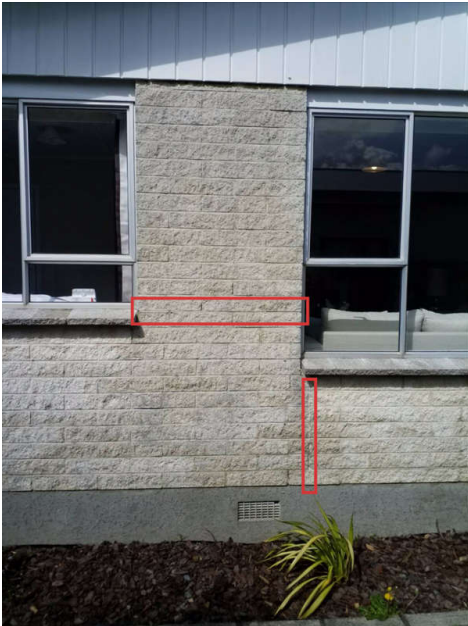
7.3.1 Brick veneer

CRACKING

Cracked, missing, loose Masonry

Maintenance or repair required in this area

Contact a qualified masonry professional.

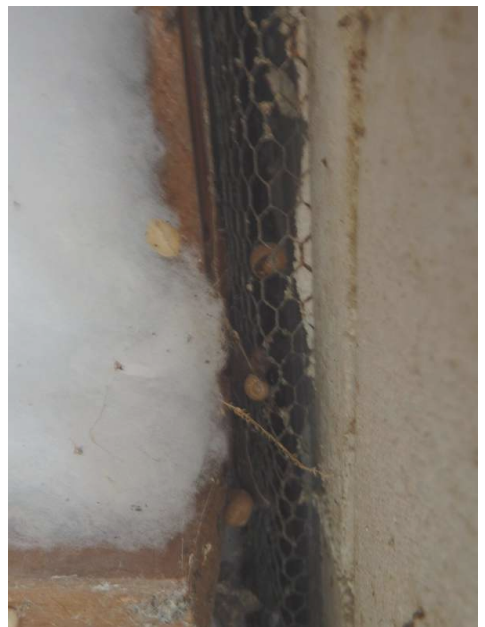
7.3.2 Brick veneer

VENTILATION/WEEP HOLES

This cladding system is not using weep holes to ventilate the cavity. The cavity system here is relying on ventilation from the subfloor, this encourages warm moist air from the underfloor to circulate the internal wall cavity thus creating a good growing environment for mould. This is considered bad building practice and should be rectified should works be carried out in this area.

Contact a qualified general contractor.

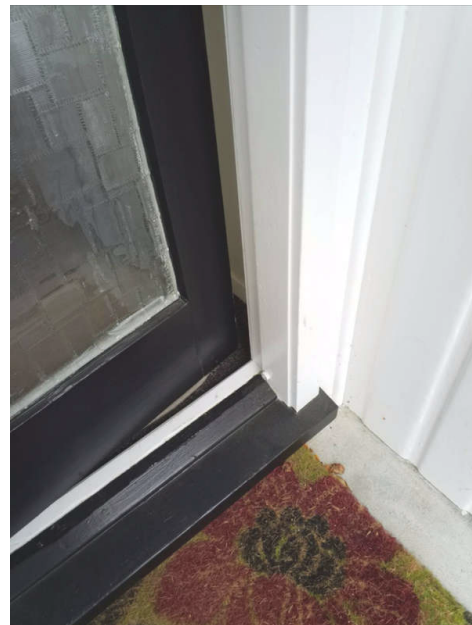
This door is missing its clashing strip at the bottom, the back door has one. Maintenance or repair required in this area

Contact a qualified carpenter.

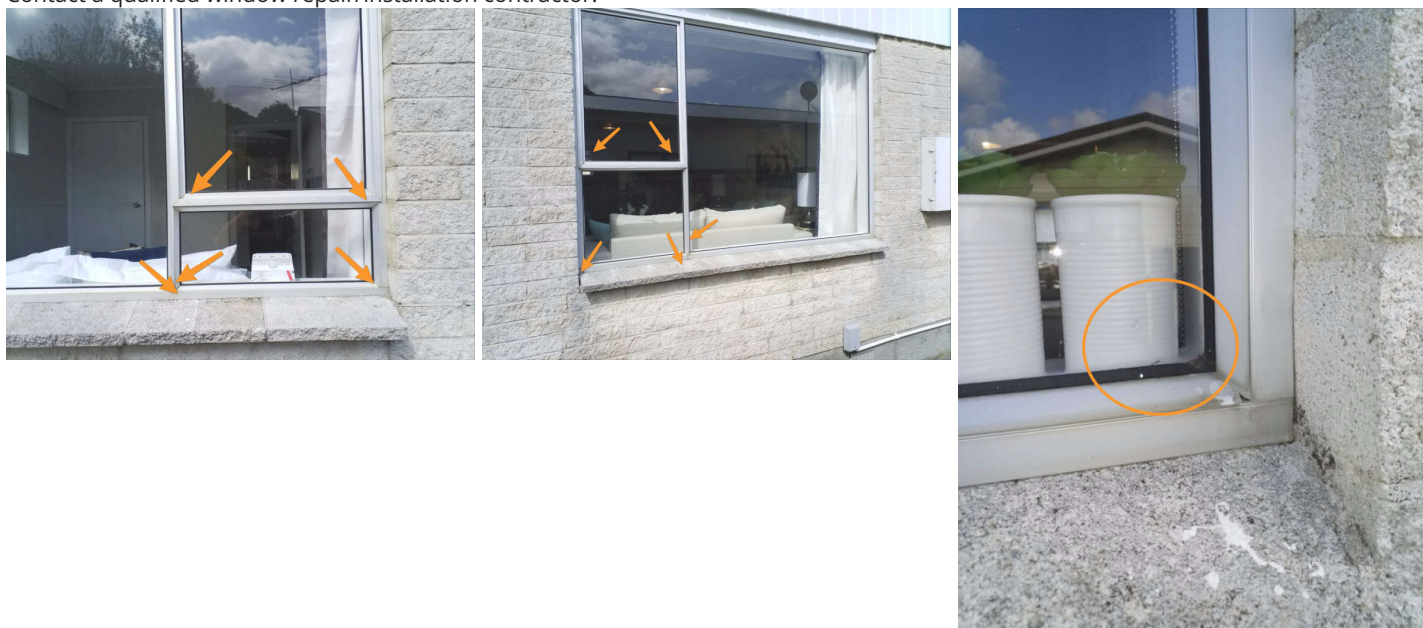
Its a common issue with older aluminium joinery, UV light causes shrinkage to the glazing seals exposing gaps typically in the corners of any glazed section.

We recommend replacement of the seals in this area.

Contact a qualified window repair/installation contractor.

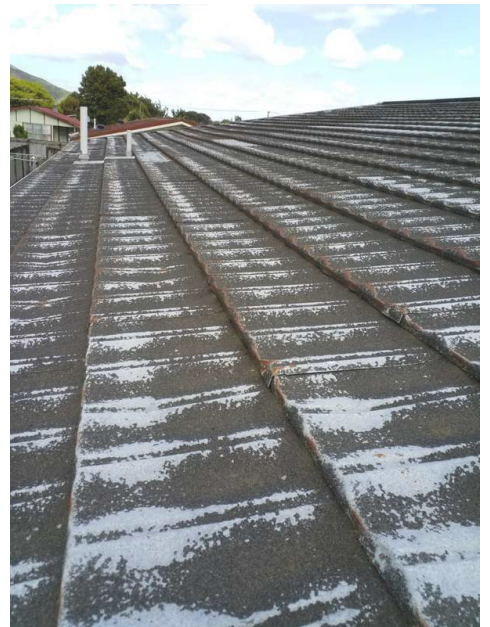
10.2.1 Material - Pressed metal tiles

CORROSION

We have found rust in this area.

Maintenance or repair required in this area.

Contact a qualified roofing professional.

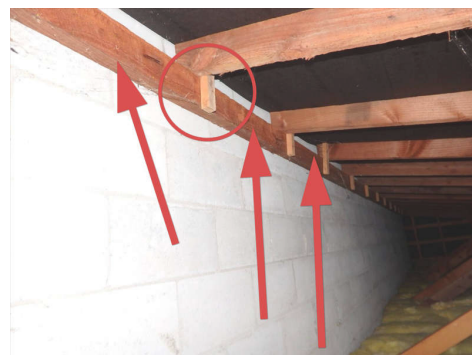
12.2.1 Roofing framing & connections

CONNECTION, INADEQUATE

We strongly recommend this plate to be bolted and proper tie connections to be installed.

Contact a qualified carpenter.

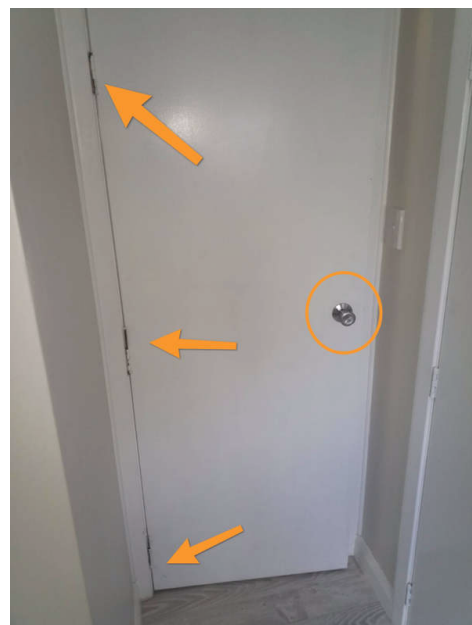
DEFECTIVE HARDWARE

Broken or defective hardware, (hinges, stays, latches, rollers, locks, handles etc.)

Maintenance or repair required in this area

Contact a qualified handyman.
