## TREC RESIDENTIAL

1234 Main St.  
Melissa TX 75454

# PROPERTY INSPECTION REPORT

**By:** Chris Scanland - Professional Inspector TREC# 23176      04/19/2019 9:00AM  
(Name and License Number of Inspector)      (Date)

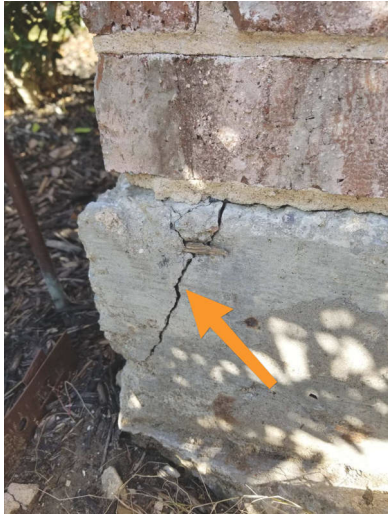
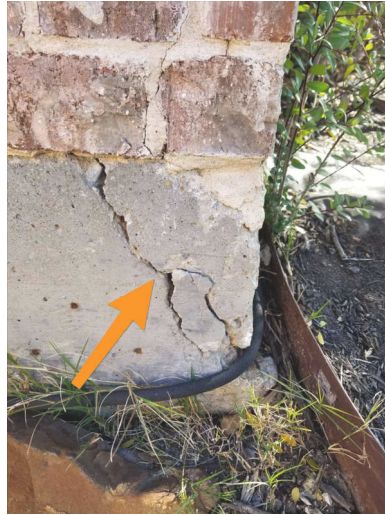
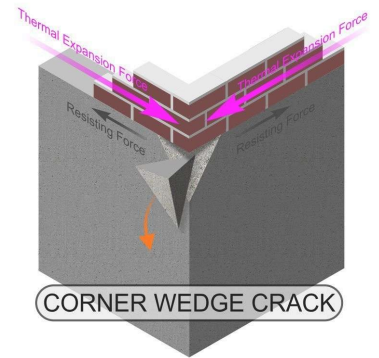
### 1: Corner Wedge Crack

One or more corners of the foundation had cracking and/or damage. This is cosmetic in nature, common and does not effect the overall integrity of the foundation. However, the Inspector recommends having corner wedge cracks repaired to prevent damage to the brick siding that rests directly above the corner of the foundation.

Recommendation: Contact a qualified masonry professional.

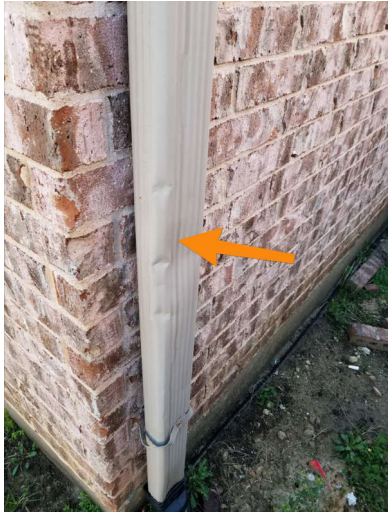
Southwest

### 1: Damaged Gutter/Drain

General gutter/drain damage noted in one or more locations. Recommend repair to ensure proper water drainage.

Recommendation: Contact a qualified gutter contractor

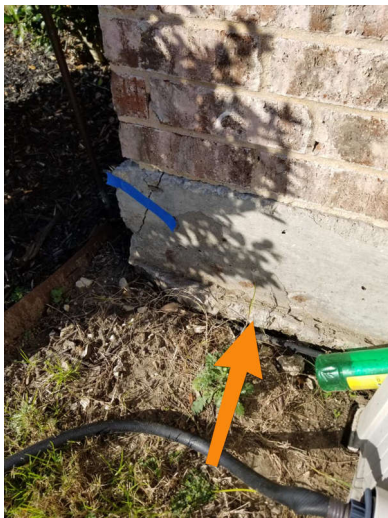
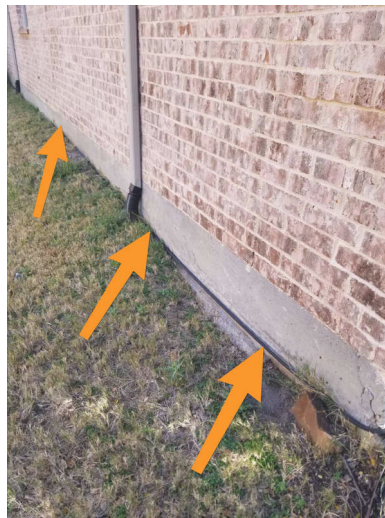
### 2: Improper Soil Level

At the time of inspection, there was an improper amount of soil around one or more areas of the foundation. The Inspector recommends allowing 4-6 inches of foundation to be visible above the grading. Too much soil may allow water intrusion into the structure. Too little soil can result in erosion under the foundation and lead to foundation issues.

Recommendation: Contact a qualified landscaping contractor

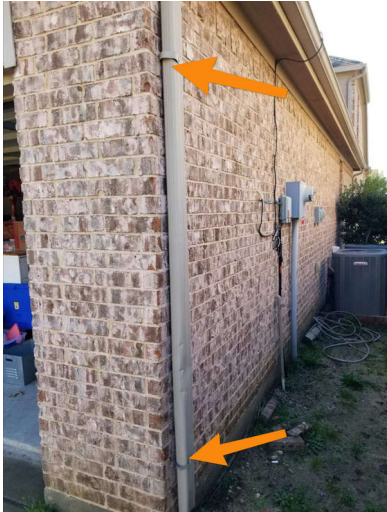
Southwest

### 3: Loose Gutters

The gutters were loose/not properly secured in on or more locations.

Recommendation: Contact a qualified gutter contractor

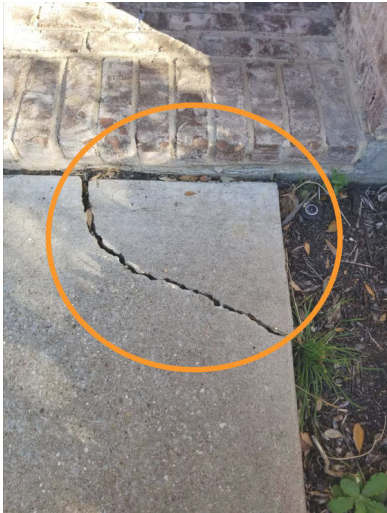
Front Porch

**4: Sidewalk Settling**

Sidewalk settling noted near the front porch. This is a trip hazard and should be repaired. It's likely caused by the absence of rebar in this location from when the sidewalk was originally poured.

Recommendation: Contact a qualified professional.

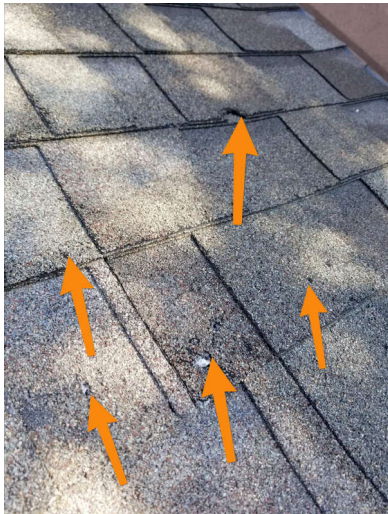
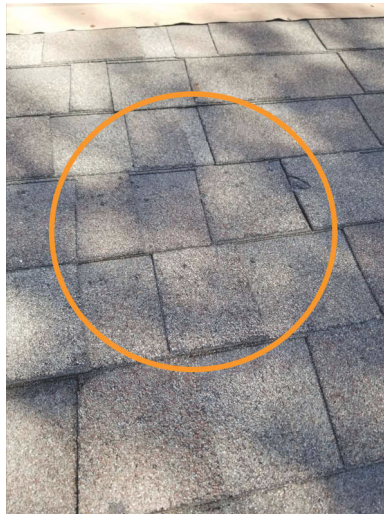
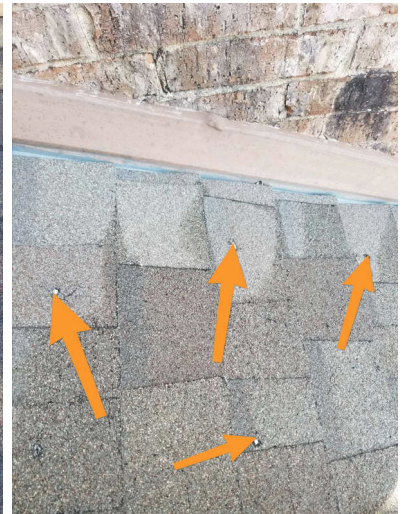
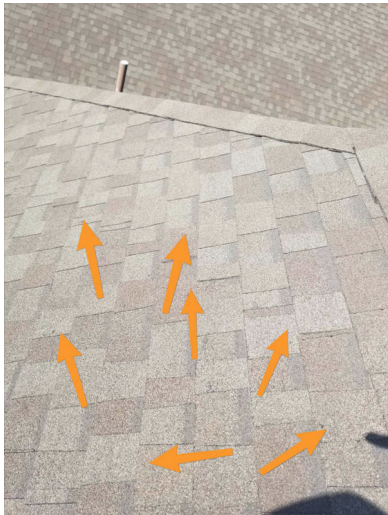
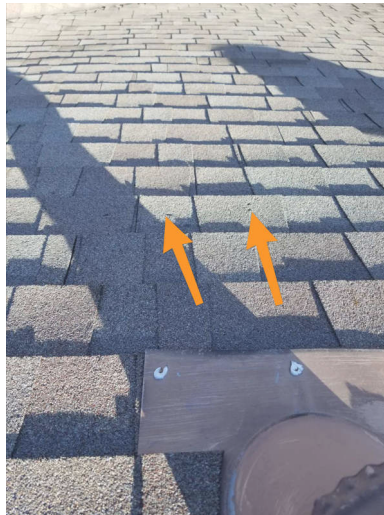
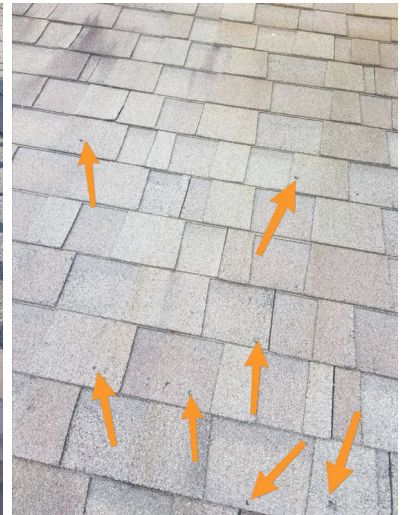
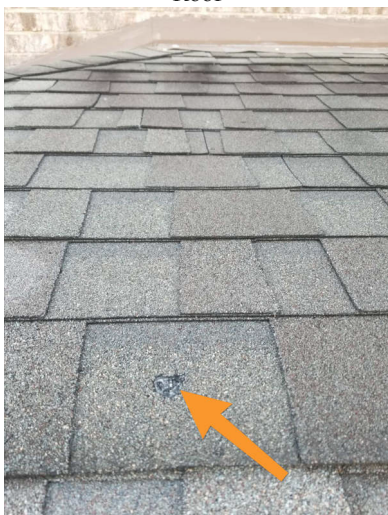
**1: Damaged Coverings**

Roof coverings exhibited general damage that could affect performance. This damage is likely hail damage. Multiple homes in this area were affected by hail within the past year.

Recommendation: Contact a qualified roofing professional.

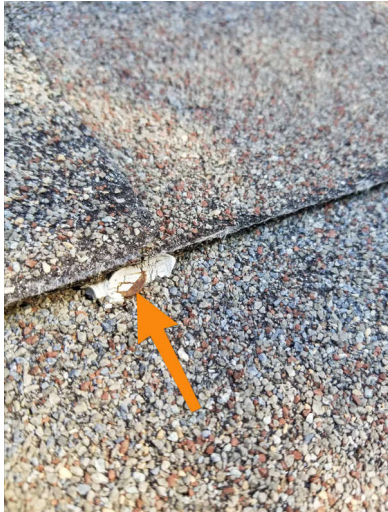
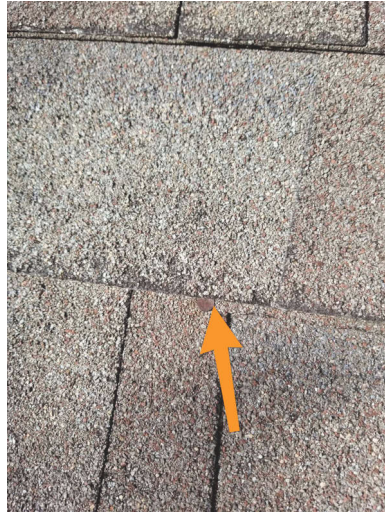
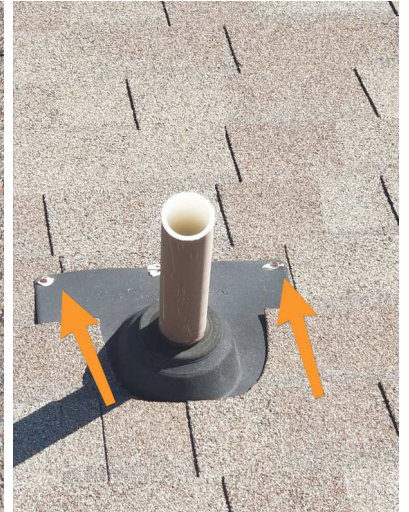
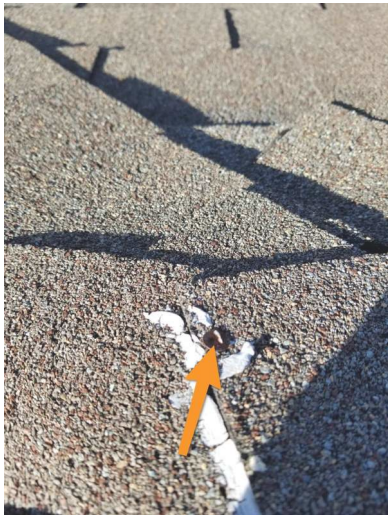
**2: Exposed Nails**

Under-driven or exposed nails/screws were found in one or more roof coverings, which may result in water intrusion in these areas.

Recommendation: Contact a qualified roofing professional.

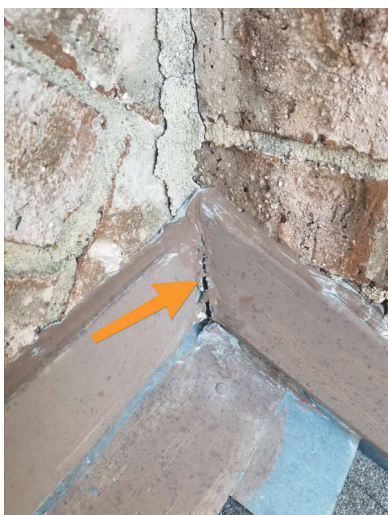
East Roof

In several locations, caulking/sealant on flashing is in need of replacement. One example is shown above.

Recommendation: Contact a qualified roofing professional.

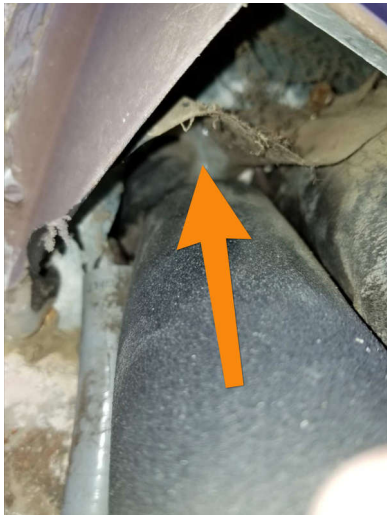
AC Lines South Exterior

Exterior wall had gaps/holes that should be sealed with an appropriate sealant to prevent moisture/pest entry.

Recommendation: Contact a qualified handyman.

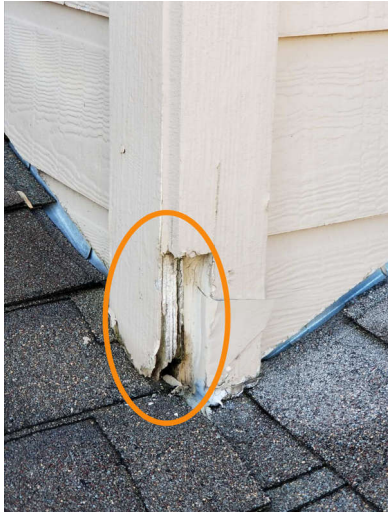
West Roof

**2: Rot in Trim Boards**

In one or more locations, a trim board showed evidence of rot and is in need of repair/replacement. If not repaired, rotting trim/siding boards can spread rot to the structural wood framing behind it.

Recommendation: Contact a qualified carpenter.

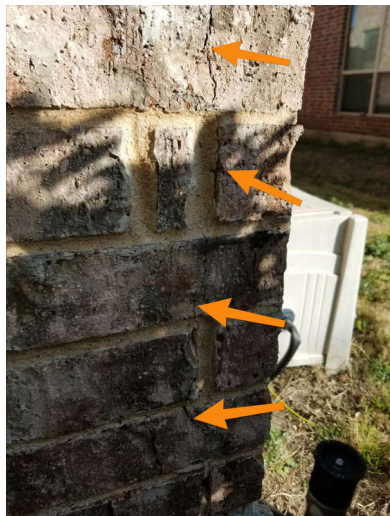
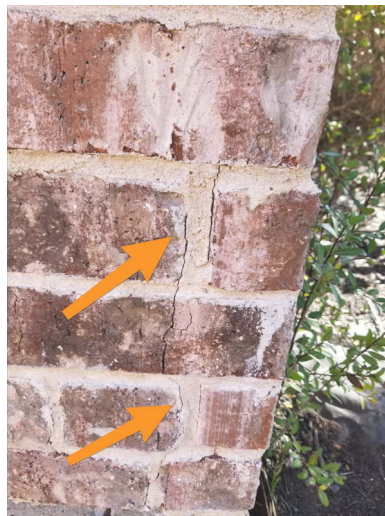
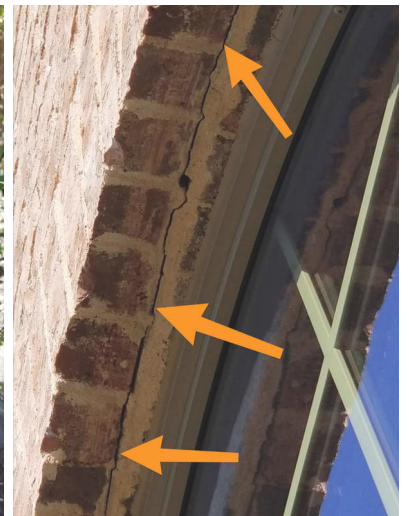
**3: Cracks in Brick/Mortar-Minor**

At time of inspection, there were one or more minor cracks in the brick and mortar siding. These appear to be mostly cosmetic in nature, however, should be repaired to prevent moisture intrusion and further damage.

Recommendation: Contact a qualified masonry professional.

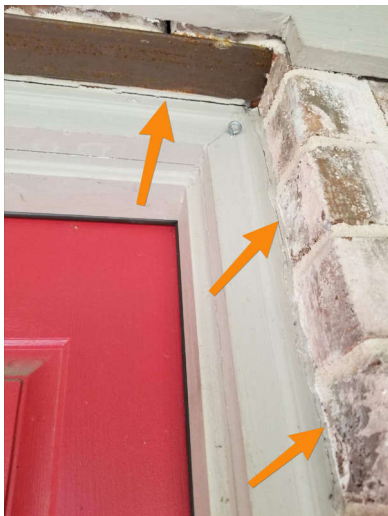
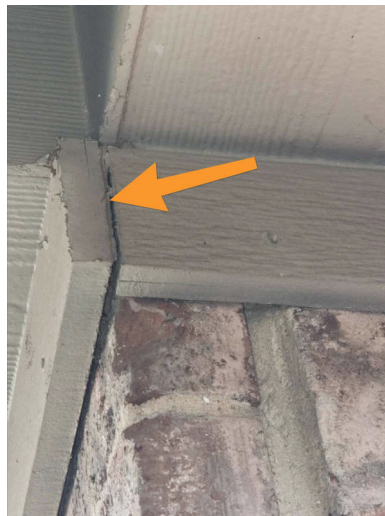
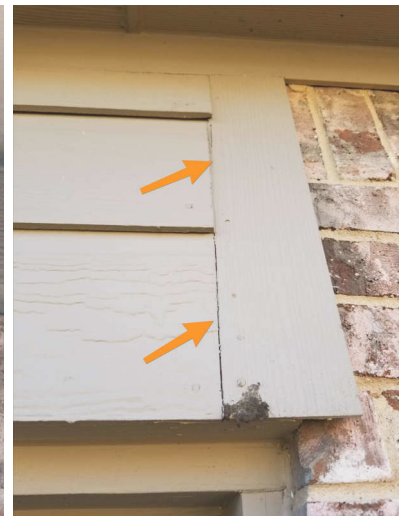
One or more locations need caulking replaced around trim/molding to prevent moisture intrusion and rot to the trim/molding and/or underlying framing. Some examples are shown above.

Recommendation: Contact a handyman or DIY project

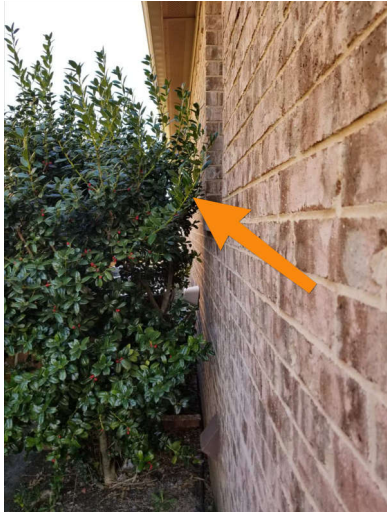
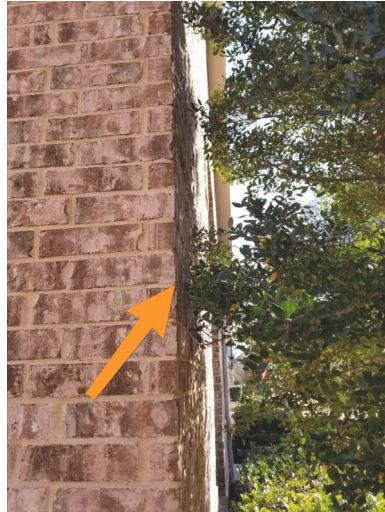
Trees/shrubs in contact with exterior structure. Recommend trimming shrubs/trees away from structure to help prevent mechanical, moisture and pest damage to the structure.

Recommendation: Contact a qualified lawn care professional.

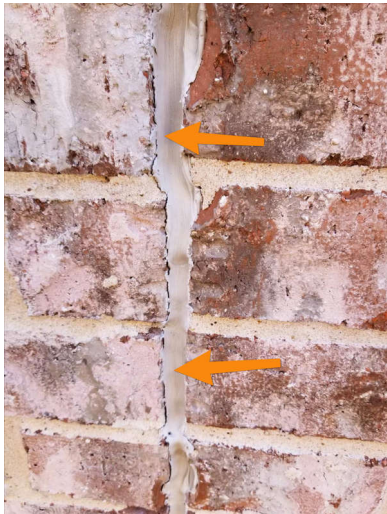
South

In all locations, the brick siding expansion joint caulking is deficient and in need of repair/replacement.

Recommendation: Contact a qualified handyman.

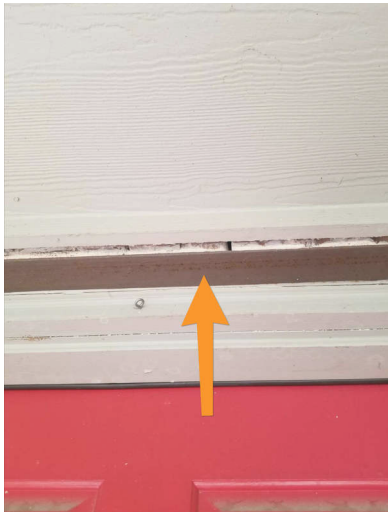
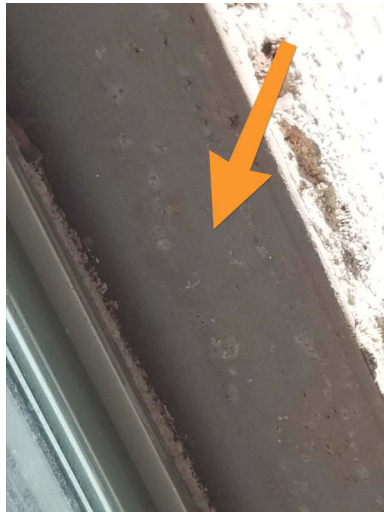
### 7: Rusted Lintel

One or more lintels are rusting and need to have the rust removed and then painted to prevent future damage. Rusting lintels can cause damage to the surrounding brick/stone. Once corrosion begins, rust is produced, which occupies up to six times the original volume of the steel. The expansion of volume leads to cracking of masonry. A couple of examples are shown above.

Recommendation: Contact a qualified painting contractor.

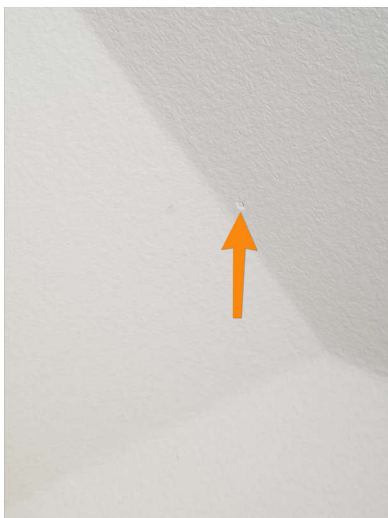
2nd Floor Southwest Bedroom

One or more nail pops observed throughout the home. Nail pops are common and usually cosmetic in nature. One example is shown above. Here's a helpful DIY article on how to repair them: [Nail Pop Repair](#).

Recommendation: Contact a handyman or DIY project

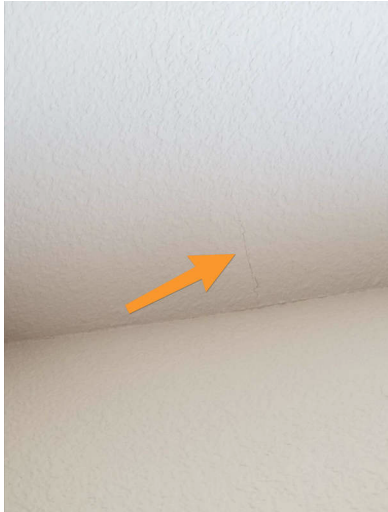
Dining Room

**2: Interior Cracks - Minor**

Minor cracking was observed in the drywall throughout the home. They're usually caused by normal contracting and expanding wood framing and/or minor settlement. They're cosmetic in nature. An example or two is shown above.

Recommendation: Contact a handyman or DIY project

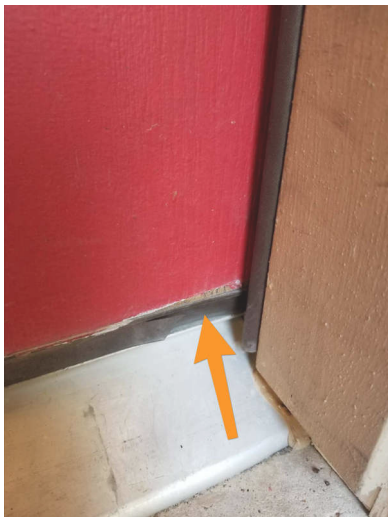
Front Door

One or more doors had deficient weatherstripping and/or door sweeps. This can result in energy loss and/or moisture/pest intrusion.

Recommendation: Contact a handyman or DIY project

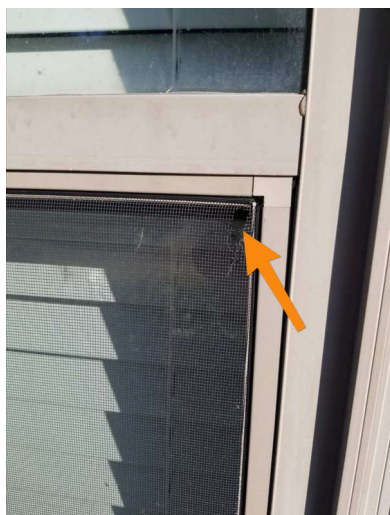
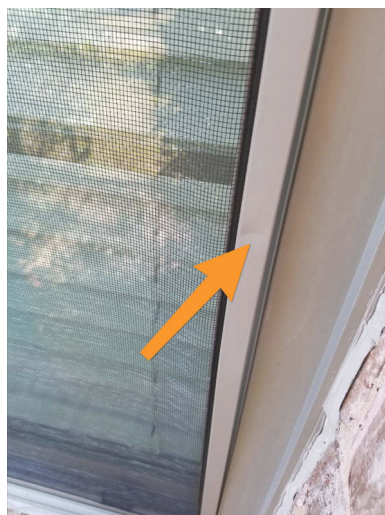
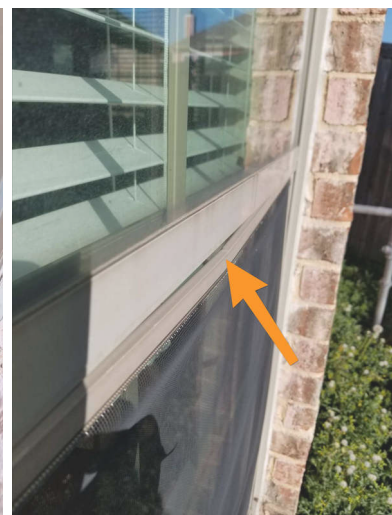
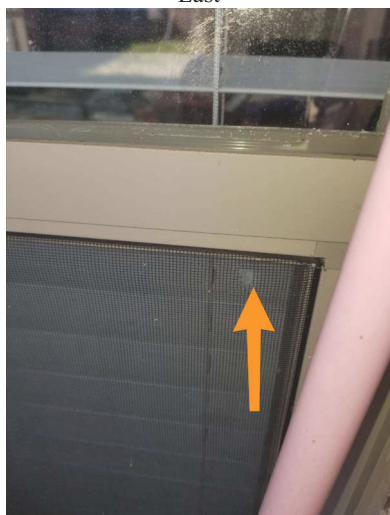
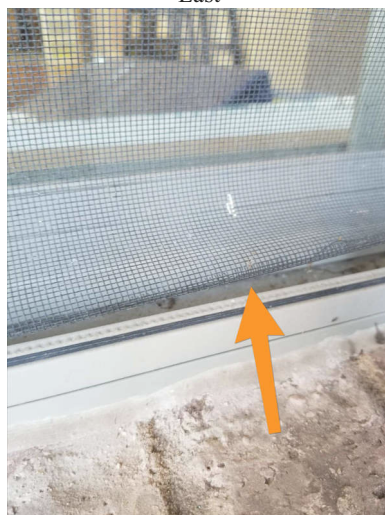
**1: Damaged Window Screen**

One or more window screens were damaged at the time of inspection.

Recommendation: Contact a qualified window repair/installation contractor.

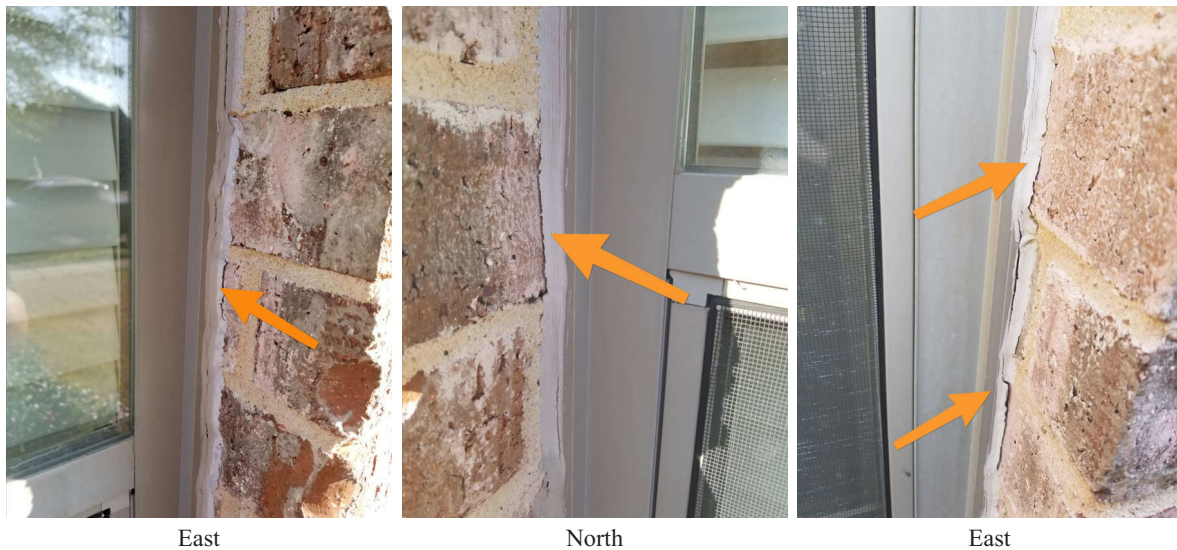
## 2: Caulking

One or more windows need caulking to prevent moisture intrusion. This applies to both the interior and exterior. A couple of examples are shown above. The Inspector recommends checking all windows and caulking them where needed.

Recommendation: Contact a qualified handyman.

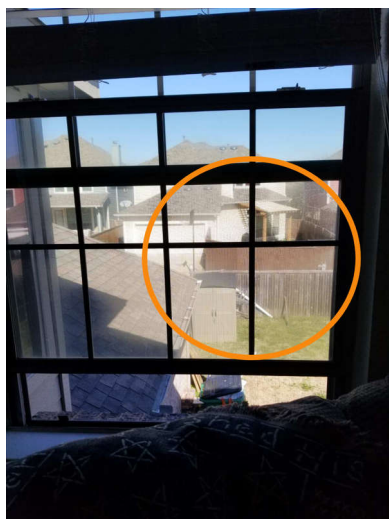
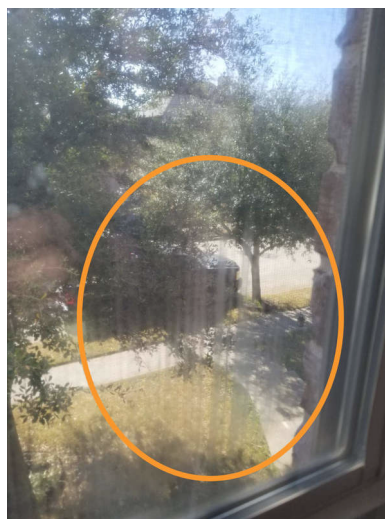
**3: Failed Seal**

Observed condensation and/or discoloration between the window panes, which indicates a failed seal. Recommend qualified window contractor evaluate & replace.

Recommendation: Contact a qualified window repair/installation contractor.

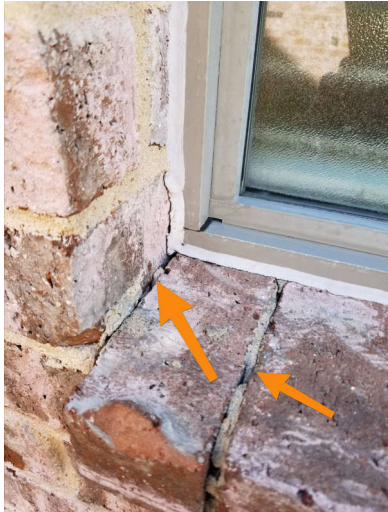
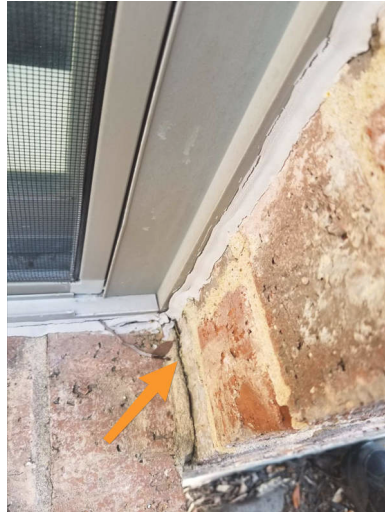
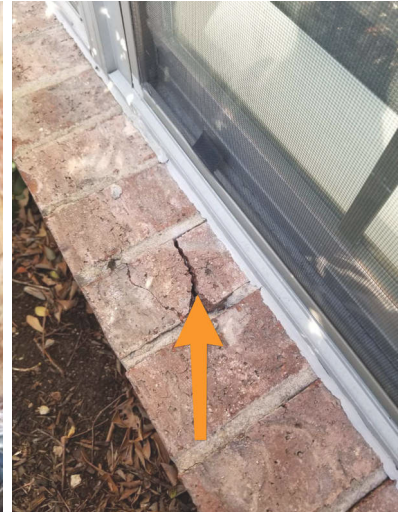
**4: Window Sill Mortar**

One or more brick window sills have cracked bricks and/or mortar. Cracks in brick window sills are very common. If they are not repaired they may result in moisture intrusion which can lead to structural damage.

Recommendation: Contact a qualified masonry professional.

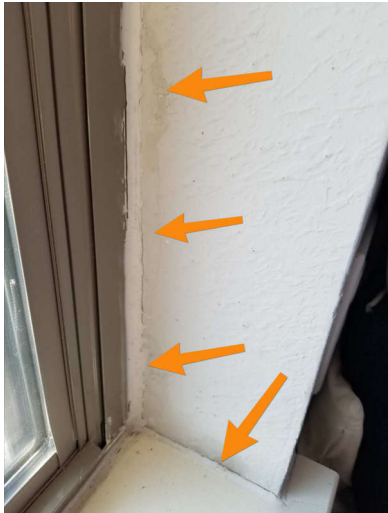
2nd Floor Northeast Bedroom

**5: Moisture Intrusion**

At the time of inspection, there was evidence of moisture intrusion around one or more windows. If not corrected, moisture intrusion can lead to mold growth and extensive repairs in sheet rock and window frames.

Recommendation: Contact a qualified window repair/installation contractor.

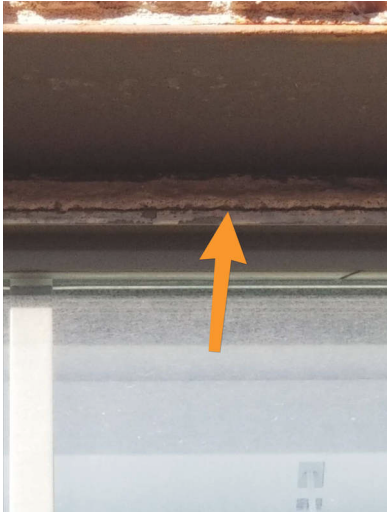
North

**6: Cracked Mortar**

Mortar is cracked on top of multiple windows. This is very common in homes this age. These cracks should be repaired to prevent moisture intrusion and further damage. One example is shown above.

Recommendation: Contact a qualified professional.

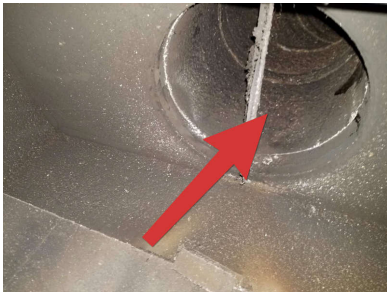
Fireplace

The chimney had a layer of creosote, so underlying structure couldn't be inspected for cracks. A buildup of creosote is a fire hazard. The chimney should be cleaned prior to using the fireplace.

Recommendation: Contact a qualified chimney sweep.

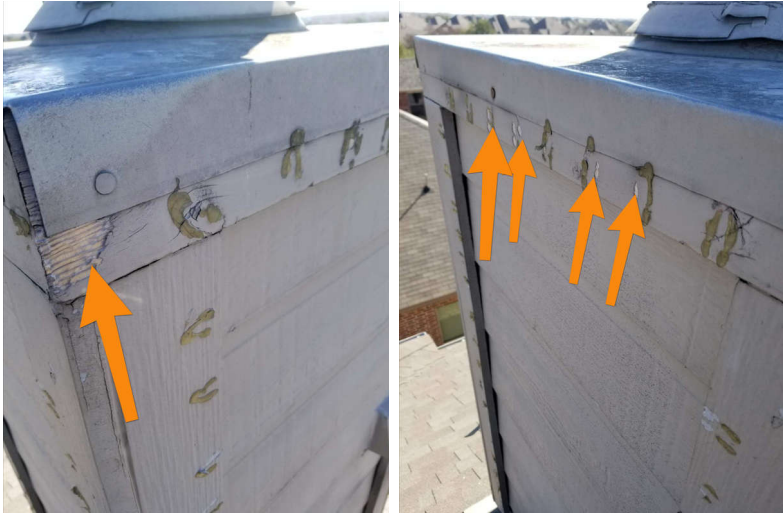
**2: Chimney Damage**

General deterioration noted on chimney in several locations. Some of this may be from hail and some from normal wear. Noted further in the report, there were indications of leaks in the attic coming from around the chimney.

Recommendation: Contact a qualified chimney contractor.

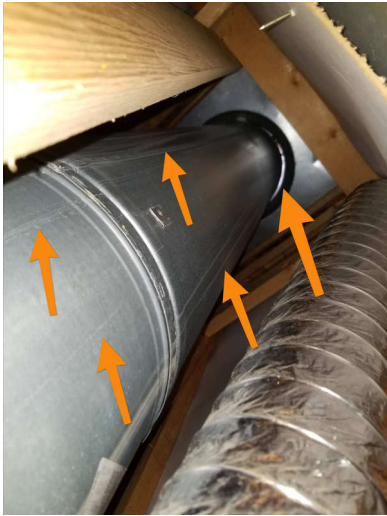
Attic

**3: Leak At Chimney**

There was evidence of water intrusion coming from the top of the chimney pipe in the attic where the pipe penetrates the roof. It appeared as though the water had run down the pipe and into the fireplace area. Once all rooftop repairs are made to the chimney, flashing around the chimney and the shingles, the problem will likely be resolved but should be monitored for any more leakage.

Recommendation: Contact a qualified professional.

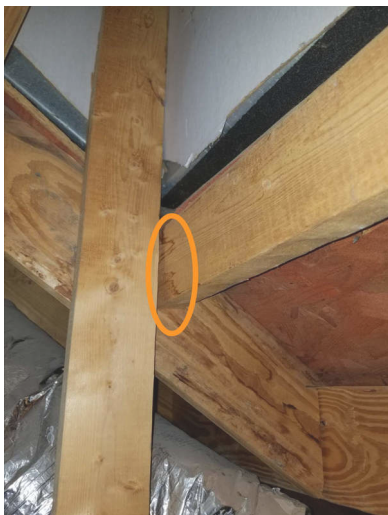
Attic

**4: Flashing Leak**

Water intrusion was also noted in the attic around the chimney flashing area. This leak is likely coming from defective rooftop flashing around the base of the chimney.

Recommendation: Contact a qualified roofing professional.

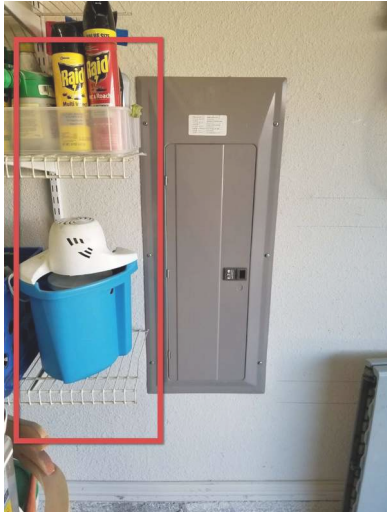
Garage

### 1: Electrical Panel- Inadequate Clearance

Recommendation: Contact a handyman or DIY project

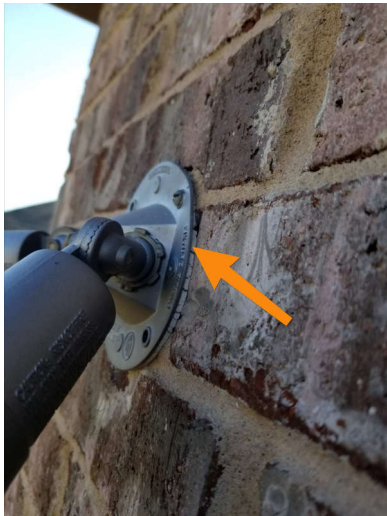
Beside Garage

One or more exterior lights need to be sealed with caulk to prevent moisture intrusion.

Recommendation: Contact a handyman or DIY project

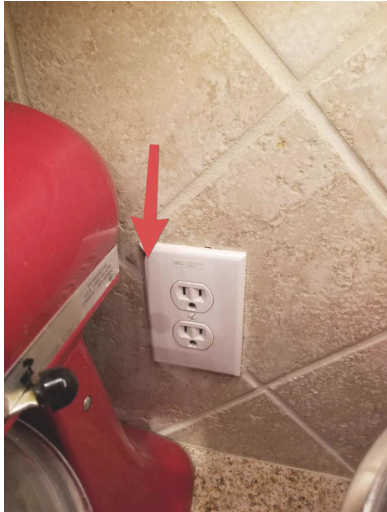
Kitchen

**2: Cover Plates Damaged**

One or more electrical receptacle/switch cover plates were damaged and in need of replacement. This is a potential shock/electrocution hazard.

Recommendation: Contact a qualified electrical contractor.

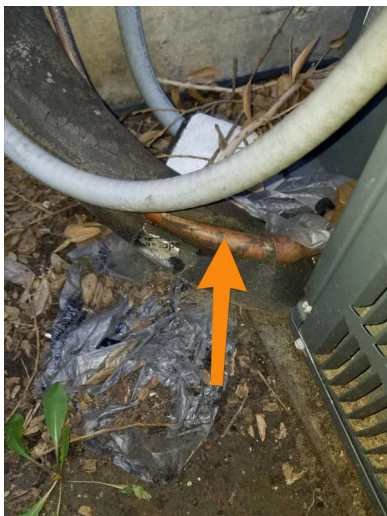
South

Missing or damaged insulation on refrigerant line can cause energy loss and condensation. Recommend installing/replacing insulation.

Recommendation: Contact a handyman or DIY project

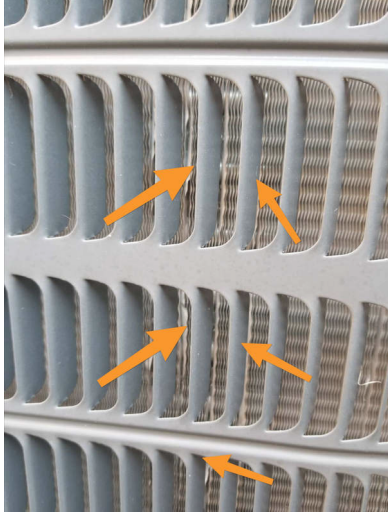
South

**2: Condenser Fin Damage**

At time of inspection, there was minor damage to some of the condenser fins.

Recommendation: Contact a qualified heating and cooling contractor

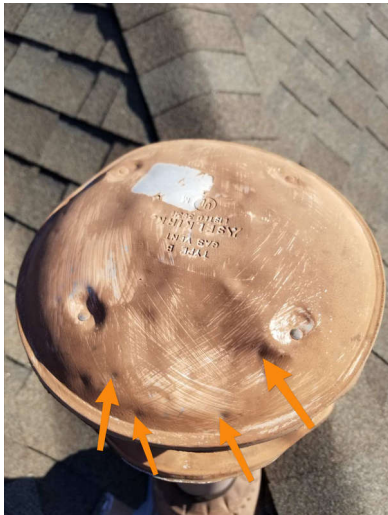
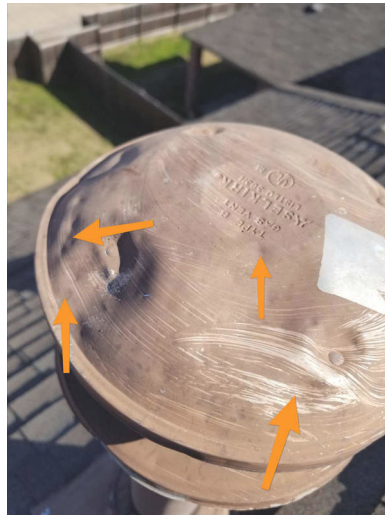
**1: Hail Damage**

Several vents on the roof had evidence of minor hail damage.

Recommendation: Contact a qualified roofing professional.

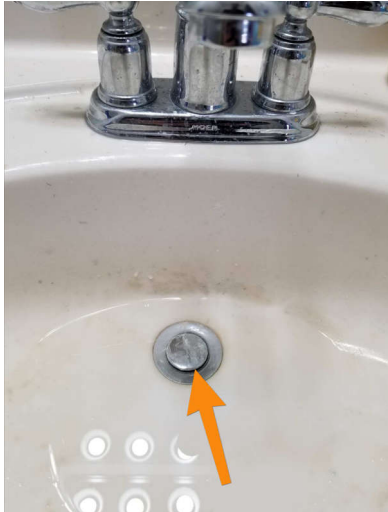
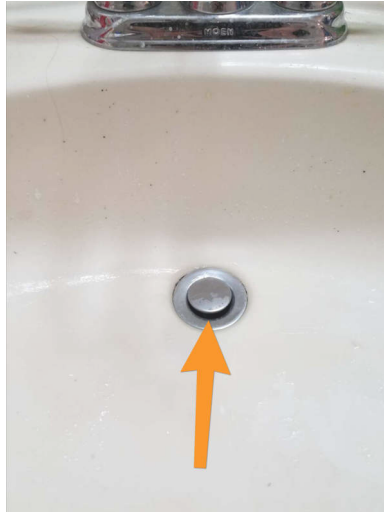
**1: Sink Stopper Leaked**

One or more sink stoppers leaked, not allowing the sink to hold water.

Recommendation: Contact a handyman or DIY project

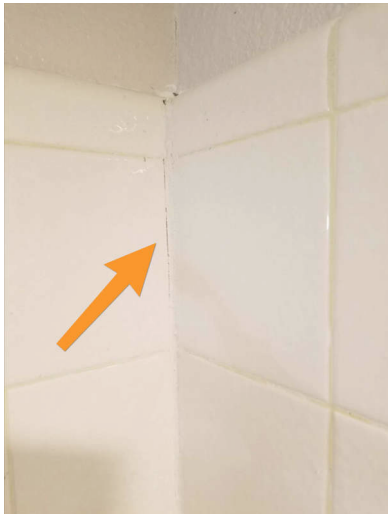
2nd Floor North Bathroom

**2: Shower Grout- Cracked/Missing**

In one or more locations a shower had cracked and/or missing tile grout. Recommend repairing grout to prevent moisture intrusion behind the tiles.

Recommendation: Contact a handyman or DIY project

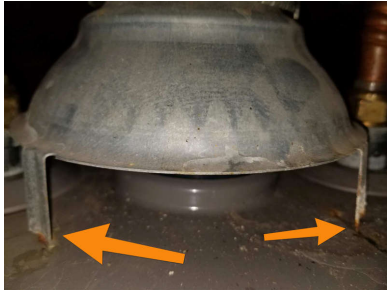
Attic

**1: Vent Loose**

South hot water heater vent is disconnected from top of hot water heater and was rattling due to the wind.

Recommendation: Contact a qualified plumbing contractor.

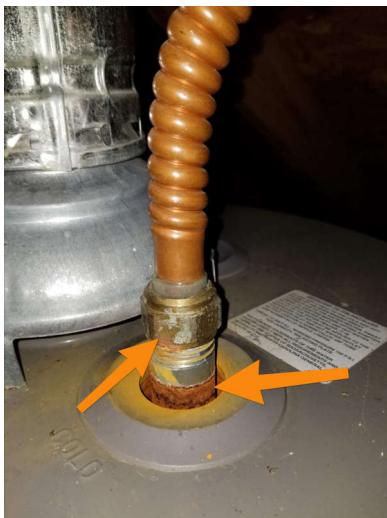
Attic

**2: Corroded Connection**

One or more water heater connections were corroded and need further evaluation to determine cause and remedy.

Recommendation: Contact a qualified plumbing contractor.

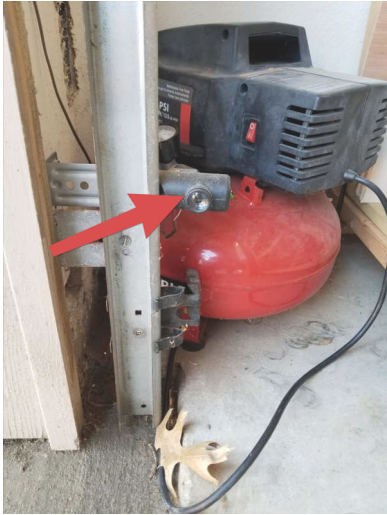
Garage door sensors were too high. Should be 6 inches from the garage floor to prevent children from being able to get under the sensors. Recommend moving sensors down to 6 inches above the garage floor.

Recommendation: Contact a handyman or DIY project
