## SAGE INSPECTORS REPORT

1234 Main St.  
Aztec NM 87410

Buyer Name  
04/15/2019 9:00AM

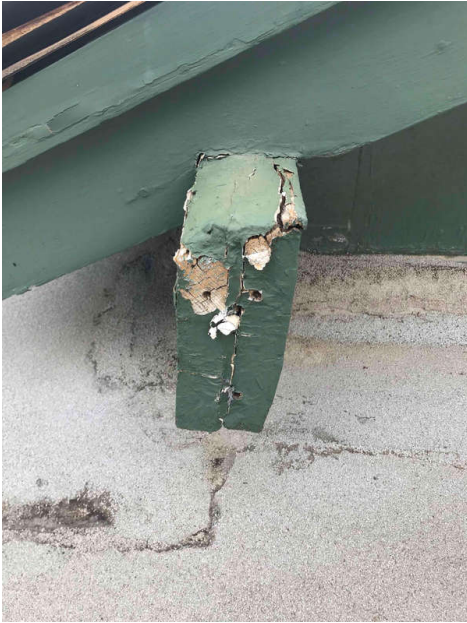
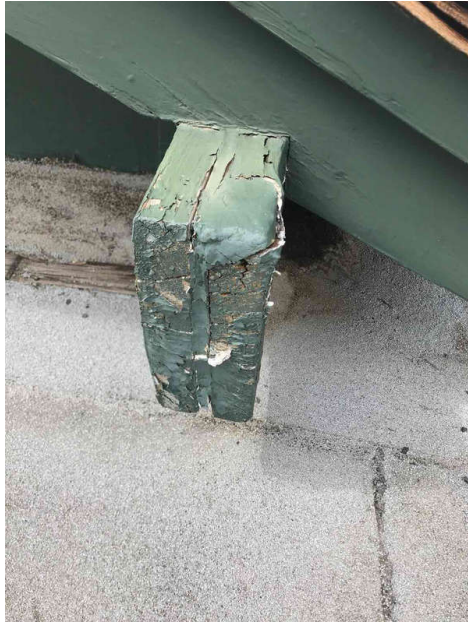
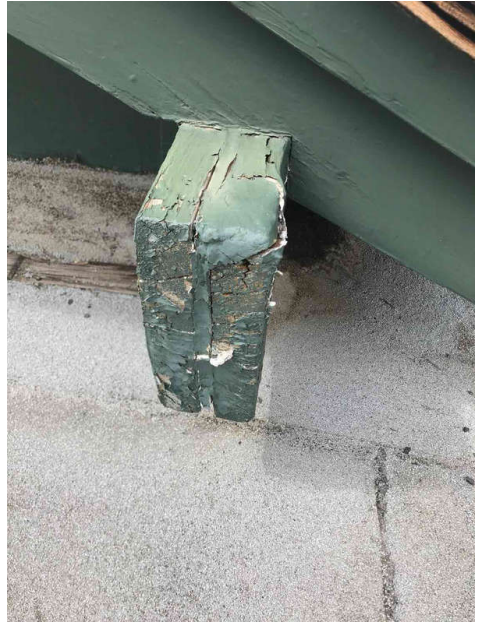
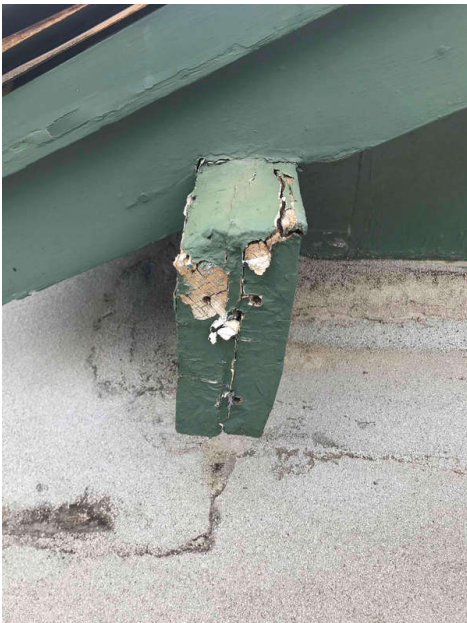
2.1.1 Roof Structure Exterior

**ROOF OVERHANG BEAM**

Roof overhang beam is rotting due to paint coming off. Recommend having a qualified roofer or contractor look at to repair.

Contact a qualified professional.

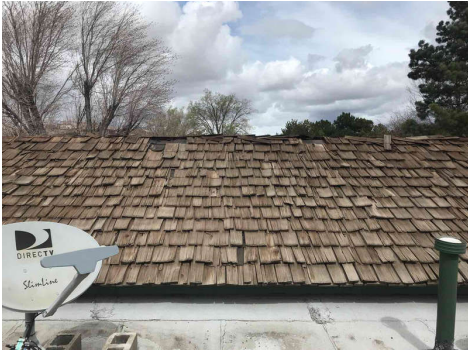
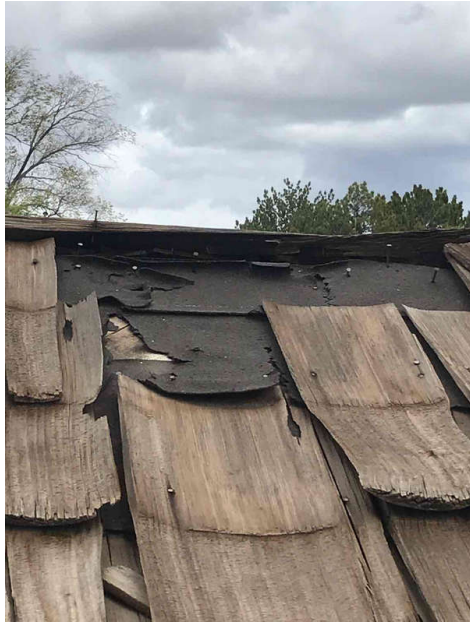
2.8.1 Asphalt Composition Shingle

**EXPOSED ROOF SHEATHING- QC**

Wind damage had exposed roof sheathing to weather. This damage should be repaired as soon as possible to help prevent damage from moisture intrusion to the home materials, the roof structure and to prevent development of microbial growth such as mold. All work should be performed by a qualified contractor

Contact a qualified professional.

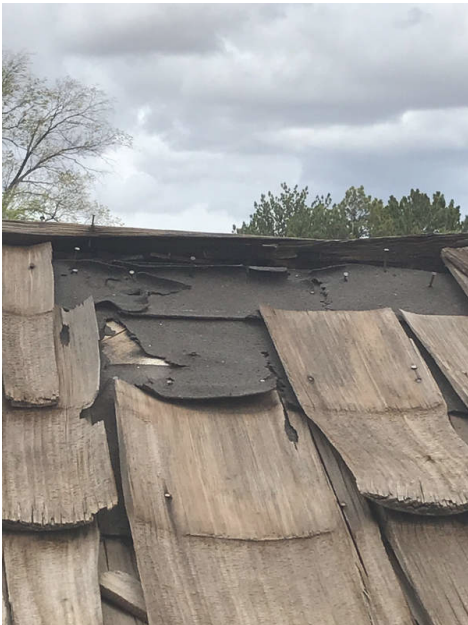
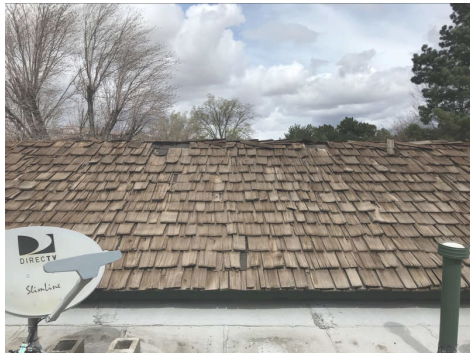
2.8.2 Asphalt Composition Shingle  
**LOOSE/MISSING SHINGLES- QC**

The roof had loose and/or missing shingles. The Inspector recommends replacement of any loose or missing shingles by a qualified roofing contractor to avoid damage from moisture intrusion.

Contact a qualified professional.

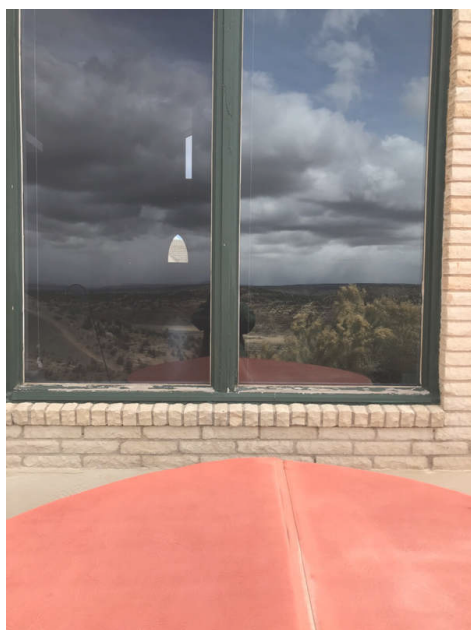
Southwest

#### PEELING PAINT, WOOD

The wood windows had peeling paint and needed maintenance at the time of the inspection. Windows appeared to have suffered some damage from sun and moisture. Wood windows eventually operate poorly if wood is left exposed to sun and moisture. Repair of long-term neglect can be expensive. The Inspector recommends maintenance be performed by a qualified contractor.

Contact a qualified window repair/installation contractor.

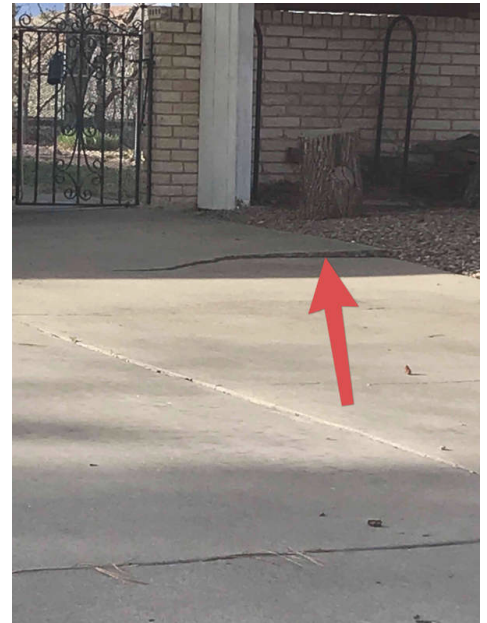
4.1.1 Driveway

**MODERATE HEAVING- QC**

Moderate heaving visible in the driveway at the time of the inspection has created trip hazards that should be corrected by a qualified contractor.

The large tree is causing this.

Contact a qualified professional.

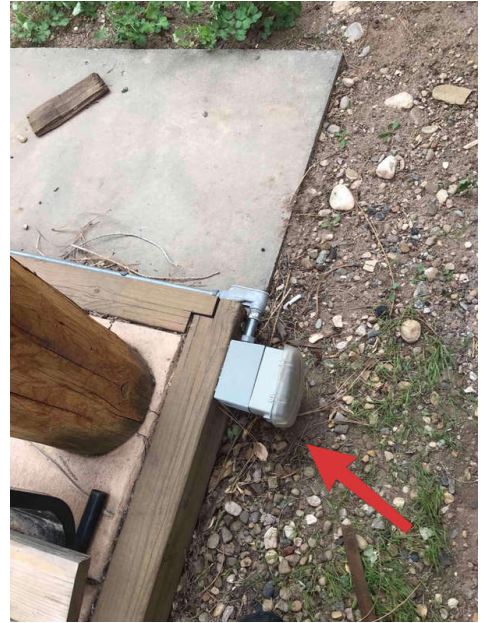
#### 5.14.1 Exterior Electrical Receptacles

### **DID NOT RESPOND**

An exterior Ground Fault Circuit Interrupter (GFCI) electrical receptacle did not respond to the test button. The Inspector recommends replacement with a new GFCI receptacle by a qualified electrical contractor.

Contact a qualified electrical contractor.

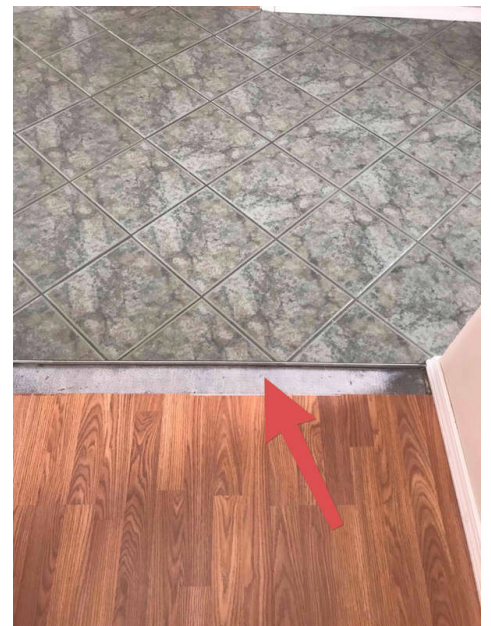
7.1.1 Floors

**POOR INSTALLATION**

NEAR ENTRY WAY

Wood floor transition is missing. Poor coverings in the entry way exhibited evidence of poor installation practices at the time of the inspection.

Contact a qualified professional.

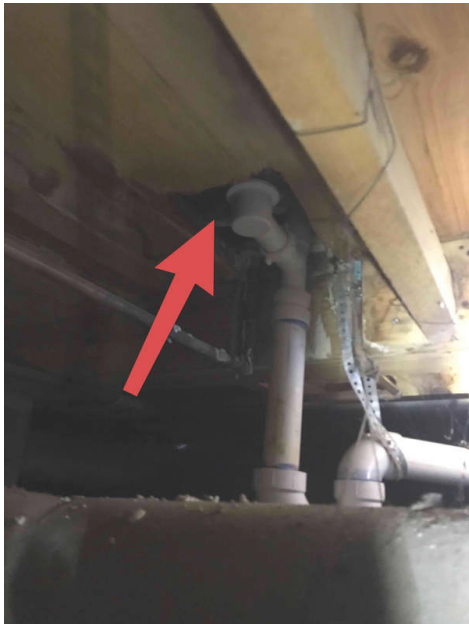
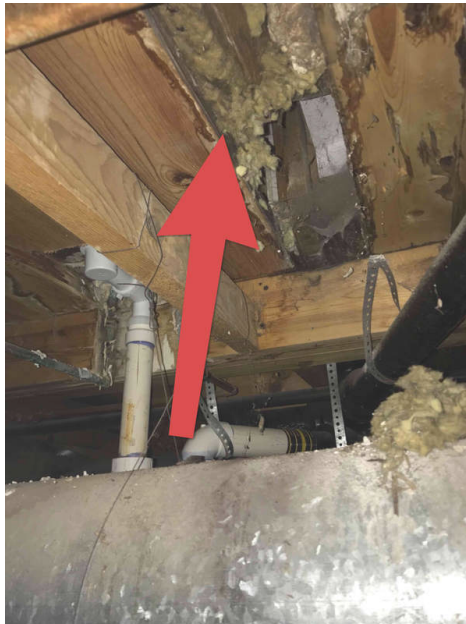
### 12.2.1 Floor Structure

#### LOCALIZED DECAY- LEAKS FIXED

The floor joists had areas of localized advanced decay that appeared to be connected with plumbing fixture leakage. At the time of the inspection, no moisture showed in the framing at these areas, indicating that leaking plumbing fixtures have been repaired.

Contact a qualified professional.

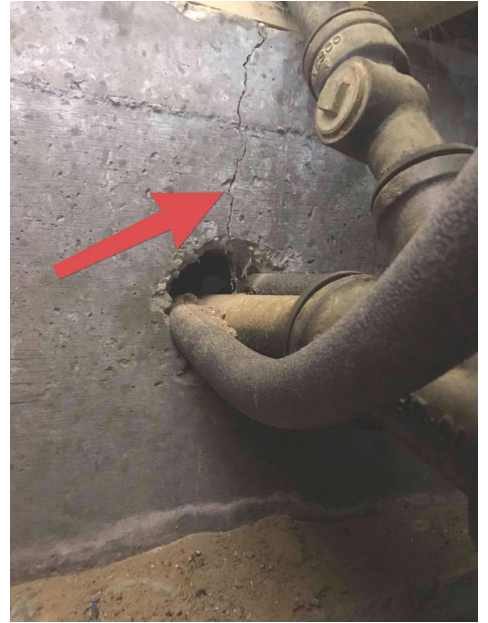
### 12.3.1 Foundation

#### MODERATE, NOT THRU-WALL- SE/QC

Moderate cracking was visible in the poured concrete foundation wall. Cracking did not appear to be continuous through the wall. Determining the cause of cracking lies beyond the scope of the General Home Inspection. The Inspector recommends that you have this condition evaluated by a qualified foundation repair contractor or structural engineer to determine the cause of cracking and the likelihood of continued damage and to discuss options and costs for stabilization.

Contact a qualified professional.

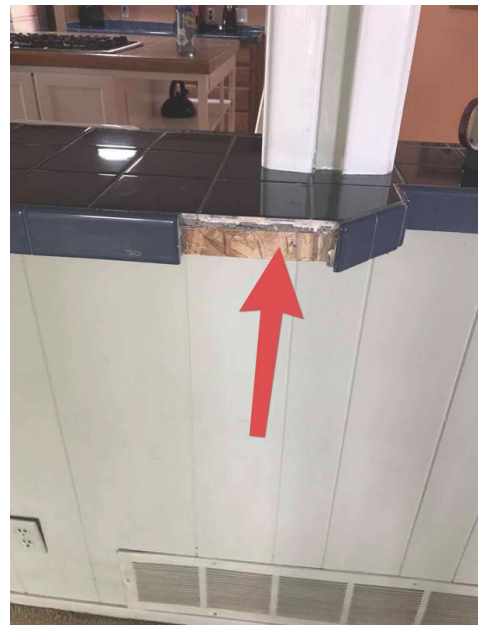
13.9.1 Cabinets

**DAMAGED TILES- QC**

The kitchen countertops had damaged tiles. The Inspector recommends repair by a qualified contractor. If matching tiles are no longer available the countertop may need to be re-tiled, which will be expensive.

Contact a qualified professional.

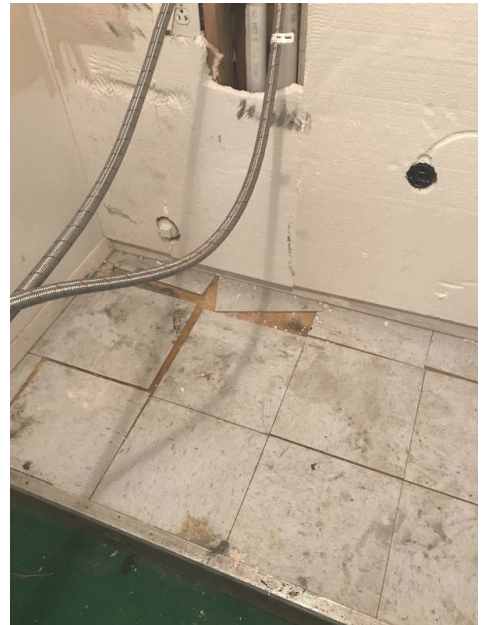
14.1.1 Floors

**POORLY INSTALLED**

Floor tiles in the laundry room were poorly installed.

Contact a qualified professional.
