SWAN HOME INSPECTIONS PLLC

HOME INSPECTION

1234 Main St. Porter TX 773654687

PROPERTY INSPECTION REPORT

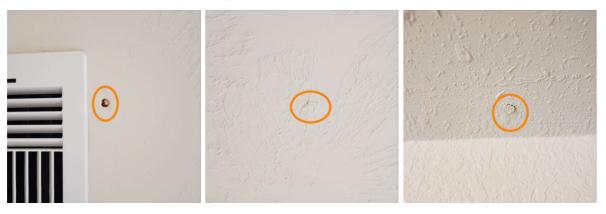
Nail pops were observed on the interior ceilings. Cosmetic improvements are recommended.

Recommendation: Contact a qualified professional.

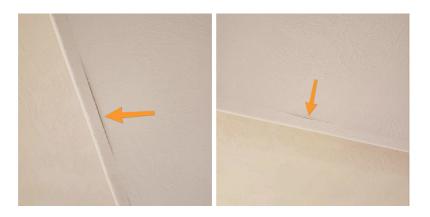
6: Drywall Joint Seperation Cracks

Dry wall joint separation cracks were observed. These cracks are mainly cosmetic. Cosmetic improvements may be necessary.

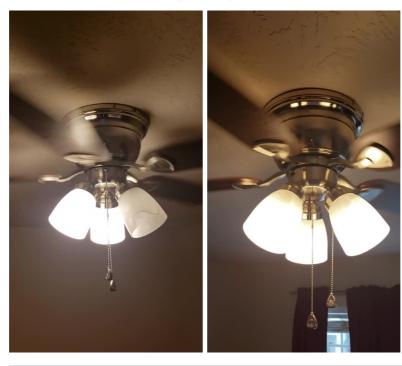
A ceiling fan was noisy during operation. This condition is typical of deteriorated fan components. Consider fan repair or replacement.

Recommendation: Contact a qualified professional.
