PEOPLE'S CHOICE HOME INSPECTIONS, LLC

RESIDENTIAL INSPECTION

1234 Main St.
Charleston SC 29412

Buyer Name
04/05/2019 9:00AM

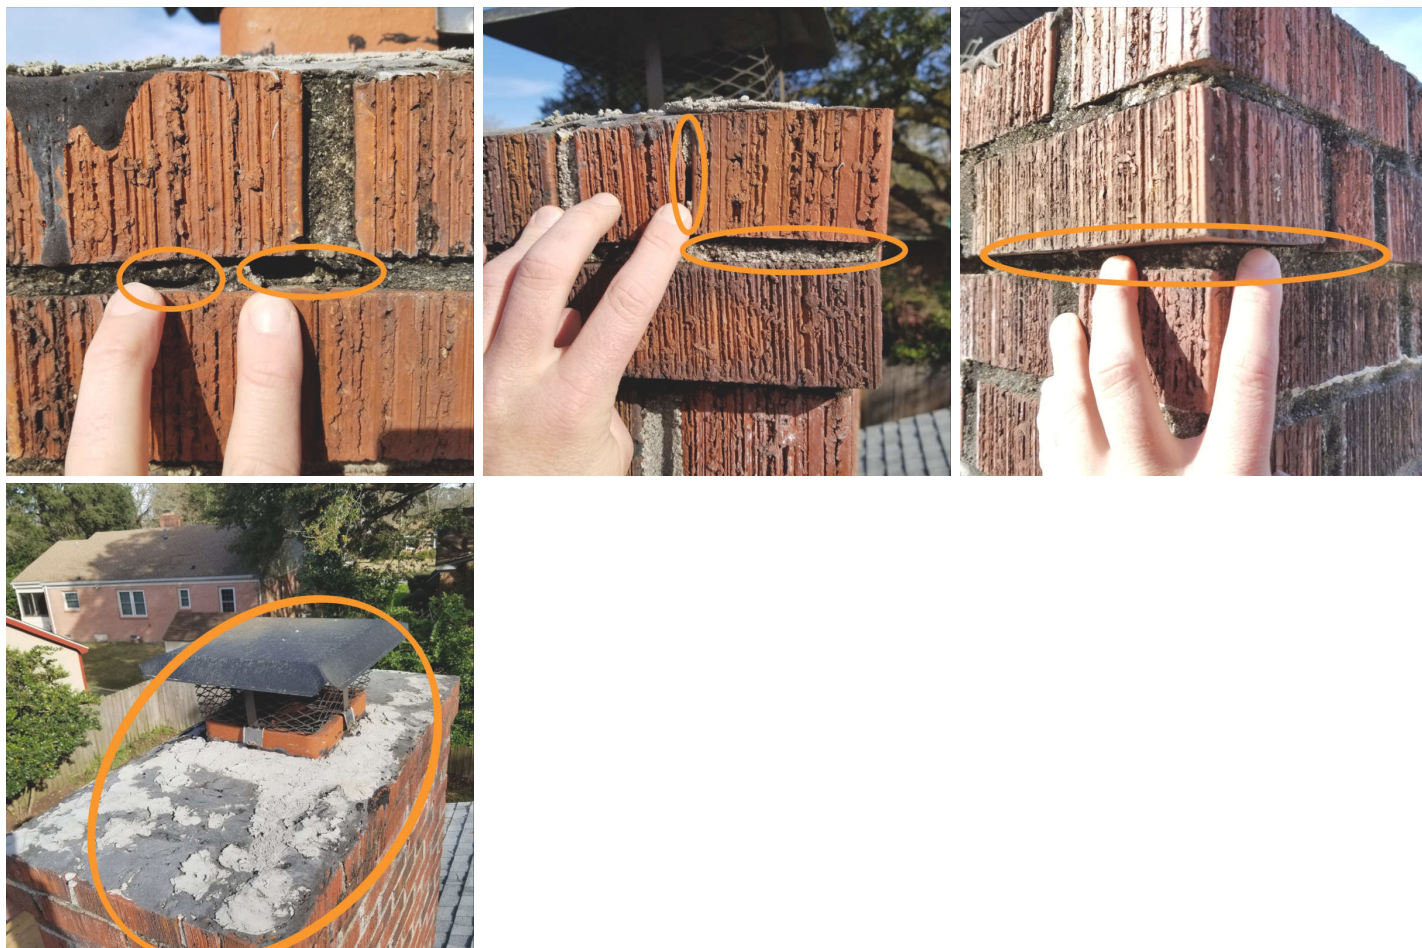
The masonry chimney's mortar is deteriorated and should be repaired to prevent further, significant deterioration. Recommend having a qualified chimney service contractor or mason evaluate chimney and repair as necessary. This will likely require repointing the mortar.

Contact a qualified chimney contractor.

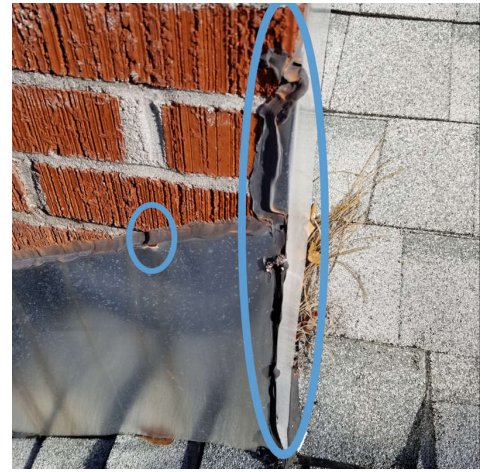
2.3.2 Chimney

Some of the roofing cement has deteriorated. Recommend applying a roofing sealant to the exposed areas so as water intrusion does not occur.

Chimney flashing

Contact a qualified professional.

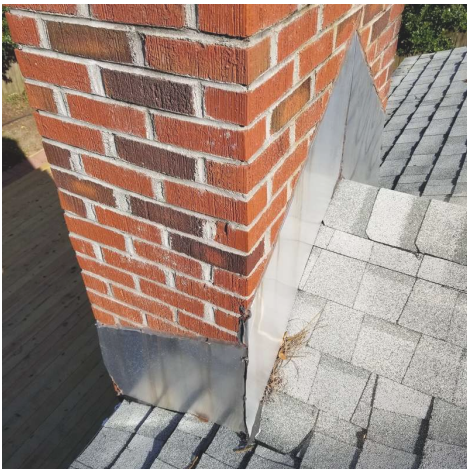
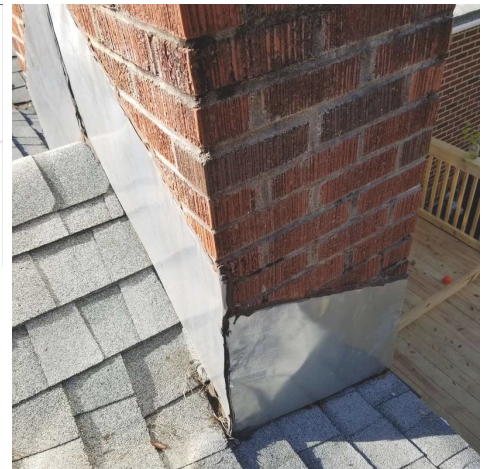
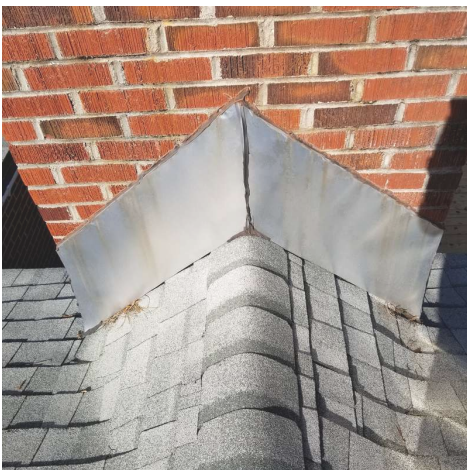
2.6.1 Flashing / Vents

IMPROPER FLASHING - METAL COVERINGS

Inspector could not confirm if counter flashing was installed 1 inch into mortar joints under the newest flashing. Improper metal roof flashing was installed which could allow for water intrusion to attic space. Recommend correction by installing proper metal roof approved vent flashing with boots.

Contact a qualified roofing professional.

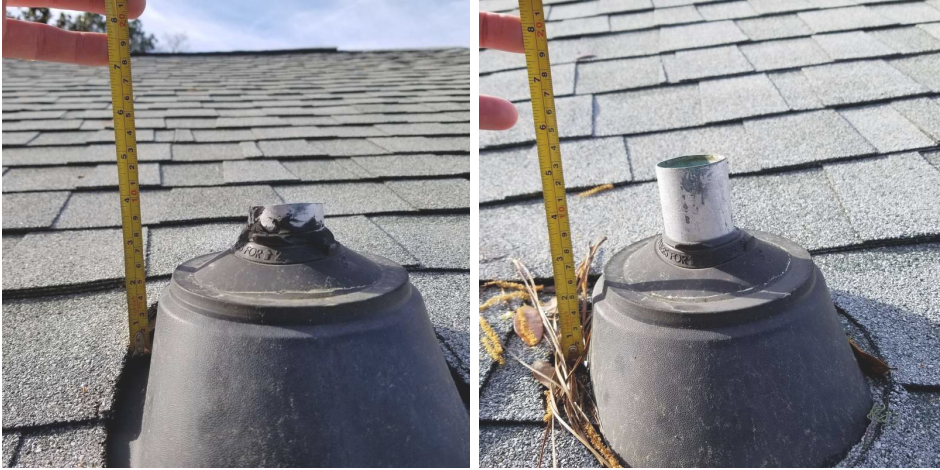
2.6.2 Flashing / Vents

One or more plumbing vent pipes terminated less than 6 inches above the roof surface below. Debris can block vent pipe openings with such short pipes. Blocked vent pipes can cause sewer gases to enter living spaces. Recommend that a qualified person repair per standard building practices. For example, by extending pipe(s) to terminate at least 6 inches above the roof surface.

Contact a qualified roofing professional.

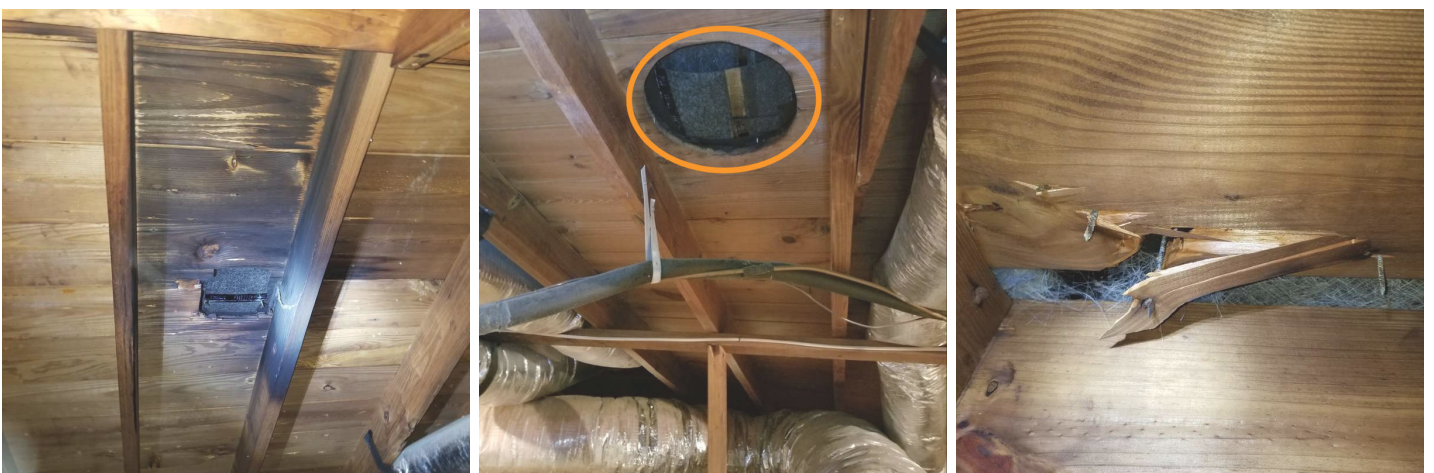
DAMAGED SHEATHING

The roof had areas of visible damage to the roof sheathing at the time of the inspection. All damaged areas should be repaired for safety reasons, and to prevent potential damage from moisture intrusion to the home materials, the roof structure and to prevent development of microbial growth such as mold. You should consult with a qualified roofing contractor to gain an idea of options and costs for repair. Old plumbing vent holes, where you see roof under layment, should be repaired. As in roof decking should be installed underneath.

Contact a qualified professional.

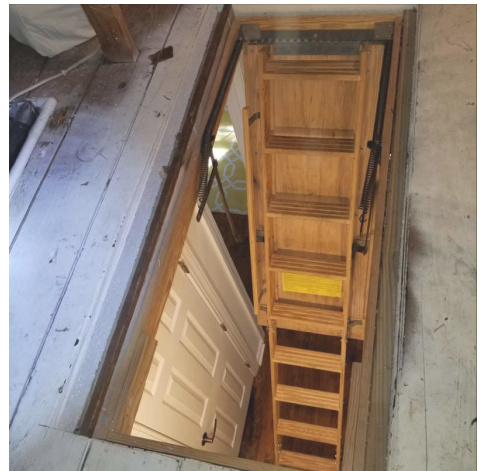
3.4.1 Attic Hatch

Pull-down stairs are installed for the attic access. No insulation is installed above the stairs and no weatherstripping is installed around the hatch perimeter. To reduce air leakage, recommend installing weatherstripping and an insulated hatch cover.

Interior air leaking into the attic results in heating and cooling losses, increased energy costs, and a possible increase in moisture levels in the attic due to condensation forming on the underside of the roof sheathing during cold weather.

Contact a qualified handyman.

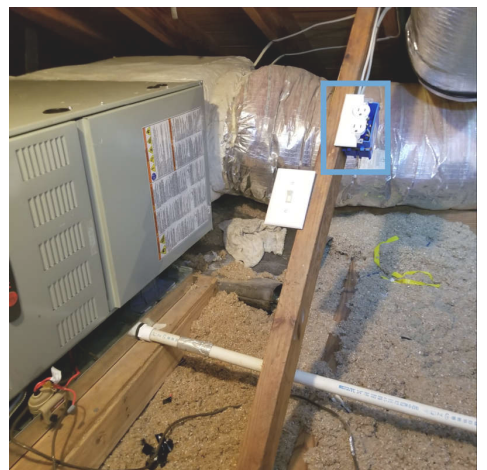
3.5.1 Electrical

COVER PLATE BROKEN

Cover plate is broken at one or more electric boxes, such as for receptacles, switches and/or junction boxes. They are intended to contain fire and prevent electric shock from exposed wires. Cover plates should be replaced where necessary.

Recommended DIY Project

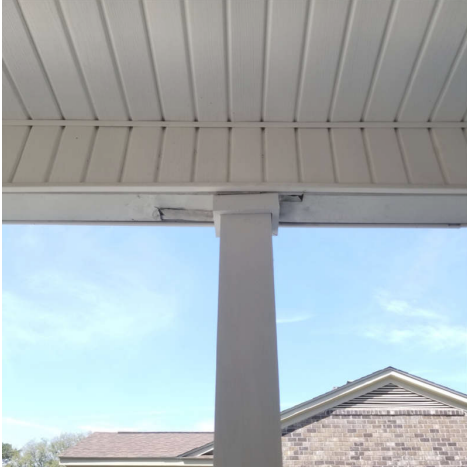
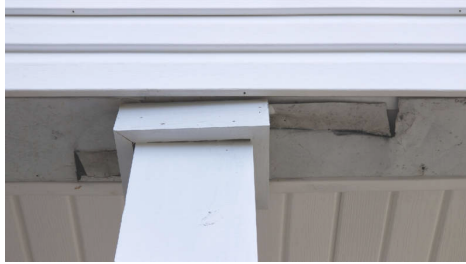
**CARPORT POSTS DAMAGED**

One or more carport and/or porch support posts were damaged. Recommend qualified contractor repair.

Contact a qualified general contractor.

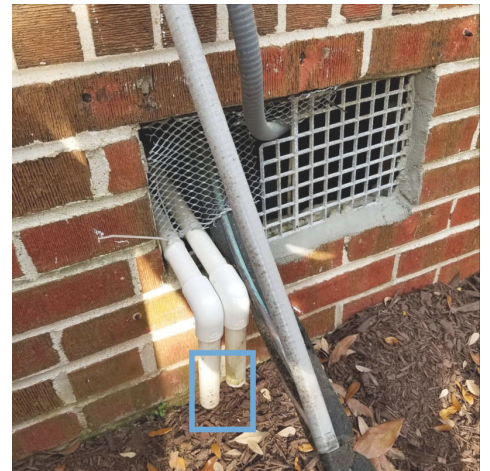
4.2.1 Exterior issues

It is recommended to have the evaporator drain for the air handler directed away from the house. The drain is too close the exterior wall and allows moisture at the wall/footing areas. Recommend to have at least 12" from exterior wall.

Contact a qualified HVAC professional.

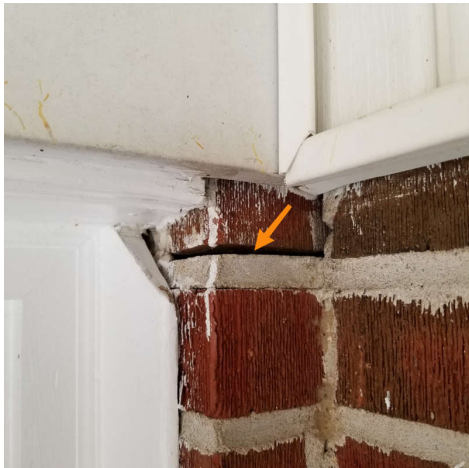
4.2.2 Exterior issues

**BRICK - CRACKS, DETERIORATION**

The masonry (brick) was deteriorated or damaged in some areas. Where cracks or openings are exposed, water can enter the wall structure causing mold, fungal growth and structural damage. This is a conducive condition for wood-destroying organisms. Recommend that a qualified contractor repair as necessary. For example, by repointing mortar, or sealing with epoxy, or replacing broken or missing masonry.

Top right. Front door

Contact a qualified professional.

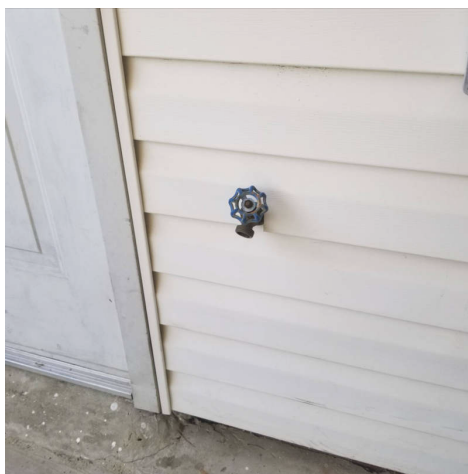
hose faucet handle was inoperable / *broken*. Recommend that a qualified person replace handles or make repairs as necessary.

Contact a qualified professional.

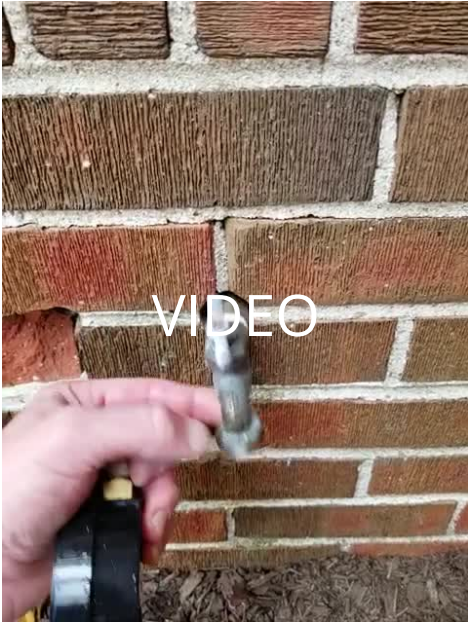
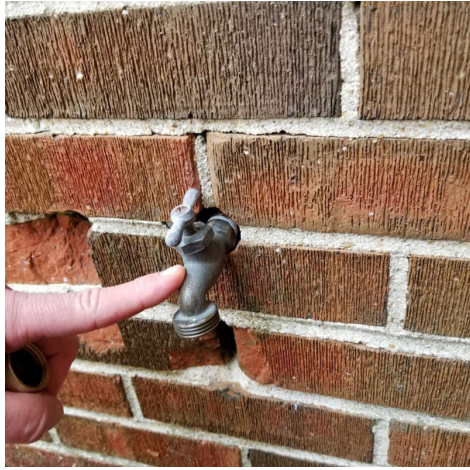
4.2.4 Exterior issues

LOOSE HOSE BIBB

One or more hose bibs weren't anchored securely to the structure's exterior. Water supply pipes can be stressed when hose bibs are turned on and off and when hoses are pulled. Leaks may occur as a result. Recommend that a qualified person install fasteners per standard building practices.

Contact a qualified professional.

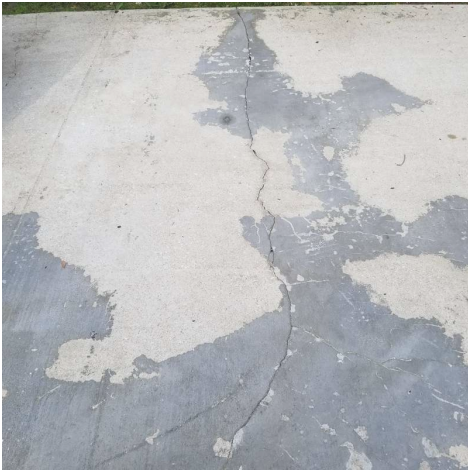
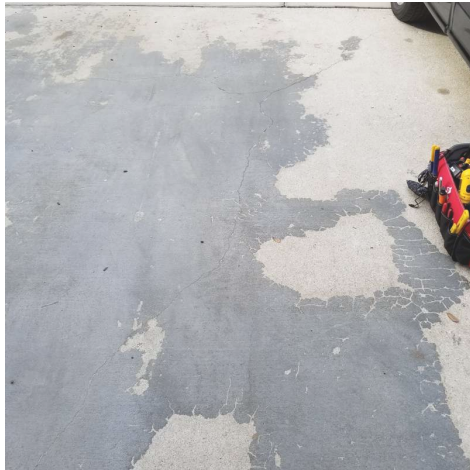
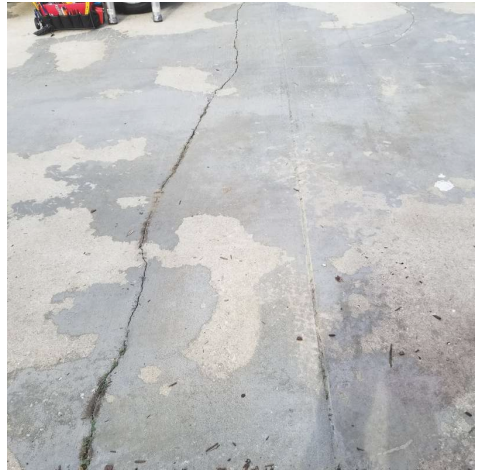
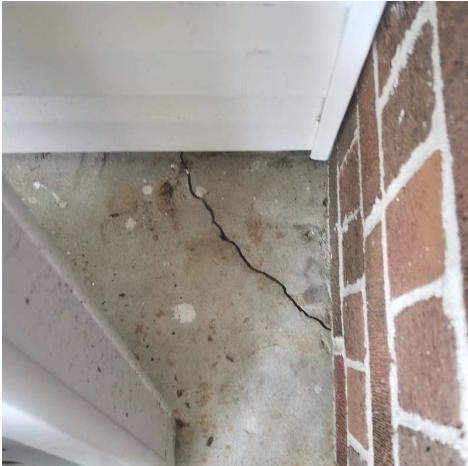
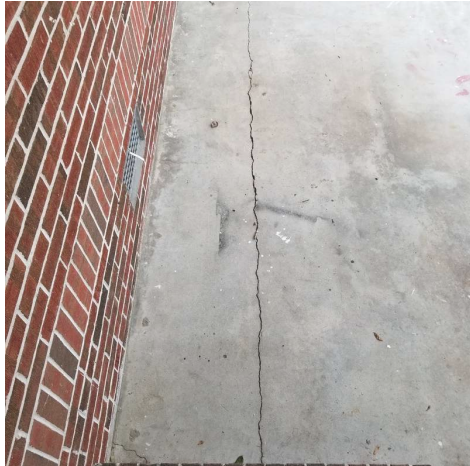
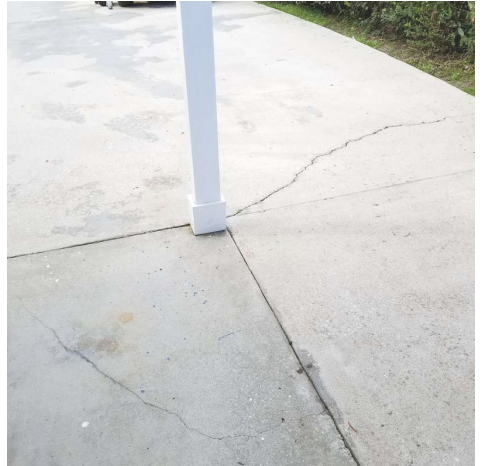
4.3.1 Driveway, Walkway, Patio

MINOR DRIVEWAY DAMAGE

Minor deterioration (e.g. cracks, holes, settlement, heaving) was found in the driveway, but no trip hazards were found. The client may wish to have repairs made for cosmetic reasons.

Contact a qualified professional.

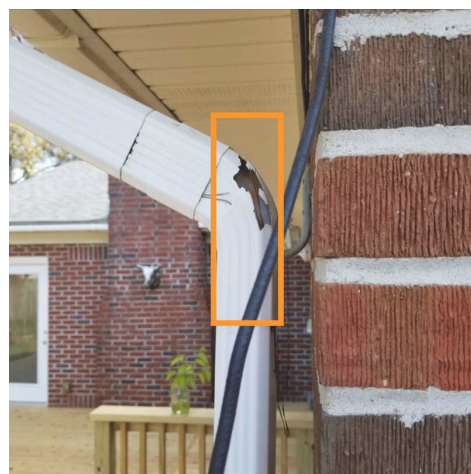
4.7.1 Gutters and Flashing

DAMAGED DOWNSPOUT

Sections of downspouts are damaged. This can result in water accumulating around the structure's foundation, or crawlspace if they exist. Accumulated water is a conducive condition to wood destroying insects and organisms, and may also cause the foundation to settle over time. A licensed contractor should replace or repair downspouts where necessary. A damaged downspout may not allow water to flow freely.

Contact a qualified professional.

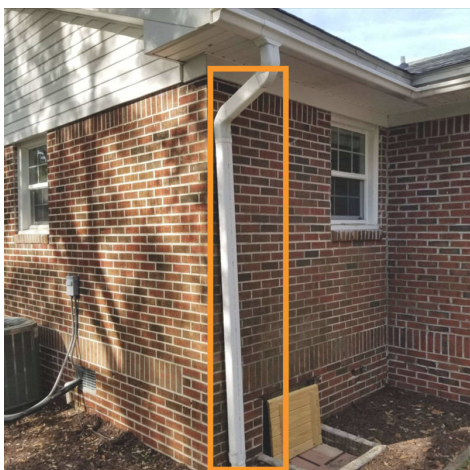
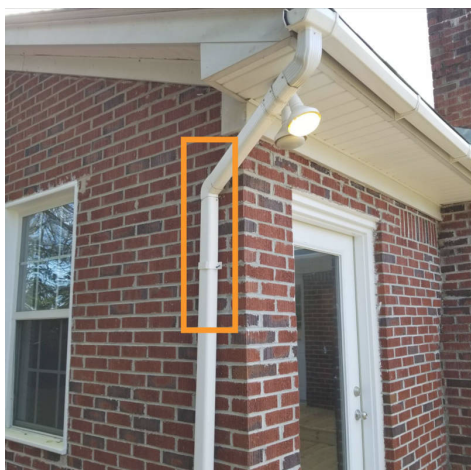
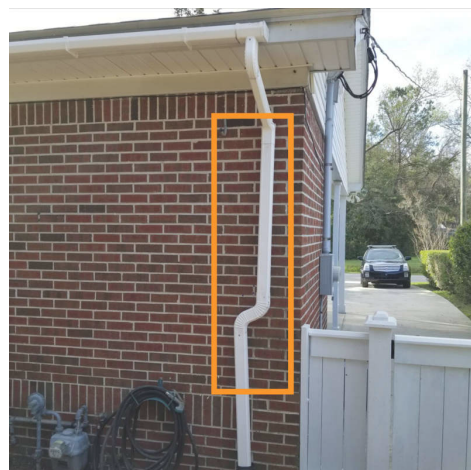
4.7.2 Gutters and Flashing

DOWNSPOUT LOOSE

One or more downspouts or elbows were loose or detached. Rainwater can come in contact with the building exterior or accumulate around the foundation as a result. This is a conducive condition for wood-destroying organisms. Recommend that a qualified person repair as necessary.

Contact a qualified professional.

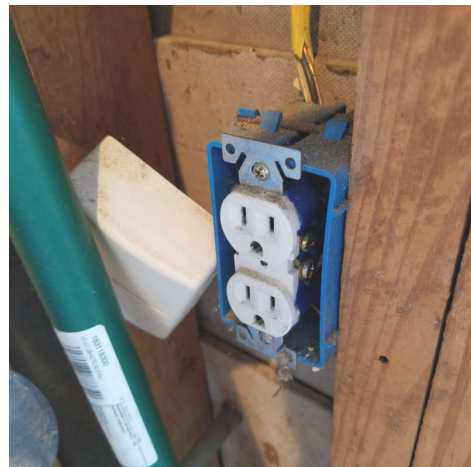
4.9.1 Electrical

One *cover plate was missing*. This is a potential shock and/or fire hazard. Recommend that a qualified professional repair as necessary.

Utility room

Contact a handyman or DIY project

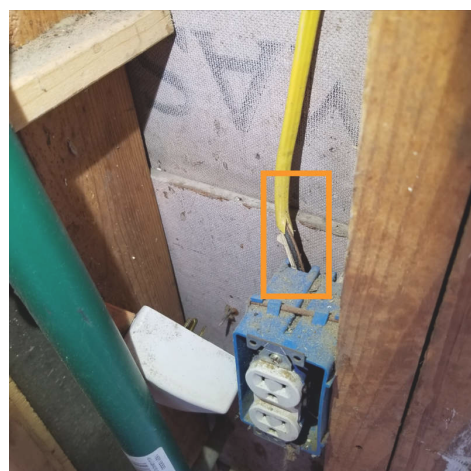
4.9.2 Electrical

One or more sections of outdoor wiring were exposed and *subject to damage*. This is a potential shock hazard. Recommend that a qualified electrician repair per standard building practices. For example, by installing conduit, re-routing wires or replacing wiring.

Utility room

Contact a qualified professional.

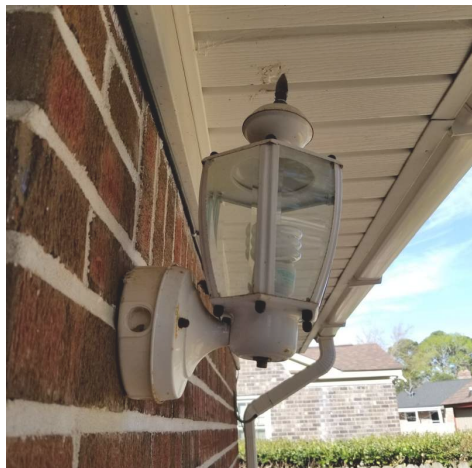
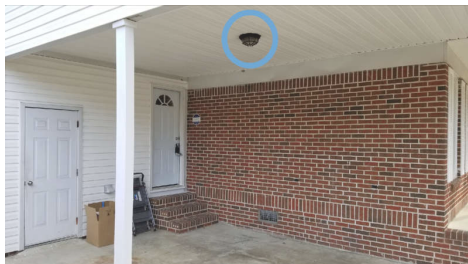
4.9.3 Electrical

One or more light fixtures appear to be inoperable. Recommend further evaluation by replacing bulb(s) and/or consulting with the property owner(s). Repairs or replacement of the light fixture(s) by a qualified electrician may be necessary.

Contact a handyman or DIY project

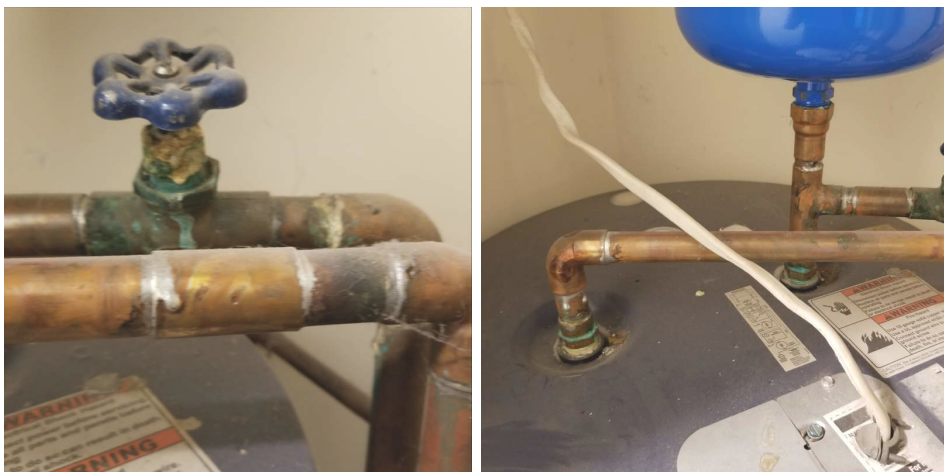
CORROSION ON FITTING/LINES

Corrosion was found on fittings and/or water supply lines for the water heater. Leaks may exist. A qualified plumbing contractor should evaluate and repair as necessary.

Recommend monitoring.

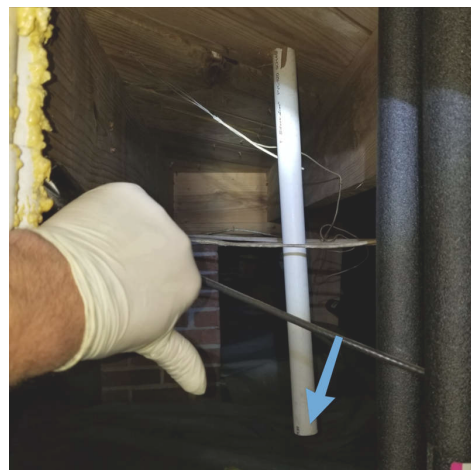
5.1.2 Water Heater

TPR DRAIN IN CRAWLSPACE

The temperature-pressure relief valve drain line is routed so as to empty into the crawl space. Water may accumulate in the crawl space if the valve develops a leak. A qualified plumber should re-route the drain line so as to drain outside.

Contact a qualified professional.

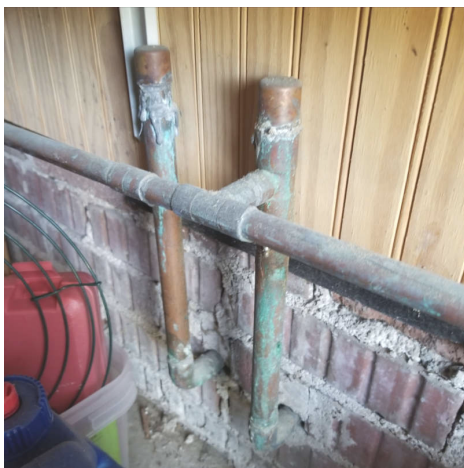
General: Corrosion on pipe

The water supply piping exhibited heavy corrosion that will shorten the expected long term service life of the pipes. The source of moisture should be identified and corrected by a qualified plumbing contractor. Recommend monitoring pipes periodically to inspect for leaks.

Utility room

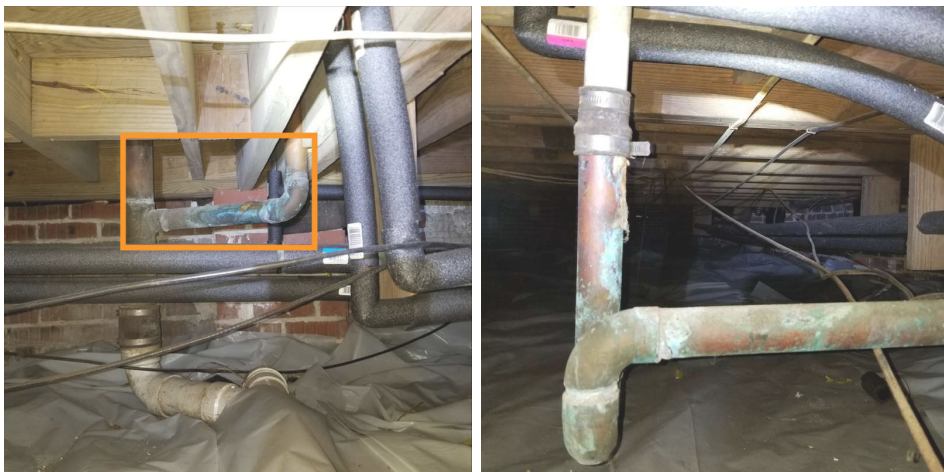
SIGNIFICANT CORROSION

Significant corrosion was found on drain or waste fittings/pipes. This is an indication of past leaks, or that leaks are likely to occur in the future. A licensed plumber should evaluate the line and repair as needed.

Contact a qualified plumbing contractor.

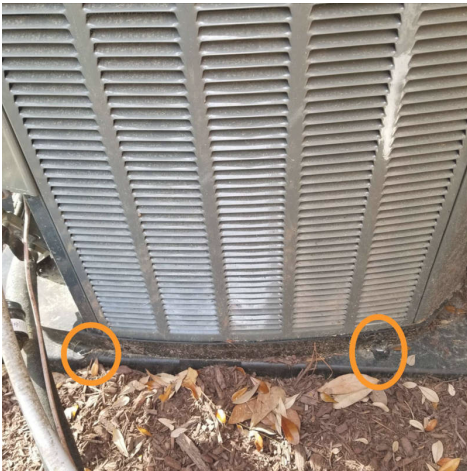
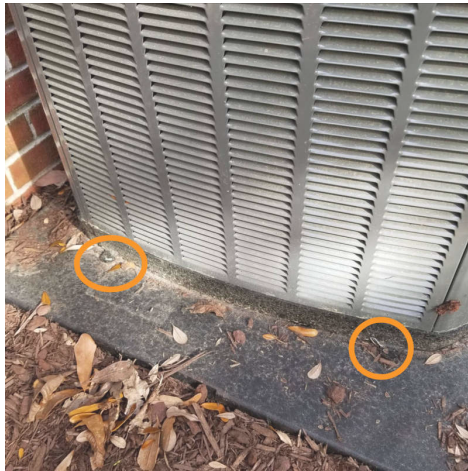
DETERIORATED ANCHORS

One of the anchors that secure the condensing unit are deteriorated. The proper anchor need to be installed to prevent the condensing unit from move, this can cause damage to the refrigeration line and electric.

Contact a qualified professional.

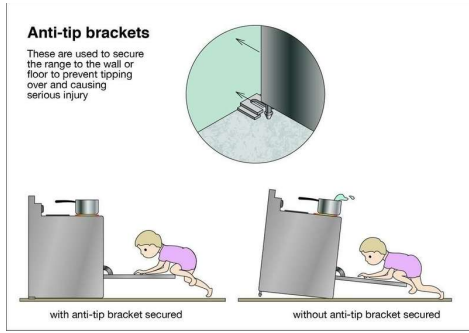
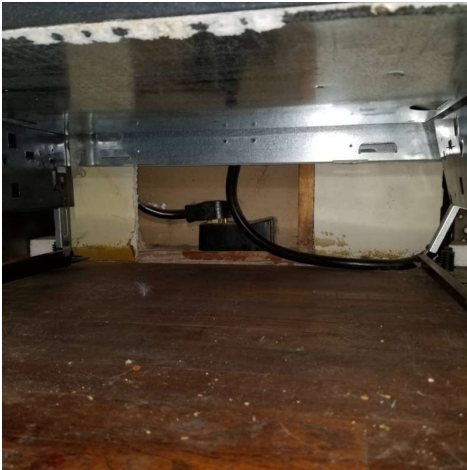
The range can tip forward, and no anti-tip bracket appears to be installed. This is a safety hazard since the range may tip forward when weight is applied to the open door, such as when a small child climbs on it, or if heavy objects are dropped on it. Anti-tip brackets have been sold with all free standing ranges since 1985. An anti-tip bracket should be installed to eliminate this safety hazard. For more information, visit <https://www.nachi.org/anti-tip.htm>

Contact a qualified appliance repair professional.

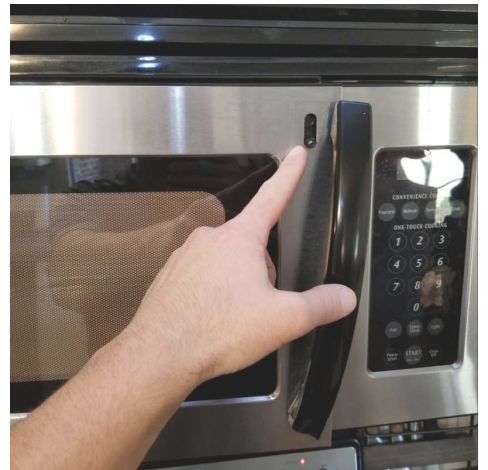
9.3.1 Microwave

HANDLE BROKEN

Contact a qualified professional.

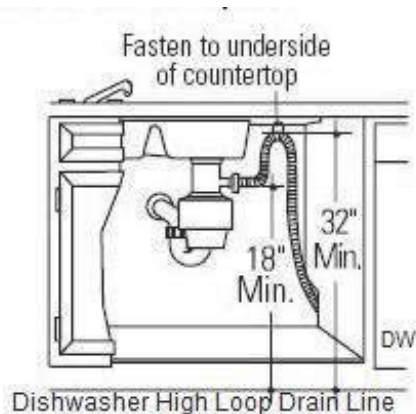
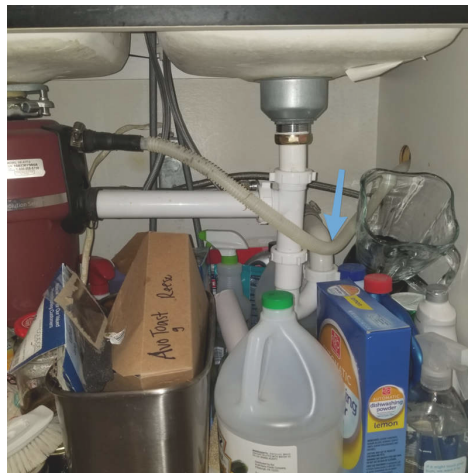
9.6.1 Dishwasher

DISHWASHER NO HIGH LOOP

Contact a qualified appliance repair professional.

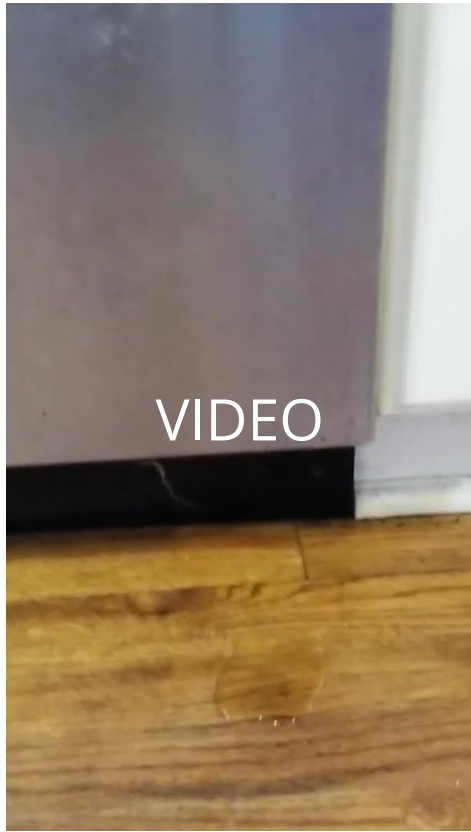
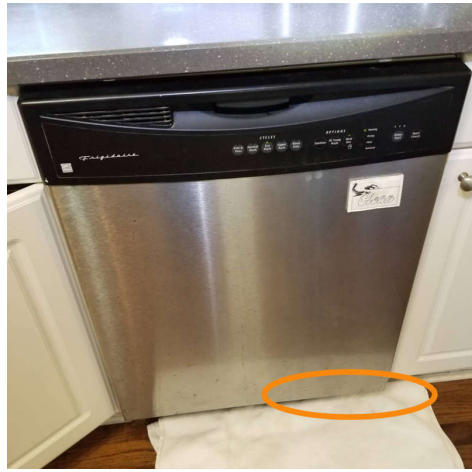
9.6.2 Dishwasher

DISHWASHER WATER BELOW

Contact a qualified appliance repair professional.

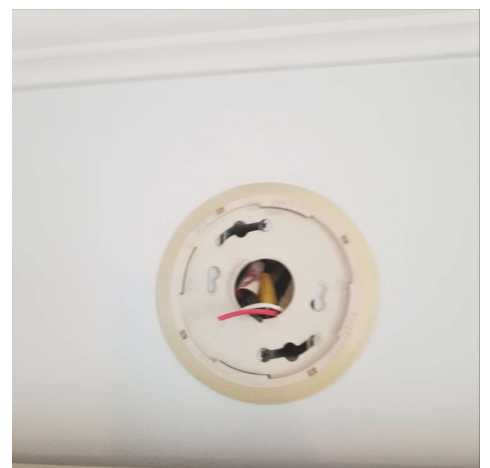
11.4.1 Smoke and CO alarms

Living Room

Contact a qualified handyman.

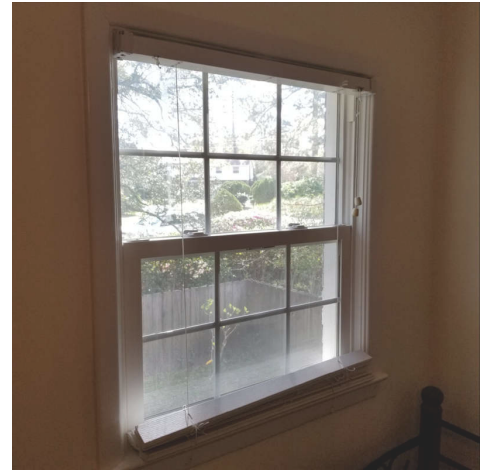
11.6.1 Windows and Door

Bedroom

Contact a qualified professional.

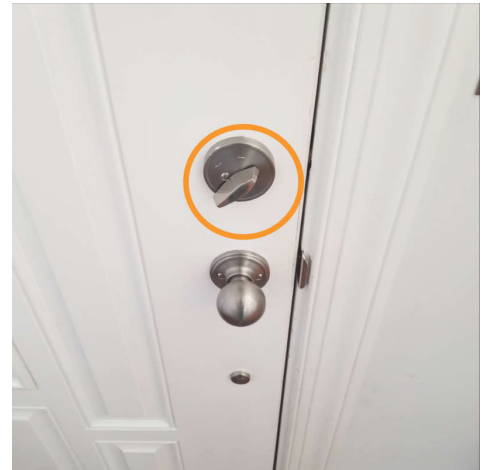
11.6.2 Windows and Door

Front door

Contact a qualified handyman.

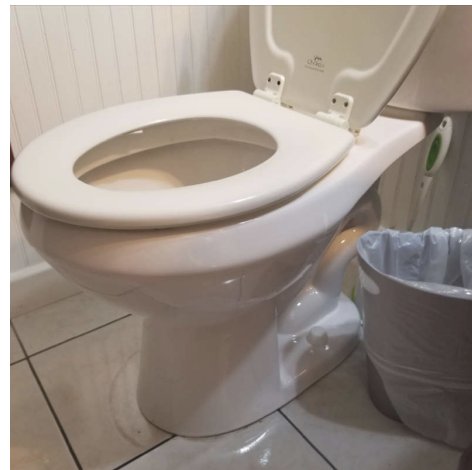
12.8.1 Toilets

Bathroom

Contact a qualified professional.

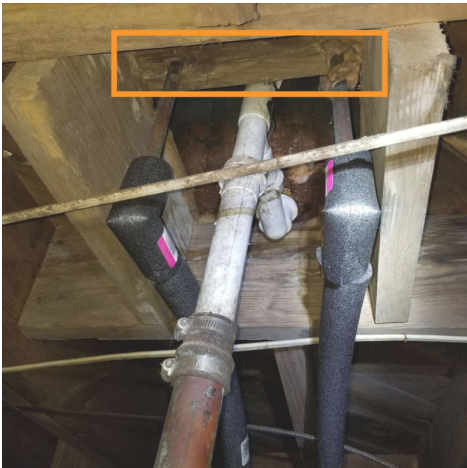
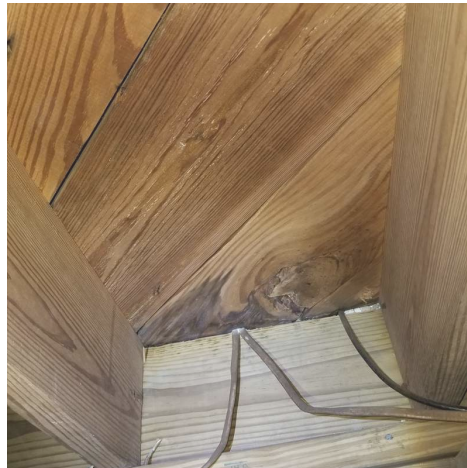
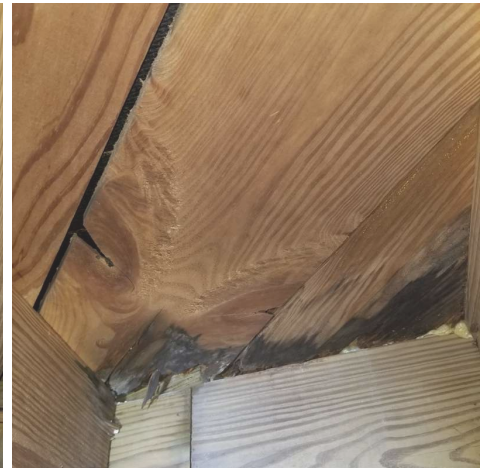
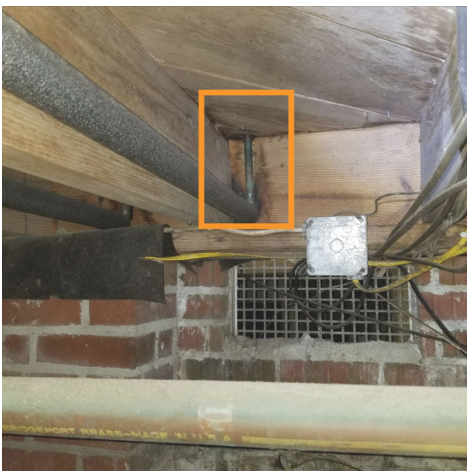
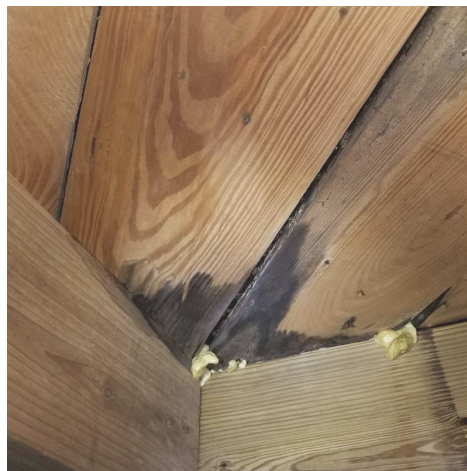
16.3.1 Substructure

DETERIORATED WOOD.

Contact a qualified professional.
