LIFESPAC HOME INSPECTIONS

LIFESPAC INSPECTION REPORT

1234 Main St.
Colorado Springs CO 80907

09/19/2018 9:00AM

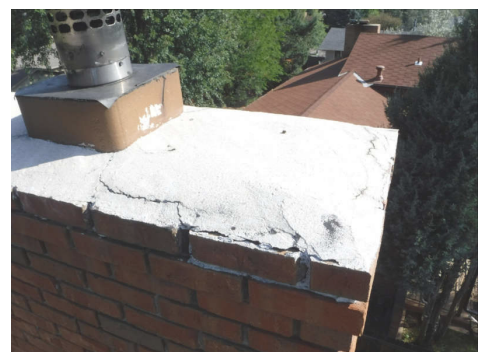
2.6.1 Chimney at Roof

MODERATE CROWN CRACKING- QC

Moderate cracking visible in the chimney crown should be filled with an appropriate sealant to prevent worsening damage caused by moisture in the cracks expanding as it freezes. All work should be performed by a qualified contractor.

Contact a qualified chimney contractor.

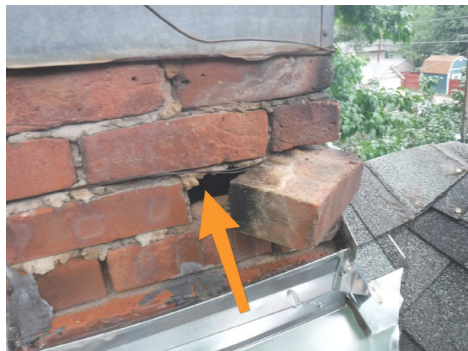
2.6.2 Chimney at Roof

UNLINED BRICK CHIMNEY

The brick chimney was unlined. This condition may deteriorate the brick and mortar and eventually allow the toxic products of combustion to enter the living space. The Inspector recommends that an evaluation and any necessary work be performed by a qualified masonry contractor.

Contact a qualified chimney contractor.

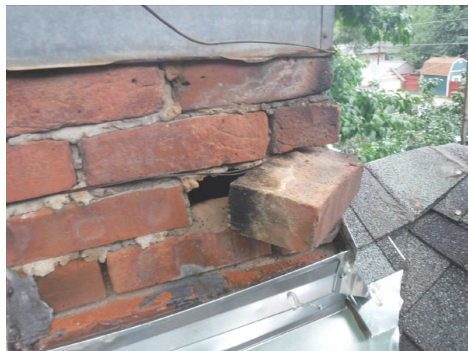
2.6.3 Chimney at Roof

LOOSE BRICK- QC

The brick chimney was severely deteriorated and had loose brick. For safety reasons, the Inspector recommends repair by a qualified contractor.

Contact a qualified chimney contractor.

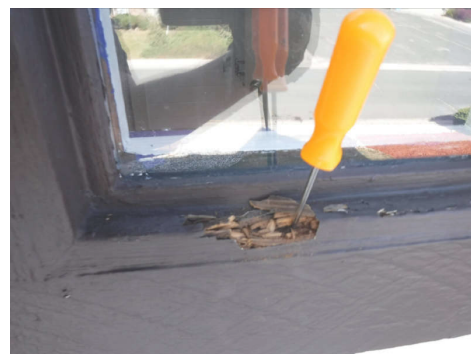
3.2.1 Window Exteriors

PEELING PAINT, WOOD

The wood windows had peeling paint and needed maintenance at the time of the inspection. Windows appeared to have suffered some damage from sun and moisture. Wood windows eventually operate poorly if wood is left exposed to sun and moisture. Repair of long-term neglect can be expensive. The Inspector recommends maintenance be performed by a qualified contractor.

Contact a qualified window repair/installation contractor.

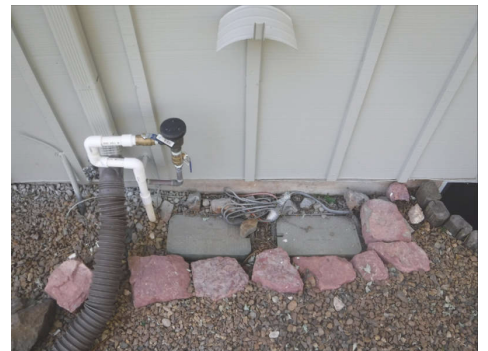
4.10.1 Landscape Irrigation

BEYOND THE SCOPE

The home was equipped with a landscape irrigation system. Inspection of irrigation systems lies beyond the scope of the General Home Inspection and the Inspector did not inspect the system. You may wish to have this system inspected by a qualified irrigation or landscape contractor. Remember to have the irrigation system winterized before weather cold enough to cause freeze damage arrives.

Contact a qualified landscaping contractor

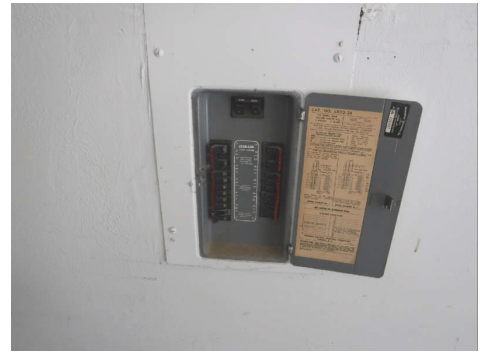
5.6.1 Service Panel Manufacturer

STAB-LOK

The service panel was made by Federal Pacific and was the Stab-lok model. Federal Pacific Stab-lok model service panels are reputed to have a high rate of circuit breaker failure which can result in a fire or shock/electrocution. The Inspector recommends that you consult with a qualified electrical contractor concerning the necessity for replacing this service panel. Information about defective Federal Pacific Stab-lok panels is widely available on the internet.

Contact a qualified electrical contractor.

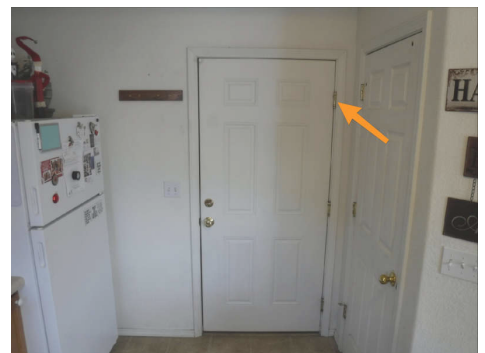
6.6.1 Fire Separation

NO SELF-CLOSING HINGES

The door in the wall between the garage and the home living space did not have operable self-closing hinges. While sometimes not required during construction, the inspector recommends this simple safety upgrade. This helps to contain fires that start in the garage, it also helps to keep harmful exhaust fumes from entering the living space.

Contact a handyman or DIY project

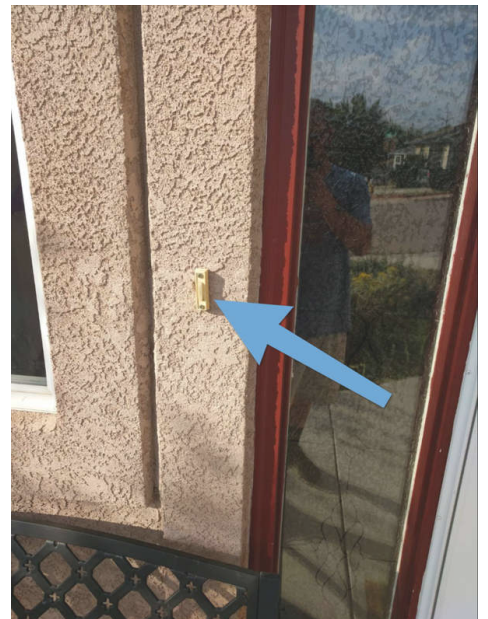
7.5.1 Misc. Components: Ceiling fans, doorbells, Env. Hazards, Detectors, etc.

INOPERABLE DOORBELL

The doorbell was inoperable at the time of the inspection. The Inspector recommends correction by a qualified electrical contractor.

Contact a qualified professional.

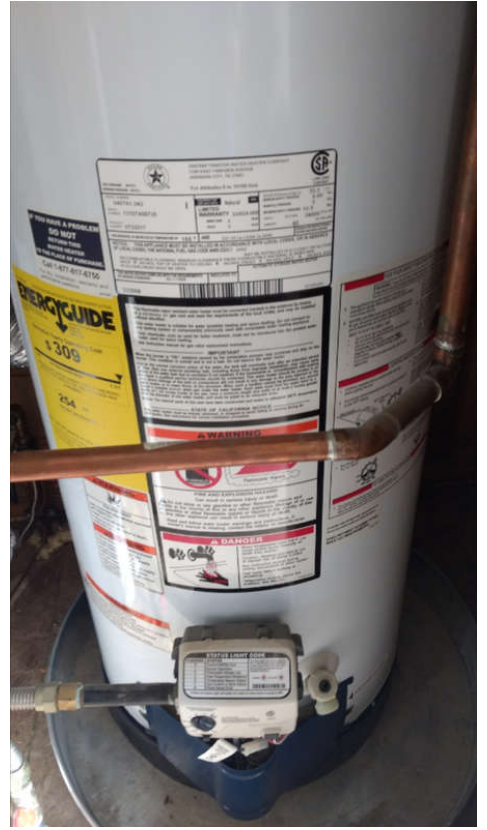
8.4.1 Gas Water Heater

PAST DESIGN LIFE

This water heater appeared to be past its design life and may need replacement soon.

Contact a qualified plumbing contractor.

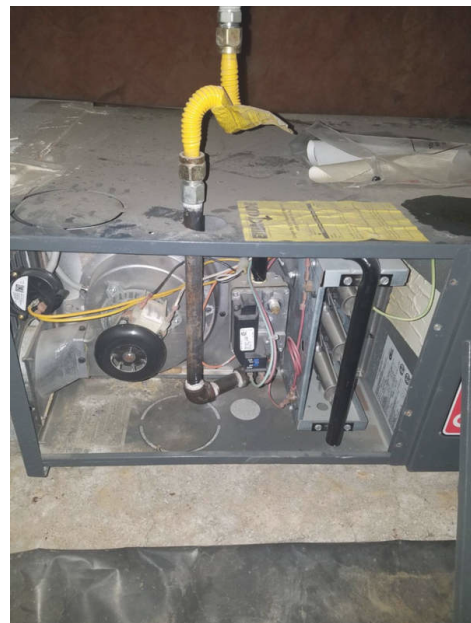
9.2.1 Furnace

RECOMMEND SERVICE

The Inspector recommends that furnace cleaning, service and certification be performed by a qualified HVAC contractor yearly.

Contact a qualified HVAC professional.

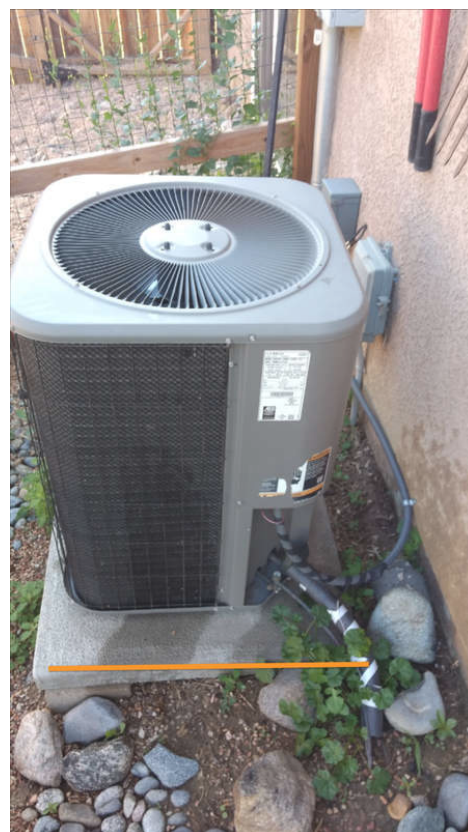
10.1.1 Central Air Conditioner

OUT OF LEVEL

The pad supporting the air-conditioner compressor housing was not level. Over time, this may result in damage to the fan bearings and a shortened fan lifespan, or it may result in movement of the compressor housing which can stress the refrigerant lines resulting in damage and expensive service. The Inspector recommends that the compressor housing be leveled by a qualified HVAC contractor.

Contact a qualified HVAC professional.

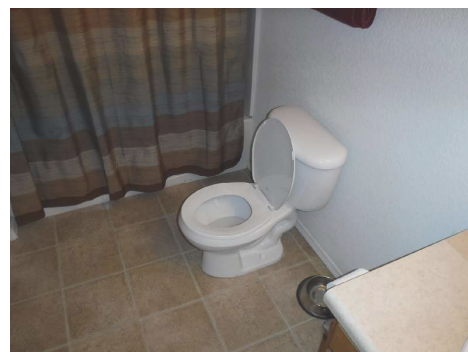
11.10.1 Toilet

LOOSE AT FLOOR

In the bathroom, the toilet was loose at the floor and should be re-attached by a qualified plumbing contractor.

Contact a qualified plumbing contractor.

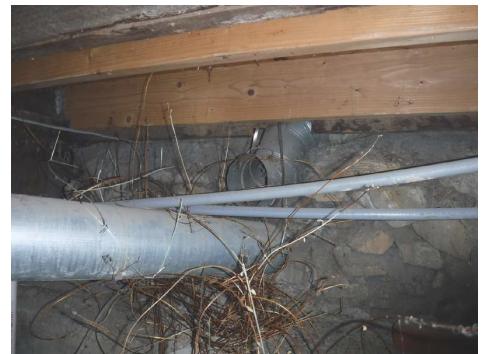
12.3.1 Foundation

DISCONNECTED AT REGISTER(S)

In the basement, a heating duct was disconnected from a register and should be reconnected to supply heat to the affected living space.

Contact a handyman or DIY project

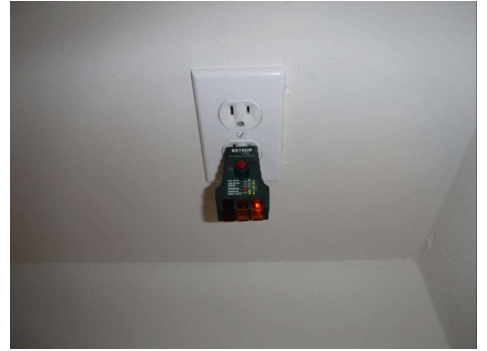
13.7.1 Receptacles and Switches

HOT AND NEUTRAL REVERSED

An electrical receptacle in the kitchen had hot and neutral wires reversed. This condition should be corrected by a qualified electrical contractor.

Contact a qualified electrical contractor.

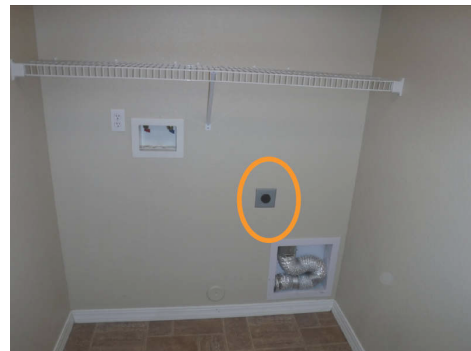
14.6.1 Receptacles, Switches, Connections

OLDER 3-PRONG RECEPTACLE

The laundry area had an older-style 3-prong 240 volt dryer receptacle. Newer dryers come equipped with 4-prong plugs. To accommodate a newer dryer, either the electrical receptacle or dryer cord will need to be replaced.

Contact a qualified electrical contractor.

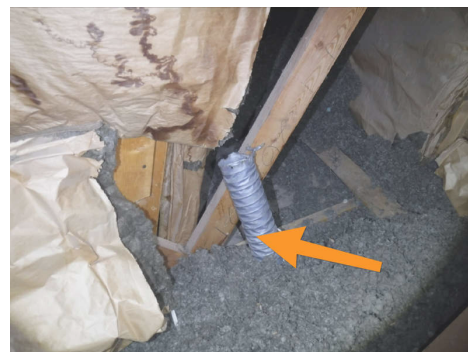
15.9.1 Attic Thermal Envelope

BATHROOM VENT

A bathroom exhaust vent terminated in the attic instead of at the home exterior. This condition can cause excessively high moisture vapor levels in the attic with the potential to damage home materials or create unhealthy conditions related to mold. The Inspector recommends correction by a qualified contractor.

Contact a handyman or DIY project

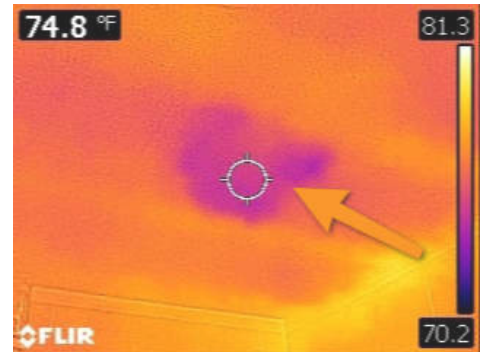
16.2.1 Moisture

CEILING MOISTURE ROOF LEAKAGE

Thermal imaging indicated excessively high moisture levels in ceiling materials. Conditions indicate that roof leakage may be the source of moisture. The inspector recommends that an inspection be performed by a qualified roofing contractor to confirm and correct the source of moisture.

Contact a qualified general contractor.
