RESIDENTIAL INSPECTION

1234 Main St.
Kilgore Tx 75662

PROPERTY INSPECTION REPORT

By: John Vaden - T.R.E.C. #21359 04/23/2019 9:00AM
(Name and License Number of Inspector) (Date)

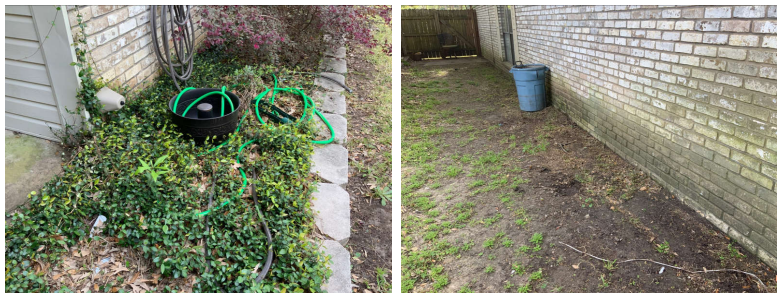
Left side of home

Soil and/or mulch levels and /or foliage against the exterior grade beam were noted to be too high around areas of the foundation making it difficult to view the foundation in various areas. When soil/mulch levels are high against the face of the foundation or foliage is covering the foundation it promotes water penetration of the structure and insect infestation. These areas should be corrected so there is some exposure of the foundation face. It is generally accepted that a brick and stone veneer house should have about 4 inches of clearance. Houses with other types of siding should have approximately 6 inches of clearance.

Recommendation: Contact a qualified professional.

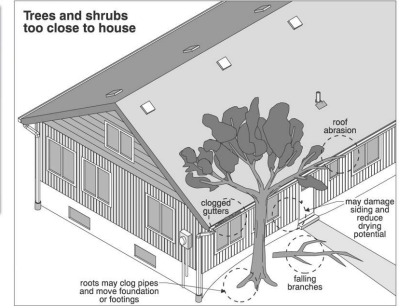
Tree(s) in close proximity of the foundation was observed. Client should consider the installation of a root barrier to reduce the possibility of damage to the foundation from tree roots and moisture removal, or have the trees taken down so that they do not damage the property over time.

Recommendation: Contact a qualified professional.

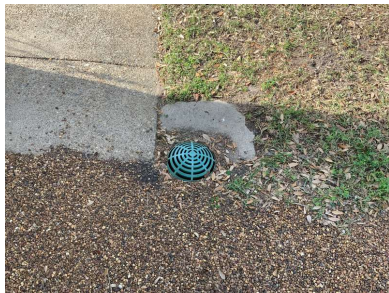
There is a sub surface draining system around this home. It is unknown whether the drainage system works properly and will be only really be evident when there is a good rain. If the drains are having problems when it rains we recommend that you have a plumber come out and clean out the drain lines.

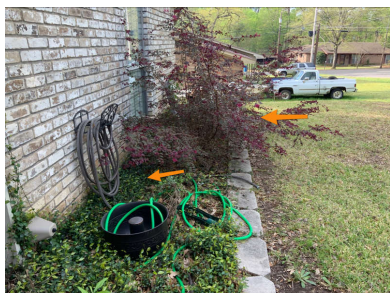
There are areas where roots are close to the foundation, these areas should be monitored over time to make sure that damage does not occur to the foundation.

Recommendation: Recommend monitoring.

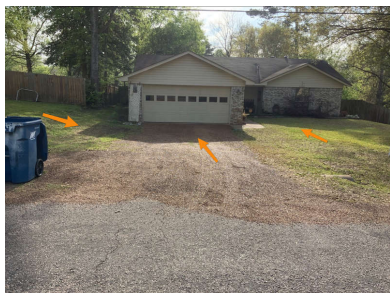
3: Grading- Negative Grade sub surface drains installed

Grading is sloped toward the structure in some areas. Low spots and negative grading promote water accumulation near the building, leading to potential foundation problems and if foundation grade beam is currently visible and you should keep it that way to prevent the possibility of moisture intrusion into the home. There appears to be a drainage system installed that visibly appears to be working at the time of inspection. We do recommend that you keep an eye on this drain in the rainy season to make sure it does not get clogged. Eventually it will need cleaning and a plumber would be the best person to call to clear the drain lines when needed.

Recommendation: Recommend monitoring.

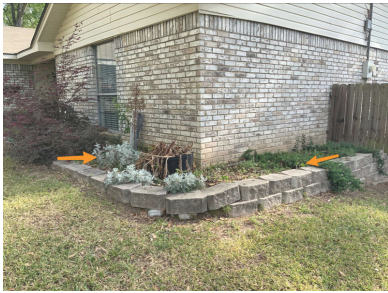
We also recommend that you make sure your downspouts extend past the planter/flowerbed to prevent excessive moisture accumulation in these areas.

Recommendation: Contact a qualified professional.

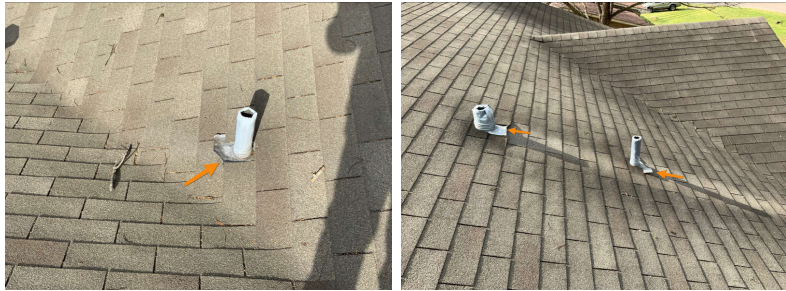
The lead plumbing vent boots are in need of repair. They have been damaged and/or the flashing is not sitting flush on the roof covering.

Recommendation: Contact a qualified professional.

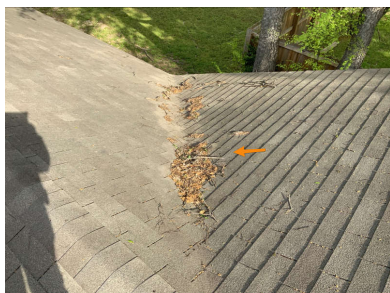
2: Debris

In most cases with a single story home or homes with out dormers or sidewalls in contact with the roof structure, twigs and other debris can damage the roof covering more than people realize and it is strongly recommended that the roof covering be cleaned now and periodically in the future.

Recommendation: Contact a handyman or DIY project

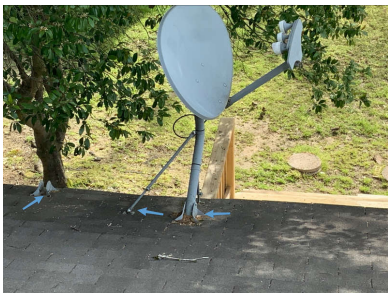
Maintenance: Items mounted to the roof such as satellites, antennas, basketball backboards, etc., may allow water penetration. As these items move (wind, adjustments to position, use, etc.), screws and bolts may enlarge mounting holes. While not in immediate need of repair, we recommend closely monitoring these areas and making repairs as soon as possible when necessary.

Recommendation: Recommend monitoring.

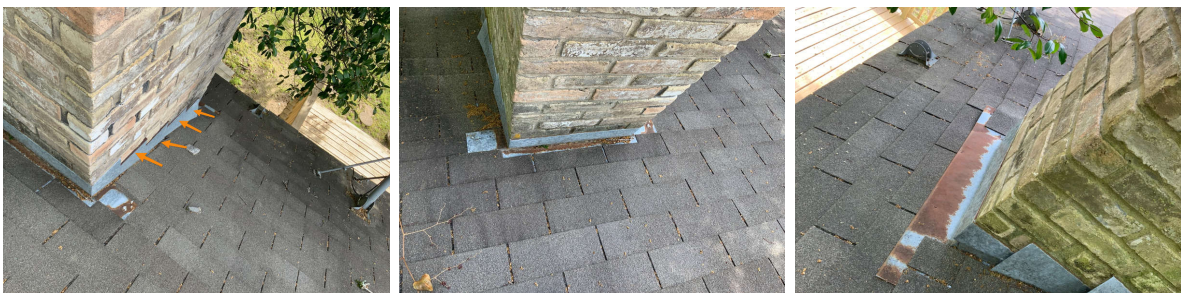
5: Flashing - Chimney Flashing Is Rusted.

The flashing around the chimney is rusted and will need replacement in the future. We recommend for the time being that the flashing be cleaned, sealed, primed and painted to prolong its life expectancy.

Recommendation: Contact a handyman or DIY project

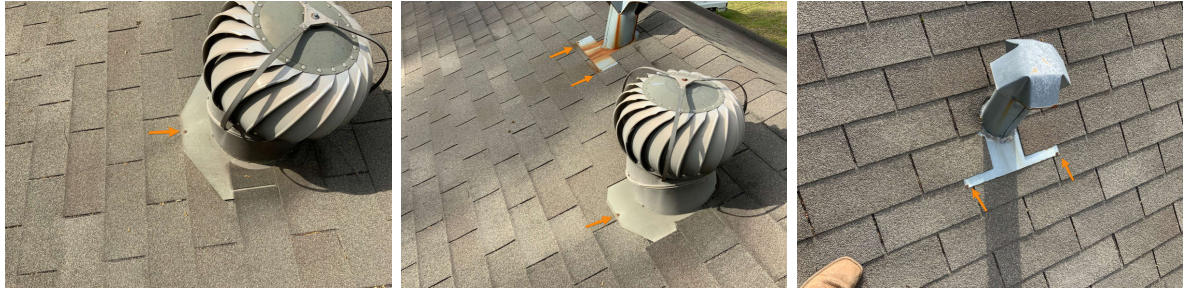
6: Flashing Exposed Nail Heads

There are exposed fasteners on the flashings of the roof we recommend that these nails be sealed.

Recommendation: Contact a qualified roofing professional.

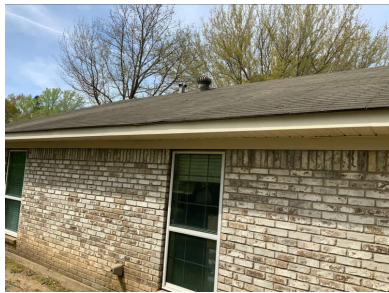
7: Shingles- Nail Pops

There were nail pop(s) present on the roof surface in a few areas. This is where a nail backs out of a shingle due to expansion and contraction and "lifts" or protrudes through the overlapping shingle. Repairs are recommended as needed by a roofing contractor or other qualified person.

Recommendation: Contact a qualified professional.

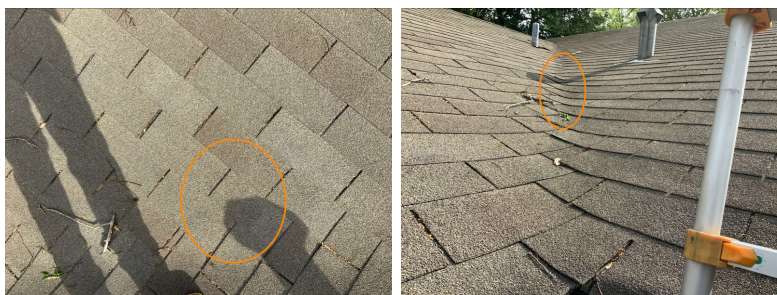
8: Sheathing- Decking Spongy In Areas

This is typical in older homes, there may be areas of decking that will need replacement in the future.

Recommendation: Contact a qualified professional.

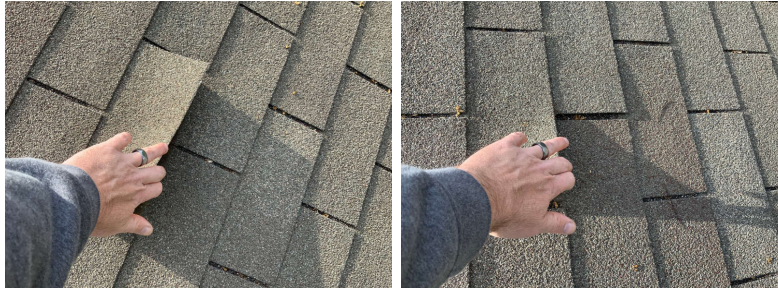
9: Shingles Need Sealing

There are areas on the roof surface where shingles are not properly adhered to the surrounding roof covering. We recommend that these shingles be sealed to help prevent wind damage in the future.

Recommendation: Contact a qualified roofing professional.

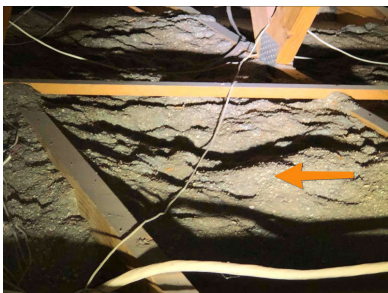
2: Insulation- Insufficient

Insulation depth was inadequate. Recommend a qualified attic insulation contractor install additional insulation.

Recommendation: Contact a qualified insulation contractor.

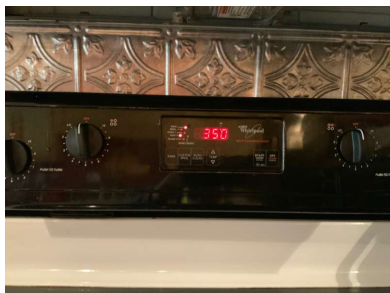
We recommend that you contact a qualified appliance technician to recalibrate the oven. If you wanted a **DIY solution** [Here is a link to a helpful video.](#)
