RESIDENTIAL HOME INSPECTION

1234 Main St.
Wellington 6022

Buyer Name
09/25/2018 9:00AM

Inspector
Adam Collins
LBP; NZQA in Carpentry (advanced), Roofing
+64 210372132
inquest.kiwi@gmail.com

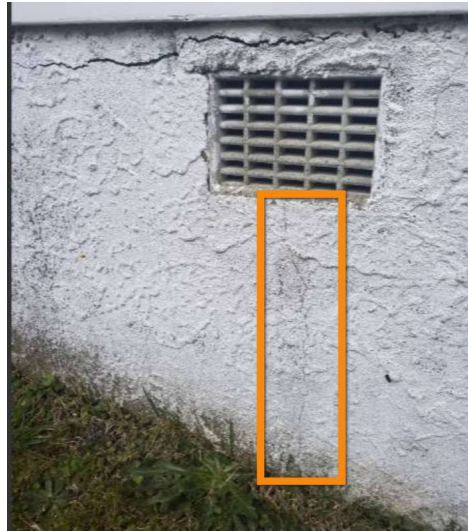
4.1.1 Perimeter wall - Concrete

CRACKING - HAIRLINE FRACTURE

There is a single crack in the foundation located near the underfloor access. The crack is detected on both sides of the wall in the same place. We don't see this as causing any future problems, everything is straight and level and well supported. If anything, some silicone applied here would help preserve the reinforcing steel from corrosion. Has not impacted verticality or alignment thus far.

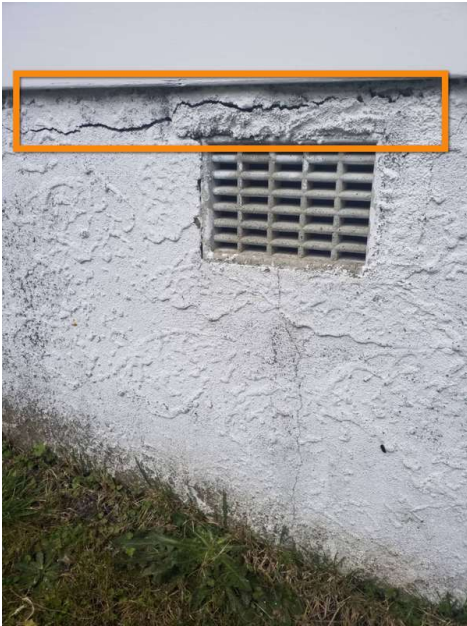
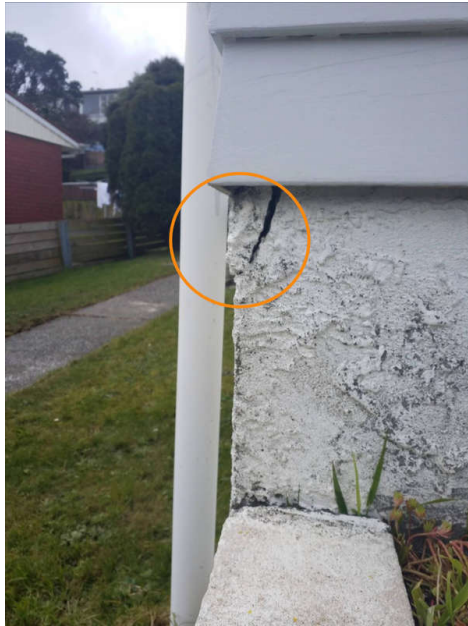
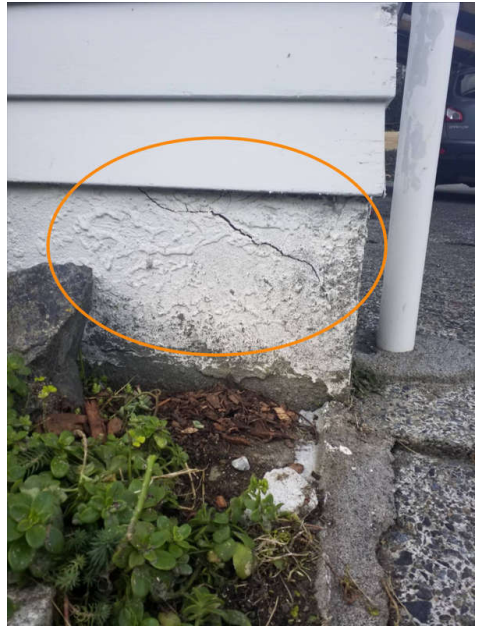
4.1.2 Perimeter wall - Concrete

CRACKING - SUPERFICIAL

The solid plaster coating in some isolated areas are showing some cracks, these are drumming when tapped. This is superficial, not structural cracking. if left, should not cause any future problems to the foundation itself.

Recommendation

Contact a stucco repair contractor

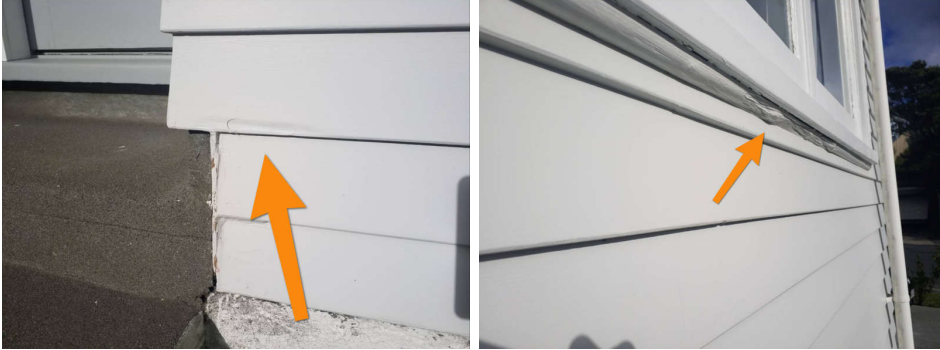
6.1.1 Weatherboard - Timber

TIMBER - ROT LOCATED

Rot is conditional to the environment surrounding the timber. There are many types of rot with many different causes. Change the environment and you will fix the issue. Replace the timber like for like using treated timber this time.

Any rotting timber should be replaced like for like

Recommendation

Contact a qualified carpenter.

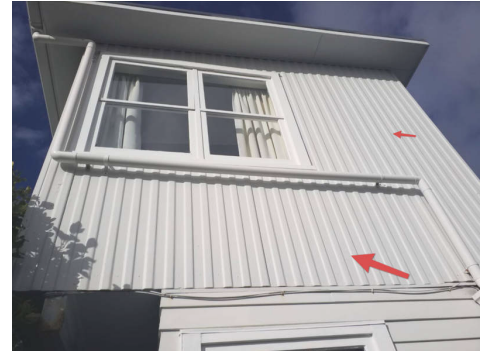
6.2.1 Fibre cement sheet product

ACM SUSPECTED.

[New regulations](#) came into effect in 2018. This involves the requirement of any trade service carrying out works on any property, to have an asbestos management system in place. It is now mandatory to carry out an independent preliminary asbestos survey to any intended area of works where asbestos is likely to be found.

Given these rules you can expect any maintenance to these products (if confirmed as asbestos) to be at a significantly higher cost than regular repair costs.

Recommendation

Contact a qualified professional.

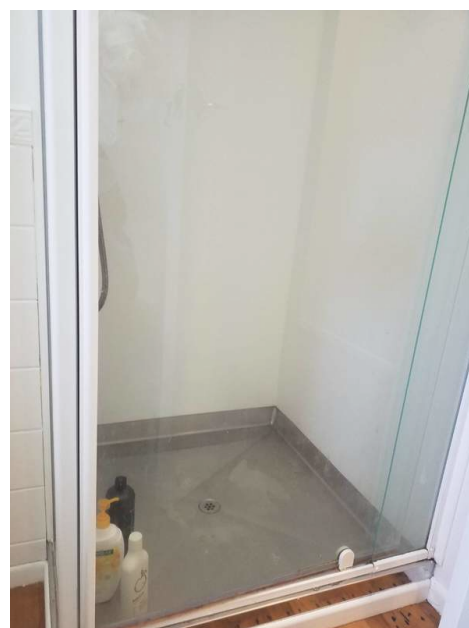
13.7.1 Shower

LEAKING - MINOR

Leaking in this section of the shower, best to get this repaired before it causes bigger problems. Easy fix and quite common for this type of product.

Recommendation

Contact a handyman or DIY project

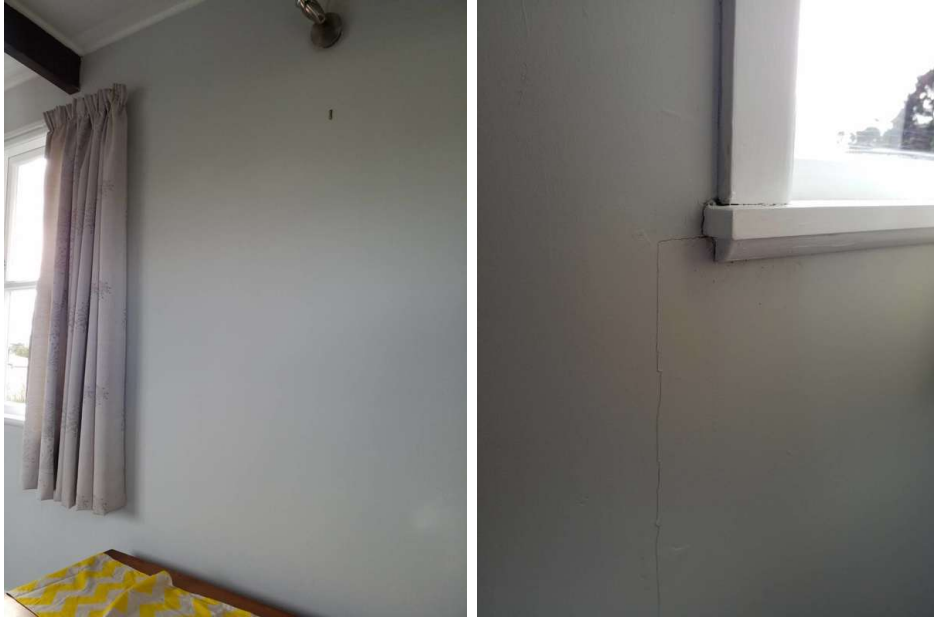
Comment: Some cracking in places due to the placement of sheet joins
