BUILDING INSPECTION REPORT

1234 Main St.
Olmsted Falls OH 44138

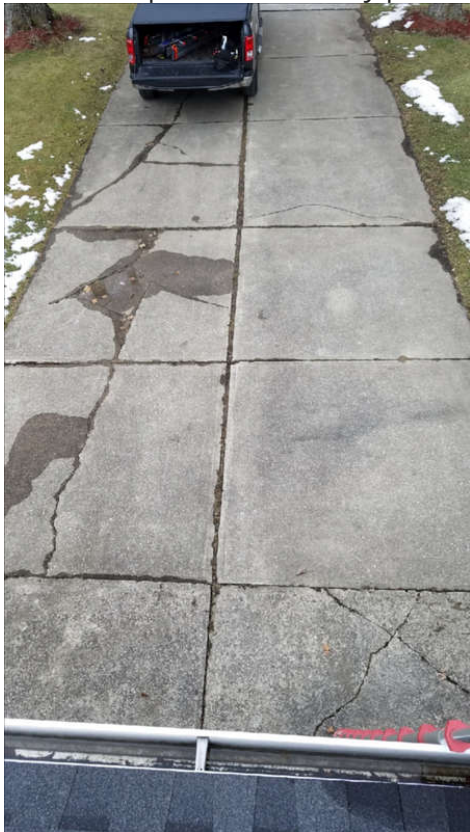
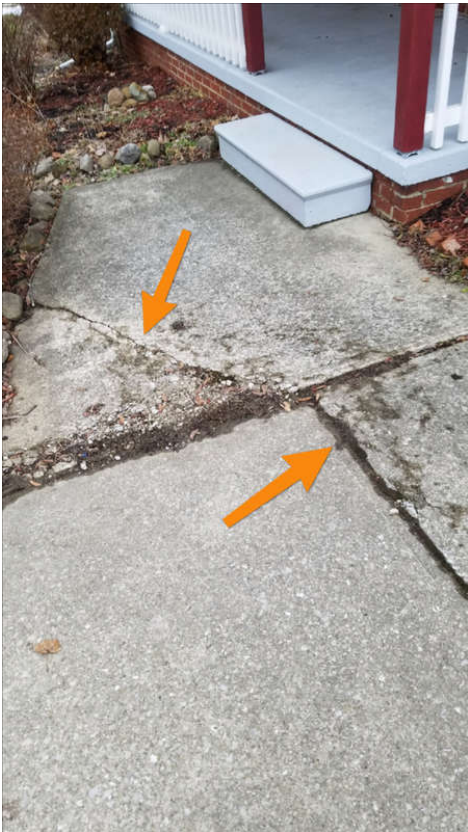
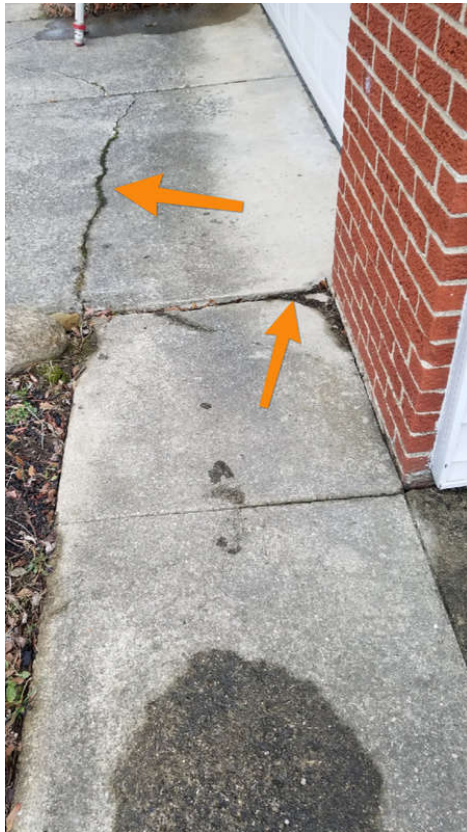
DRIVEWAY/SIDEWALK TRIP HAZARD

Cracks, holes, settlement, heaving and/or deterioration resulting in trip hazards were found in the driveway, For safety reasons, recommend that a qualified contractor repair as necessary.

Contact a qualified masonry professional.

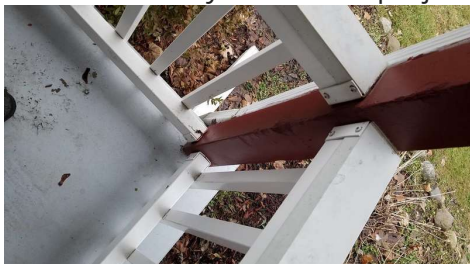
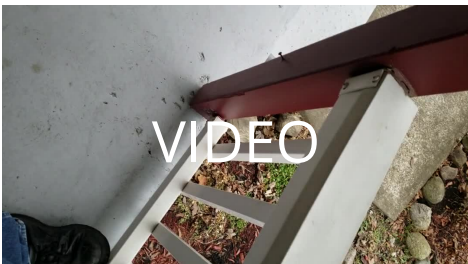
2.3.1 Front porch and steps/guardrail

GUARDRAIL LOOSE

The front porch guardrail is loose in one or more areas. The porch is not more than 30" above grade, so it's not a major safety issue, however it needs to be repaired.

Contact a handyman or DIY project

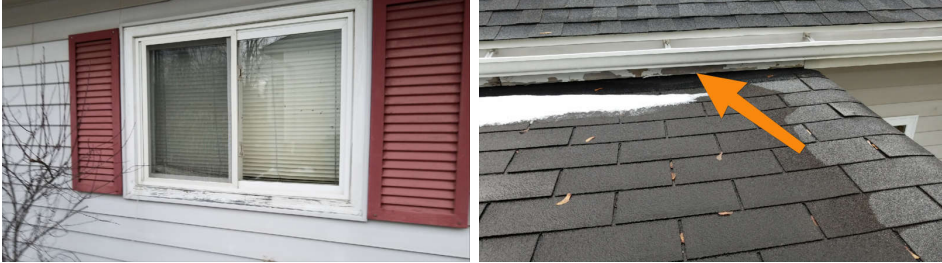
3.1.1 Exterior Walls/Trim

**PAINT FAILING SOME**

The paint finish in some areas was failing (e.g. peeling, faded, worn, thinning). Siding and trim with a failing finish can be damaged by moisture. Recommend that a qualified contractor prep (e.g. clean, scrape, sand, prime, caulk) and repaint the building exterior where necessary and per standard building practices. Any repairs needed to the siding or trim should be made prior to this.

Contact a qualified painter.

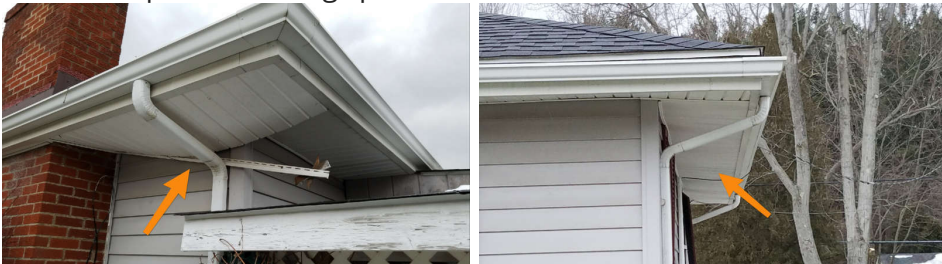
3.1.2 Exterior Walls/Trim

**SIDING/TRIM DAMAGED/LOOSE**

One or more sections of siding and/or trim were damaged. Recommend that a qualified person repair, replace, or install siding or trim as necessary.

Contact a qualified siding specialist.

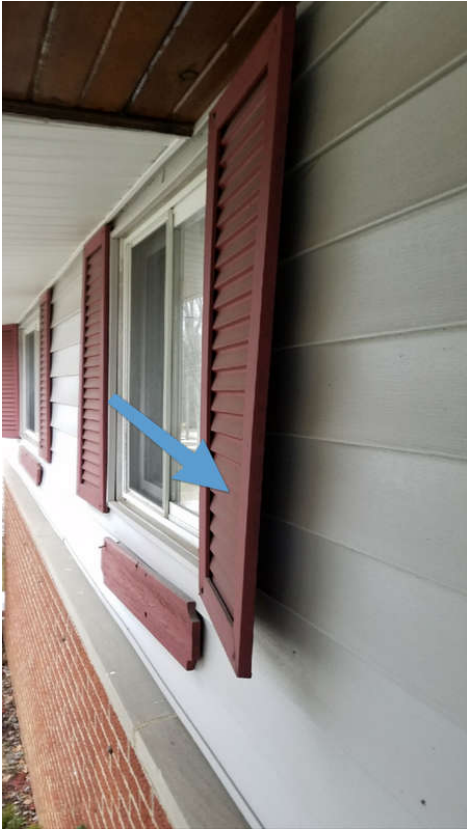
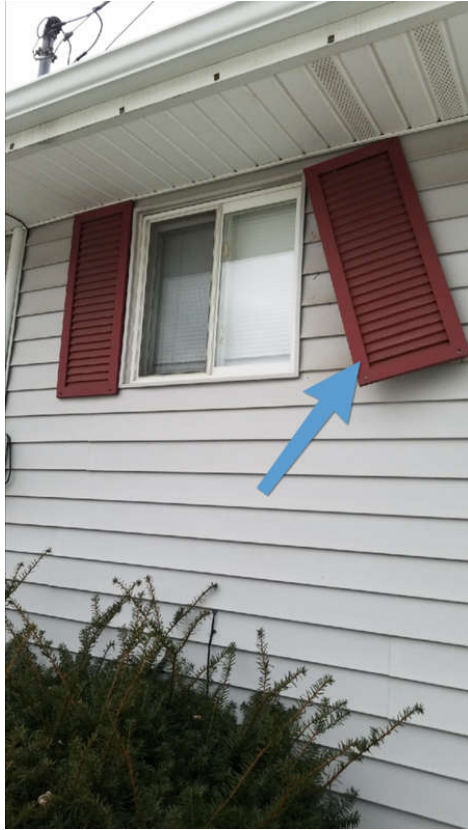
3.2.1 Shutters

**SHUTTERS LOOSE**

One or more shutters were loose. This is generally a simple fix by a qualified handyman. Note however, if the screws are relocated to a different spot be sure to seal the old holds in the siding with a high grade silicone sealant to prevent water infiltration.

Contact a handyman or DIY project

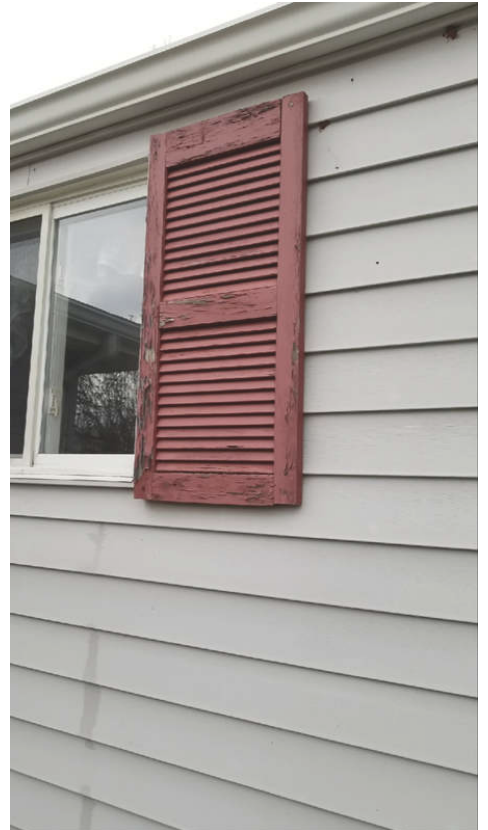
3.2.2 Shutters

FAILING PAINT

Failing paint on one or more shutters was noted. Recommend repair/painting by a qualified person or simply replace them.

Contact a qualified professional.

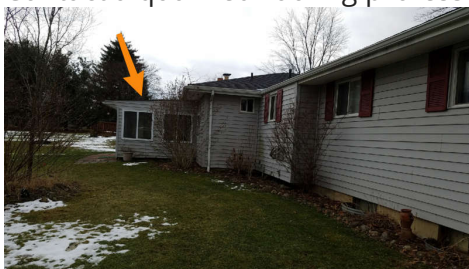
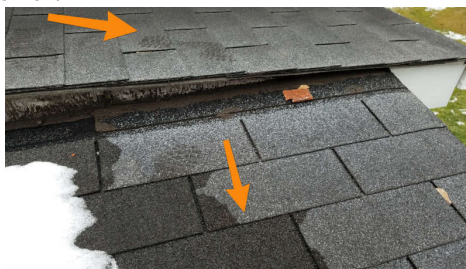
4.2.1 Shingles

Composition shingles were installed on a slope with less than 3/12 (3 inches rise for every 12 inches run). Such low-slope shingle installations are prone to leaks due to the slow rate at which water runs off the shingles. Roof decking can also be prone to sagging. Most shingle manufacturers won't warranty shingles if installed on a roof with a slope less than 3/12. Consult with a qualified contractor regarding this and monitor these roof area(s) and interior spaces below for leaks in the future. Ideally, or if leaks occur, recommend that a qualified contractor repair per standard building practices. Such repairs may involve installing a new roof surface approved for low slopes.

Contact a qualified roofing professional.

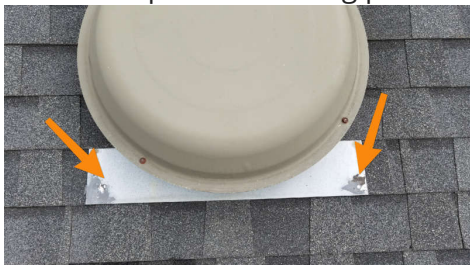
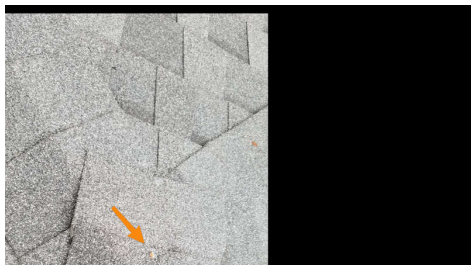
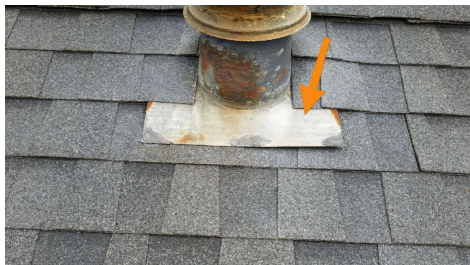
4.2.2 Shingles

Nail heads were exposed at one or more shingles. Recommend applying an approved sealant over exposed nail heads now and as necessary in the future to prevent leaks.

Loose, nail heads exposed

Contact a qualified roofing professional.

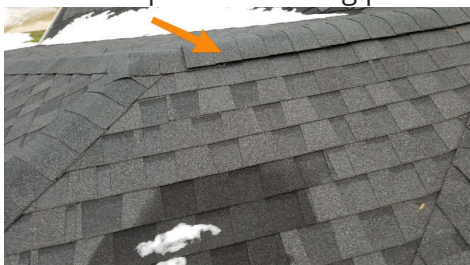
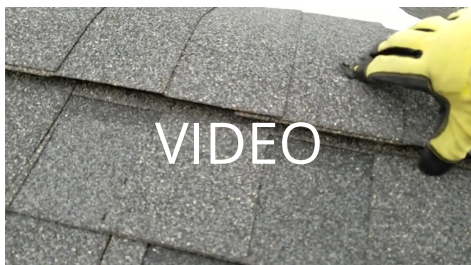
4.2.3 Shingles

LOOSE

Shingles were loose in one or more areas. This will make them very susceptible to being damaged by wind. Recommend qualified roofer to rena and seal as needed.

Contact a qualified roofing professional.

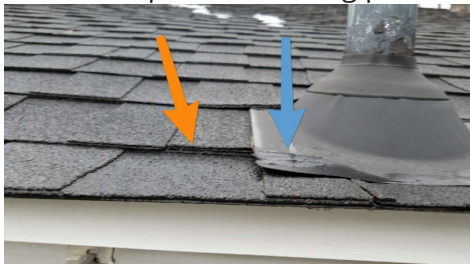
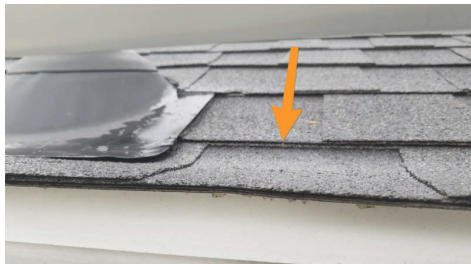
4.2.4 Shingles

In one or more areas the shingles are being pushed up by the drip edge. Recommend qualified roofer to further evaluate and repair as needed so the water runs off unimpeded.

Example location.

Example location

Contact a qualified roofing professional.

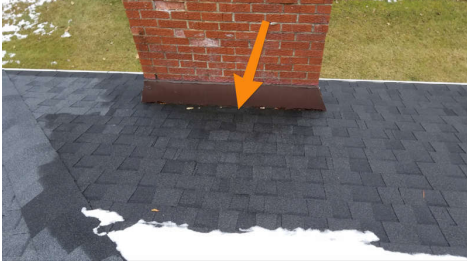
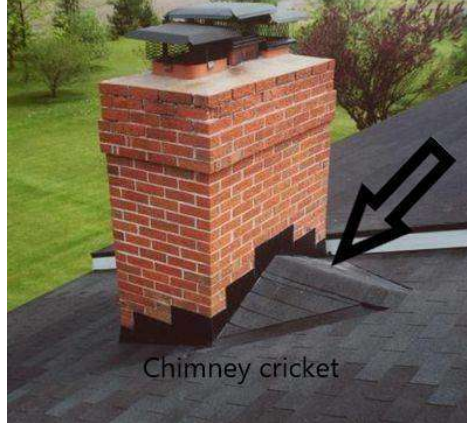
4.3.1 Flashings

**CHIMNEY CRICKET MISSING**

Chimney cricket flashing was missing at one or more chimneys greater than 30" wide. Crickets provide an angular surface to divert water away from behind the chimney where it is prone to collect water and leak. Recommend a qualified roofing contractor evaluate and repair.

Contact a qualified roofing professional.

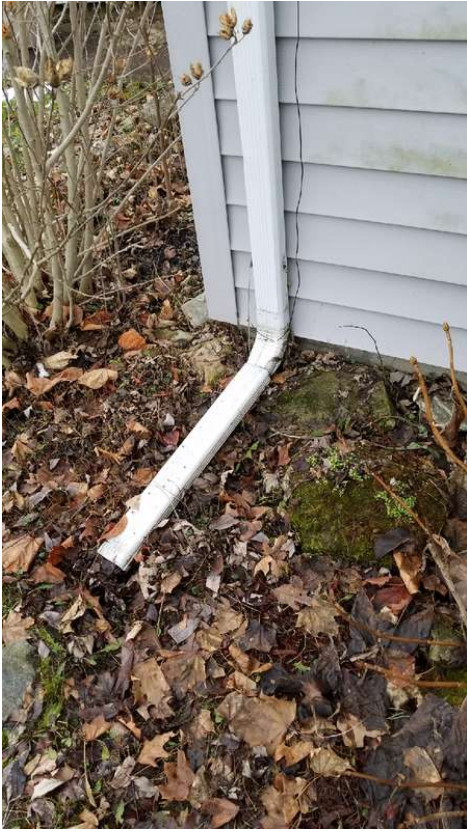
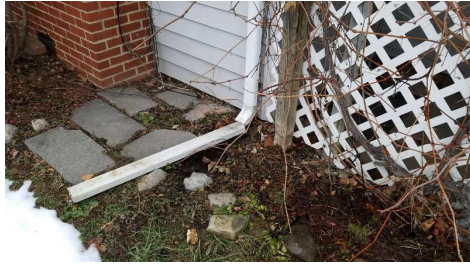
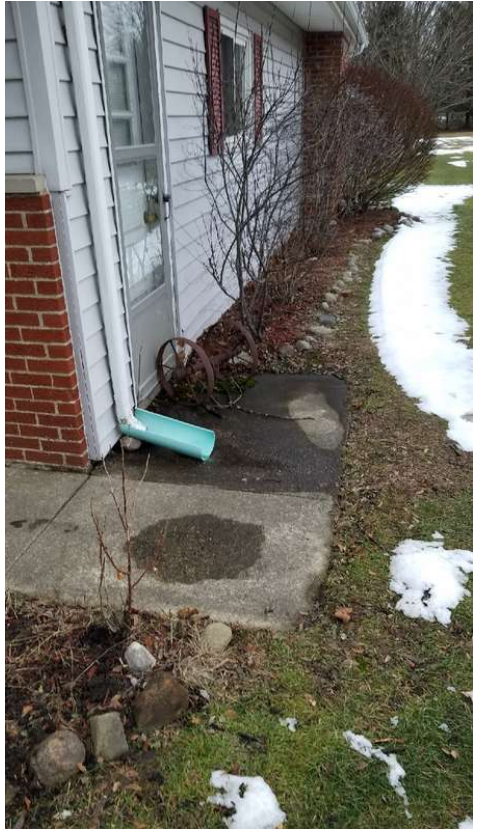
**EXTENSIONS DAMAGED/MISSING**

Extensions such as splash blocks or drain pipes for one or more downspouts were damaged or missing. Recommend that a qualified person install, replace or repair extensions as necessary so rainwater drains away from the structure. Ideally the rain water should drain at least 6ft away from the foundation.

Contact a qualified professional.

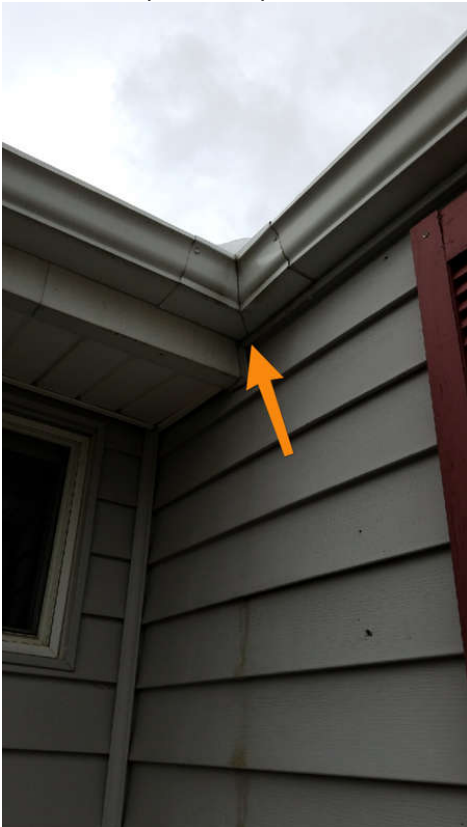
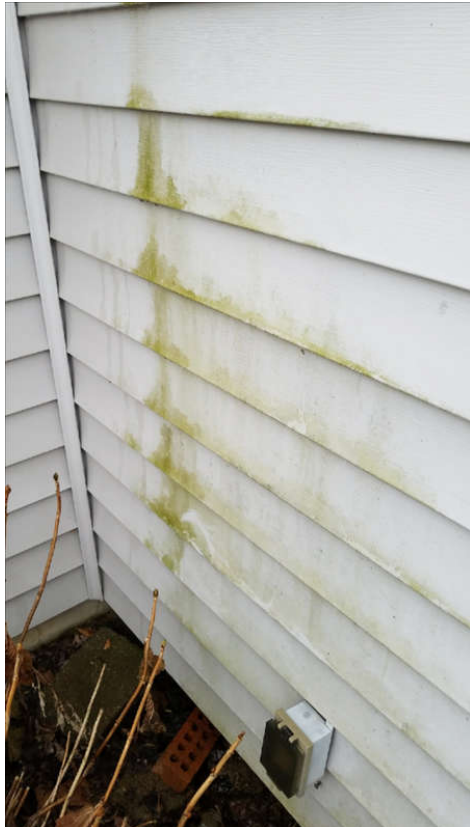
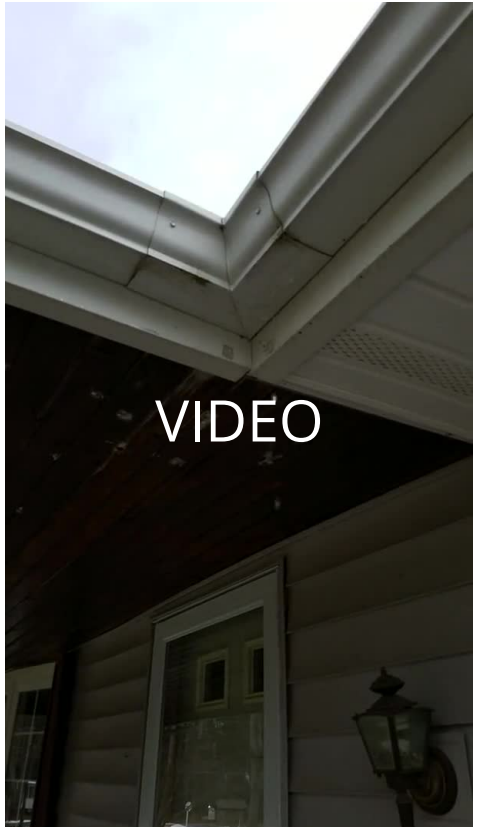
4.4.2 Gutters

LEAKING

One or more portion of the gutters are actively leaking. Recommend repair by a qualified gutter company.

Mildew from leaking gutter

Contact a qualified professional.

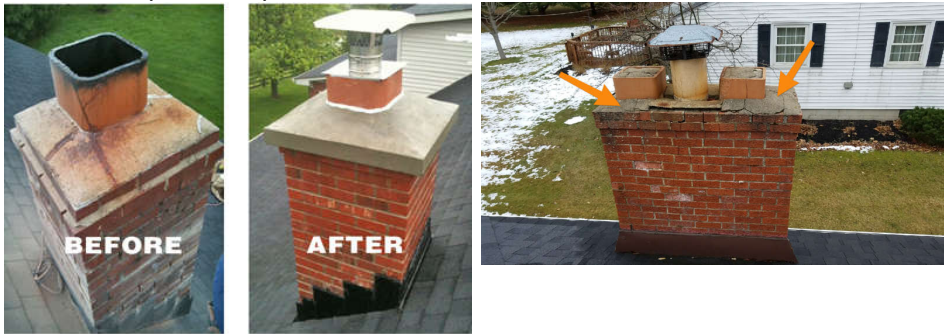
CROWN WORN, CRACKED OR MISSING

The crown on top of the chimney allows rain water to be shed off and away from the chimney masonry. A worn or cracked crown will allow water to penetrate into the mortar joints and cause deterioration of the chimney. Recommend mason to repair/replace crown as needed.

Contact a qualified professional.

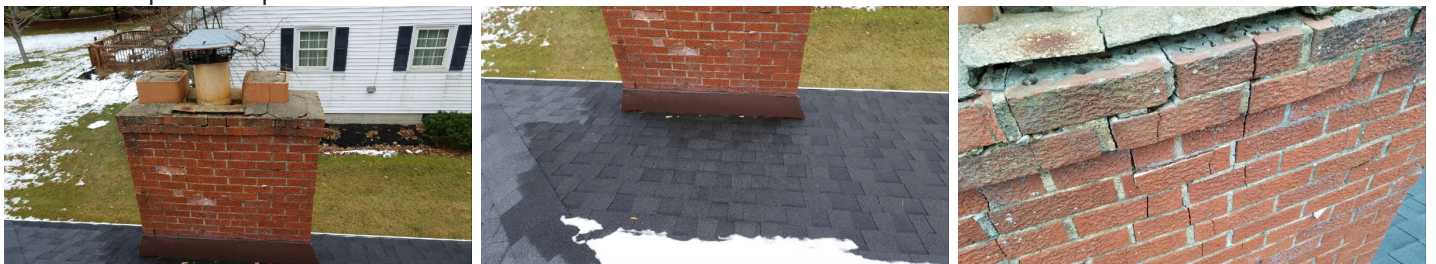
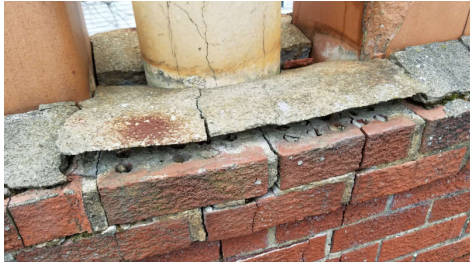
5.1.2 Masonry chimney

SEVERELY DETERIORATED

For example, loose or missing mortar, cracked, broken, loose or spalled bricks. Loose bricks can pose a safety hazard, and deteriorated masonry can allow water to infiltrate the chimney structure and cause further damage. Recommend that a qualified contractor repair as necessary.

Contact a qualified professional.

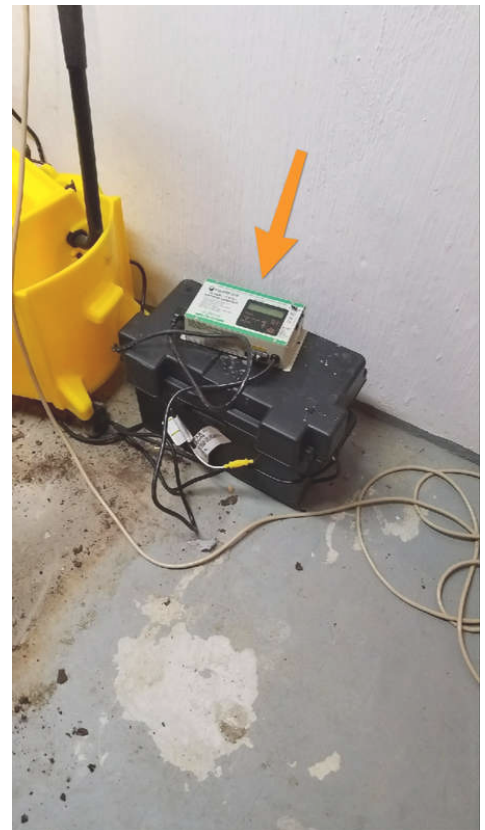
The backup battery system that provides power to the backup pump was not functional at time of inspection. This setup allows for a limited time a way to remove water from the sump pit during a power failure.

Contact a qualified professional.

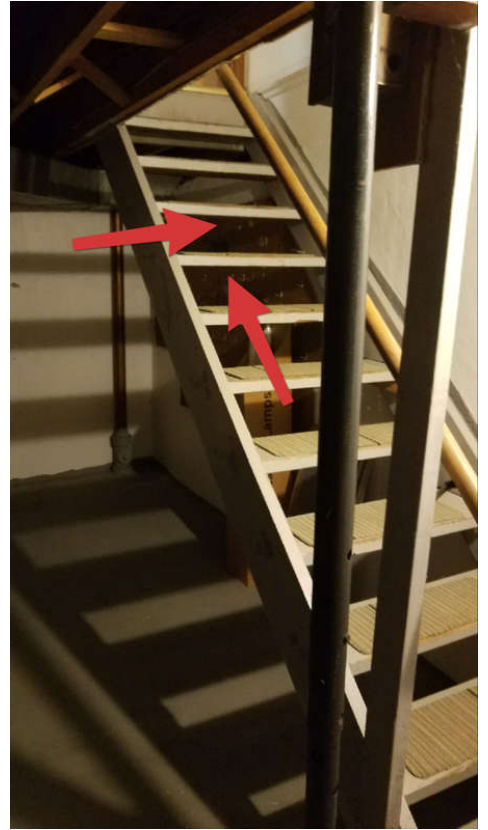
7.2.1 Stairway

No guardrail was present at the stairway that will prevent a little human from falling off and causing bodily harm. Further the stairway also has open risers which is also a hazard to said little human. Recommend a qualified carpenter to close the risers and install a guardrail.

Contact a qualified carpenter.

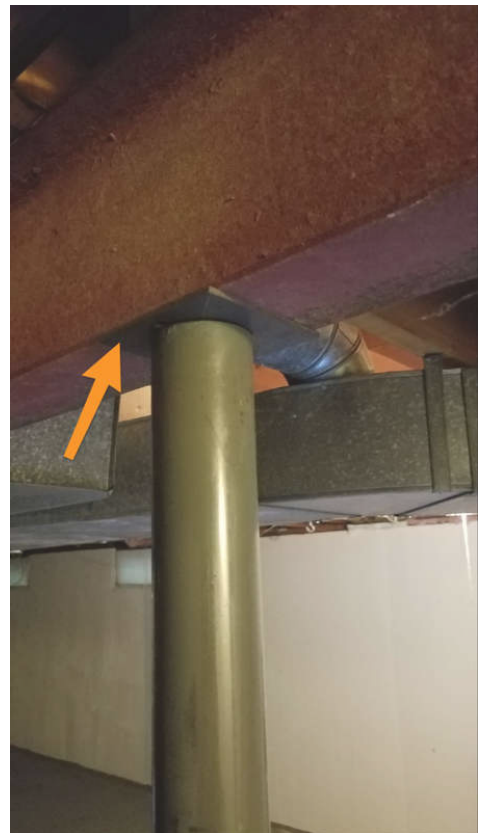
7.3.1 Support post(s)

The top of the steel support posts are not secured to the steel support beam as required to prevent movement should a seismic event occur. Recommend repair by a qualified handyman.

Contact a handyman or DIY project

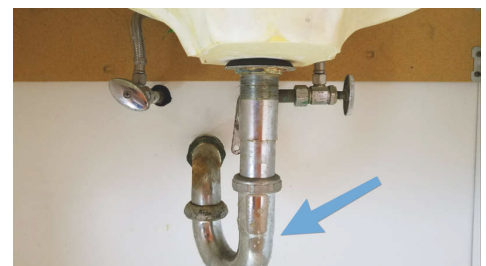
CORROSION P TRAP

Corrosion was noted on one or more chrome plated brass drain line P-traps under sinks. Recommend monitoring for leaks, or be proactive and replace with pvc.

Contact a qualified plumbing contractor.

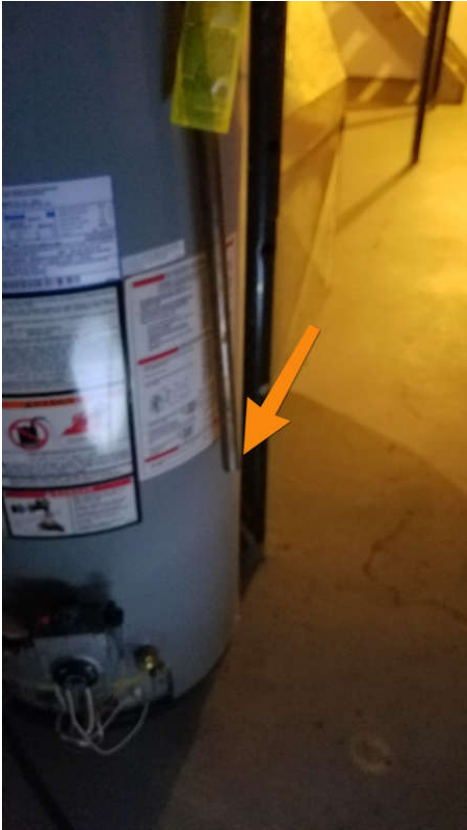
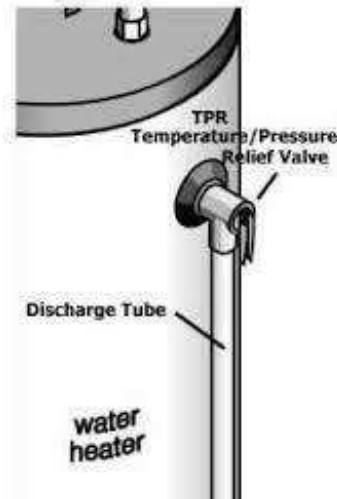
The TPR (temperature-pressure relief) valve drain line was too short. This is a potential safety hazard due to the risk of scalding if someone is standing next to the water heater when the valve opens. Recommend that a qualified plumber repair per standard building practices. For example, by extending the drain line to within 6 inches of the floor for indoor hot water heaters.

Contact a qualified plumbing contractor.

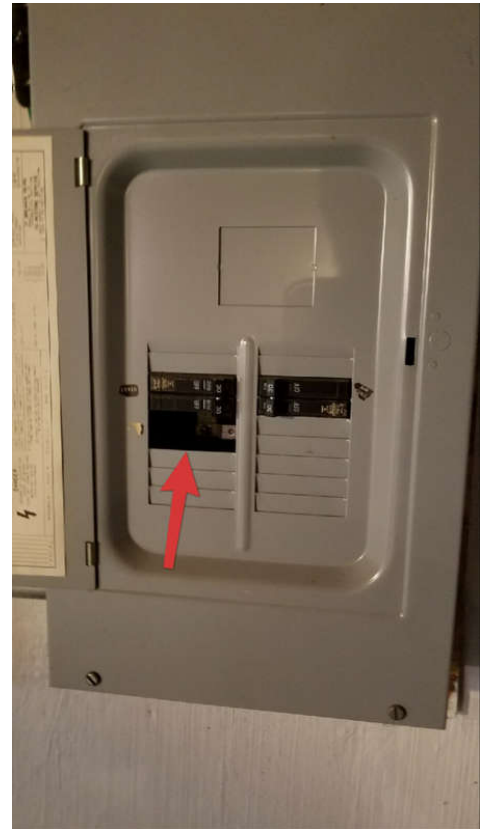
ONE OR MORE SLOTS WHERE CIRCUIT BREAKERS ARE NORMALLY INSTALLED WERE OPEN IN PANEL

One or more slots where circuit breakers are normally installed were open in panel. While they have been covered with duct tape, it is recommend that a more permanent solution be implemented for safety.

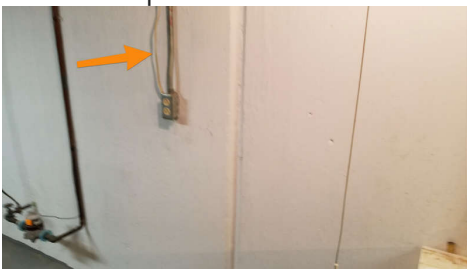
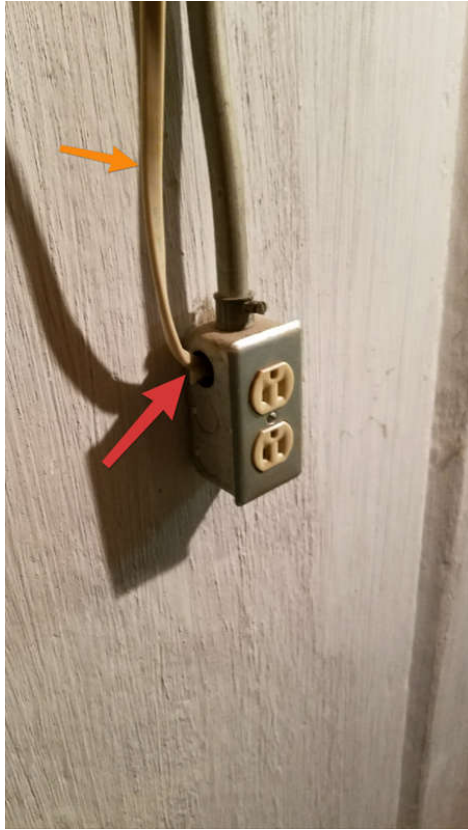
9.4.1 Wiring

EXPOSED NM CABLE

p. Exposed NM was noted in the basement. All NM cable must be protected from damage. Also note the missing cable clamp. Recommend licensed electrician to repair as needed.

Also note missing cable clamp

Contact a qualified electrical contractor.

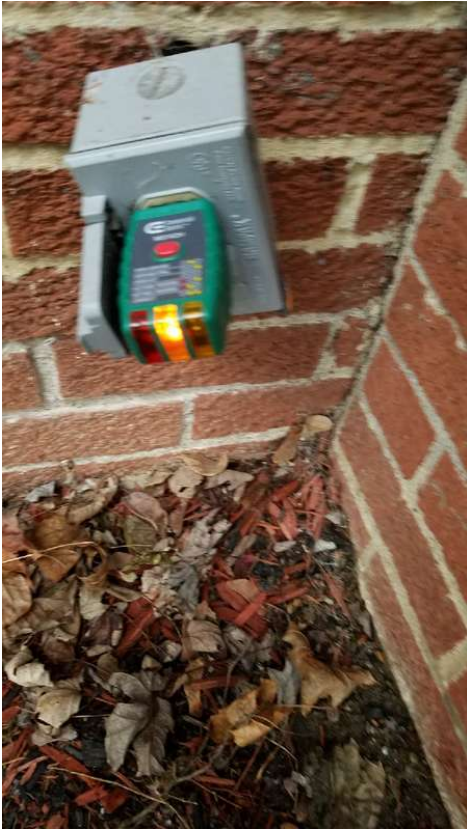
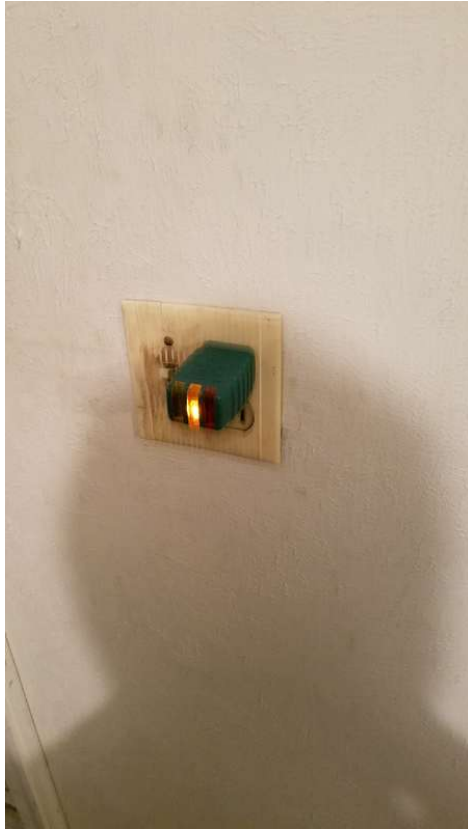
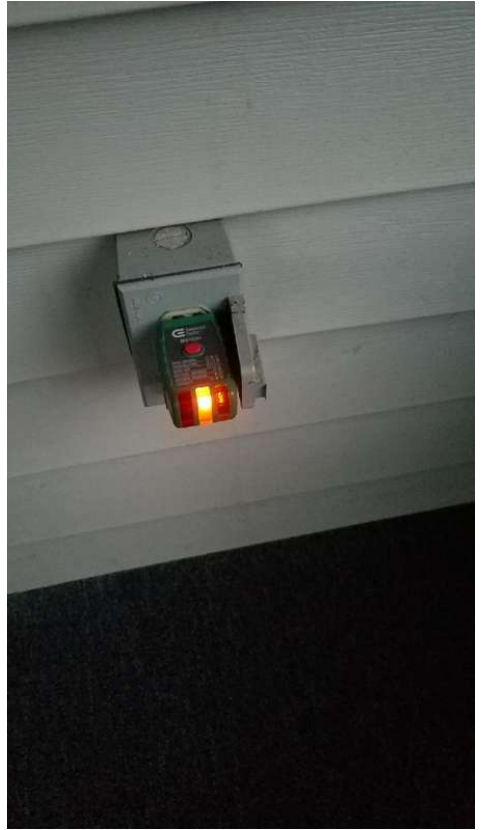
9.5.1 Receptacles

3-slot receptacles (outlets) were installed in one or more areas and tested as not having a ground wire hooked up. As this electric system appears mostly or all grounded, it is likely the wire could be loose, or not hooked up, or a splice somewhere is loose. Recommend a qualified electrician evaluate and repair.

Contact a qualified electrical contractor.

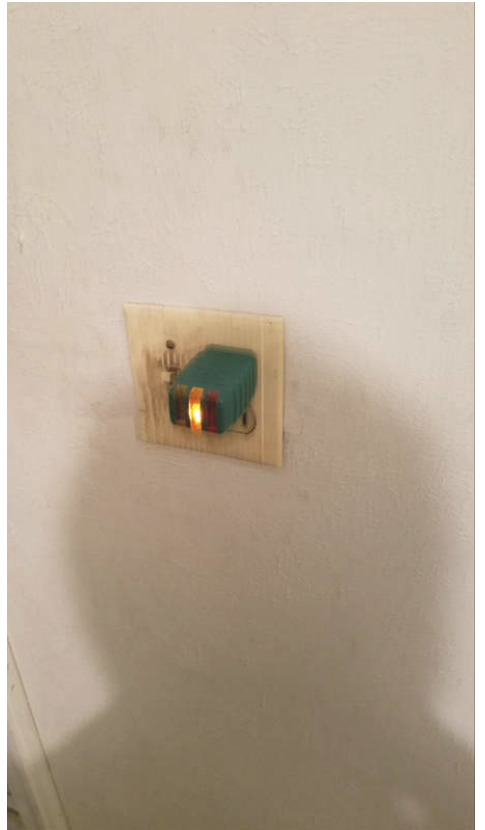
Garage, right of house door

DAMAGED

One or more receptacles (outlets) were broken or damaged. Recommend repair.

Contact a qualified electrical contractor.

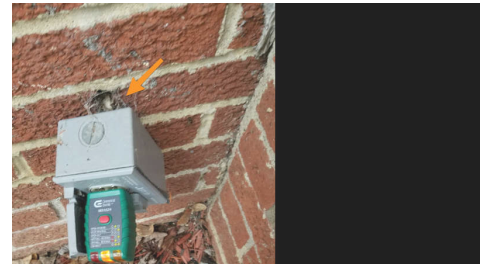
9.5.3 Receptacles

LOOSE WALL BOXES

One or more electric receptacles wall boxes in which they were installed were loose and/or not securely anchored. Recommend that an electrician secure properly.

Contact a qualified electrical contractor.

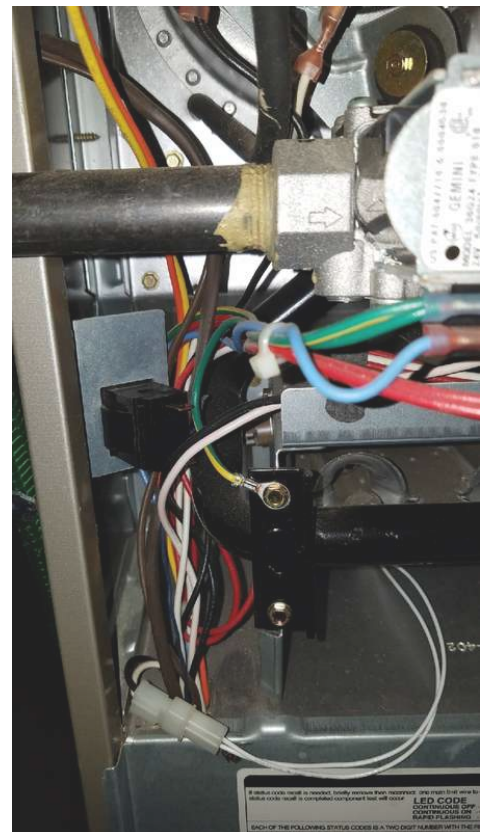
The safety switch that will shut the furnace off if the cover is removed is not functioning properly or is missing. Recommend repair by a qualified HVAC tech next time the furnace is serviced.

Wrong place for safety switch.

Contact a qualified HVAC professional.

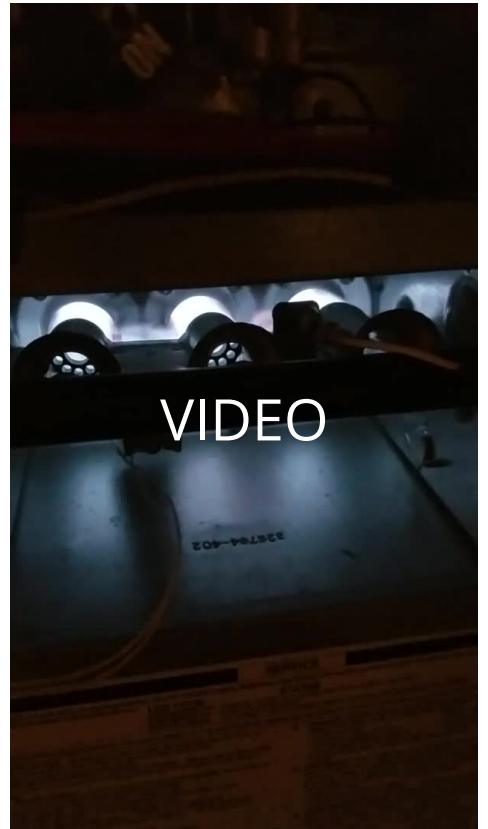
10.1.2 Equipment

The boiler burner flame was not blue in color. Various conditions can cause incorrect flames including incorrect drafting, dirty burner orifices and improper gas pressure. Recommended that a qualified heating contractor evaluate and repair as necessary

Contact a qualified professional.

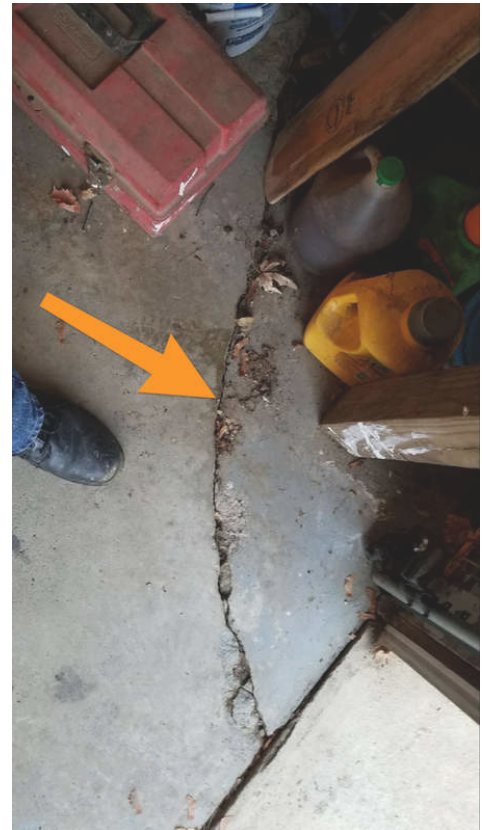
CRACKING MAJOR

Significant cracks, heaving and/or settlement were found in one or more sections of concrete slab floors. Uneven surfaces can pose a trip hazard. Recommend that a qualified contractor repair or replace concrete slab floors where necessary.

Contact a qualified masonry professional.

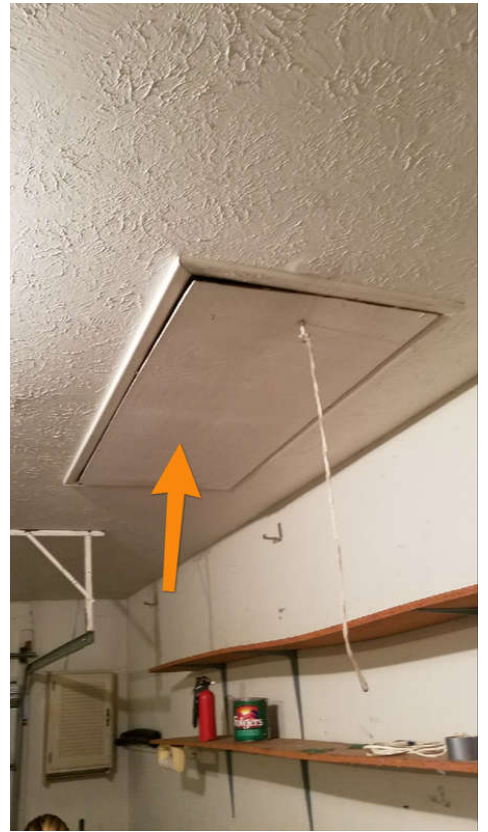
11.3.2 Floor, Walls, Ceiling

Substandard attic pull down steps are installed that compromised the fire barrier of the garage. Attic pull down steps need to be fire resistant if they're to be installed in a garage. Recommend qualified person to install proper pull down steps or close of opening with 5/8ths drywall and finish to match.

Contact a qualified professional.

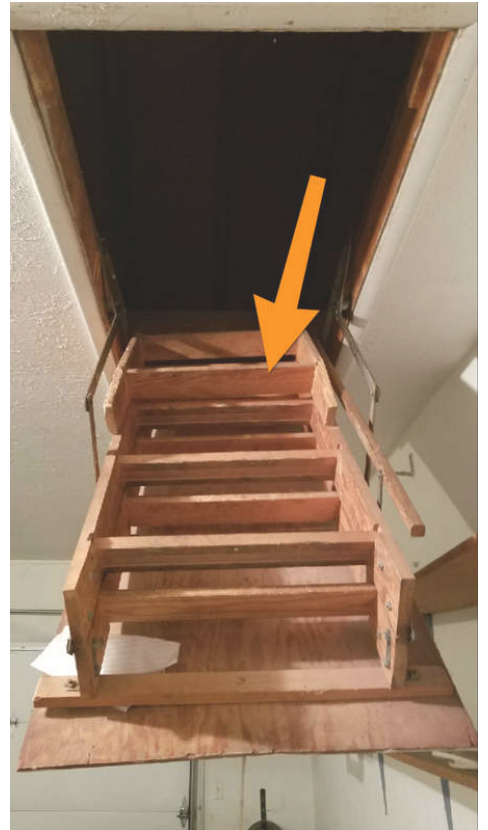
11.3.3 Floor, Walls, Ceiling

**ATTIC PULL DOWN STEPS
DAMAGED**

The attic pull down steps were damaged and pose a severe safety hazard. Recommend replacement by a qualified contractor. Note that since they are in the garage, they will need to be fire rated.

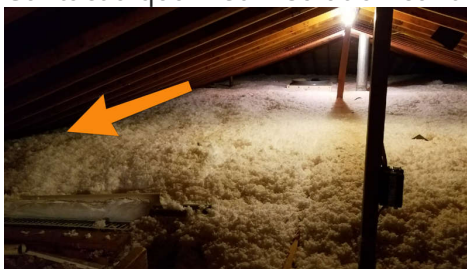
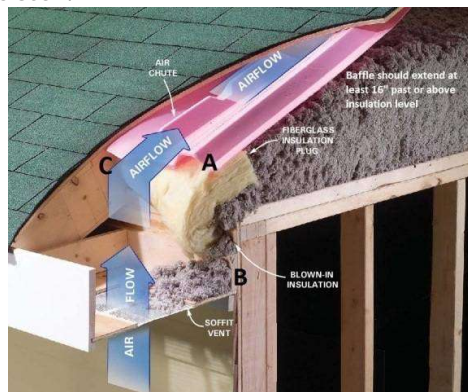
The ceiling insulation in one or more areas of the attic was uneven or substandard. Heating and cooling costs may be higher due to reduced energy efficiency. Recommend that a qualified person repair, replace or install insulation as necessary and per standard building practices (typically R-38).

Contact a qualified insulation contractor.

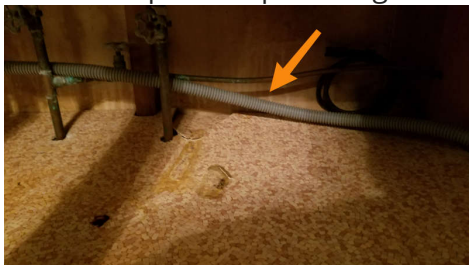
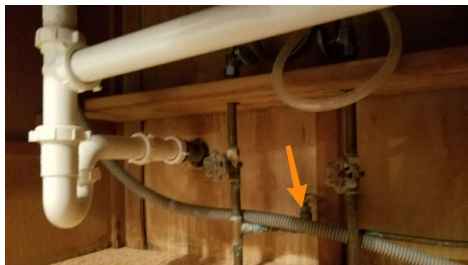
The dishwasher does not appear to have a high loop installed in the drain line, or the inspector was not able to determine if one was present, as some dishwasher come with the high loop already installed on the back of the unit. The high loop prevents water from being siphoned out of the dishwasher. Recommend a qualified plumber to evaluate and install if needed.

Contact a qualified plumbing contractor.

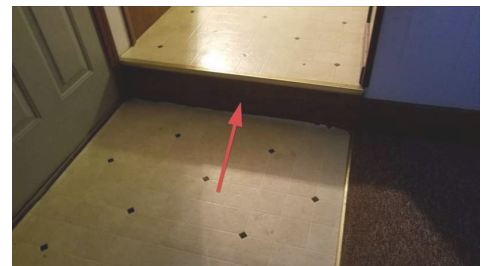
TRIP HAZARD

Note that this step into the kitchen is more than 7 3/4" which makes it a trip hazard. Trying to repair it probably won't make much sense, just know that if you were to adding thick flooring in the kitchen it will worsen the problem. Recommend if possible to remove any existing flooring and subflooring before a new floor is put down.

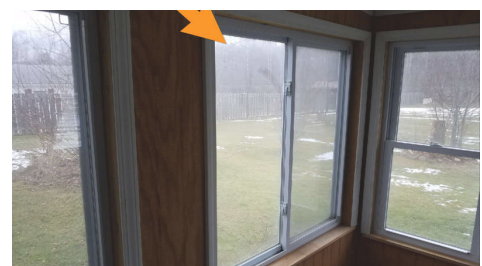
16.2.1 Windows

FOGGING

Condensation or staining was visible between multi-pane glass in one or more windows. This usually indicates that the seal between the panes of glass has failed or that the desiccant material that absorbs moisture is saturated. As a result, the view through the window may be obscured, the window's R-value will be reduced. Recommend that a qualified contractor evaluate and repair windows as necessary. Usually, this means replacing the glass or the entire window.
