WEBER HOME INSPECTION SERVICES

RESIDENTIAL REPORT

1234 Main St.
Marine on St. Croix MN 55047

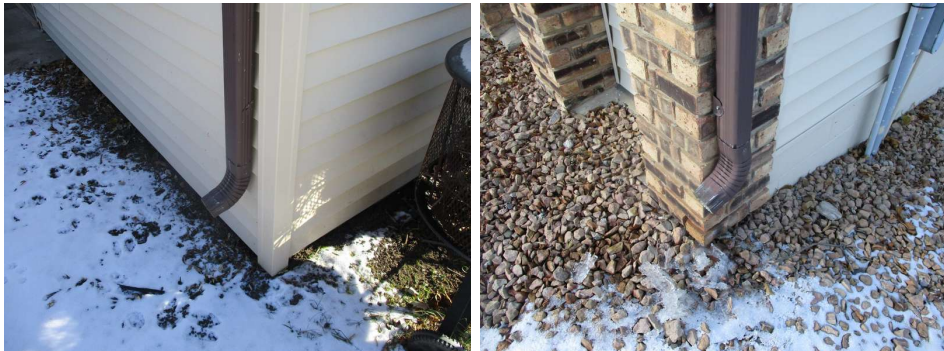
2.2.1 Roof Drainage Systems

DOWNSPOUTS DRAIN NEAR HOUSE

One or more downspouts drain too close to the home's foundation. This can result in excessive moisture in the soil at the foundation, which can lead to foundation/structural movement. Recommend a qualified contractor adjust downspout extensions to drain at least 6 feet from the foundation.

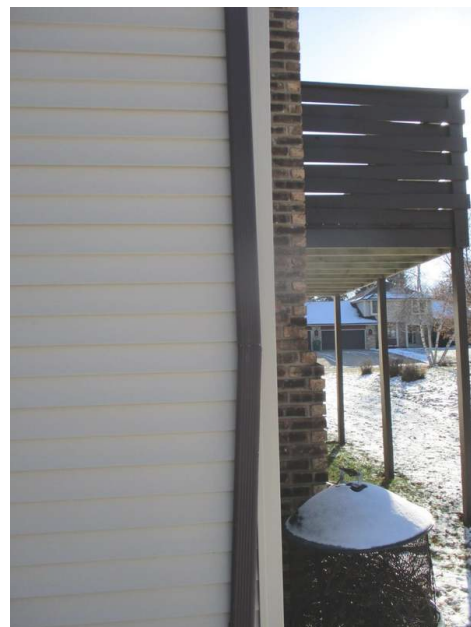
2.2.2 Roof Drainage Systems

LOOSE DOWNSPOUTS

Downspouts that are loose should be resecuring to the side of the house.

Contact a qualified professional.

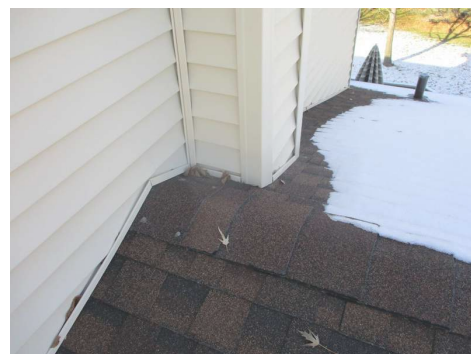
2.3.1 Flashings

LOCATION VULNURABLE

AT THE EAST SIDE

The location of flashings leaves them vulnerable to leakage. They should be carefully monitored.

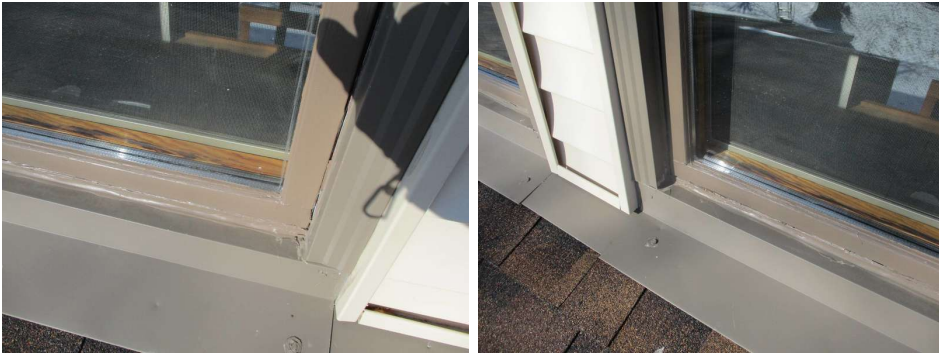
3.4.3 Windows

CLERESTORY WINDOWS

The clerestory windows are old and vulnerable. They have previously been caulked shut.

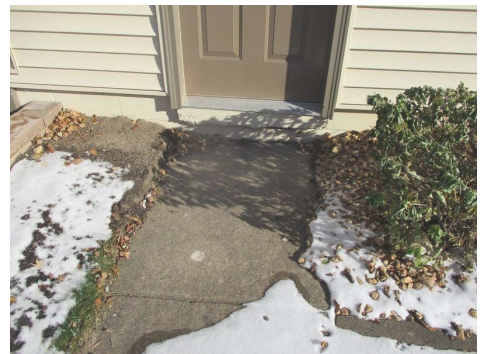
3.5.1 Walkways, Patios & Driveways

WALKWAY SETTLED TOWARD HOUSE

AT THE SIDE GARAGE ENTRY.

The walkway appears to slope towards the house. This condition can promote moisture seepage. Unfortunately, it is difficult to improve this situation without resurfacing the walkway adjacent to the foundation.

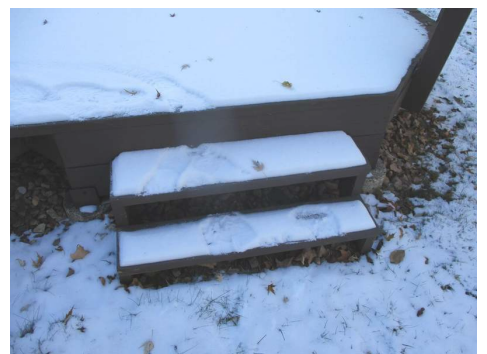
3.6.1 Decks, Balconies, Porches and steps

STAIRS

Contact a qualified professional.

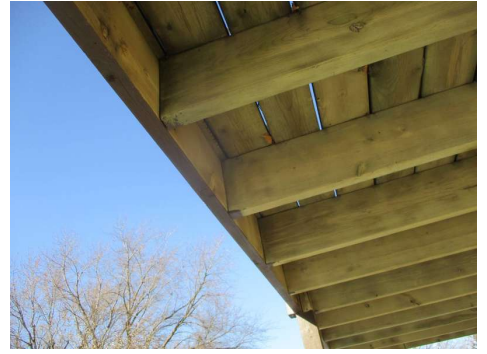
3.6.2 Decks, Balconies, Porches and steps

AT THE WEST ELEVATED DECK

Joist hanger(s) are missing or improperly installed. This could cause the deck structure to fail. Recommend that joist hangers be properly installed by qualified contractor.

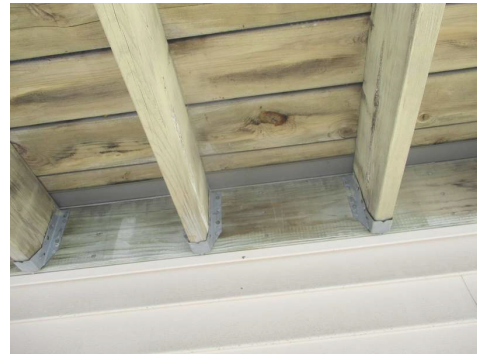
3.6.3 Decks, Balconies, Porches and steps

LEDGER BOARD IMPROPERLY INSTALLED

The ledger board is not properly attached to the building. This can cause the deck to pull away from the building and possibly collapse. Recommend that the deck and/or ledger board be properly attached by qualified contractor using through bolts or lag screws.

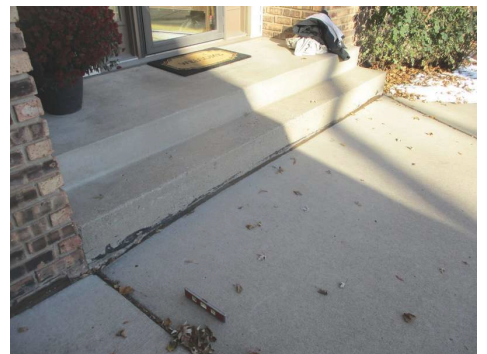
TRIP HAZARD

Heaving or settling of the concrete can create a trip hazard. Often, the step down at the stoop exceeds what is typical or normal for a step. This also creates a trip hazard. Improvements should be undertaken as necessary.

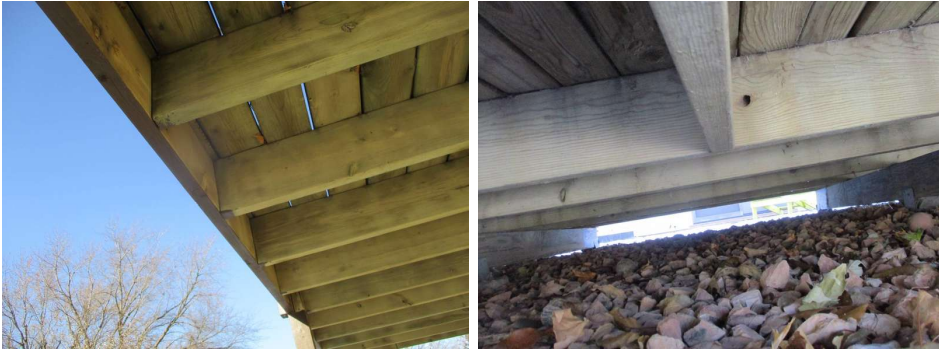
3.6.6 Decks, Balconies, Porches and steps

OVERSPANNED JOISTS

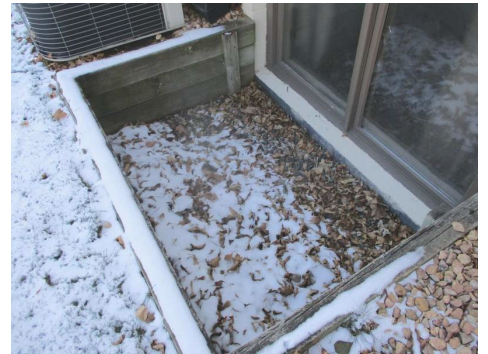
3.8.1 Vegetation, Grading, Drainage & Retaining Walls

WINDOWS WELL IMPROVEMENT

Window wells should be cleaned and improved to prevent leakage and to protect the window.

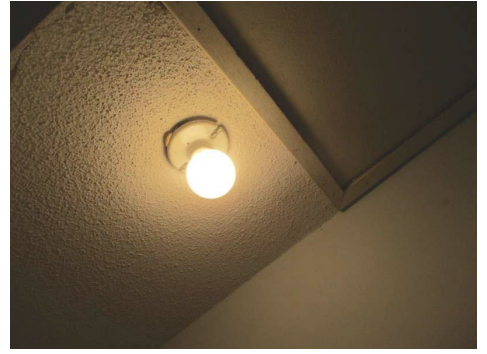
Exposed light bulb fixtures in closets or storage spaces can be a fire hazard. Covered fixtures should be used.

Contact a qualified professional.

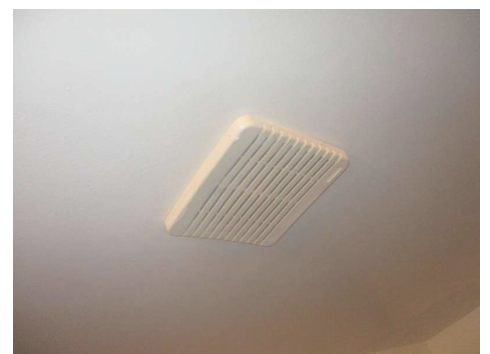
BATHROOM FAN INADEQUATE

IN THE HOT TUB ROOM

Exhaust fans with inadequate flow should be repaired or replaced.

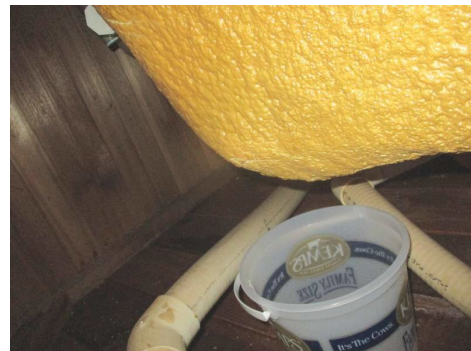
12.9.10 Bathrooms

WHIRLPOOL TUB LEAK

Leaks in the whirlpool tub should be repaired as required.

Contact a qualified professional.

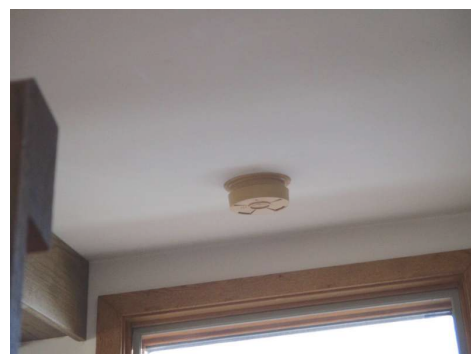
AT THE TOP OF THE LOFT

Old smoke detectors lose their effectiveness and should be replaced.
