RESIDENTIAL PROPERTY INSPECTION

1234 Main St.
Mt. Pleasant MI 48858

Buyer Name
05/14/2019 9:00AM

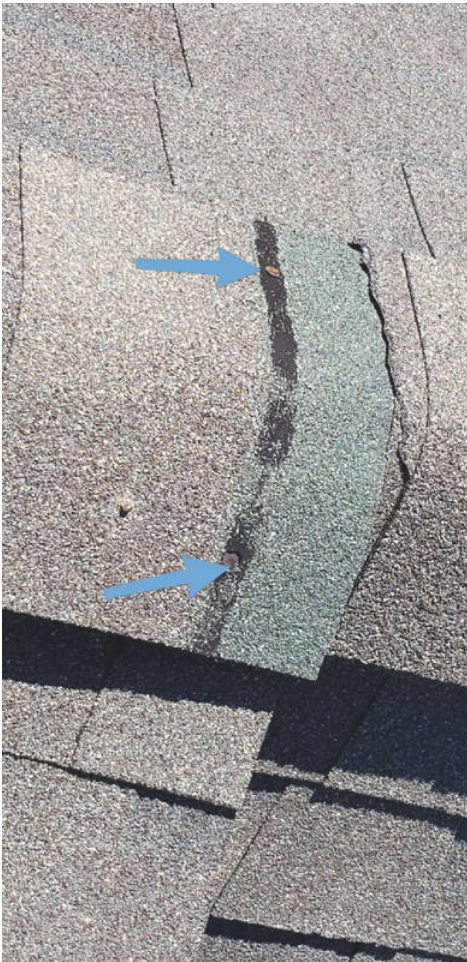
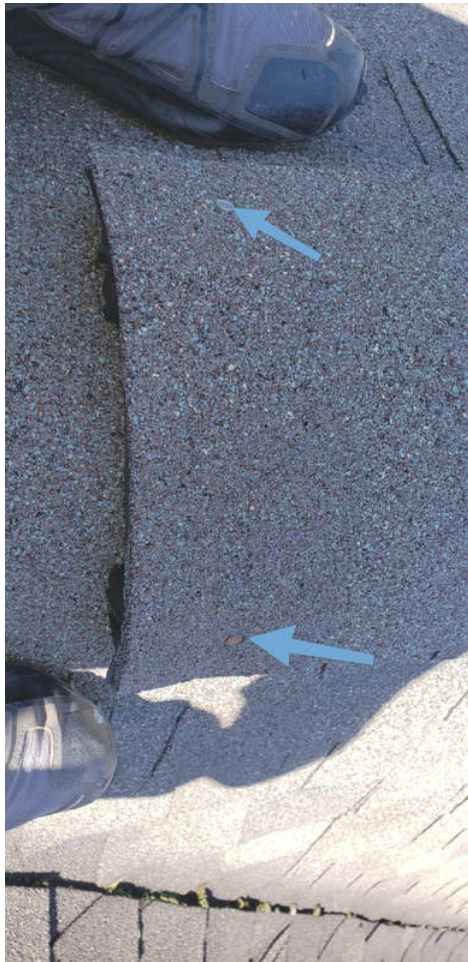
-   2.1.1 Roof - Roof Surface Condition: Exposed Nail Heads - Ridge Vent
-   2.1.2 Roof - Roof Surface Condition: Moss Growth on Shingles
-   2.1.3 Roof - Roof Surface Condition: Unsecured Shingles Present

Contact a qualified professional.

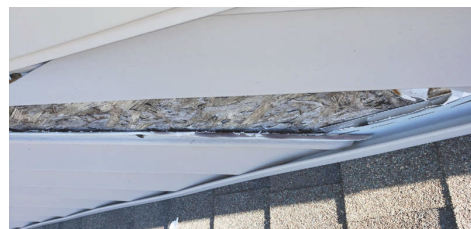
4.1.4 Walls / Cladding

SIDING MISSING

Marginal Defect

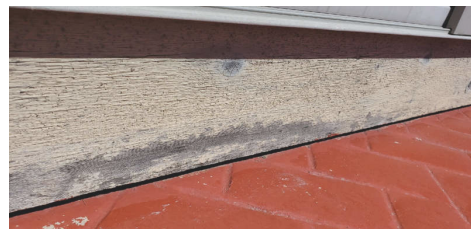
4.5.1 Sealant / Paint Overall

FLAKING PAINT - WEATHERED WOOD

Marginal Defect

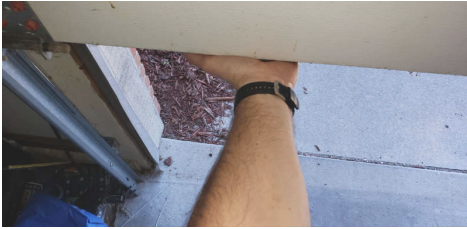
5.4.1 Garage Door Safety

Without a properly installed safety reversal system, persons (particularly small children) could be SERIOUSLY INJURED or KILLED by a closing garage door.

Contact a qualified garage door contractor.

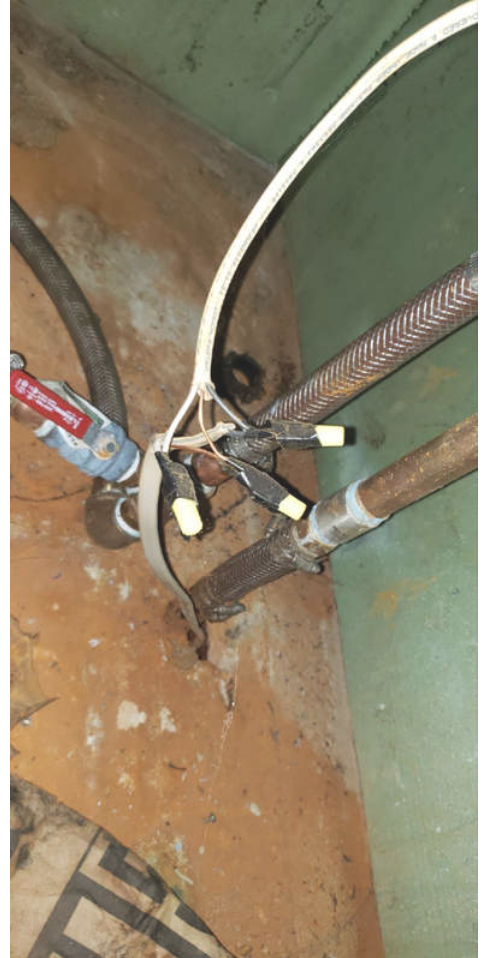
8.9.1 Branch Wiring

Marginal Defect

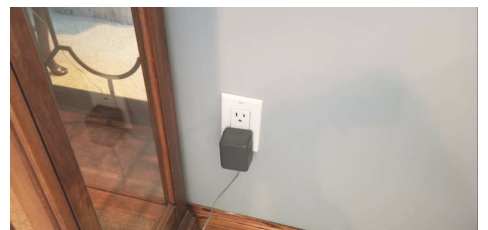
8.10.1 Receptacles

LOOSE AT WALL

Marginal Defect

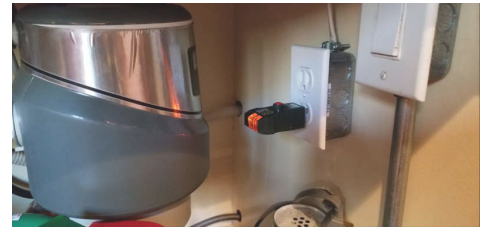
8.11.1 GFCI Protection

GFCI protection was not present/found at the areas referenced at the top of the electrical section of the report, at the time of inspection. GFCI protection is recommended for the exterior, garage, and basement receptacles for safety, as well as kitchen and bathroom receptacles within 6 feet of a water source. Installation or repairs as needed to ensure GFCI protection is present at all recommended locations for safety is recommended by a licensed electrician.

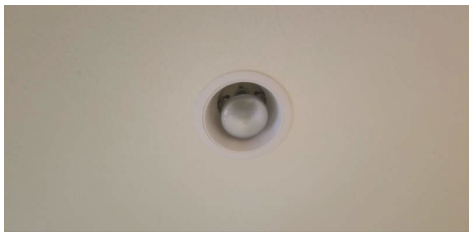
There were light(s) present that were not functional. This could be something as simple as a burned out bulb, or be more extensive. Confirming proper operation is recommended prior to closing. If these lights can not be verified to be functional prior to closing, evaluation and repairs as needed for proper operation is recommended by a licensed electrician.

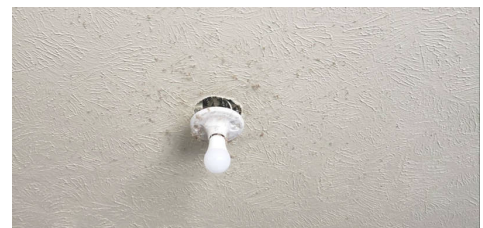
There were exterior light(s) present that were not secured properly. Repairs are recommended as needed to properly secure the fixture(s) by a licensed electrician or other qualified person.

Contact a qualified handyman.

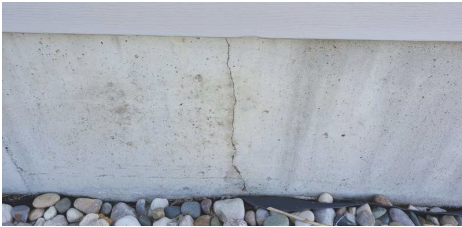
Cracking was present on the foundation wall(s). The crack(s) appeared to have no irregular gapping, visible signs of settlement, or lateral displacement associated with them at the time of inspection.
