GOLDEN STAR RESIDENTIAL REPORT COPY

1234 Main St.
Spokane, WA 99205

Buyer Name
07/02/2019 9:00AM

Inspector
Aaron Storer

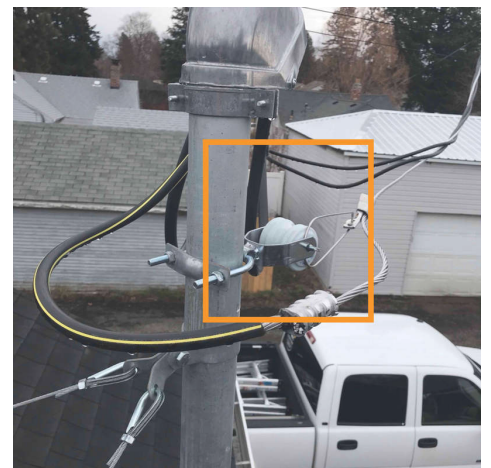
2.9.1 Service Entrance Conductors

IMPROPERLY SUPPORTED

SOUTH

The overhead service entrance conductors were not properly secured. Recommend repair by a licensed electrical contractor.

Contact a qualified electrical contractor.

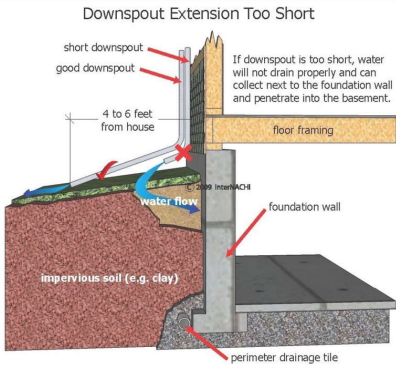
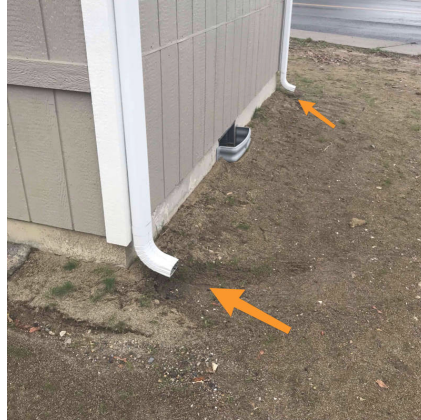
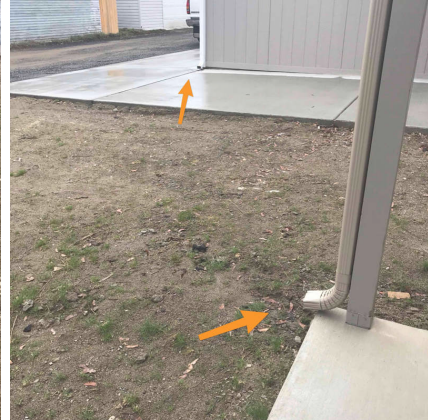
3.2.1 Roof Drainage Systems

DOWNSPOUTS DRAIN NEAR HOUSE

One or more downspouts drain too close to the home's foundation. This can result in excessive moisture in the soil at the foundation, which may lead to foundation/structural damage. Recommend a qualified contractor adjust downspout extensions to drain at least 6 feet from the foundation.

Contact a qualified professional.

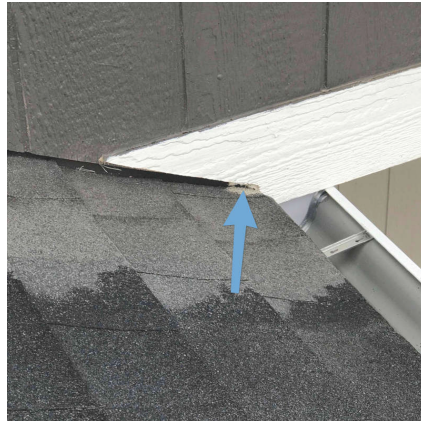
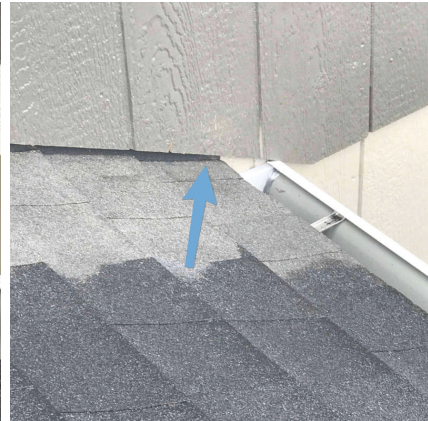
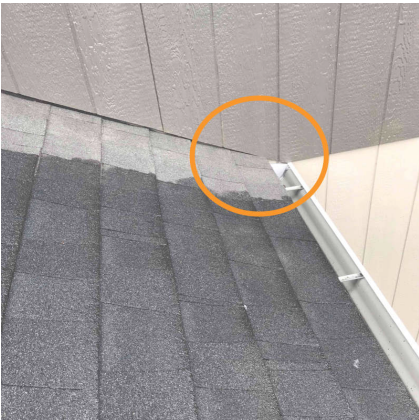
3.3.1 Flashings

KICKOUT FLASHING

Some kick-out flashing appeared to be missing where the roof meets the siding. Some siding was too close or touching the roofing materials. This may allow for faster deterioration of siding and trim or possible moisture intrusion. Recommend repair by a licensed roofing contractor.

Contact a qualified roofing professional.

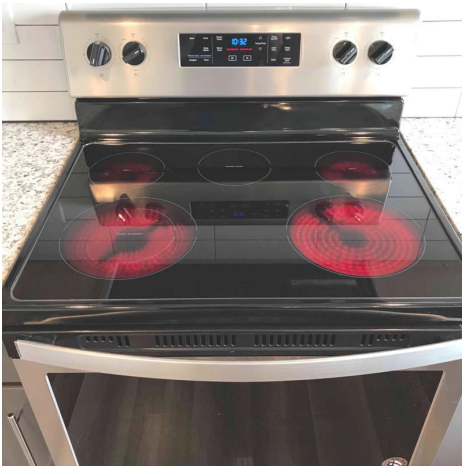
Range And Oven: New Appliance

The oven was new and when tested produced some smoke. This was likely due to it being the first time it was started and the smoke was from the light coat of protective oil applied during manufacturing. Recommend monitoring closely the next time it is started.

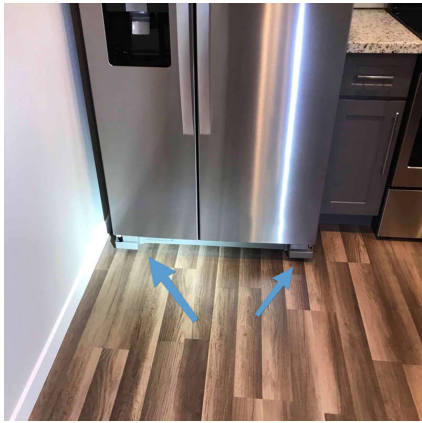
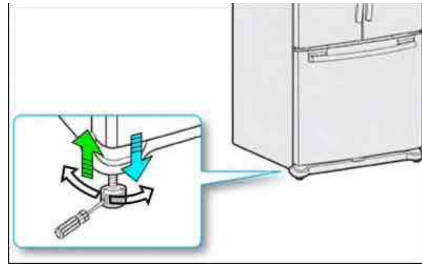
5.8.1 Refrigerator

LEVELING PADS

The refrigerator appeared to be missing the leveling pads. The refrigerator rolled/moved easily when opening the doors. Recommend repair by a qualified appliance repair professional.

Contact a qualified appliance repair professional.

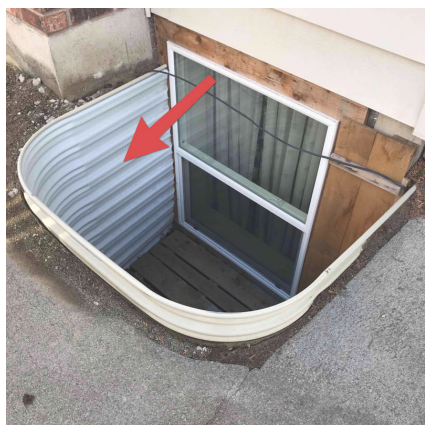
7.1.1 Exterior Doors, Windows

BASEMENT EGRESSABLE WINDOW

Basement egressable window well appeared to be deeper than 44 inches. A permanently affixed ladder is recommended when higher than 44 inches. Recommend repairs and painting the trim by a qualified professional.

Contact a qualified professional.

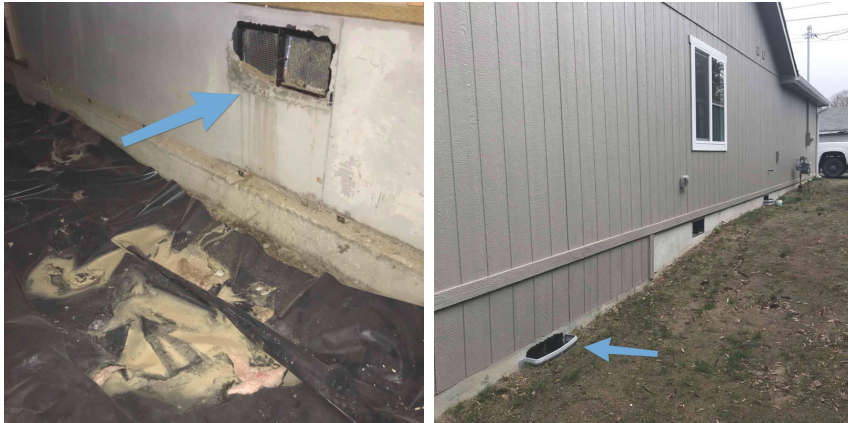
11.2.1 Foundation

FOUNDATION WALL VENTS

One or more wall vents has allowed for moisture intrusion. Recommend removing excessive snow from these vents during the winter months.

Recommend monitoring.

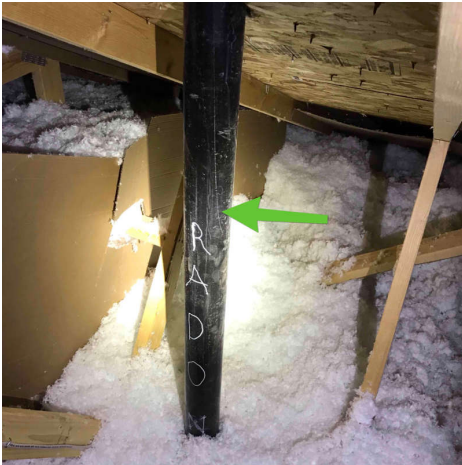
Radon Mitigation: Radon Mitigation Partially Installed

A radon mitigation system was observed at the time of inspection. It appeared to be partially installed and was not finished.

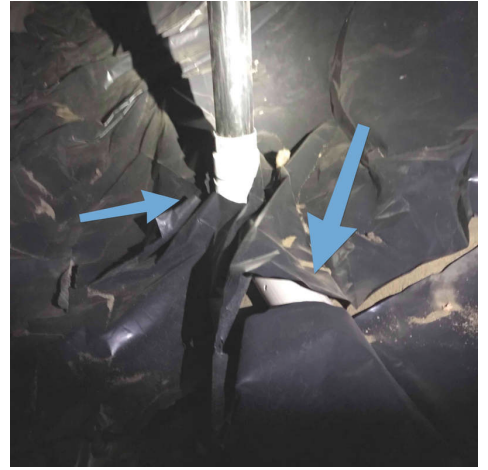
12.7.1 Radon Mitigation

IMPROPER INSTALLATION

CRAWLSPACE

The radon mitigation system appeared to be partially installed (ruffed-in) as seen from the crawlspace. The piping for radon should be under a sealed vapor barrier and the gases should be directed/exhausted above the roof. Recommend testing for elevated radon levels above 3.9 pCi/L of air. If found to be elevated then evaluation and repairs as needed by a licensed/certified radon mitigation contractor may be warranted.

Contact a qualified environmental contractor
