RESIDENTIAL

1234 Main St.
Humble TX 77339

07/18/2018 9:00AM

PROPERTY INSPECTION REPORT

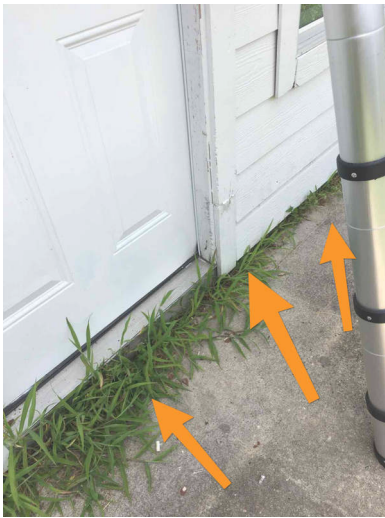
Back of home

1: Vegetation growth

Weeds and vegetation are growing in the back of the home between the foundation and the back patio slab. This could be a water intrusion problem and should be corrected by removing the vegetation and sealing the area.

Recommendation: Contact a qualified landscaping contractor

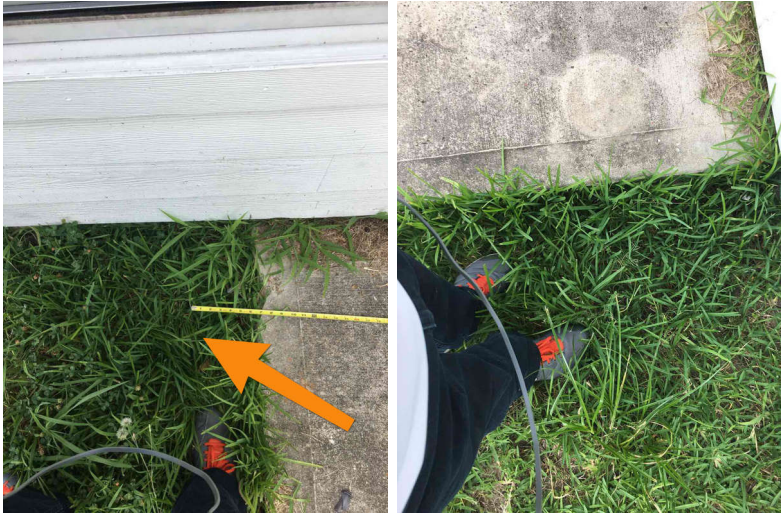
Throughout the perimeter of the home.

1: Negative Grading

Grading is sloping towards the home in some areas. This could lead to water intrusion and foundation issues. Recommend qualified landscaper or foundation contractor regrade so water flows away from home.

My foot is in a hole about 4 this inches below grade.

Recommendation: Contact a qualified landscaping contractor

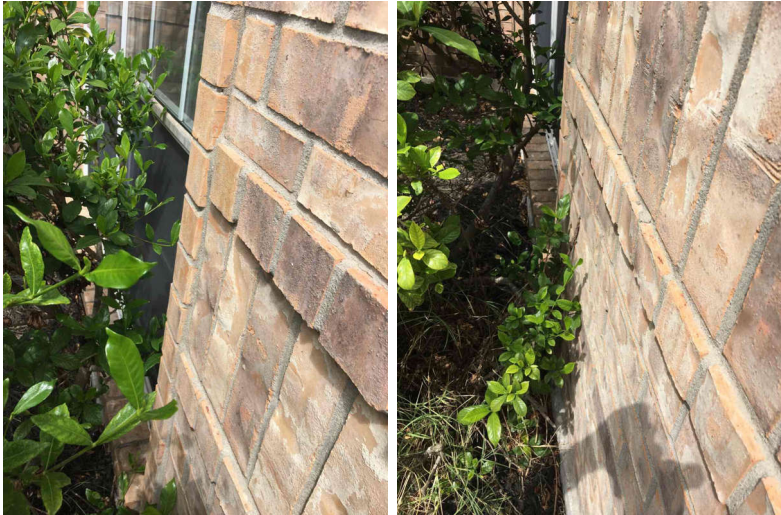
2: Vegetation close to structure

Vegetation close to structure. There are bush branches rubbing up against the exterior of the house and the front screen window.

Recommendation: Recommended DIY Project

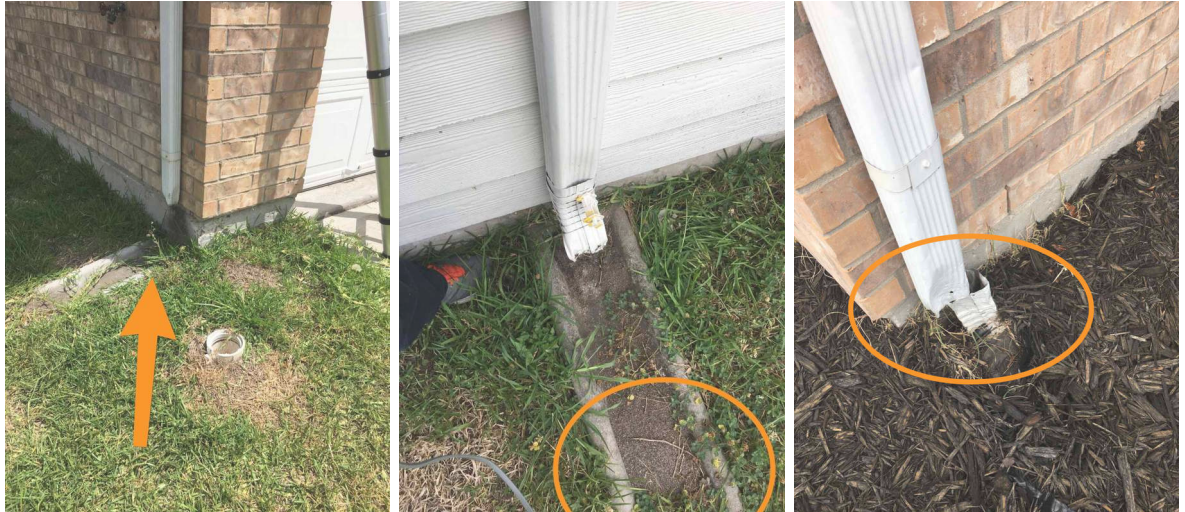
All downspouts around the house.

3: Downspouts and splashblocks

Drainage splash blocks are sunken below grade. This should be brought up to grade and re-leveled so that it moves water away from the structure. They are also filled with debris at the end. This will cause puddling which could result in water resting up against the foundation.

The bottom elbows of several of the down spouts are damaged or missing.

Debris

Recommendation: Contact a qualified landscaping contractor

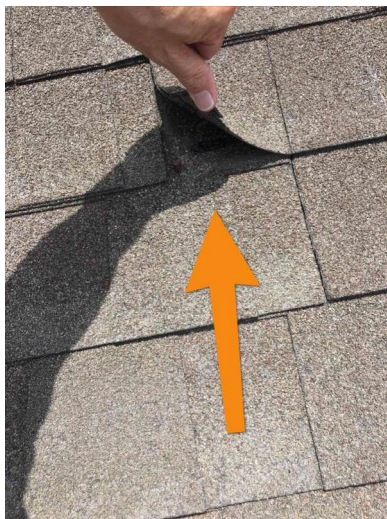
1: Exposed Nails

Under-driven or exposed nails were found in one or more roof coverings. Recommend a qualified roofer evaluate and correct.

Recommendation: Contact a qualified roofing professional.

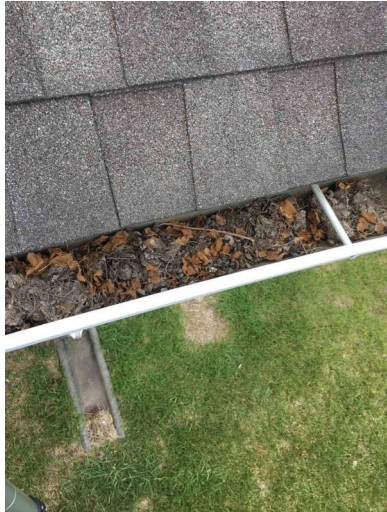
2: Clogged gutters

Gutters are clogged the back rear of the house. This will prevent proper water shed from roof and lead to possible water intrusion. Gutters should be checked and cleaned annually.

Recommendation: Recommended DIY Project

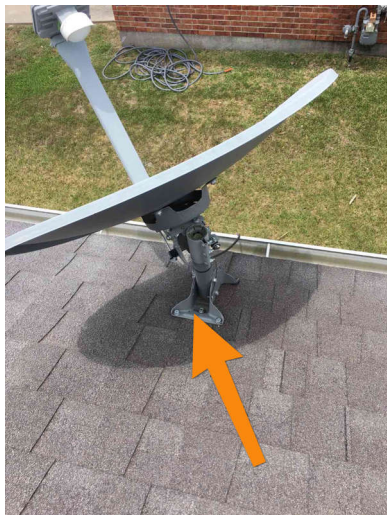
Rooftop

3: The satellite dish

The satellite dish fasteners are not sealed. These must be sealed properly to avoid water intrusion.

Recommendation: Contact a qualified professional.

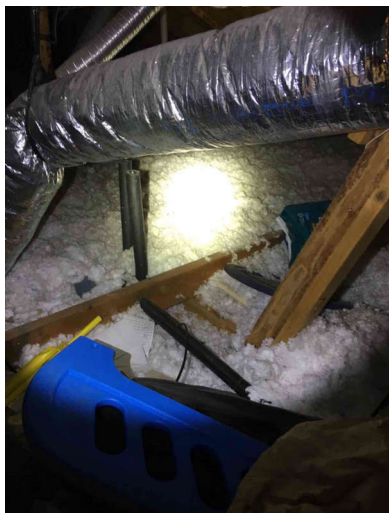
Above master bath

4: Skylight

Skylight over the master bath has some nails that need to be sealed on the section closest to the eave.

Recommendation: Contact a qualified professional.

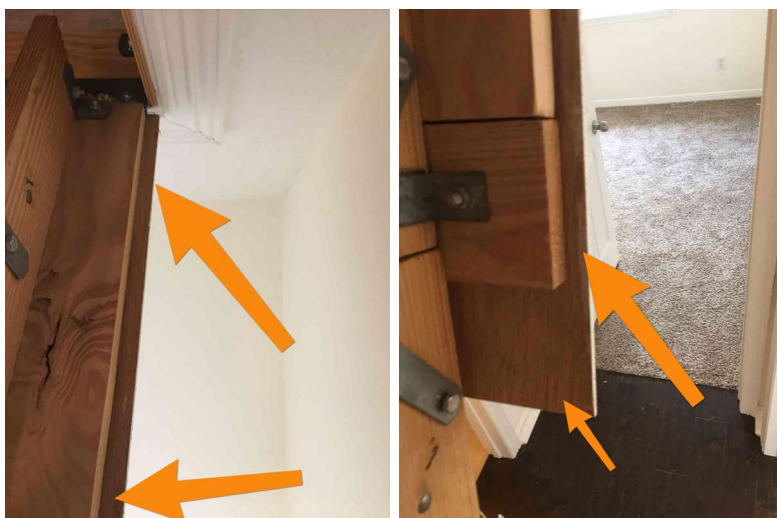
1: Attic entrance

Attic entrance has no weatherstripping around the hatch. This should be sealed to reduce energy loss.

Recommendation: Contact a handyman or DIY project

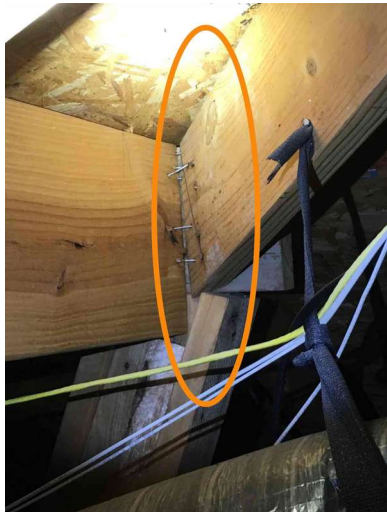
There are several rafters connected to the hip ridge at the front of the building that are either separating or cracked and should be looked at by a structural professional.

Rafter separation, nails visible

Recommendation: Contact a qualified structural engineer.

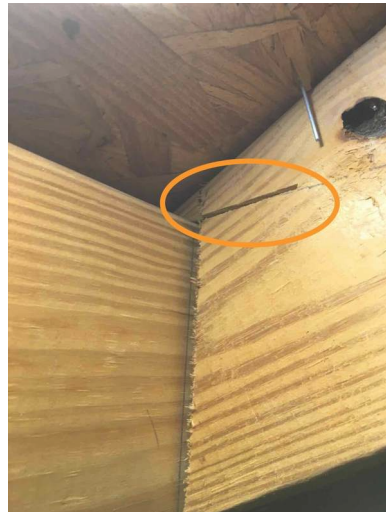
Oversawed

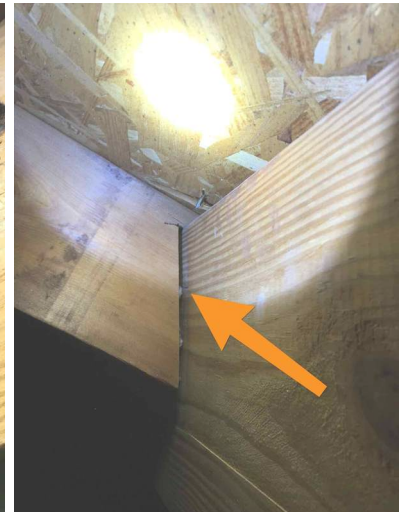
Excessive gapping; no fasteners visible

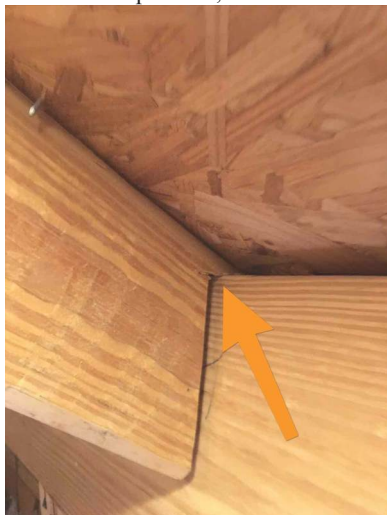
Minimal bearing

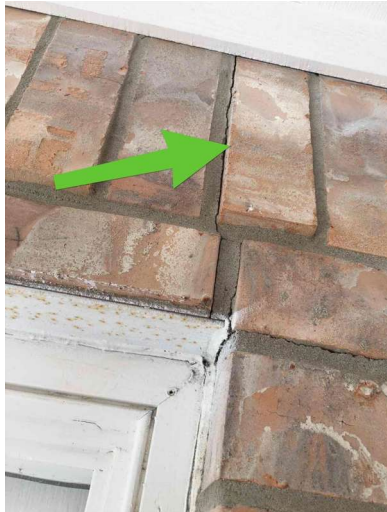
Front entrance

Settlement cracks :

There are some settlement cracks above the lentil of the front entrance.

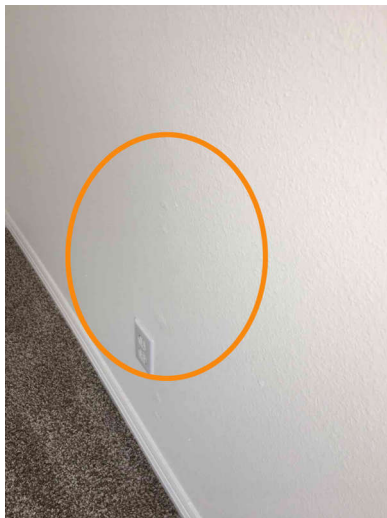
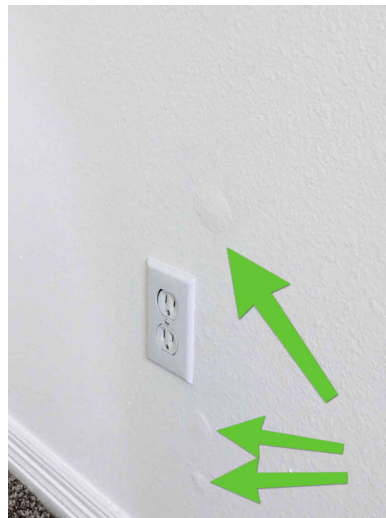
Front bedroom

Dry wall repair:

There appears to be some repair work done near the electrical outlet on the east side

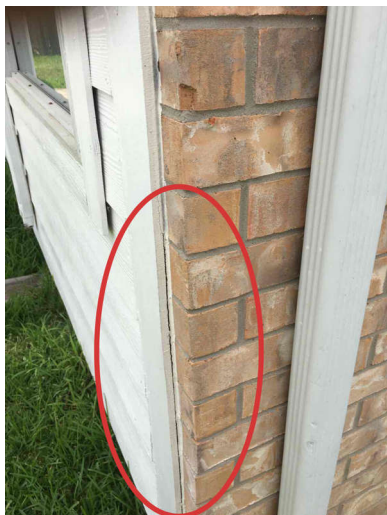
Trim board:

On north west corner trim board should be caulked.

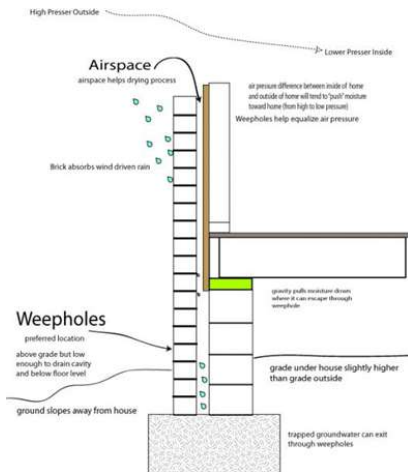
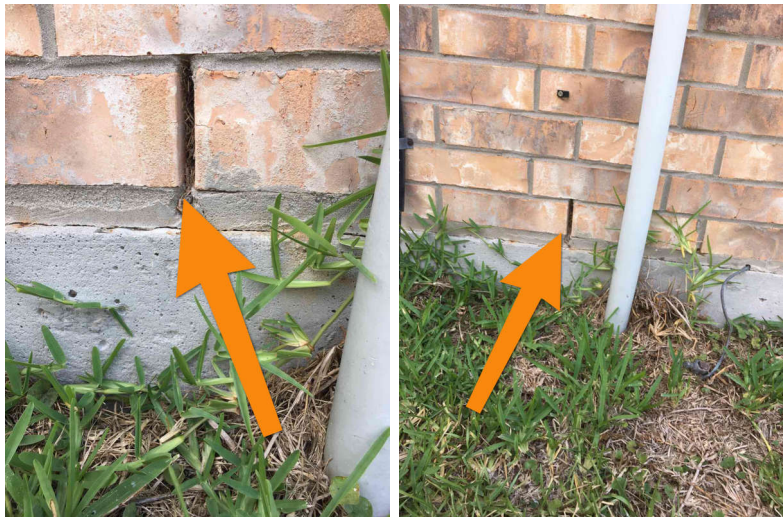
1: Weep holes clogged

Many of the weep holes in the brick veneer are clogged, especially on the west wall of the structure. Weep holes are designed to allow moisture to be released from the back of the brick veneer; when they are clogged the moisture has nowhere to go and could cause water damage. See the included illustration.

Recommendation: Contact a qualified masonry professional.

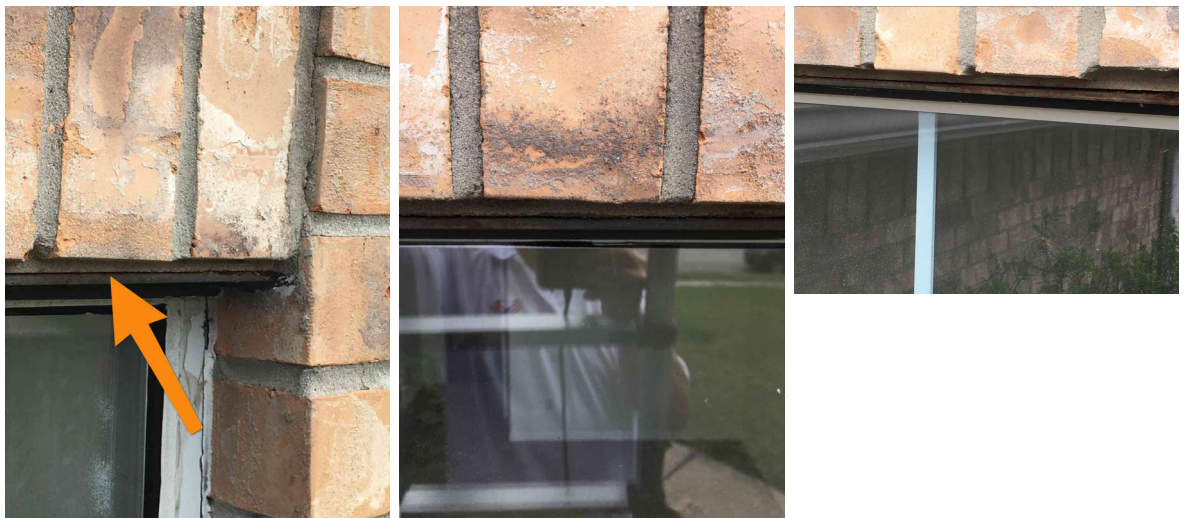
Above front window

2: Mortar separation

The lintel above the front window supporting the brick course is separating from the mortar.

Recommendation: Contact a qualified professional.

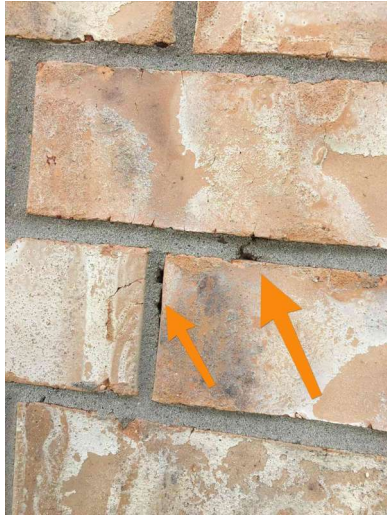
Throughout the exterior perimeter of structure

3: Mortar missing

There is mortar missing between bricks in many areas around the outside of the structure. These should be repointed- remortared/caulked and checked annually.

Gaps in mortar

Recommendation: Contact a handyman or DIY project

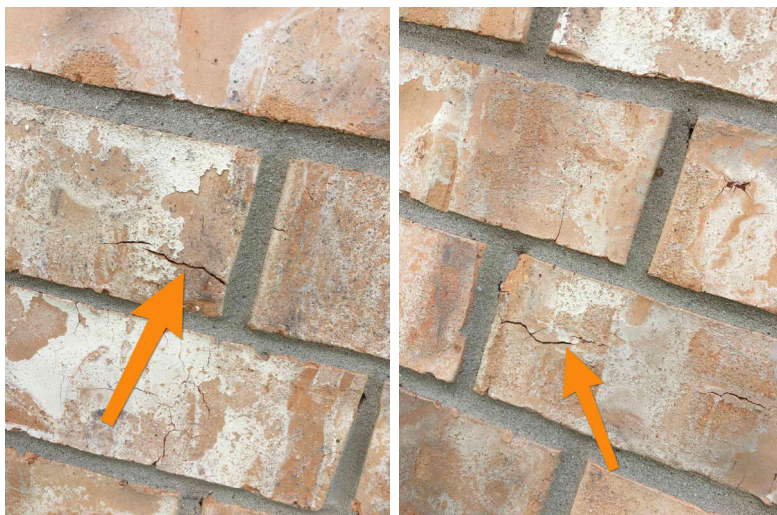
Throughout exterior veneer

4: Cracked bricks

There are many cracks in the bricks throughout the structure. This could be due to heat stress and settlement. I recommend a second opinion.

Recommendation: Contact a qualified masonry professional.

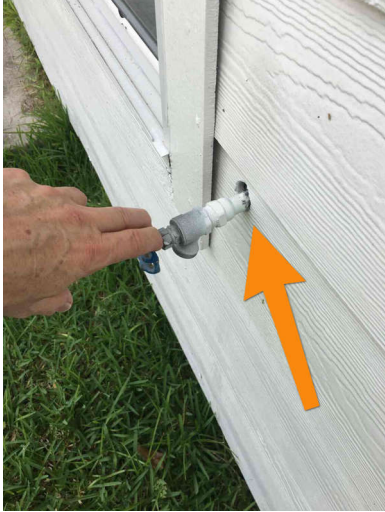
Rear of house

5: Hose bib pipe

Hose bib at the rear of the home has no backflow preventer and it is loose and needs to be sealed.

Recommendation: Contact a qualified plumbing contractor.

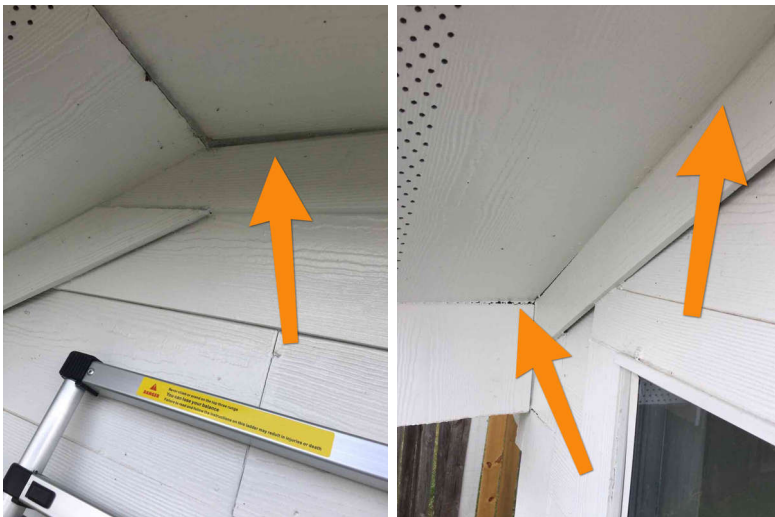
Rear left

6: Soffit and trim board separation

The soffit and trim boards are separating from the rear left house. This area appears to have had some prior repairs done to it.

Recommendation: Contact a qualified professional.

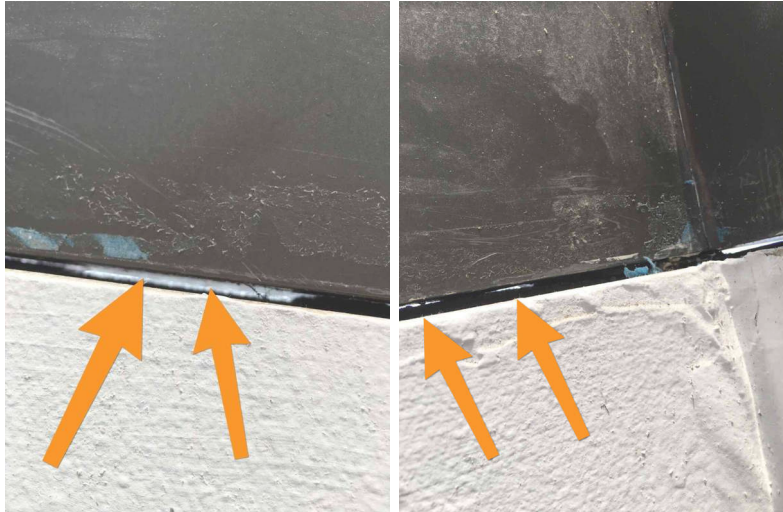
1: Skylight

There is daylight visible through the bottom of the skylight. This needs to be resealed. The skylight housing moves slightly when pushed up.

Outside light visible

Contact a skylight contractor.

Recommendation: Contact a qualified professional.

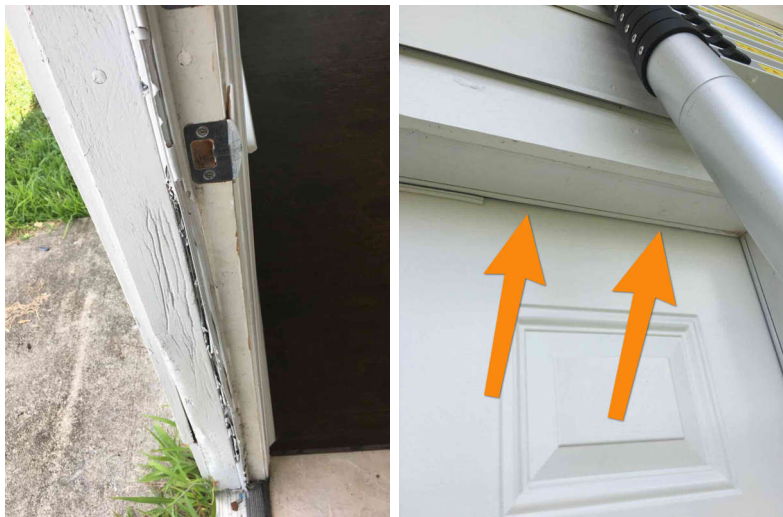
2: Weatherstripping Insufficient

Back door weatherstripping is defective. This can result in significant energy loss and moisture intrusion. Recommend installing new weatherstripping.

Recommendation: Recommended DIY Project

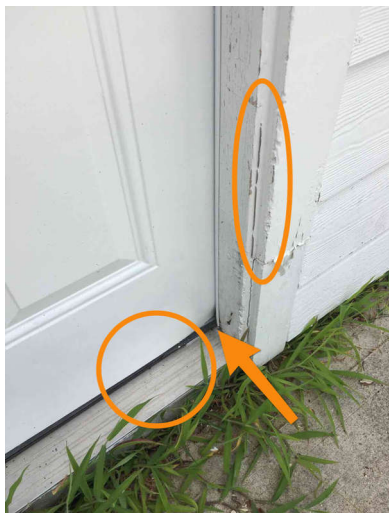
Back of house.

3: Back door damaged

Back door damaged In the lower right corner. Also the bottom weatherstripping is defective and there is caulking missing from the trim board of the doorframe.

Recommendation: Contact a handyman or DIY project

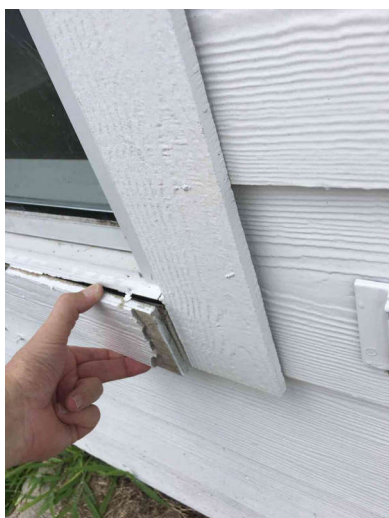
Back of house

4: Trim board

Trim board beneath window in the rear of house to the immediate left of the back door needs to be replaced

Recommendation: Contact a handyman or DIY project

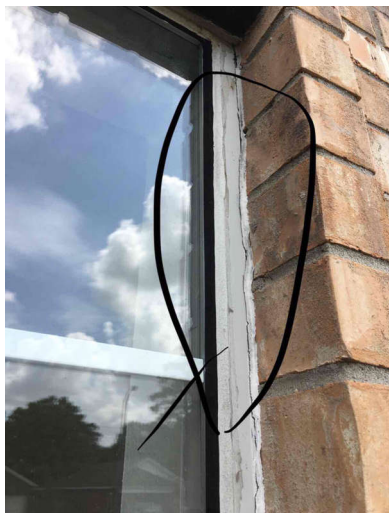
Front window

Cracked caulking :

There are caulked areas that need to be recaulked on the front window.

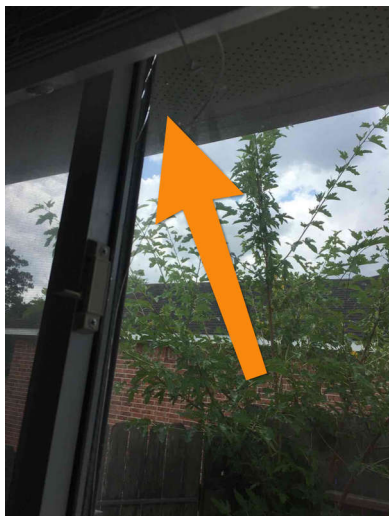
West bedroom

2: Broken glass

Recommendation: Contact a qualified window repair/installation contractor.

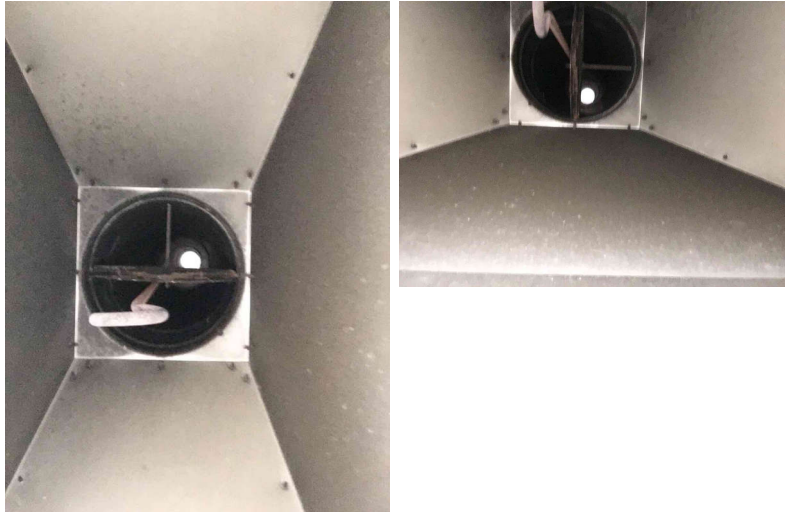
Gas fireplace:

The gas fireplace has been used to burn wood. I did not test to see if the gas was operating because there was no key present. I suggest having a fireplace professional double check to see if this fireplace is rated to burn both wood and gas. I would recommend not using until this determination has been made.

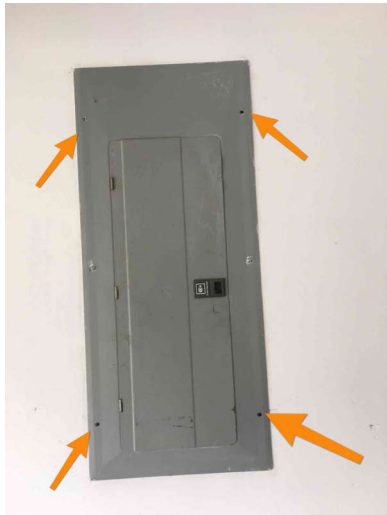
Garage

1: Electrical Panel

Panel cover is missing screws.

Recommendation: Contact a qualified electrical contractor.

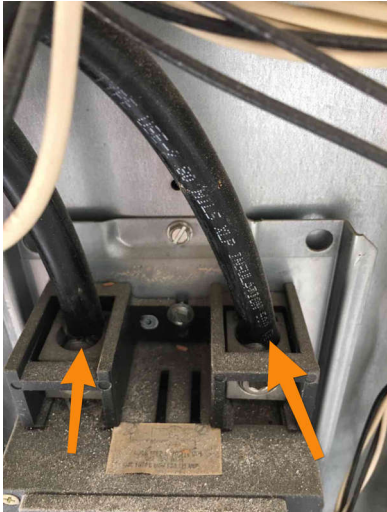
Garage

2: Aluminum entrance conductors

The service conductors do not have any antioxidant paste.

Recommendation: Contact a qualified electrical contractor.

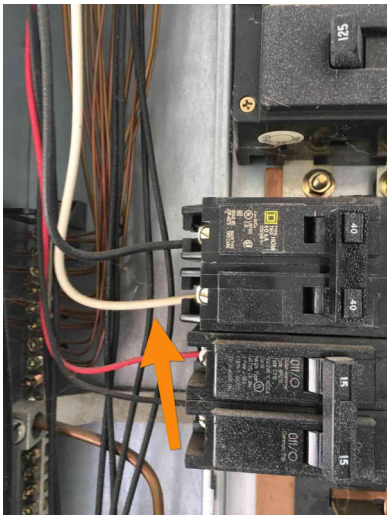
3: White wire used as hot

This wire should be marked with a black tape or marker to indicate that it is a hot wire.

Recommendation: Contact a qualified electrical contractor.

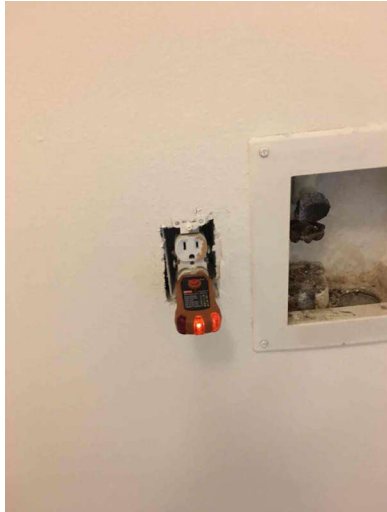
Laundry room

2: Cover Plates Missing

One or more receptacles are missing a cover plate. This causes short and shock risk. Recommend installation of plates.

Recommendation: Contact a qualified electrical contractor.

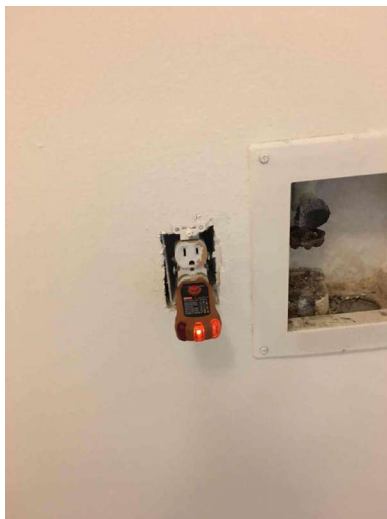
Laundry room

3: No GFCI Protection

No GFCI in the laundry room.

Recommendation: Contact a qualified electrical contractor.

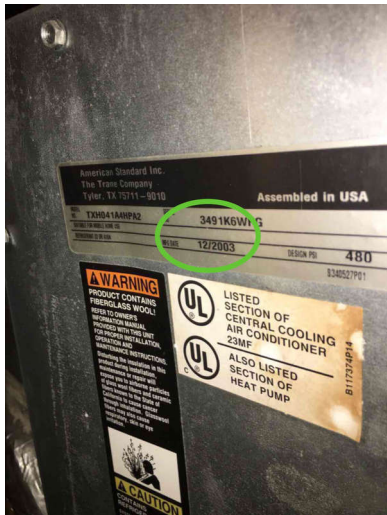
Attic

Furnace:

The furnace was manufactured in 2003. Heat exchangers have a life expectancy of 15 to 20 years. I would strongly recommend having the furnace serviced and inspected by a HVAC professional.

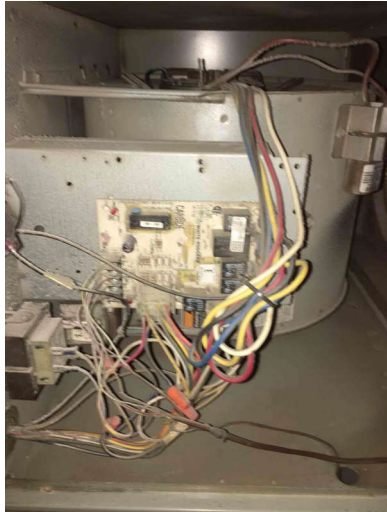
1: Needs Servicing/Cleaning

Furnace should be cleaned and serviced annually. Recommend a qualified HVAC contractor clean, service and certify furnace.

Recommendation: Contact a qualified HVAC professional.

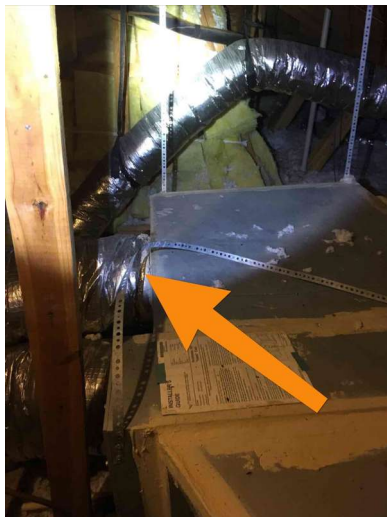
2: Missing furnace support strap

There are four metal straps that support the furnace; one of them is disconnected and should be repaired.

Disconnected support strap

Recommendation: Contact a qualified HVAC professional.

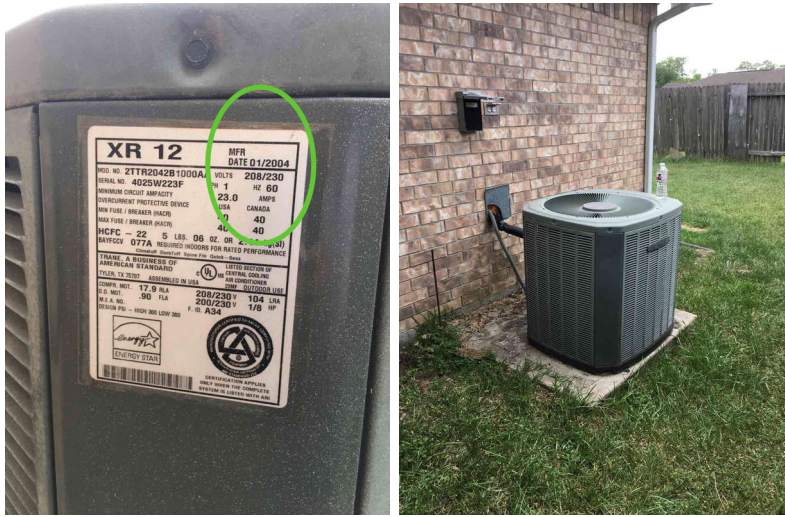
This air conditioning unit was manufactured in 2004. The life expectancy of this type of unit can be 15 to 25 years depending on how it has been maintained. I strongly recommend an HVAC professional to service and inspected unit.

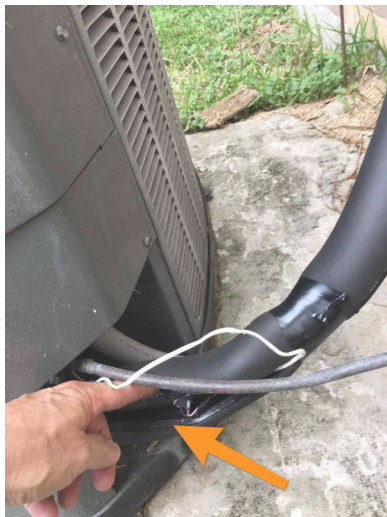
Condenser unit

1: Insulation Missing or Damaged

Missing or damaged insulation on refrigerant line can cause energy loss and condensation.

Recommendation: Contact a qualified HVAC professional.

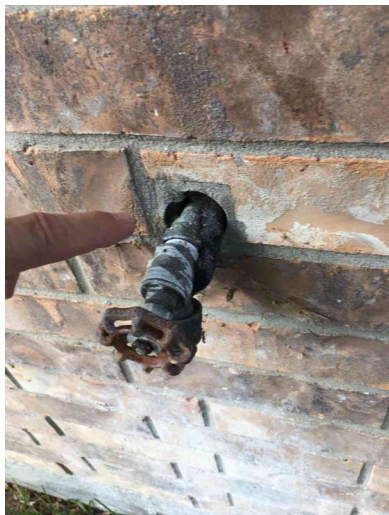
Exterior water faucets unsecured:

One or more water spigots are not secured properly and are lacking proper insulation to the building. Sealing these areas will help prevent unwanted vermin entering the home.

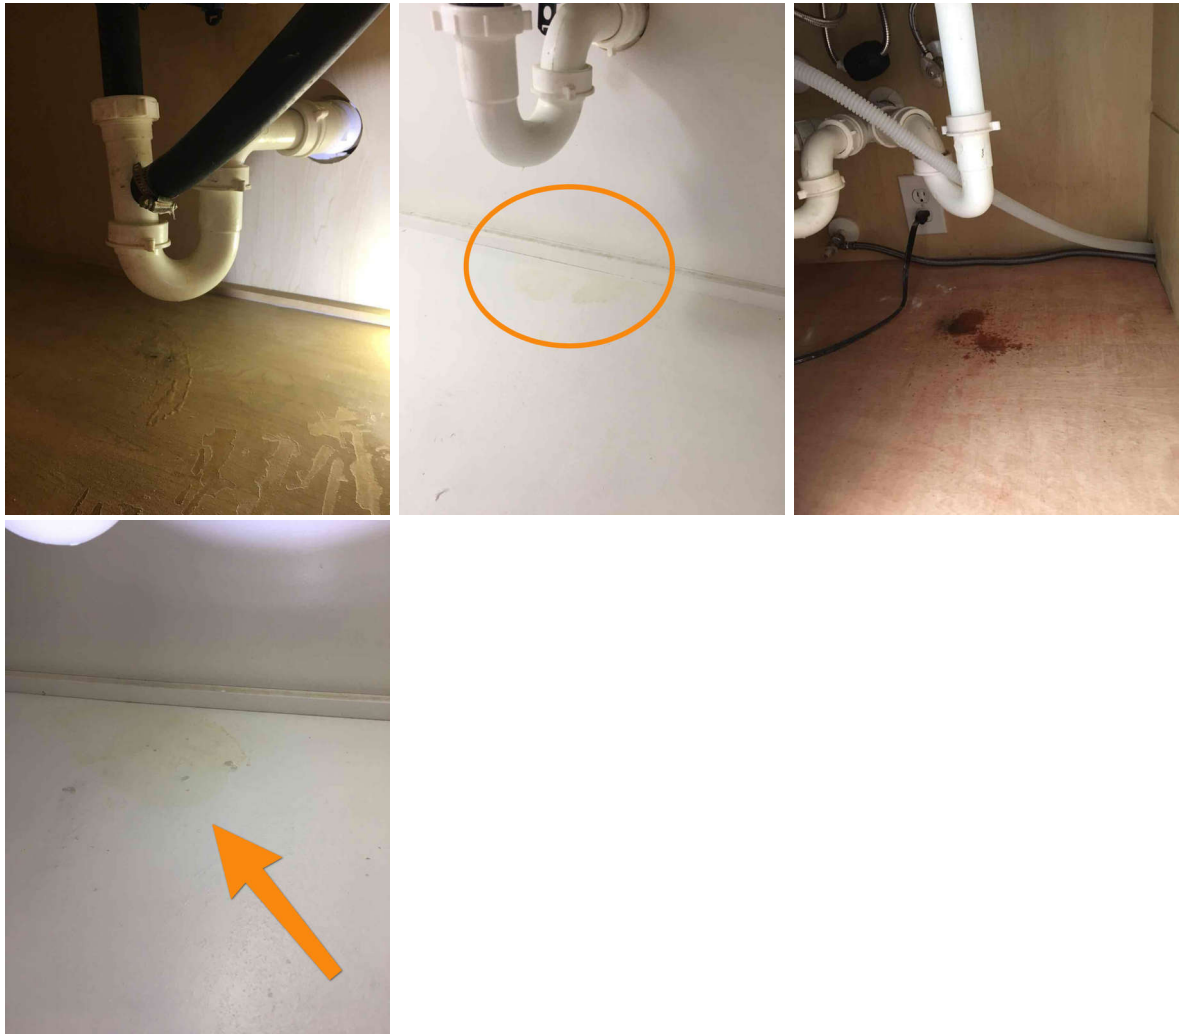
1: Sinks leaking

One or more sinks are leaking underneath beneath the 'P' trap. Recommend having them repaired by a qualified professional.

Recommendation: Contact a qualified plumbing contractor.

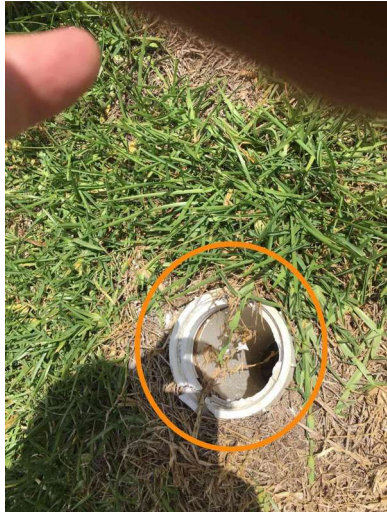
1: Sewer cleanout missing cap

Sewer cleanout missing cap

Recommendation: Contact a qualified plumbing contractor.

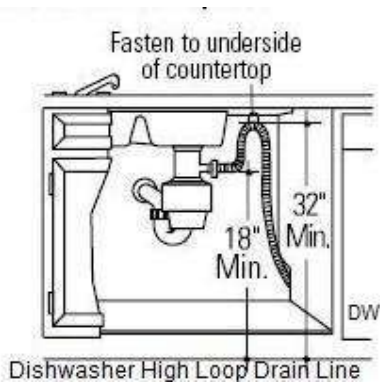
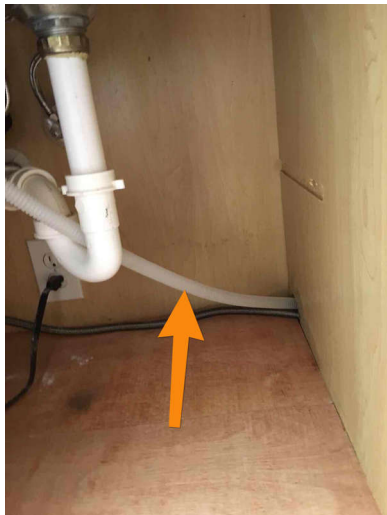
2: Hi Loop missing

There is no high loop in the water line for the dishwasher. A High loop prevents used dish water from reentering into the clean house water. See diagram.

Recommendation: Contact a qualified plumbing contractor.

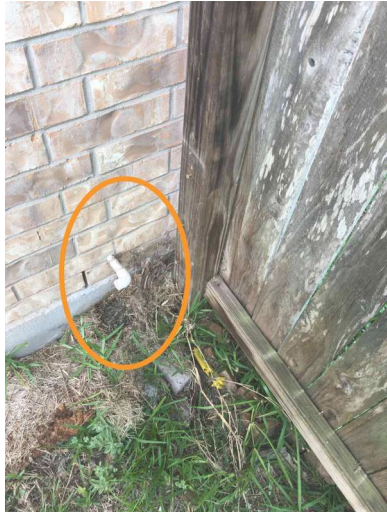
3: Temperature pressure relief valve drain

The drain outside is turned 90° from the ground that should be re-oriented to face grade.

TPR valve drain facing the wrong direction

Recommendation: Contact a qualified plumbing contractor.

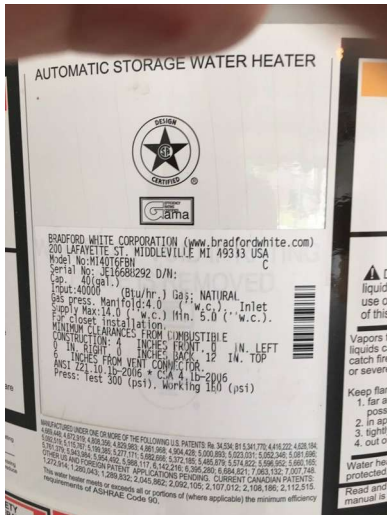
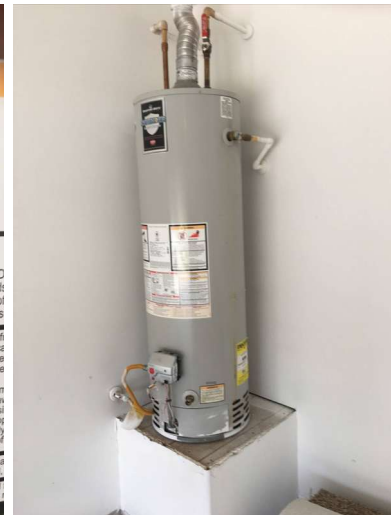
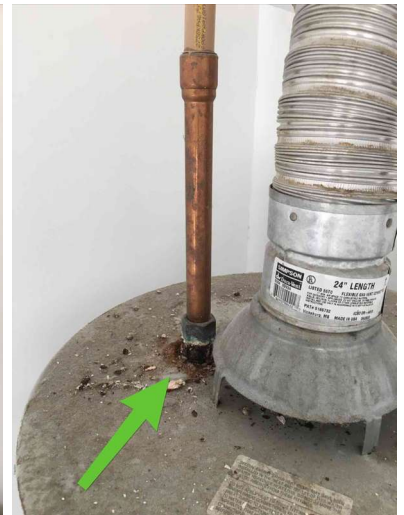
Rusted outlet pipe:

This water Heater was manufactured in 2012. Typical life expectancy is 8 to 12 years. There is some rust at the top hot water outlet. Recommend having it looked at by a plumber.

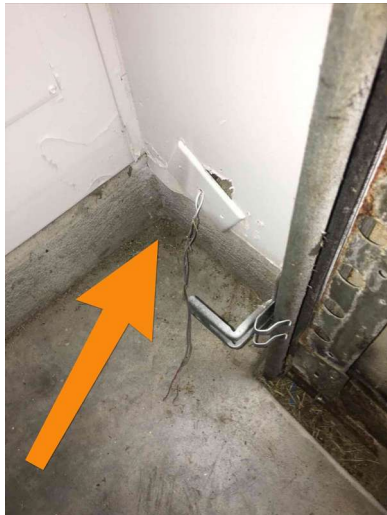
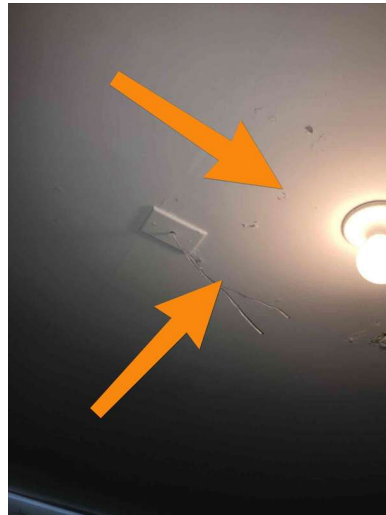
Ceiling

1: Missing components

The complete automatic garage door opening system has been removed. The ceiling mounted motor is not present. The electric eyes are not present. The wires that these items would be connected to are dangling in the air and unprotected. The garage door only operates manually. The garage door is very rusted and should be replaced.

Recommendation: Contact a qualified garage door contractor.
