STRILER HOME INSPECTIONS, INC.

RESIDENTIAL REPORT

1234 Main St.
Raynham MA 02767

12/12/2018 9:00AM

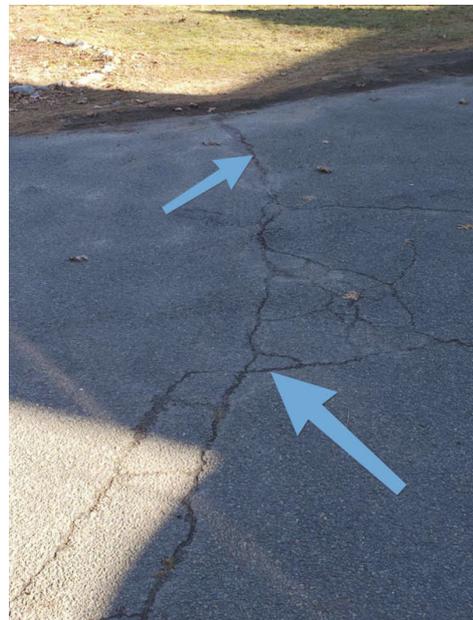
Significant cracks were visible in the surface material at the time of the inspection. Large cracks should be filled with an appropriate sealant to avoid continued damage to the driveway surface from freezing moisture.

Contact a handyman or DIY project

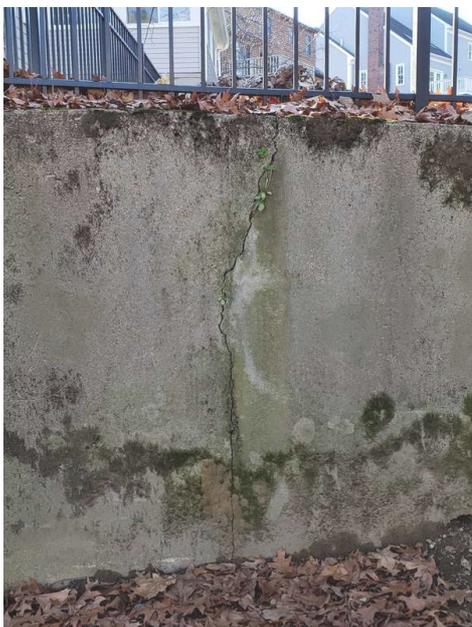
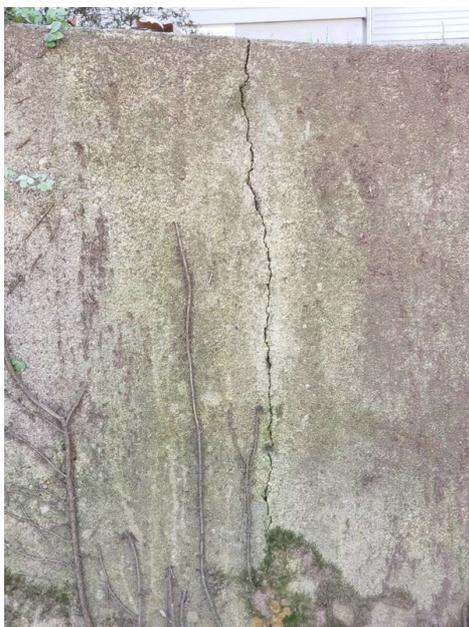
2.3.1 Retaining Wall(s)

CRACK(S) (TYPICAL)

Displacement or cracks are typical. Recommend you repair and monitor in the future. If the situation continues, contact landscape contractor for cost options to repair or replace.

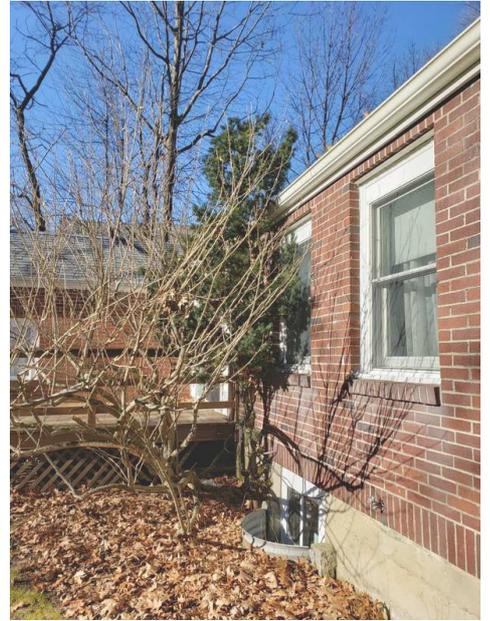
2.5.1 Landscaping

TOO CLOSE TO HOME

Landscaping is in contact or too close to the home. Trim plants away from the structure by at least 8 - 12". This space is recommended to prevent direct access to the structure by insects and to keep the bushes from damaging the siding.

Contact a handyman or DIY project

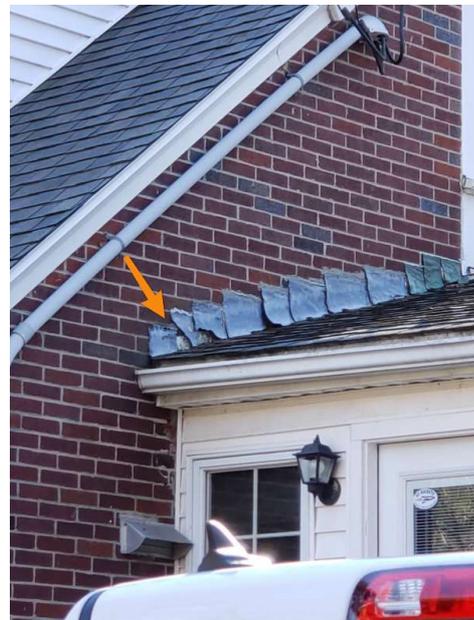
Areas of the metal flashing are exposed to the weather and a potential of leakage could occur in wind-driven rain, usually, the side and top edges are covered by the roofing shingles. Further investigation and cost estimates to repair or replace are recommended.

Contact a qualified roofing professional.

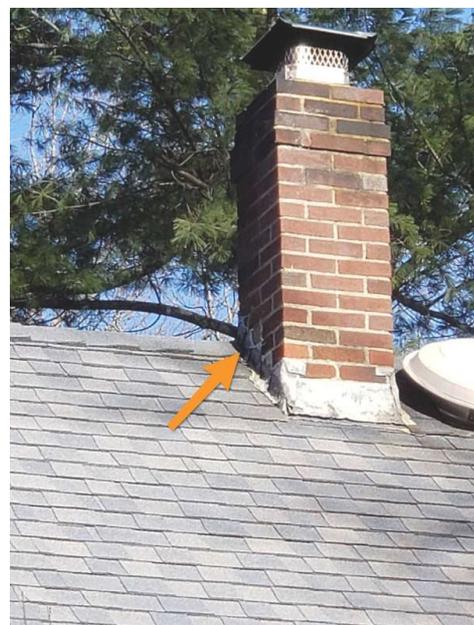
3.2.2 Roof Flashings

SQUIRREL DAMAGE

Squirrel damage is noted. Repair is recommended to prevent water intrusion.

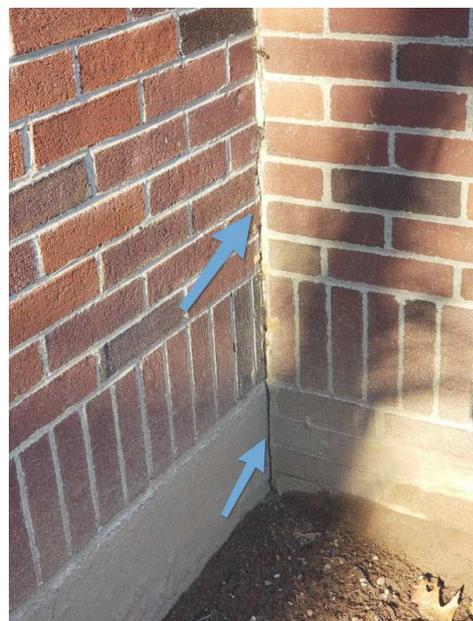
FOUNDATION CRACK (MINOR)

A small crack is noted where the chimney foundation meets the house foundation. Recommend monitoring for future movement.

Contact a qualified professional.

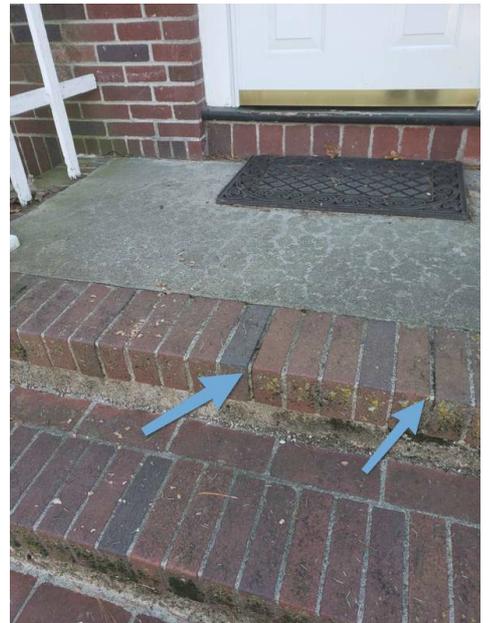
The stair(s) have some minor separation. Repair is recommended to prevent moisture intrusion and freezing that could possibly damage the stair material.

Contact a qualified handyman.

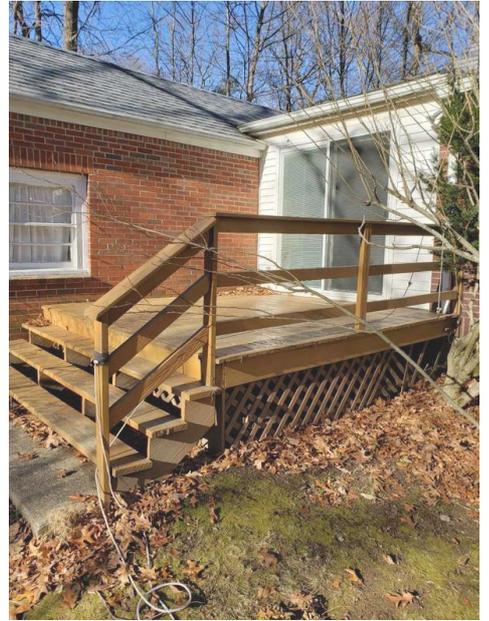
4.6.1 Decks, Balconies & Porches

GUARDRAIL (CLIMBABLE)

Railing design made the handrail system climbable. Balusters should be installed with spacing no more than 4" between vertical balusters. Safe building practices dictate that the handrail system should not be climbable (especially by children). This condition may be hazardous to small children. Repair as needed

Contact a qualified professional.

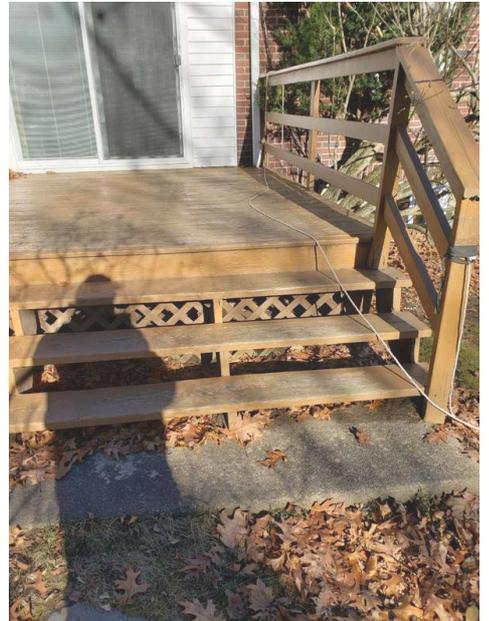
4.6.2 Decks, Balconies & Porches

The wooden stair(s) are missing risers. Risers are the vertical boards that rise up from one tread to the next. Repair is recommended.

Contact a qualified handyman.

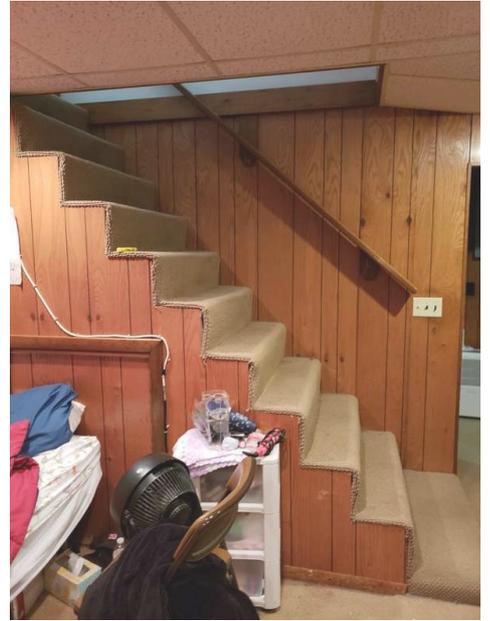
The open side of the stairway is missing a graspable handrail. When the handrail is installed, balusters should be included and spaced no further than 4" apart for safety. Repair is recommended.

Contact a qualified carpenter.

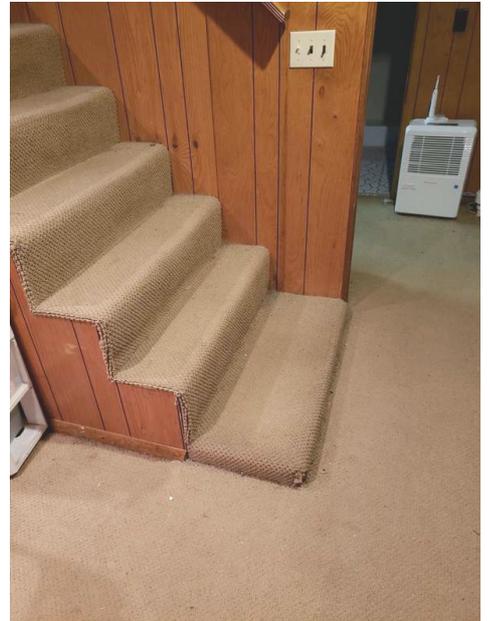
5.1.2 Basement Staircase

STAIRS (UNEVEN RISERS)

The stair risers are of various heights and pose a potential tripping situation, all risers should be no more than 8-1/4" in height. You may get used to these conditions but may have difficulty navigating stairway. If possible, updating to present standards is recommended.

Contact a qualified professional.

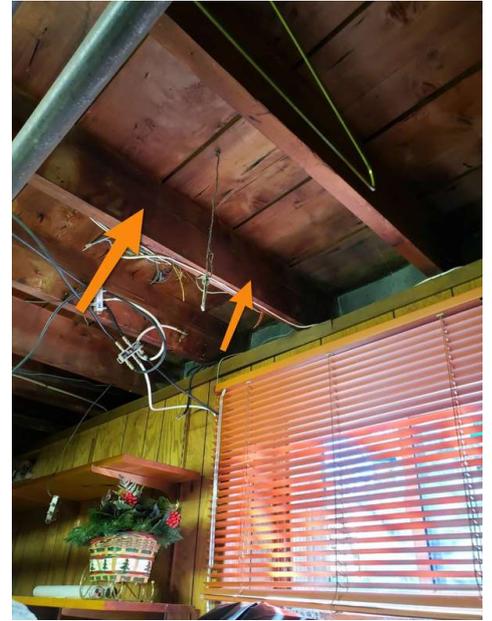
5.3.1 Floor Joists

CRACKED

Cracks in one or more joists were noted. Additional support or replacement may be needed. Repair is recommended.

Contact a qualified carpenter.

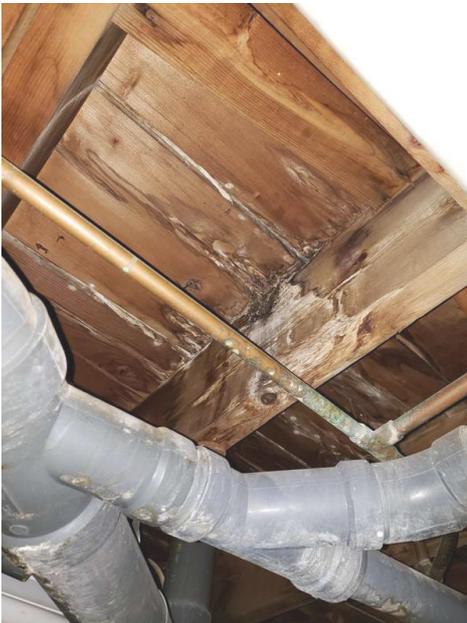
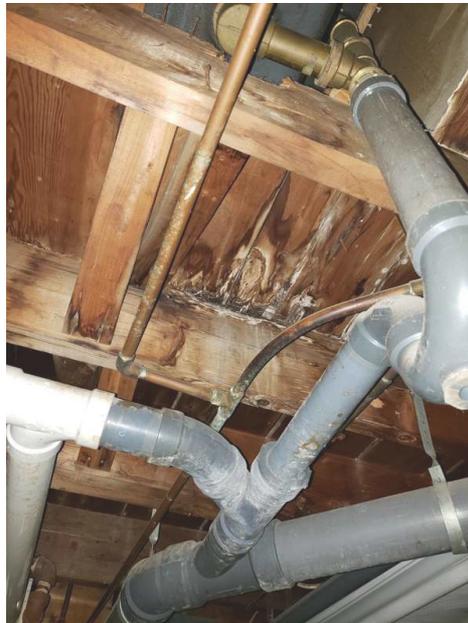
5.4.1 Subfloor

MOISTURE DAMAGE

One or more areas of moisture damaged wood were noted. Further investigation and or repair is recommended.

Contact a qualified carpenter.

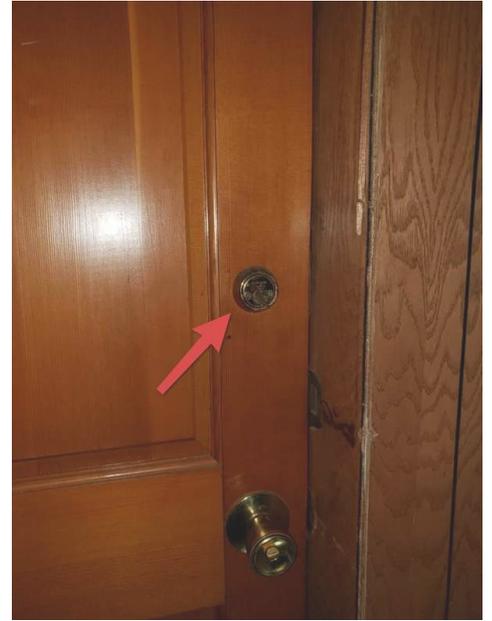
5.8.1 Basement Entry/Exit Door

DOUBLE KEYED DEADBOLT

The door has a deadbolt that is keyed on both sides. This is a potential safety hazard if you need to exit the house quickly and there is no key readily available. Repair is recommended.

Contact a handyman or DIY project

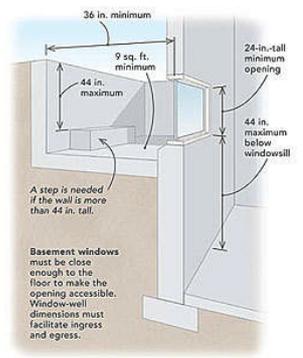
5.9.1 Means Of Basement Egress
NO WINDOW EGRESS

This basement had no means of window egress. As a result of the lack of egress, the areas should not be considered as living space nor used as a sleeping area for safety reasons.

To comply with generally-accepted current standards, this basement should have a means of egress in addition to the stairway to the main floor. Means of egress are safe pathways to the exterior such as windows, window wells, etc. installed to allow escape and rescue in the event of an emergency such as a fire in which escape using the stairway is not possible. Proper egress openings have the following requirements:

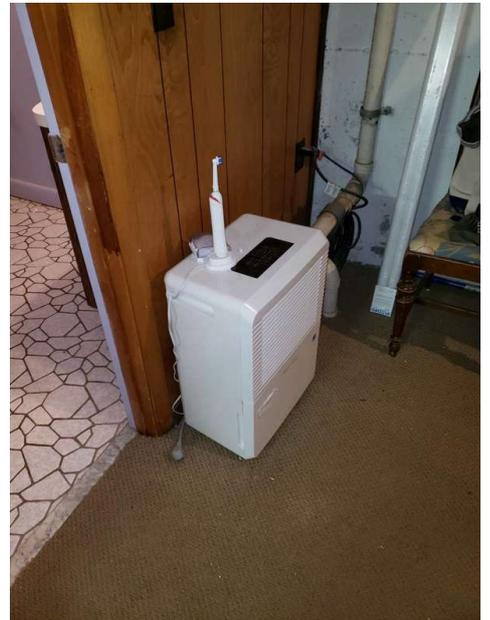
5.11.1 Dehumidifier

A dehumidifier was installed at the time of the inspection. It was not on or not working at the inspection.

The dehumidifier is easier to maintain if it drains constantly. If there is no sink that can be used as a drain, sometimes the heating system or A/C system in the basement will have a small condensate pump. this is a good location to allow drainage from the dehumidifier tank to drain into, the pump will come on as needed to evacuate any dehumidifier condensation. Pumps can also be purchased separately.

Recommended DIY Project

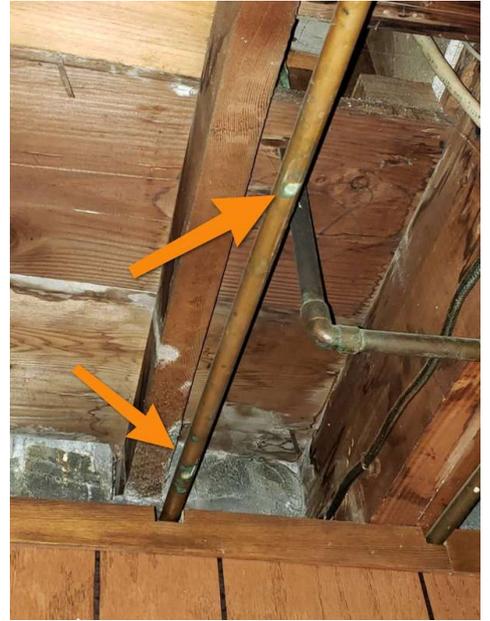
6.2.1 Domestic Water Supply Distribution System

CORROSION (NOT LEAKING)

Corrosion was noted in one or more areas of the water supply system. A visible build-up of mineral deposits or encrustation is an early warning sign of future leakage. Consider repair of the affected areas before leakage becomes an issue.

Contact a qualified plumbing contractor.

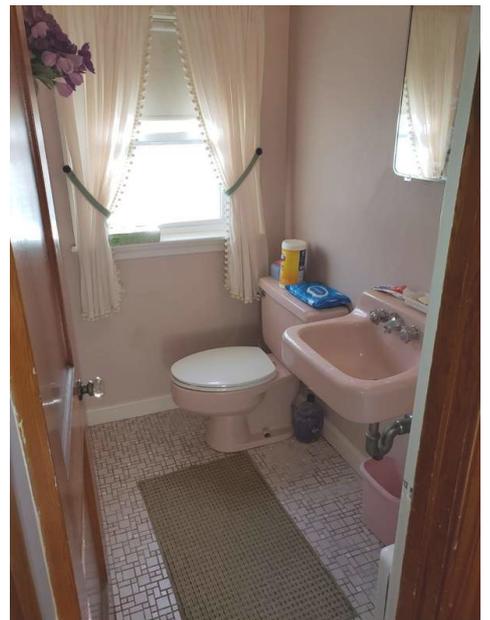
6.6.1 Toilet

The toilet made a high pitch screeching noise while refilling the tank. Further investigation and or repair is recommended.

Contact a qualified professional.

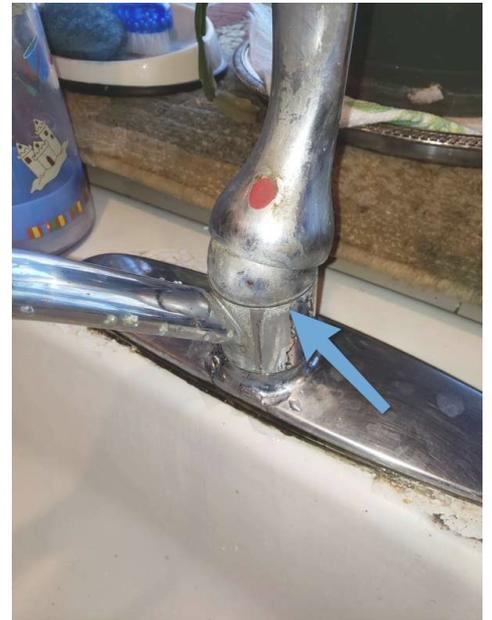
6.8.1 Sinks/Vanity

FAUCET (LEAKING)

The faucet was leaking. Repair is recommended.

Contact a handyman or DIY project

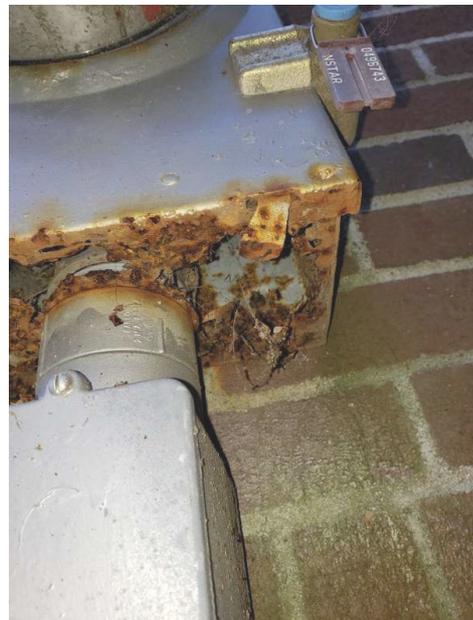
The meter socket was rotted thru in one or more areas. The source of moisture needs to be identified and resolved. Replacement is needed.

Contact a qualified electrical contractor.

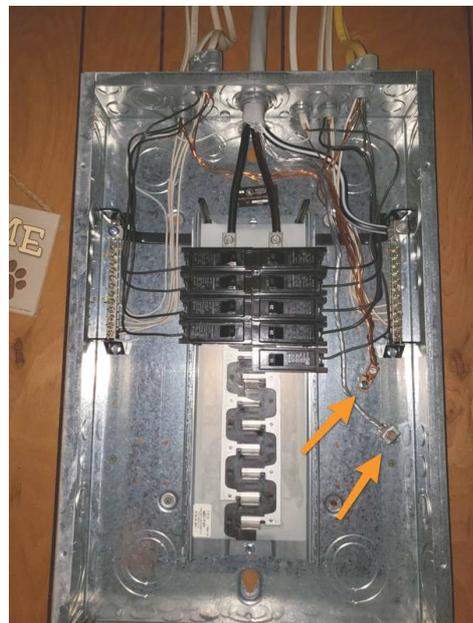
7.2.1 Panel Enclosure, Cover, & System Grounding

Multiple grounds are attached to a single "foot lug" screwed into the panel. This is not up to current standards. Further evaluation and or repair is recommended.

Contact a qualified electrical contractor.

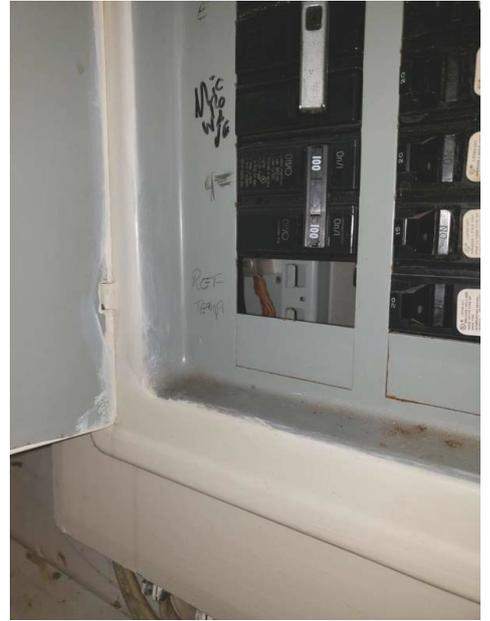
PANEL COVER (MISSING FILLER PLATES)

One or more filler plates were missing from the panel cover. A gap in the dead front cover of the main electrical service panel where a circuit breaker was missing may allow a person to come into contact with energized electrical components. Repair is recommended.

Contact a qualified electrical contractor.

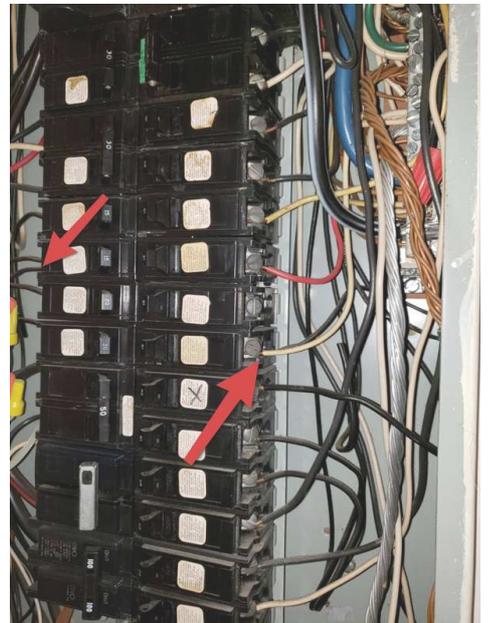
7.3.1 Condition Of Wiring In Panel

BREAKER (MULTI TAP)

Two or more wires were connected to a breaker designed for only one wire. This is known as a "multi-tap" and is a defective condition. Further evaluation and or repair is recommended.

Contact a qualified electrical contractor.

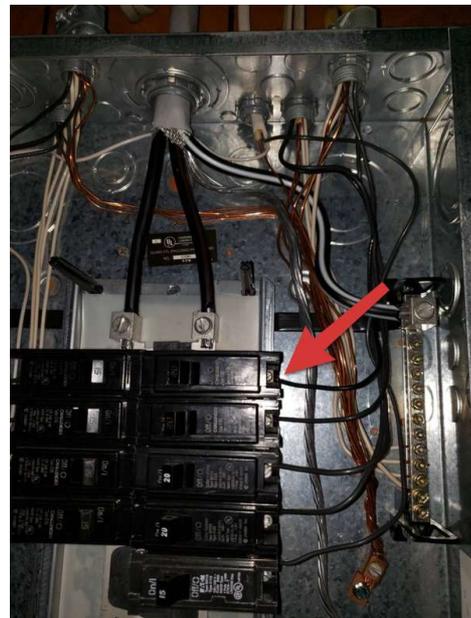
7.3.2 Condition Of Wiring In Panel

BREAKER (OVER AMPED)

One or more over-amped breakers were found. Over-amped means that the breaker is rated to carry more amperage than the wire attached to it. An overdraw condition could cause melting, insulation overheating, or fire. Further evaluation and or repair is recommended.

Contact a qualified electrical contractor.

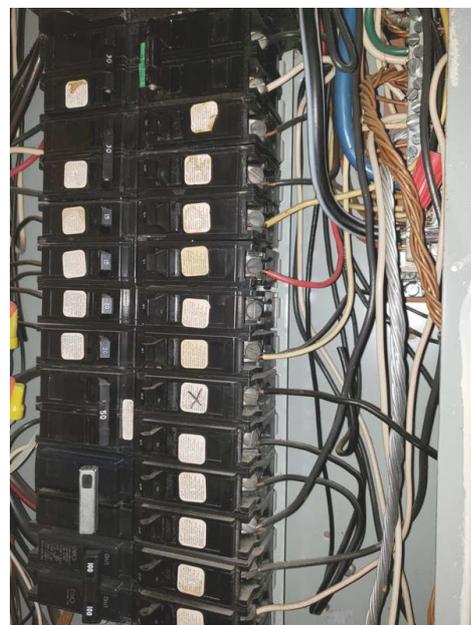
7.3.3 Condition Of Wiring In Panel

NEUTRAL BAR (MULTIPLE NEUTRALS, SAME SCREW)

One or more neutral (white) wires are under a single screw, this is not up to current standards. There should only be one neutral wire under each screw. Further evaluation and or repair is recommended.

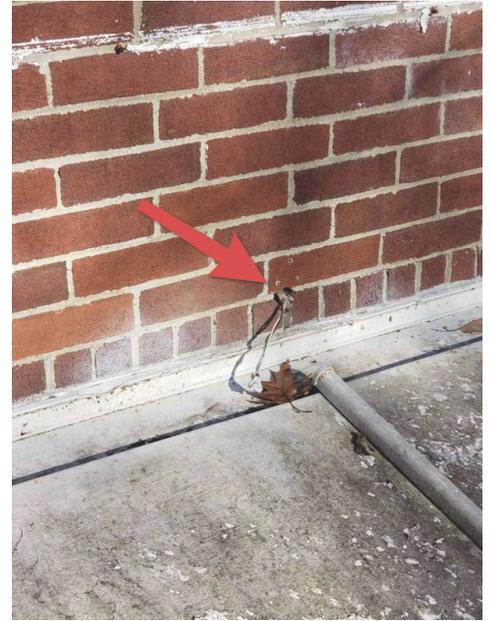
One or more uncapped wires are noted. Further evaluation and or repair is recommended.

Contact a qualified electrical contractor.
