# CAL-PRO REAL ESTATE INSPECTIONS

## PROPERTY INSPECTION REPORT

1234 Main St.  
Bakersfield California 93306

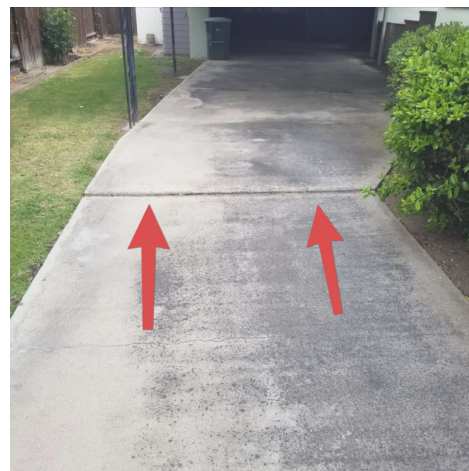
Cracks, holes, settlement, heaving and/or deterioration resulting in trip hazards were found in the driveway, For safety reasons, recommend that a qualified contractor repair as necessary.

Contact a qualified concrete contractor.

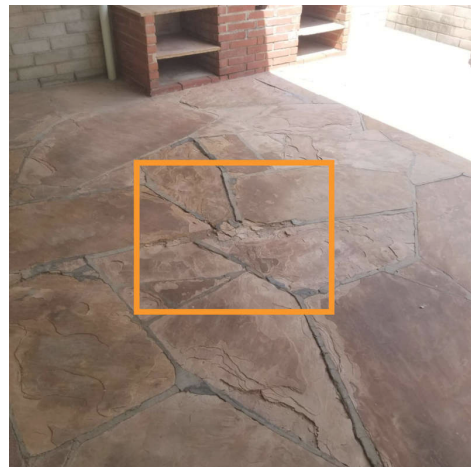
4.3.2 Driveways, Sidewalks, Patios

**SIDEWALK / PATIO CRACKS / DETERIORATION - REPAIR**

Cracks, holes, settlement, heaving and/or deterioration were found in sidewalks and/or patios. Recommend that qualified contractor repair as necessary.

Contact a qualified concrete contractor.

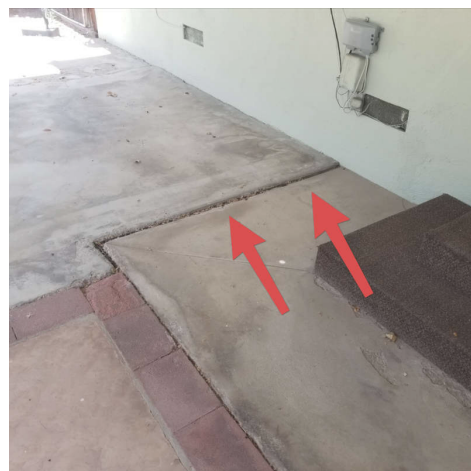
4.3.3 Driveways, Sidewalks, Patios

**SIDEWALK / PATIO CRACKS / DETERIORATION - TRIP HAZARD - REPAIR**

Cracks, holes, settlement, heaving and/or deterioration resulting in trip hazards were found in the sidewalks or patios. For safety reasons, recommend that a qualified contractor repair as necessary to eliminate trip hazards.

Contact a qualified concrete contractor.

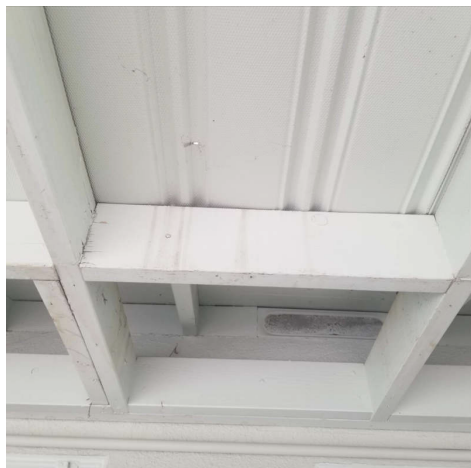
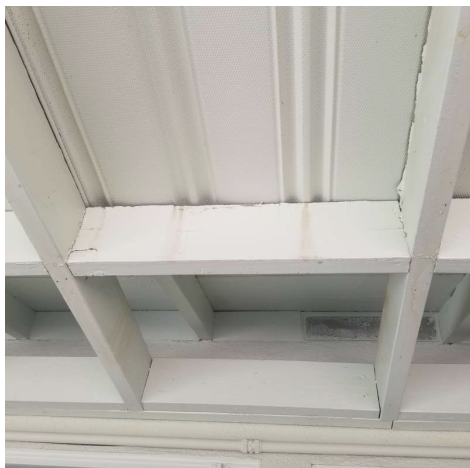
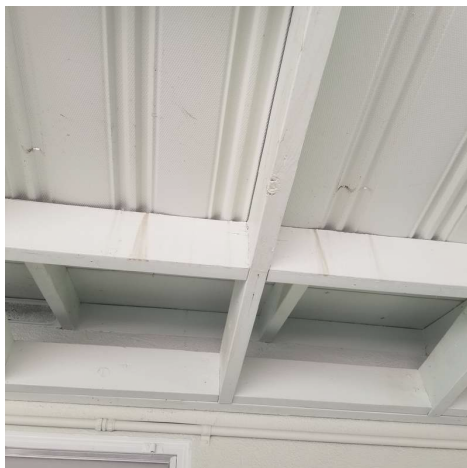
4.5.1 Patio / Porch Covers

**WATER STAINS AT UNDER-SIDE**

Stains were found at one or more covered patio areas. The inspector was unable to determine if an active leak exists (e.g. recent dry weather, inaccessible height). Recommend asking the property owner about this, monitoring the stains in the future, and/or having a qualified contractor evaluate and repair if necessary.

Contact a qualified general contractor.

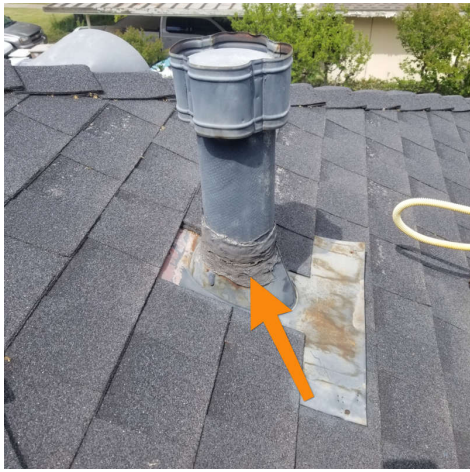
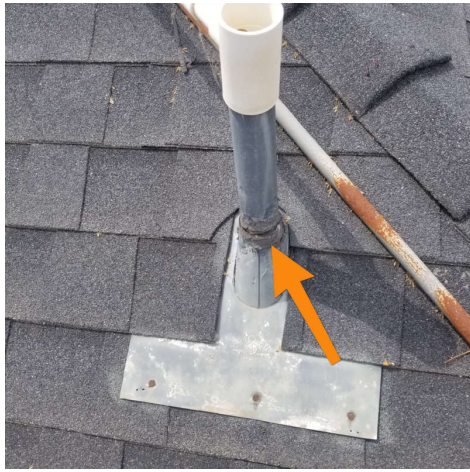
One or more roof jacks in need of tar maintenance at pipes and/or other penetrations. Leaks can occur as a result. This is a conducive condition for wood-destroying organisms. Recommend that a qualified contractor seal roof jack flashing where necessary.

Contact a qualified roofing professional.

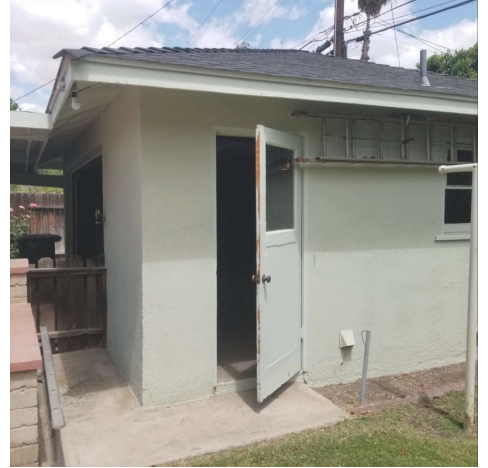
One or more exterior entrance doors were of hollow-core or thin panel construction rather than solid core or metal. This may represent a security hazard since these doors are easily broken or can easily become deteriorated and/or weathered over time. Recommend that a qualified contractor replace hollow-core / thin panel exterior entrance doors with solid core or metal doors.

Contact a qualified door repair/installation contractor.

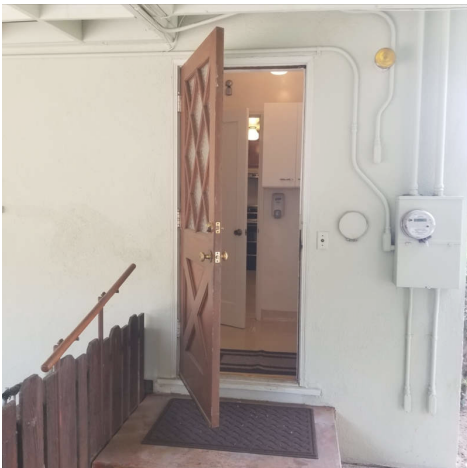
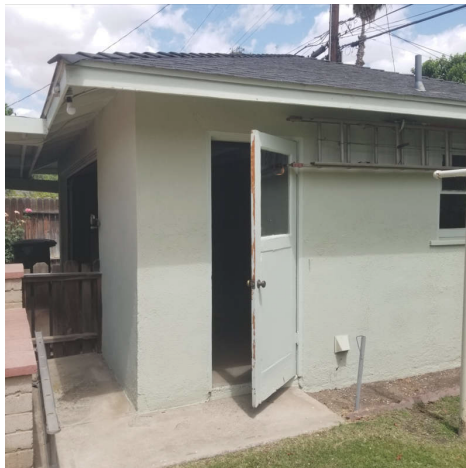
## 7.1.4 Exterior Doors

One or more exterior entry doors opened outwards and didn't appear to have security hinges and/or an anti pry plate over the lockset area. Doors that open outwards have hinges oriented so the pins are exposed outside and can easily be removed also strikers and/or deadbolts can be pried open. Without security hinges, the door can also be removed allowing someone to gain entry. Recommend that a qualified person install security hinges and an anti pry plate on outward-opening doors where needed for better security.

Contact a qualified door repair/installation contractor.

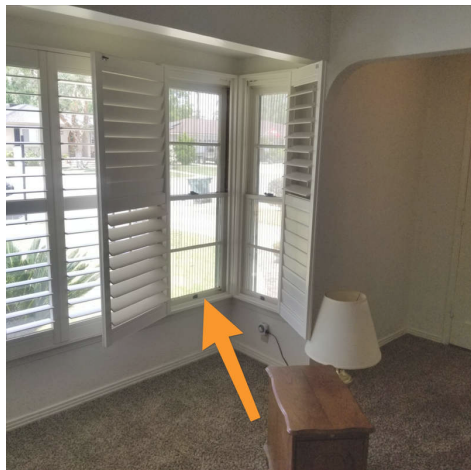
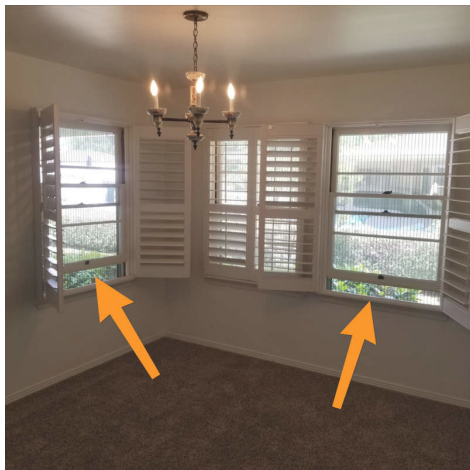
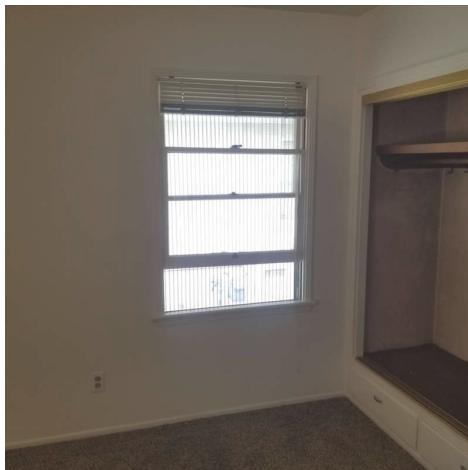
One or more windows were difficult to open and close. Recommend repair by window contractor.

Contact a qualified window repair/installation contractor.

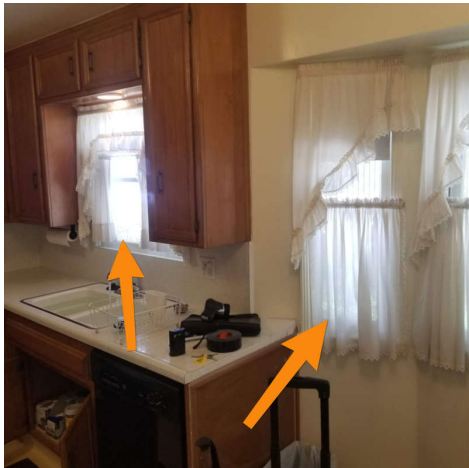
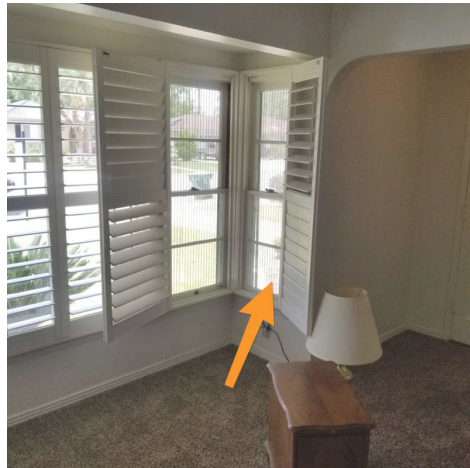
7.3.2 Windows

One or more windows wouldn't open or were painted shut (older homes). Recommend that a qualified person repair windows as necessary so they open and close easily.

Contact a qualified window repair/installation contractor.

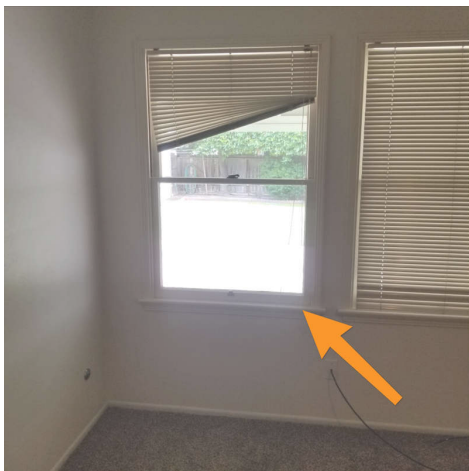
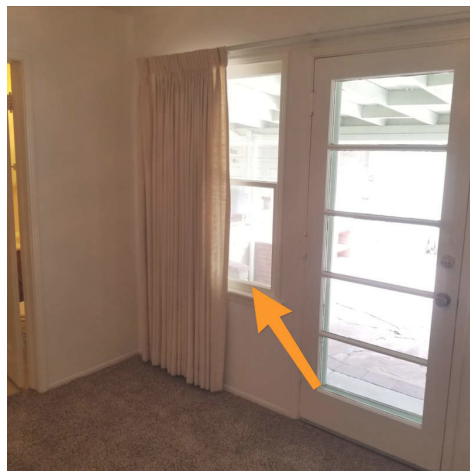
Single / Double-Hung window does not stay in the open position (no friction / latch not engaging). Recommend repairs be made by a window specialist.

Contact a qualified window repair/installation contractor.

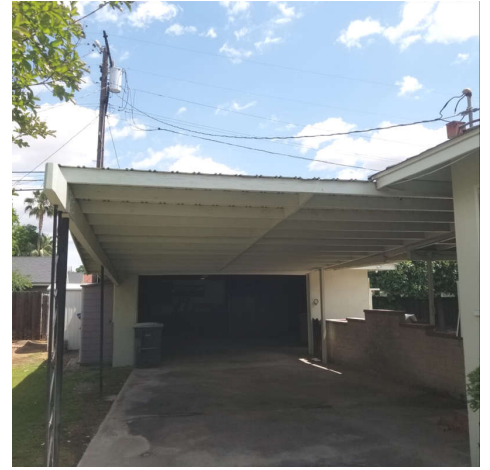
One or more carport covers were substandard, non-standard and/or over-spanned. Recommend that a qualified licensed contractor repair or replace as necessary, and per standard building practices.

Contact a qualified general contractor.

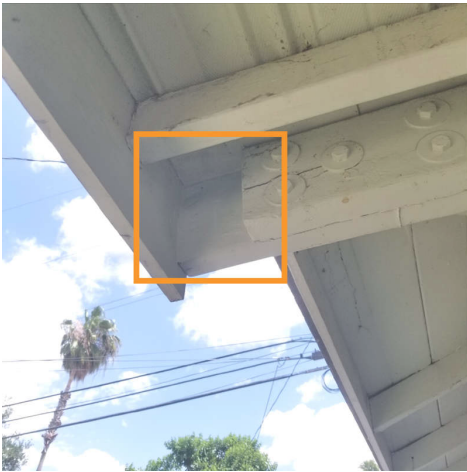
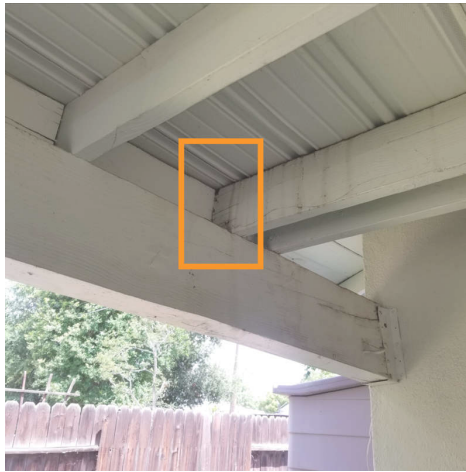
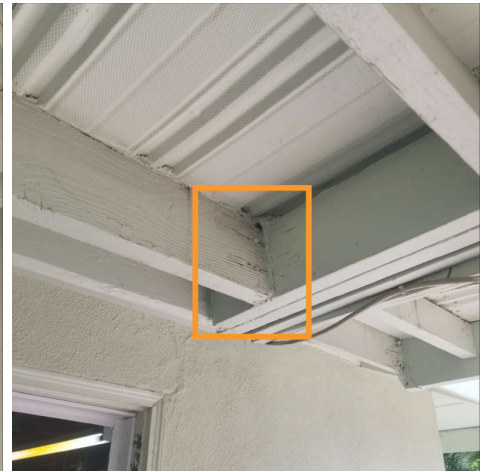
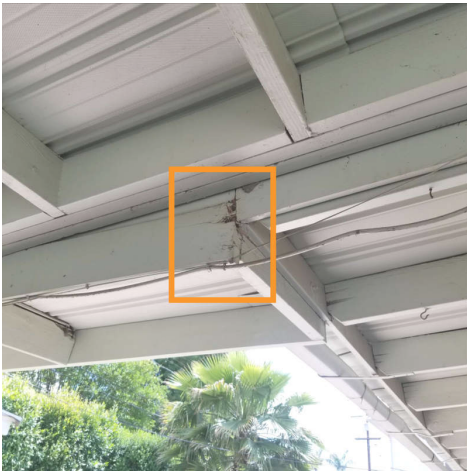
8.2.2 Structure

**DAMAGED FRAMING**

Framing members damaged at one or more areas. Recommend repairs be made by a qualified licensed contractor.

Contact a qualified general contractor.

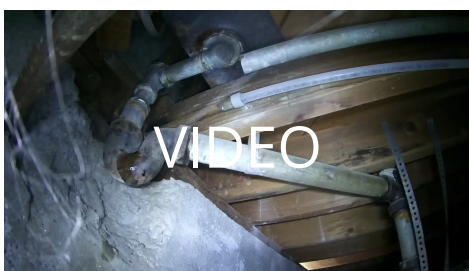
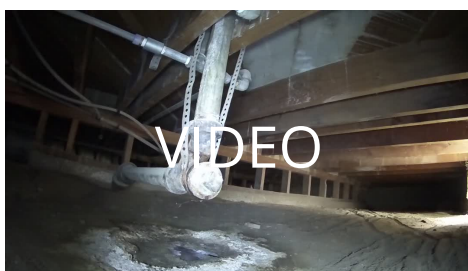
### LEAKS

A leak was found in drain or wastepipes or fittings. A qualified plumber should evaluate and repair as necessary.

Contact a qualified plumbing contractor.

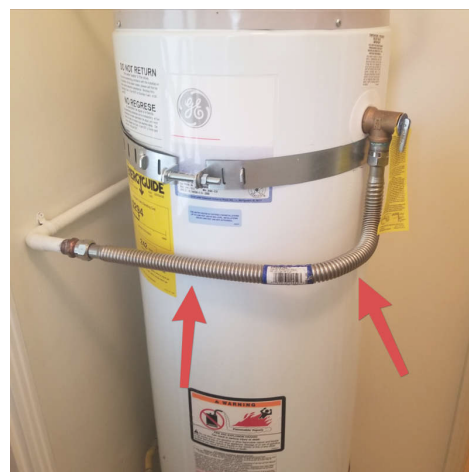
One or more flexible connectors were used for the temperature-pressure relief valve drain line. Flex connectors can be bent or kinked so as to restrict the flow of the drain line and impair the operation of the valve. They typically are not rated for the temperature and pressure of water being discharged (potentially 150 psi and 210 degrees F). Flex connectors used this way pose a potential safety hazard for explosion. Recommend that a qualified plumber repair per standard building practices. For example, by installing a drain line made of rigid copper or CPVC plastic pipe.

Contact a qualified plumbing contractor.

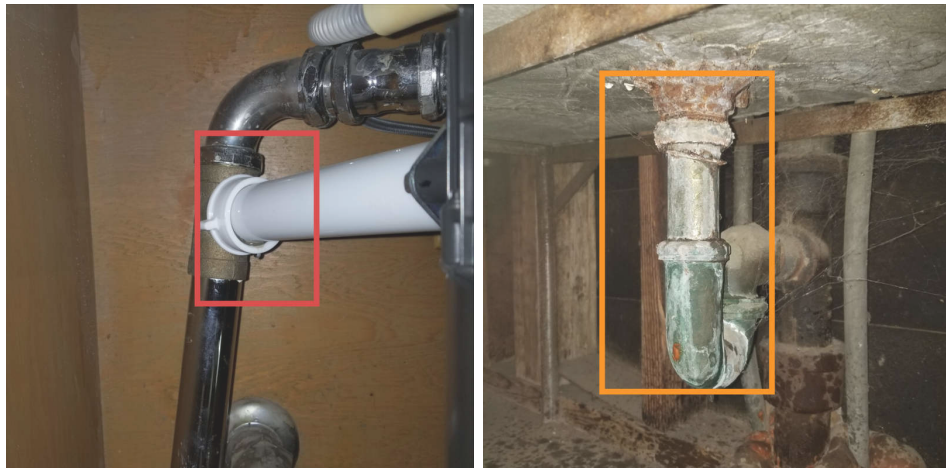
Garage Laundry

**DRAIN LEAK**

One or more leaks were found at the sink drain. A qualified plumber should repair as necessary.

Contact a qualified plumbing contractor.

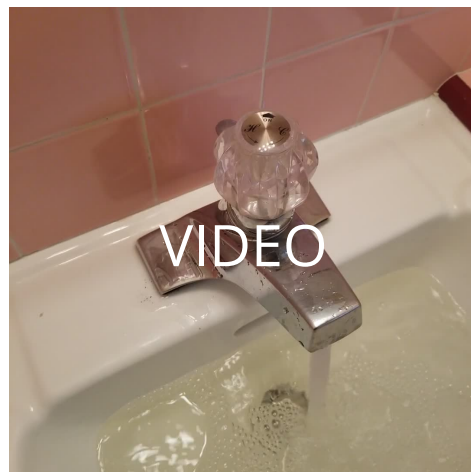
**LEAKING FAUCET BASE / HANDLES**

Water was leaking at one or more sink faucet base or handles. Recommend that a qualified plumber repair as necessary.

Contact a qualified plumbing contractor.

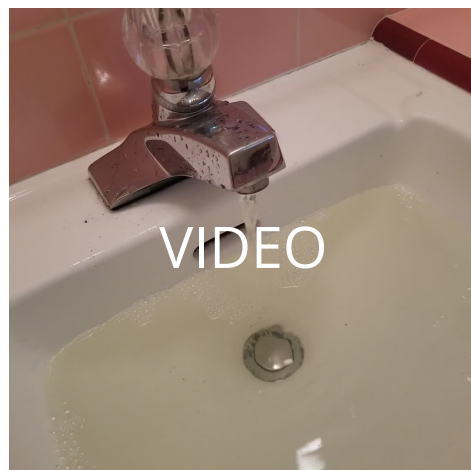
The flow from one or more water supply areas was low or inoperable. Recommend that a qualified person evaluate and repair as necessary. Shut-off valves may be partially or fully closed. Note that the inspector may or may not operate shut-off valves. If repairs are needed, a qualified plumber should make them.

Contact a qualified plumbing contractor.

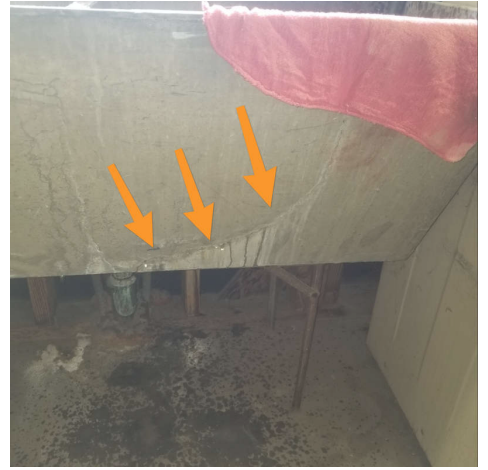
## 9.6.4 Sinks / Fixtures

**SINK DAMAGED - REPAIR OR REPLACE**

The sink was damaged or significantly deteriorated. Recommend that a qualified plumber repair or replace the sink.

Contact a qualified plumbing contractor.

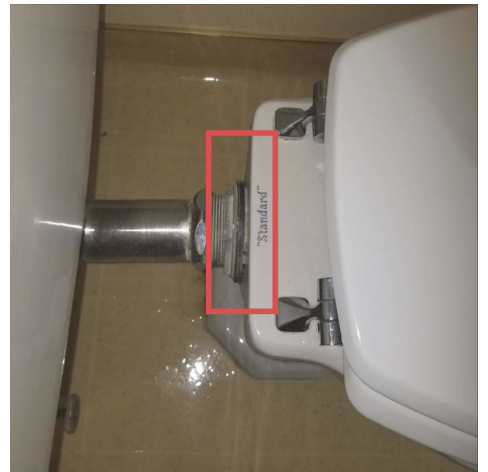
Rear Bath

**TOILET TANK LEAKS**

The toilet tank was leaking where it attached to the toilet. Flooring, the sub-floor or areas below may get damaged. Recommend that a qualified contractor remove the tank(s) and install a new rubber ring and tank(s) should be securely anchored to the toilet to prevent movement and leaking.

Contact a qualified plumbing contractor.

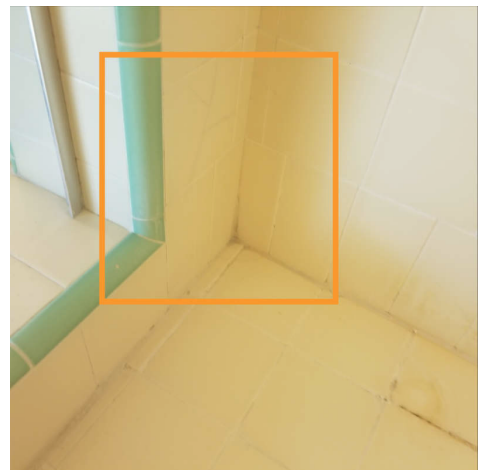
Laundry Bath

Tile and/or grout in one or more locations were damaged, deteriorated, or substandard (e.g. loose or cracked tiles, missing grout). Water can or may have damaged the wall structure as a result. Recommend that a qualified contractor repair as necessary.

Contact a qualified general contractor.

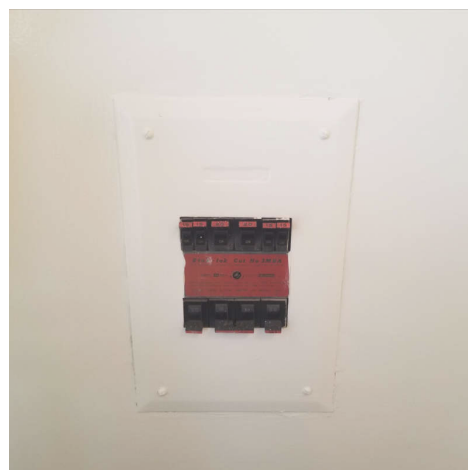
## UTILITY SUB PANEL

One or more panels were manufactured by the Federal Pacific Electric company and used "Stab-Lok" circuit breakers. There is evidence that both double and single pole versions of these circuit breakers fail by not tripping when they are supposed to, which in term often leads to breakers overheating and in some cases, electrical fires. However, in 2011 the Consumer Products Safety Commission (CPSC) closed an investigation into this product because they did not have enough funding to establish that the circuit breakers pose a risk of injury/fire to consumers. Regardless, and due to other evidence of safety issues, it is recommended that a qualified electrician carefully evaluate all Federal Pacific panels and make recommendations. Some insurance companies in the state are not offering property insurance with this manufacturer's panel installed in single family homes that require a 4 point insurance inspection.

Contact a qualified electrical contractor.

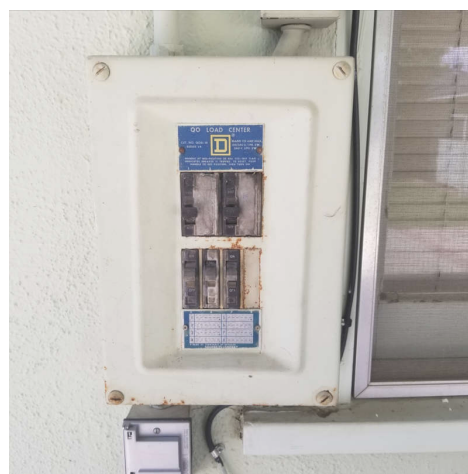
## EXTERIOR RIGHT REAR SUB PANEL

The electrical panel that is installed at the exterior of the building is not designed for exterior installation. This is a safety issue due to the risk of electrical shock. Recommend that repairs be made by a qualified licensed electrical contractor.

Contact a qualified electrical contractor.

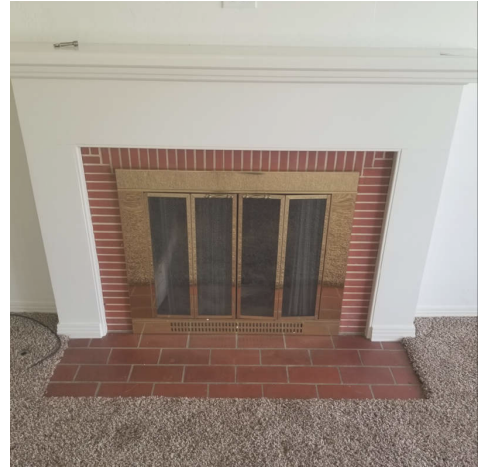
Moderate
**"LEVEL 2" CHIMNEY INSPECTION**

One or more wood-burning fireplaces or stoves were found at the property. When such devices are used, they should be professionally inspected and cleaned annually to prevent creosote build-up and to determine if repairs are needed. The National Fire Protection Association states that a "Level 2" chimney inspection should be performed with every sale or transfer of property with a wood-burning device. Recommend consulting with the property owner about recent and past servicing and repairs to all wood-burning devices and chimneys or flues at this property. Recommend that a qualified specialist evaluate all wood-burning devices and chimneys, and clean and repair as necessary. Note that if a wood stove insert is installed, it may need to be removed for such an evaluation

Contact a qualified chimney contractor.
