BLESS THIS NEST INSPECTIONS, LLC

PROPERTY INSPECTION REPORT

1234 Main St.
Margate Florida 33063

Buyer Name
02/18/2019 9:00AM

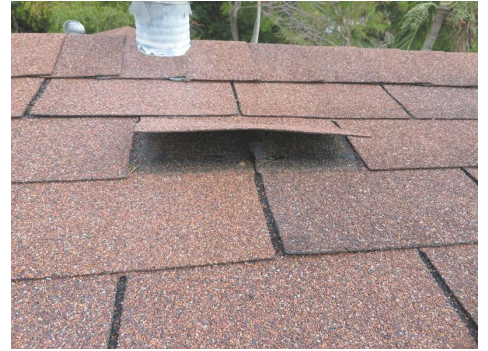
2.2.1 Shingles

SELF SEAL STRIPS LOOSE

Composition shingles were loose because the adhesive, self-sealing strips weren't sealed. Leaks can occur as a result. Self-sealing strips secure the lower edge of shingles and reduce vulnerability to wind damage. Strips may not be sealed because the sealant has failed or because the sealant never activated and cured after the original installation. Recommend that a qualified contractor repair as necessary. For example, by hand sealing shingles with an approved sealant.

Contact a qualified roofing professional.

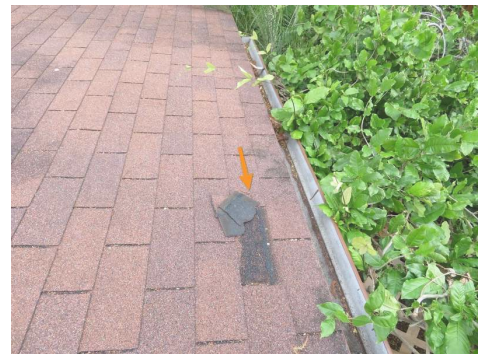
2.2.2 Shingles

SHINGLES DAMAGED

One or more composition shingles were Damaged. Recommend that a qualified contractor repair as necessary. For example, by repairing or replacing shingles. This can reduce the life expectancy of the roofing material.

Contact a qualified roofing professional.

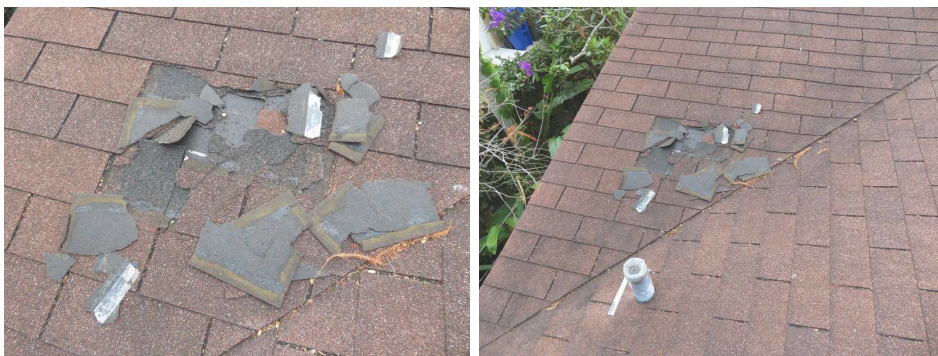
2.2.3 Shingles

SHINGLES MISSING

Roofing shingles were missing. This can cause deterioration and moisture intrusion. Leaks can occur as a result. Recommend that a qualified contractor repair as necessary. For example, by replacing shingles.

Contact a qualified roofing professional.

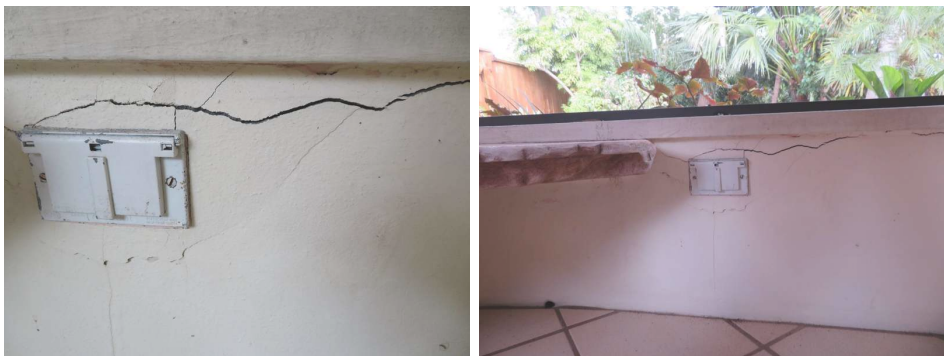
3.2.1 Driveway, Walkway, Patio

SIGNIFICANT CRACKS

One area on the interior side of the the exterior wall of the enclosed porch has a significant crack that appears to be structural. Due to the size and gapping at the cracks, a structural engineer should evaluate. *We recommend Troy Bishop of Axiom Structures.*

Contact a qualified structural engineer.

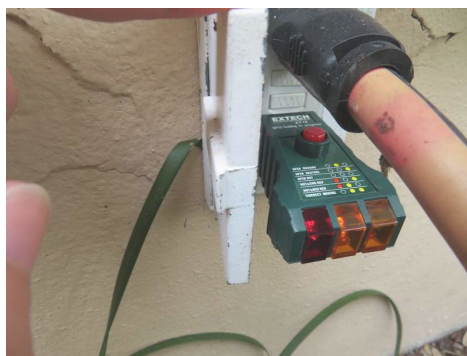
EXTERIOR PORCH WALL

GFCI ISSUE

One or more ground fault circuit interrupter (GFCI) receptacles (outlets) were not functioning properly (would not trip/would not reset). Recommend a licensed electrical contractor replace with new GFCI outlet.

Contact a qualified electrical contractor.

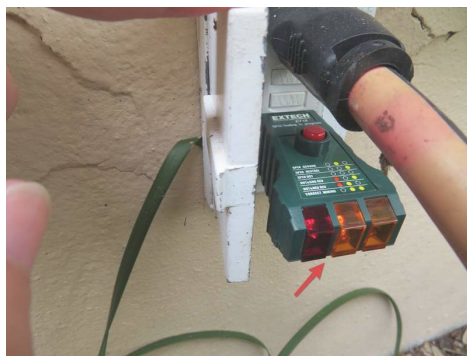
EXTERIOR PORCH WALL

HOT-NEUTRAL REVERSE

One or more electric receptacles had reverse-polarity wiring, where the hot and neutral wires were reversed. Sensitive electronics may result in damage. Recommend that a qualified electrician repair as necessary.

Contact a qualified electrical contractor.

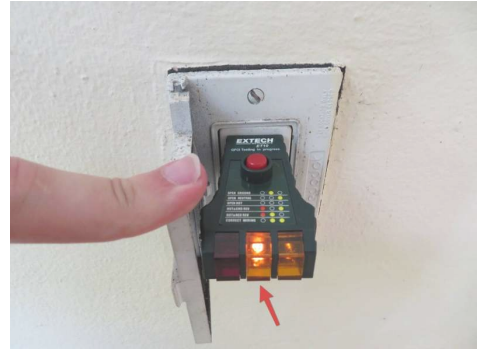
EXTERIOR WALL SIDE OF HOUSE

OPEN GROUND

One or more modern, 3-slot electric receptacles were found with an open ground. This is a shock hazard when appliances that require a ground are used with these receptacles. Examples of such appliances include computers and related hardware, refrigerators, freezers, portable air conditioners, clothes washers, aquarium pumps, and electrically operated gardening tools. Recommend that a qualified electrician repair as necessary so all receptacles are grounded per standard building practices.

Contact a qualified electrical contractor.

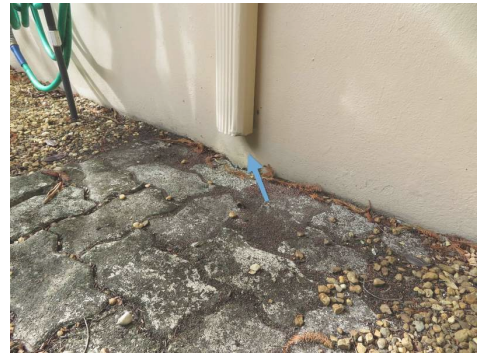
3.7.1 Gutters and Flashing

DOWNSPOUT EXTENSIONS

Extensions such as splash blocks or drain pipes for one or more downspouts were *missing / poorly sloped / misaligned / clogged / substandard / damaged*. Water can accumulate around the building foundation or inside crawl spaces or basements as a result. Recommend the installation of downspout extensions to discharge roof drainage a minimum of 6 feet from the foundation.

Contact a qualified professional.

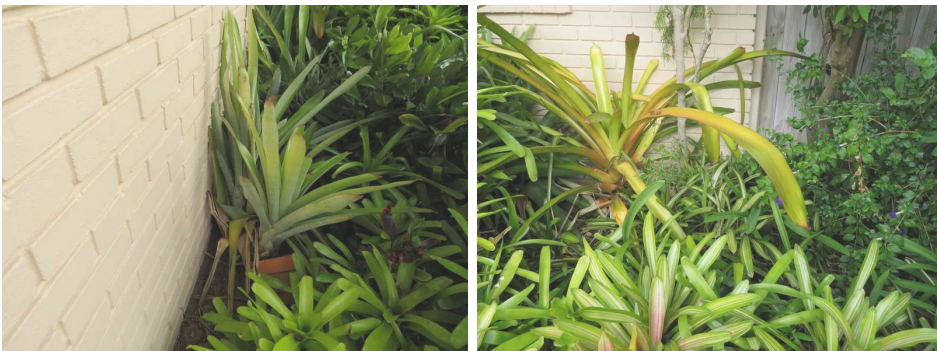
FRONT OF HOUSE

VEGETATION

Vegetation such as trees, shrubs and/or vines was in contact with or close to the building exterior. Vegetation can serve as a pathway for wood-destroying insects and can retain moisture against the exterior after it rains. This is a conducive condition for wood-destroying organisms. Recommend pruning, moving or removing vegetation as necessary to maintain at least 6 inches of space between it and the building exterior. A 1-foot clearance is better.

Contact a handyman or DIY project

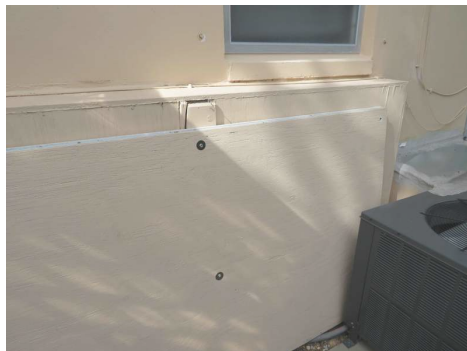
EAST SIDE OF HOUSE

SHUTTER STORAGE

The storm shutters are stored in an area that is not protected from the elements of the weather. Per the Insurance standards, storm shutters are to be stored in a location that is protected from the elements of the weather. It is recommended to have the storm shutters located in a protected area from the elements of the weather.

Contact a handyman or DIY project

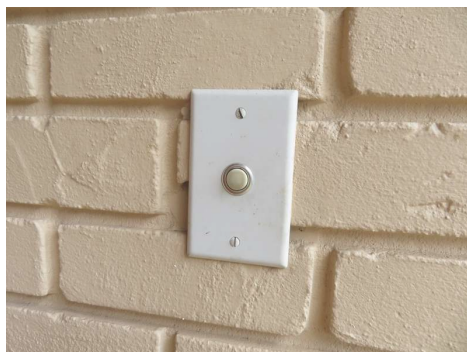
FRONT OF HOUSE

DOORBELL INOPERABLE

The doorbell appears to be inoperable. It does not ring when pressed. Recommend having a qualified electrician evaluate and repair as necessary.

Contact a qualified electrical contractor.

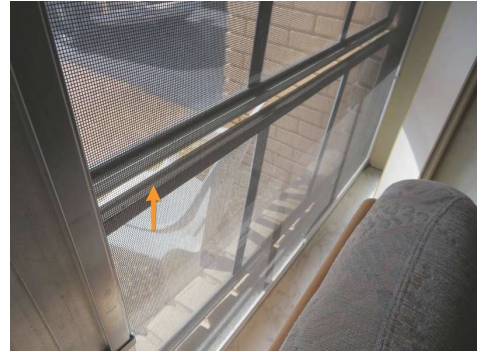
FRONT AND MASTER BEDROOM

WINDOW HARD TO OPEN

One or more windows are difficult to open and close. The windows should be adjusted so that they will open and close freely all necessary repairs should be made.

Contact a qualified professional.

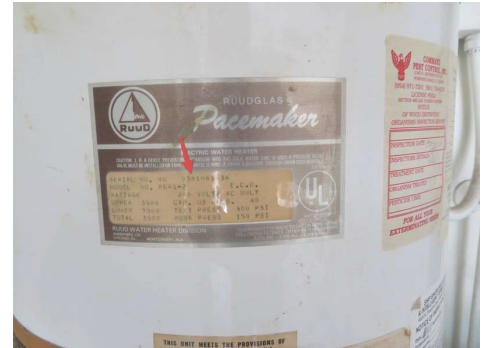
GARAGE

EXCEEDS LIFE EXPECTANCY

Water heater was operable during time of inspection and no signs of rust or leaks. However, the estimated useful life for most water heaters is 8 to 12 years. This water heater appears to be much older and could need replacing at any time. Recommend budgeting for a replacement in the near future.

Contact a qualified plumbing contractor.

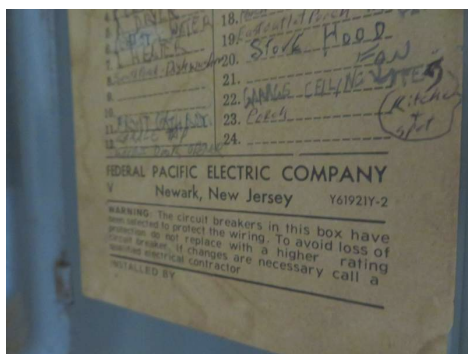
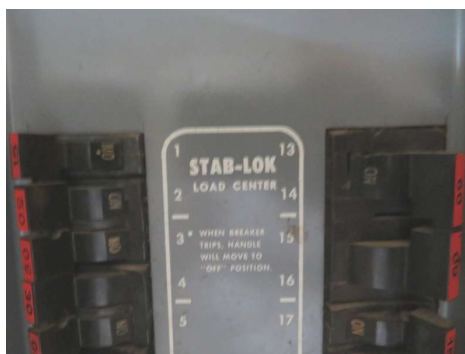
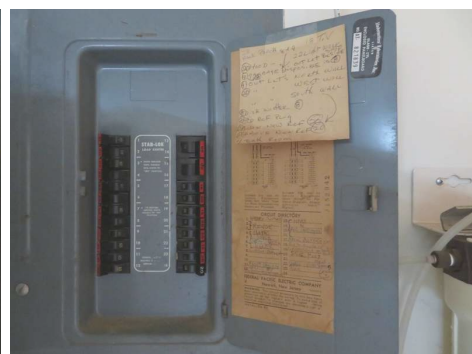
An electric panel was manufactured by the Federal Pacific Electric/Challenger company and used "Stab-Lok" circuit breakers. There is evidence that both double and single pole versions of these circuit breakers fail by not tripping when they are supposed to. However, in 2011 the Consumer Products Safety Commission (CPSC) closed an investigation into this product because they did not have enough data to establish that the circuit breakers pose a serious risk of injury to consumers. Regardless, and due to other evidence of safety issues, recommend that a qualified electrician carefully evaluate all Federal Pacific panels and make repairs as necessary. Consider replacing Federal Pacific panels with modern panels that offer more flexibility for new, safer protective technologies like ground fault circuit interrupters (GFCIs) and arc fault circuit interrupters (AFCIs).

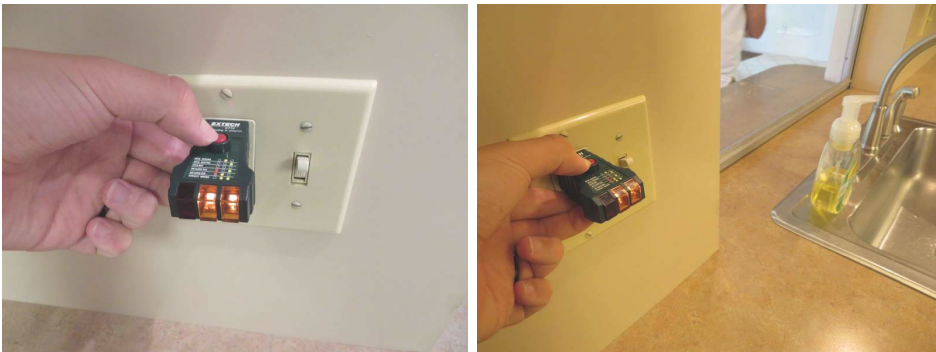
One or more ground fault circuit interrupter (GFCI) electric receptacles did not trip when tested. A qualified electrician should evaluate and repair as necessary.

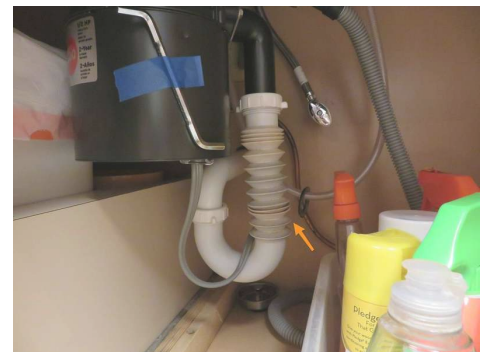
9.5.1 Sink

DRAIN FLEXIBLE PIPE

One or more sink drains use flexible drain pipe. This type of drain pipe is more likely to clog than smooth wall pipe. Recommend having a qualified plumber replace this pipe with standard plumbing components (smooth wall pipe) to prevent clogged drains.

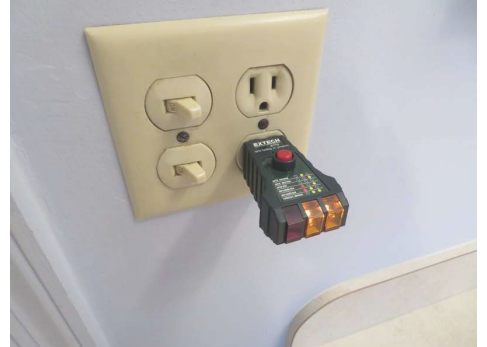
GFCI MISSING

One or more electric receptacles at the bathroom(s) had no visible ground fault circuit interrupter (GFCI) protection, or the inspector was unable to determine if GFCI protection was present. If not GFCI-protected, receptacles in wet areas pose a shock hazard. Recommend that a qualified electrician evaluate and install GFCI protection if necessary and per standard building practices. General guidelines for GFCI-protected receptacles include the following locations:

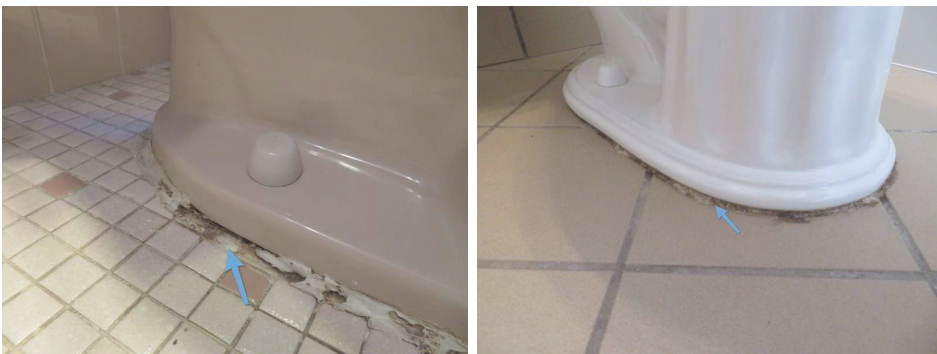
10.8.1 Toilets

NO OR BAD CAULK BASE

Caulk around the base of the toilet was missing, substandard and/or deteriorated. Modern standards require caulk to be installed around the entire toilet base where it meets the floor for sanitary reasons. Without it, soiled water can soak into flooring and sub-floor materials if the toilet overflows. Condensation from the toilet can also soak into the flooring. Recommend that a qualified person caulk around toilet bases per standard building practices.

Recommended DIY Project

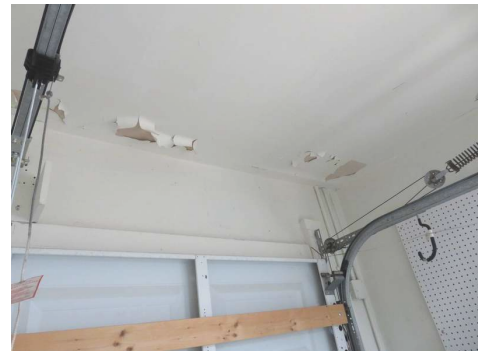
Paint is peeling at one or more locations in the ceiling. This is typically due to the heat in the garage and/or poor preparation. The areas should be properly repaired.

Contact a qualified professional.

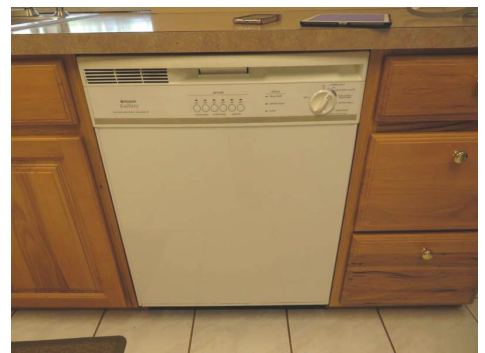
The dishwasher was not run during the inspection. The inspector was informed of a leak and asked not to run it. The client(s) should ask the property owner(s) about this, and if necessary, the dishwasher should be replaced, or a qualified appliance technician should evaluate and repair.

Contact a qualified appliance repair professional.
