## RESIDENTIAL PROPERTY INSPECTION

1234 Main St.  
Fall Branch Tennessee 37656

Buyer Name  
02/23/2018 9:00AM

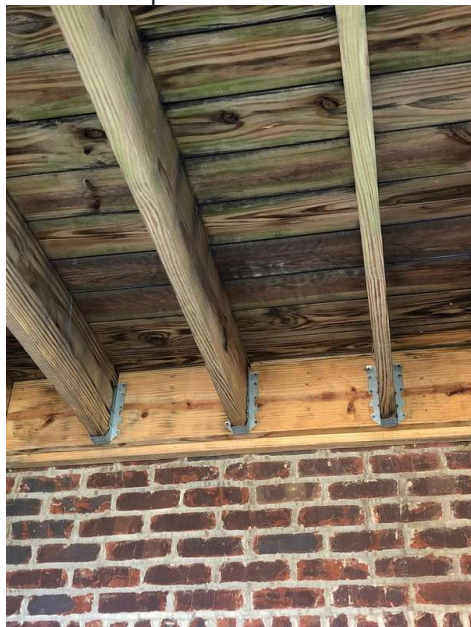
2.4.1 Porches / Decks

**LAG SCREWS NOT PRESENT**

Contact a qualified deck contractor.

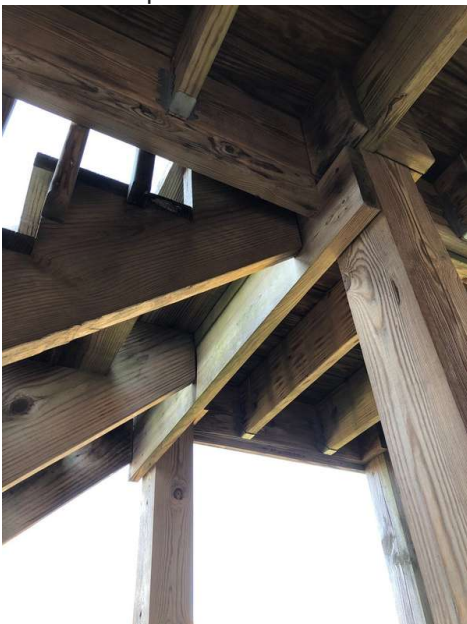
### 2.5.3 Stairs

## STRINGERS MISSING HANGERS

Contact a qualified deck contractor.

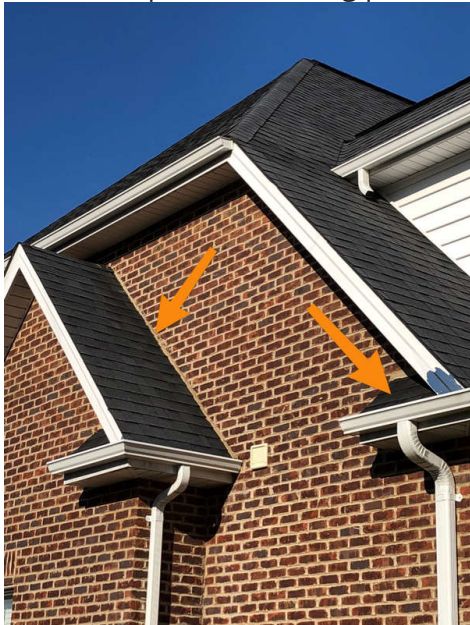
3.3.2 Flashings

**PROPER SIDEWALL FLASHING MISSING**

Contact a qualified roofing professional.

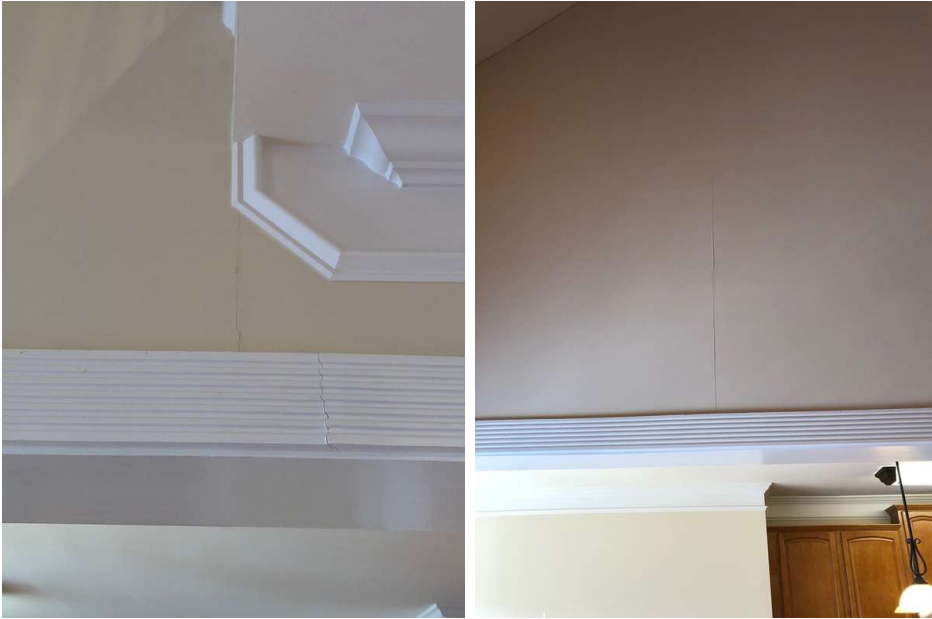
Settlement cracking was present on the wall(s). Some cracks in homes may be present due to standard settlement of the structure; but if the cracking is accompanied by sloping or unlevel floors, binding doors, or settlement cracking on foundation walls, a structural problem may exist. Evaluation of the structure by a structural engineer is recommended if cracks are present with any accompanying signs of settlement.

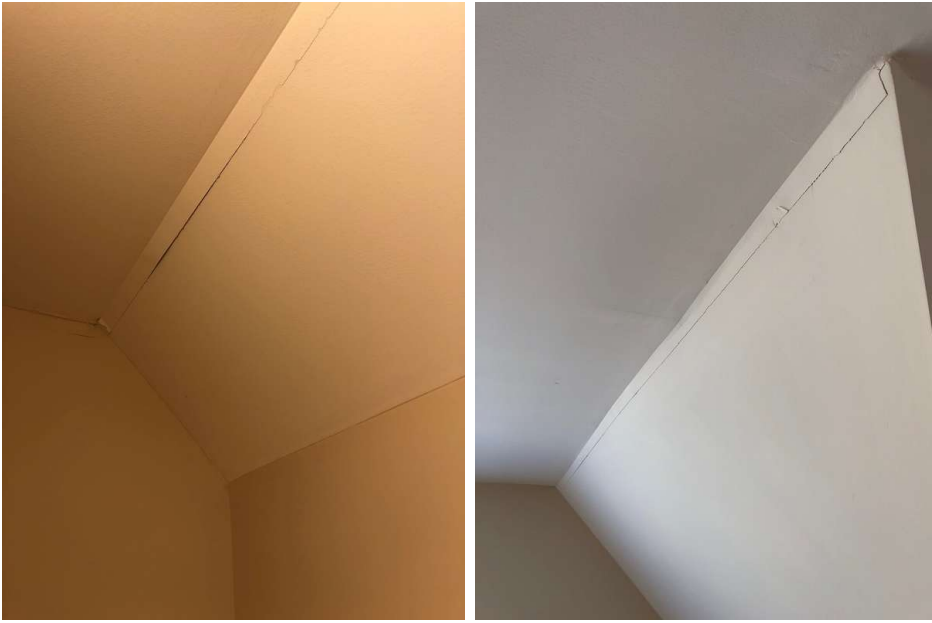
Drywall tape was visible in areas. This is typically due to standard settlement and expansion and contraction. If a concern, have a drywall contractor to evaluate for repair.

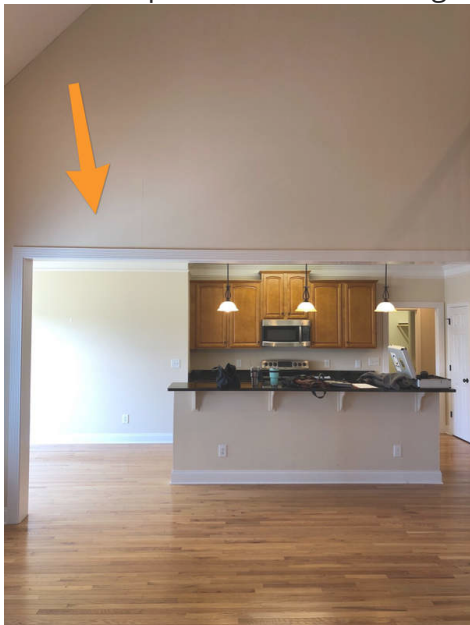
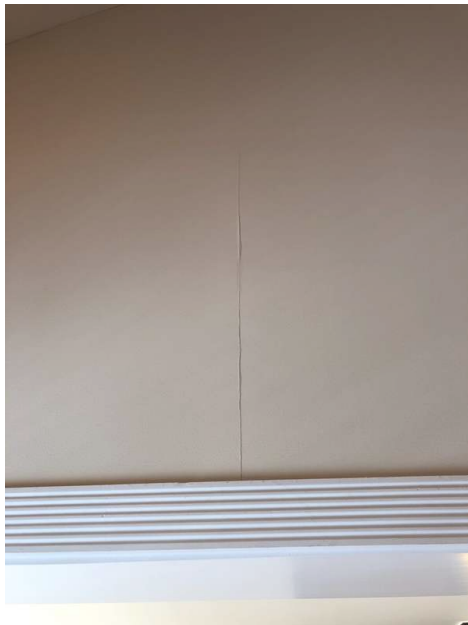
7.13.1 Wall Condition

**POSSIBLE SAGGING HEADER**

Contact a qualified structural engineer.

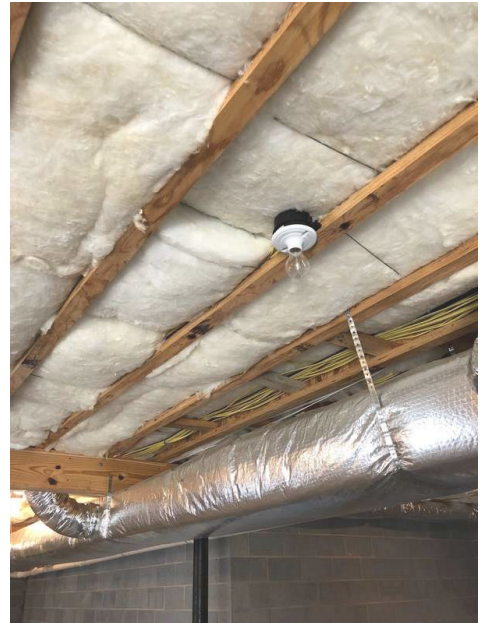
## 13.11.1 Switches, Lights

There were overhead light(s) that were not functional. This could be something as simple as a burned out bulb, or be more extensive. Recommend confirming proper operation prior to closing.

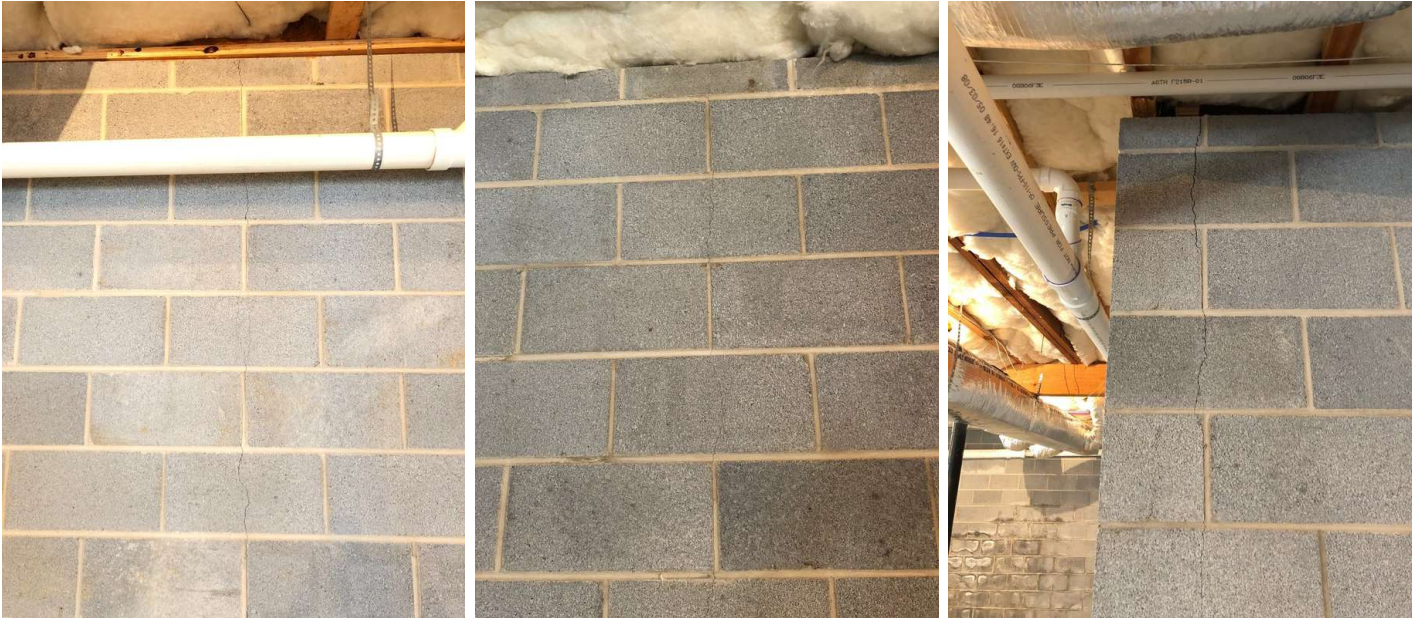
Settlement cracking was present on the foundation walls in areas. The crack(s) appeared to be within normal tolerances at the time of inspection. I recommend sealing the crack(s) and monitoring periodically for movement or expansion, with the understanding that if further movement is observed, repairs may be needed. If a concern, have a foundation contractor or structural engineer to evaluate.
