A PREMIER HOME INSPECTION, LLC

RESIDENTIAL INSPECTION

1234 Main St. Virginia Beach VIRGINIA 23453

Buyer Name 04/06/2019 9:00AM

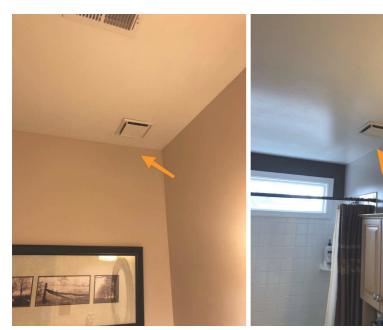
1st Floor Bathroom

7.4.1 Exhaust Fan

NOISY

Contact a qualified electrical contractor.

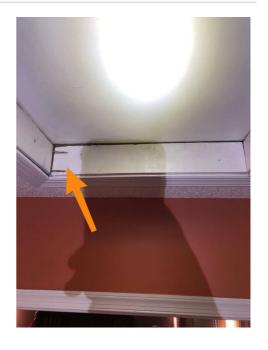
13.2.1 Attic Hatch

ACCESS COVER DAMAGE

The drywall access cover is damaged. The exit to cover should be replaced as a repair is not adequate. The cover was repaired once before.

Contact a qualified professional.

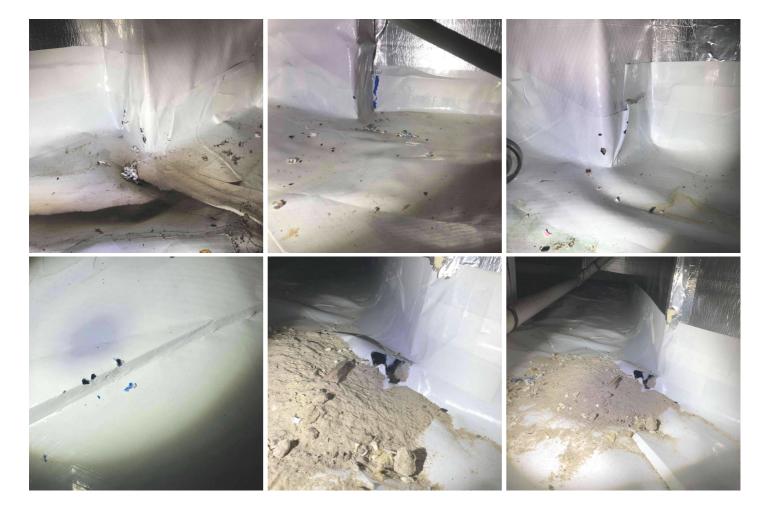
14.3.1 Substructure

PRIOR MOISTURE ON JOISTS

There is staining/film/fungal growth/ microbial growth on a number of floor joists throughout the crawlspace. Areas of minor wood rot have been noted in separate comment. Recommend treatment to crawlspace wood structures to prevent further deterioration of floor/subfloor/ substructure.
