TREC RESIDENTIAL HOME INSPECTION

1234 Main St.
Colleyville TX 76034

PROPERTY INSPECTION REPORT

Concerning: 205 Timberline Dr N, COLLEYVILLE TX 76034
(Address or Other Identification of Inspected Property)

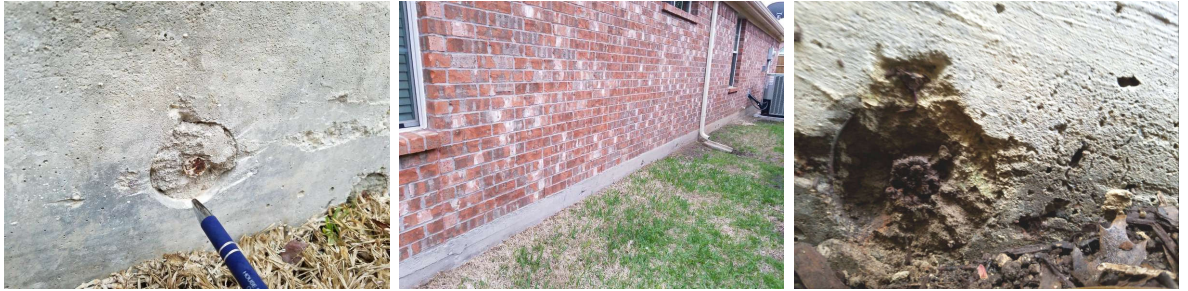
1: Exposed Cable Ends

Multiple places along the foundation including - Right front wall behind bushes in flower bed.; Right

One or more of the post tension cable ends are exposed and need to be properly sealed.

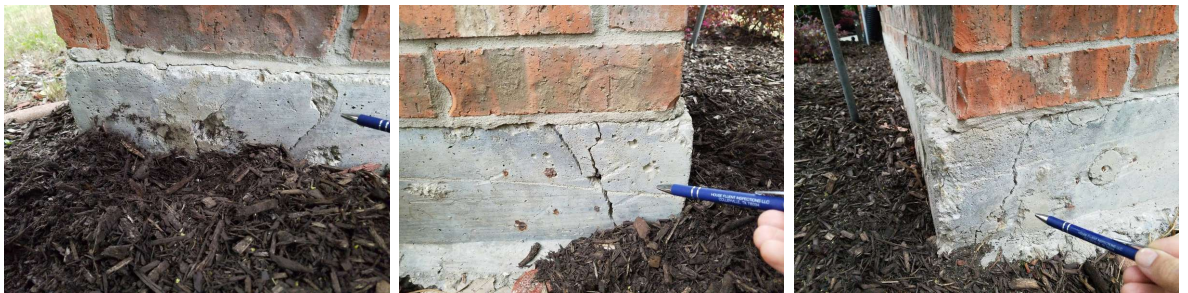
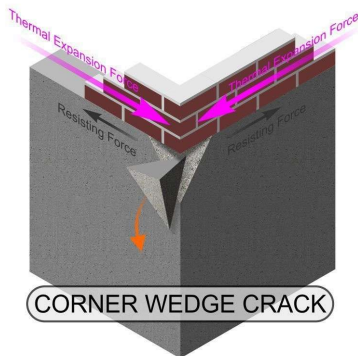
2: Corner Wedge Crack

Right Front wall in flower bed

Corner Popping (A.K.A. Corner Wedge Cracking) is extremely common and is almost always cosmetic in nature. This is typically an easily correctable condition and should be remedied.

Brick, especially in the Texas summers, expands due to thermal expansion and water absorption. A slab foundation, is less porous than the brick, is mostly underground and has much less exposure. The stress develops is between the brick mortar below the bottom bricks and the top of the concrete. This puts the brick in compression and the concrete foundation in tension. Concrete is very weak in tension but brick is very strong in compression, the concrete loses and the corner cracks.

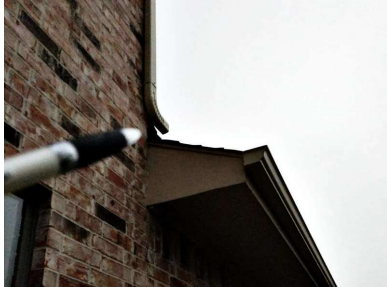
Multiple

Downspout(s) that discharge onto the roof should be extended to discharge directly into the gutters below. This condition, if left unattended, can result in premature deterioration of the roofing under the end of the downspout.

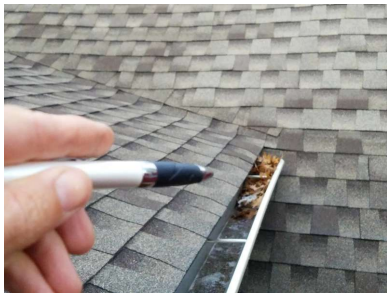
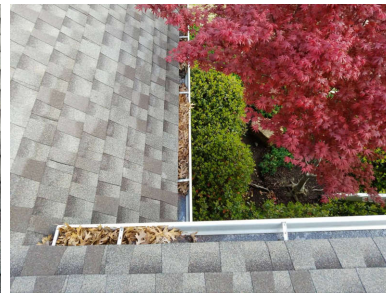
2: Gutters Clogged

The gutters are clogged and require a simple cleaning to avoid spilling roof runoff around the building. This is a common maintenance concern, which if not corrected, has potential to become a source of water entry or water damage. In addition, gutters that overflow can allow water to pool or pond near the foundation which could lead to result in structural issues over time.

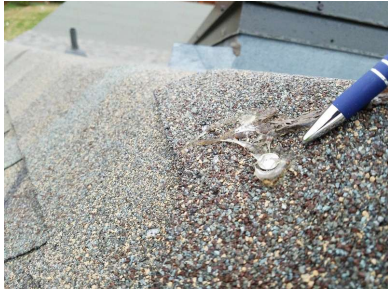
1: Nail Heads Exposed

Under-driven or exposed nails were found in one or more roof coverings. While this is often not an immediate threat for water penetration, it can lead to further, more rapid degradation to the roof covering material at these locations. Under-driven or exposed nails should be sealed or otherwise repaired..

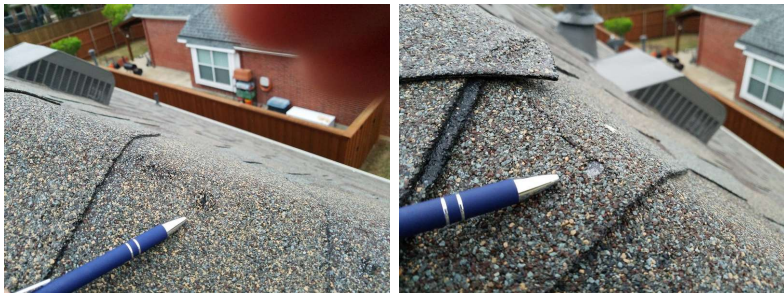
2: General Damage to Coverings

Roof coverings exhibited minor general damage that could affect performance over time.

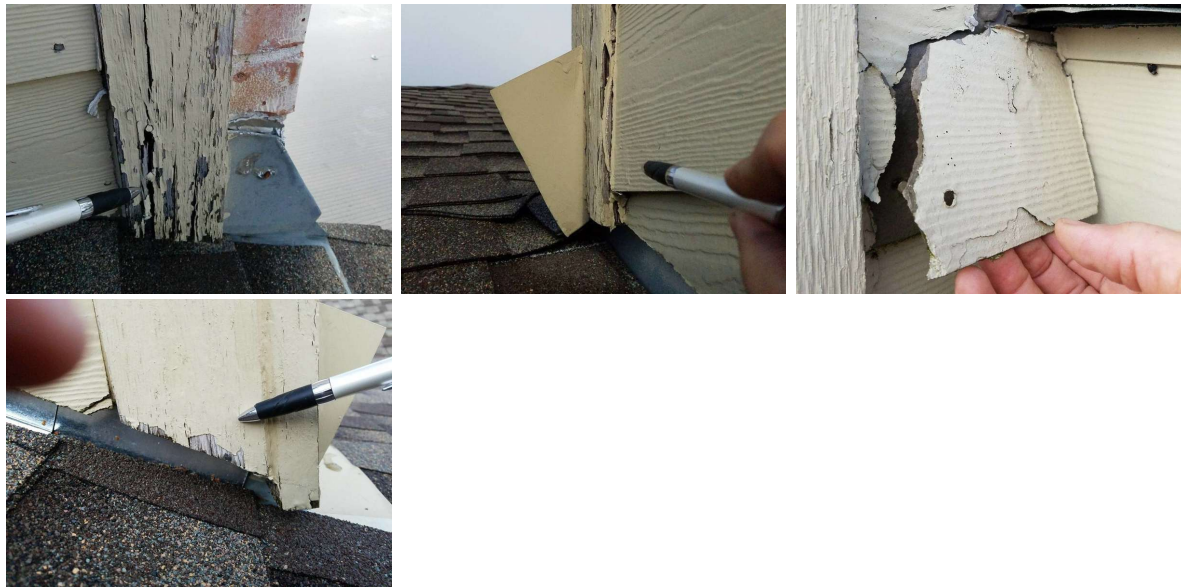
1: Exterior Walls - Siding Deterioration

Left wall of Dormer

Deterioration of the siding was observed. Improved roof flashing and guttering to properly shed water from the roof surface can reduce the impact of this type of deterioration. Once repaired, monitoring and regular maintenance are recommended to maintain the integrity of the siding. When the roof covering material is due for replacement it is recommended that the roofers understand where these vulnerable points are and install flashing to help protect them.

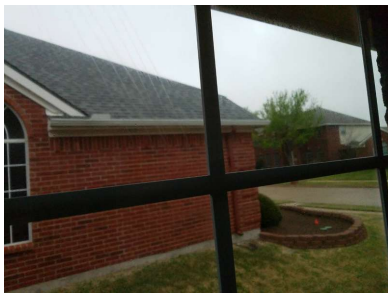
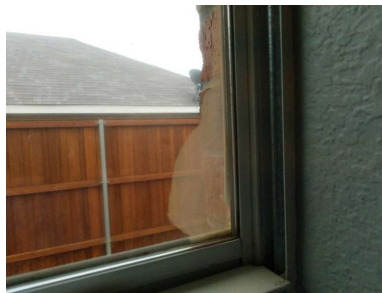
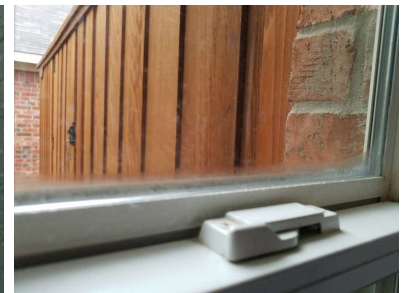
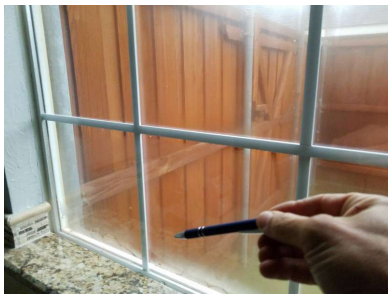
1: Lost Seal

The window(s) have lost their seal. This has resulted in condensation developing between the panes of glass and can cause the glass to loose its insulating properties. The glass should be repaired or replaced.

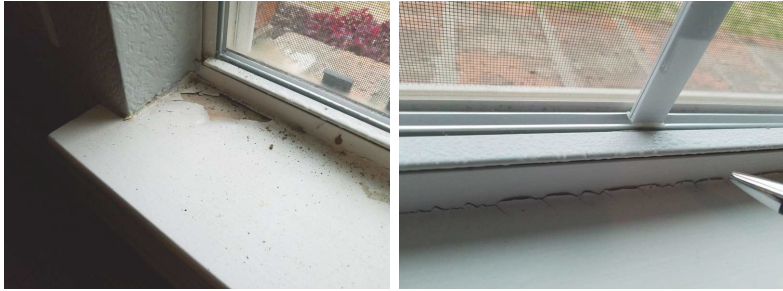
2: Window Condensation

The windows show evidence of condensation. This is not a major concern. Controlling indoor humidity levels and/or improving window efficiency (if needed) would help to control this condition.

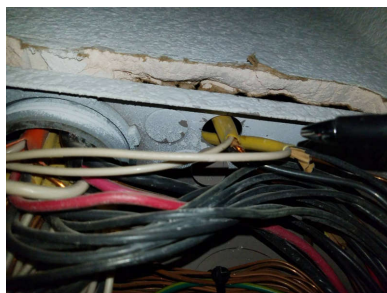
2: Openings In Panel

Any openings in the main panel should be covered.

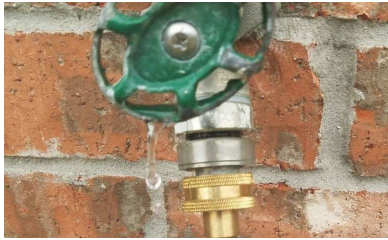
1: Hose Bib Leaks

The hose bib is leaking at the handle when turned on and should be repaired.

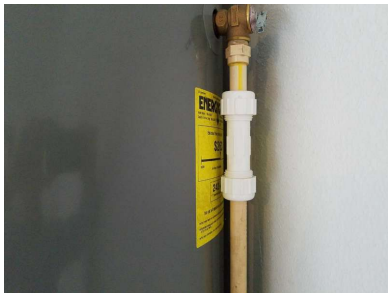
1: Discharge Tube Needs Improvement

The discharge piping serving the Temperature and Pressure Relief (TPR) Valve for the water heater has a questionable fitting, this should be replaced with an appropriate fitting.

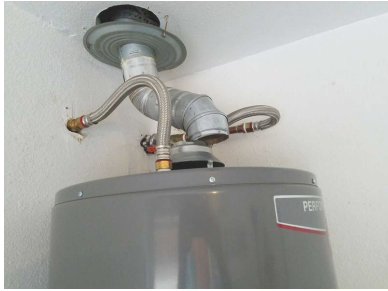
2: Spillage Of Exhaust

The water heater venting system shows evidence of exhaust "spillage". This is a serious condition that could be a health threat to the occupants of the home. This condition should be addressed promptly.

For enhanced safety, it is recommended that the connections of the water heater venting system be improved.

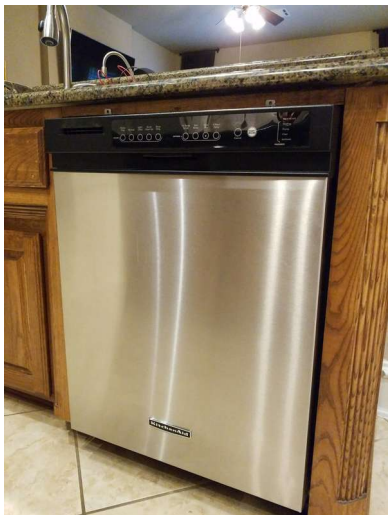
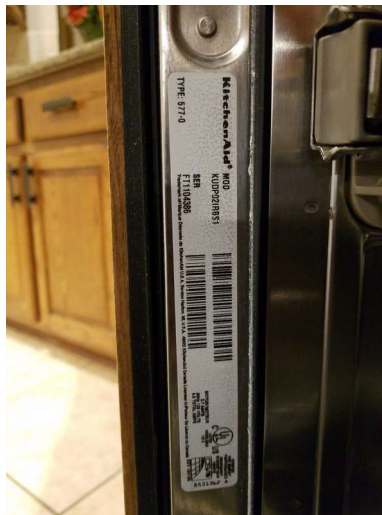
1: Airgap Device Missing
The dishwasher lacks an airgap device. Air gaps are now standard equipment to assure a separation between supply and waste water. It is advised that one be installed.

2: Dishwasher Poorly Attached
The dishwasher should be properly secured.

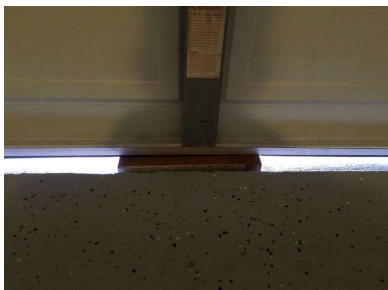
1: Opener Auto Reverse Defective

▲ Safety Hazard

The garage door opener did not automatically reverse under resistance to closing. There is a serious risk of injury, particularly to children, under this condition. Improvement may be as simple as adjusting the sensitivity control on the opener. This should be repaired immediately.
