ROYO INSPECTIONS

PROPERTY INSPECTION REPORT

Concerning: 1234 Main St. Katy TX 77450

By: Brian Royo - TREC# 23623

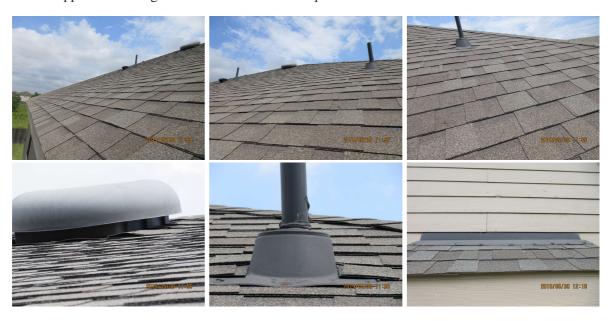
1: Boots

Vent boots are deteriorating/damaged. Recommend repair

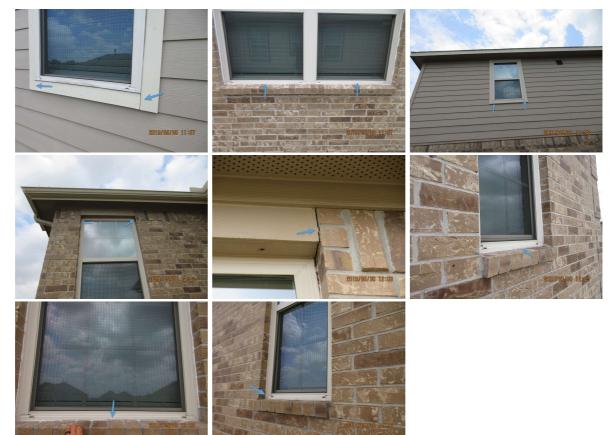
Recommend recalling around windows to prevent any moisture intrusion. This should be part of annual home maintenance program.

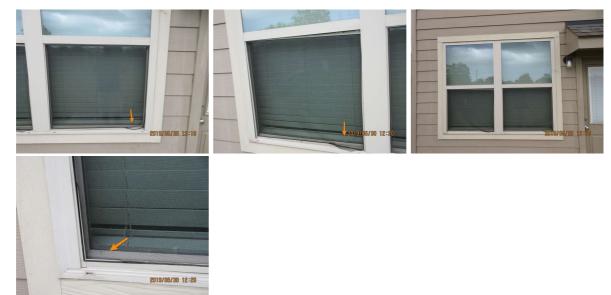
3: Missing/Damaged Screen(s)

One or more windows are missing a screen or have damaged screens. Recommend replacement.

Recommendation: Contact a qualified window repair/installation contractor.

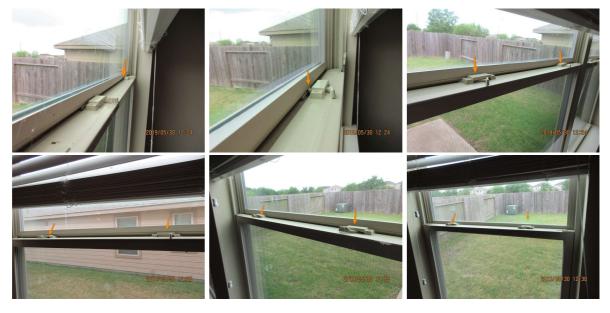
Window does not close completely. This could be from improper installation, settling or foundation issues. Recommend repair. If problem persists contact a structural engineer for further evaluation.

Recommendation: Contact a qualified window repair/installation contractor.

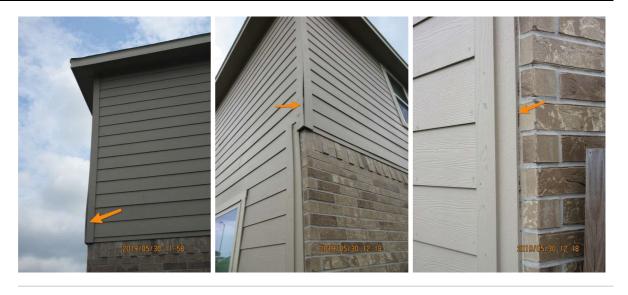
8: Wall Damage

Damage to wall. Recommend patching/repairing.

Recommendation: Contact a qualified professional.

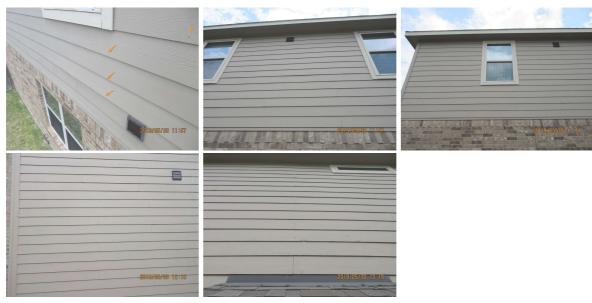
9: Improper Fastening of Siding

Siding was improperly fastened. Nail heads should be hidden by the layer above it. Nail heads should not be exposed. Exposed nail heads are potential entrances for moisture. Recommend having a qualified professional repair all siding
