SAVIOR INSPECTION SERVICES, LLC

TREC RESIDENTIAL

1234 Main St.
Melissa TX 75454

PROPERTY INSPECTION REPORT

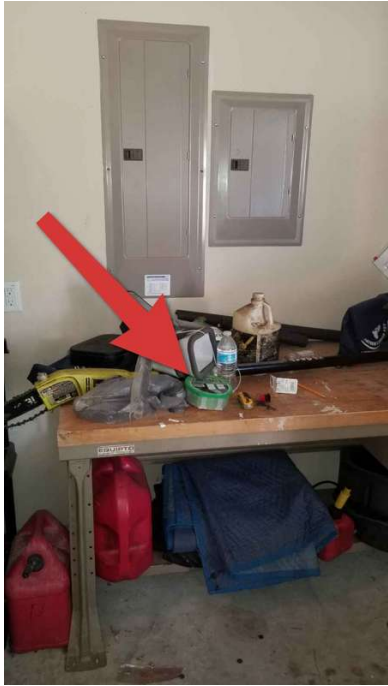
Garage

1: Not Enough Clearance

The service panel did not have proper clearances to provide quick access for an emergency disconnect. The clear working space required in front of a panel is 30" wide by 36" deep with a minimum headroom clearance of 6 feet-6 inches. Recommend moving the work bench from in front of the panel to satisfy these requirements.

Recommendation: Contact a handyman or DIY project

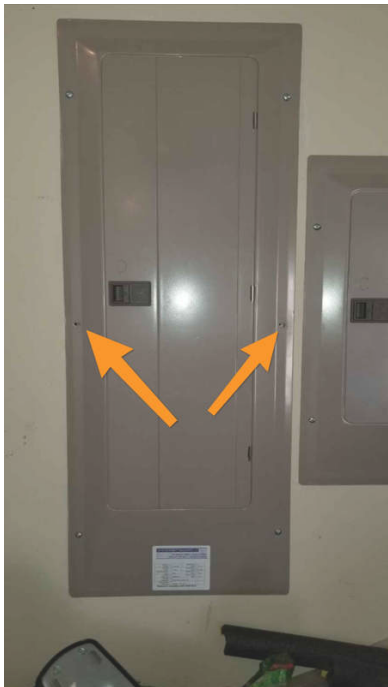
Garage

2: Missing Screws

Service panel was missing 2 screws at time of inspection.

Recommendation: Contact a qualified electrical contractor.

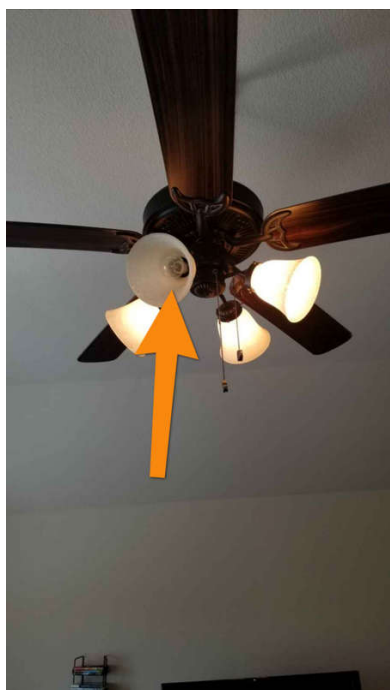
2nd Floor Gameroom

1: Light Did Not Respond

One or more lights did not respond to the switch. The bulb may need to be replaced or there may be a problem with the switch, wiring or light fixture. If after the bulb is replaced this light still fails to respond to the switch, the Inspector recommends that an evaluation and any necessary repairs be made by a qualified electrical contractor.

Recommendation: Contact a qualified electrical contractor.

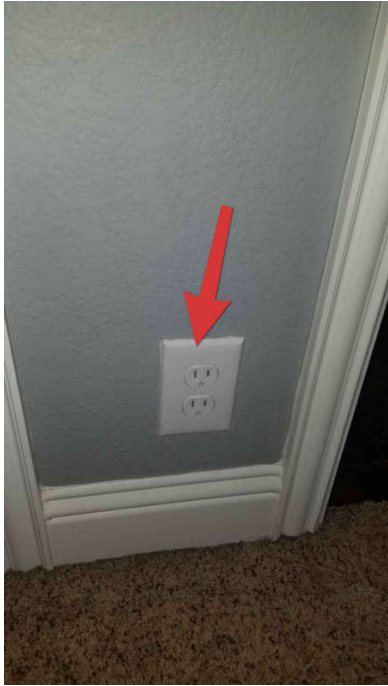
Master Bedroom

2: Loose Outlet

One or more electrical receptacles in the home were improperly secured and moved when plugs were inserted. Receptacles should be securely installed to prevent fire, shock and/or electrocution hazard.

Recommendation: Contact a qualified electrical contractor.

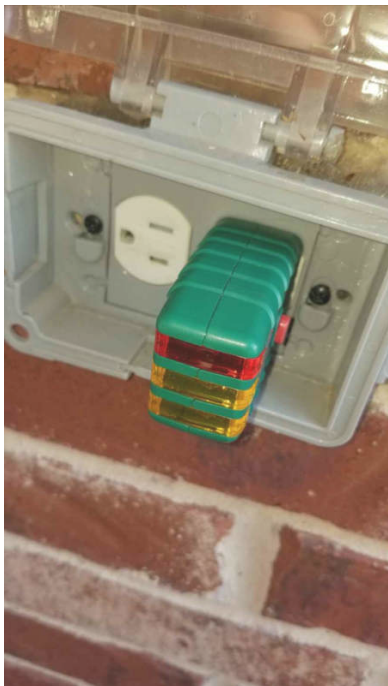
Front Porch

3: Receptacle - Inoperable

Two receptacles were inoperable at the time of the inspection. There was a breaker that was in the OFF position at time of inspection. These receptacles may be on that particular circuit, however, since the breaker was already off at the time of inspection, it was not turned to the on position. Also, these are GFCI receptacles, so there may be a tripped GFCI outlet that needs to be reset, however one could not be located. The Inspector recommends service by a qualified electrical contractor if the OFF breaker or GFCI reset is not the reason why they are inoperable.

Recommendation: Contact a qualified electrical contractor.

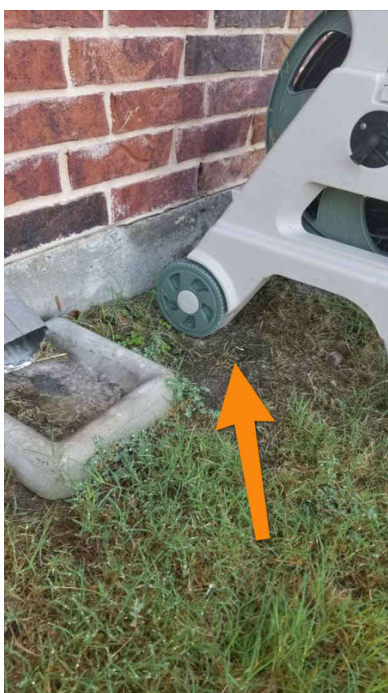
West

1: Erosion Due to Downspout

In one or more locations, gutter downspouts causing minor erosion near foundation. Recommend installing downspout extensions to channel moisture away from foundation.

Recommendation: Contact a handyman or DIY project

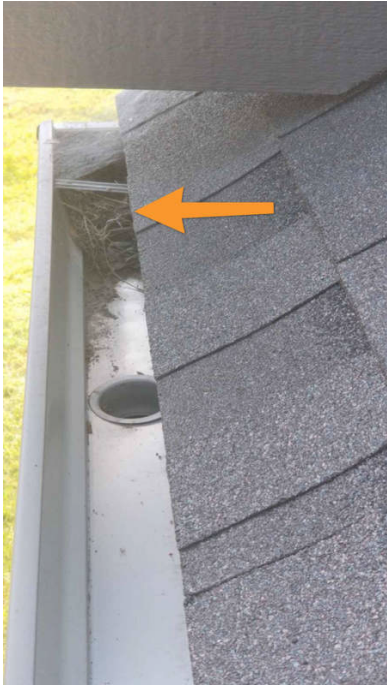
North

2: Debris in Gutters

Debris found in gutters which could adversely gutter performance. Recommend having gutters cleaned to ensure proper drainage.

Recommendation: Contact a handyman or DIY project

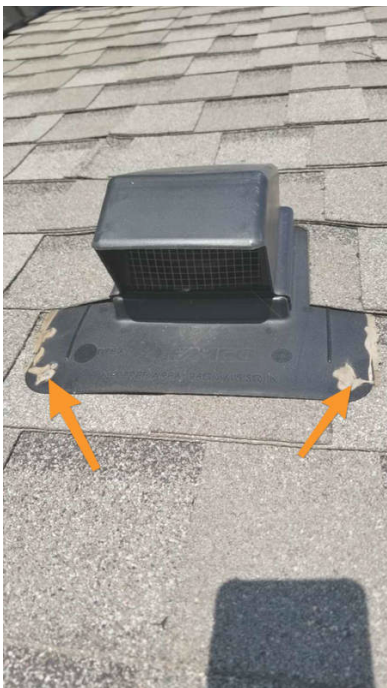
East

1: Exposed Nails

Under-driven or exposed nails were found in one or more roof coverings. Recommend a qualified roofer evaluate and correct.

Recommendation: Contact a qualified roofing professional.

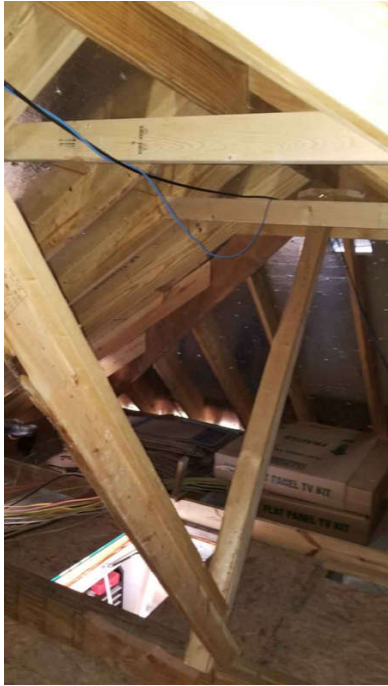
1: No Light in the Attic

The attic space above garage was not provided with a light.

Recommendation: Contact a qualified electrical contractor.

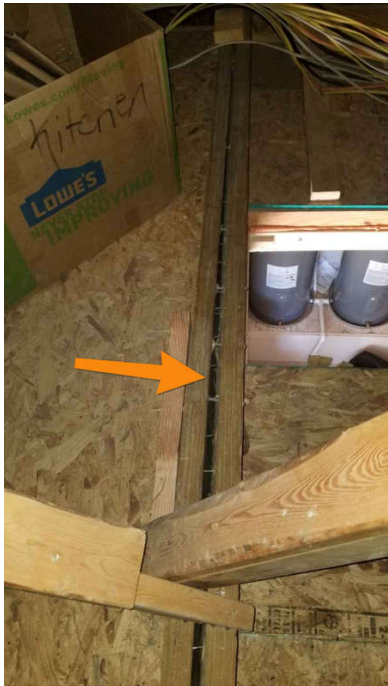
Attic Above Garage

2: Twisted Engineered Beam

In attic above the garage, there are two engineered beams that parallel each other. One of those beams appear to have rotated or twisted and is separating from the other. There also appears to be a failed attempt at attaching these beams together.

Recommendation: Contact a qualified structural engineer.

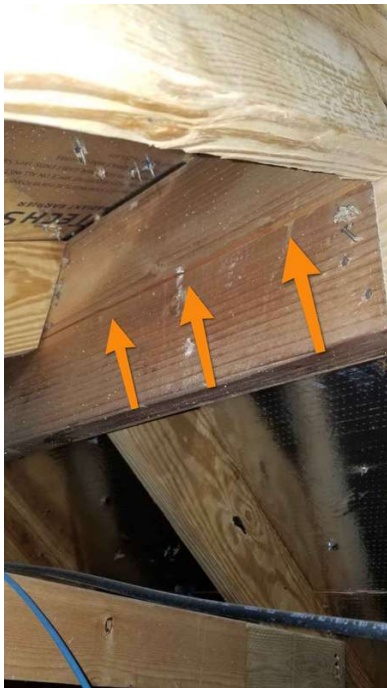
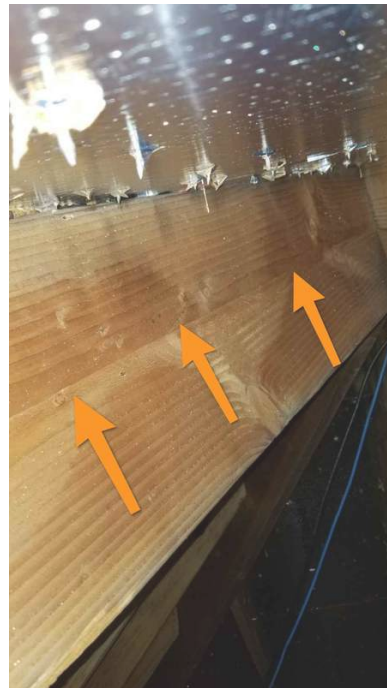
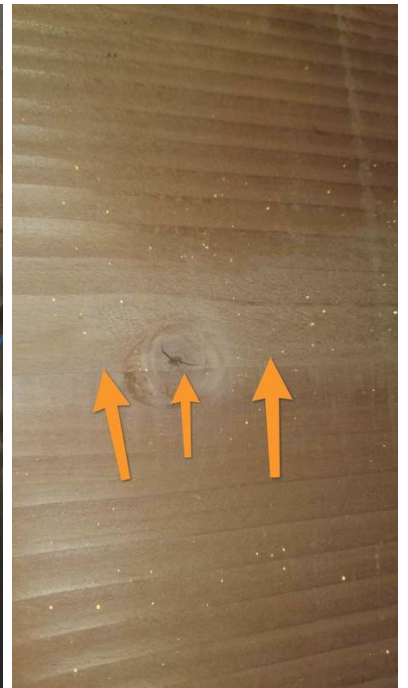
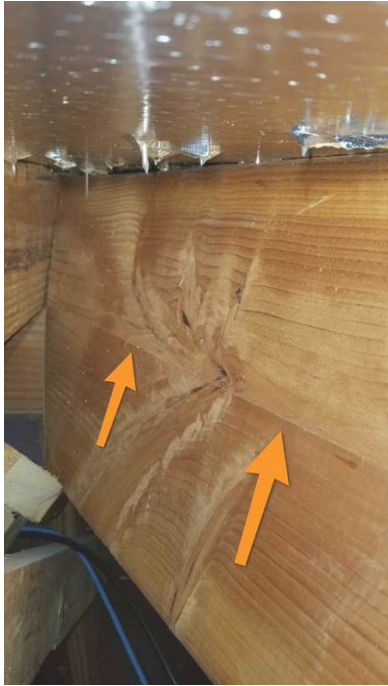
Above Garage Attic Hatch

3: Split Framing

In the attic above the garage, above the access hatch, there were three framing members that are split. These appear to be a combination of hip rafters and ridge beams. All of these are 2x12 boards and come together at the peak. Although difficult to see in photos, the split continues almost the entire length of a couple of the boards.

The Inspector highly recommends that a Structural Engineer evaluate the safety and integrity of the roof structure.

Recommendation: Contact a qualified structural engineer.

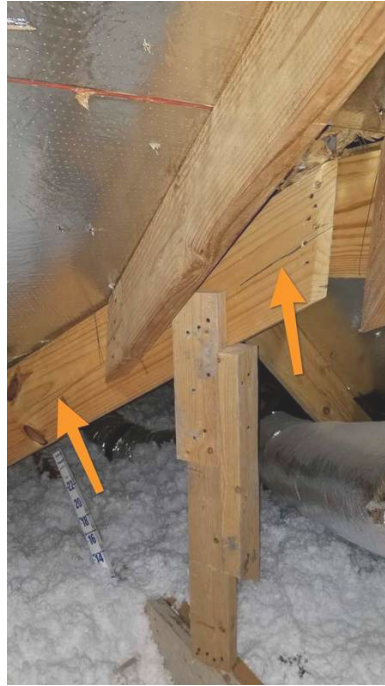
Attic Above Master Bedroom

In addition, in the portion of the attic above the master bedroom/bath, there was another split framing member.

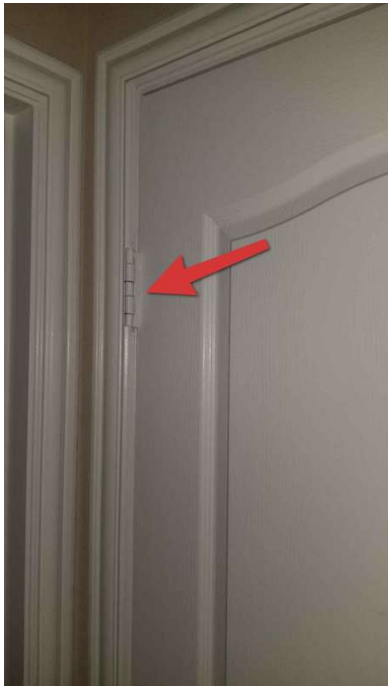
The walls separating the garage from the home living space did not meet generally-accepted current safety standards firewall requirements. Firewalls are designed to resist the spread of a fire which starts in the garage for a certain length of time in order to give the home's occupants adequate time to escape.

This home failed to meet requirement number (5).

Door Leading to Garage Needs Self-closing Hinge

Recommendation: Contact a handyman or DIY project

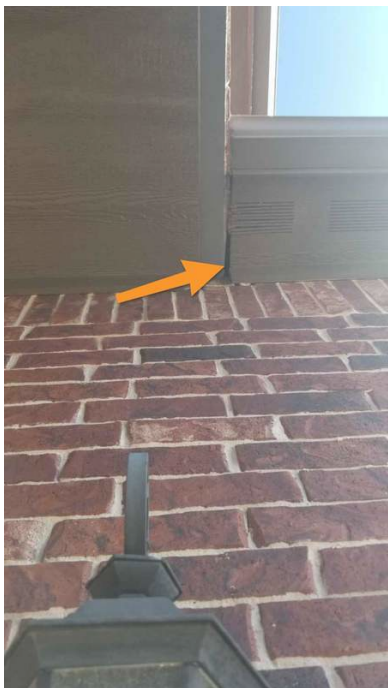
Above Front Porch, Exterior View

2: Exterior Gap Needs Sealed

In one or more locations, gaps/holes were observed that are big enough for vermin intrusion. Recommend sealing gaps/holes to prevent vermin from entering attic space.

Recommendation: Contact a handyman or DIY project

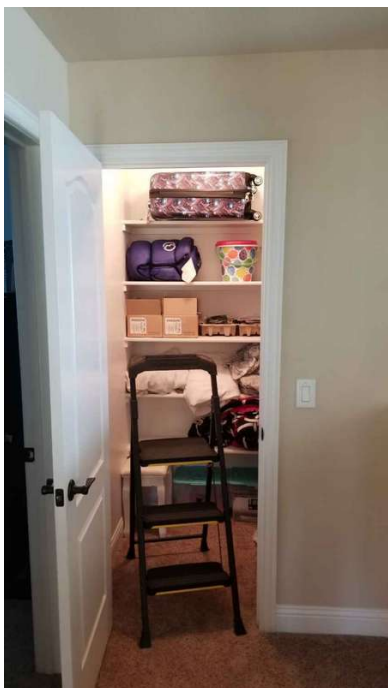
The ceiling in the 2nd floor closet showed signs of water intrusion, which could lead to more serious structural damage. In the ceiling area and wall area near the ceiling, there were very high levels of moisture present. This closet is directly underneath the air handler, which is leaking onto the attic floor. Once the leaking air handler is repaired, the Inspector recommends a qualified professional evaluate and repair the area of high moisture.

2nd Floor Closet Where Moisture is Present

Recommendation: Contact a qualified professional.

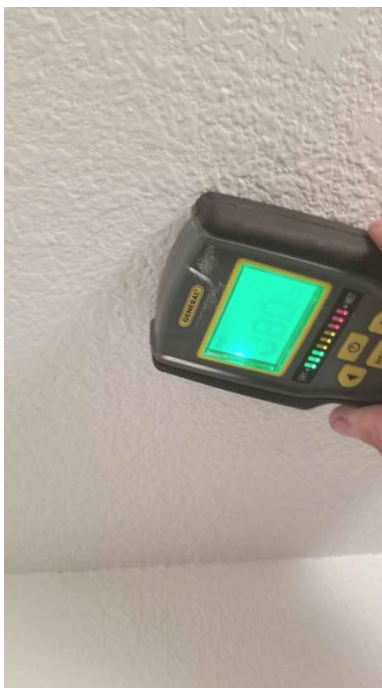
High Moisture, 2nd Floor Closet Ceiling

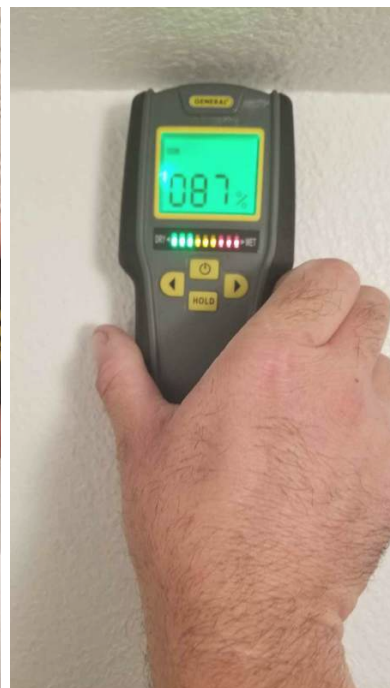
High Moisture Level , 2nd Floor Closet Wall

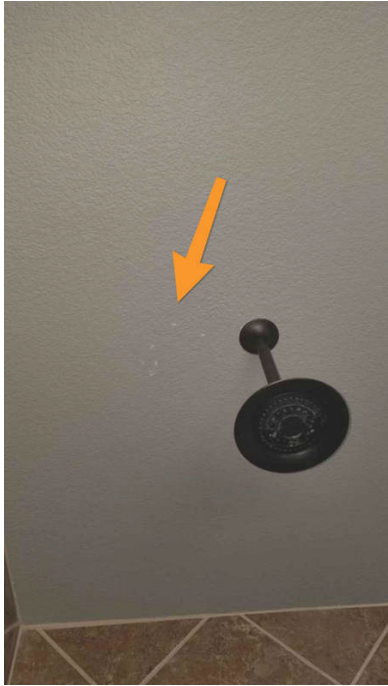
Master Bathroom

In the master bathroom shower, there is a small area right beside the overhead shower head that may be the result of water intrusion. However, the moisture meter showed very low levels of moisture in this area. The Inspector was unable to positively confirm the presence of moisture in this area and recommends monitoring the area to see if it worsens. Contact a qualified plumbing contractor to evaluate and repair if needed.

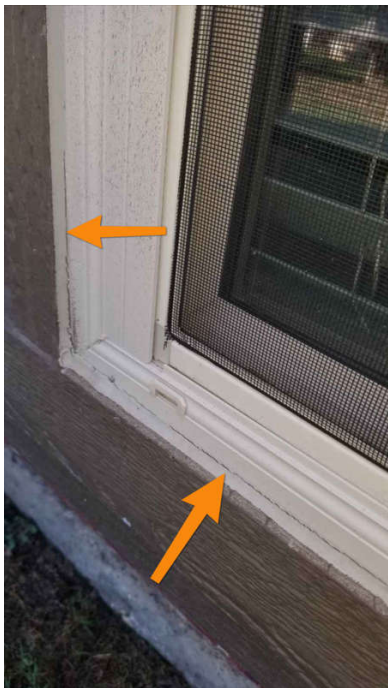
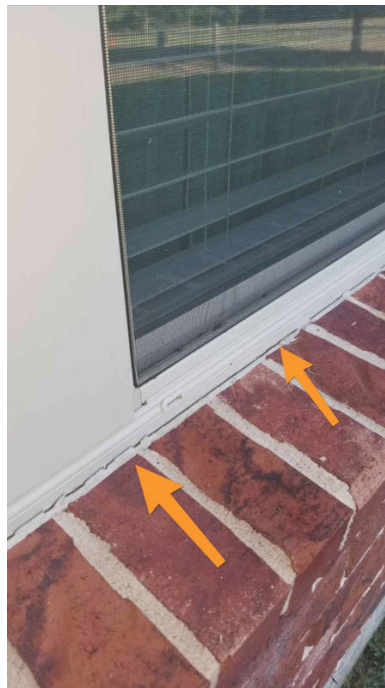
West

1: Caulking

One or more windows need new exterior caulking to prevent moisture intrusion.

Recommendation: Contact a qualified handyman.

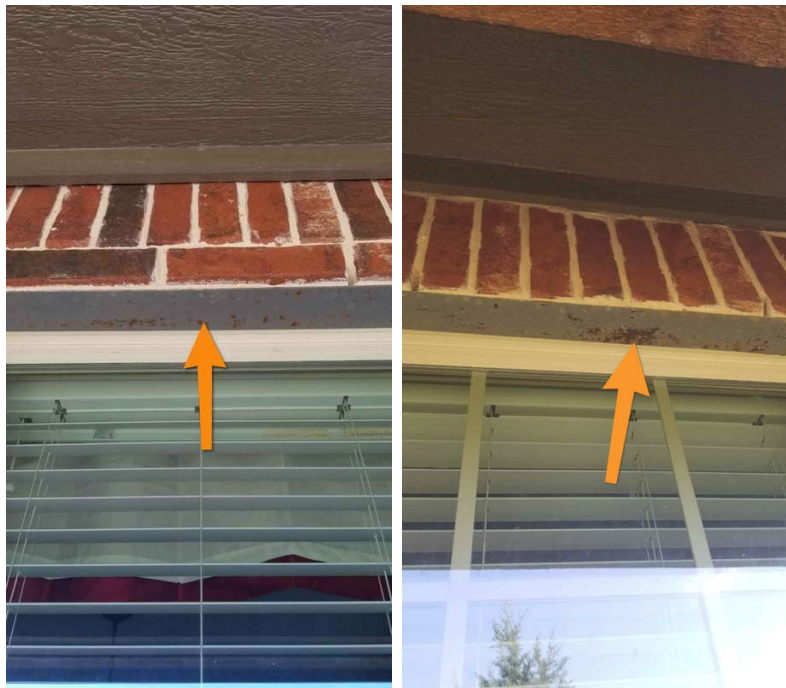
2: Lintle Rusted

In one or more location, lintels are rusted. Recommend having lintels painted to help prevent corrosion, which can damage the brick around it.

Recommendation: Contact a qualified professional.

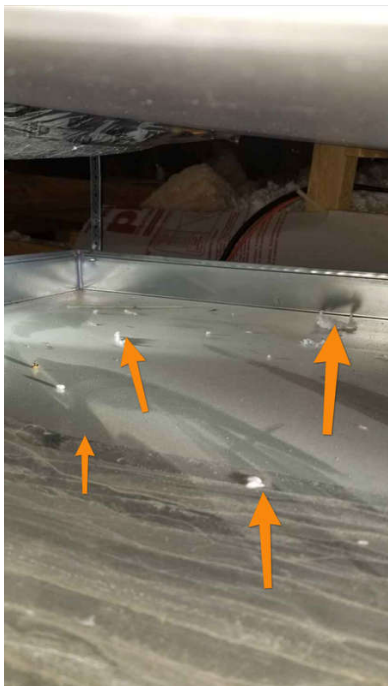
1: Drip Pan Debris

Both secondary drip pan contain debris which can clog the drain line. If drain gets clogged it can result in overflowing the pan which will cause moisture damage to surrounding area. Recommend cleaning drip pan.

Recommendation: Recommended DIY Project

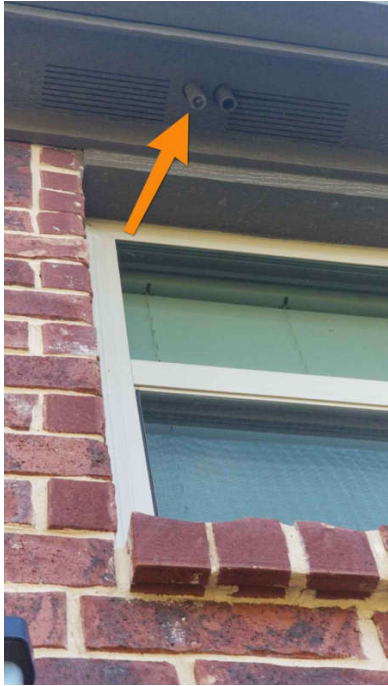
Northeast

2: Clogged Secondary Drain Line

One of the secondary condensation drain lines appear to be clogged. This can result in moisture intrusion in the attic and the structure below the air handler.

Recommendation: Contact a qualified HVAC professional.

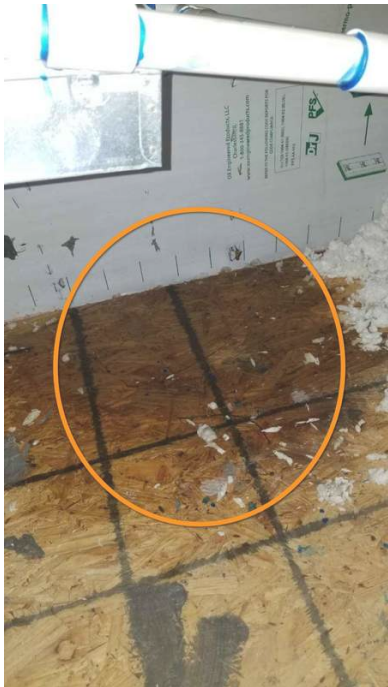
Return side of air handler is leaking condensate onto the attic floor and running down the wall to the structure below. Water intrusion can cause mold and structural damage if not corrected.

Area of Moisture

Recommendation: Contact a qualified heating and cooling contractor

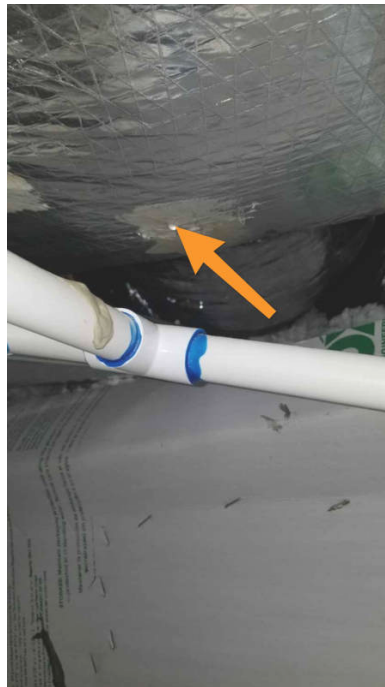
Dripping From Here
