## SAMPLE REPORT

1234 Main St.  
Katy Tx 77449

# PROPERTY INSPECTION REPORT

**Concerning:** 1234 Main St. Katy Tx 77449  
(Address or Other Identification of Inspected Property)

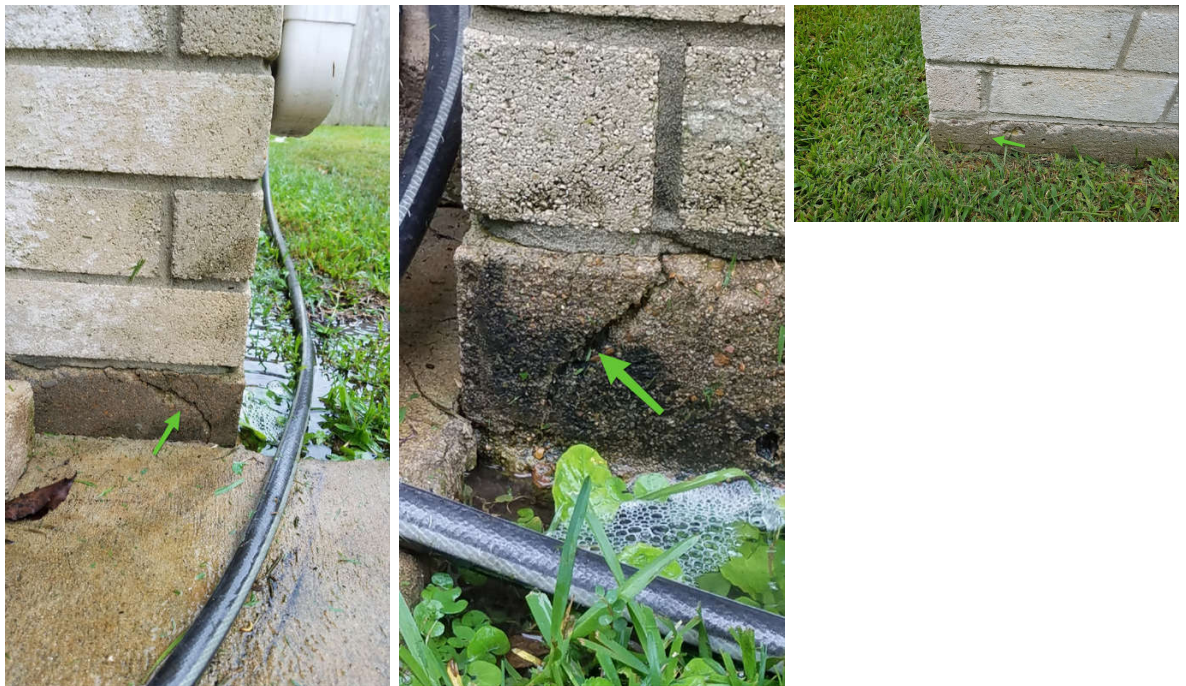
Rear

One or more of the foundation perimeter beam corners were observed to be sheared off (corner pop). This is a common condition in slab on grade foundations. This condition does not adversely affect the performance of the foundation. However, in some cases, some cosmetic improvements may be desired.

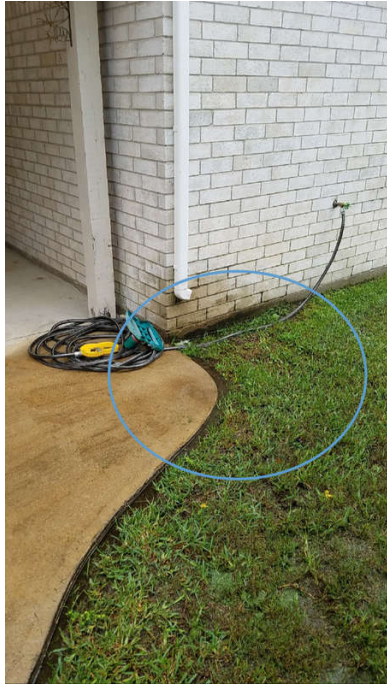
Rear

The home appears to have areas of neutral or negative drainage at grade which will route runoff from precipitation to the foundation. Excessive moisture content in soil supporting the foundation can cause foundation and other structural damage from undermining, heaving or settling, depending on soil composition, moisture content and other conditions. The ground should slope away from the home - inch per foot for a distance of at least six feet from the foundation. The Inspector recommends re-grading these areas to improve drainage near the foundation.

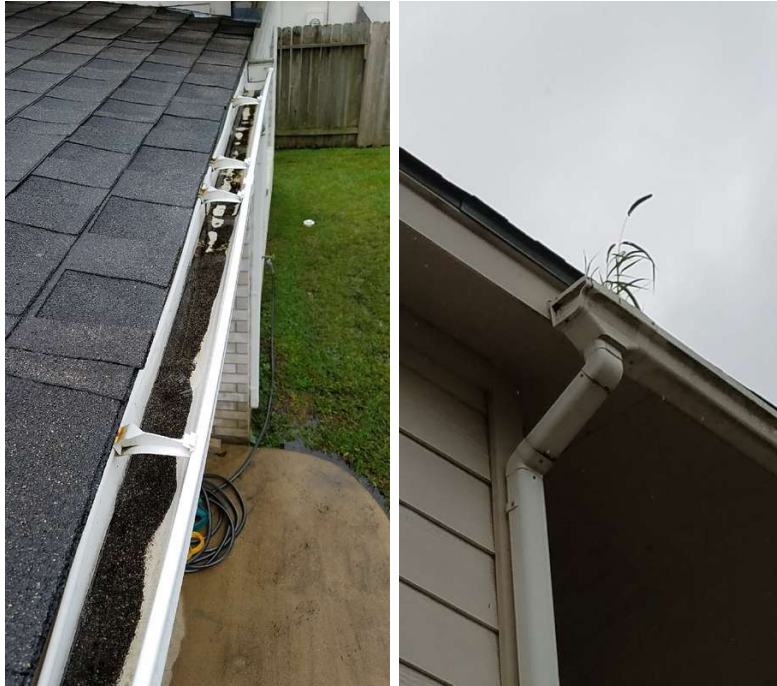
North, Rear

*Gutter full of debris:*  
Gutter full of debris

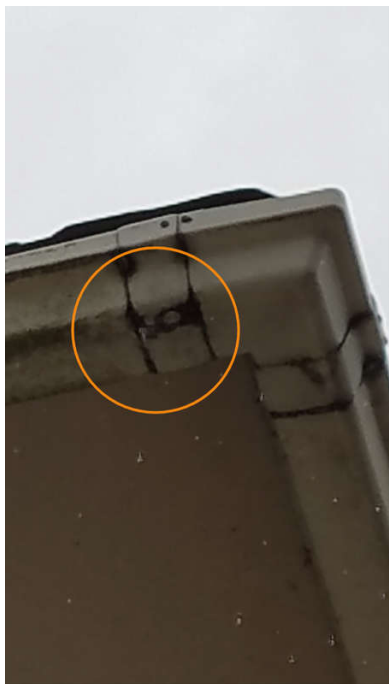
Northwest

**1: Gutter Minor Leaks**

Minor leaks in the gutter joints and seams should be repaired.

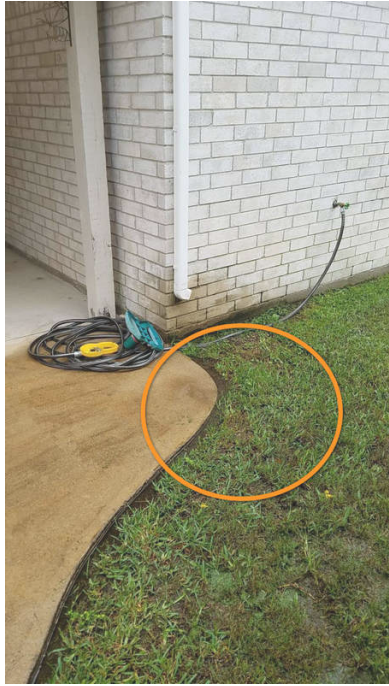
Standing water observed, which could indicate poor drainage and/or grading. Recommend monitor and/or have landscaper correct.

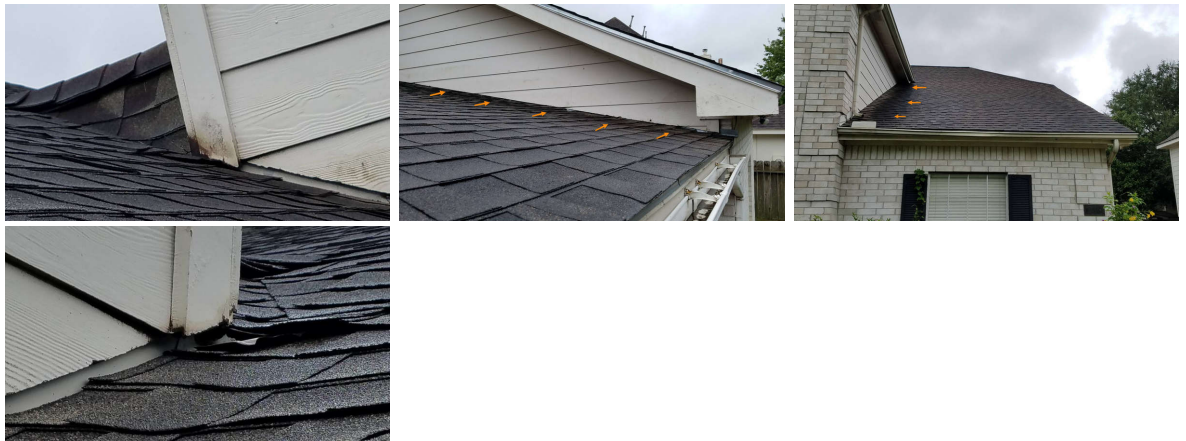
Rear

Moderate deterioration

Asphalt composition shingles covering the roof of this home exhibited moderate general deterioration commensurate with the age of the roof. They appeared to be adequately protecting the underlying home structure at the time of the inspection.

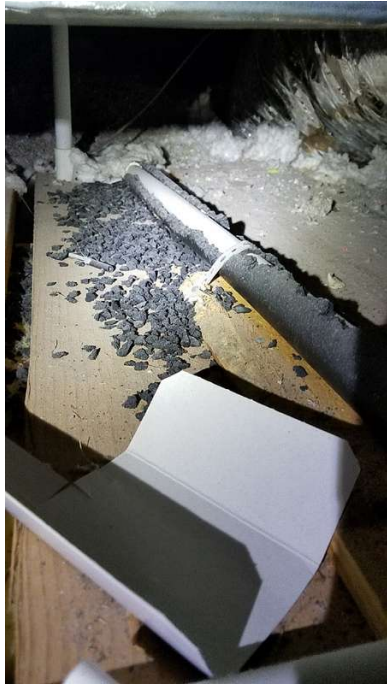
Attic

Visible evidence of possible rodent activity was observed in the attic area. It is recommended to have a Certified Pest Control Operator further evaluate this condition and make corrections as necessary.

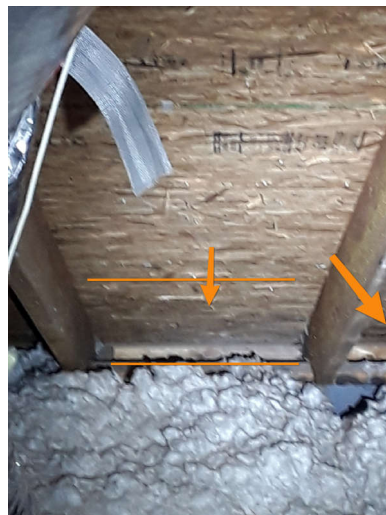
Rear

**1: Water Stains on Decking**

There are visible water stains on the roof sheathing (decking) in one or more locations. This condition should be further evaluated by a qualified roofer and repaired as necessary.

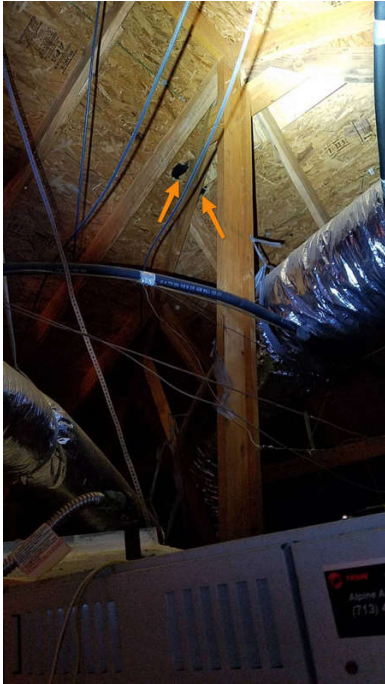
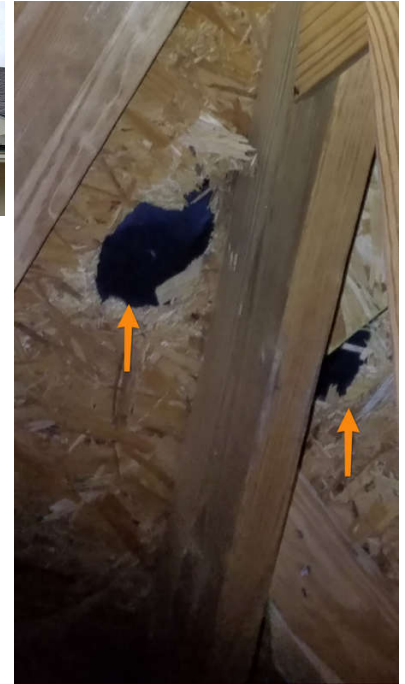
Attic

**2: Decking Damaged**

Some roof sheathing (decking) deterioration and/or damage was observed in one or more locations. This condition should be further evaluated by a qualified roofer and repaired as necessary

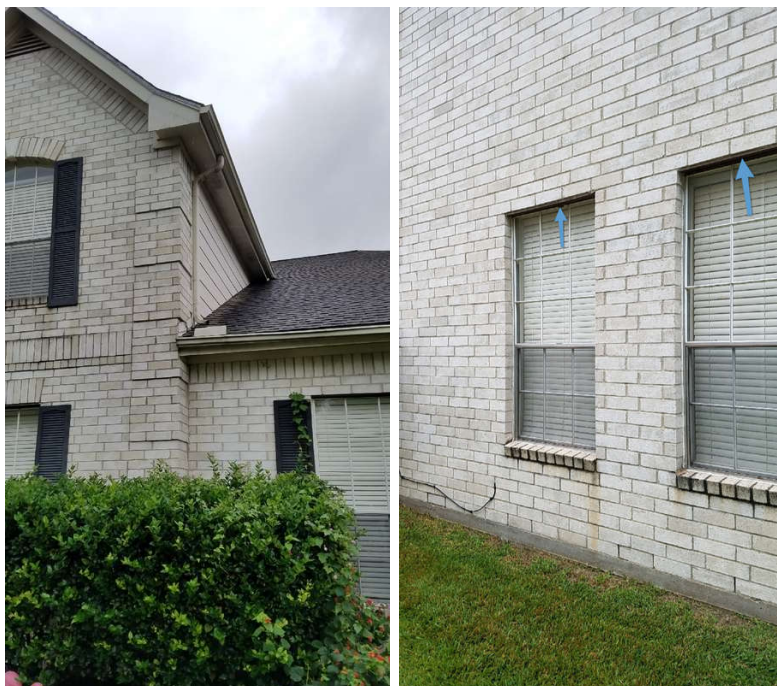
Front, Rear, Left, Right

**1: Rusted Lintel**

Lintels above one or more exterior doors or windows were visibly rusted at the time of the inspection. Rust damage to the exterior wall covering will continue unless loose rust is removed, existing rust chemically neutralized and exposed steel protected from weather.

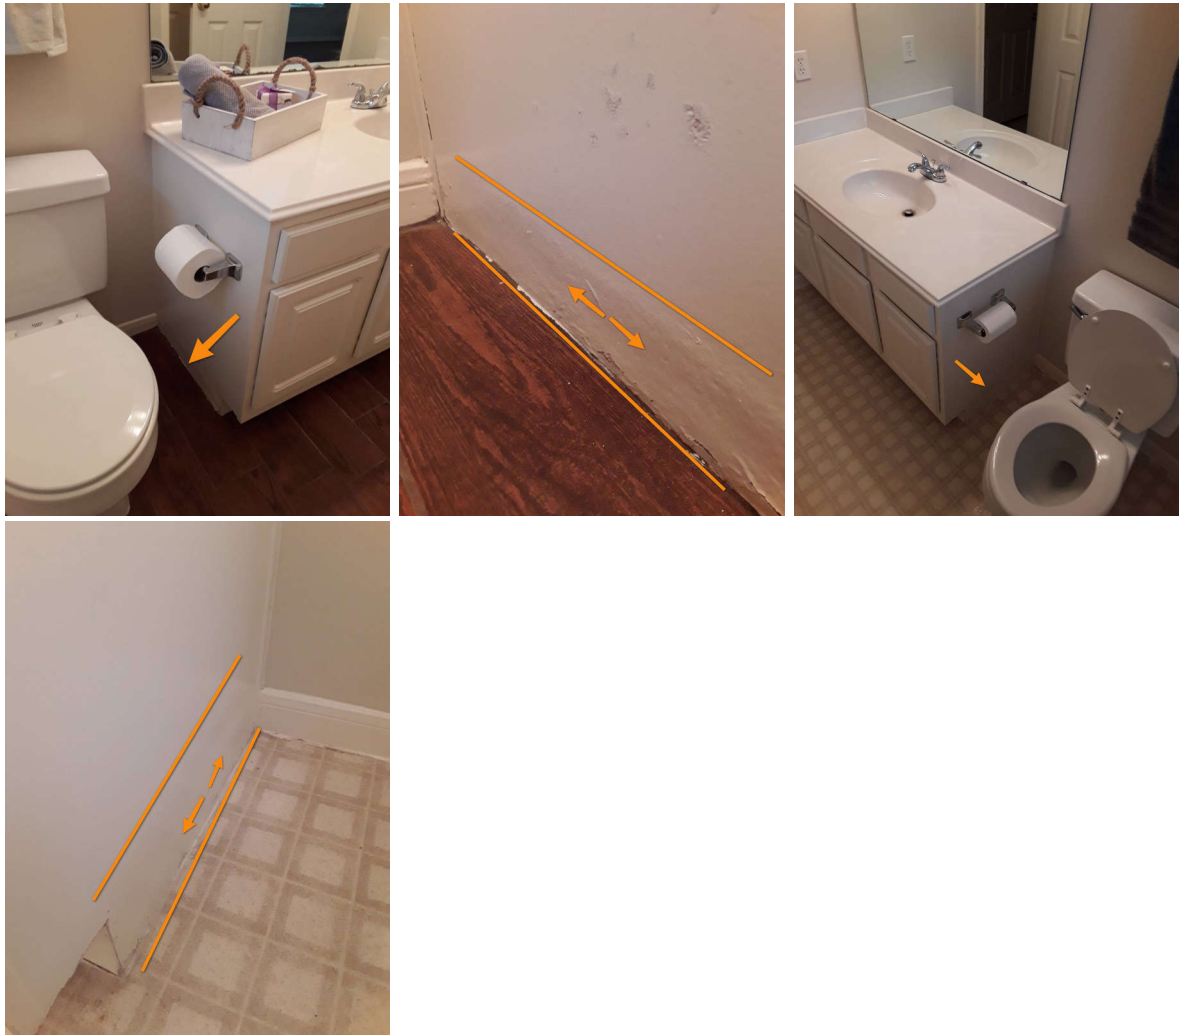
Upstairs North Bathroom, Downstairs South Bathroom

**2: Old Water Stain**

Water stains were observed on the bathroom cabinetry walls. The cause and remedy should be further evaluated and corrected as necessary. It did not appear to be wet at the time of inspection. It is likely that this is not an active leak, however due diligence should be exercised, and the current owner should be queried about this condition.

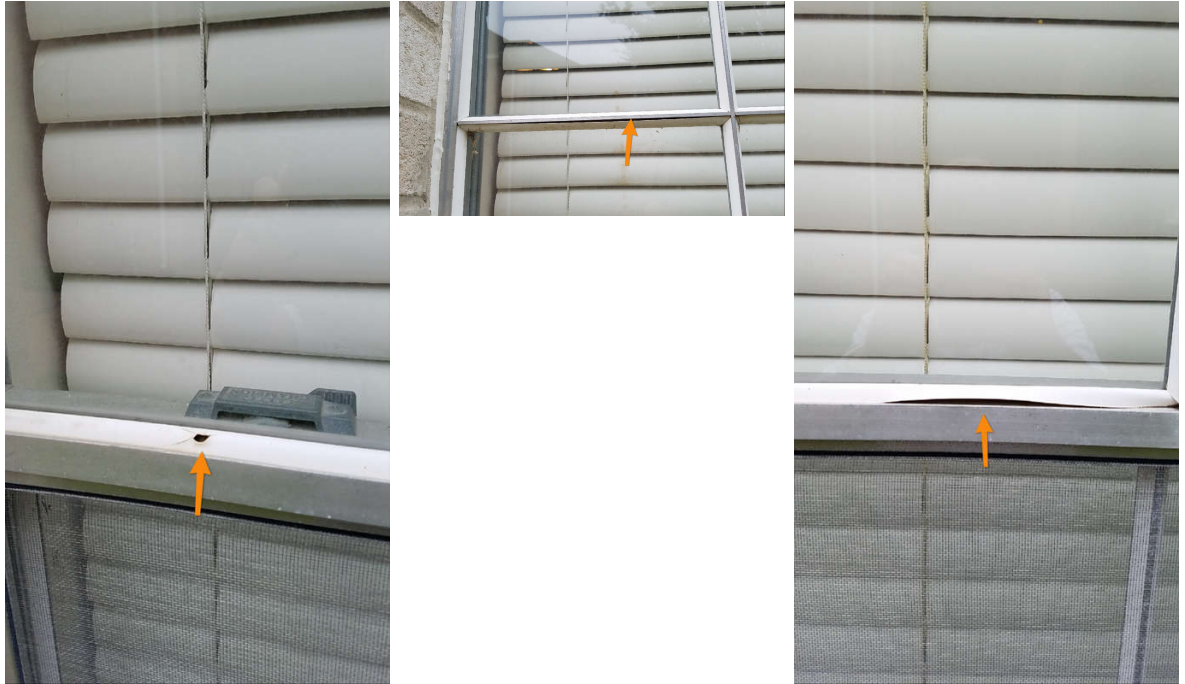
The plastic window glass glazing bead is damaged and/or missing at one or more of the windows and improvements are recommended.

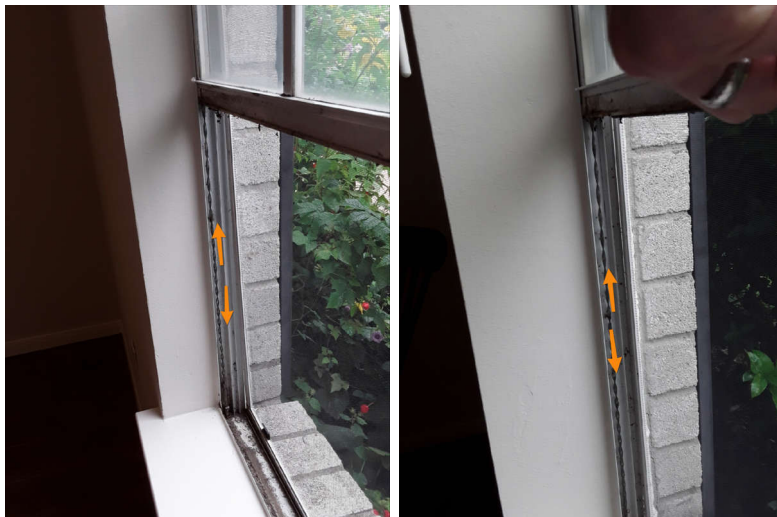
Dining Room, Living Room

**2: Window Guide**

The window guide in one or more areas was observed to be damaged. The window may not stay in the open position.

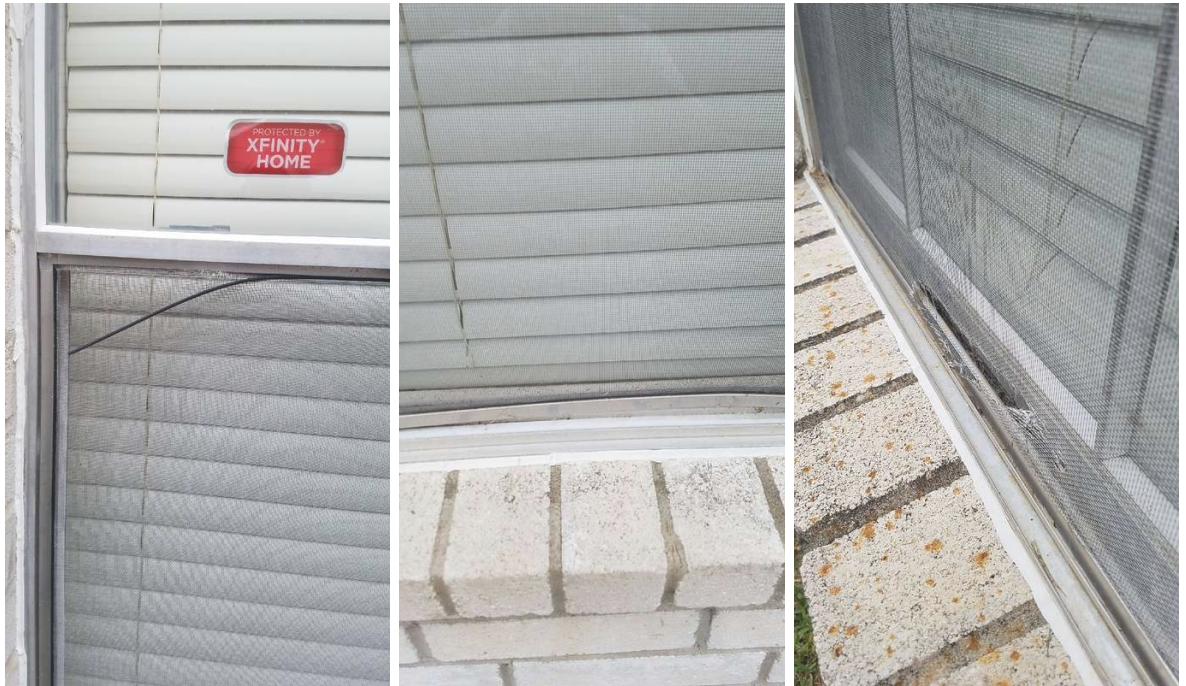
**3: Missing / Damaged Screen**

One or more of the window screens were observed to be missing or damaged.

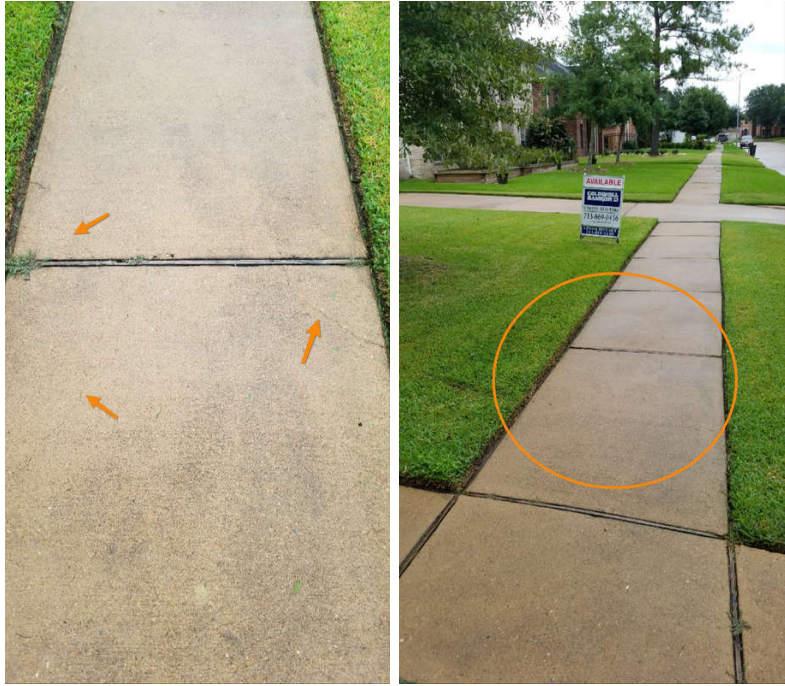
**1: Minor Sidewalk Cracks**

The sidewalk was observed to have minor cracks and/or deficiencies.

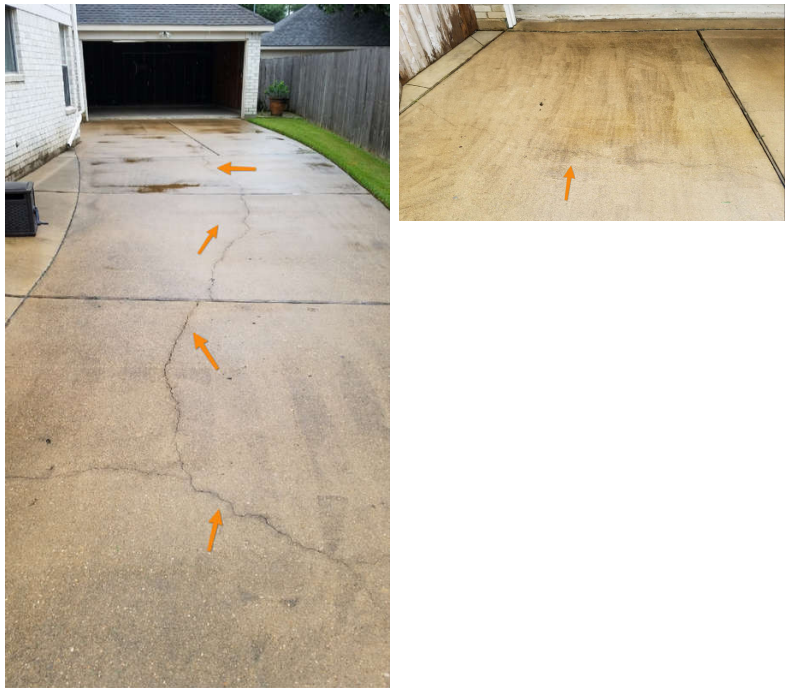
**2: Minor Driveway Cracks**

Minor cracks and/or deficiencies were observed in the driveway.

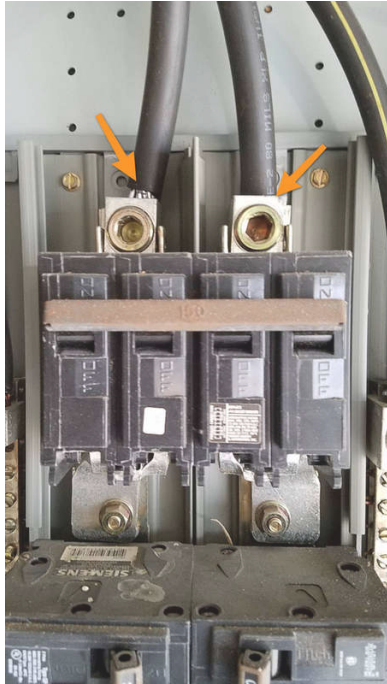
There was no anti-oxidant gel observed on the exposed aluminum conductor terminations.

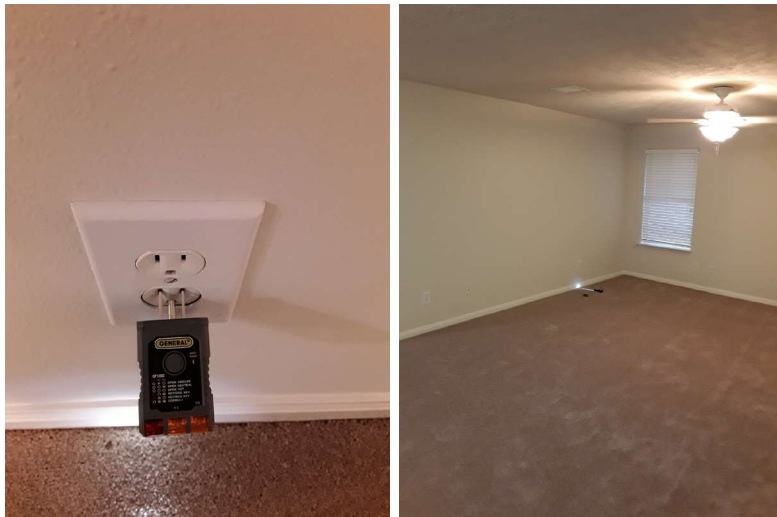
Upstairs Game Room

**1: Damaged Receptacle**

One or more of the receptacles were observed to be damaged

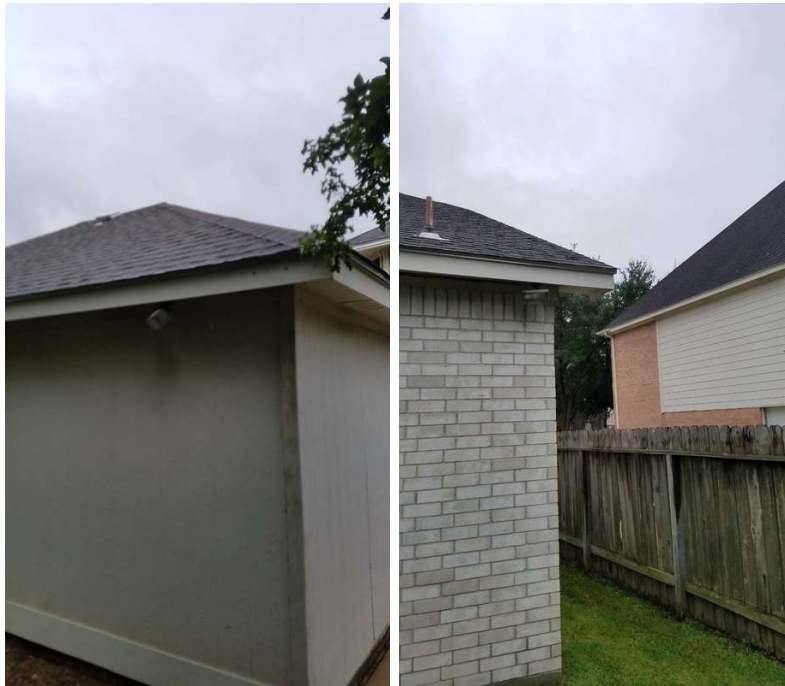
**2: Exterior light inop**

If after bulb replacement the lights still fail to respond to the switch, consider evaluation by a qualified electrical contractor. This condition may be a potential fire hazard.

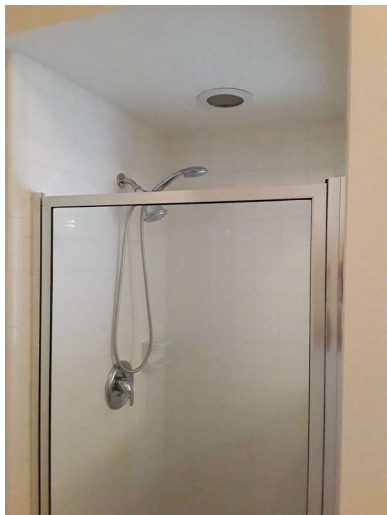
Master Bathroom

**3: Bulb?**

One or more of the light fixtures appear to be inoperative. This may be due to a bad bulb or some other unknown condition. This condition should be further evaluated and corrected as necessary.

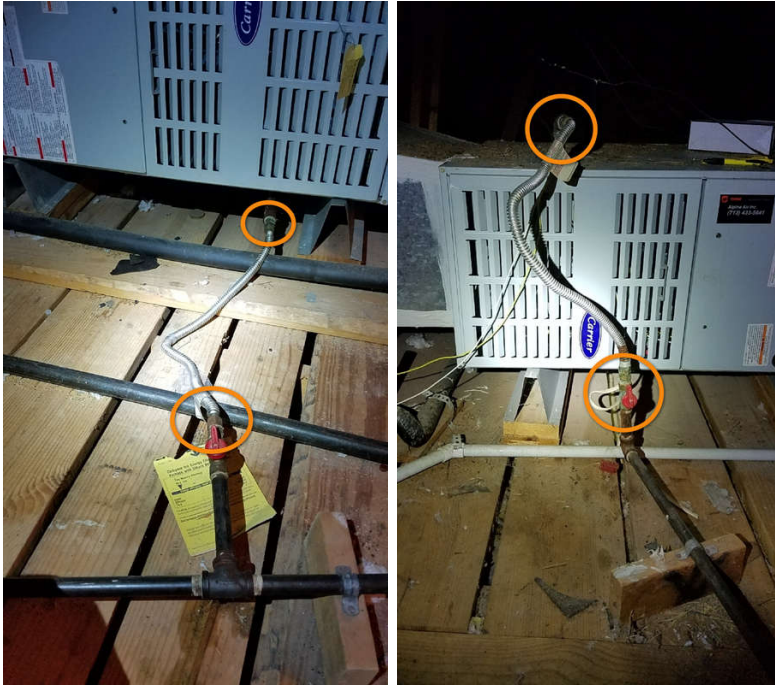
The heater gas supply line is not equipped with a sediment trap just before the gas appliance connector. This condition does not meet current installation requirements and should be corrected.

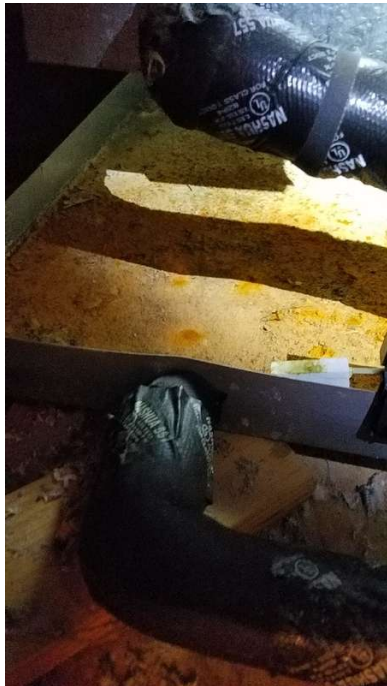
**1: Rust in pan**

The auxiliary/secondary drain pan under the coil housing has some water staining and/or a rust build-up. This would indicate that the pan has held water in the past and should be closely monitored.

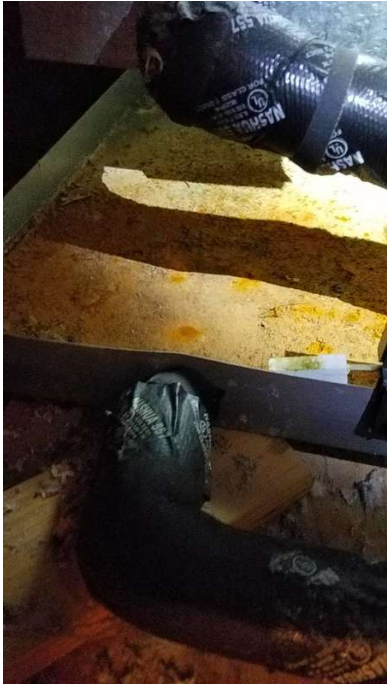
**2: Debris in pan**

The auxiliary/secondary drain pan under the coil housing should be free of all debris. The debris in the pan could clog the drain line and cause water to leak to the interior of the house.

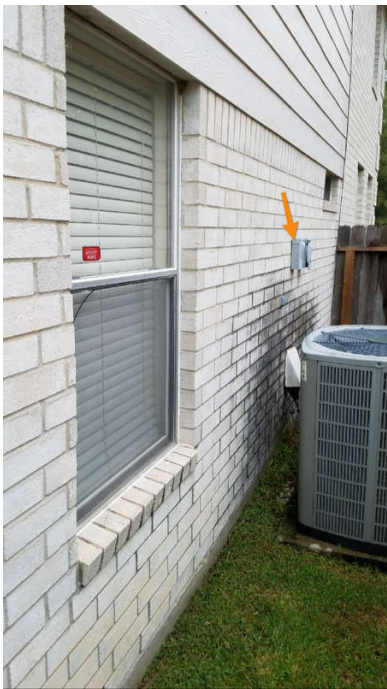
**3: Disconnect behind unit**

The electrical service disconnect is installed behind the outside condenser/coil. This does not meet the clearance requirements of the National Electrical Code or the International Residential Code and should be corrected as necessary.

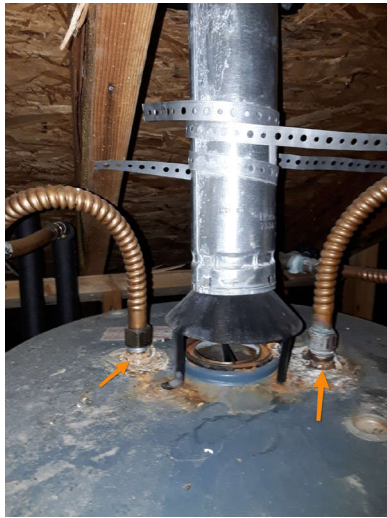
Dissimilar metals observed to be in use in the water supply system in one or more locations. In some cases this will cause electrolysis to occur which will result in water leaks at these connections. It is recommended to install dielectric fitting at any dissimilar metal connection locations.

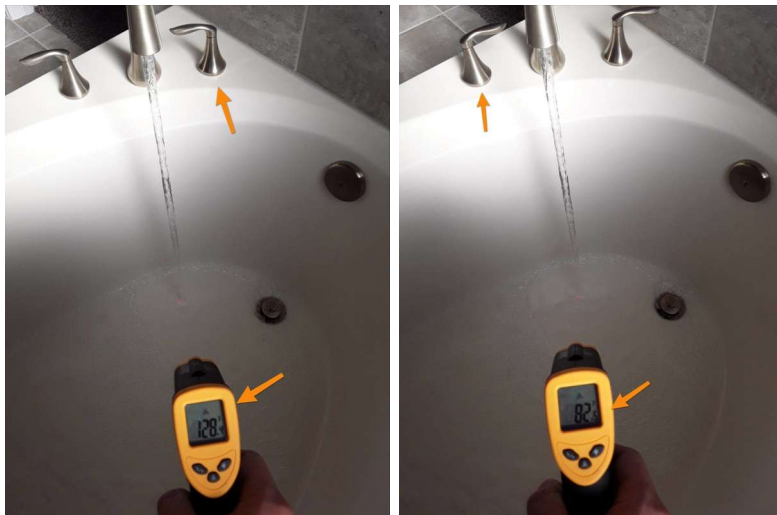
**2: Hot Cold reversed**

The faucets hot/cold water orientation is reversed.

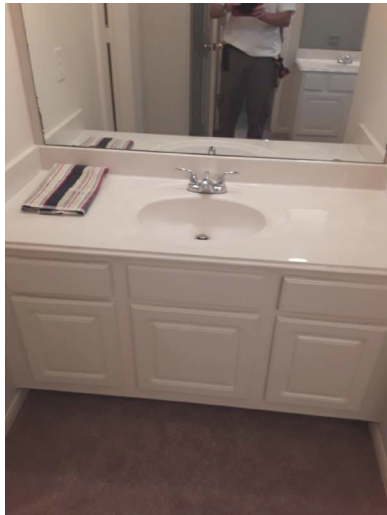
The sink was observed to drain slowly, suggesting that an obstruction may exist.

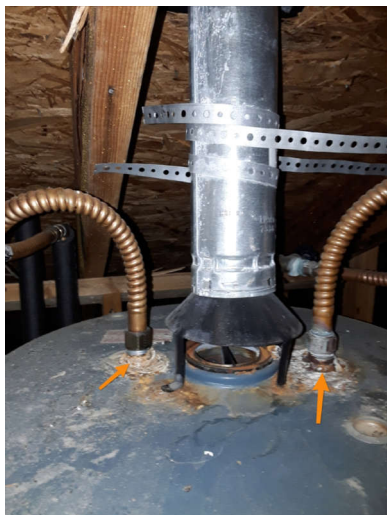
**1: Corrosion**

Some corrosion was observed at the water supply connections at the top of the water heater.

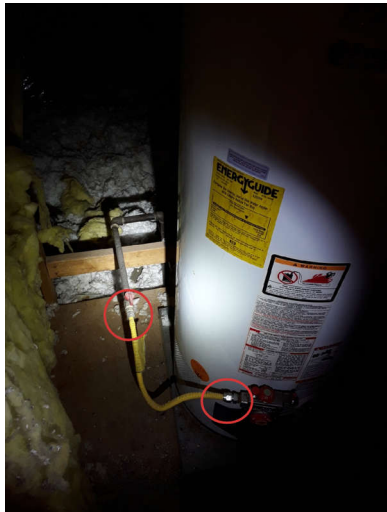
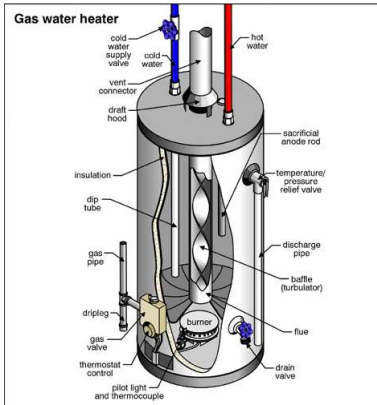
**2: No drip leg**

There is no sediment trap / drip leg present.

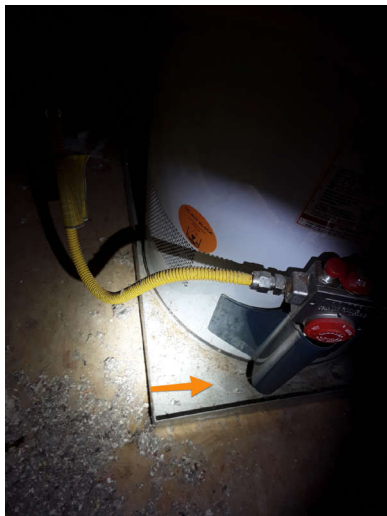
### 3: Debris in pan

The debris in the water heater pan should be cleaned out to help prevent the pan drain line from being clogged.
