HOMESCAN INSPECTION SERVICES LLC

## HOMESCAN RESIDENTIAL INSPECTION REPORT

1234 Main St.  
OMAHA NE 68124

Buyer Name  
07/14/2018 9:00AM

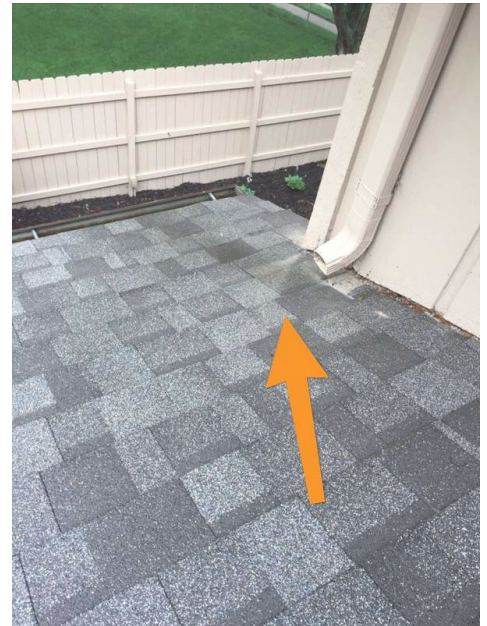
ROOF/REAR OVER DINING ROOM

#### DOWNSPOUT EXTENSIONS OVER ROOF COVERINGS

Downspout extensions are recommended over roof coverings to extend the life of the roof covering and prevent water intrusion.

Prolonged periods of concentrated water travel from downspouts can remove granular coatings and if too close to wall structures can cause leaks. Recommend extending the downspout closer to the nearest downstream gutter.

Contact a handyman or DIY project

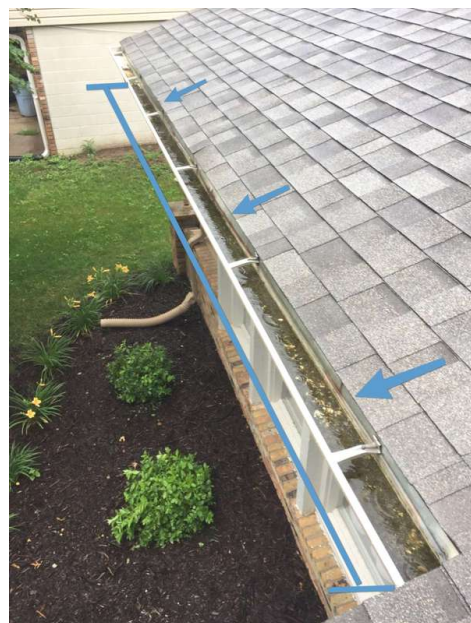
FRONT OF HOME ABOVE LIVING ROOM WINDOWS

#### GUTTER PITCH ADJUSTMENT NEEDED

One or more gutters are installed with negative pitch. If left in this condition, gutters with negative pitch will hold water limiting their capacity during storms causing overflow which can lead to moisture intrusion in basements, as well as foundation or structural issues. Recommend it be repaired by a qualified gutter contractor.

Approximately two inches of standing water in gutter.

Contact a qualified gutter contractor

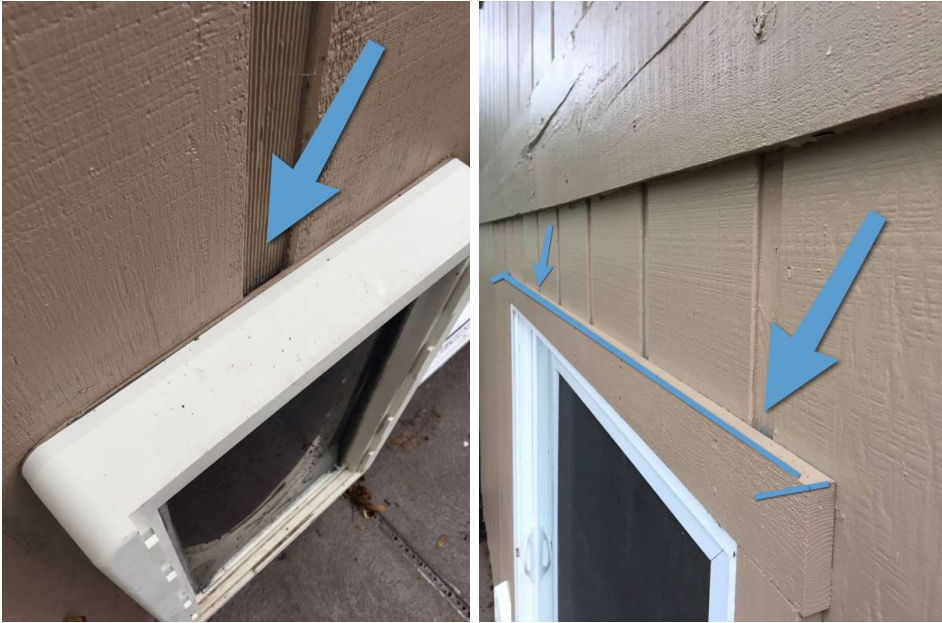
REAR SLIDING DOOR AND PET ENTRANCE DOOR

#### TRIM CAULK PAINT - WINDOWS/DOORS

Trim on one or more exterior doors / windows requires caulk and paint repairs to prevent water penetration.

Contact a handyman or DIY project

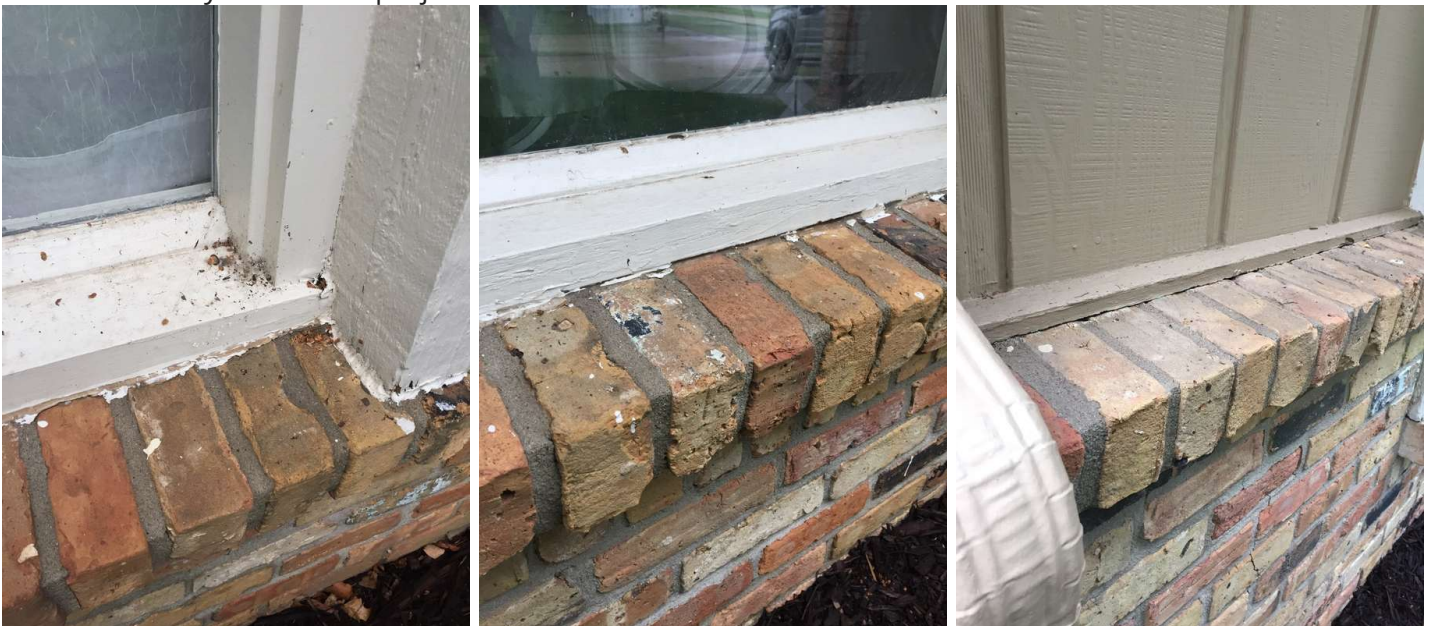
3.2.1 Siding, Flashing & Trim  
**SIDING/TRIM DAMAGE**

*Some / Many* sections of siding and/or trim were *deteriorated / loose / split / warped / missing / damaged / substandard*. Recommend that a qualified person repair, replace or install siding or trim as necessary.

Contact a handyman or DIY project

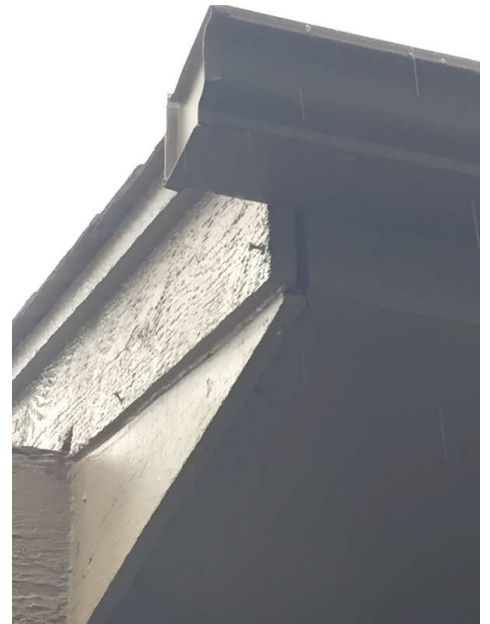
3.2.2 Siding, Flashing & Trim  
**NAIL HEADS NEED CAULK OR NOT FLUSH**

Some nail heads at the composition wood siding were protruding from the wood, or had been nailed in so as to break the surface of the siding, and caulk was missing. Most manufacturers of composition wood siding specify that nail heads should be flush with the surface, and that the surface of the siding should not be broken. If broken, then caulk should be applied to the nail heads to prevent water penetration and subsequent deterioration of the siding. Recommend that a qualified person repair per the siding manufacturer's specifications.

Contact a handyman or DIY project

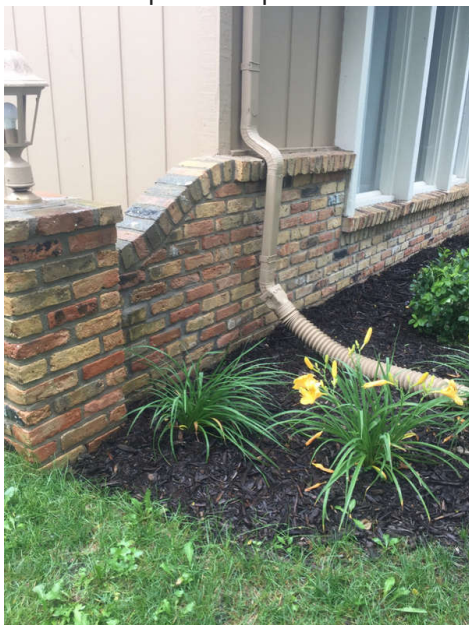
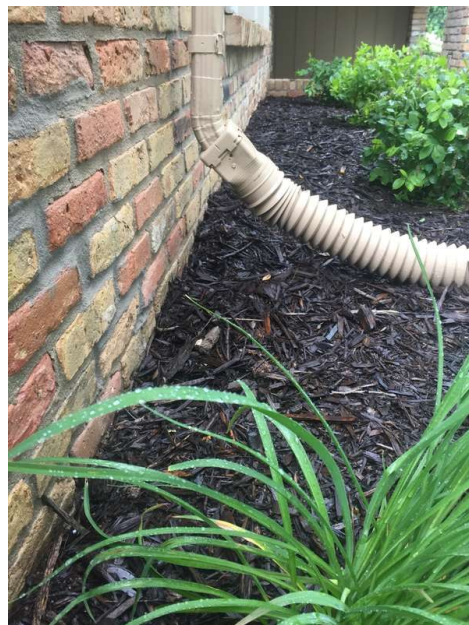
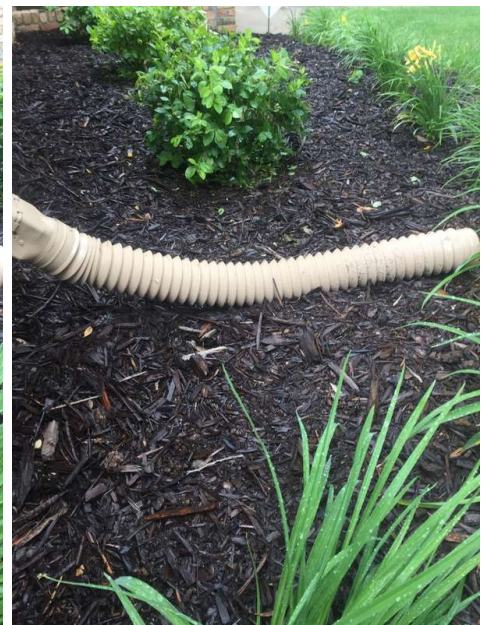
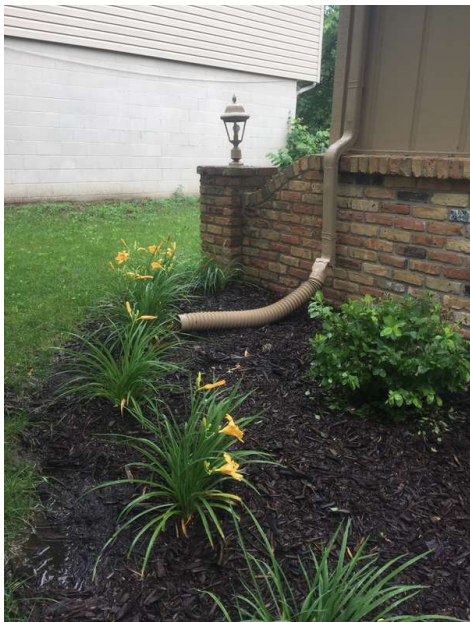
NORTHWEST CORNER FRONT

### REVERSE PERIM SLOPE - SOIL, REPAIR

The soil or grading sloped down towards building perimeters in one or more areas. This can result in water accumulating around building foundations or underneath buildings. It can be a conducive condition for wood-destroying organisms. Recommend grading soil so it slopes down and away from buildings with a slope of at least 1 inch per horizontal foot for at least 6 feet out from buildings.

Contact a qualified professional.

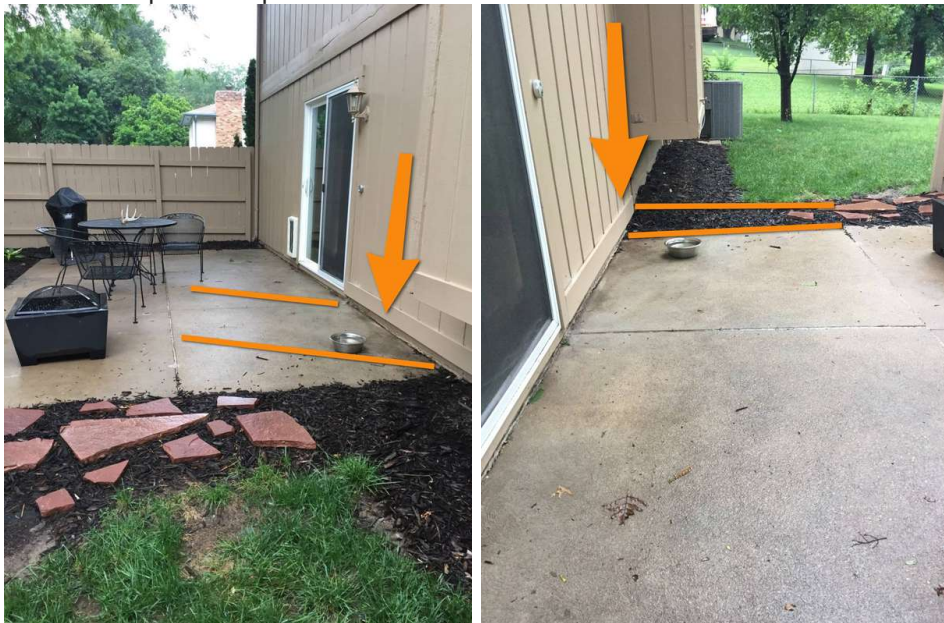
REAR PATIO SECTIONS CLOSEST TO HOME

**REVERSE PERIM SLOPE - PAVEMENT, MONITOR**

Pavement sloped down towards building perimeters in one or more areas. This may result in water accumulating around building foundations or underneath buildings. Monitor these areas in the future, especially during and after periods of rain. If significant amounts of water are found to accumulate, then recommend that a qualified contractor evaluate and repair as necessary. For example, by installing drain(s) or removing old pavement and installing new.

Contact a qualified professional.

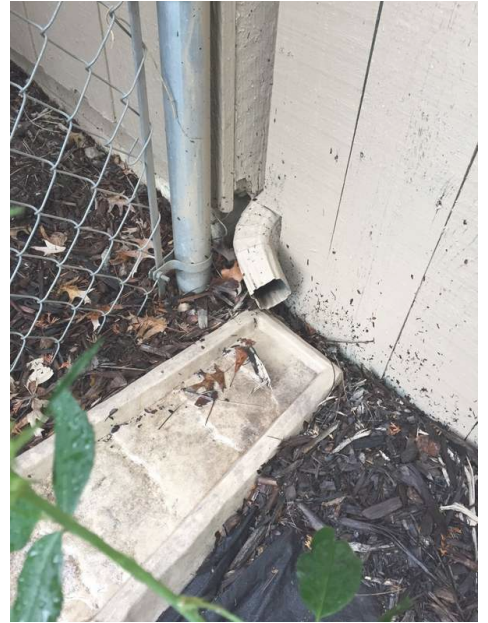
SOUTHEAST

**DOWNSPOUT EXTENSIONS**

Extensions such as splash blocks or drain pipes for one or more downspouts were *missing / poorly sloped / misaligned / clogged / substandard / damaged*. Water can accumulate around the building foundation or inside crawl spaces or basements as a result. Recommend that a qualified person install, replace or repair extensions as necessary so rainwater drains away from the structure.

Contact a qualified professional.

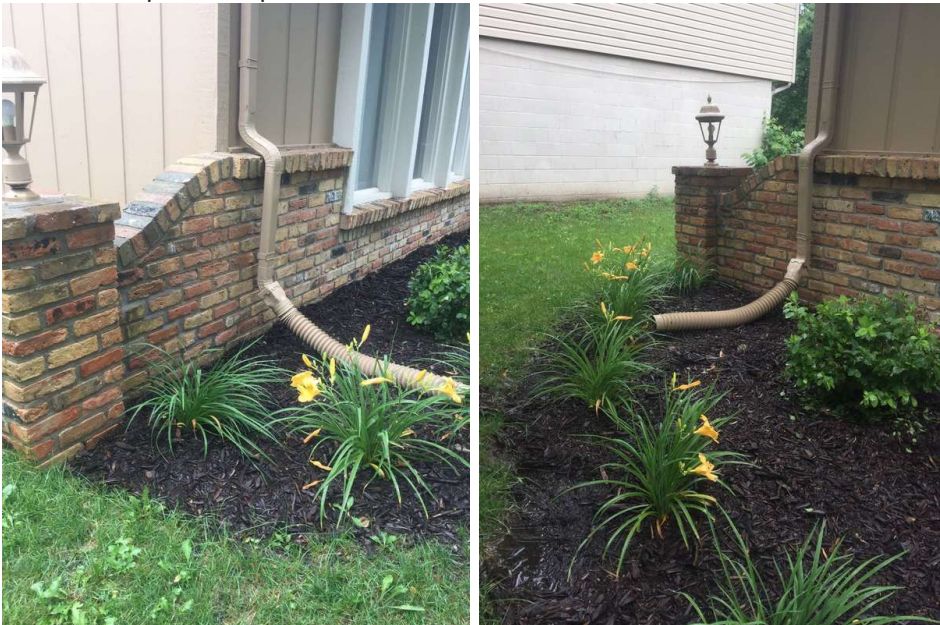
#### **DRAINAGE SYSTEM**

One or more *gutters / downspouts* were *loose / incomplete / missing / leaking / corroded / damaged*. Rainwater can come in contact with the building exterior or accumulate around the building foundation as a result. This is a conducive condition for wood-destroying organisms. Recommend that a qualified person repair as necessary.

Contact a qualified professional.

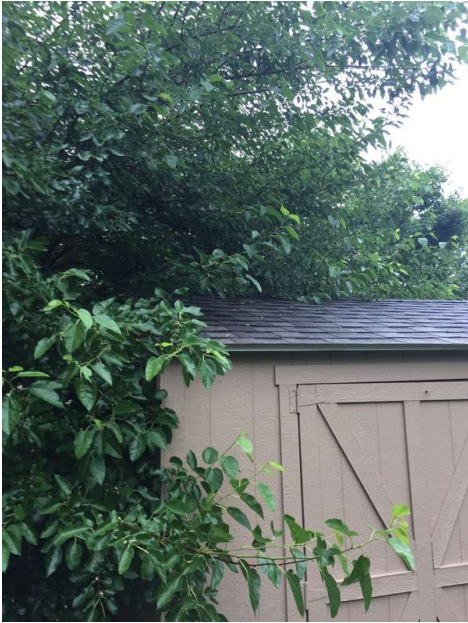
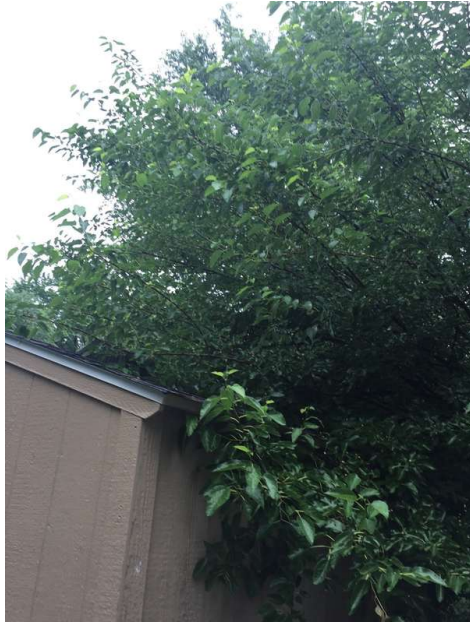
SHED REAR EXTERIOR

#### **VEGETATION CONTACT WITH ROOF/SIDING**

Contact a handyman or DIY project

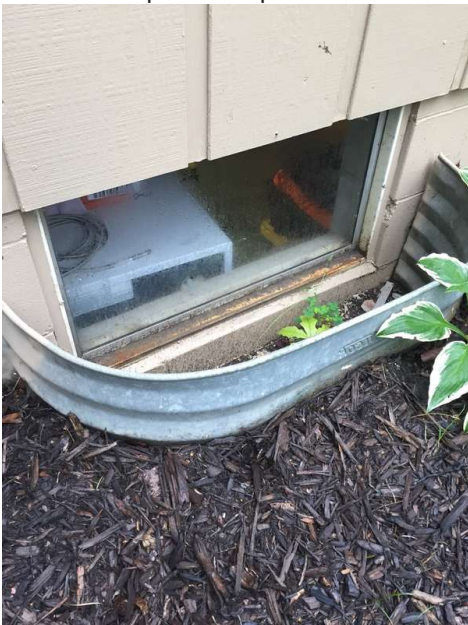
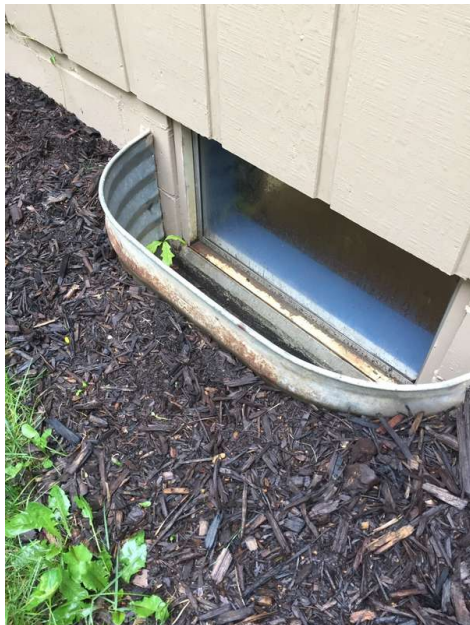
**BASEMENT WINDOW COVERING**

Recommend installing egress covers to prevent moisture intrusion.

Contact a qualified professional.

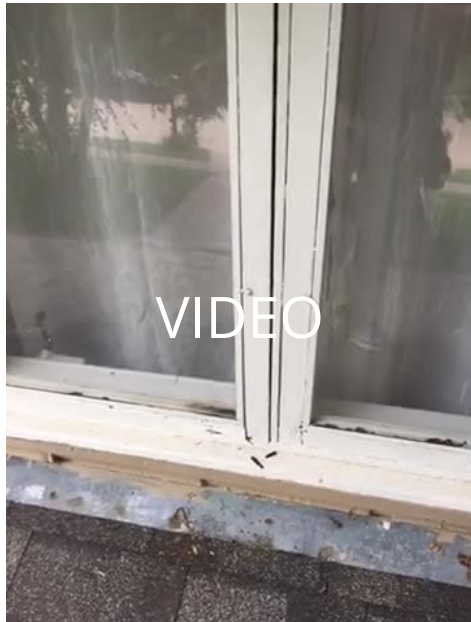
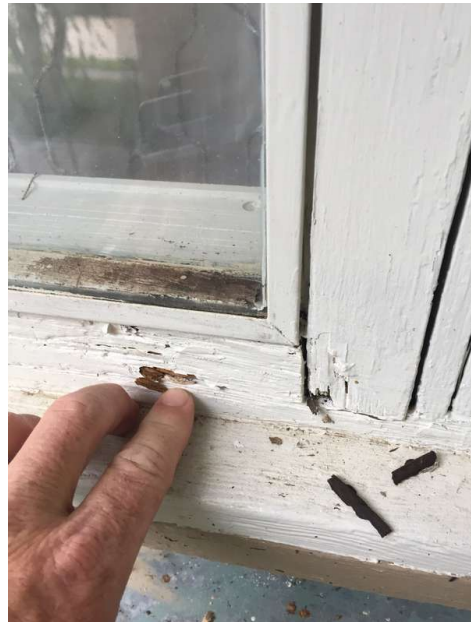
FRONT WINDOWS ABOVE GARAGE

**WINDOW TRIM**

Windows above garage have damaged trim. recommend monitoring or repair if necessary.

Contact a qualified professional.

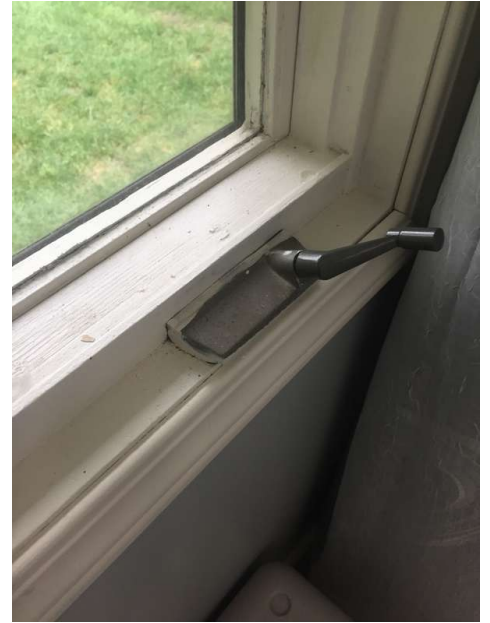
Crank handles at *some / many* windows were *missing / stripped / loose / broken*. Recommend that a qualified person replace handles or make repairs as necessary.

Contact a qualified professional.

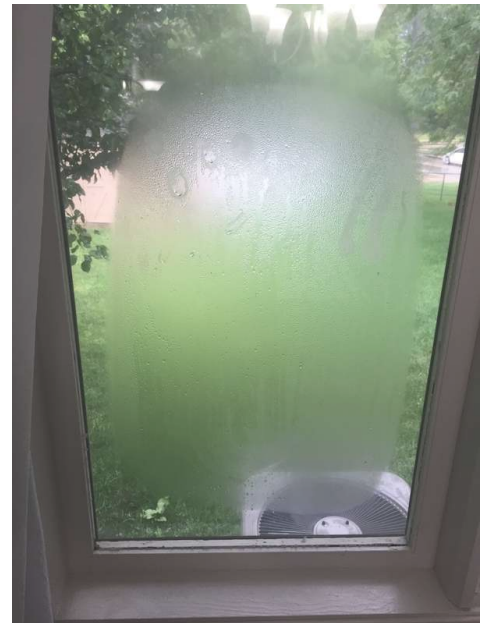
Condensation or staining was visible between multi-pane glass in *one or more / many windows / skylights*. This usually indicates that the seal between the panes of glass has failed or that the desiccant material that absorbs moisture is saturated. As a result, the view through the window may be obscured, the window's R-value will be reduced, and accumulated condensation may leak into the wall structure below. Recommend that a qualified contractor evaluate and repair windows as necessary. Usually, this means replacing the glass in window frames.

Be aware that evidence of failed seals or desiccant may be more or less visible depending on the temperature, humidity, sunlight, etc. Windows or glass-paneled doors other than those that the inspector identified may also have failed seals and need glass replaced. It is beyond the scope of this inspection to identify every window with failed seals or desiccant.

Contact a qualified professional.

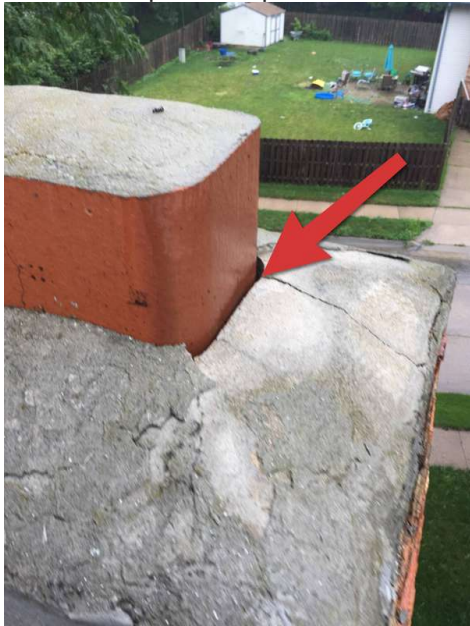
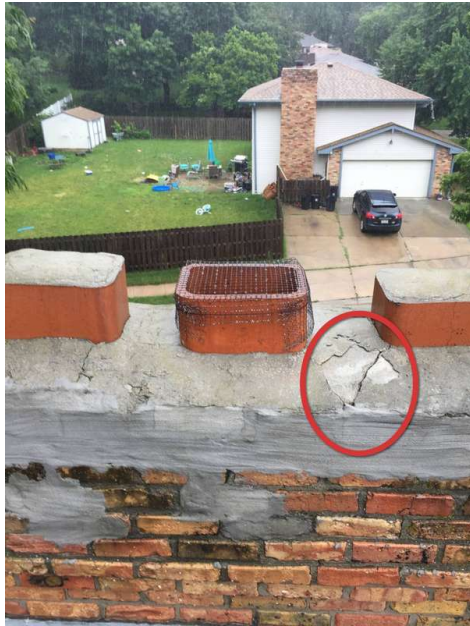
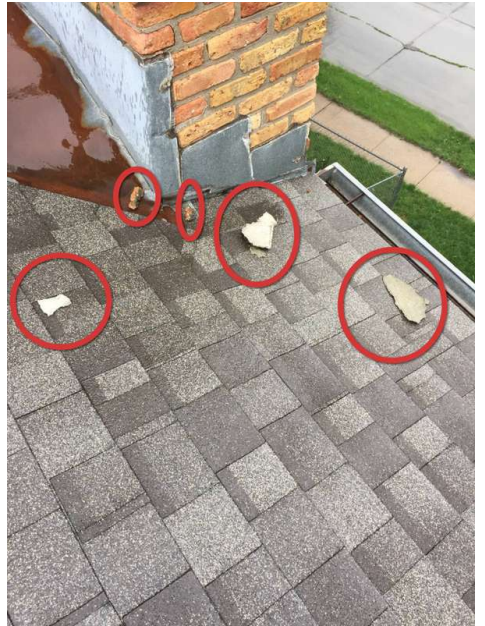
Chimney Crown/Mortar Cap appears defective allowing water penetration. This condition can lead to water or ice penetrating mortar joints damaging the brick veneer. Additionally, water intrusion can lead to structural damage as well as the formation and growth of mold. Recommend repair as necessary by qualified professional.

Contact a qualified professional.

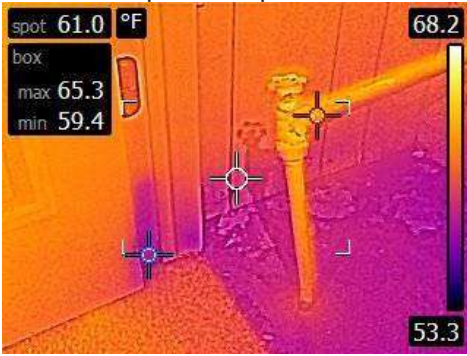
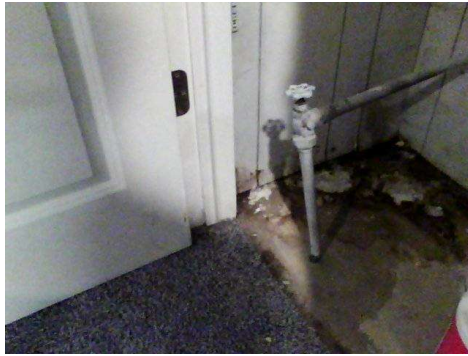
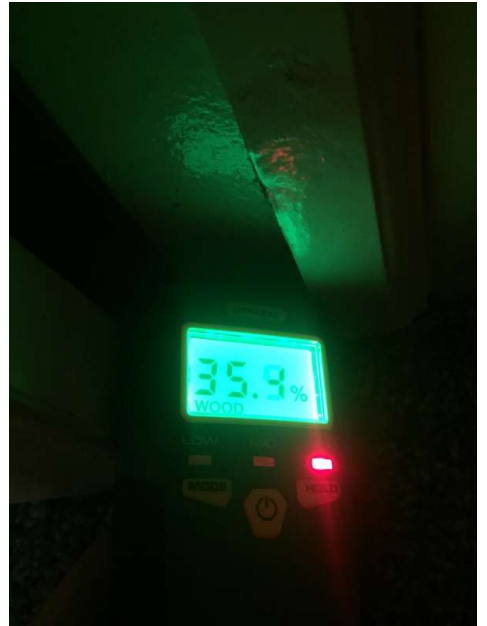
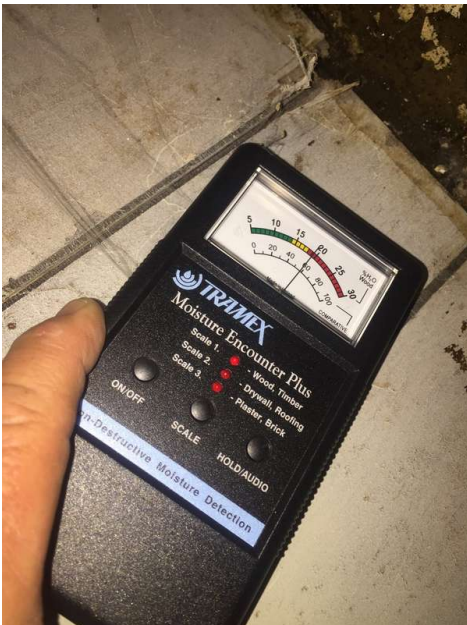
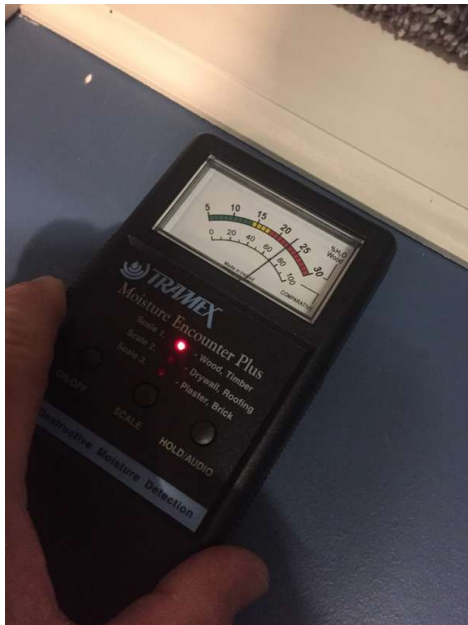
Evidence of water intrusion was found in one or more sections of the basement. For example, water stains or rust at support post bases, efflorescence on the foundation, etc. Accumulated water is a conducive condition for wood-destroying organisms and should not be present in the basement. Recommend reviewing any disclosure statements available and ask the property owner about past accumulation of water in the basement. The basement should be monitored in the future for accumulated water, especially after heavy and/or prolonged periods of rain. If water is found to accumulate, then recommend that a qualified contractor who specializes in drainage issues evaluate and repair as necessary. Typical repairs for preventing water from accumulating in basements include:

- Repairing, installing or improving rain run-off systems (gutters, downspouts and extensions or drain lines)
- Improving perimeter grading
- Repairing, installing or improving underground footing and/or curtain drains

Ideally, water should not enter basements, but if water must be controlled after it enters the basement, then typical repairs include installing a sump pump.

Contact a qualified professional.

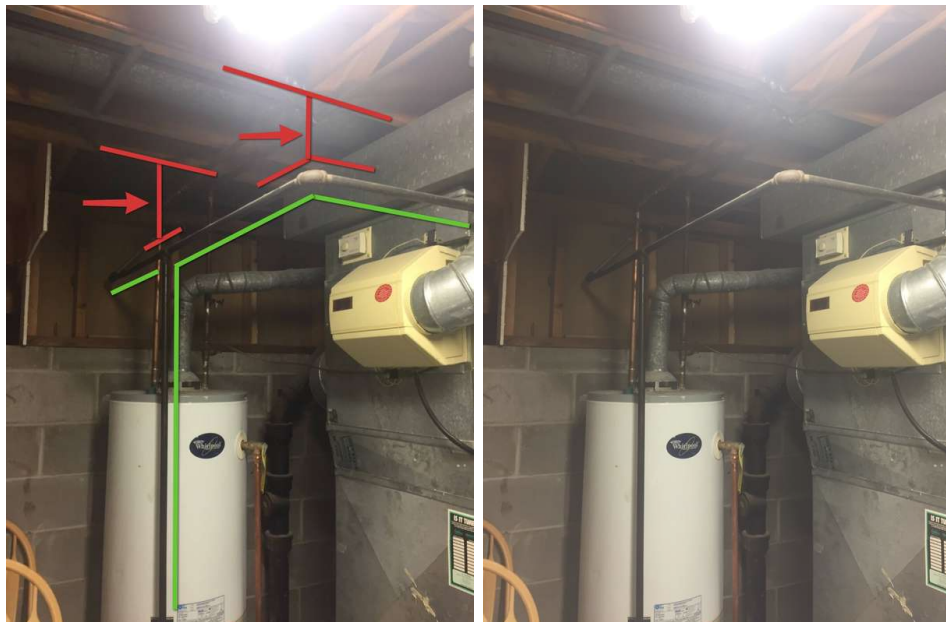
Gas line - Green Supports are need in the areas in Red Gas line joint should be protected by supports when suspended.

Contact a qualified professional.

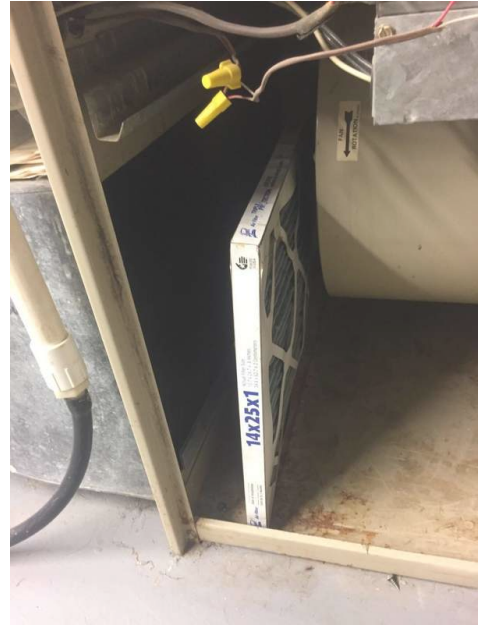
At the time of inspection, the furnace was functioning as designed, however the estimated useful life for most forced air furnaces is 15-20 years. This furnace appeared to be *near / at / beyond* this age and/or its useful lifespan and may need replacing or significant repairs at any time. Recommend budgeting for a replacement in the near future.

Contact a qualified professional.
