HOME CHECK INSPECTION SERVICES, LLC.

COLEEN AMSTEIN'S CUSTOM INSPECTION REPORT

1234 Main St.
Johnson City Tennessee 37604

03/05/2019 9:00AM

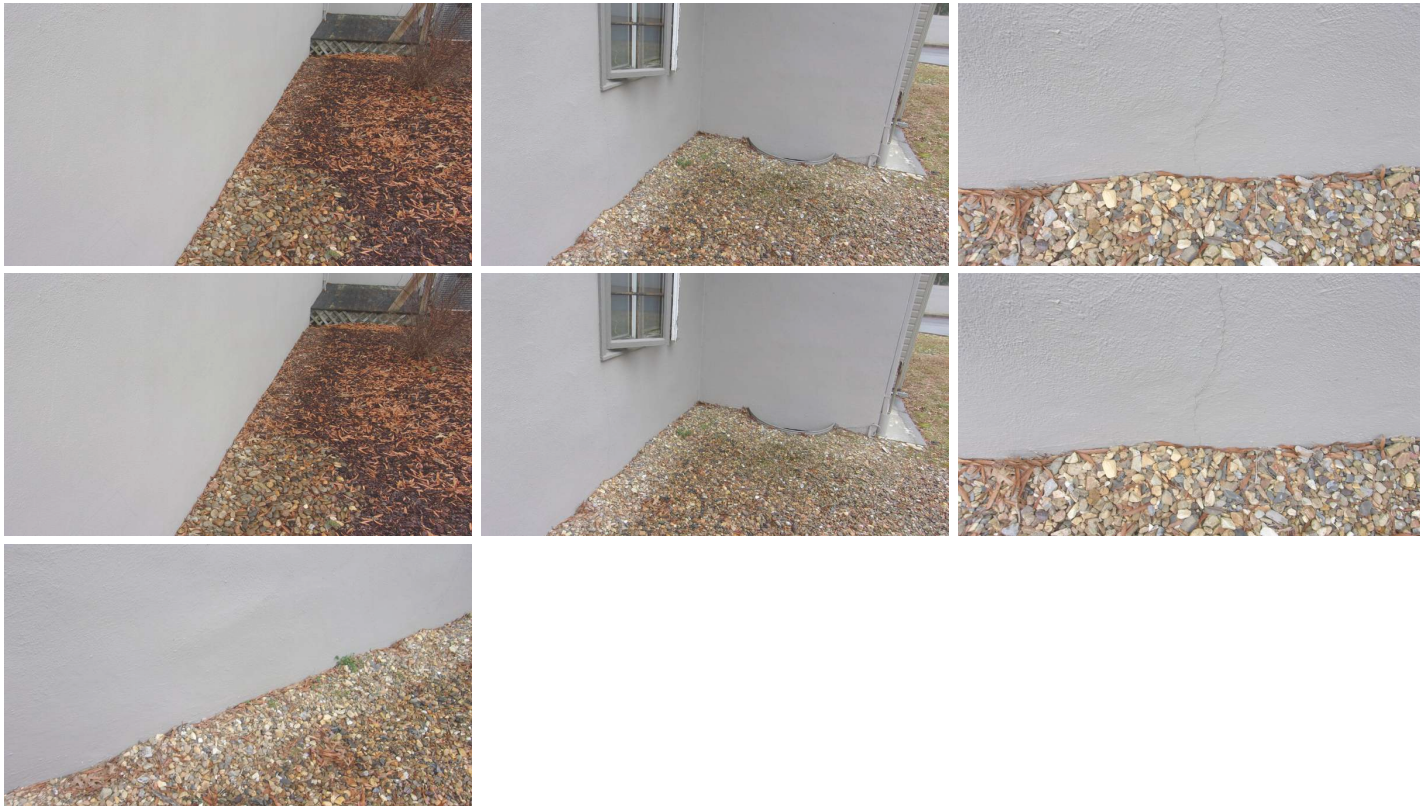
There are areas around the home where the soil grade is flat or negatively sloped toward the home or there are holes in the soil at the base of the home's exterior. Water is not forgiving, some say it is the leading cause of damage to a home. Water infiltration of a foundation wall or structural issues due to hydrostatic pressure or soil heaving or freezing is always possible. To help remove water from the base of the home's foundation the soil around the home should be positively sloped away from the home.

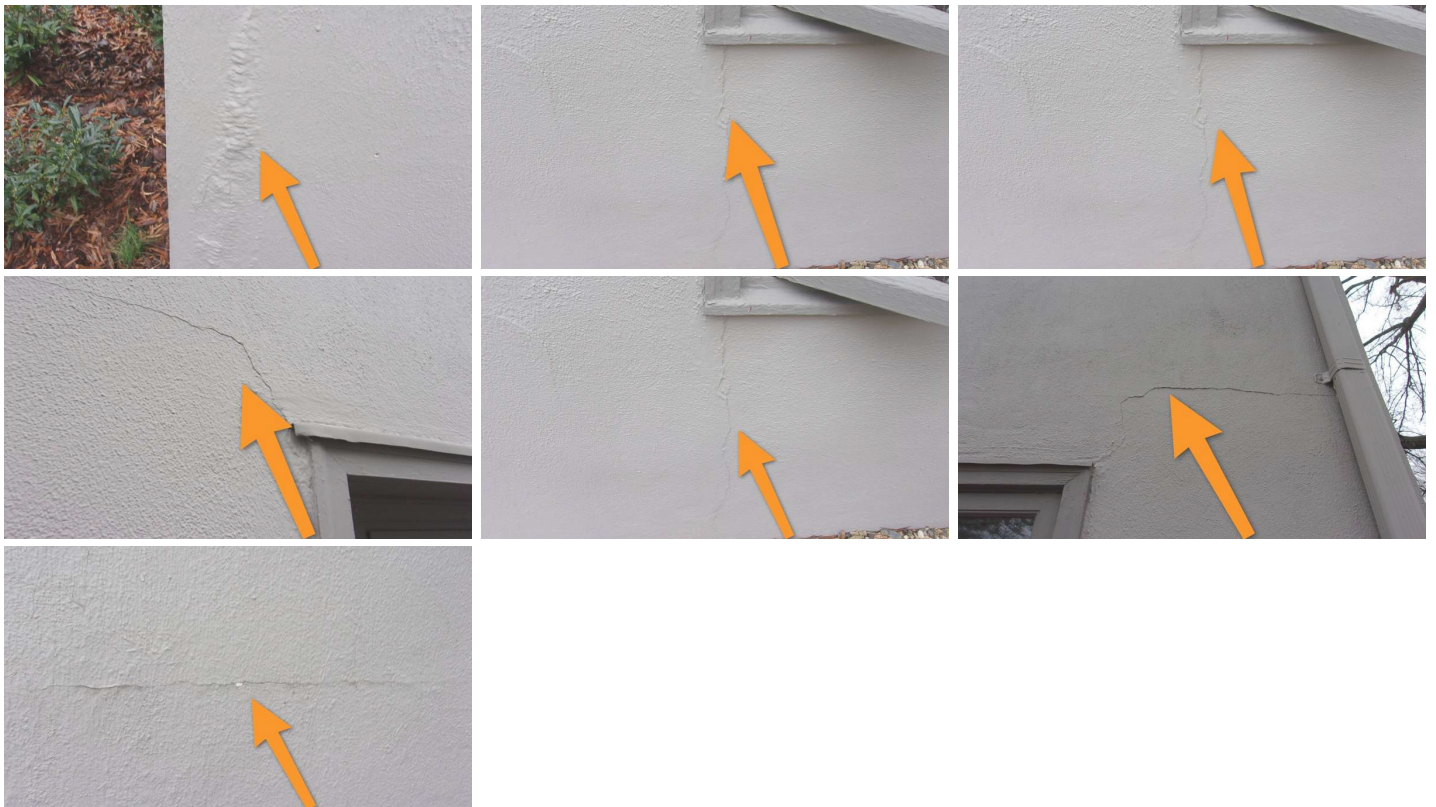
The home's exterior cladding has minor cracking in places. Some have been painted over and some that were painted have since cracked. There were a few areas where there was some lateral displacement around the cracking. To prevent water entry into the stucco recommend sealing the cracks and periodically monitoring

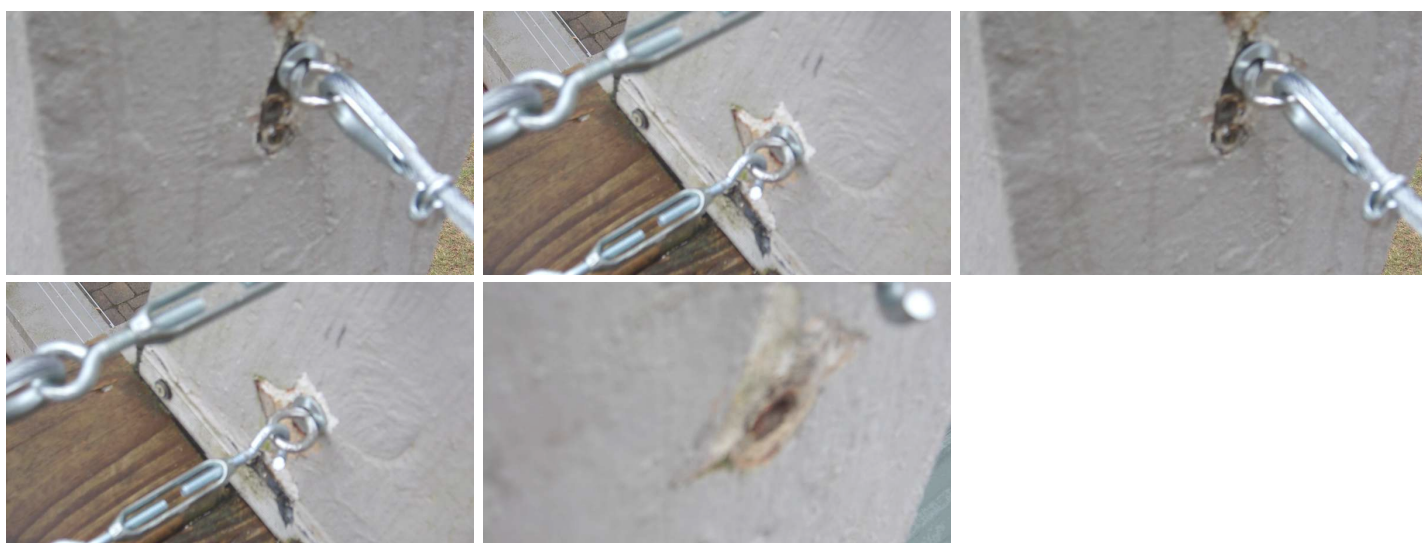
There are a few damaged areas or areas where screws or bolts have been removed that will allow water entry into the stucco. Recommend patching, sealing and painting all chipped areas or holes to prevent water entry.

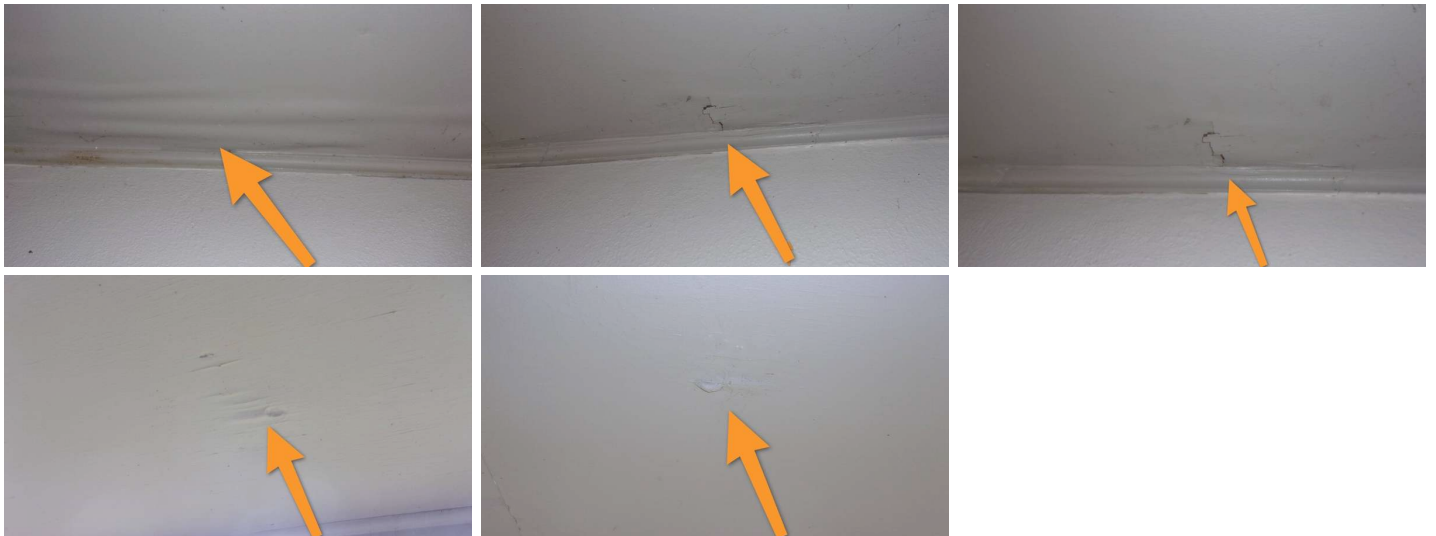
There are a number of areas around the front porch and back patio soffits where there is water damage / wood rot. Most of these areas have been painted over but were probed to be sure.

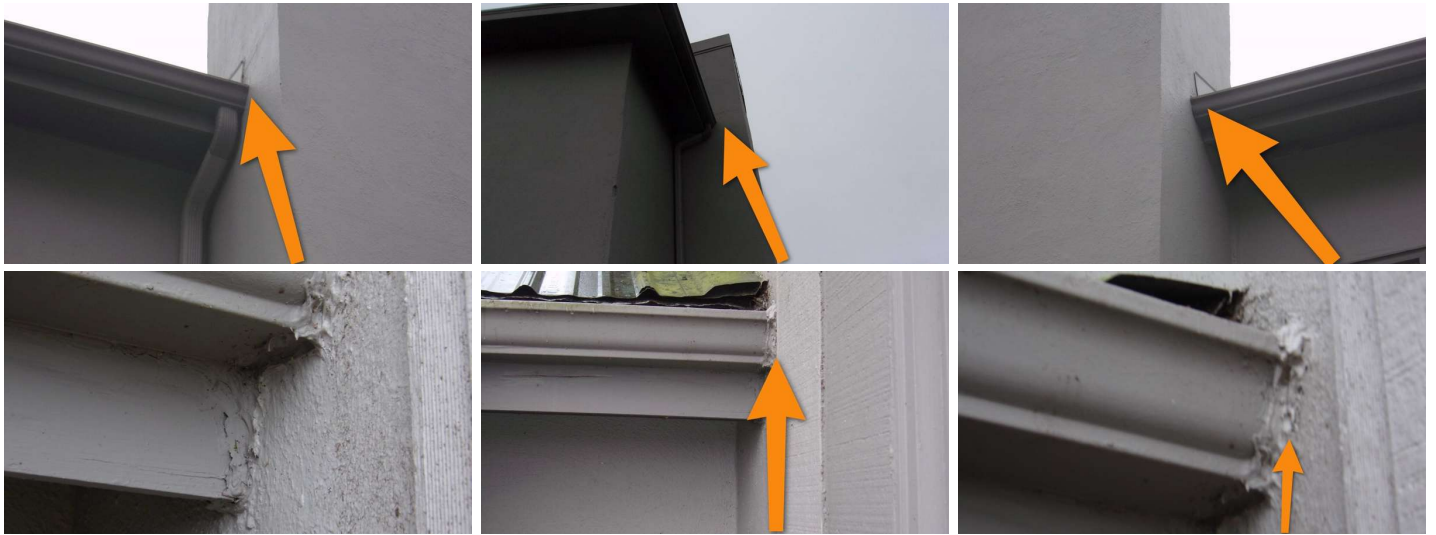
"Kickout" flashing is an important detail in preventing water damage to a building. It is simply a little piece of metal that directs water out and away from a building where a roof surface ends at a wall. Recommend evaluation and correction by a licensed contractor.

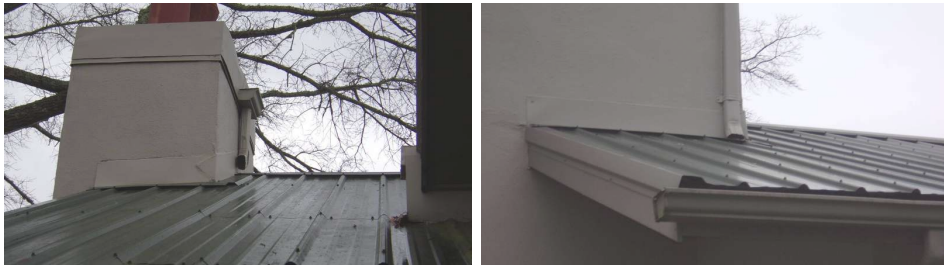
There are downspouts that are releasing water directly onto the upper metal roofing with water then draining down the roof to the lower gutter. This is not recommended simply because of the impact of a concentrated flow of water on the roof. It may also cause water to splash onto the stucco chimney cladding or the flashing at the base of the chimney.

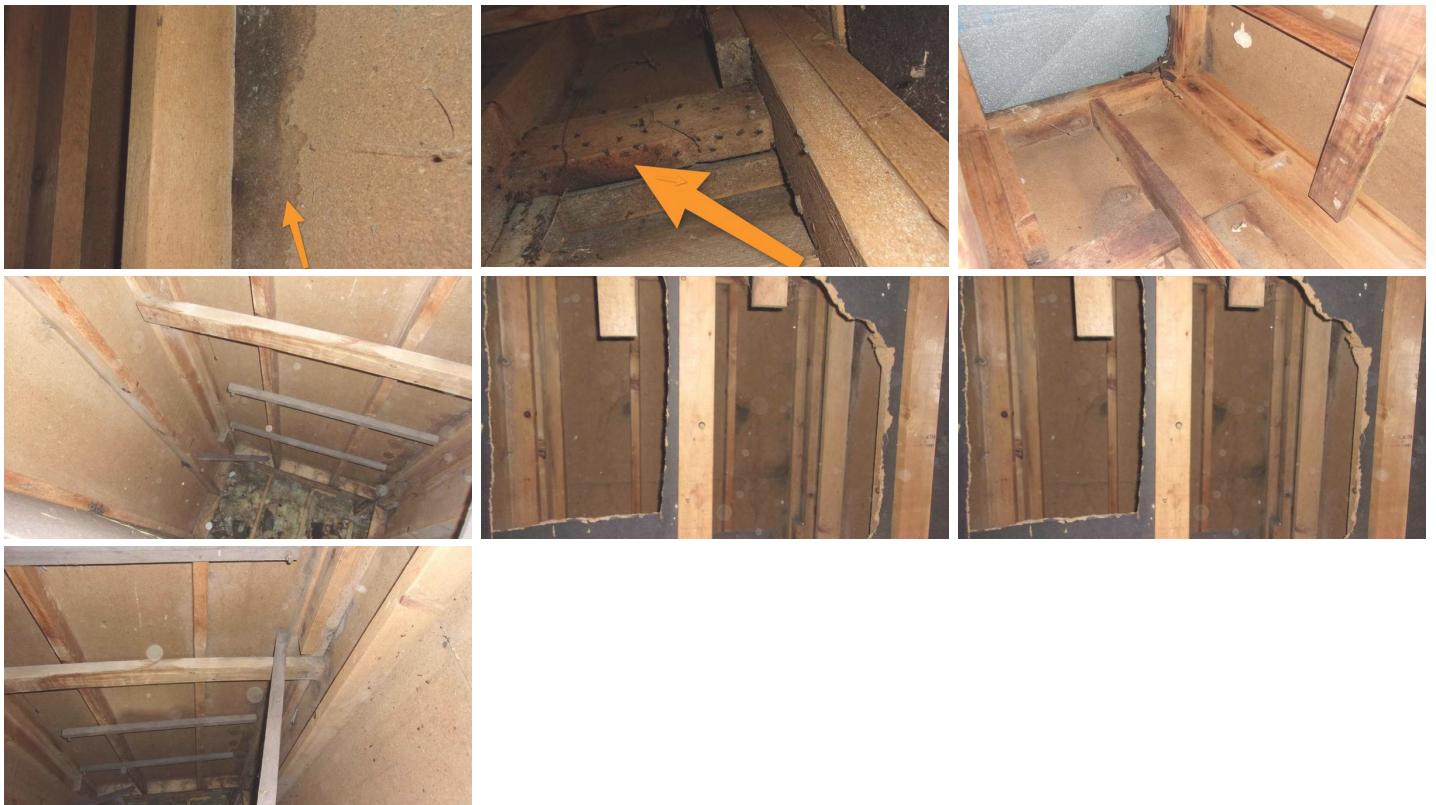
Also there was water staining on the interior walls of the chase but no sign of moisture. Also in the upper right side of the chase was a nest of insects. The type of insect is unknown. The inspector is not a professional bug guy.

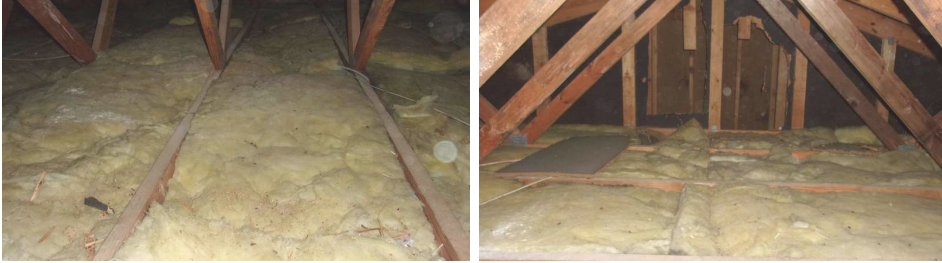
Insulation depth is less than the recommended standard. The insulation appears to be R-19. The minimal insulation R-Value for attics in our region is R-30, while the DOE recommends R-49. Recommend a additional insulation be added. If rolled fiberglass insulation is installed over the current it needs to be unfaced.

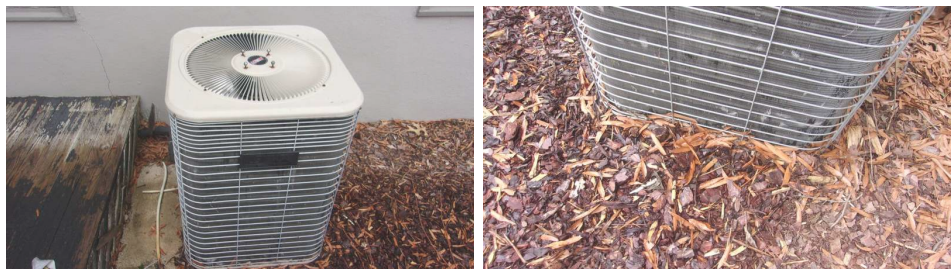
The outside condensing unit should be raised at least 6 inches off the ground in moderate snowfall areas. Recommend evaluation.

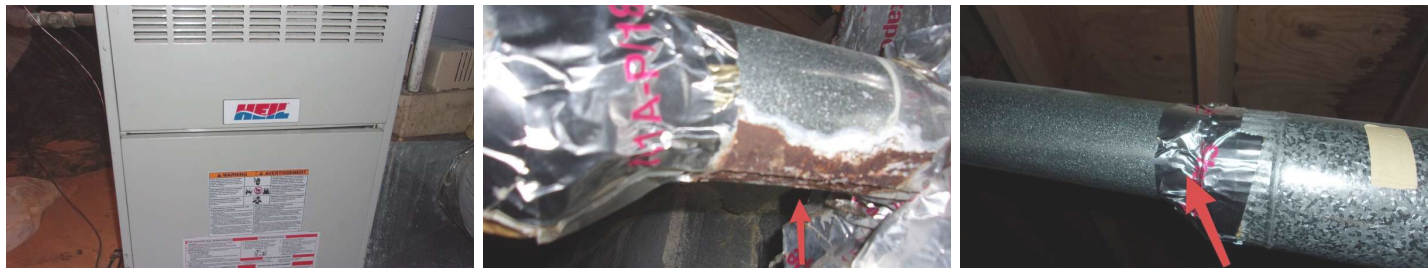
The exhaust line off the crawlspace located gas furnace is rusted, the line is differing sizes (instead of one sized piping), the seams are taped and the end point of the exhaust line is not connected and appears to be exhausting carbon monoxide into the home (crawlspace). This needs to be corrected immediately.

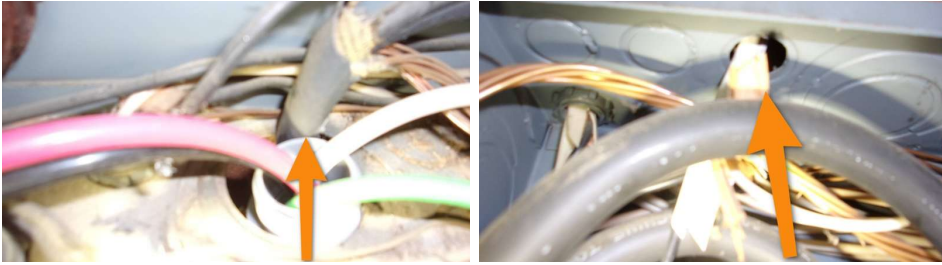
There are conductors entering the service panel that are not protected from the edges of the panel openings with bushings. I recommend a licensed electrician be consulted and their recommendation for correction be followed.

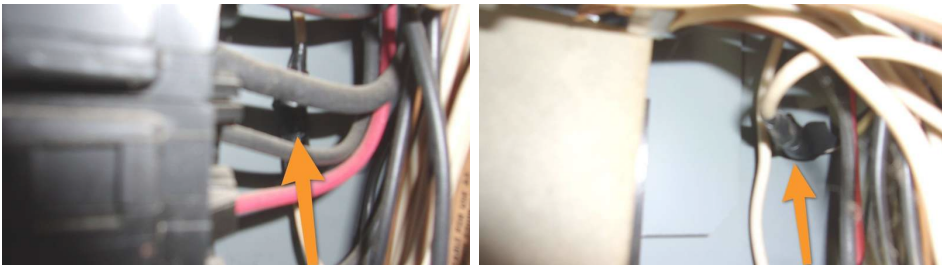
There are two grounded conductor (white wire) splices in the panel. The splices are taped but because of their size do not appear to be capped before tapping.

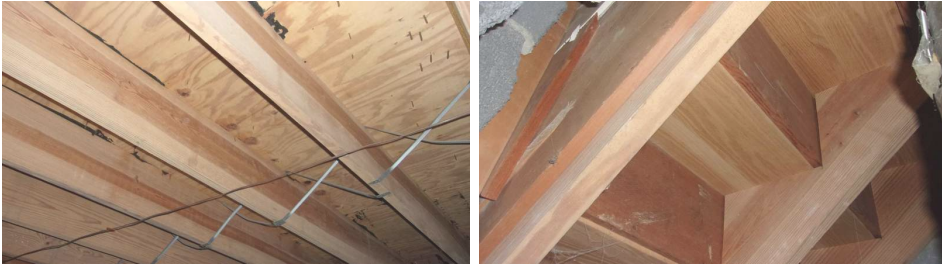
Additionally, the underside of the steps from the main to lower level, in the crawlspace, are not insulated. Recommend this be done as well.

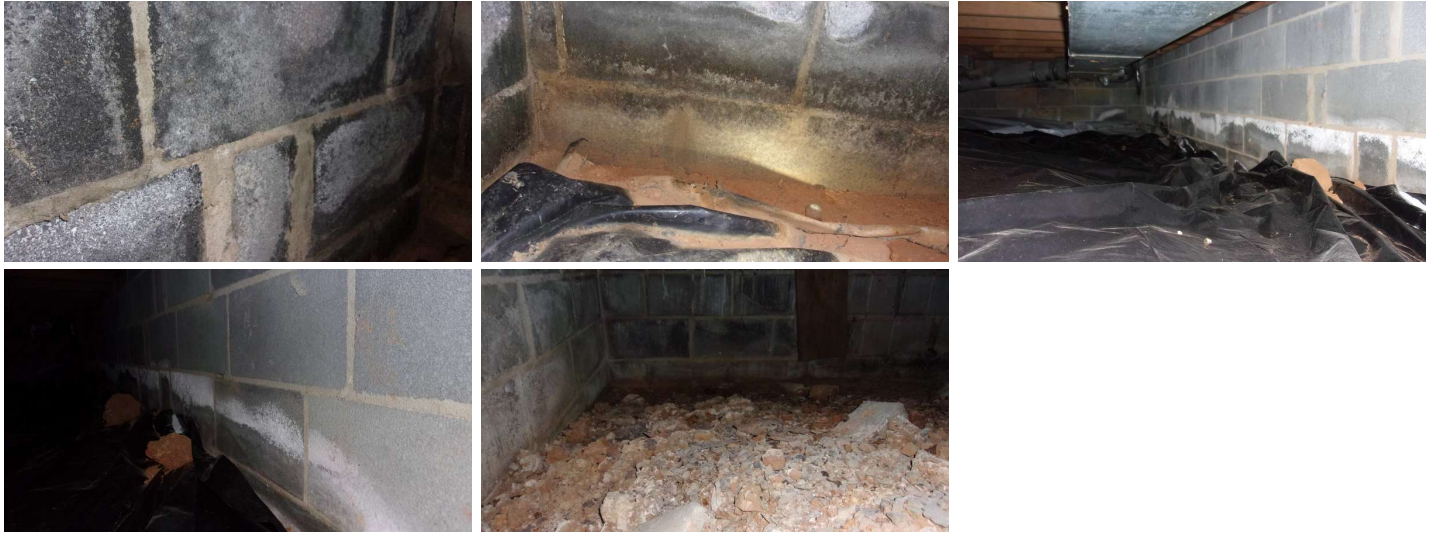
There is efflorescence present on the foundation block in the crawlspace. This is a sign of water penetration of the block presumably from the flat to negatively sloped grading at the exterior of the home. The soil at the base of the block in these areas is wet / muddy indicating current / recent water entry.

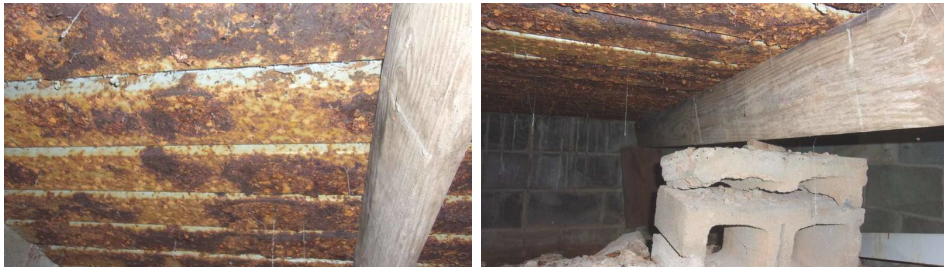
The metal subfloor under the front porch area is heavily rusted and a support beam one a block has been added. The integrity of the support beam and block is in question.

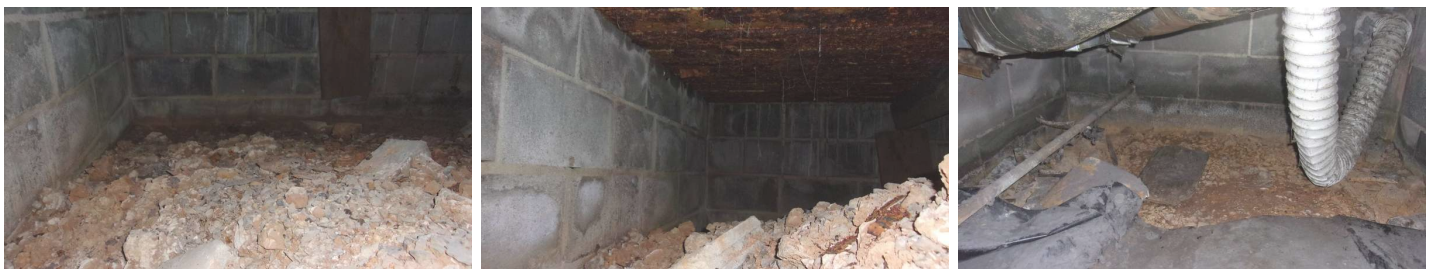
Vapor barrier is improperly installed. This can result in unwanted moisture. Typically a vapor barrier or retarder should be at least 6 mil plastic that completely covers the soil; free of holes and tears; and all seams overlapped at least 6 inches and taped / sealed. The vapor retarder should be cleanly cut around foundation walls and columns or be extended up and be secured / sealed to the walls and columns. Recommend repair.

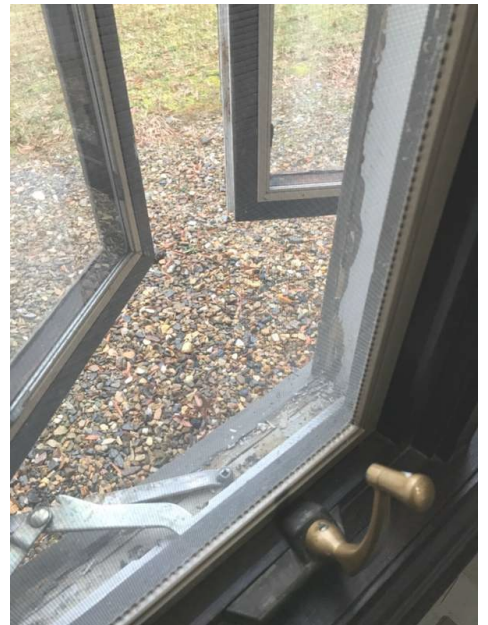
One or more windows appears to have general damage, but are operational.

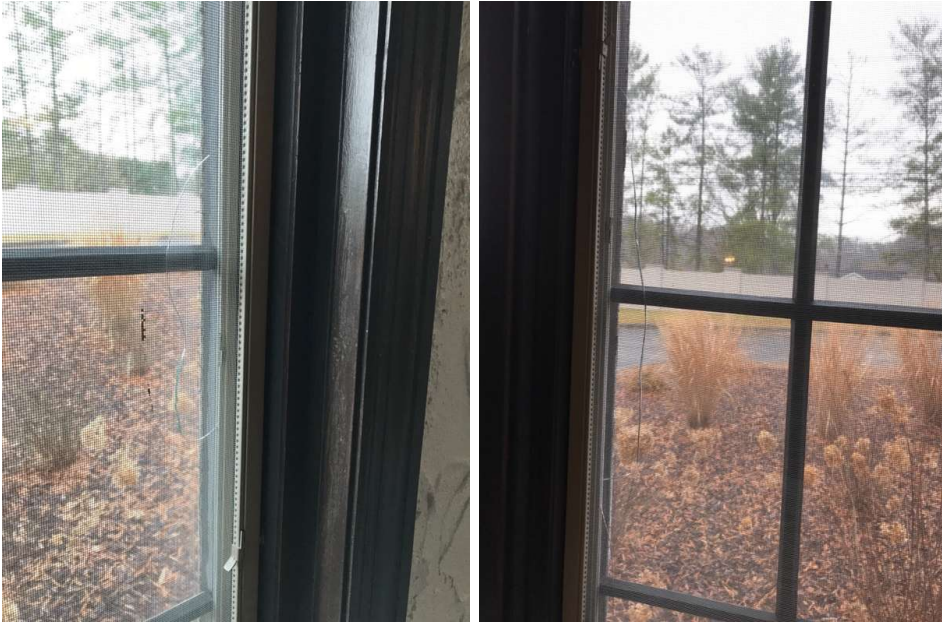
There are windows with cracked or broken window glazing. Recommend repair / replacement of the glazing (glass).

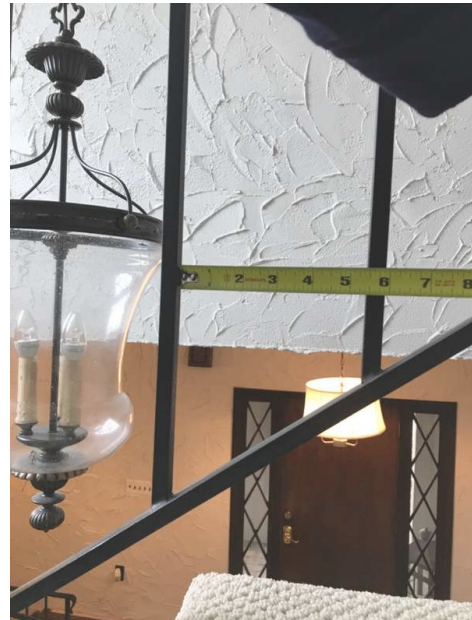
The spacing between the stair railing balusters or fillers is 5.5 inches. There should be no more than 4 3/8 inches of space between stair railing balusters to prevent children heads or other body parts from getting trapped. For safety reasons it is recommended that these steps be brought up to baluster recommended standards.

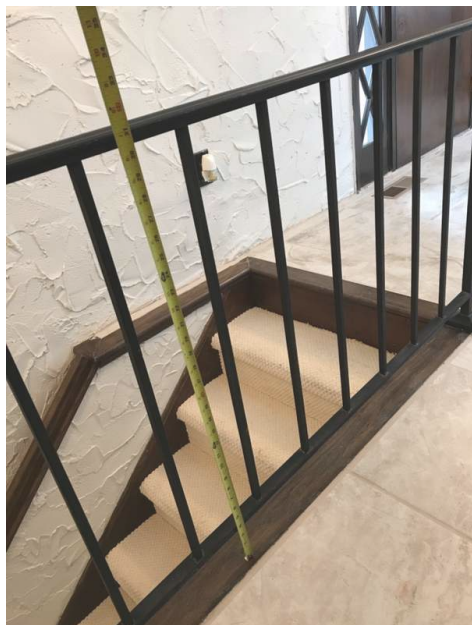
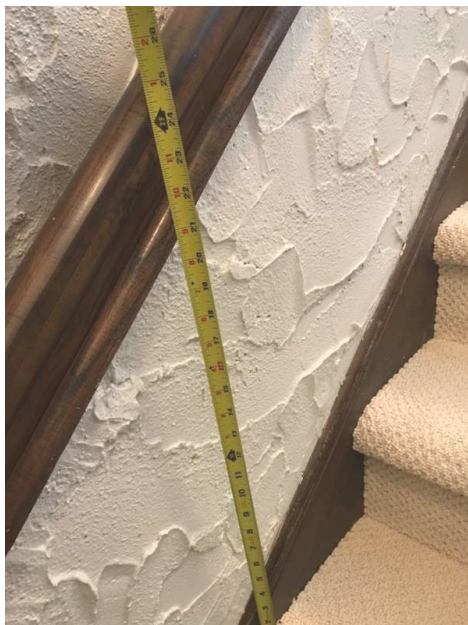
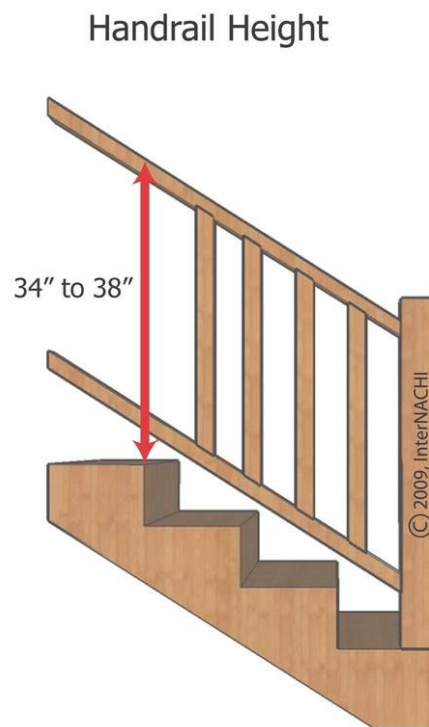
The stair railings are 31.5/25 inches high. They do not meet the recommended building standard railing height of 34 to 38 inches. This is considered a safety issue, recommend addressing.

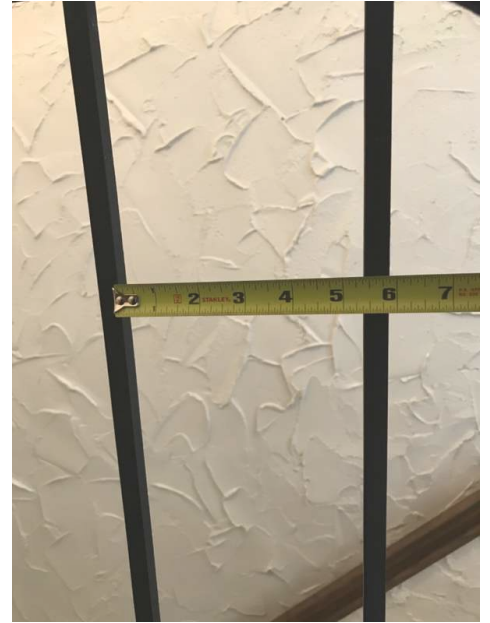
The spacing between the stair railing balusters or fillers is 5.25 inches. There should be no more than 4 3/8 inches of space between stair railing balusters to prevent children heads or other body parts from getting trapped. For safety reasons it is recommended that these steps be brought up to baluster recommended standards.

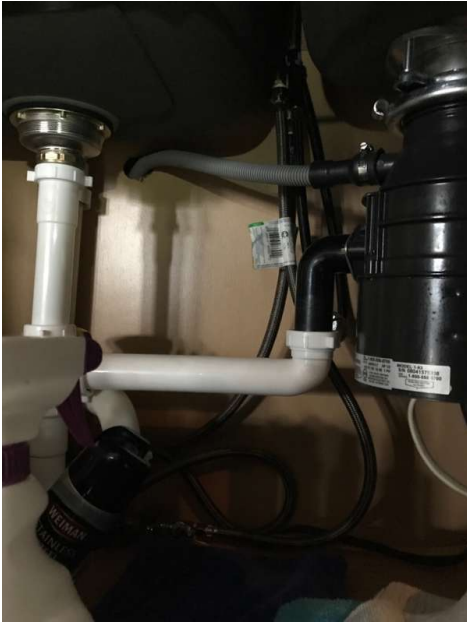
The dishwasher drain line should either connect to an air system at the top of the sink or be installed so it has a loop in the line that touches the under side of the counter top. This air gap system or high loop will help prevent drain water from the sink draining into the dishwasher. Recommend correcting the line positioning to create this high loop.

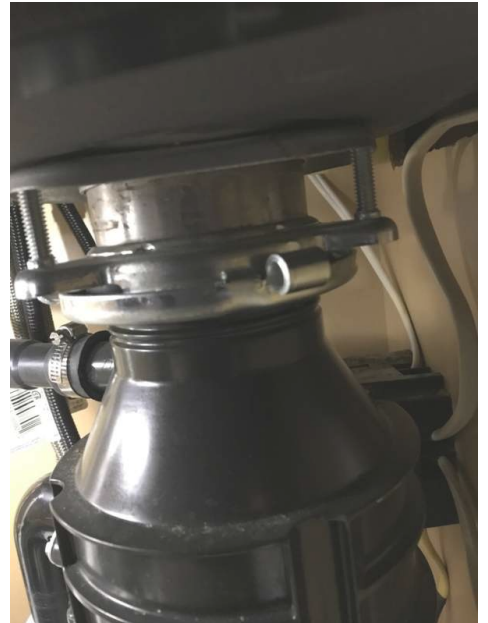
The Romax wiring to the dishwasher and the wiring to the disposal are both unprotected under the sink and both need to be in protective conduit

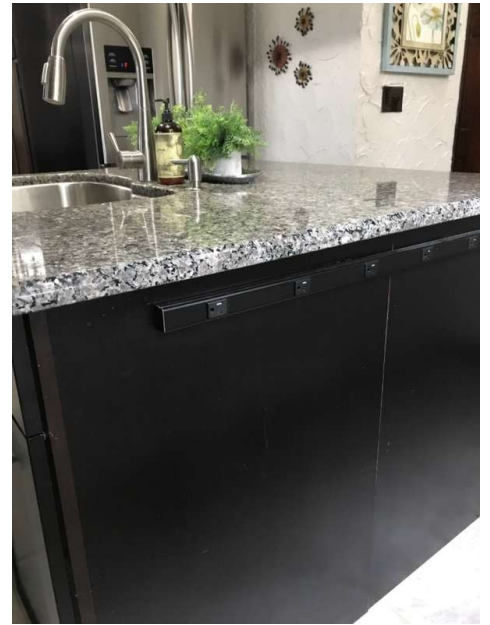
This receptacle strip is within 3 feet of the sink on the island and should be GFCI protected .

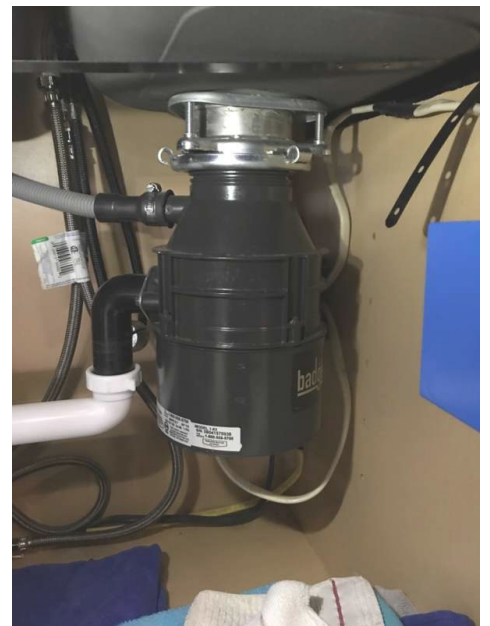
Romex wiring that is connected to the garbage disposal directly should be protected by being placed in conduit. Recommend this be done.

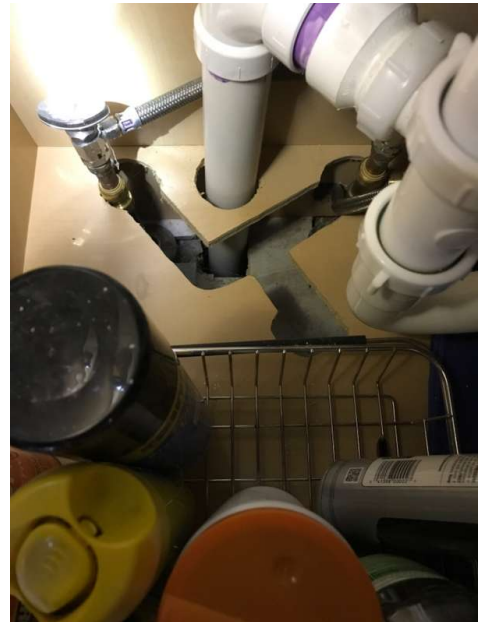
The area under the sink where the drain line exits the cabinet is large and open.

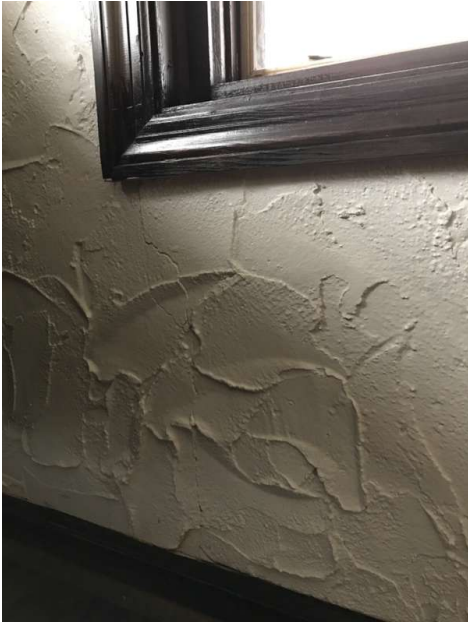
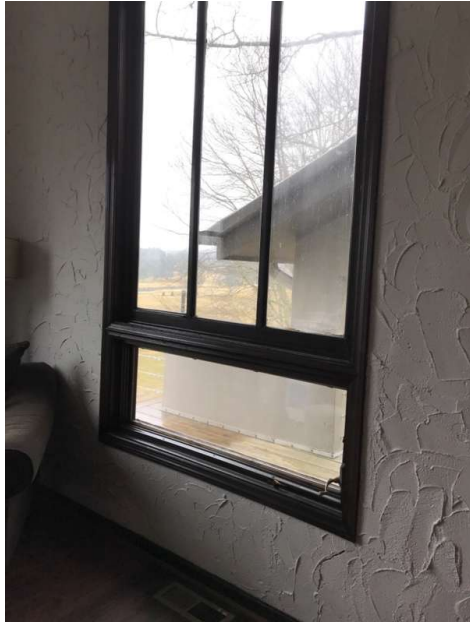
There are minor cracks in the walls /ceiling. Cracks at the corners of doors and windows are not uncommon. They may be due to long-term settlement or from the shifting / shrinking of a door or window header. Joint cracks can be the result of expansion and contraction of framing or structural stress.

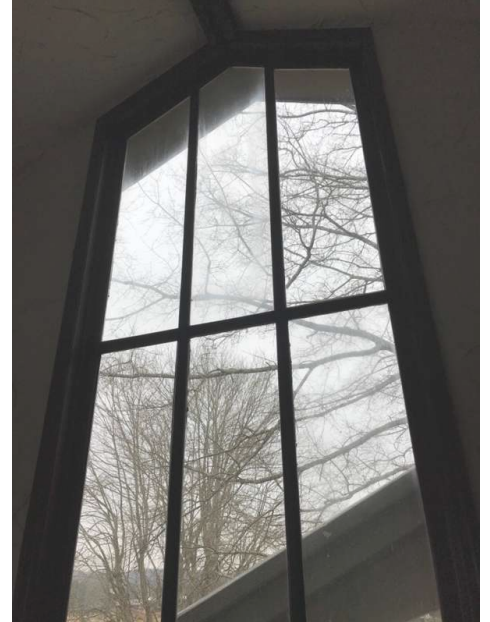
Observed condensation / condensation stains between some window panes, which normally indicates a failed seal. This does not normally reduce the window's efficiency but may negatively impact the windows appearance and the visibility through the glazing.

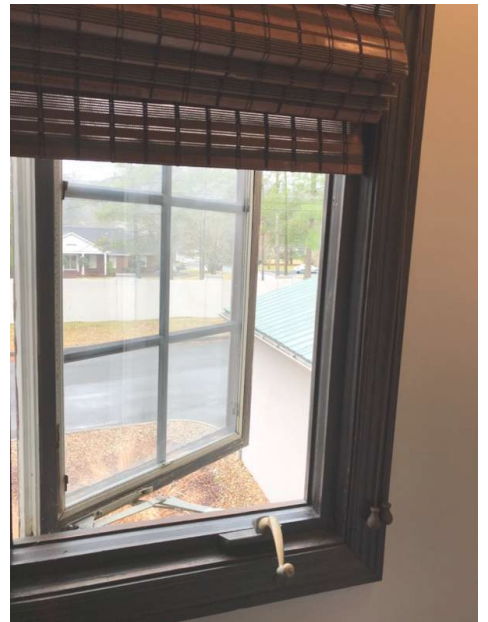
There are window screens or storm windows missing. They may be in storage. Recommend addressing with the homes current owner to see if the are locateable.

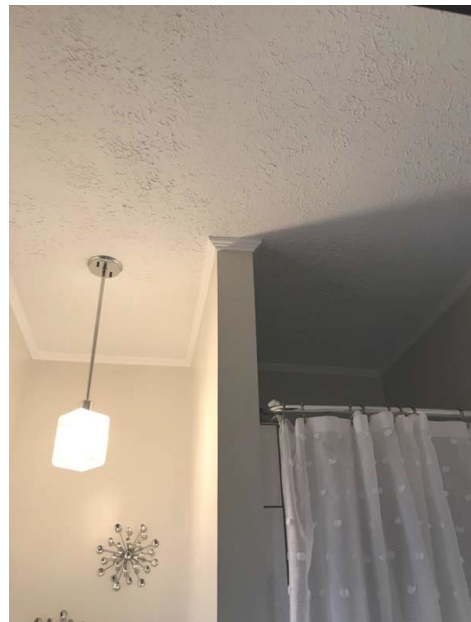
There is no bathroom moisture exhaust venting. Bathroom venting is installed to remove moisture from the bathroom not to keep the air fresh. Even with a window in the bathroom exhaust venting is recommended simply because opening a window in freezing weather is usually not done. Many times we don't always remember to open the window before showering. If installed an exhaust fan should vent to the homes exterior not to the attic.

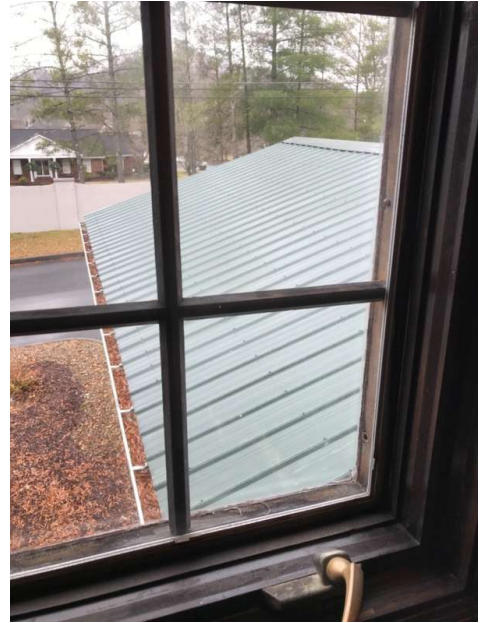
There are window screens or storm windows missing. They may be in storage. Recommend addressing with the homes current owner to see if the are locateable.

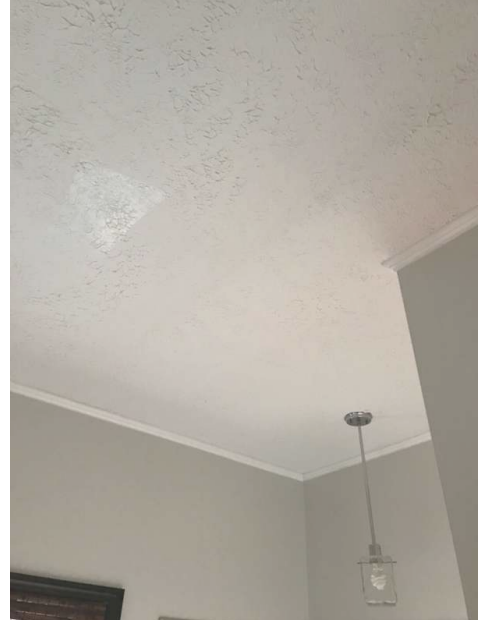
There is no bathroom moisture exhaust venting. Bathroom venting is installed to remove moisture from the bathroom not to keep the air fresh. Even with a window in the bathroom exhaust venting is recommended simply because opening a window in freezing weather is usually not done. Many times we don't always remember to open the window before showering. If installed an exhaust fan should vent to the homes exterior not to the attic.

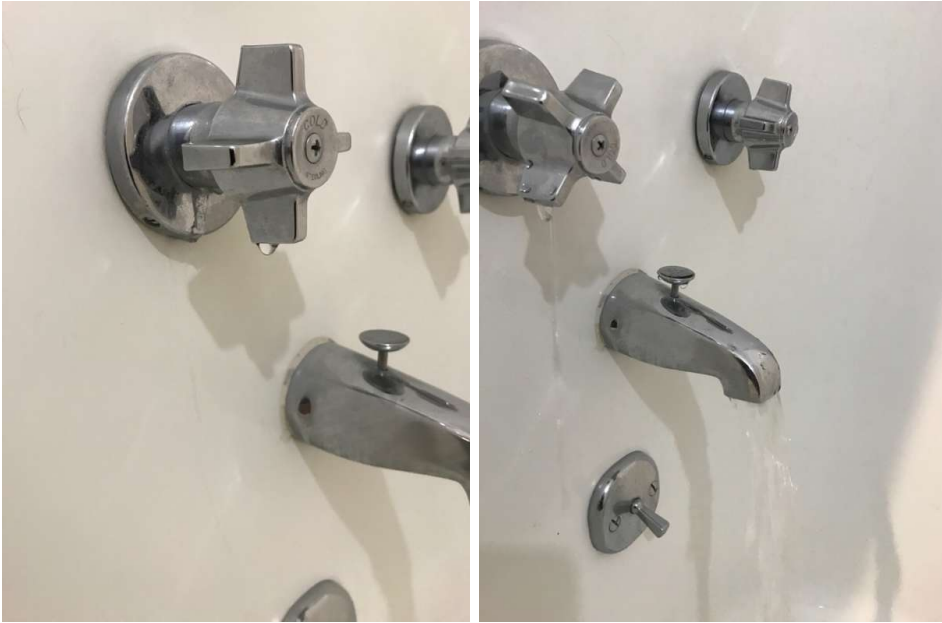
There is water leaking from the shower head assembly / the water faucets. Replacement or repairs are recommended.

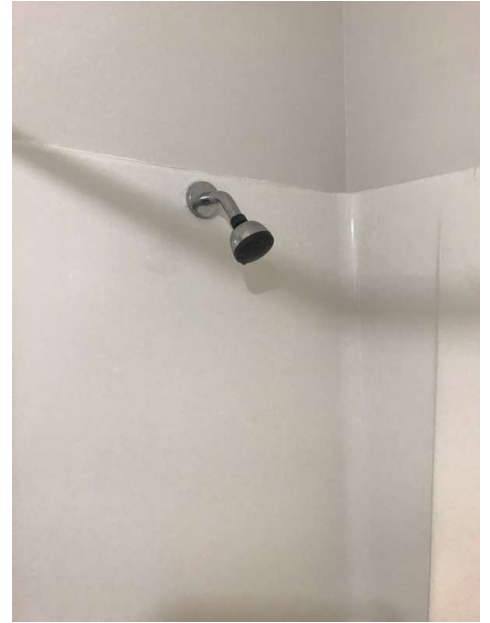
Shower Head is not secure in the wall.

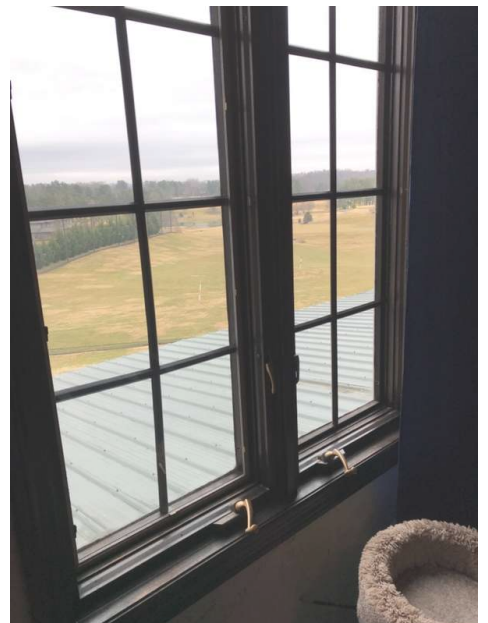
There are window screens or storm windows missing. They may be in storage. Recommend addressing with the homes current owner to see if the are locateable.

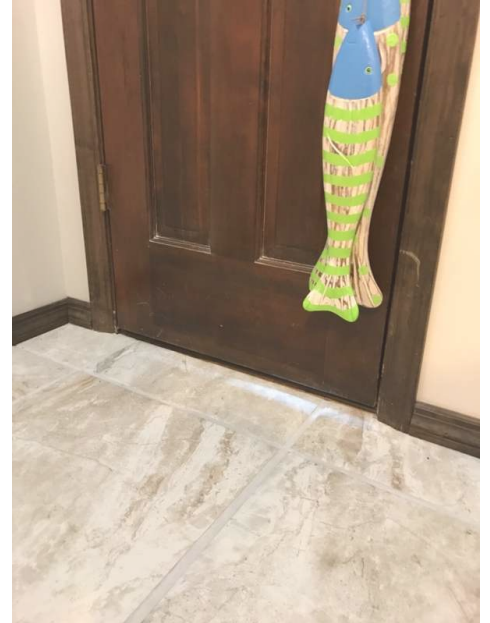
Since there is no HVAC return air vent in the bathroom the clearance at the base of the doors should be at least 3/4 of an inch to allow for airflow back to the HVAC return vent. If door is closed a great deal of the time it is recommended the door base be trimmed to allow for adequate air return.

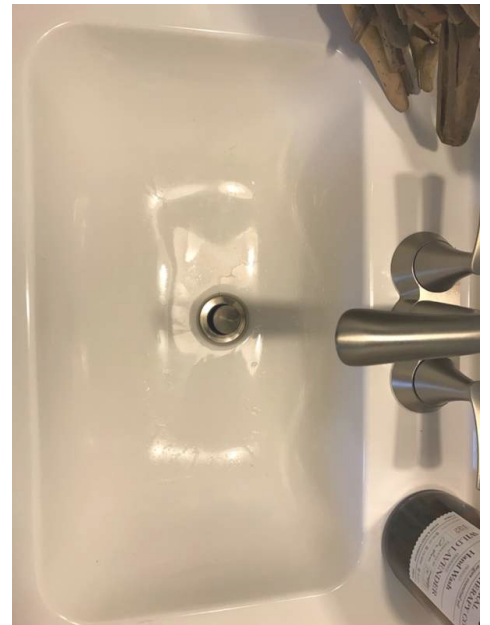
Just a heads up that the sink does not have a water overflow hole. So caution should be taken when filling the sink with the stopper closed.
