RED CARPET HOME INSPECTIONS

RED CARPET HOME INSPECTIONS - SFH/TH/DUPLEX

1234 Main St.
Haymarket VA 20169

Buyer Name
02/24/2019 9:00AM

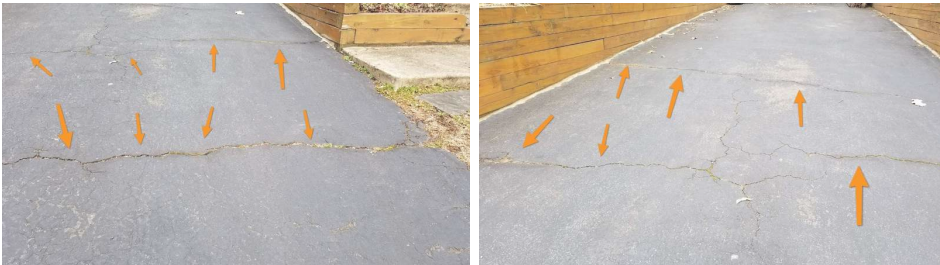
DRIVEWAY CRACKING - MINOR

Minor cosmetic cracks observed, which may indicate movement in the soil. Recommend to monitor and/or have concrete contractor patch/seal.

Contact a qualified driveway contractor.

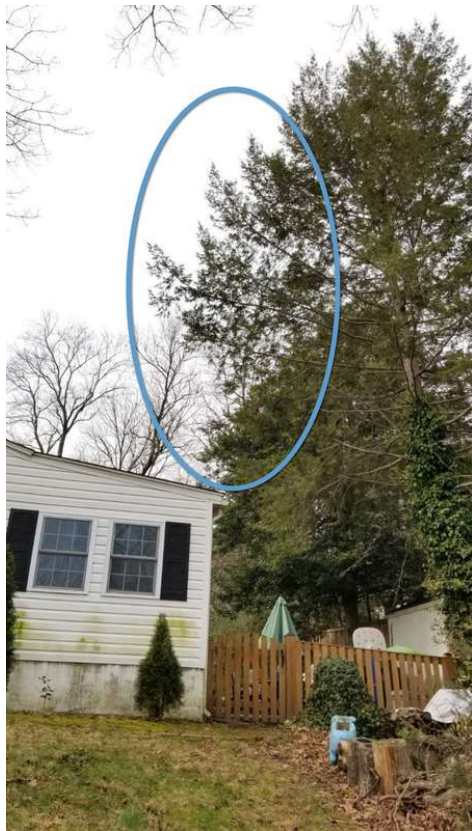
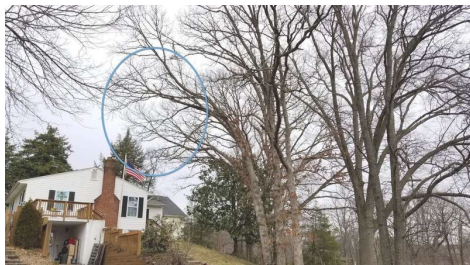
Trees observed overhanging the roof. This can cause damage to the roof and prevent proper drainage. Recommend a qualified tree service trim to allow for proper drainage.

Large tree branch overhang

Trees overhang the roof which cause debris and potential branch falling hazard

Contact a qualified tree service company.

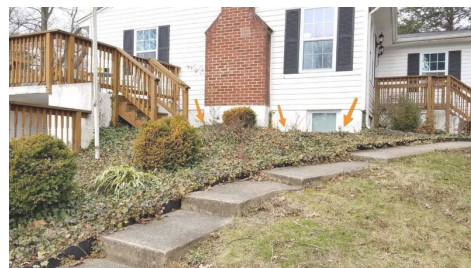
Area has a large concentration of vegetation near the homes foundation that has been known to hold a lot of moisture and could potentially cause moisture intrusion into the homes foundation.

Recommend trimming back and controlling some of the vegetation be a qualified professional.

Contact a qualified lawn care professional.

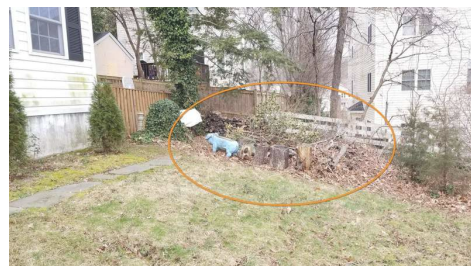
Wood Destroying Insects are known to inhabit lumber and fallen other various forms of vegetation. Large amounts of lumber should be kept as far away for the house structure as possible. To prevent the possibility of WDI inhabiting the dwelling. Recommend moving wood much further away from the house. At least 25 feet or so.

Recommended DIY Project

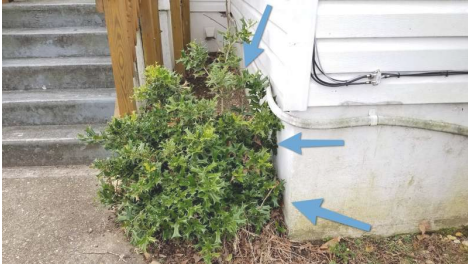
North front entryway

Recommend to remove vegetation that is in contact with exterior of home.

Recommended DIY Project

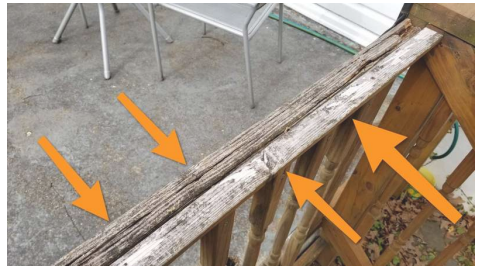
One or more deck boards are showing signs of rot. Recommend a qualified deck contractor replace.

Deck gate top rail

Contact a qualified deck contractor.

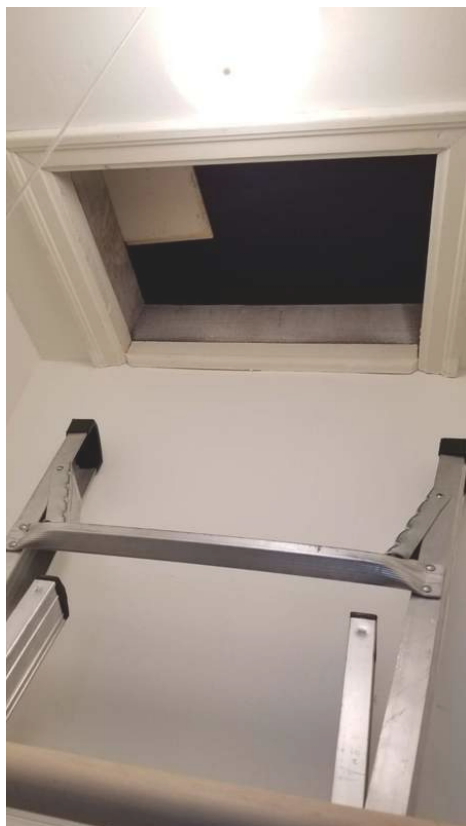
Attic entrance small

One or more attic access hatches or doors were too small to allow easy access. Such hatches should be at least 22 x 30 inches in size, and in safely accessed areas. Recommend that a qualified person modify attic access points per standard building practices. Noted in upper level closet ceiling.

Contact a qualified professional.

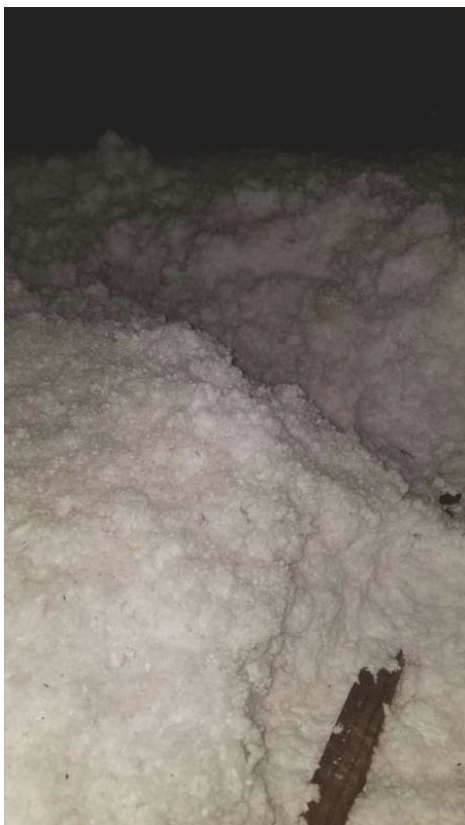
Lack of insulation around attic access door causes energy loss

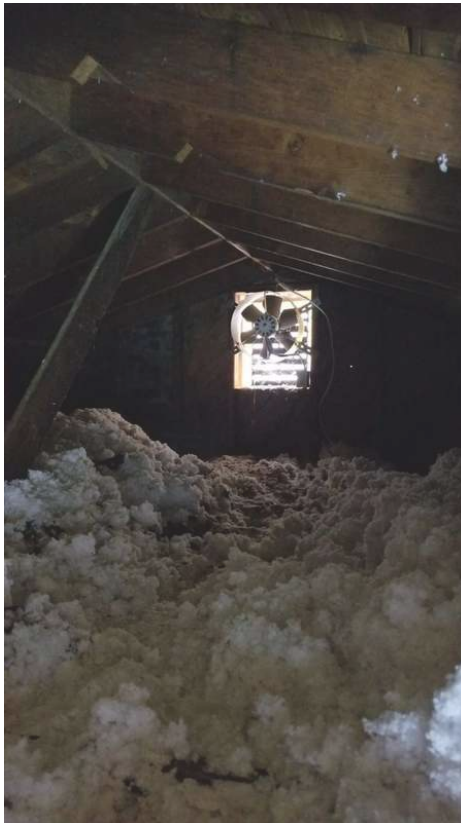
Gable attic fan observed but could not determine whether the unit was working. Recommend having a qualified electrician evaluate

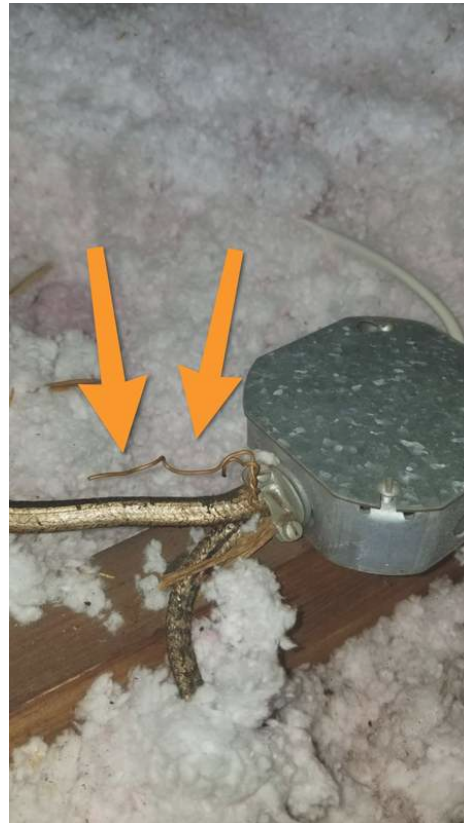
Possibly aluminum wiring in the attic leading to the Gabel attic fan needs to be evaluated further by a qualified licensed electrician

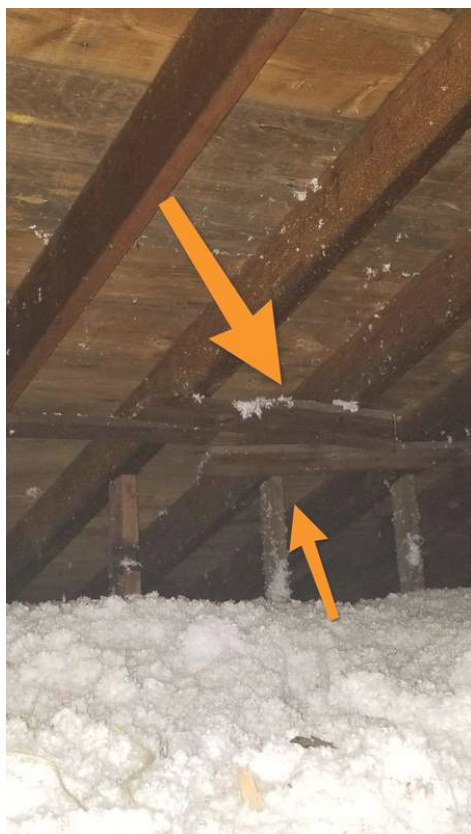
Observed one or more rafters broken, cut or notched out while inspecting the roofing structure. Recommend a qualified roofing professional to evaluate.

Improper bracing of rafters with wood not deemed suitable

Contact a qualified roofing professional.

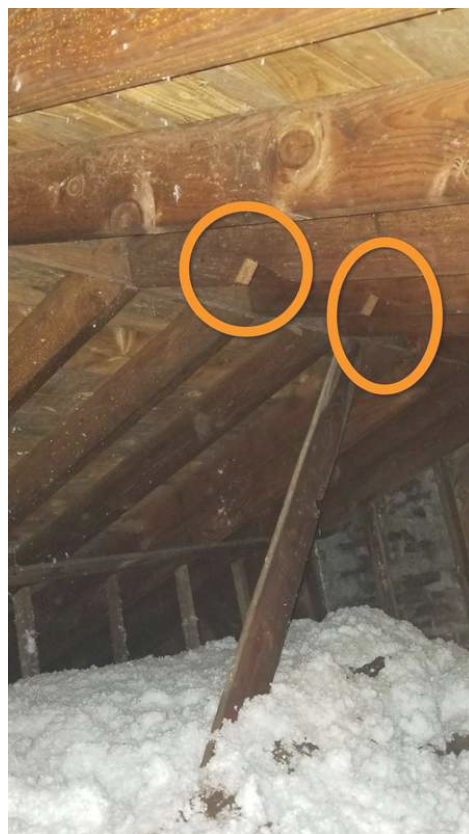
Notches cut out of rafters

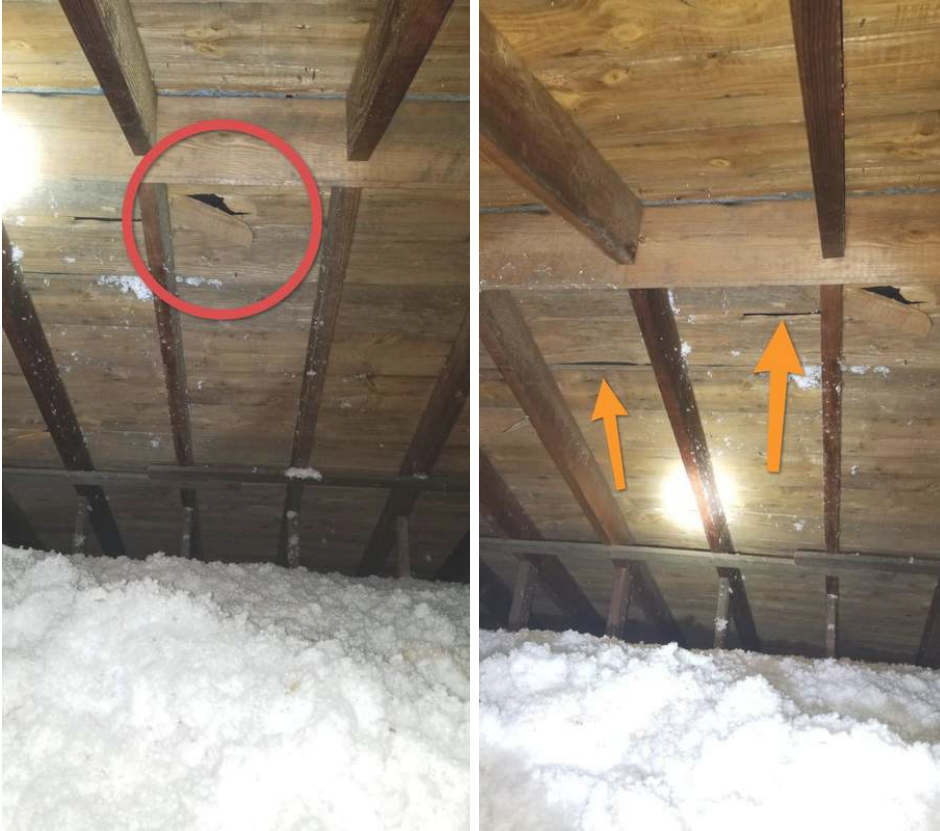
One or more plank boards are broken or have signs of major wear and tear. Recommend a roofing professional to further evaluate

Large hole from broken roof plank covered with underlayment and shingles

Planks are showing splitting and signs of separation occurring. Recommend a roofing professional to further evaluate

Contact a qualified roofing professional.

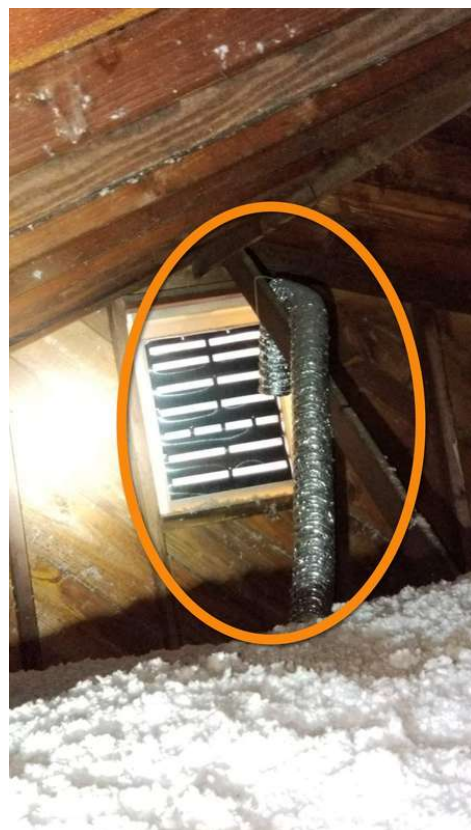
Observed a vent pipe possibly discharging into the attic. Was not able to determine whether or not it was hooked to anything. Nothing should exhaust into the attic. Everything should exhaust to the exterior of the home. Recommend further evaluation by a qualified HVAC professional

Vent hose appears to discharge into the attic. Proper venting is needed to discharge out of the attic and to the exterior of the house

Contact a qualified HVAC professional.

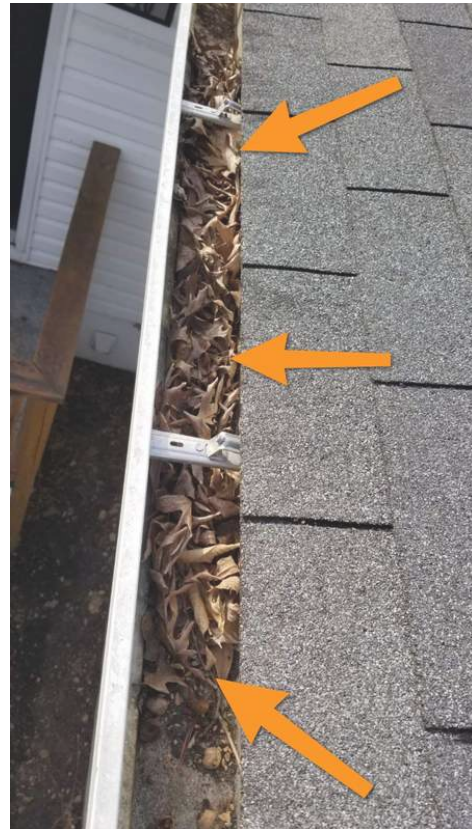
Debris has accumulated in the gutters. Recommend cleaning to facilitate water flow.

Contact a handyman or DIY project

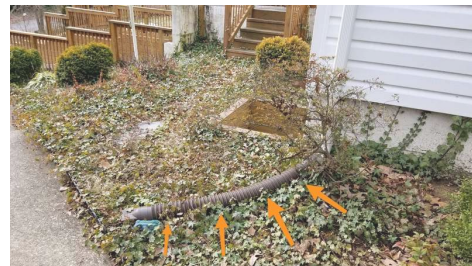
Northwest front

One or more downspouts drain to nearby steps and/or walkway. This may cause a fall hazard when water freezes/thaws. Recommend adjusting or relocating downspout extensions.

Contact a handyman or DIY project

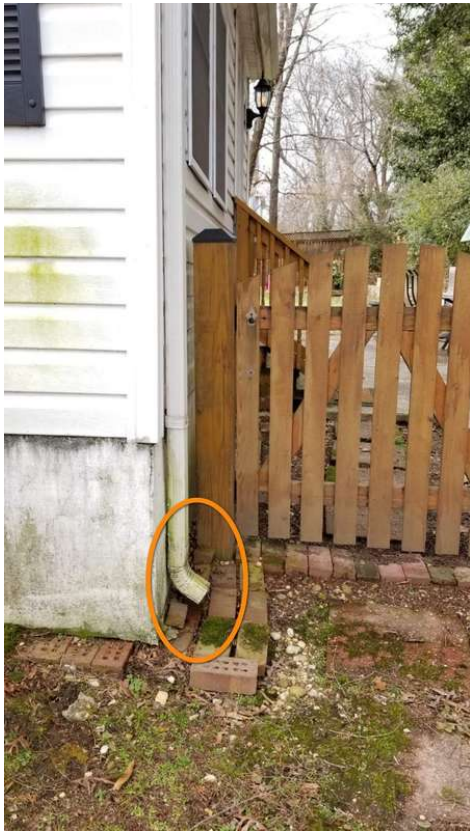
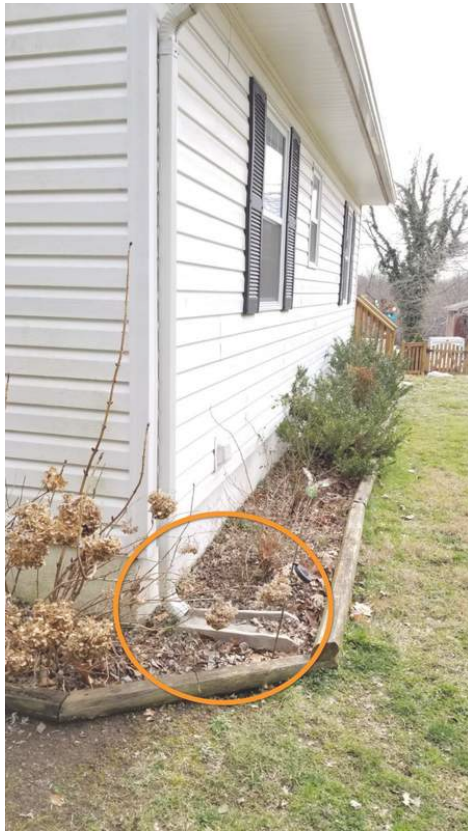
Home was missing downspouts in one or more areas. This can result in excessive moisture in the soil at the foundation, which can lead to foundation/structural movement. Recommend a qualified person install downspout extensions that drain at least 6 feet from the foundation.

Contact a handyman or DIY project

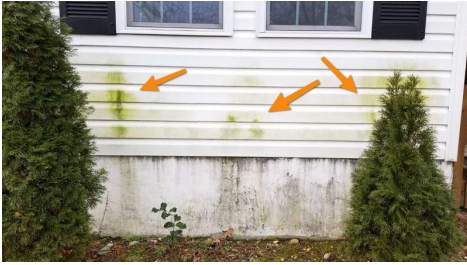
East

Recommend power washing of siding.

Recommended DIY Project

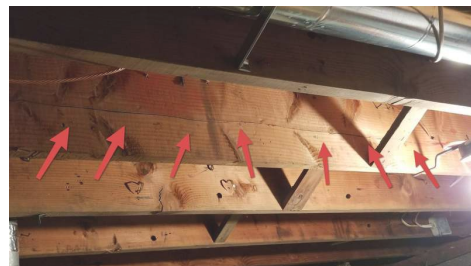
Floor joist is damaged and could potentially cause a major structural issue. Recommend that a qualified professional structural engineer evaluate further.

Floor joist is completely split down the center throughout 80% of the beam

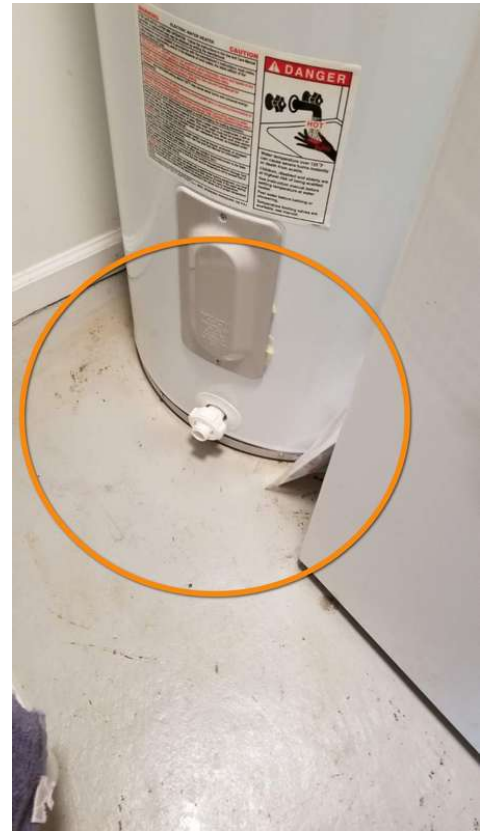
No drip pan was present. Drip pan must also drain into a floor drain. Recommend installation by a qualified plumber.

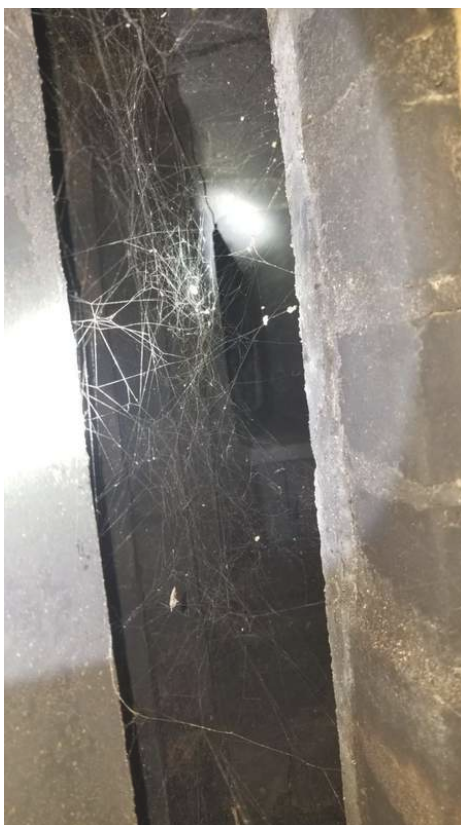
Visual of Inside the firebox and flue pipe. Recommend a level 2 chimney inspection to determine condition of flue pipe

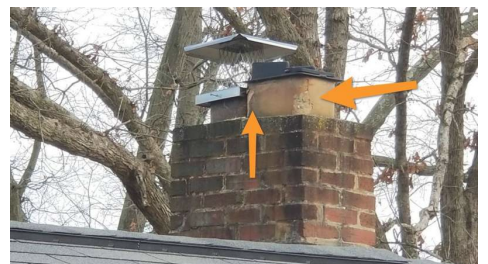
The chimney flue had one or more cracks, which can lead to further damage to the chimney structure. Recommend a qualified contractor repair.

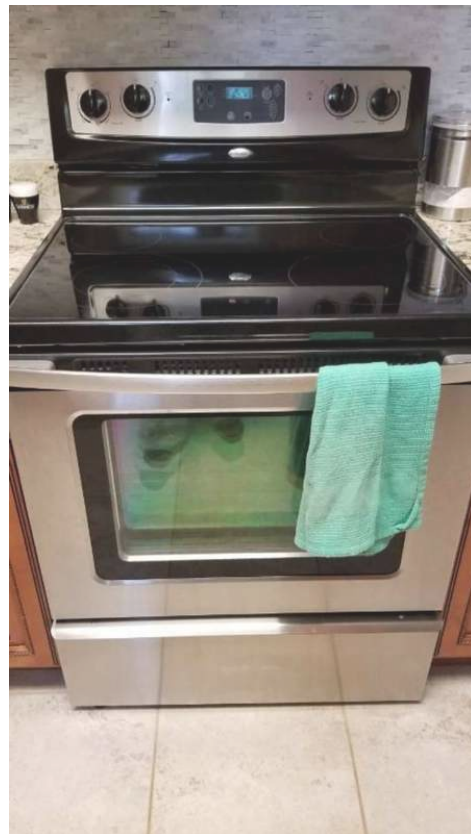
Range was not fastened to the wall with anti tip mechanism. This poses a safety hazard to children. Recommend a qualified contractor secure range so it will not tip over and potentially cause harm.

No anti tip attached to the range

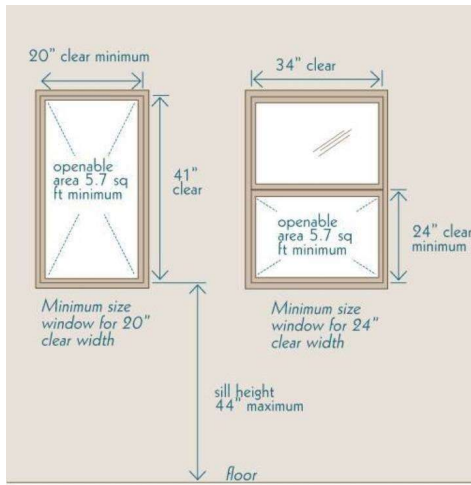
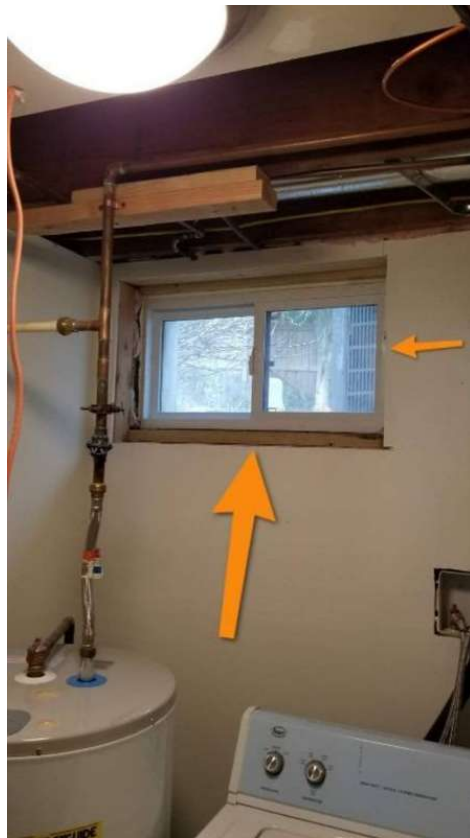
Laundry room window. Not an egress window

Contact a qualified window repair/installation contractor.

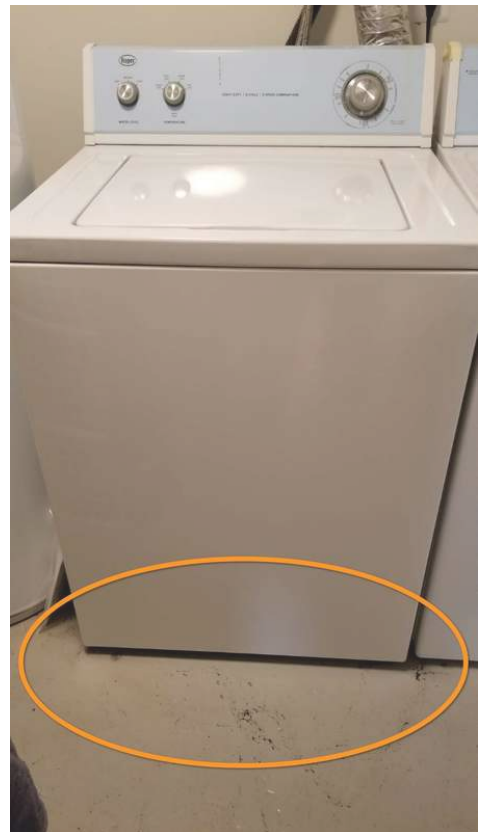
Drip pan needed under washer to prevent flooding if leakage occurs

Contact a qualified professional.

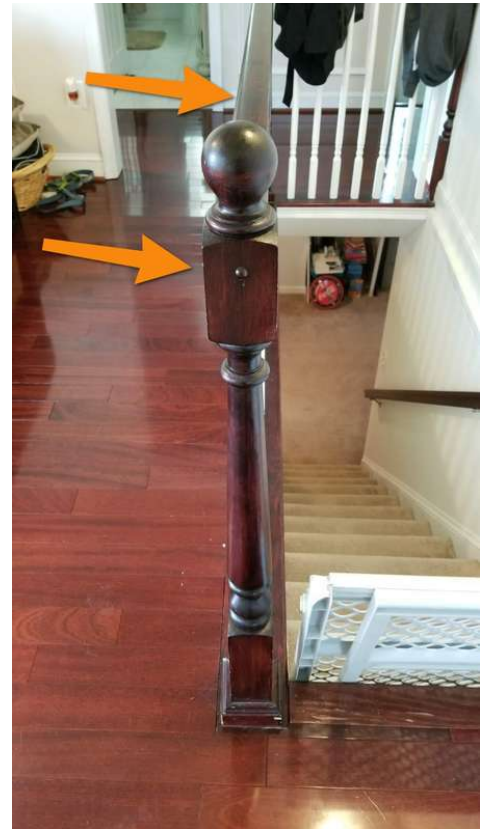
Railing is loose and needs to be secure tightly to prevent accidental leaning on and railing breaking

Contact a qualified professional.

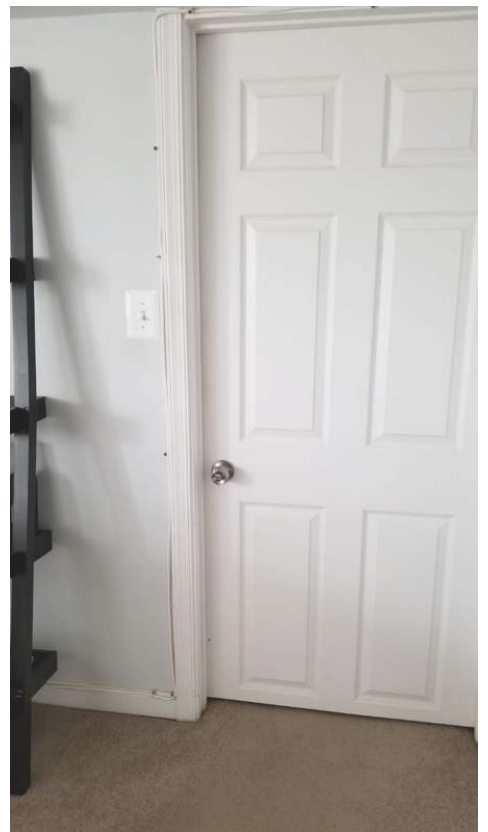
Door knob, latch and/or strike plate is out of alignment. Should be installed a minimum of 34 inches to a maximum of 48 inches above the floor. Recommend a professional qualified door contractor.

Basement bedroom door handle low.

Should be installed a minimum of 34 inches to a maximum of 48 inches above the floor

Contact a qualified door repair/installation contractor.

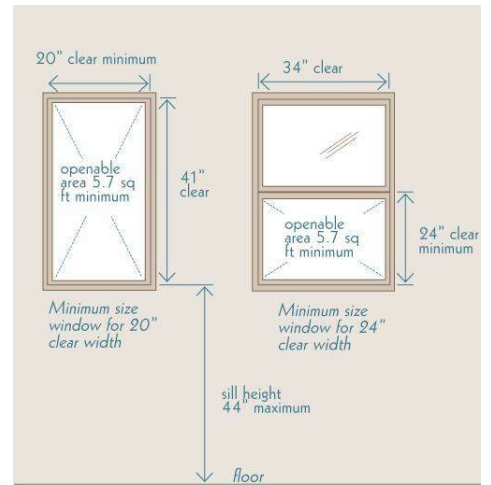
Recommend installing a egress window in the bedroom. Current window installed does not meet specs.

Contact a qualified professional.

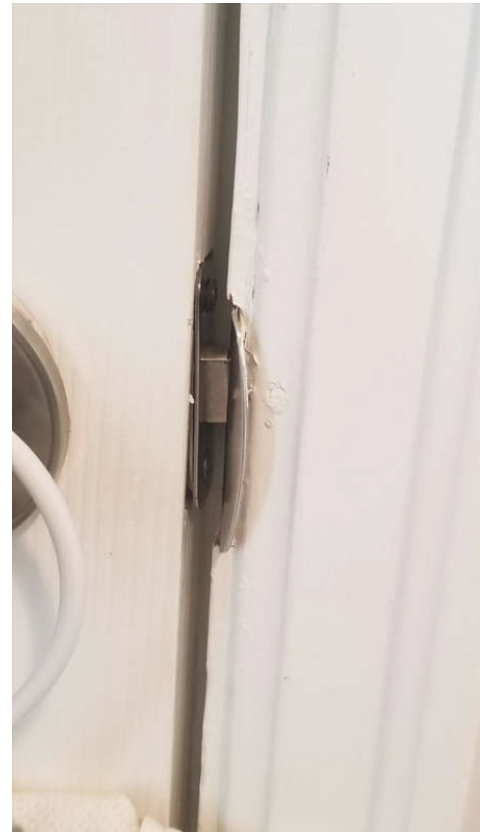
East bedroom closet

Door doesn't latch properly. Recommend handyman repair latch and/or strike plate.

Contact a qualified handyman.

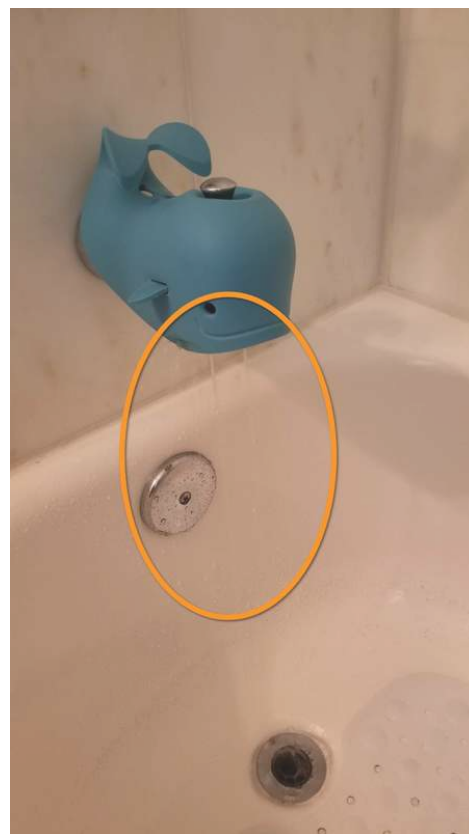
Tub/Shower diverter was not working properly, recommend repair.

Water not properly diverting to the shower head

Contact a qualified professional.

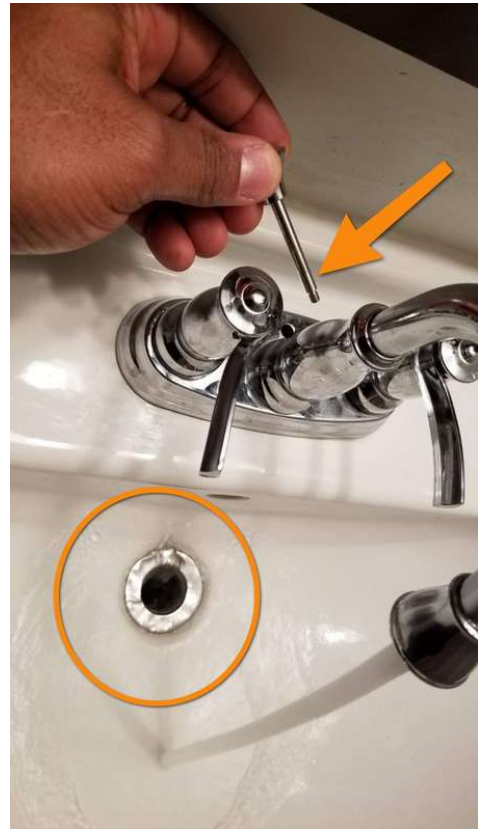
Sink drain stop was not operating as intended or was missing, recommend repair.

Stopper missing and broken

Contact a qualified plumbing contractor.

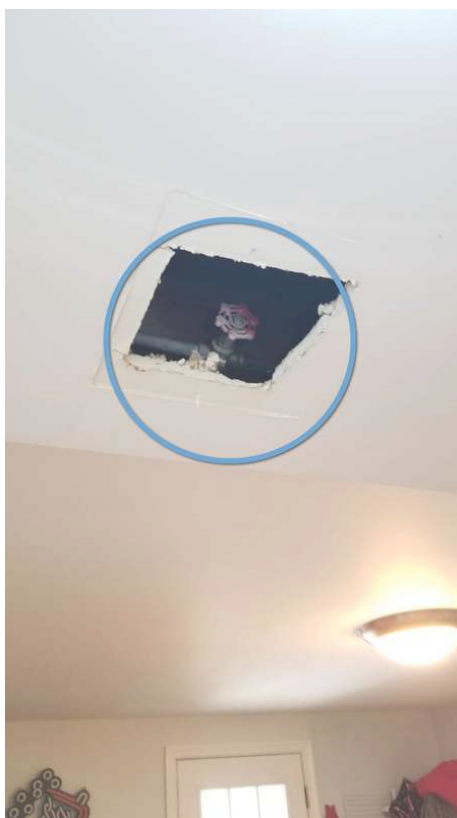
Basement ceiling has a shut off valve in the ceiling. Ask owner what it might possibly lead to
